## **ARCHAEOLOGICAL EVALUATION: STREATLEY HOUSE SHARPENHOE ROAD STREATLEY BEDFORDSHIRE**

*on behalf of Mr & Mrs R Page*

**ASC: 585/SSH/02**

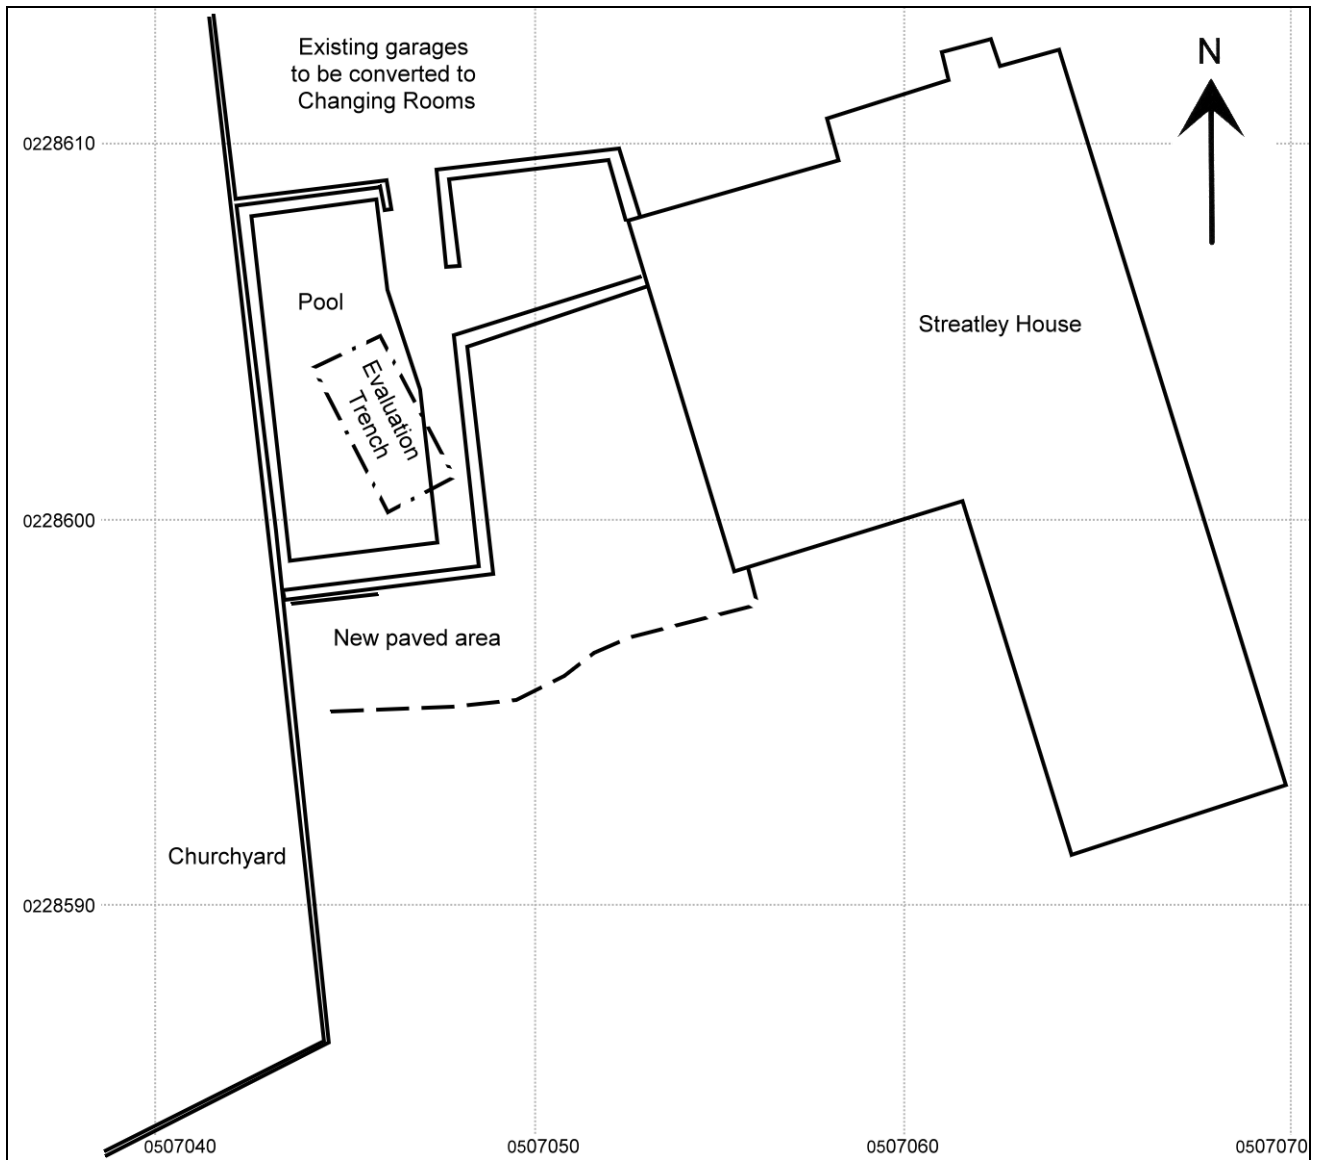
**Figure 3:** Simplified plan of the proposed development & trench location (1:200)

Due to the density of trees and roots the trench was rotated from the proposed layout in the project design to maximise the available trenching whilst avoiding the trees and their root systems as much as possible.

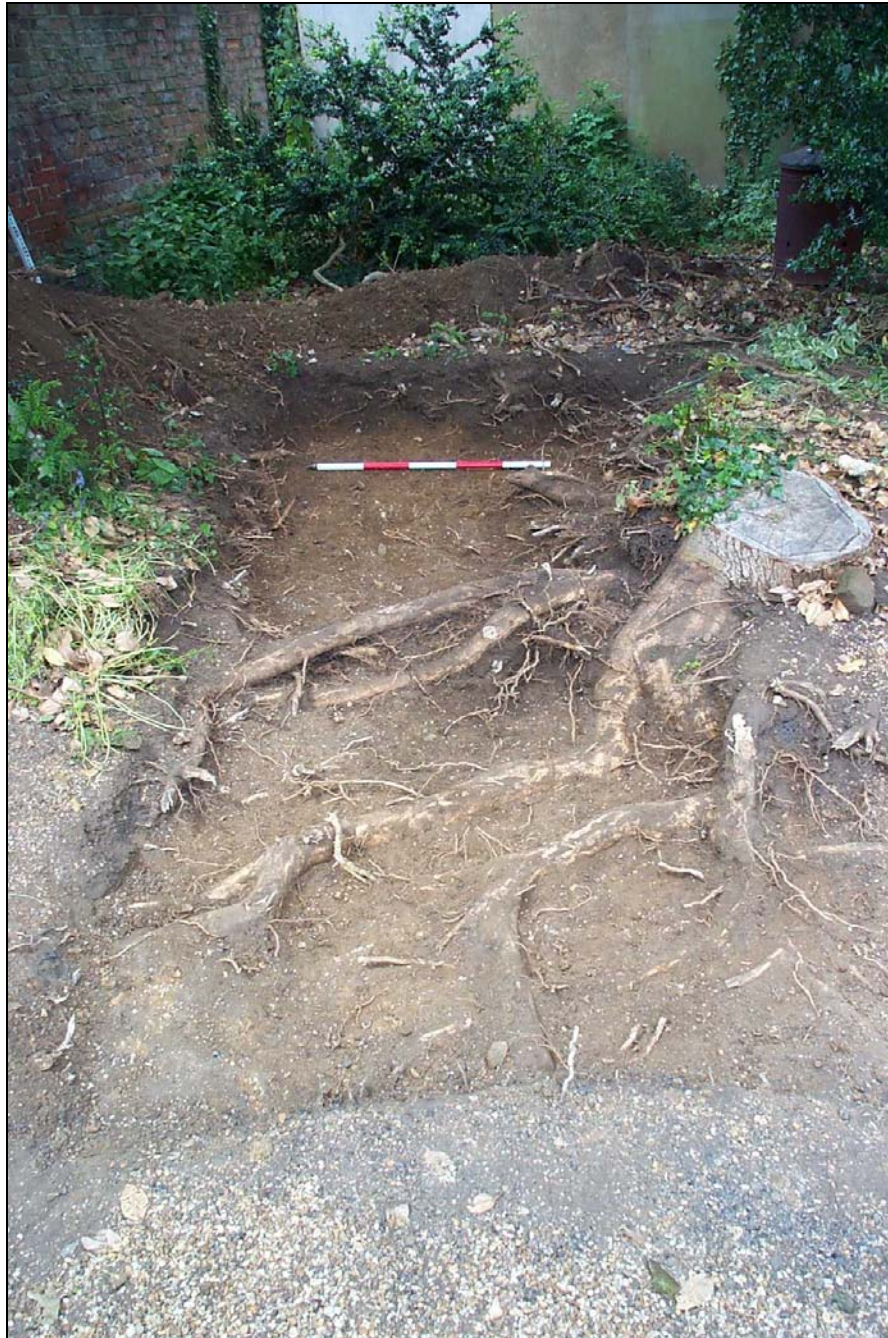
**Plate 1:** General view of the trench looking NW

- 4.1 A single 4.3 x 1.9m NW to SE trench was hand excavated over part of the footprint of the new swimming pool, avoiding the existing trees as much as possible. The surface deposit over the northern 3.75m of the trench comprised c.0.25m of very dark loamy garden soil, whilst the southern end had been scraped and dressed with fine gravel to form a garden path. Tree roots were widespread throughout the topsoil layer. Below the topsoil the undisturbed yellowish brown silty clay was exposed. Throughout the subsoil small fragments of chalk were seen.

- 4.2 No evidence was identified to suggest that the area of the evaluation trench had ever been used for any purpose other than garden.

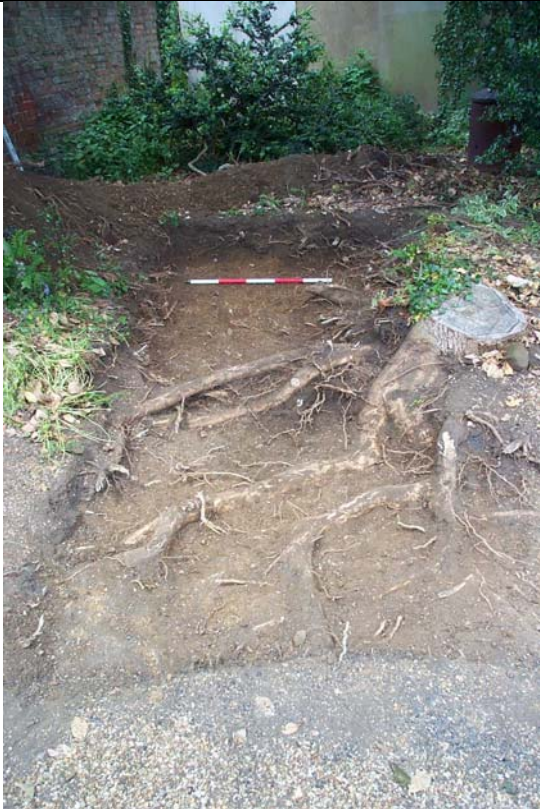
<b>Trench 1</b>

<b>Max Dimensions</b>			
	<b>Width</b>	1.9	<b>Depth</b>	2.3
	<b>Levels</b>			
	Top NW		152.70m OD	
	Base NW		152.29m OD	
	Top S		152.45m OD	
Base S		152.28m OD		
<b>NGR Co-ordinates</b>				
0507046		0228600		
0507048		0228601		
0507044		0228604		
0507046		0228605		
<b>Orientation</b>				
<b>Reason for Trench</b>				
<b>Context</b>	<b>Type</b>	<b>Description and Interpretation</b>	<b>Max Thickness (mm)</b>	<b>Depth BGL (mm)</b>
1	Layer	Dark greyish to black top soil	250	0-250
2	Layer	Natural silty clay some chalk fragments		>250
