**WATCHING BRIEF:
SALDEN MANOR
COOKS LANE
MURSLEY
BUCKINGHAMSHIRE**

NGR: SP 82509 29708

March 2011

ASC: 1375/MSM/2

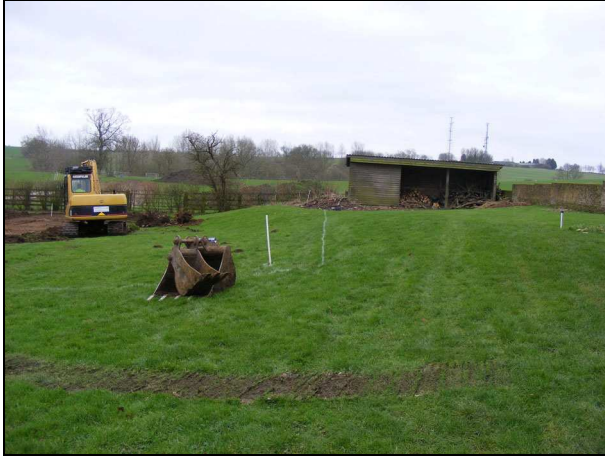
The topography of the site comprised a moderately sloping bank along the western side of the development area (Plate 1 & 6). The bank slopes down towards the east where the ground seems to level out towards the sites boundary.

Plate 1: Bank, looking south

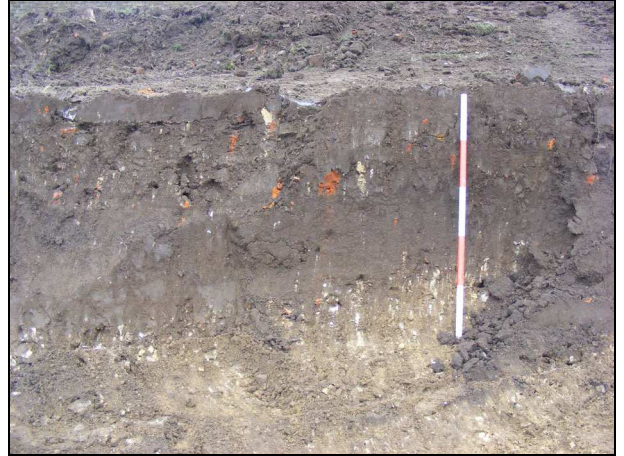
The bank along the west end of the site was excavated and the spoil used to level the remaining site area. At the southern end of the bank it measured a maximum height of *c.*1.6m and consisted of mid brown, soft, silty clay, made-up ground that contained frequent orange brick fragments, metal wiring, cloth, wood and a number of large limestone blocks (Plates 2 & 3). Towards the centre of the bank there was a made-up ground deposit that consisted of light mottled orangey yellow gravely sand with frequent orange brick and tile fragments (Plate 4). At the northern end of the bank it measured a maximum height of *c.*1m and consisted of *c.*200mm of topsoil overlying *c.*140mm of mid brown silty clay made-ground with traces of orange brick fragments. Underlying this was the natural yellowy orange sand (Plate 5).

Plate 2: East facing southern section of bank
(scale 1m)

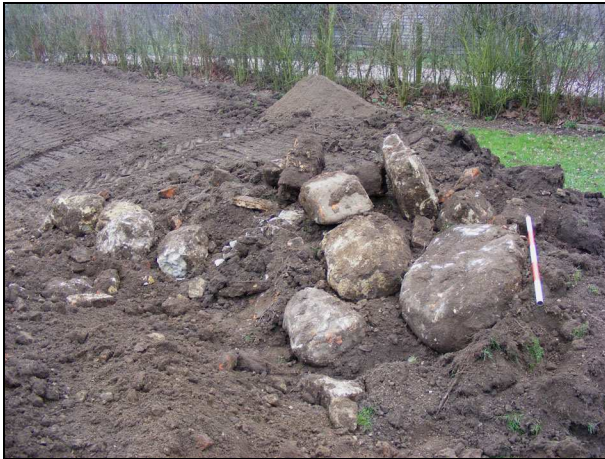
The significant quantities of orange brick fragments, tile and the large limestones may possibly be linked to either Salden Manor which once stood north of the development or the 16th century house that has now mostly been demolished, again to the north of the site.

Plate 3: Large limestone blocks uncovered from
the southern end of bank
(scale 1m)

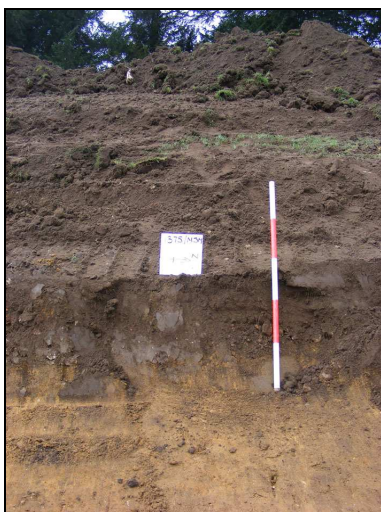
Plate 5: East facing northern section of bank
(scale 1m)

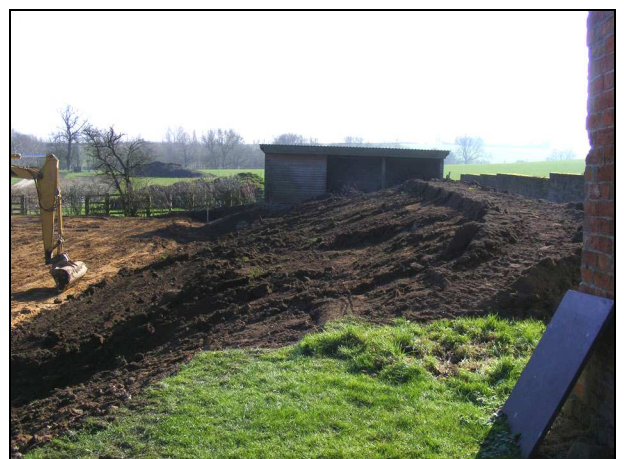
Plate 6: Bank fully excavated and sloped, looking
south
