**HISTORIC BUILDING SURVEY:
ST EDMUND'S HOSPITAL
WELLINGBOROUGH ROAD
NORTHAMPTON**

on behalf of Rochmills Ltd

May 2004

ASC: 566/NWR/02

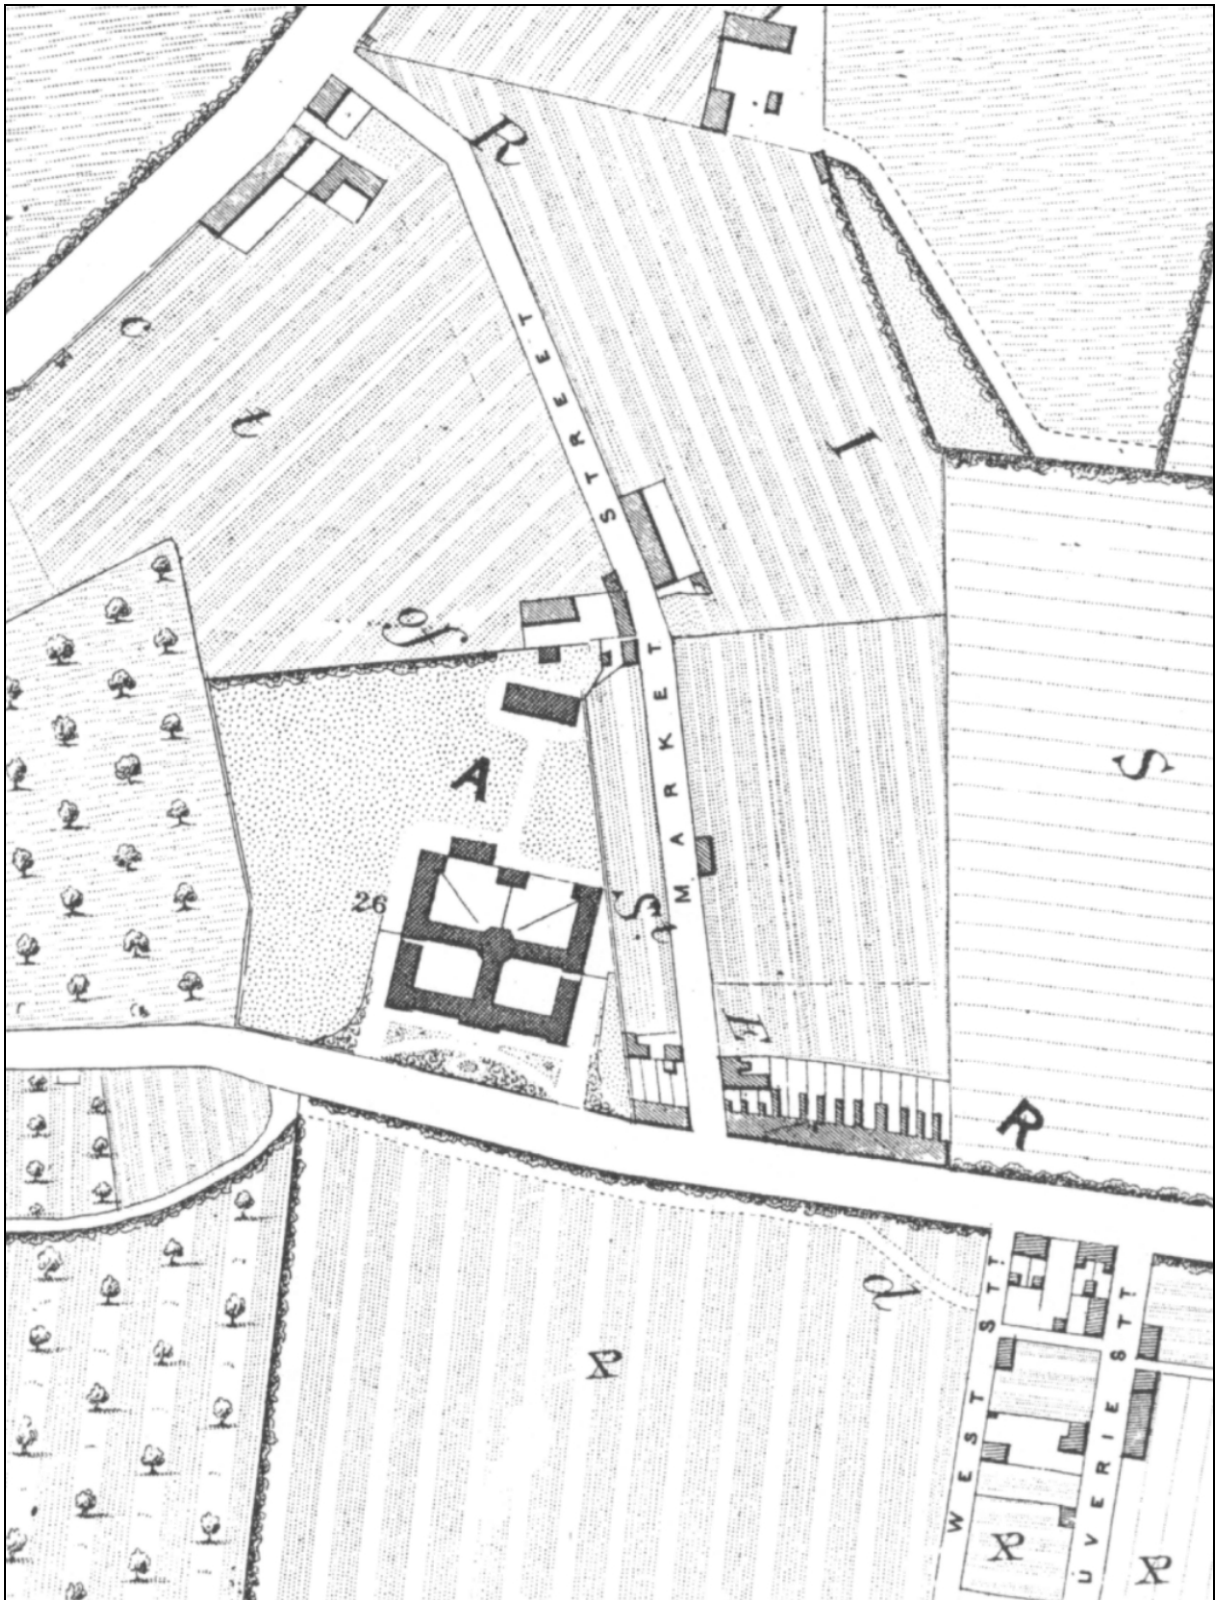
Figure 3: Extract from Low's Map of Northampton, 1847

- 3.4 The earliest extant plan (not recorded in the evaluation) is Low's **1847** map (Fig. 3). This shows the main workhouse complex [01] as having a similar but much less encumbered plan than at present. The main elements are all shown: the frontage with central projecting section and ranges to the rear, and the central octagonal hub with ranges to the west, south and east, separating the four yards. However, the plan is too small a scale to determine which of these elements survives without significant alteration today. To the rear of the main complex is a large detached structure on the site of the east half of the present infirmary [08]. Behind this in turn, along the north boundary of the site, three small buildings are shown. One stands on the site of the west end of the present mortuary building [09]. It is not possible to determine whether it has been incorporated into the present structure. It is notable on this early plan of

the site that the west boundary is shown further east than it is today, excluding the area containing the former laundry [04] and school [05]. The land at the north-east and south-east corners of the present site, respectively containing [10] and [17], also appears to be outside the site at this time. From later maps, it is apparent that this depiction of the building plan is somewhat stylised, showing a rather more symmetrical structure than existed in reality.

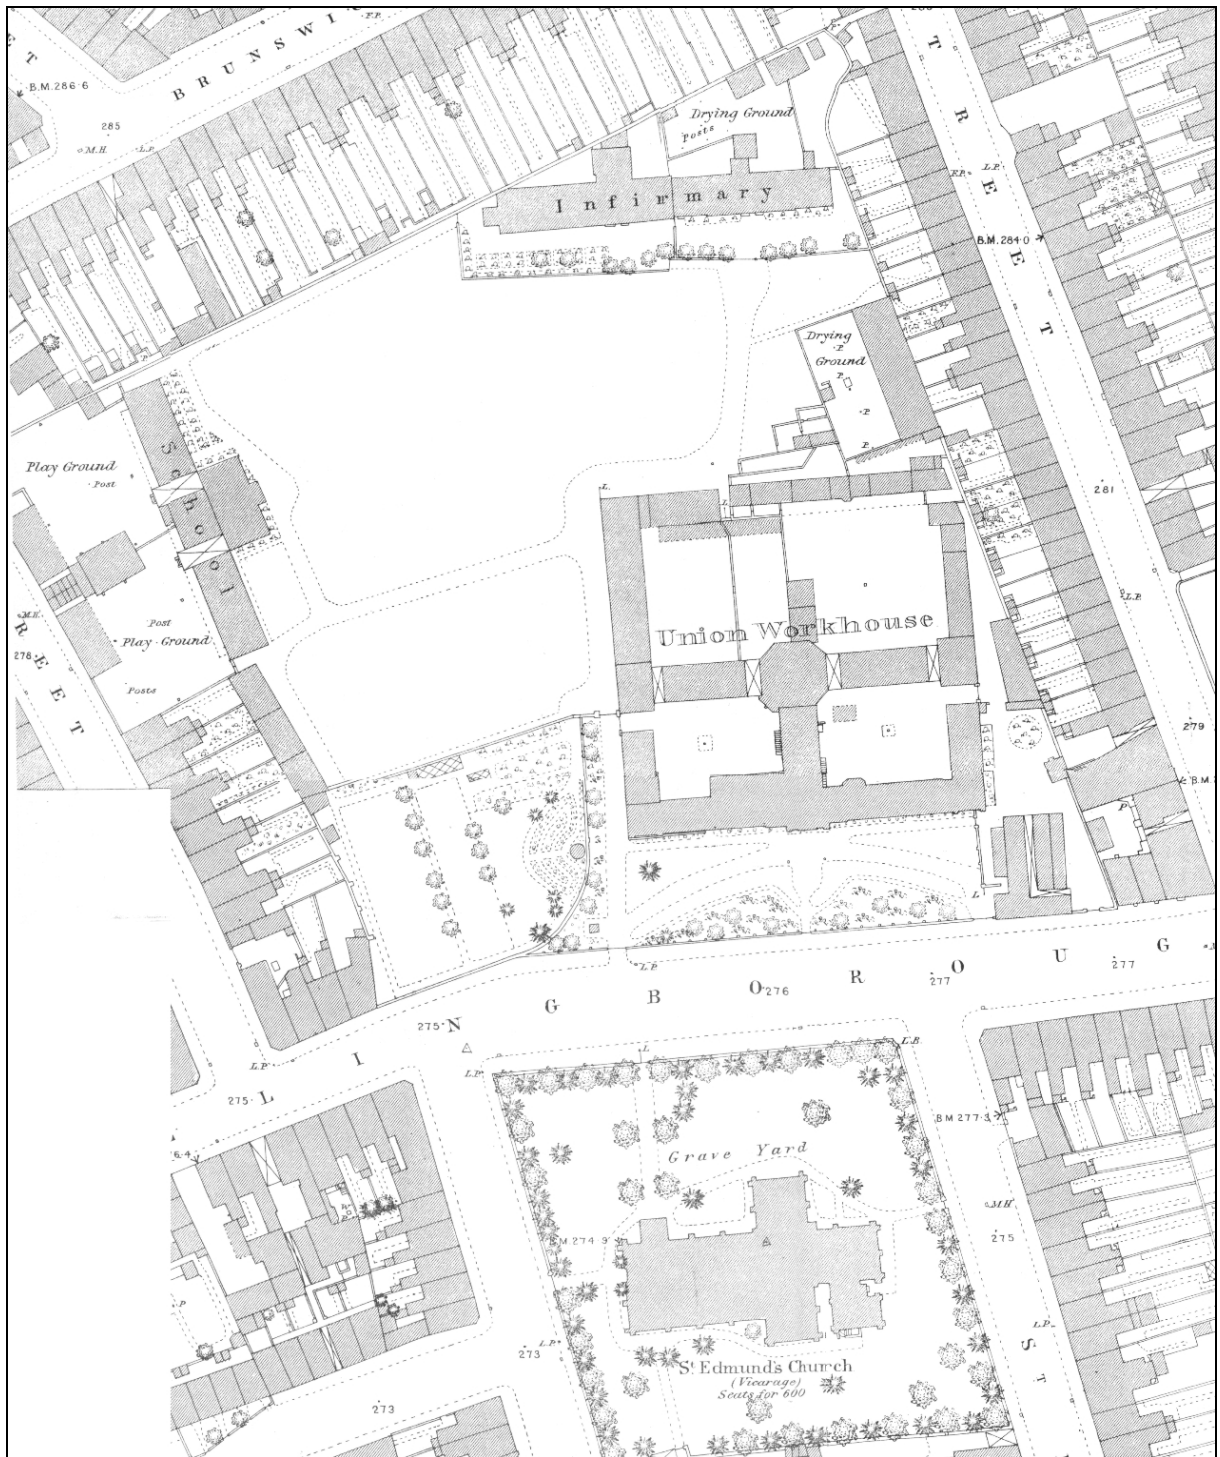
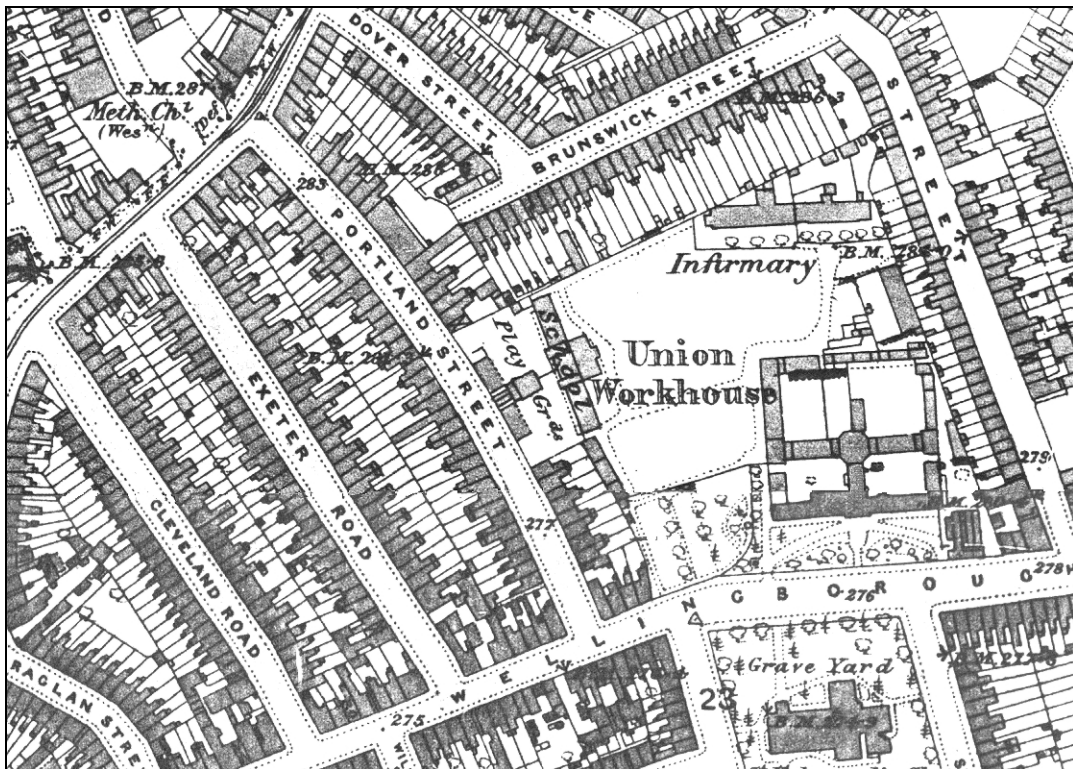
Figure 4: Extract from 1:500 1st Edition Ordnance Survey, 1885

- 3.5 The First Edition Ordnance Survey maps of **1885** and **1887** (Figs 4 & 5) show the site in rather more detail. The southern and central wings of the main building are present [01a-01h], as is [13]. At the west end of the central wing, on the site of the present [19], is a block linking [01e] and [13], a mirror image of the east end of the wing. The site of [15] is occupied by a range comprising two structures, and that of the later kitchen [14] by a smaller structure, aligned north - south. A gap is shown between [01f] and the building on the site of [01a], mirroring the gap on the west side of the complex. On the north side of the main complex is a row of small structures, probably workshops. To the immediate north of the main complex is the central part of [11], with associated yards and other features. The full length of the infirmary is now shown, with extensions to the north but none to the south. In the north-east corner of the site are three small buildings, on the site of the present mortuary [09]. The mission hall [10] is also shown, but appears not to be part of the site. In the south-east corner is shown the casual block, erected in the wake of the Casual Poor Act of 1882. This was intended to provide very basic accommodation for vagrants, and to discourage them with tasks such as rock-breaking for men and picking oakum for women (Morrison 1999, 184). North of the casual block is a building on the site of the present [16]. To the north-east of the casual block, a building occupies the site of the present [17], though from the style and materials used in the latter, is likely to be a different structure. At the north-west corner of the site, a block of land fronting Portland Street had been added to the workhouse site, and the school, playground and associated structure ([04] & [05]) had been built. South of this, three linked buildings are shown on the site of the present boiler house [03]. Fronting the main building is a curving drive, with adjoining shrubbery and lawns: to the south-west is a formal garden area.
