**ARCHAEOLOGICAL OBSERVATION,
INVESTIGATION AND RECORDING:
SEGENHOE HOUSE
SEGENHOE
RIDGMONT
BEDFORDSHIRE**

NGR: SP 9824 3588

March 2011

ASC: 1402/SSH/2

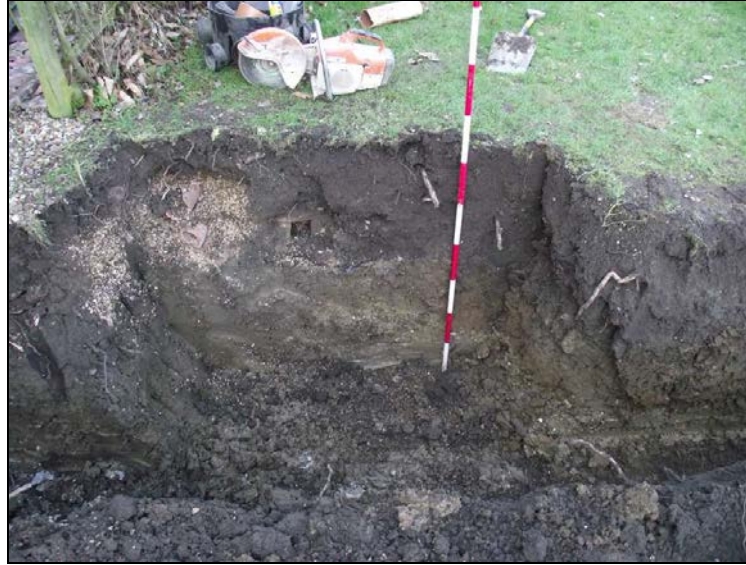
- 4.2 ***Excavated areas*** (Fig 4, Plates 1-3)
- 4.2.1 The foundation trenches were 0.6m wide and 1.2m deep. They were cut through 0.1m of turf, 0.8m of modern made ground containing brick and tile and then into the natural grey clay (Plate 1).

Plate 1: Foundation trench stratigraphy, 1x2m scale

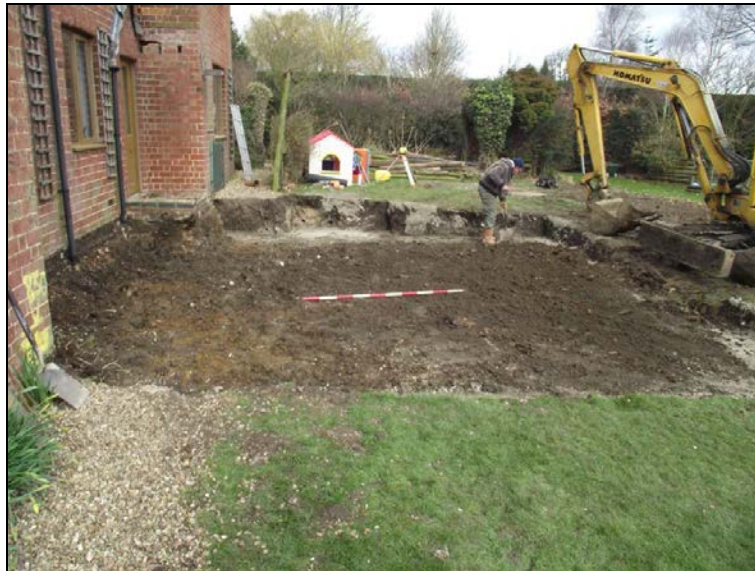
- 4.2.2 The ground reduction took place over the footprint of the new build. About 0.4m of overburden was removed. The layer of modern made ground was not breached (Plate 2).

Plate 2: Oversight reduction, 1x2m scale

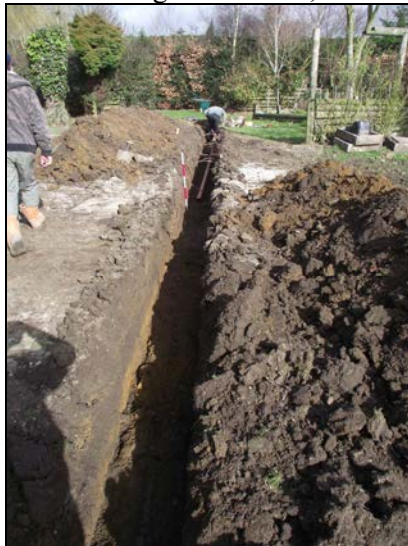
- 4.2.4 The service trench was 0.5m wide, *c.*0.9m deep and 14m in length. The northern 7m of the service trench was cut through the same deposits as the manhole, whilst the southern 7 0m was cut through the modern made ground seen within the foundation trenches (Plate 3).

Plate 3: Service trench, looking north, 1x1m scale
