**ARCHAEOLOGICAL EVALUATION:
THE OLD SHOE FACTORY
GORDON STREET, ROTHWELL
NORTHAMPTONSHIRE**

on behalf of T Grocock & Co (Rothwell) Ltd

May 2004

ASC: 561/RGS/03

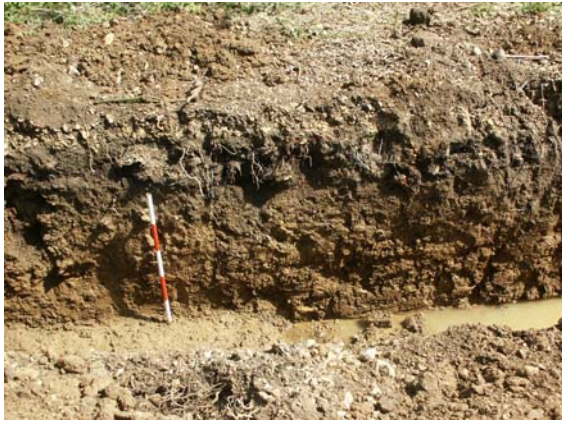
Plate 1: Trench 1. east-facing section (104), (105)

Layer (105) overlay the natural orange clay (107). It comprised mid brown silty clay with occasional small rounded pebbles and rare late Saxon/early medieval pot sherds, 0.35m in thickness, being redeposited natural clay. Layer (104) overlaid (105) (Plate 1), comprised of mid brown silty clay with occasional small rounded pebbles and frequent animal bone, 0.4m in thickness, being redeposited natural clay.

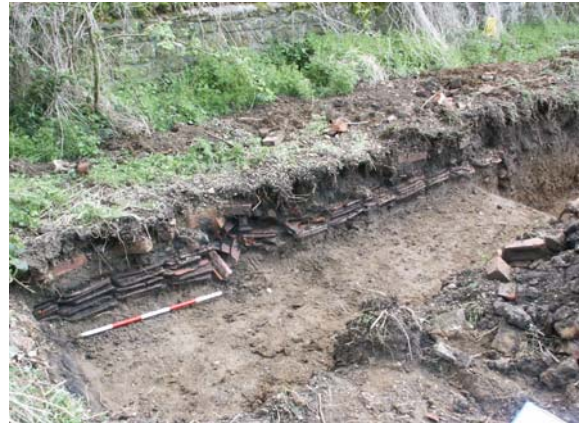
Plate 2: Trench 1. east-facing section. Tile Stack (103).

(103) overlay (104), being a tile stack seen in east section of the trench, exceeding 4.4m in length and being 0.22m in height (Plate 2). Eleven stacks of up to six tiles were seen, with a break after four stacks from the north end of the trench. The tiles were 0.32m long. Their function is unclear.

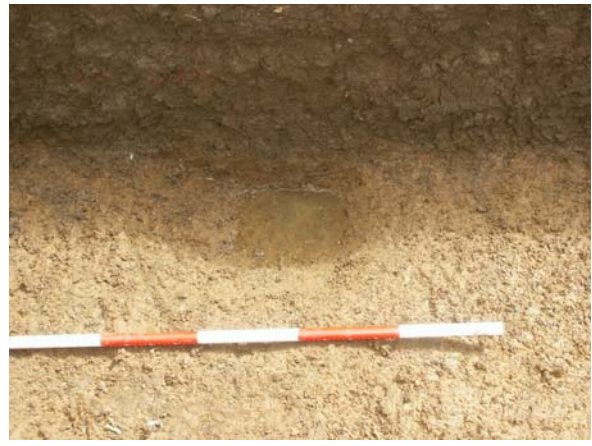
Plate 4: Trench 2. NW facing section. Posthole [207]

[207] circular cut 0.55m in width, 0.15m in depth containing (208) a mid grey brown silty clay with charcoal.

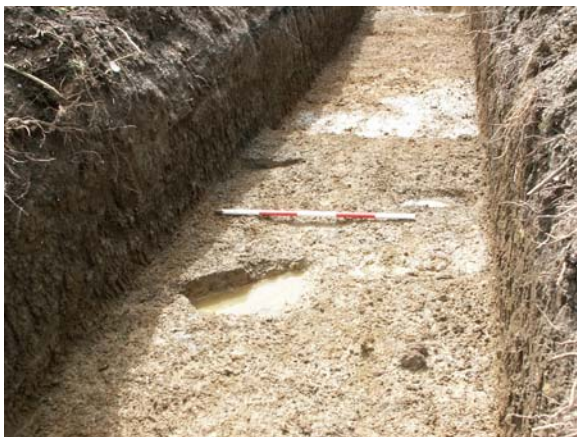
Plate 5: Trench 2. View SE. Postholes [205] [203] [201]

The bases of four truncated small pits/postholes were revealed cut into the natural geology (213) (Plates 4,5):

[201] oval cut, max. 0.6m in diameter and 0.08m in depth with a flat base, containing (202) a mid grey brown silty clay.

[203] circular cut, 0.45m in width and 0.14m in depth, containing (204) a mid grey brown silty clay with occasional charcoal flecks and a late Saxon pottery sherd.

[205] oval cut (max.0.75m in diameter) 0.15m in depth, containing (206) a mid grey brown silty clay with charcoal, burnt sandstone, animal bone and a late Saxon pottery sherd.

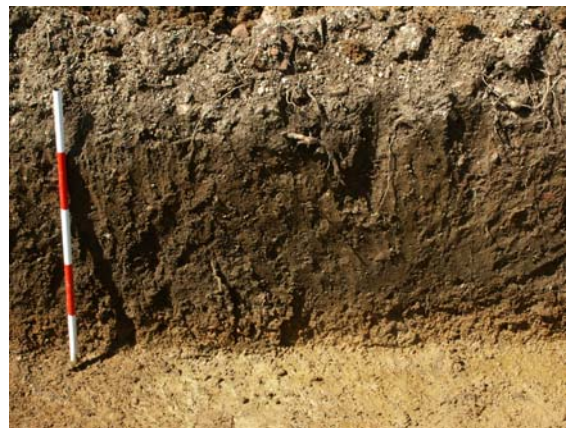
Plate 6: Trench 2. SE facing section. (210) (211).

Layer (211) sealed the natural orange clay, being mid grey brown silty clay with moderate late Saxon/early medieval pot sherds, burnt sandstone fragments, animal bone, a lump of slag, charcoal flecks and a residual flint flake. This soil horizon overlaid the features that cut into the natural clay, and being of the same character represents activity from the same period. Layer (210) sealed (211), being mid brown silty clay with occasional small rounded pebbles. This deposit represents a later and more sterile phase at the site (Plate 6).

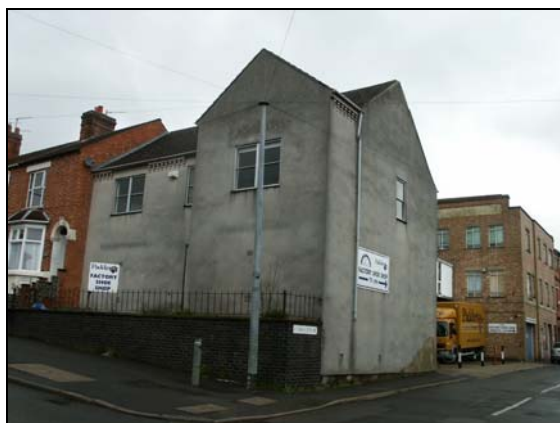
Plate 17: 41 Kettering Road, from west

41 Kettering Road (Plate 17) is a two-storey brick house, pebble-dashed externally, with a concrete tile roof. It is clear that this structure has undergone significant alterations since it was built, because of its association with the shoe factory. As well as housing some of the company's offices, the ground floor has also been used for the factory shop (pers. comm.. R Burrows). Consequently most internal partitions have been altered, fireplaces and all original internal fittings have been removed, Ground-floor windows have been bricked up and first-floor windows have been replaced with modern aluminium-framed units.

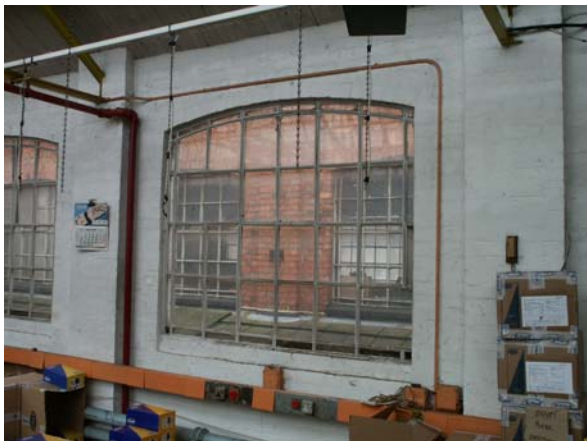
Plate 21: Factory extension: reused window from main factory building

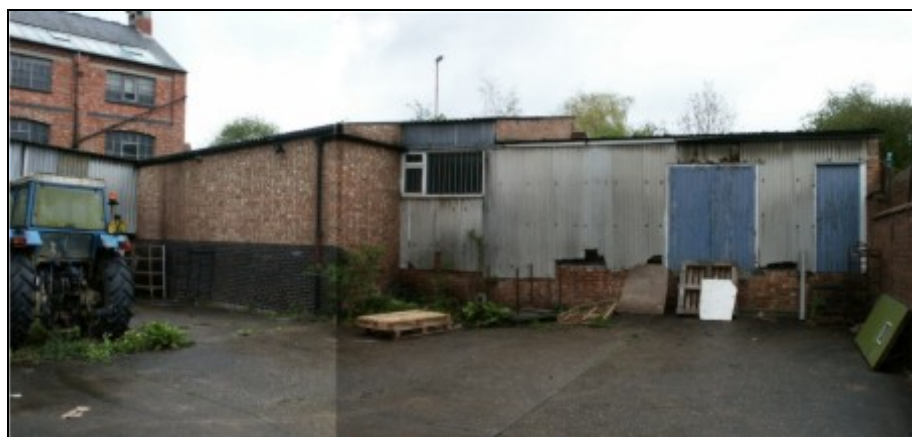
Plate 23: Leather store, from south-east

The leather store (Plate 23) consists of several linked structures, built of Fletton brick or corrugated sheet, all with flat roofs. At the core of the brick building is a concrete-roofed structure, described by Rod Burrows as the 'air-raid shelter', though it may never have been used as such. The floor level of the buildings is about one metre above the factory yard, presumably to facilitate unloading from lorries.

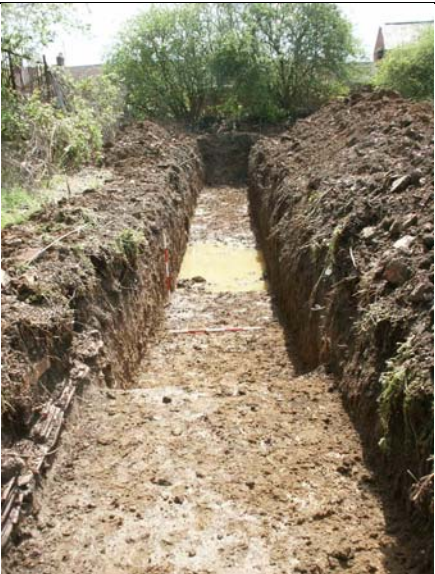
Trench 1

Max Dimensions					
	Length	23m	Width	1.8m	Depth	2m
	Coordinates			SP 58179 80921 (SE end) SP 81568 80942 (NW end)		
	Levels					
	Trench top north			109.9m OD		
	Trench base north			109.16m OD		
	Trench base south			107.82m OD		
	Trench top south			109.10m OD		
	Orientation			North-South		
	Reason for Trench			Evaluate manor potential		
Context	Type	Description and Interpretation	Max Width (m)	Max Thckn (m)	Depth BGL (m)	
100	Layer	Topsoil	Tr	0.2	0	
101	Masonry	Victorian brick floor	Tr	0.07	0.2	
102	Layer	Silty clay levelling	Tr	0.15	0.27	
103	Masonry	Tile stack	4.4	0.22	0.42	
104	Layer	Redeposited clay	Tr	0.4	0.64	
105	Layer	Redeposited clay	Tr	0.35	0.99	
106	Layer	Modern hardcore	Tr	0.1	0.1	
107	Layer	Natural clay	Tr	-	1.34

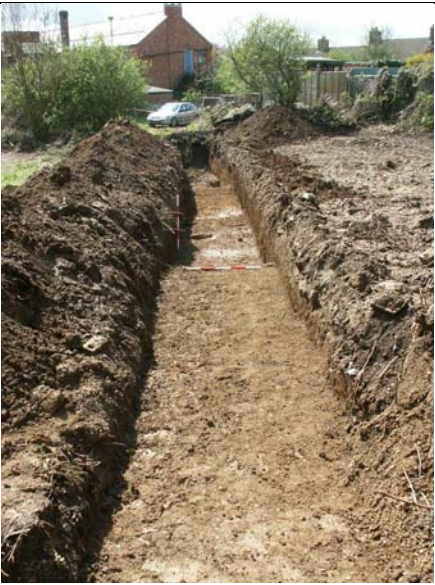
Trench 2

Max Dimensions					
	Length	26m	Width	1.8m	Depth	1.6m
	Cordinates			SP 58155 80913 (SW end) SP 81568 80942 (NE end)		
	Levels					
	Trench base north		109.44m OD			
	Trench top north		110.08m OD			
	Trench base south		107.64m OD			
	Trench top south		108.83m OD			
	Orientation			Northeast-southwest		
	Reason for Trench			Evaluate manor potential		
Context	Type	Description and Interpretation	Max Width (m)	Max Thckn (m)	Depth BGL (m)	
201	Cut	Posthole	0.7	0.08	1.0	
202	Fill	Silty clay fill of 201	0.7	0.08	1.0	
203	Cut	Posthole	0.45	0.12	1.0	
204	Fill	Silty clay fill of 203	0.45	0.12	1.0	
205	Cut	Posthole	0.6	0.2	1.0	
206	Fill	Silty clay fill of 205	0.6	0.2	1.0	
207	Cut	Posthole	0.7	0.14	1.0	
208	Fill	Silty clay fill of 207	0.7	0.14	1.0	
209	Layer	Topsoil	Tr	0.7	0	
210	Layer	Silty clay subsoil	Tr	0.5	0.45	
211	Layer	Silty clay soil horizon	Tr	0.1	0.9	
212	Fill	Primary fill of 217	Tr	0.08	1.2	
213	Layer	Natural clay	Tr	-	1.0

214	Fill	Fill of 215. Dumped clay	Tr	0.9	0.5	
215	Cut	Linear feature	Tr	0.9	0.5	
216	Fill	Silty clay fill of 217	Tr	0.4	1.0	
217	Cut	Linear feature	Tr	0.4	1.0
