The Late Saxon Town of Thetford: An Interim Report on the 1964-6 Excavations

By BRIAN K. DAVISON

Inspector of Ancient Monuments, Ministry of Public Building and Works

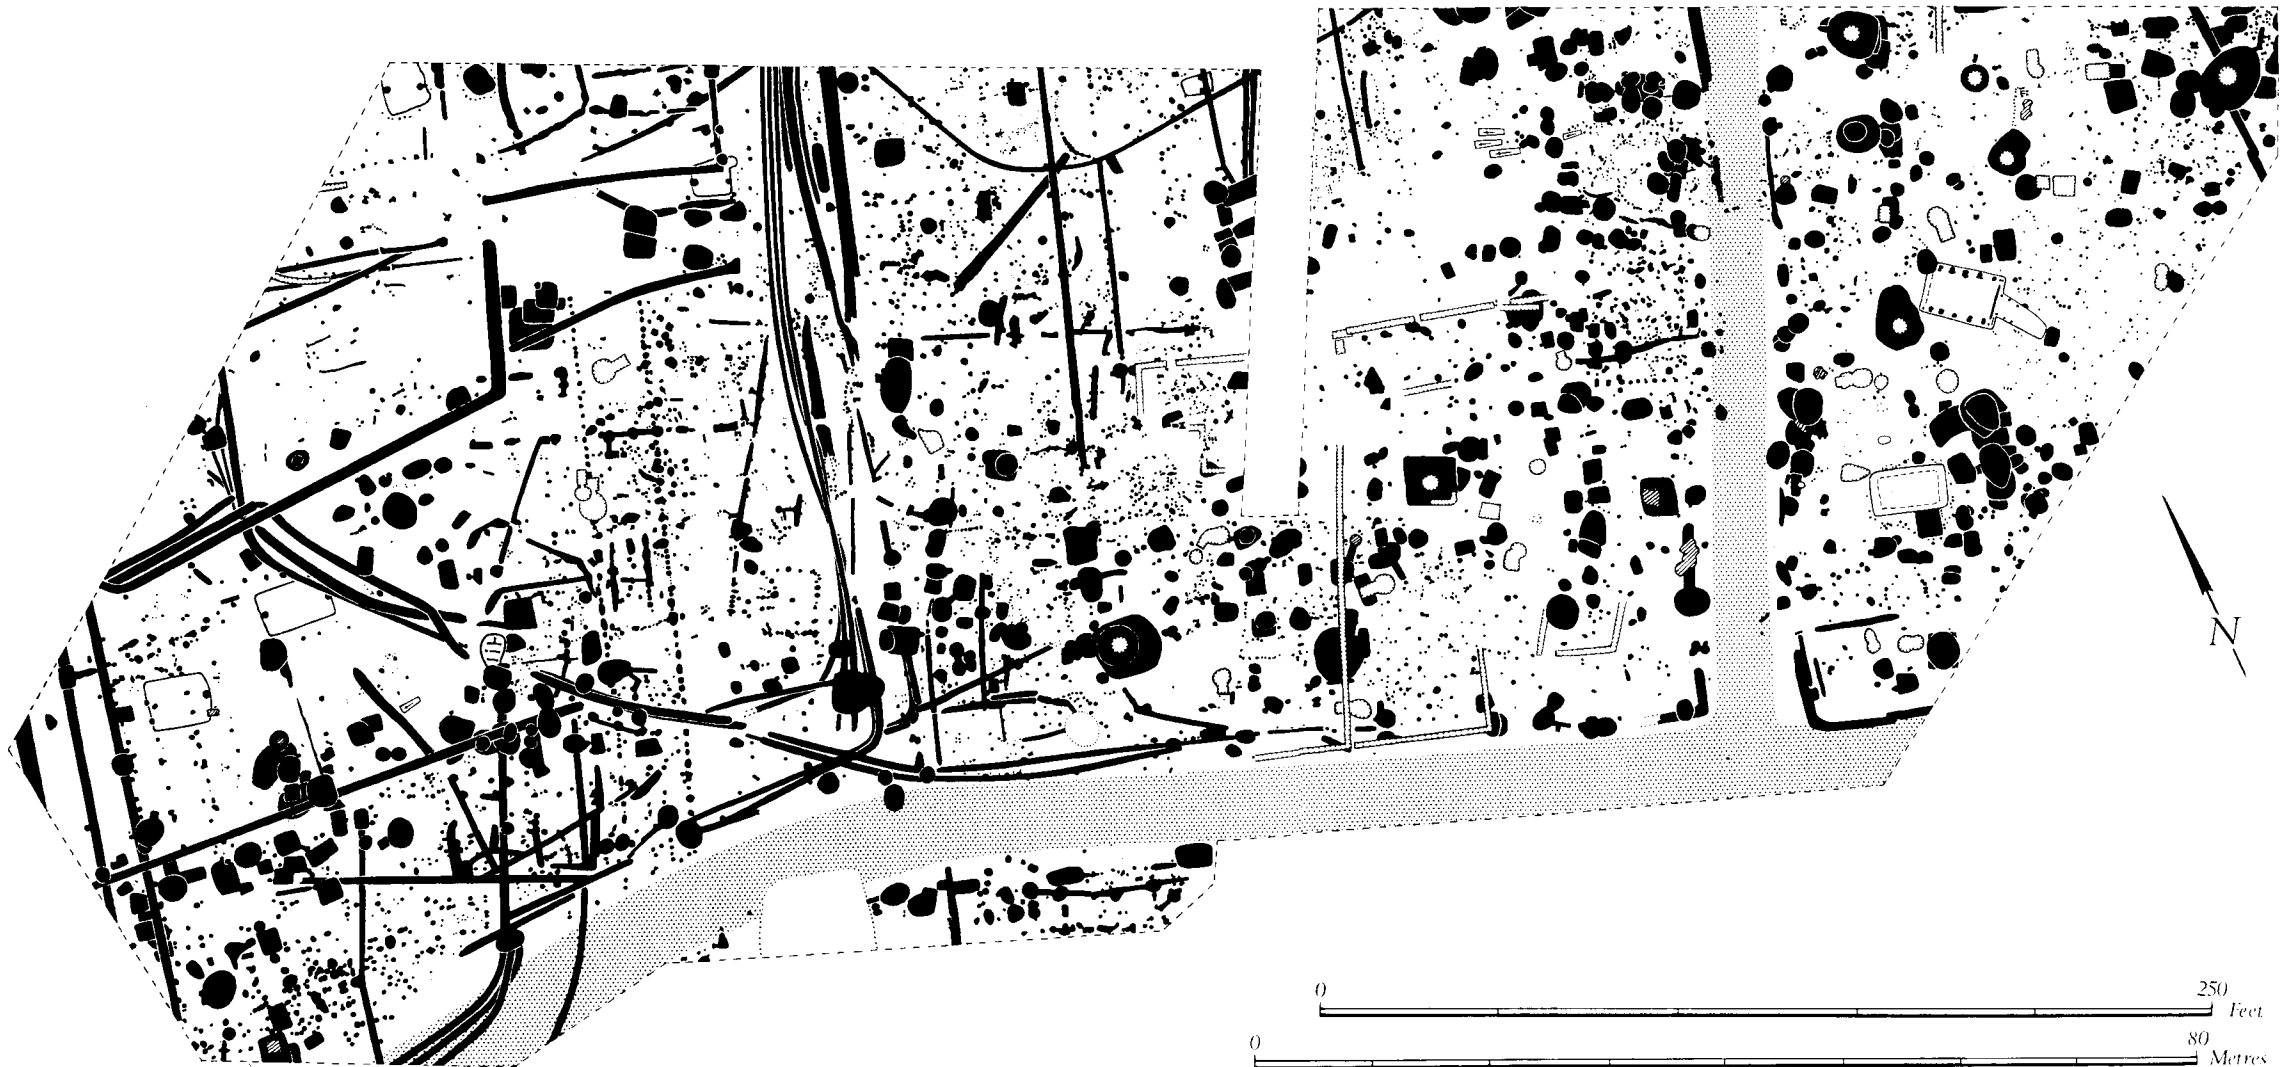
FIG. 39
MAP OF EAST ANGLIA
showing position of Thetford in relation to the surface geology (p. 189).

EAST ANGLIA
DRIFT GEOLOGY

Thetford first made its appearance in the written record as a wintering place for the Danish army in the year 869. Set on the tract of open country running between the forest and the fen, and connected by river traffic with the ports of the Wash and the North Sea (FIG. 39),* the position of Thetford favoured its growth as a trading town. By the reign of Edgar the town was important enough to be the site of a mint, and the East Anglian see was transferred there from North Elmham in 1072. At the time of the Domesday survey the population must have been well over four thousand. Possibly, however, the population was at that date already declining and the move across the river saw the end of Thetford's rapid expansion. The see was moved to Norwich in 1094, though the mint remained in production until the middle of the following century.

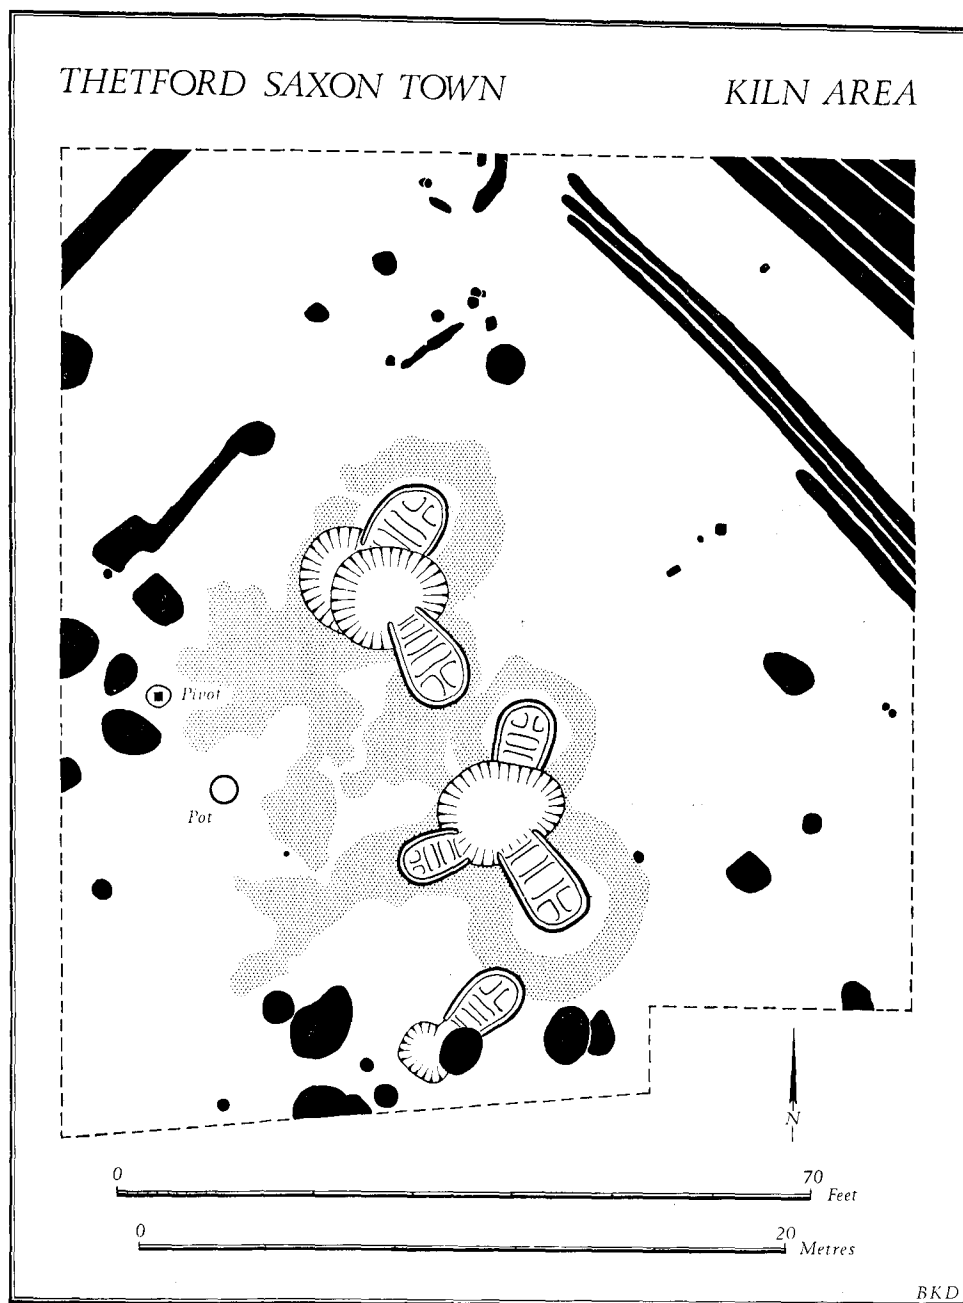
FIG. 53

KILN AREA, THETFORD, NORFOLK (p. 192 f.)

Ditches, pits and post-holes in black; trampled areas stippled. Kiln C (FIG. 54) is overlying one in the northerly pair

During the 1964 season an isolated pottery-kiln was found. The following year a concentration of pottery wasters was noted to the south of the main excavation, in a peripheral area just inside the town defences. The presence of kilns was confirmed by a geomagnetic survey, and an area 96 ft. by 84 ft. was excavated in 1966 (FIG. 53). This peripheral zone was divided from the main part

The kilns themselves were grouped in the centre of the yard. Three were single-oven structures, the stoke-pits of two of them overlapping in such a way as to provide evidence of the succession. However, at one period there seems to have been a battery of three kilns served from a single stoke-pit, though one of the kilns evidently went out of use before the other two were finally abandoned. The kiln-type is very distinctive, and is similar in principle to that of the kilns found by Knocker in 1948. The clay-lined oven-pits vary in length from 6 to 9 ft. internally. During firing the pots were apparently supported on a series of permanent clay arches constructed on a centering of withies set into carefully prepared abutments. The space between these arches was sometimes as much as 18 in. and during firing must have been bridged by the larger pots, since no evidence was found for the use of movable firebars. The cross-arches supporting the pots stood 18 in. to 2 ft. above the bottom of the oven-pit. The unusually large air-space thus formed under the oven floor seems to have acted as a 'heat-mixing' chamber, resulting in greater uniformity of temperature in all parts of the kiln. In two of the kilns (e.g. FIG. 54) the clay dome of the clamp had collapsed into the oven-pit, sealing the smashed remains of the stacked pots. The number of vessels in both these kilns seems to have been small—about 25–50 pots. This suggests that the load need not have been stacked more than three pots high, and the clay dome may have been correspondingly low.⁴ The clay dome evidently rested on the flue-arch, which sometimes received an extra reinforcing of withies to enable it to withstand the weight. The eventual failure of the flue-arch to carry the load seems to have been the most frequent cause of the collapse of the superstructure. There was no evidence to show how the flue-arch was 'stopped' when the correct temperature had been reached. Surprisingly, a considerable amount of ash seems to have been allowed to accumulate in the flue itself, where it must have greatly reduced the effective draught. Some indication of the way in which the kilns were served is perhaps given by trampled areas, shown stippled on FIG. 53.
