PLATE I

CARMARTHEN GREYFRIARS

SHAPWICK, SOMERSET

CITY OF LONDON

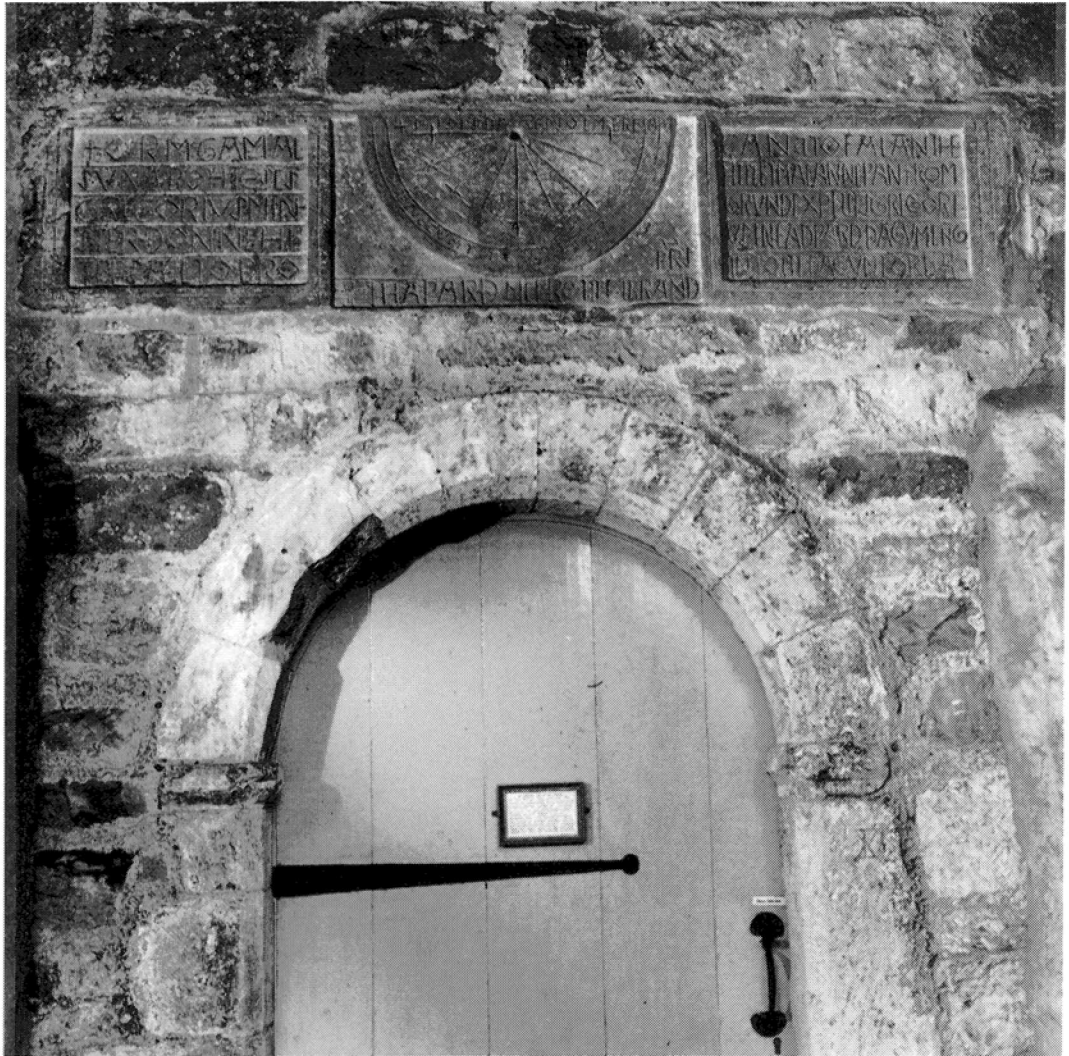
PLATE II

S. doorway of St Gregory's Minster.

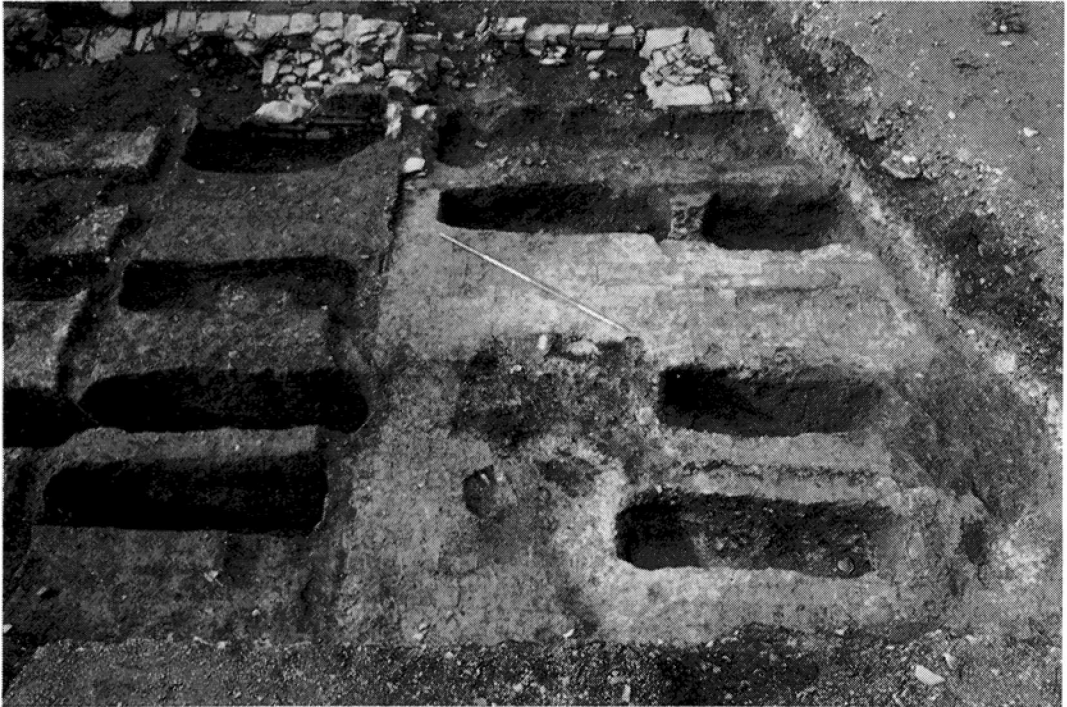
A. Layer of tile impressions (1861) within the choir, viewed from N., with position of steps centre and left. The disturbed area in the centre is where a tomb or slab would have stood proud of the tiles

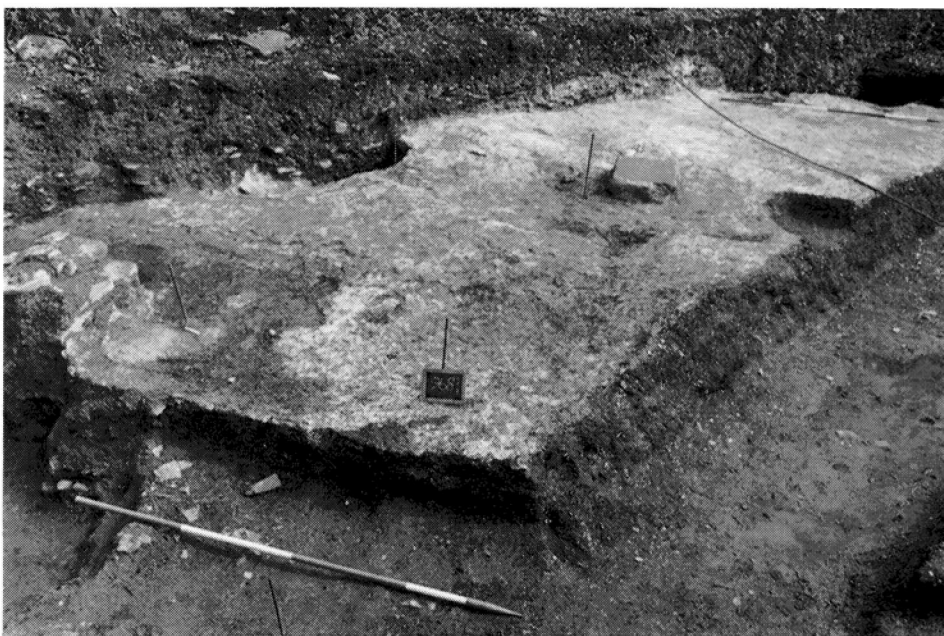
A. SE. corner of the Chapter House and robber trench 935 on the left, with mortar floor and stone block 977 of Building 1324. Part of the Civil War ditch 496/500 can be seen on the right. Looking E.

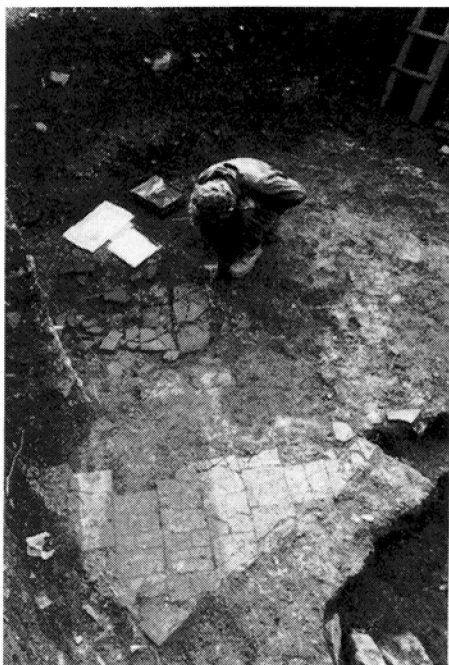
B. Plain floor tile (type 2) within NW. angle of the Chapter House, and associated robbed wall and benching in B1; from WNW.

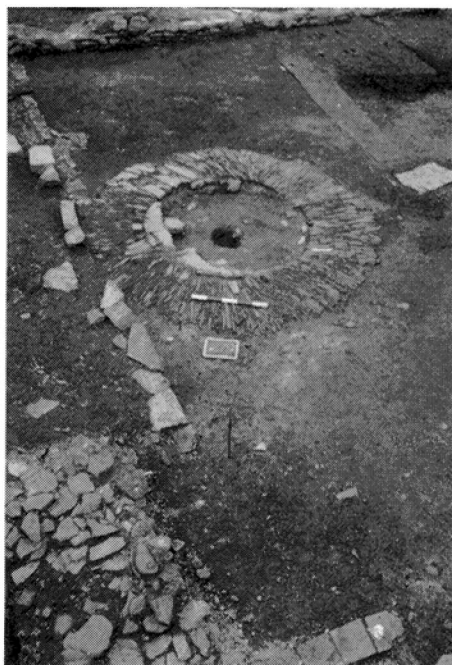
C. Circular feature 279 with step 280 to the left and Normandy tiles to bottom right. From NNW.

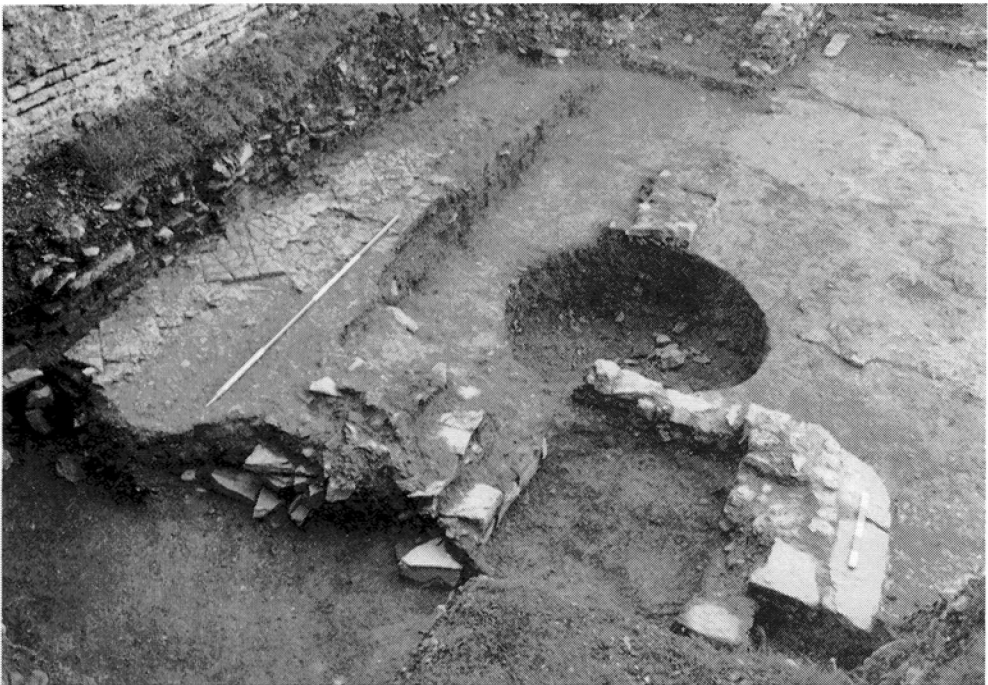
B. Building 24, steps 275 and doorway leading to the Cloister Alley

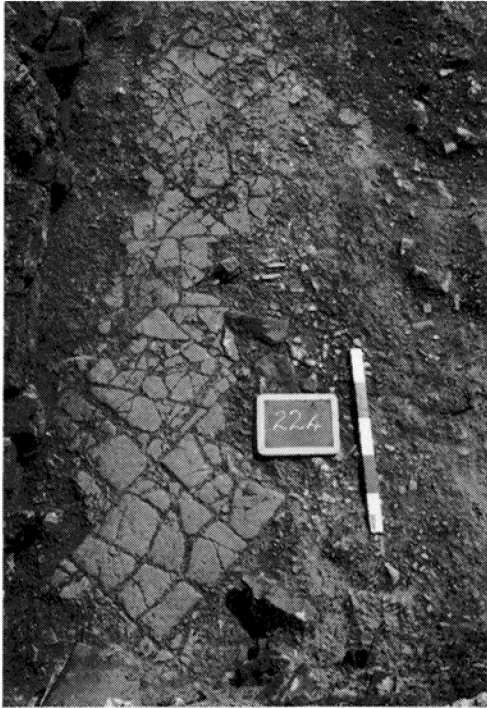
A. Oolitic tiles 224 in the Cloister Alley

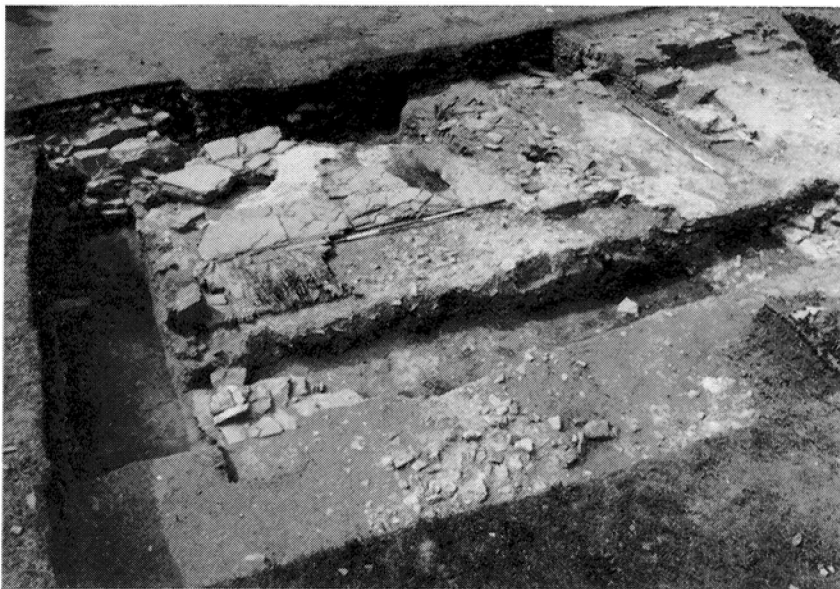
C. Building 198 from the ESE. with Phase 3-4 surfaces 183-84

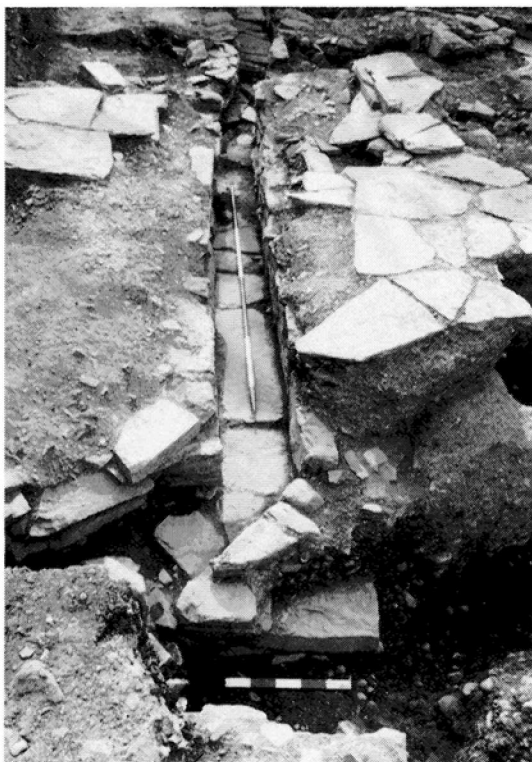
A. Drain 11 and flagstones 134 within Building 97, from the W.

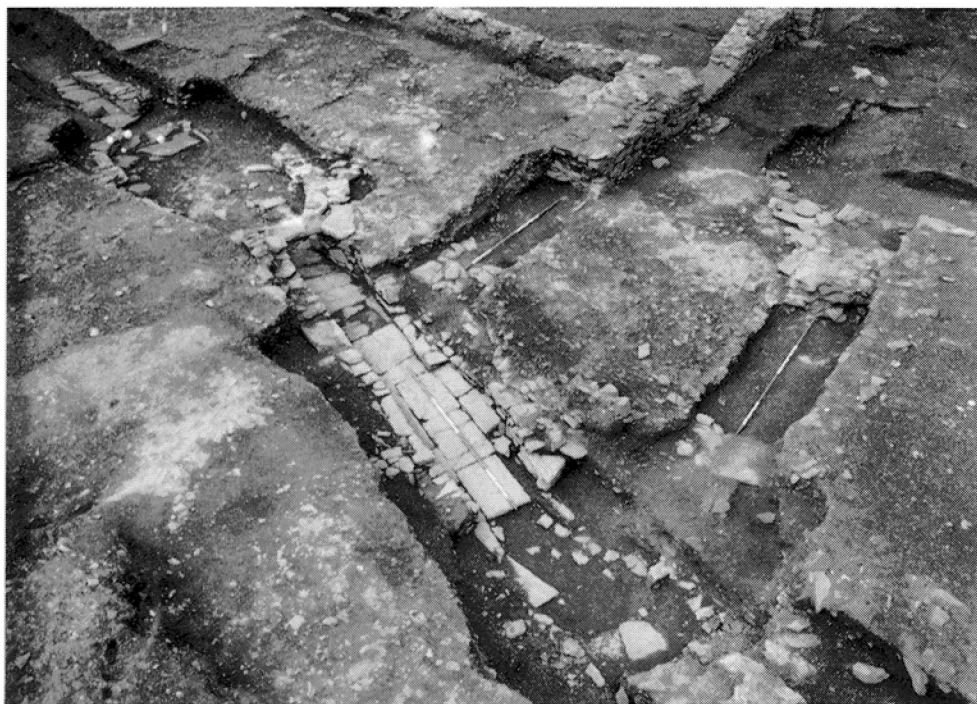
B. Privy 80 from the SE., with ranging poles centre and right in robber trenches 56, 68

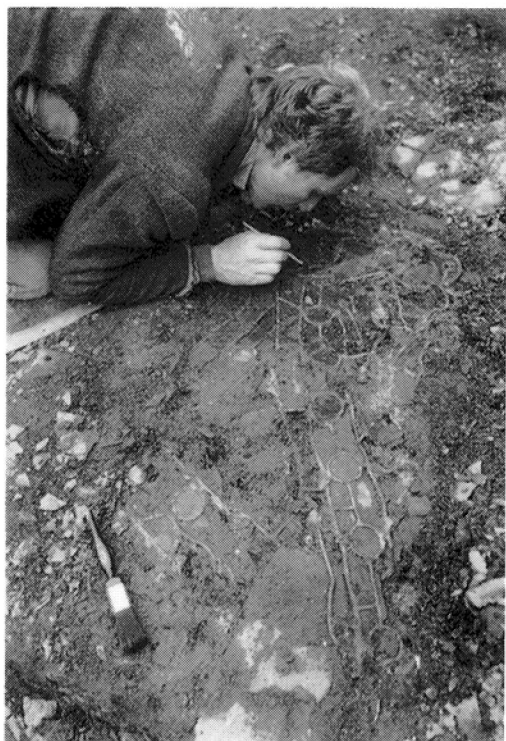
A. Window in layer 92, room 84,
under excavation

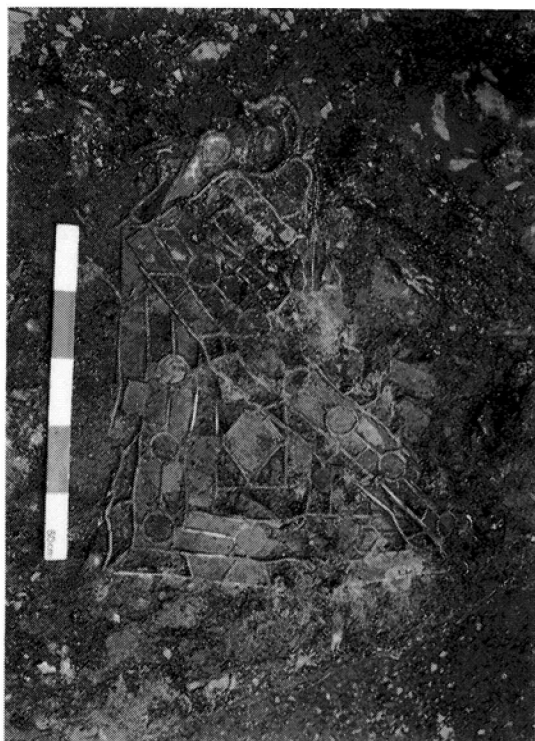
B. Window in layer 92, room 84,
prior to lifting (scale 0.5 m)

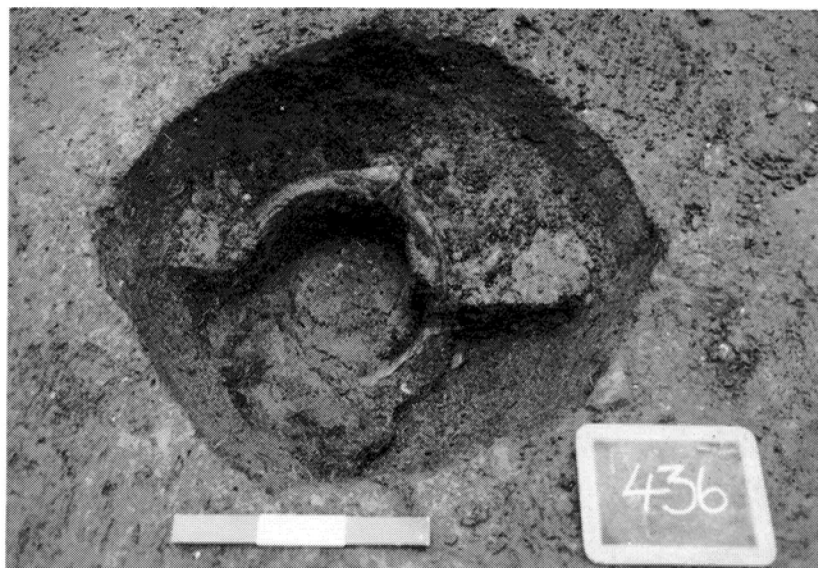
C. The 'portable' hearth within pit 436, partly excavated (scale 0.5m)

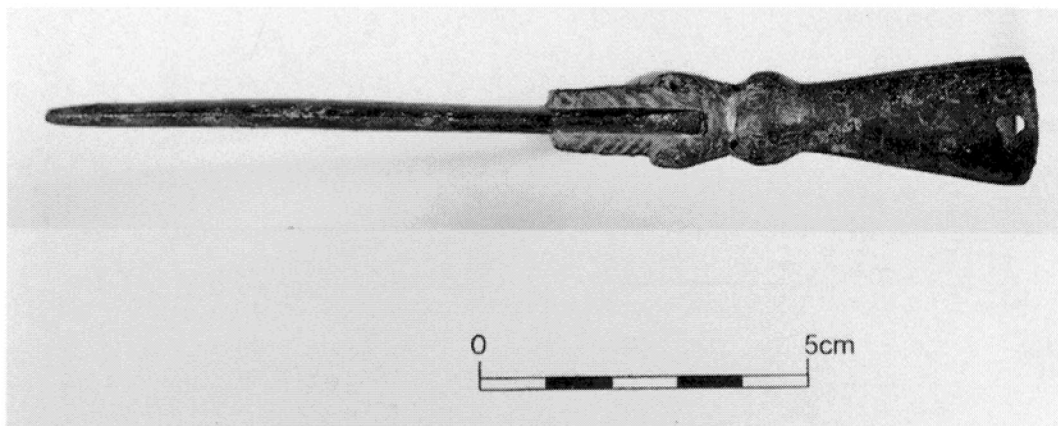
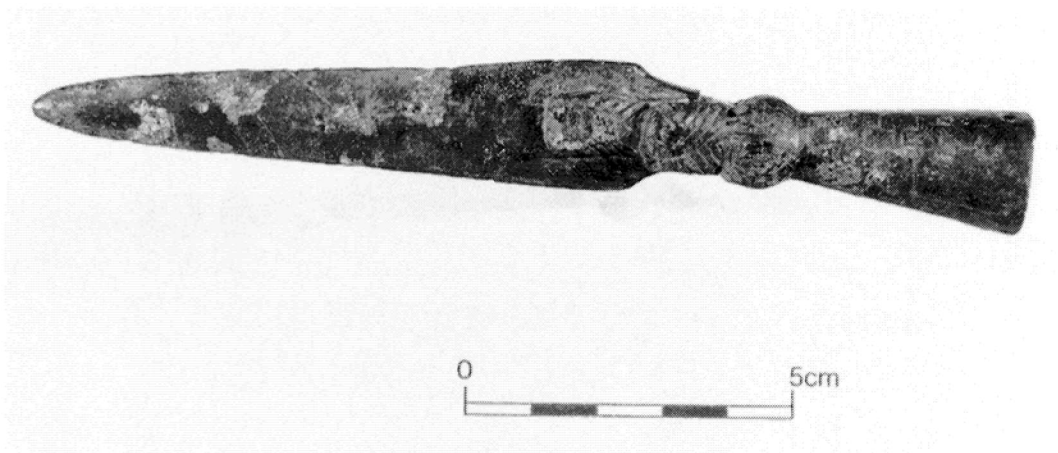
A., B., C. Bronze socketed mount and blade

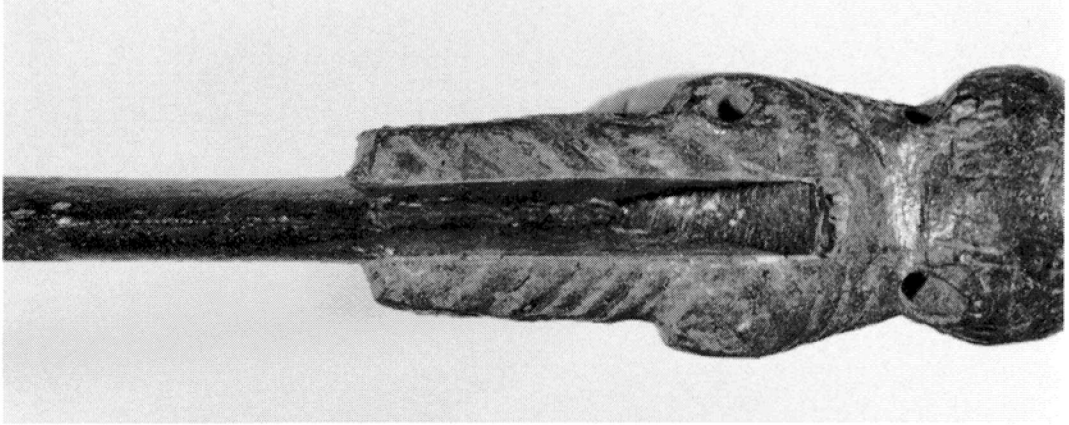
A. Detail of the bronze socketed mount

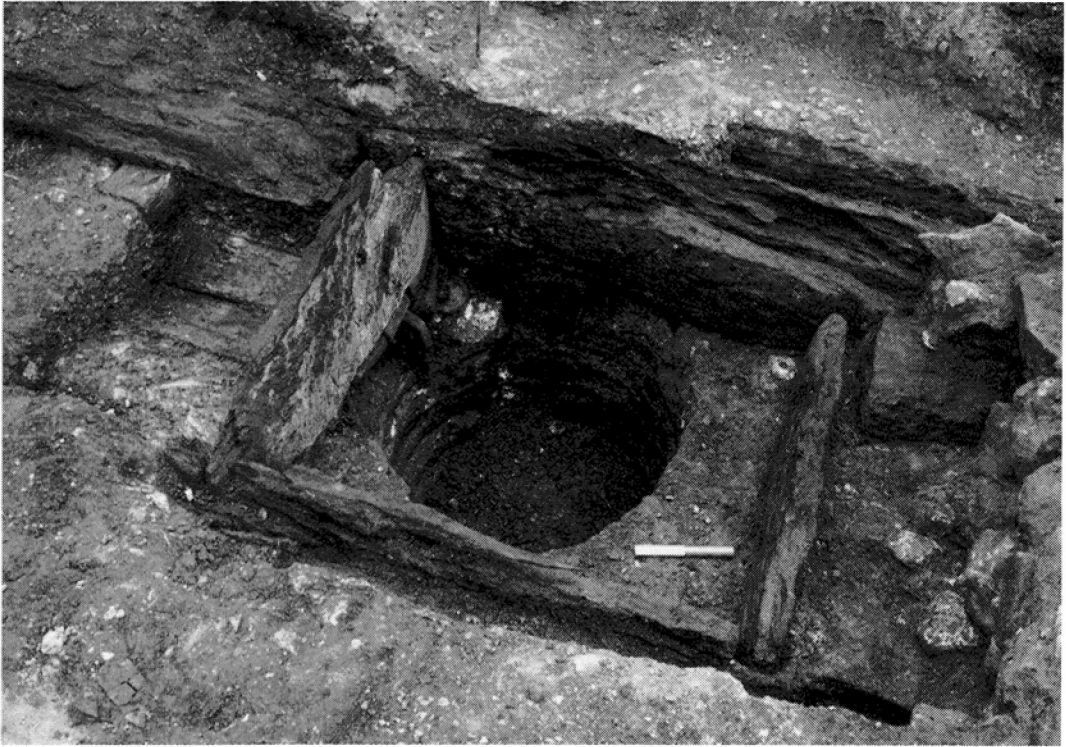
A. Bull Wharf, City. A timber-framed sump, part of a drain complex in a 12th-century cellar

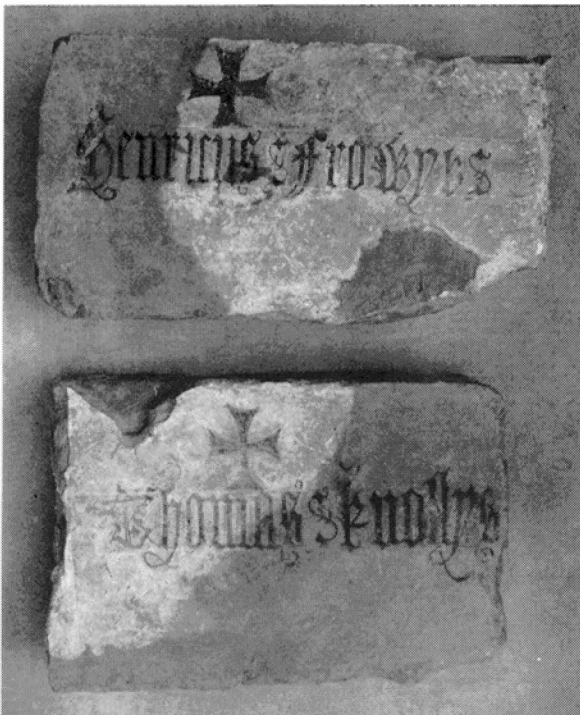
B. Guildhall Yard, City. Two 'dedication' stones found at Guildhall chapel

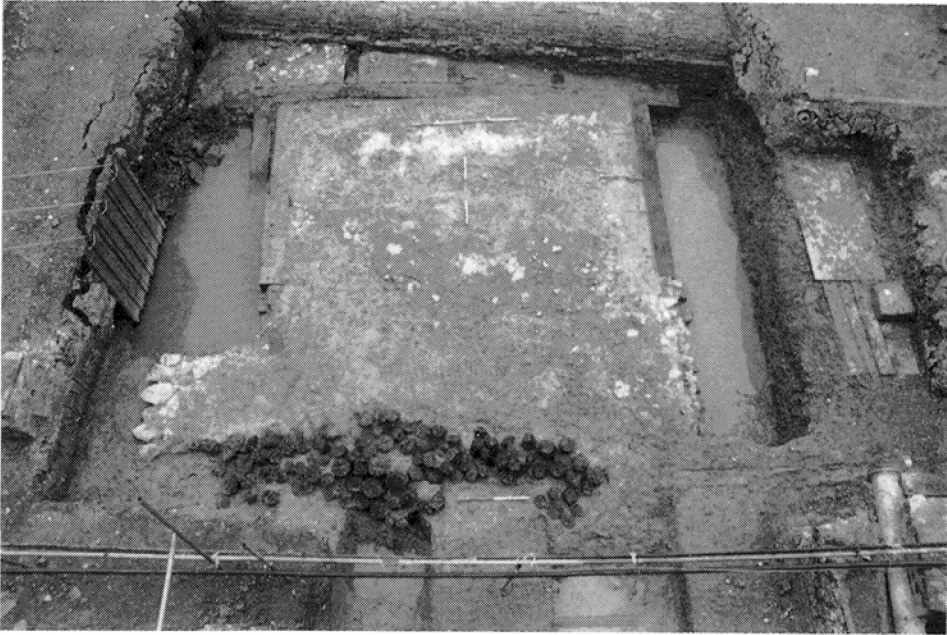
A. The Henry III structure viewed from the top of Edward I's outer curtain wall. Oak timbers are clearly visible on three sides of the building, with beech piles visible on the fourth side. The Royal Engineers' brick culvert, built *c.* 1843, runs across the top of the photograph

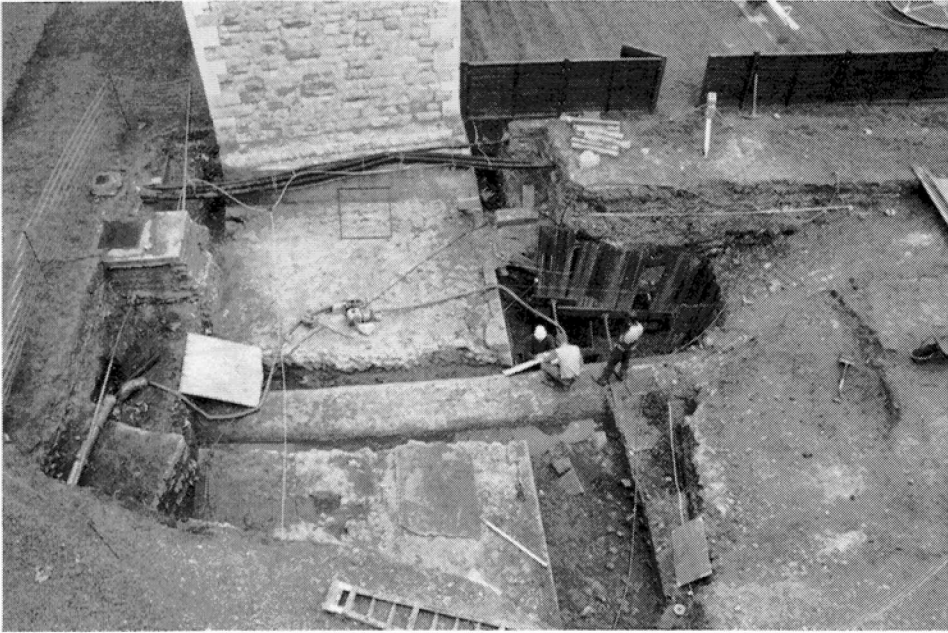
- A. Excavation of the late 13th- or early 14th-century stone causeway between the Develin Tower and the Iron Gate seen from Tower Bridge Approach. The Royal Engineers' brick culvert, built c. 1843, can be seen running through the centre of the masonry

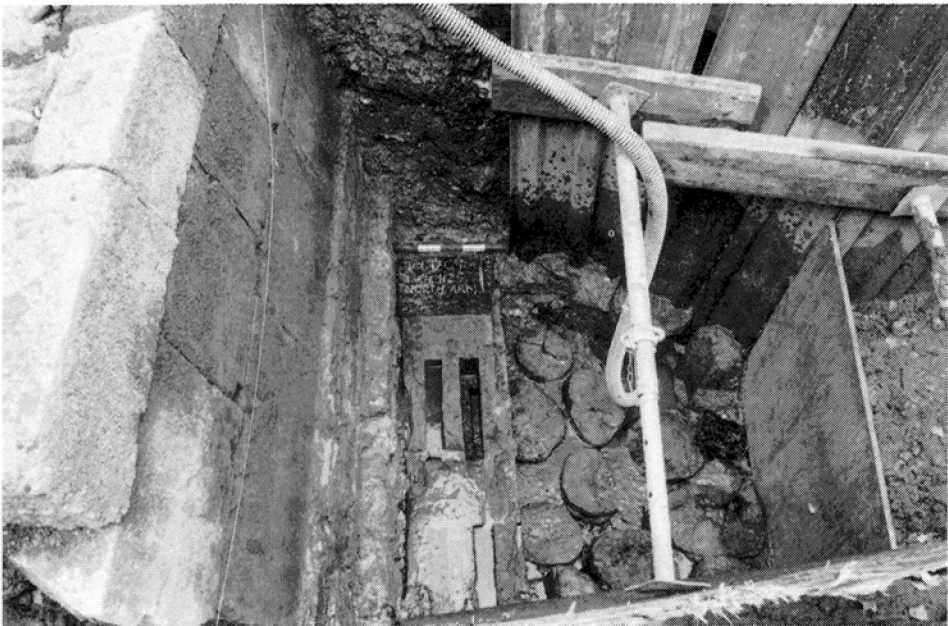
- B. Beech piles and a beech beam under the stone causeway between the Develin Tower and the Iron Gate. The piles have been dated to the summer of 1275, and beech to after 1266, by dendrochronology

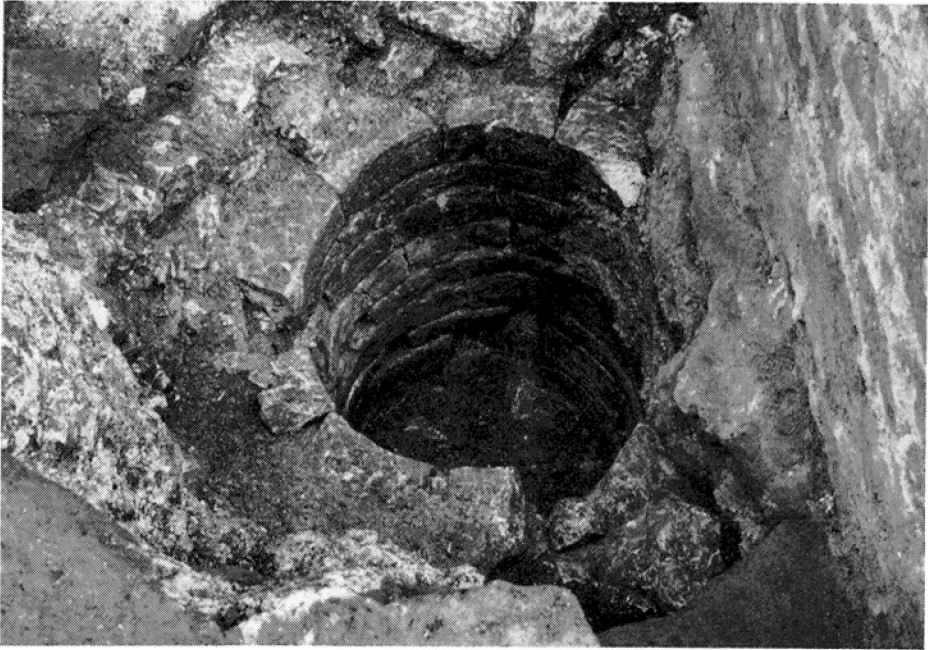
A. St Mary Axe, City. Medieval chalk-lined well from which a good assemblage of medieval pottery was recovered.

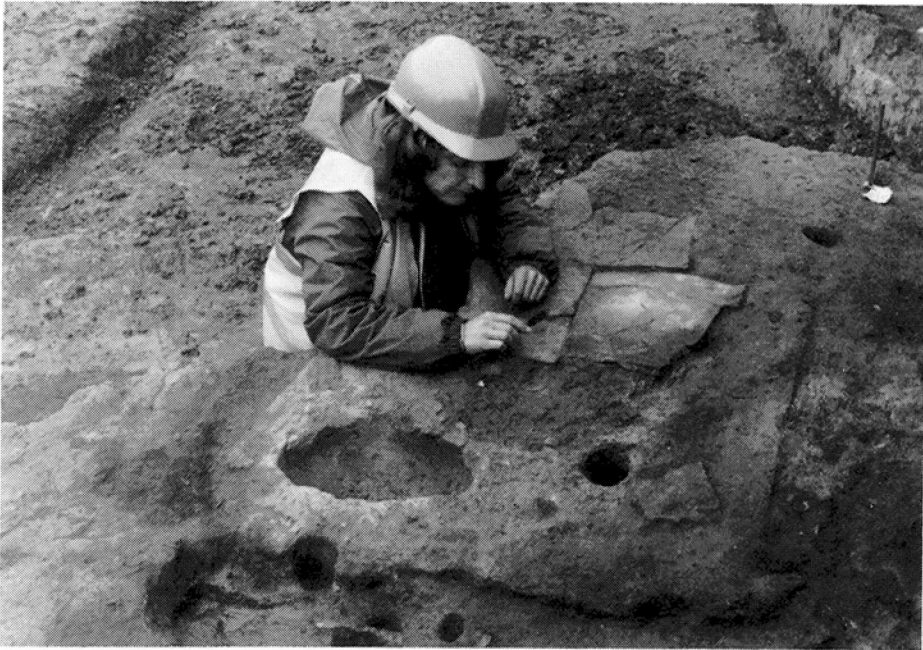
B. Royal Opera House, Westminster. A mid Saxon timber-framed hearth with a reused Roman tile base, under excavation

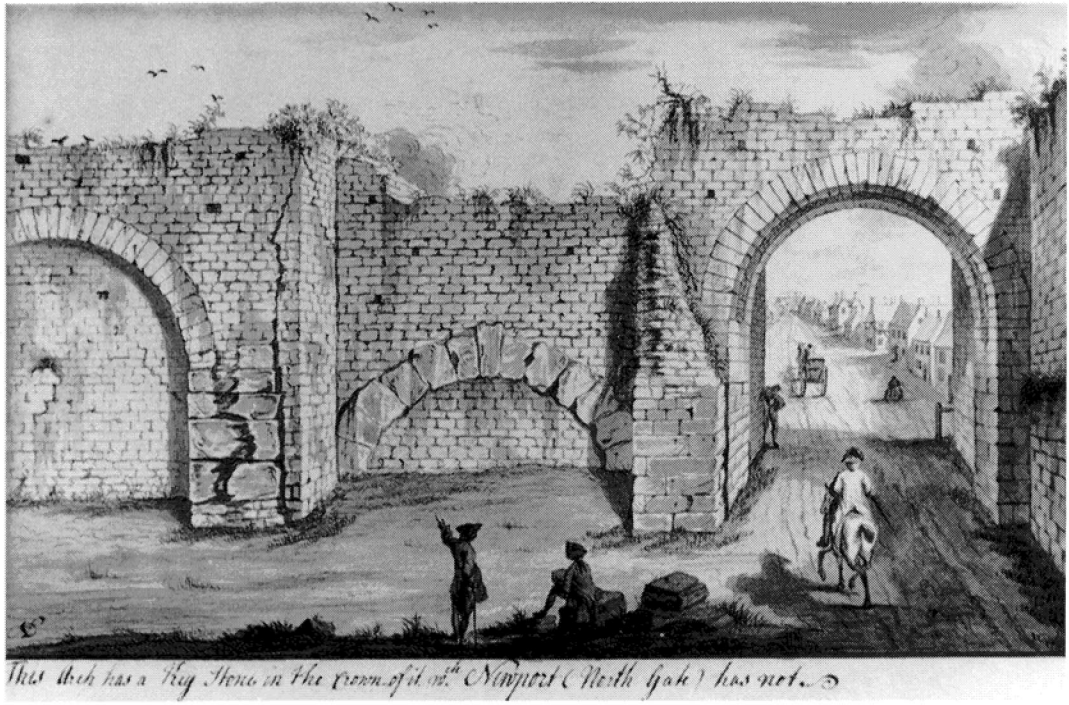
PLATE XVI

View of East Bailgate, Lincoln from the west by Nathan Drake, c. 1730. Pen and wash drawing in Usher Art Gallery Lincoln
