Glastonbury Abbey

The SE Crossing Pier

Archaeological Survey of the standing fabric - 2005

Jerry Sampson

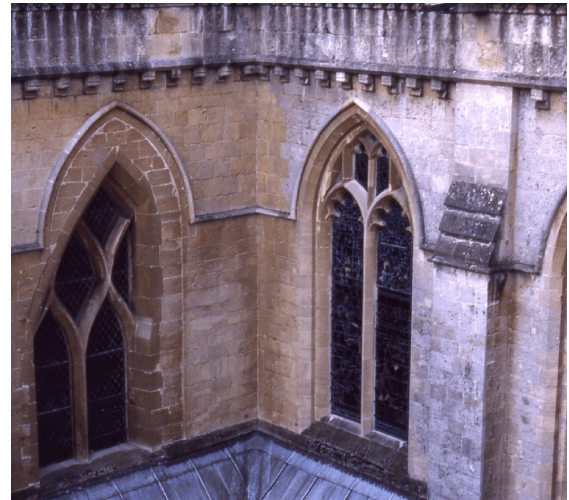
At Wells Cathedral (left and above) the choir was constructed first, with the side walls at clerestory level just turning onto the north (above) and south transepts - the break line defined on the change from yellow Doultong to grey Chilcote stone

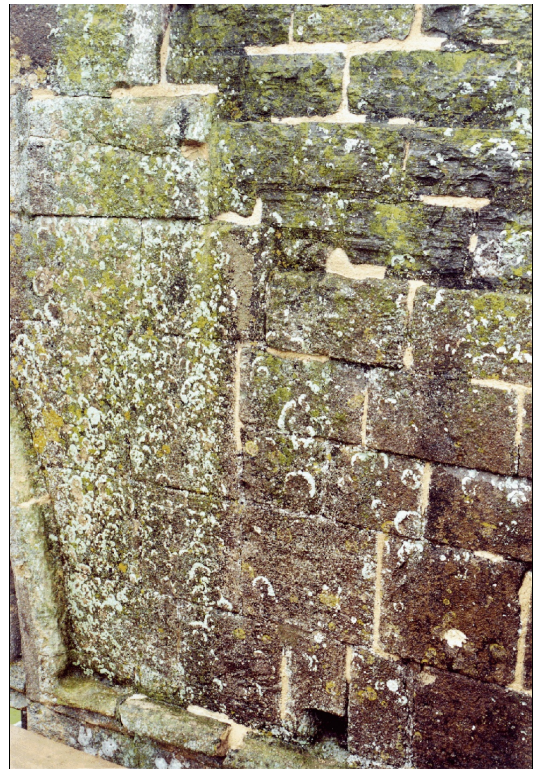
At Glastonbury a break occurs in the same place, the change being defined by a change in the height of the courses. Note that the putlog hole from the original construction scaffold (immediately above the string-course) is laid against the completed stonework of the choir phase.

- 2.1.3.5.6 This marked increase in the course-heights of the southern fabric in the north bay of the south transept clerestory represents an intermediate stage between the coursing of the 1180s fabric and that of the upper parts of the south nave aisle, where the average course heights are more usually in the range of 33-36 cm., and courses of 40 cm. and more are not uncommon. Indeed the general range of course heights in this fragment of the transept are close to those seen in the masonry of Bays 3W and 4E in the south nave aisle, where architectural features (in particular the variation in the form of the parapet) suggested that a further break in the construction may have occurred.¹² In these eastern fragments of the nave the average course heights above the break-line are 26.56 [3W] and 24.7 [4E] - close to those in the upper parts of the southern crossing pier - but both have three 30+ cm. courses in their surviving height.

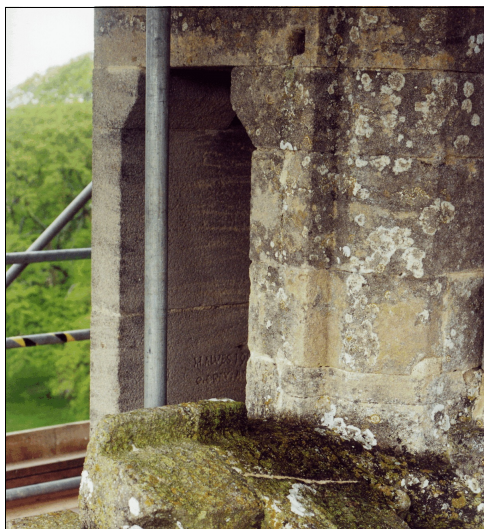
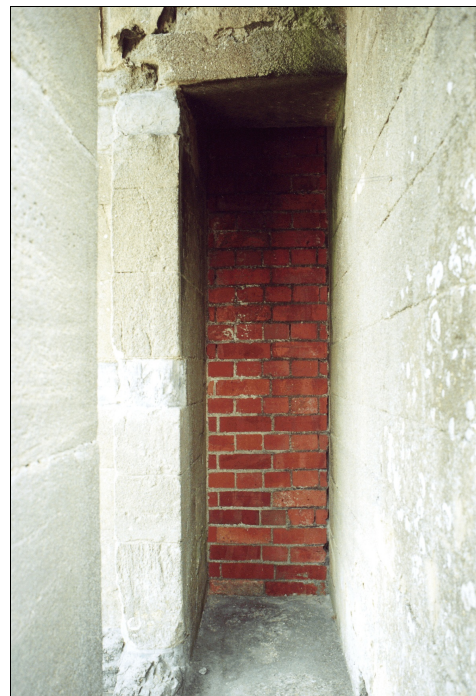
The Clerestory wall-passage (above and right), now blocked with brick, originally gave access to a stair in the thickness of the crossing pier rising to the SE angle of the tower.

- 2.2.1.5 Only the discovery of drawings or documentation from the c.1909 period, or the removal of the capping of the stair or the brick blocking of the transept clerestory passageways will clarify whether the choir possessed clerestory passages prior to Monington's work; but it is clear that the transept passages gave access to a stair in the upper parts of the eastern crossing piers when they were built in the late twelfth century. At the apex of the south-eastern crossing pier the interior of this stairwell has been capped off horizontally, and above this the medieval fabric of the stair rises for a further 193 cm. 60 cm below the apex of the surviving medieval fabric lies the top of the uppermost of two stair treads, each 20 cm deep, the lower of which has a tread surface 36 cm wide at the face of the wall. These two survivals confirm the supposition (based on the geometry of the stair) that the treads rose clockwise; the corresponding staircase in the north-east pier rising counter-clockwise. The course-heights of the stairwell are, of course, conditioned by the height of the treads, the courses varying between 19.5 and 20 cm in height.

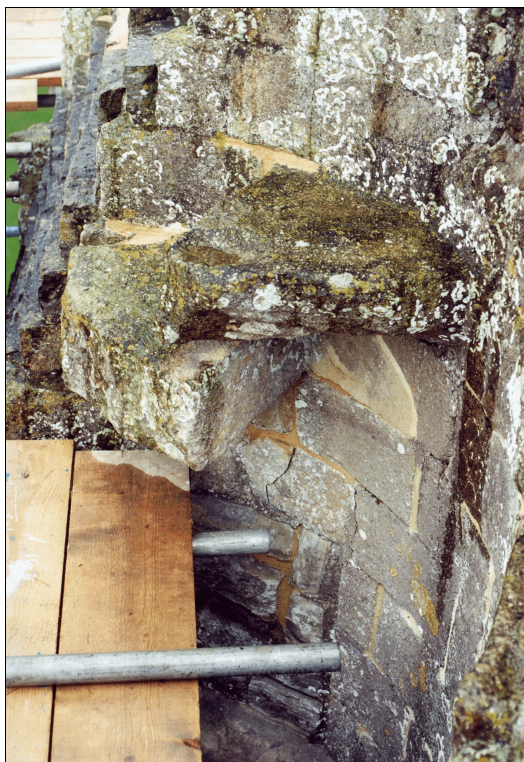
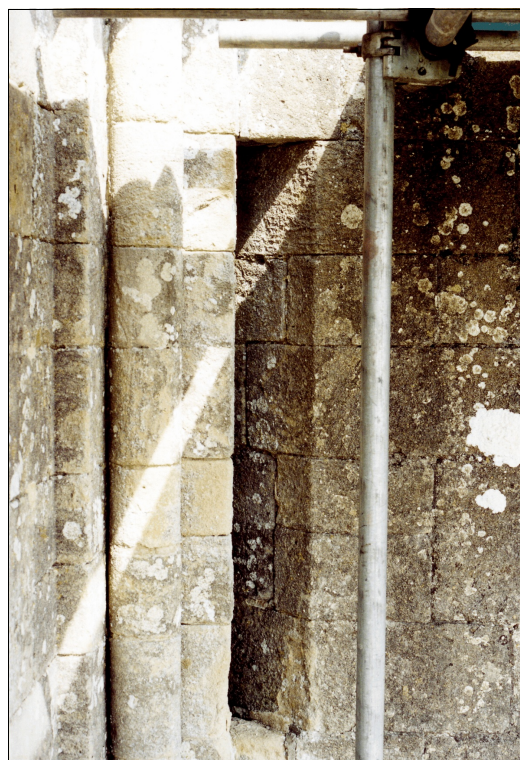
Below left shows the remaining treads of the newel stair at the apex of the ruin, with internal C19 blocking visible below. The window is still visible on the exterior (below right)

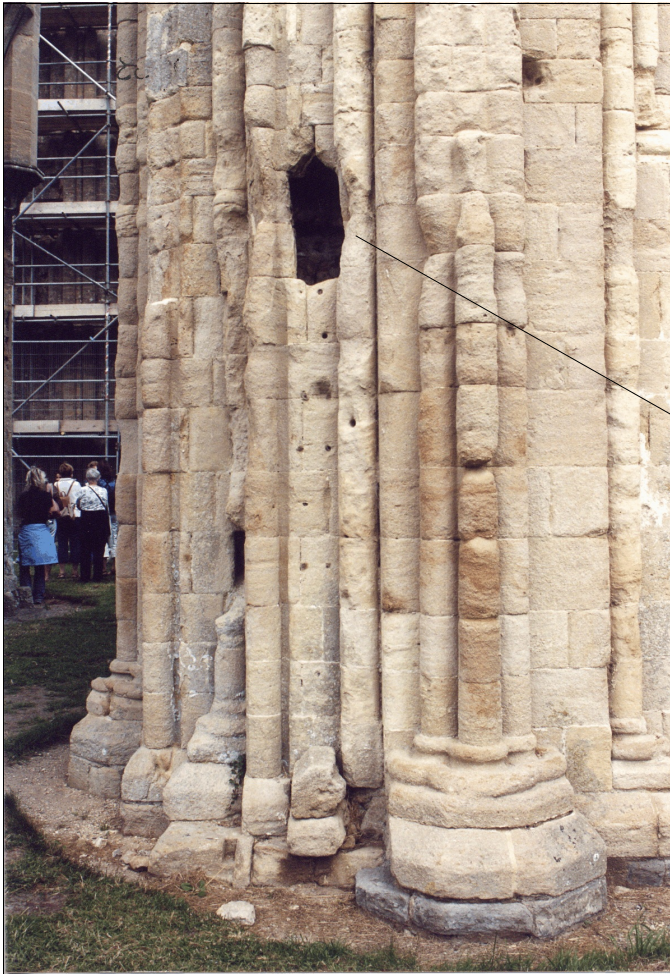
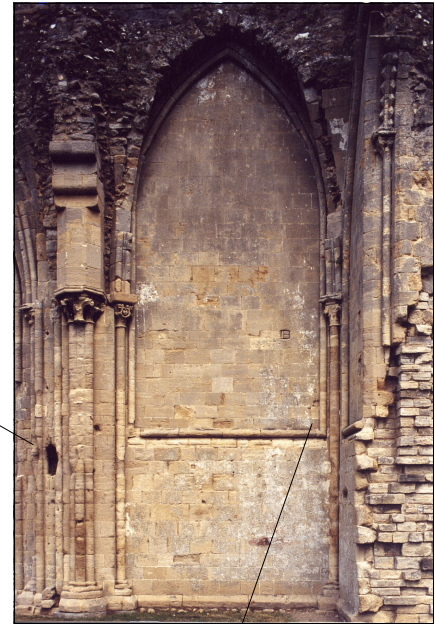
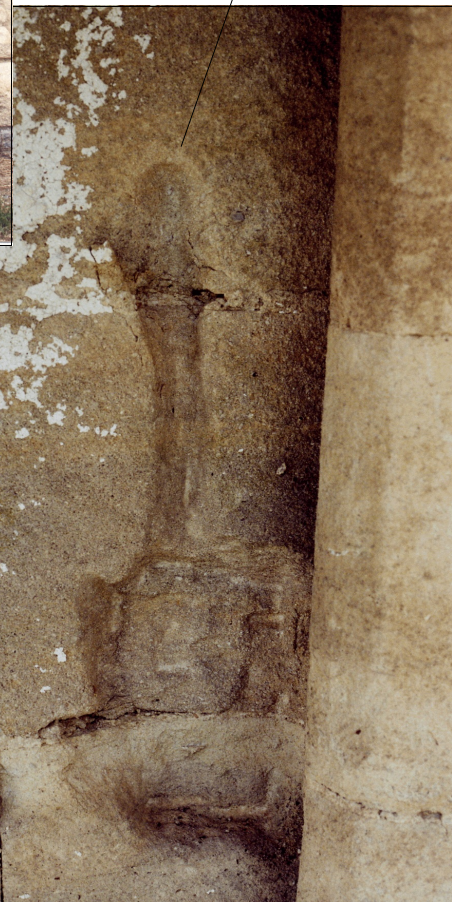
S Transept, northern chapel

Above: traces of a screen across the entrance, with pairs of pins defining the position of the tracery and ending above the height of the dado, the large hold perhaps to locate the bresummer.

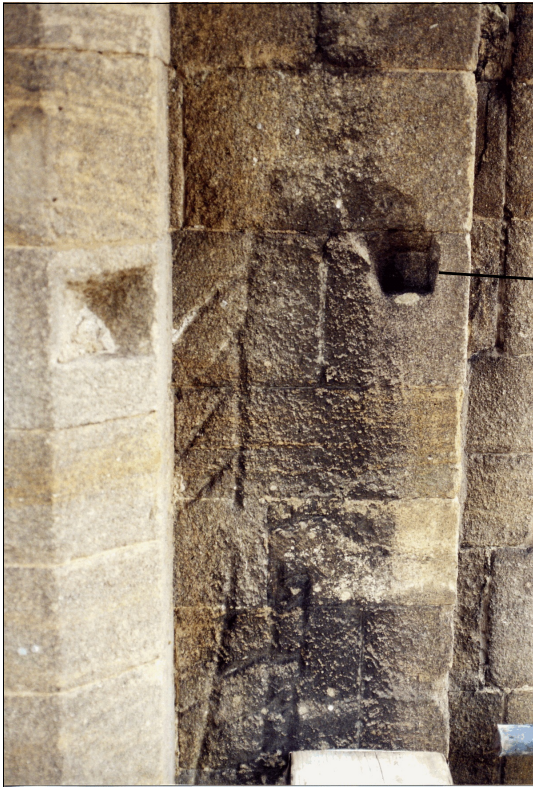
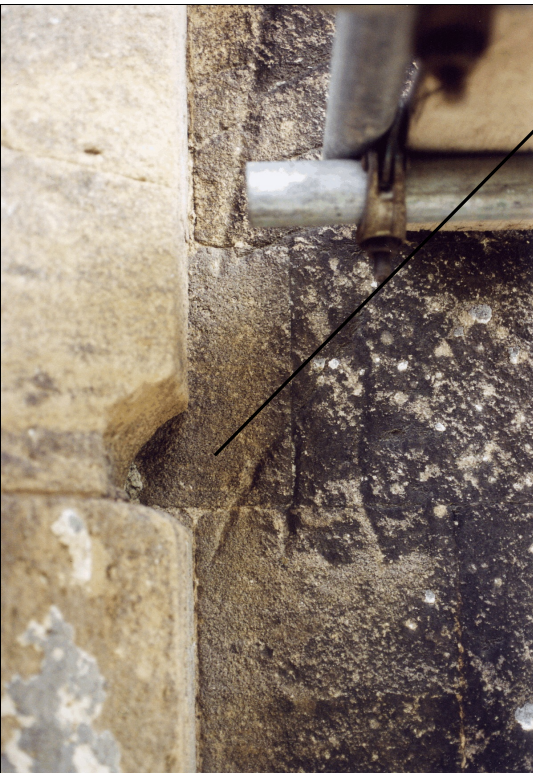
The traces of Abbot Monington's pulpitum.

In addition to the chases cut into the ashlar to assist in the bonding of the projecting parapet there are recesses which probably correspond to the position of the top (upper left) and bottom (lower left) mouldings of the parapet. Immediately below the level of the latter the corresponding moulding at the eastern side of the pier has been cut away, probably to accommodate the eastern face of the screen.

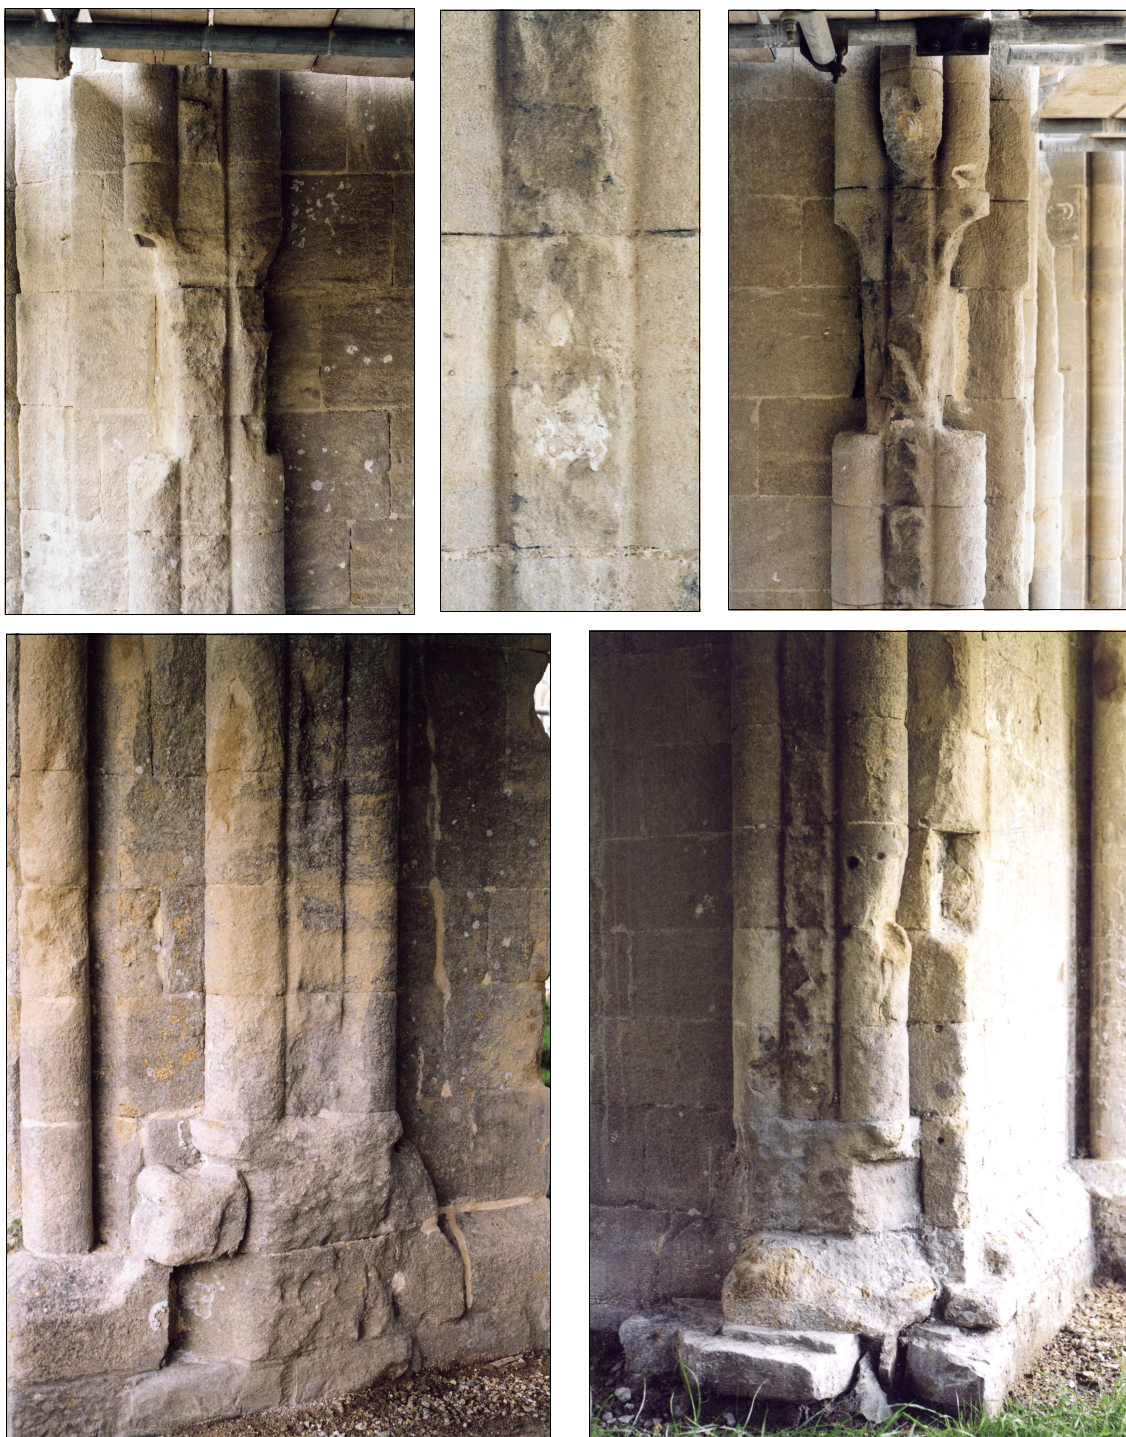
Traces of the South Choir Aisle screen: cut away areas of the arch mouldings at the entrance to the choir, at the height of the parapet (top left and right), and at the bases and down the centre roll moulding (bottom); traces of mortar on the latter show that the screen was of masonry (top centre).

2.3.3.1 Probably inserted at the same time as the Monington period pulpitum, screens also existed across the western arches of the choir aisles, leaving identical marks on the north and south arches. Initially appearing to be no more than areas of accidental damage to the outer roll mouldings of the responds of the arches, sections of the mouldings have been deliberately cut away at the same heights on both sides of the missing central roll, the profile of the cuts being curved at the top and flat at the base in all instances. That the central roll has been worked off (rather than merely broken) is proved by the cutting-back of the inner faces of the bases on both sides of the arch, and by the presence of small patches of mortar on the 'broken' face of the southern respond, presumably from the fixing of the stonework of the screen (and incidentally proving that the screens were of stone rather than being of wood).

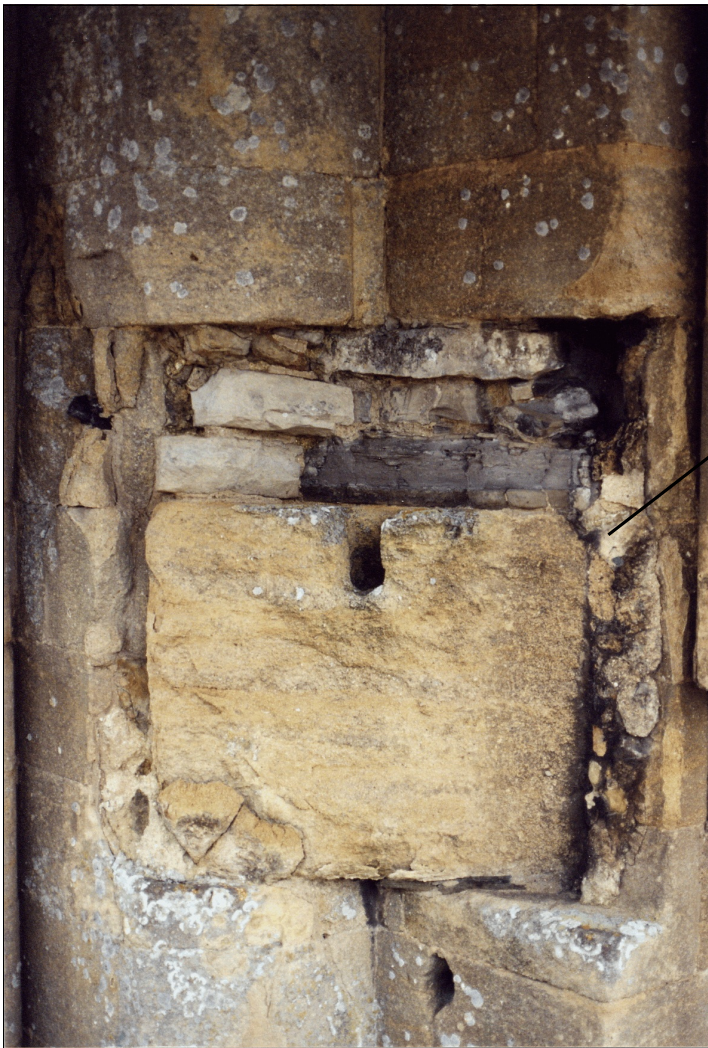
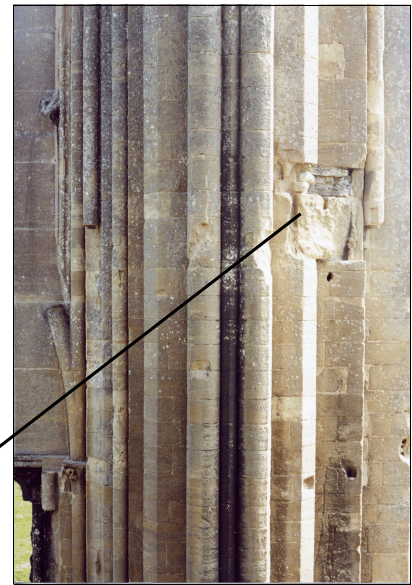
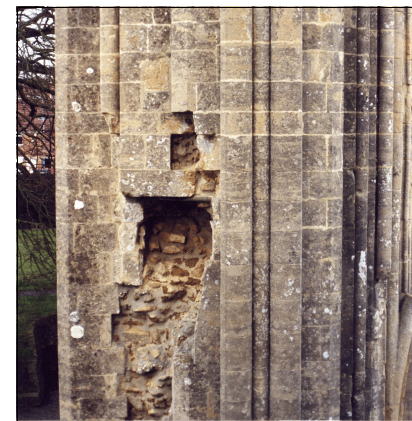
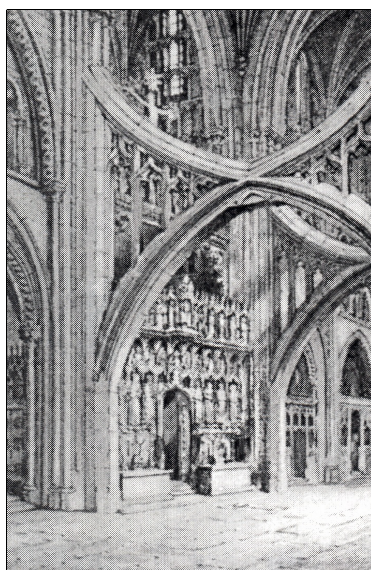
Traces of the sockets for the great rood-beam above the 14th century pulpitum.

The hole in the southern pier (above left) has been blocked up - presumably before the dissolution, suggesting the rood was taken down as part of the 1538 legislation against roods which were the object of pilgrimage or offerings. The hole in the northern pier (above right) is badly damaged.

2.4.1.6 The hole could only have been blocked after the rood beam was taken down; but if the beam was taken out as part of the despoilation of the Abbey church following the Dissolution there would have been no point in blocking the hole. The earliest period at which a concern for the stability of the ruins might have prompted a repair to be inserted in the hole would be the early nineteenth century, but the mortar fixing the blocking is of an earlier type, quite unlike the coal/lime mix used on the south transept triforium in or prior to 1849. The only likely explanation, therefore, is that the beam was taken down before the destruction of the Abbey, and the roughness of its blocking suggests that this was done right at the end of its existence as a monastery.

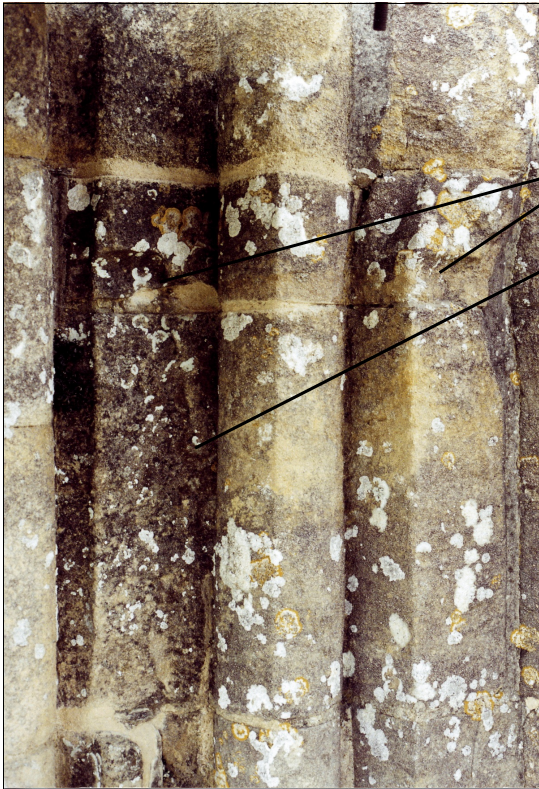
Left: C12 capital and abacus cut away in the C14 remodelling of the choir

The hollow moulding of the underside of the abacus

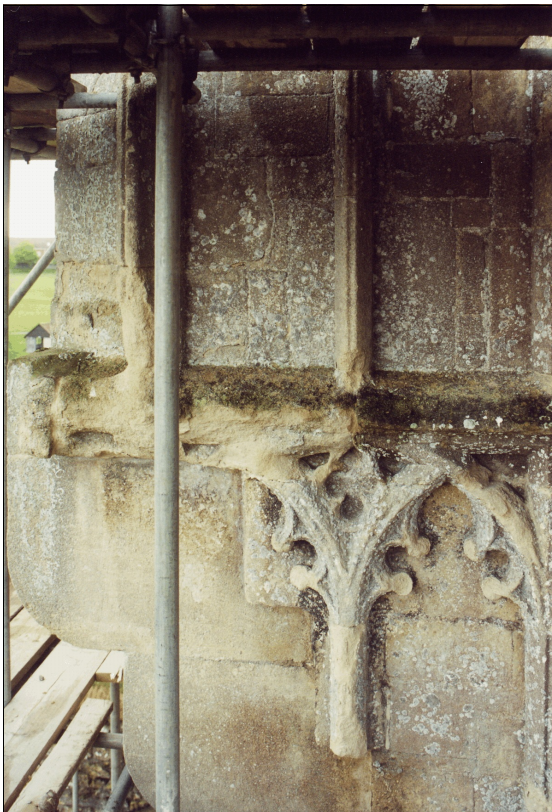
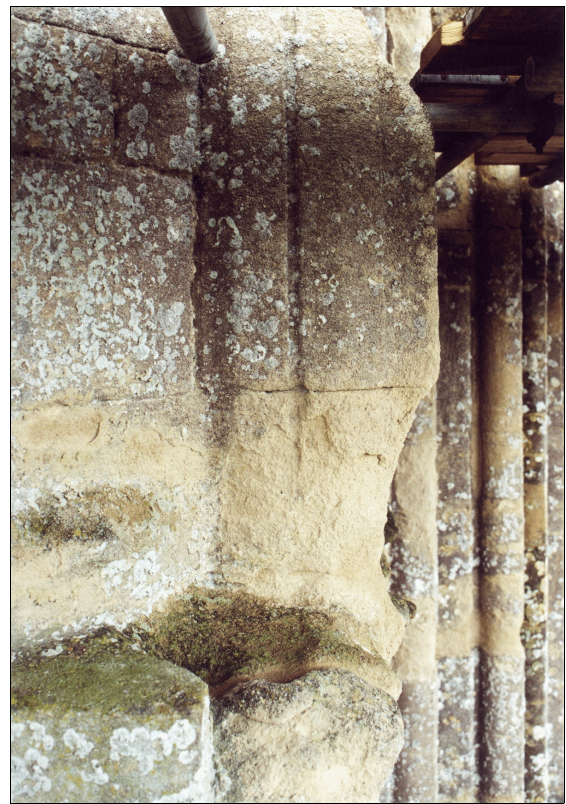
Below left: the transom of the blind panelling of Monington's remodelling continuing eastwards to form the window tracery.

Below right, the glazing line of Monington's window.

70 cm inside the more normal position near the face of the outer window jamb. The outer window jamb appears, in part at least, to be that of the twelfth century building, and the glazing of the original windows seems to have consisted of glazed lights set in wooden frames fitted into the recessed outer moulding of the window and tied back onto square saddle-bars at springing and two intermediate levels beneath - this certainly being the system adopted on the south transept clerestory. However, no signs of the former existence of square sockets for saddle bars were found on the early outer jamb, the only significant sockets in this vicinity being a series of round holes, possibly for light saddle-bars, the lowest one centred 5 cm below the bottom bed of the nook-shaft base level; the next one 96 cm above this, and the third 86 cm above again. These may all lie in 12/13th century block, and could, therefore, be original - though the lowest one must have been so close to the original sill level of the early window as to perhaps render this unlikely.

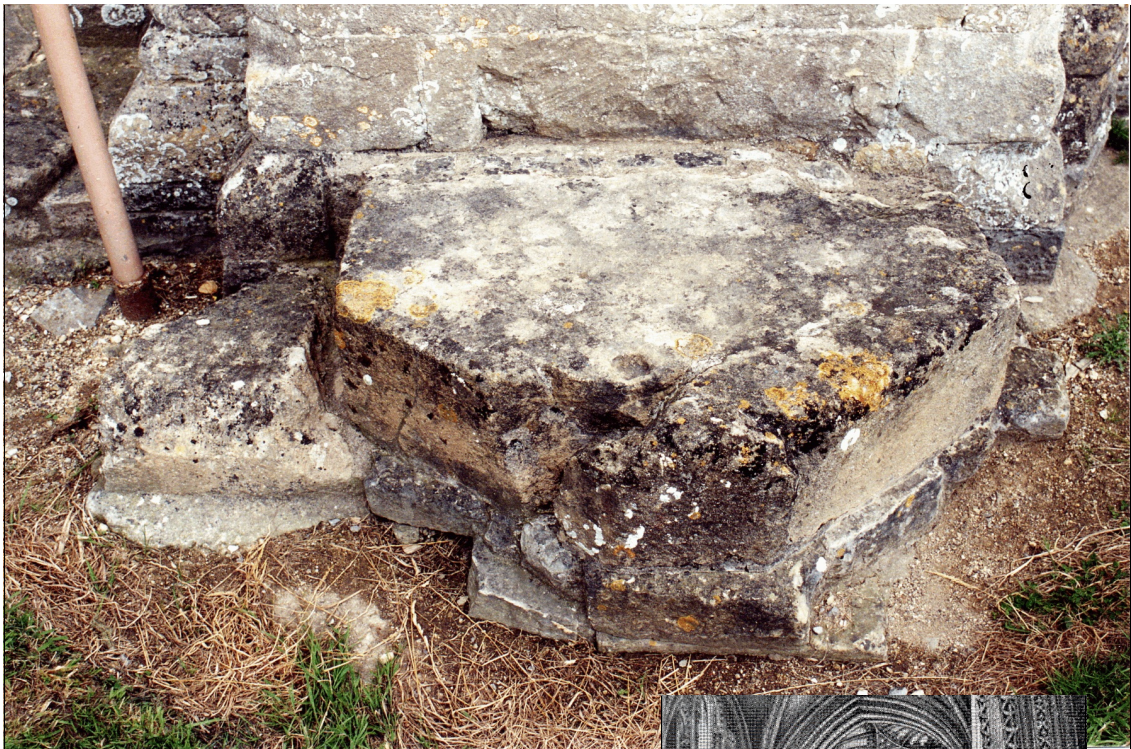
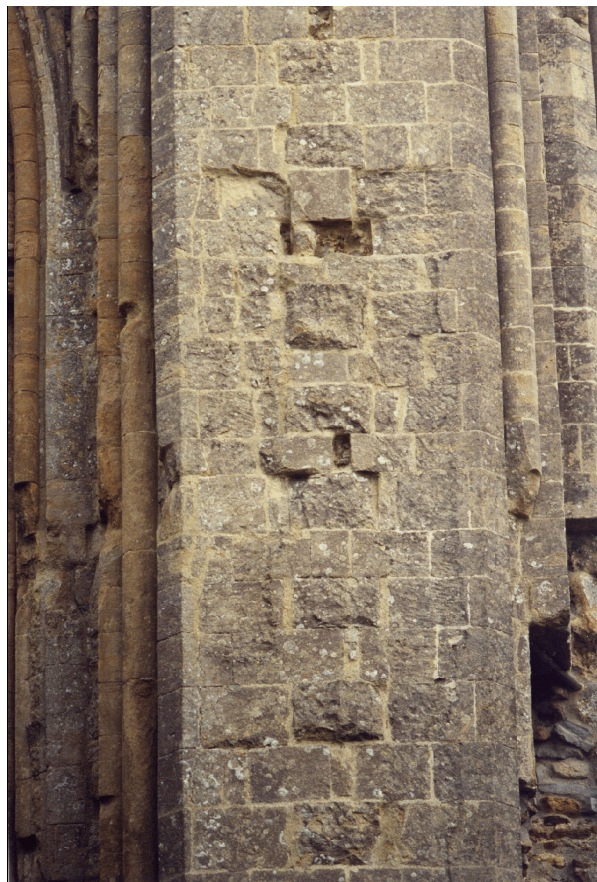
Traces of Abbot Bere's scissor arches: the semi-octagonal base to the west of the southern pier (top); the cut back mouldings and the rectangular recess on the west face of the NE pier (left)

These traces were used by Bond in his reconstruction of the crossing viewed from the north transept (above).

However, what is very obvious from the remaining projections of the cut-away bonding stones of this moulding is that it was much narrower than the double roll of the eastern crossing arch - the latter being 75 cm wide overall, the scars of the former barely 40 cm wide - and, as noted in Section 2.1.2., it would appear to have been a triple roll with a central projecting keeled shaft, rather than the double roll of the eastern crossing arch.

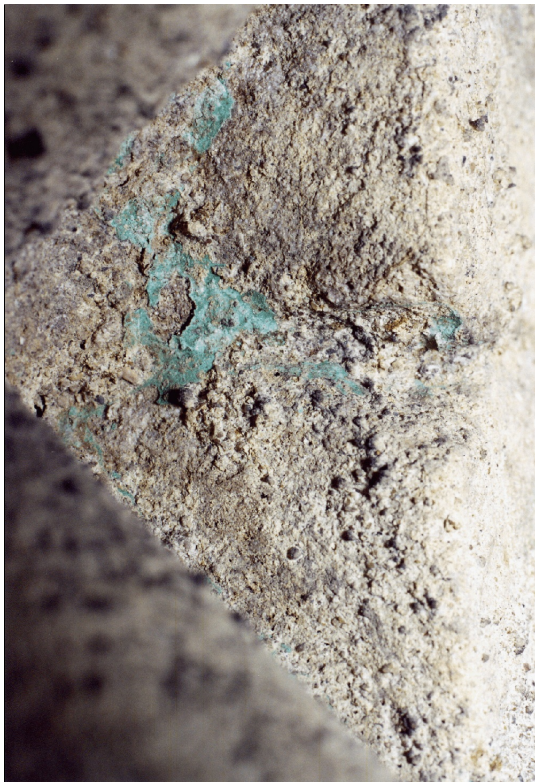
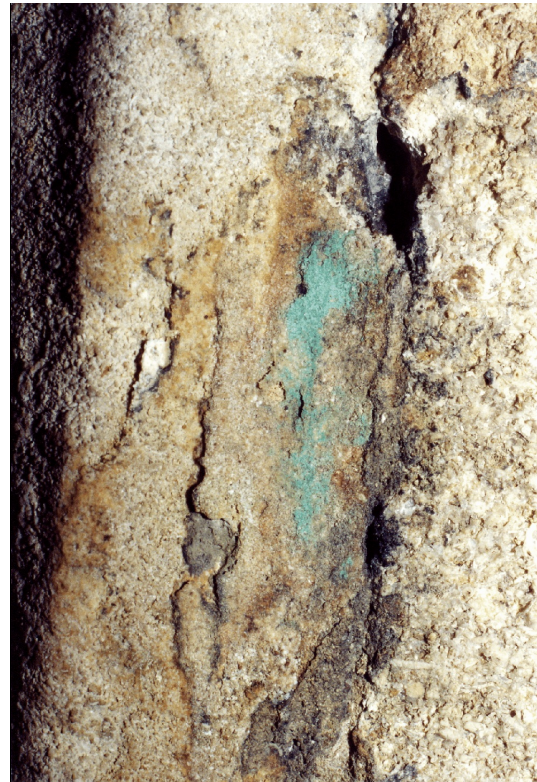
Traces of paint

Upper left: copper green on the zig-zag mouldings of the arcade arch

- 2.7.2 At the present time the visible paint traces are almost all restricted to the northern side of the west elevation, and consist almost exclusively of copper green pigment, located either on the square innermost moulding which forms the ‘background’ of the zig-zag rolls, or on the innermost angle of the zig-zag on the rolls, which coincides with the joint between blocks. This area was also the focus for the 1988 report, but whereas only green was found in the 2005 inspection, considerable traces of red were noted in the earlier report.

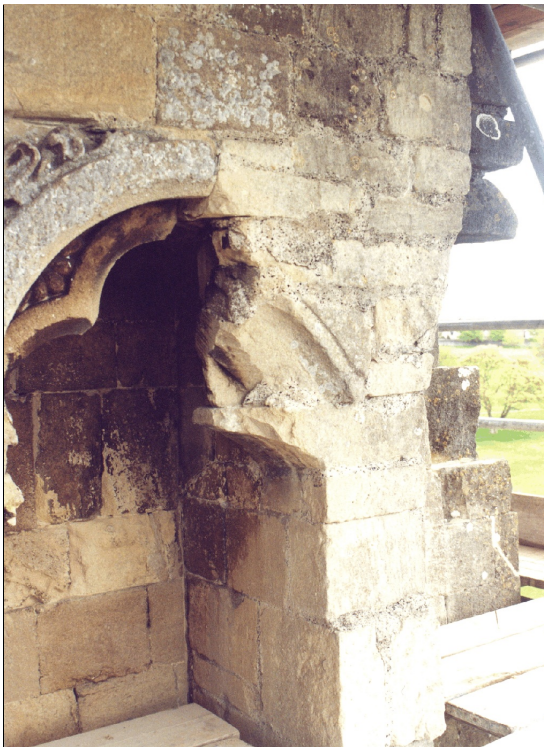
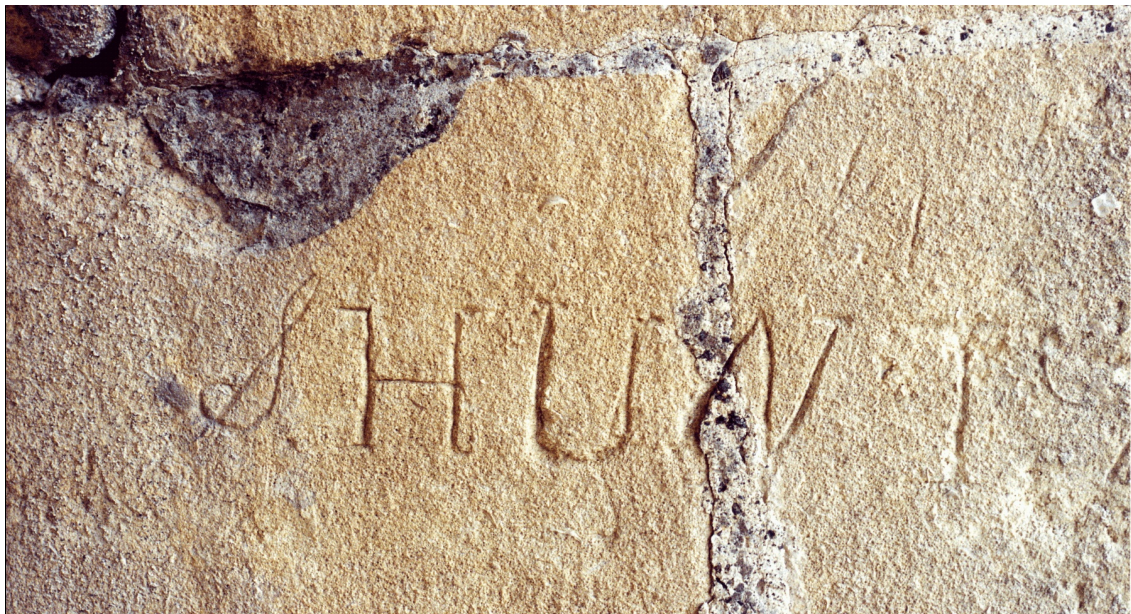
Evidence of repairs in 1849: the southern half of the south arch of the triforium arcade has been rebuilt using an ashy lime mortar and reclaimed rubble and ashlar. On the renewed stonework are two graffiti: S. Hunt's name apparently incised while the mortar was still wet, and G.Diy's dated 1849 - presumably the date of the repair.

- 3.1.3 On the north elevation of the inserted 'pier' are graffiti which appear to provide a date for the work. Towards the top is the name 'S. HUNT', the initials 'J.P.', and beneath these, 'G. Diy[?] / 1849 / Saddler[?]'. The lettering is relatively well cut, Hunt's name being incised across a mortar joint, proving that it postdates the erection of the pier; 'Diy's name is neatly cut with a chisel, the curved lines of the lettering looking more like the work of a mason than a saddler.

- 3.1.4 The position of the graffiti, cut into a single area of the repair work in a part of the fabric which could only easily be reached from scaffolding, strongly suggests that these are the names of the men who carried out this repair to the triforium.
