Glastonbury Abbey

The Lady Chapel

Polychrome Survey:

Record Drawings –

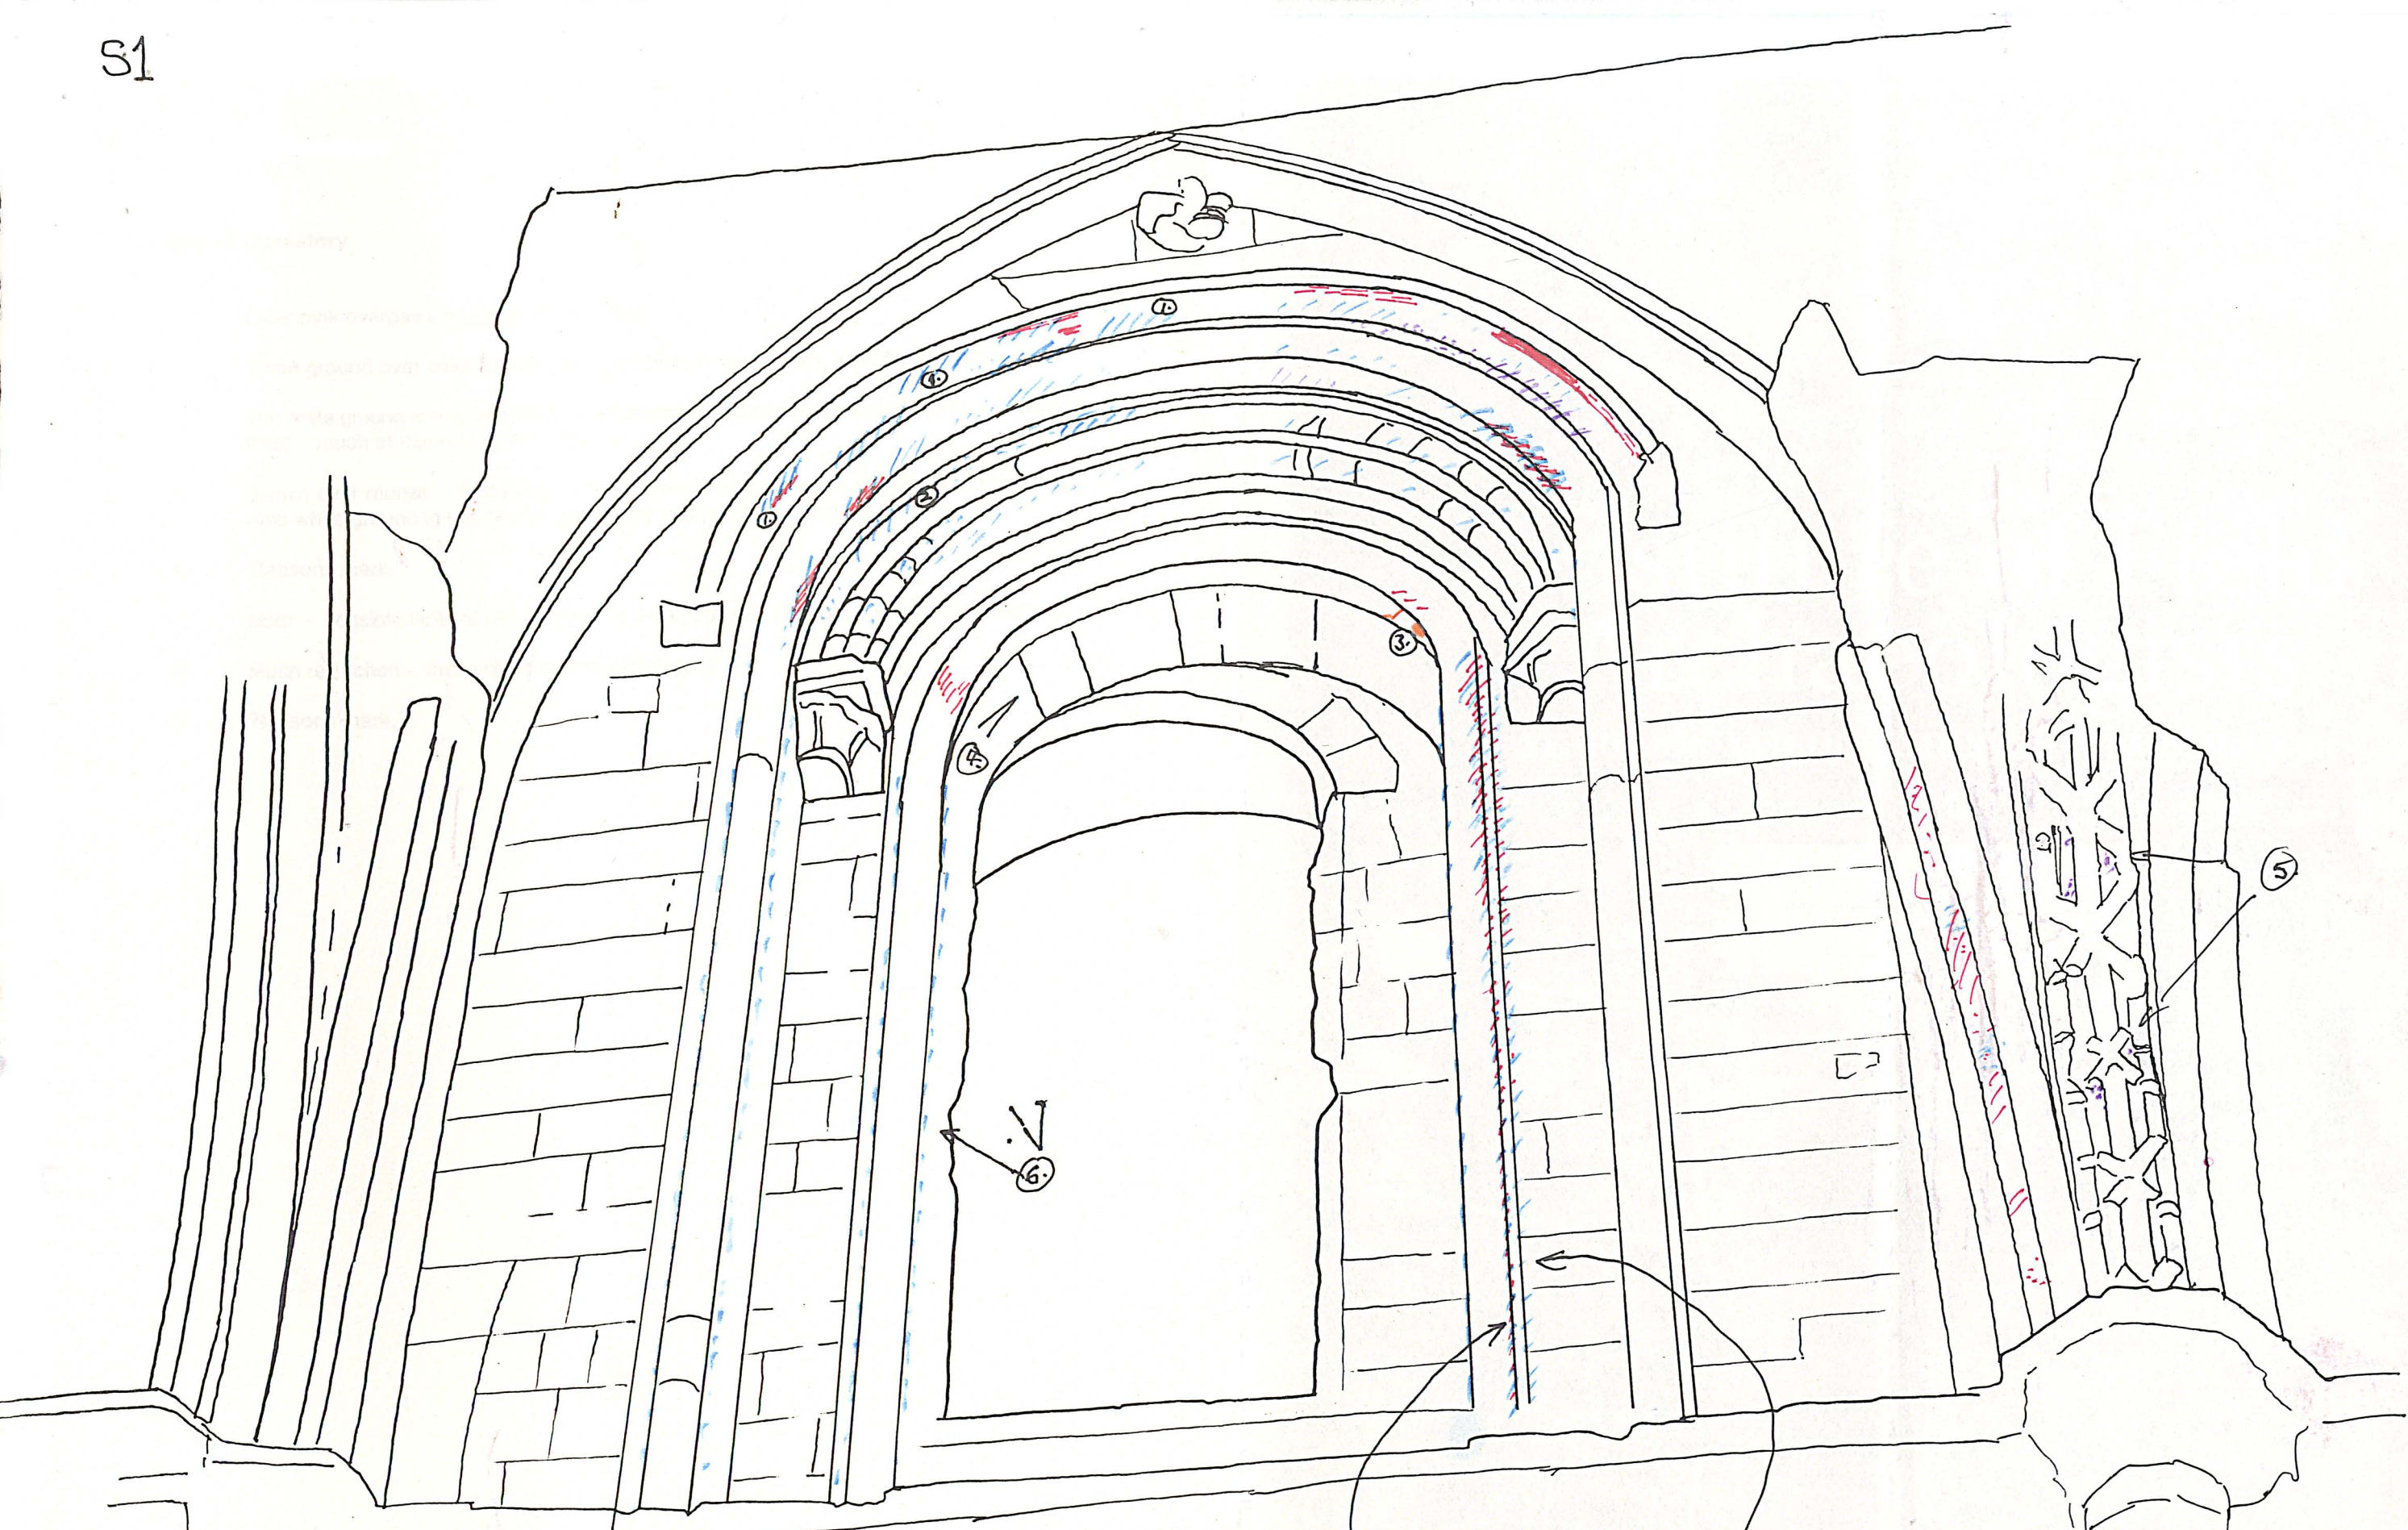
Bay 1S clerestory

important - mistake :
red with white | white only
over only on | on outside
inside of bead |
moulding

1. Later pink overpaint on some of this white.
2. White ground over calcining on this order and on next orders, including chevron work.

The white ground is only indicated on all orders of this head as most areas have some at least – much of this with pink overpaint.
3. Brown over mortar – ?old fixing. This in reveal and therefore not shown on drawing. Also white ground in this reveal; also spots and patches of red.
4. ?Masons mark.

Note: – possible hints of red on chevron work, but if so only dots over heavy calcining.
5. Much red lichen – these spots of red are suspect!
6. ?Masons mark.

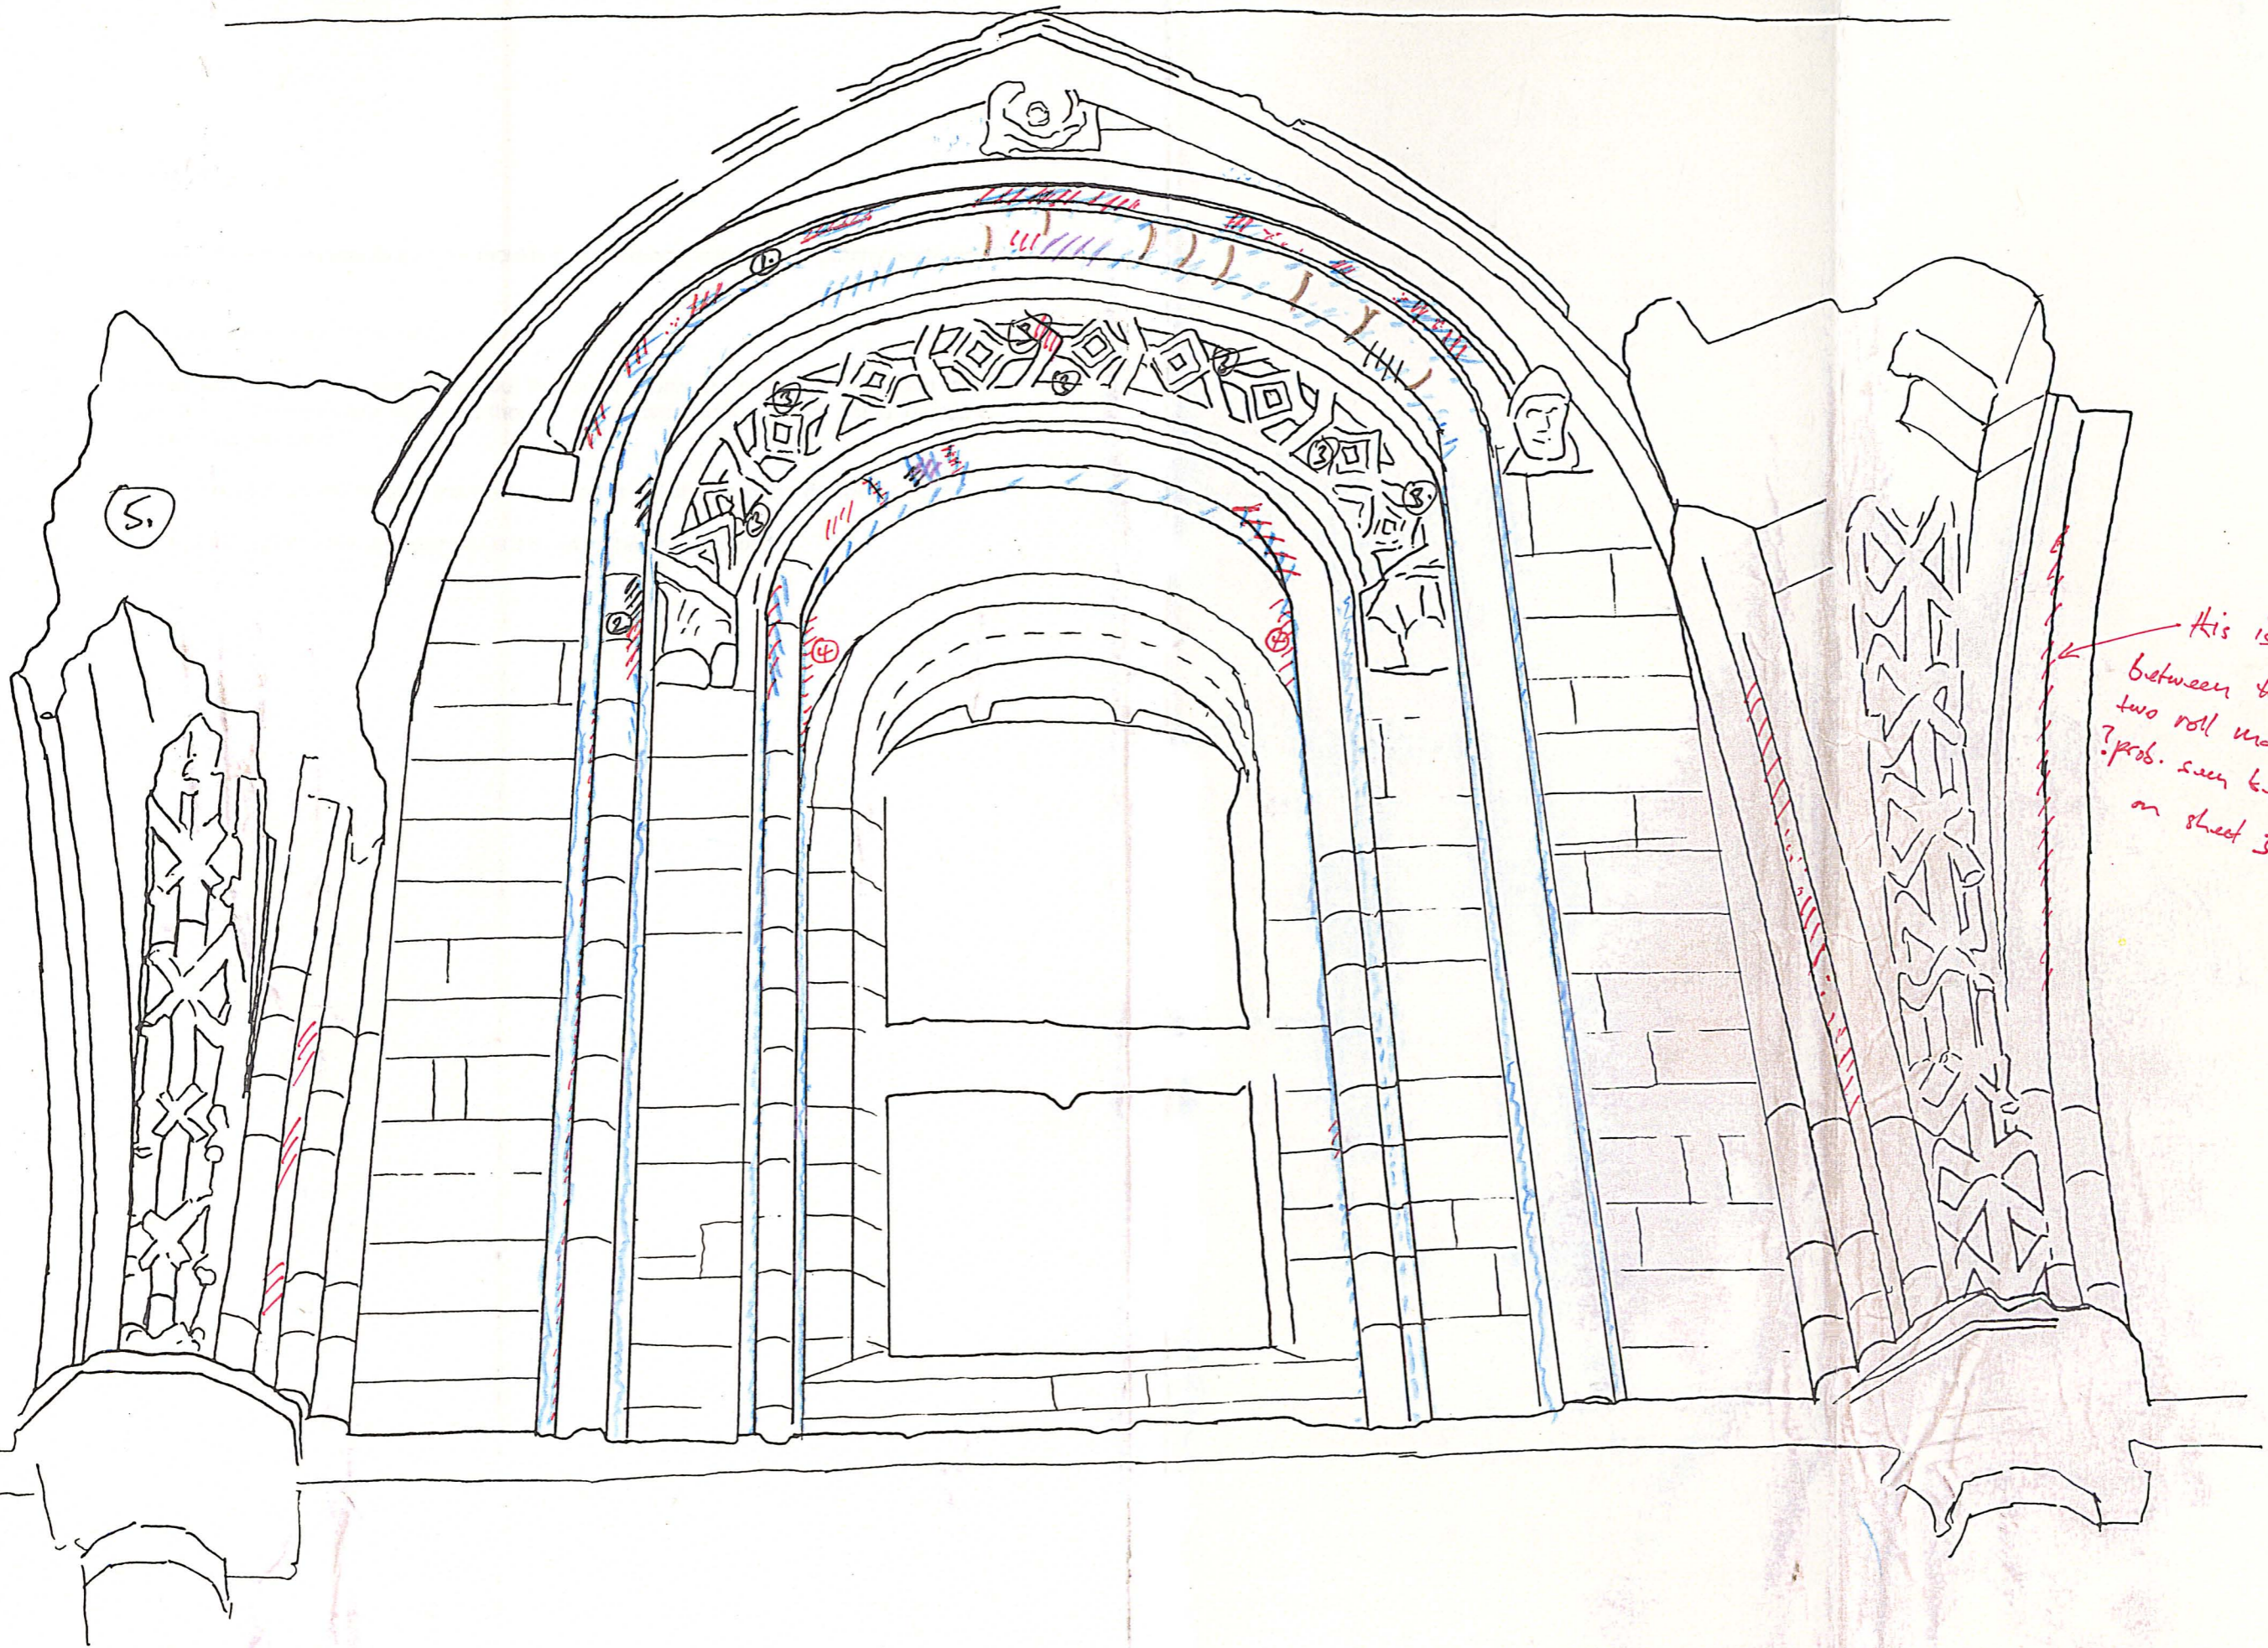
Bay 2S clerestory

This is
between the
two roll mouldings
? prob. seen better
on sheet 35

1. All the red on the vertical face of this moulding is a strong thick red with patchy white paint over it.
2. Red and black, both under white.
3. Patches and spots of white throughout this order – only the one patch of strong red is definite. There are also speckles thought to be calcining, but which could include or incorporate red paint.
4. The red here is on the edge of the reveal, which is not shown in the drawing.
5. Most of this vault springer assembly is shown in the drawing for 1S.

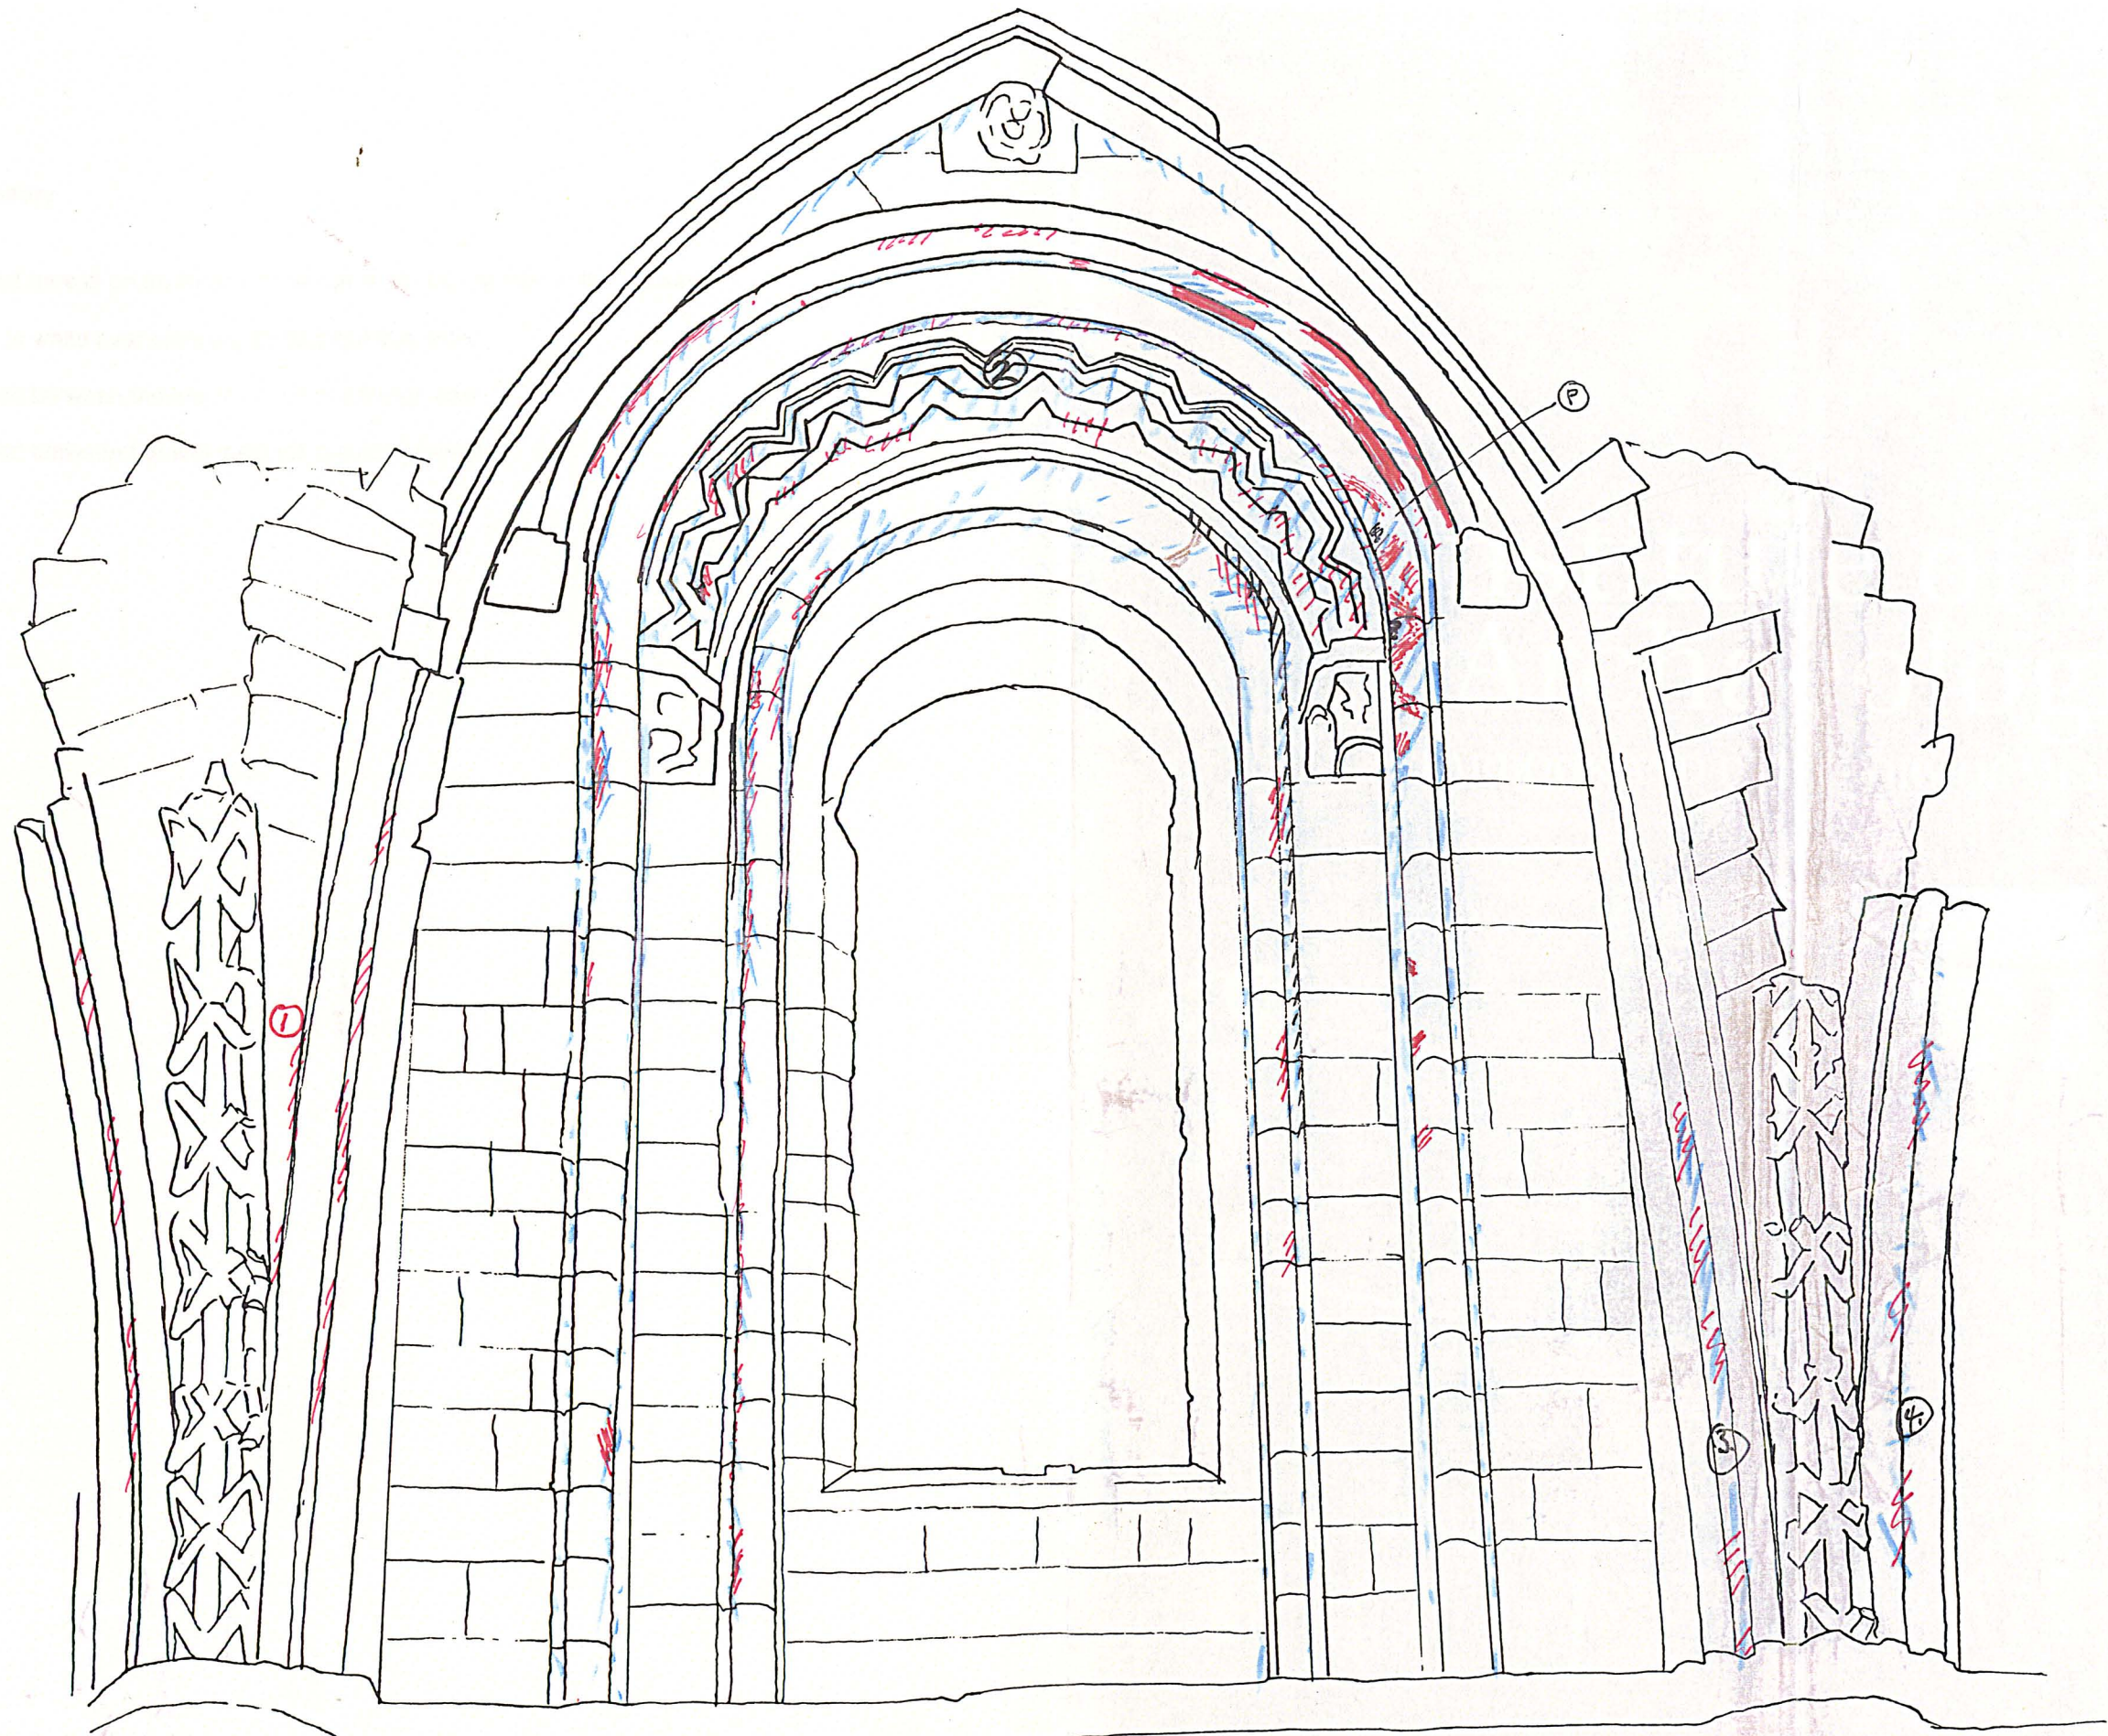
Bay 3S clerestory

1. The red here is on an inner face which is not fully shown in the drawing.
2. There is white over calcining throughout this order.
3. Located between the two main roll mouldings east.
4. Located between the two main roll mouldings west.

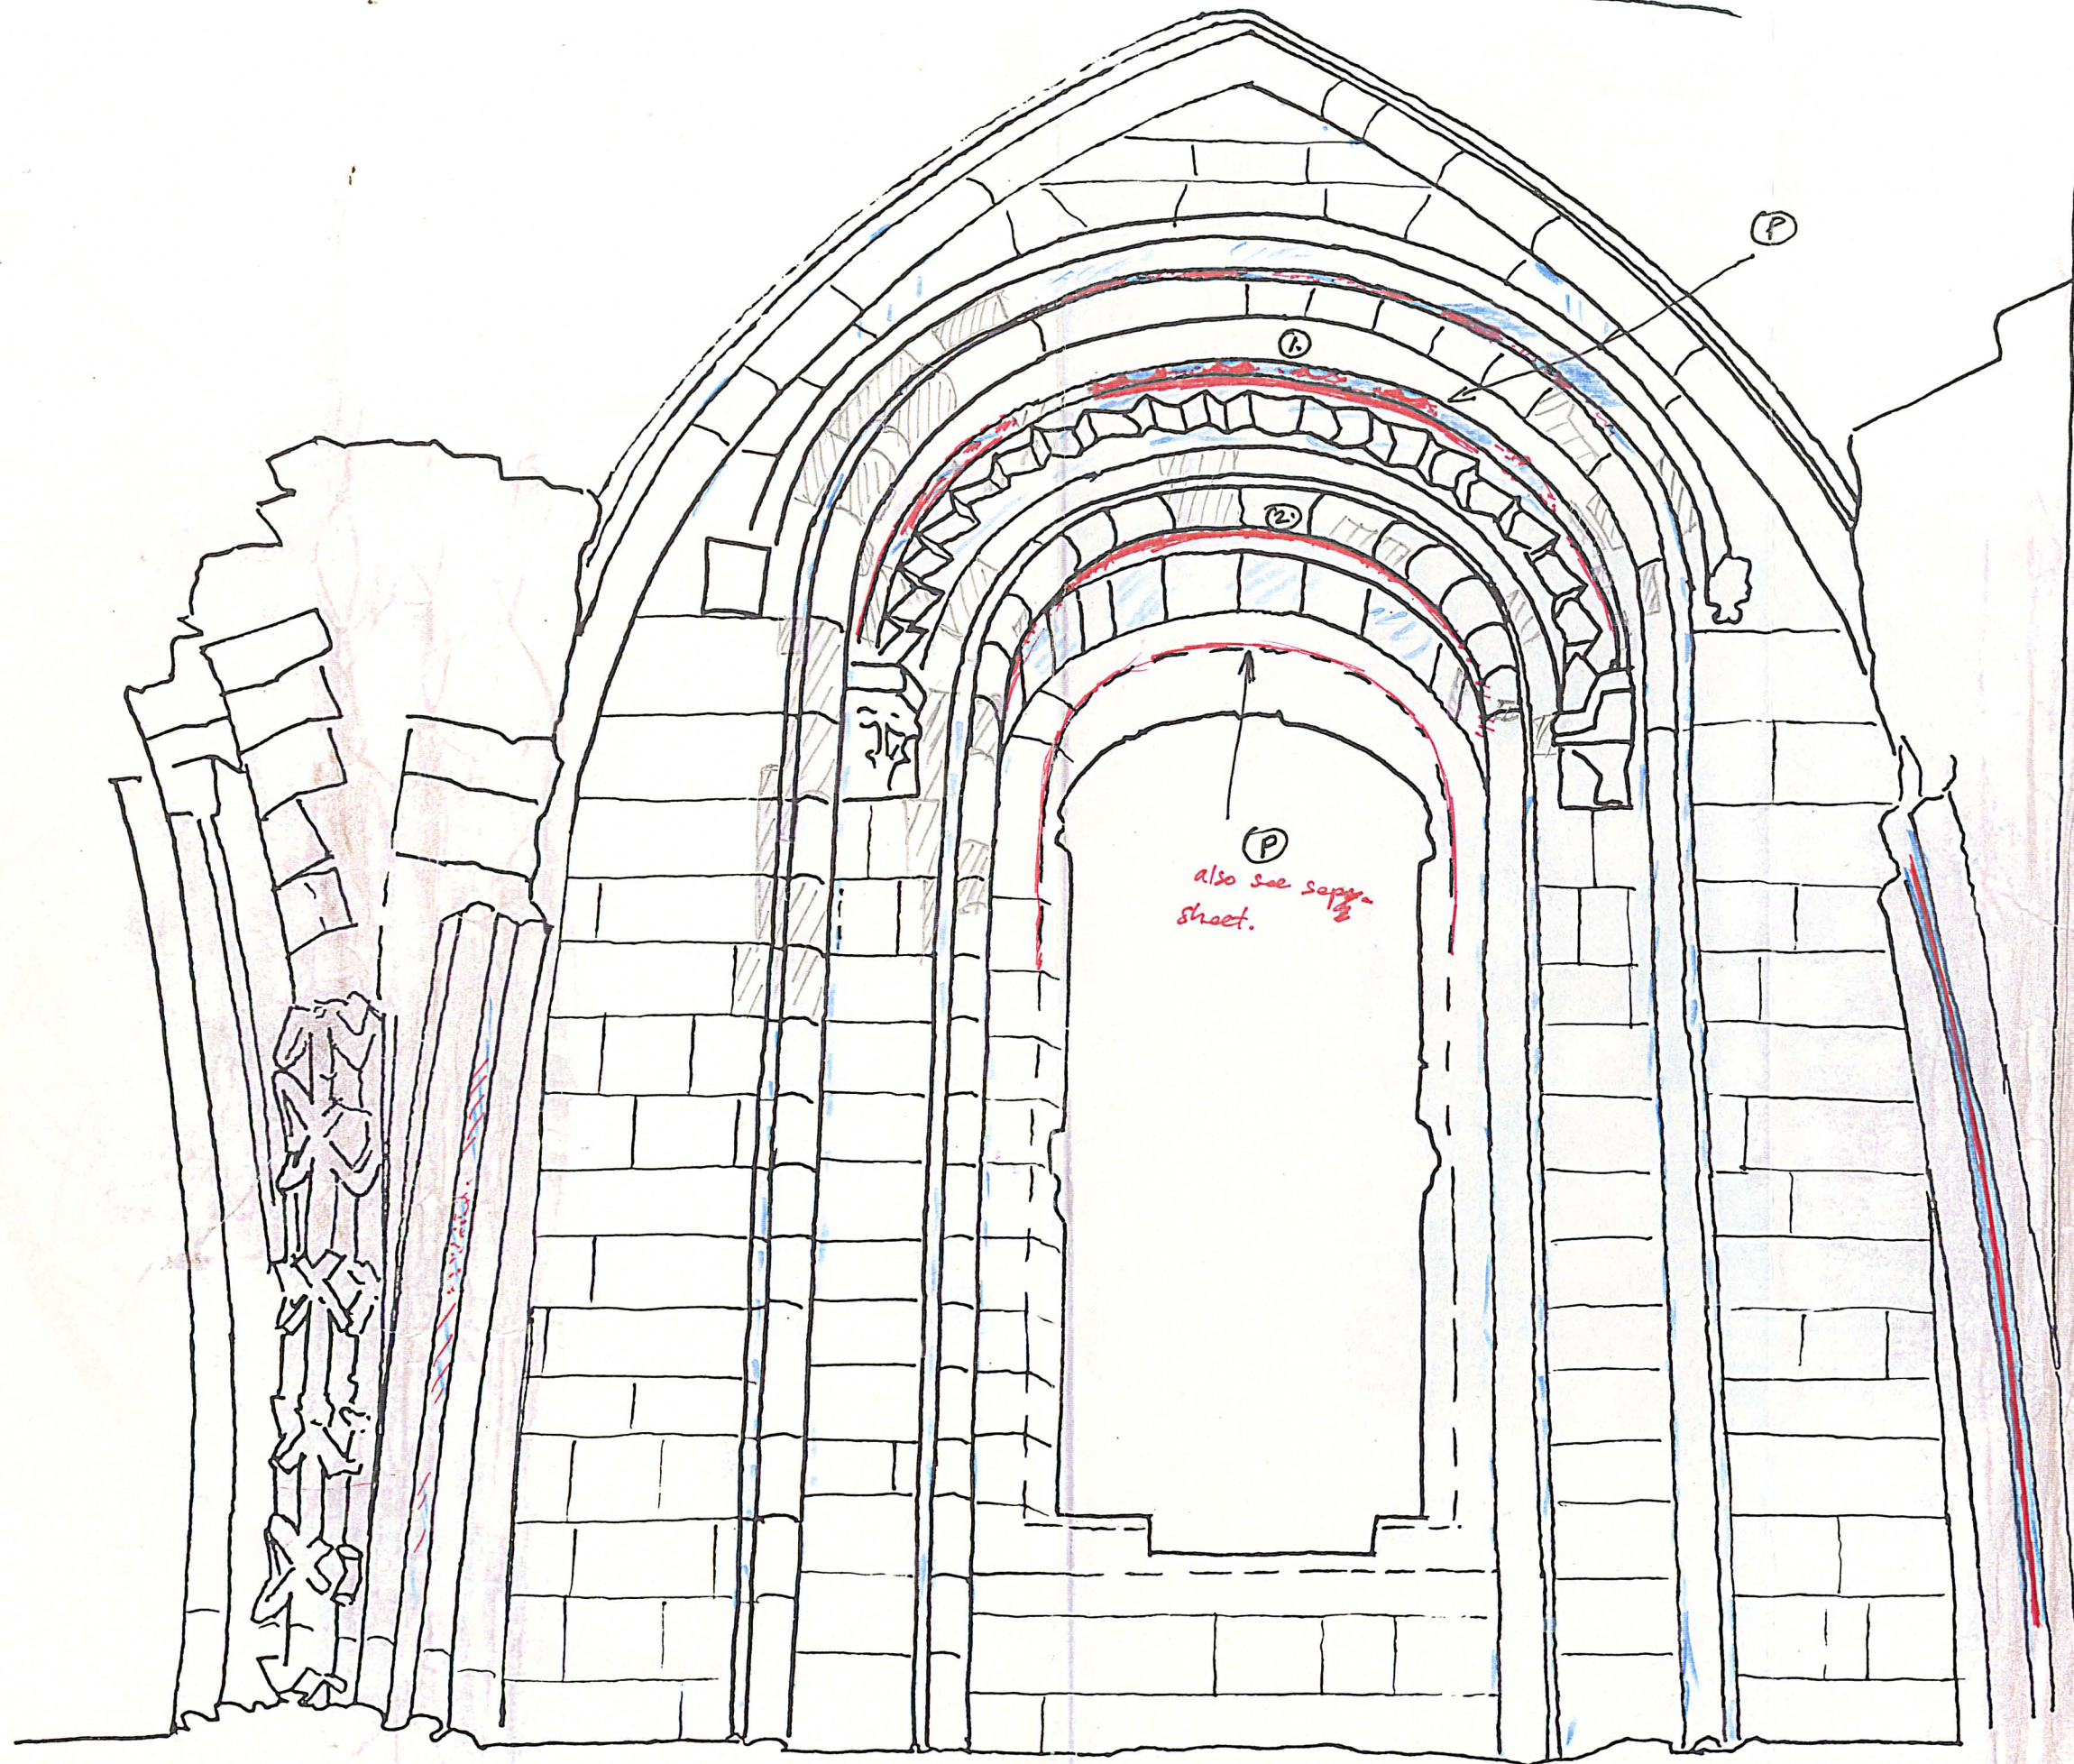
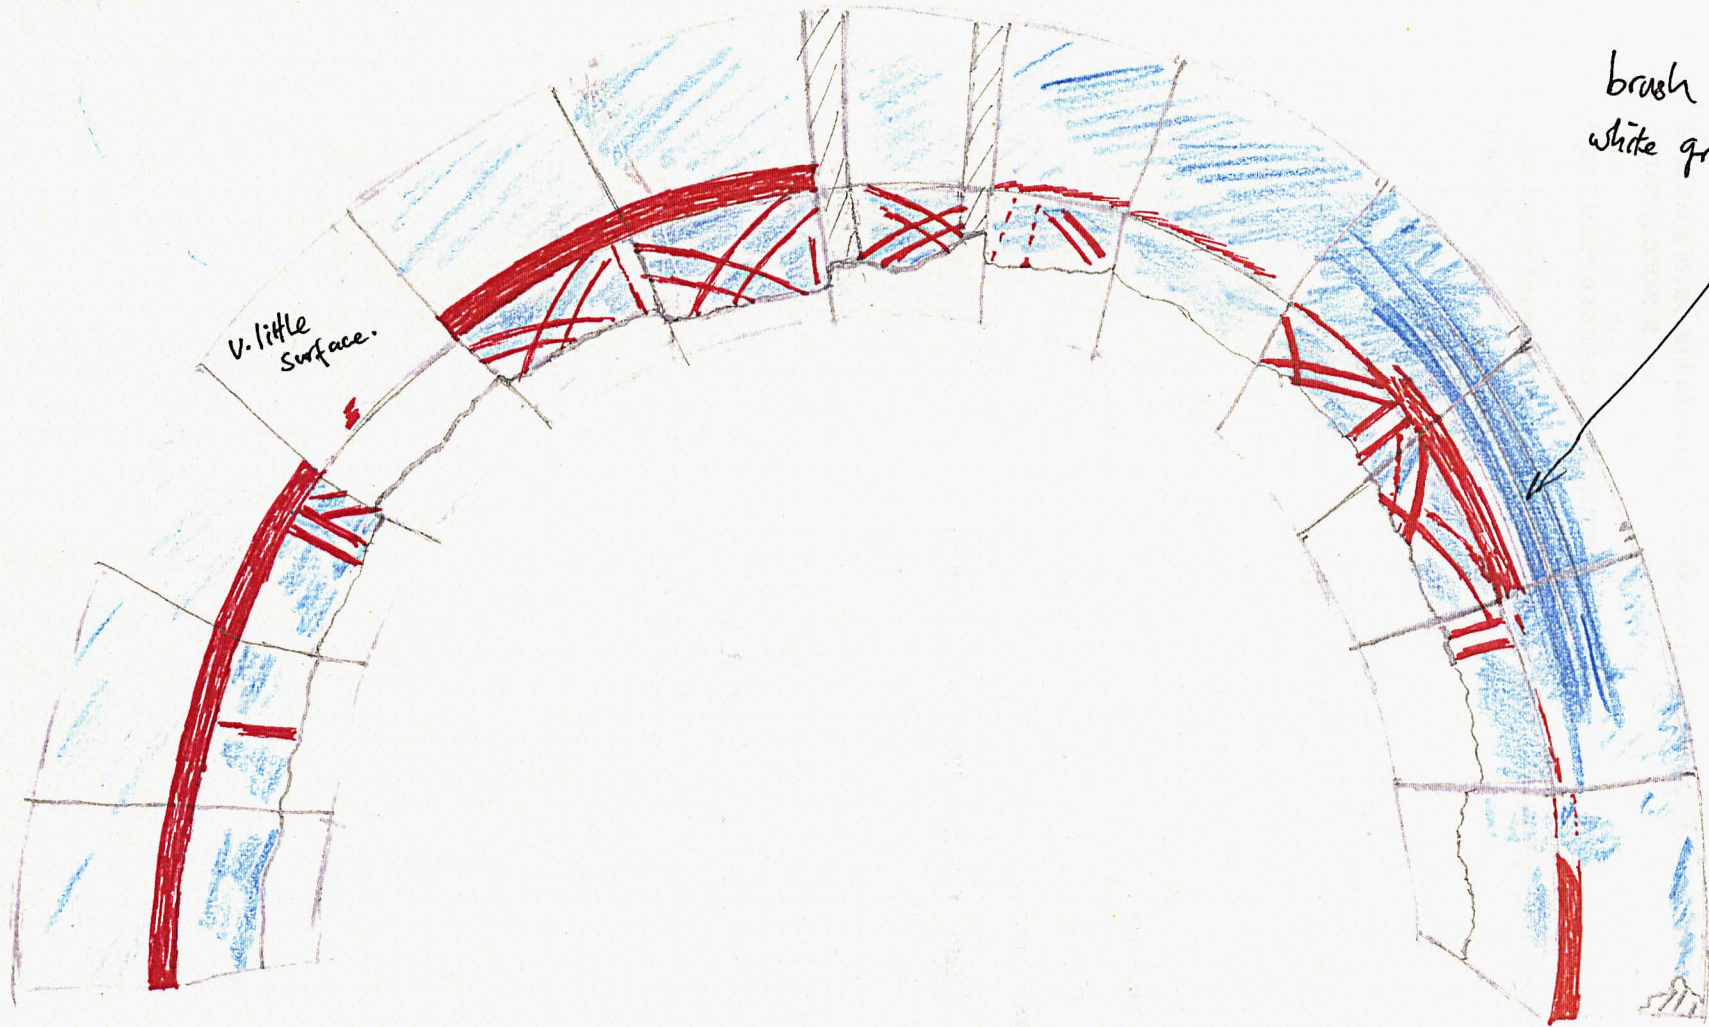
Bay 4S clerestory

v. little
surface.

brush marks in the
white ground runs
thus.

1. Scalloping in red and white on complex moulding between the chevron work and the roll moulding above it.

It also bears a white overpaint/wash.

2. This red is covering the next chamfered moulding in from the roll – not shown in the drawing.

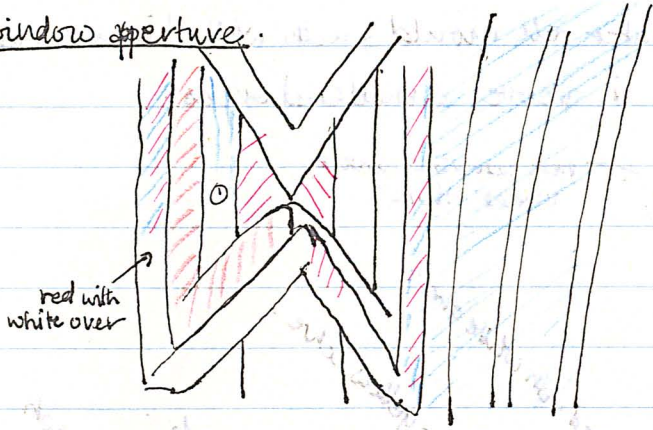
SW window aperture.

red with white over

① white limewash with brownish colour over.

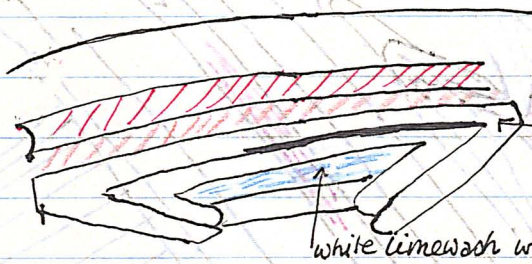
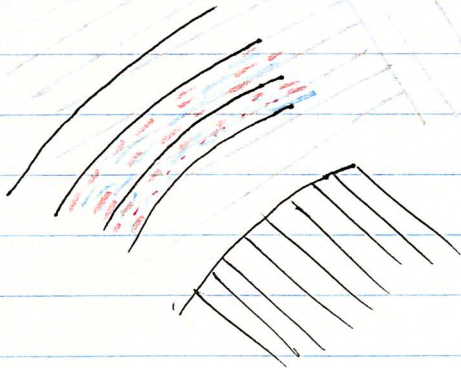
CENTRAL WINDOW

← dark red over white underneath roll.

possible black lining.

white limewash with brown over.

Inside orders of arch have white limewash; with traces of red over yellow ochre.

Thick dark red inside outer roll mould, with white linewash over.
Many traces of white in grooves & sheltered areas.

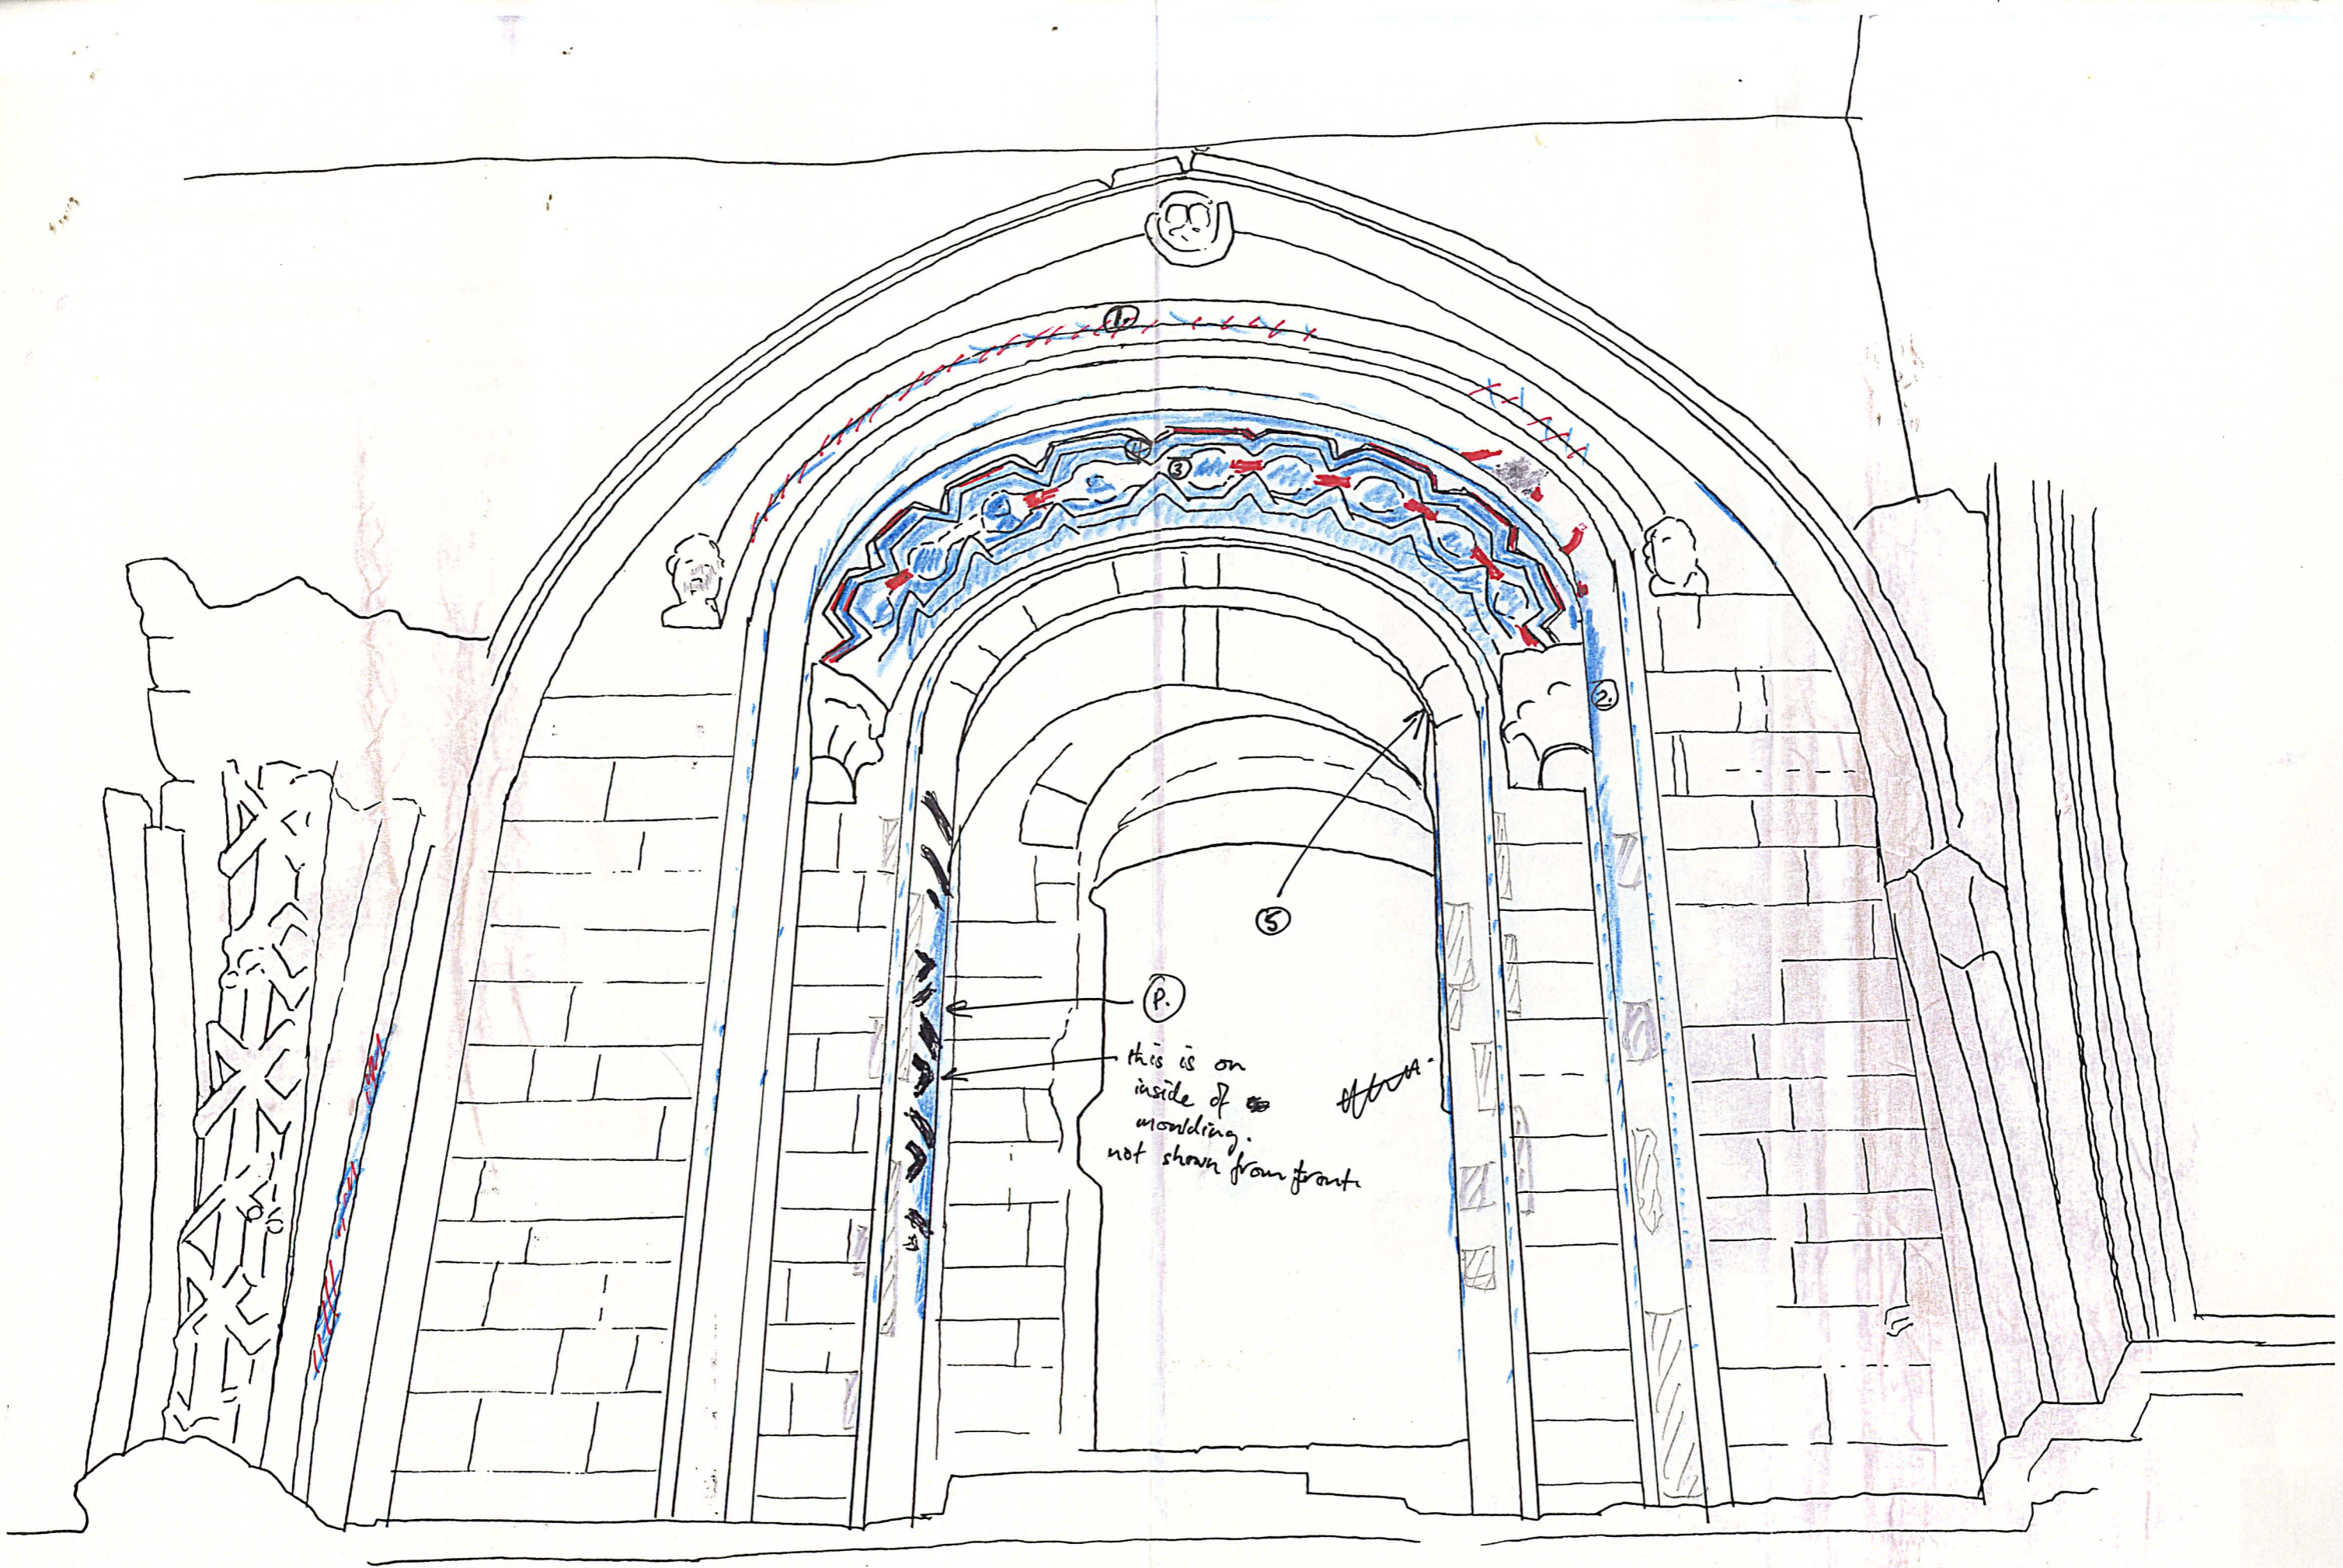
Bay 1N clerestory

①
②
③
④
⑤
P.
this is on
inside of
moulding.
not shown from front
HWA

1. Red with white over underside of hood moulding between label stops – not quite in the area of the drawing.
2. Much of the white here, especially on the roll moulding, looks more 'solid' than the overpaint/ground encountered elsewhere – though the latter type is also present here.
3. Three orders of chevron work here – white over most of it, with red only on the outer flank of the top order and the 'joining pieces' of the middle order (not on the teeth).
4. Some of this is pink overpaint.
5. The inside of the reveal.
