Glastonbury Abbey

The Lady Chapel

Polychrome Survey:

Record Drawings –

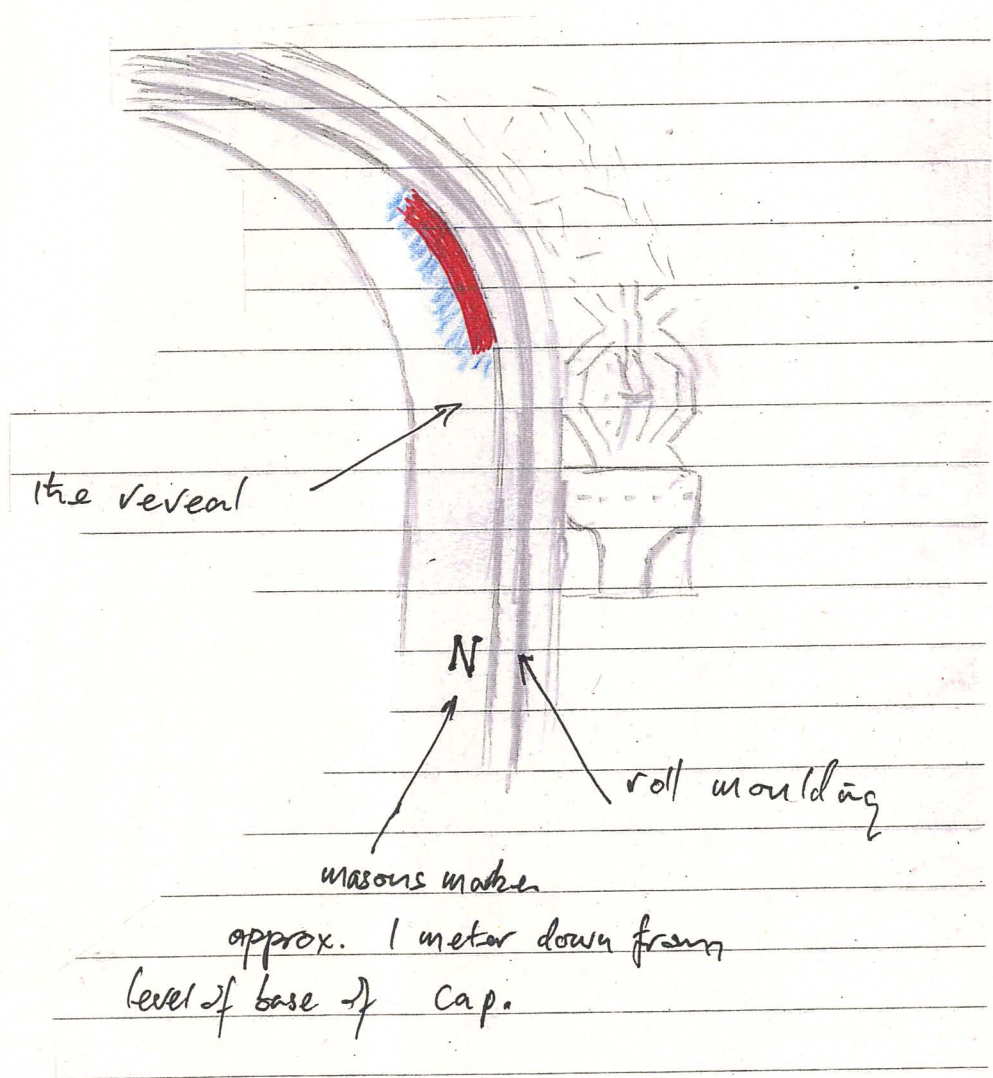
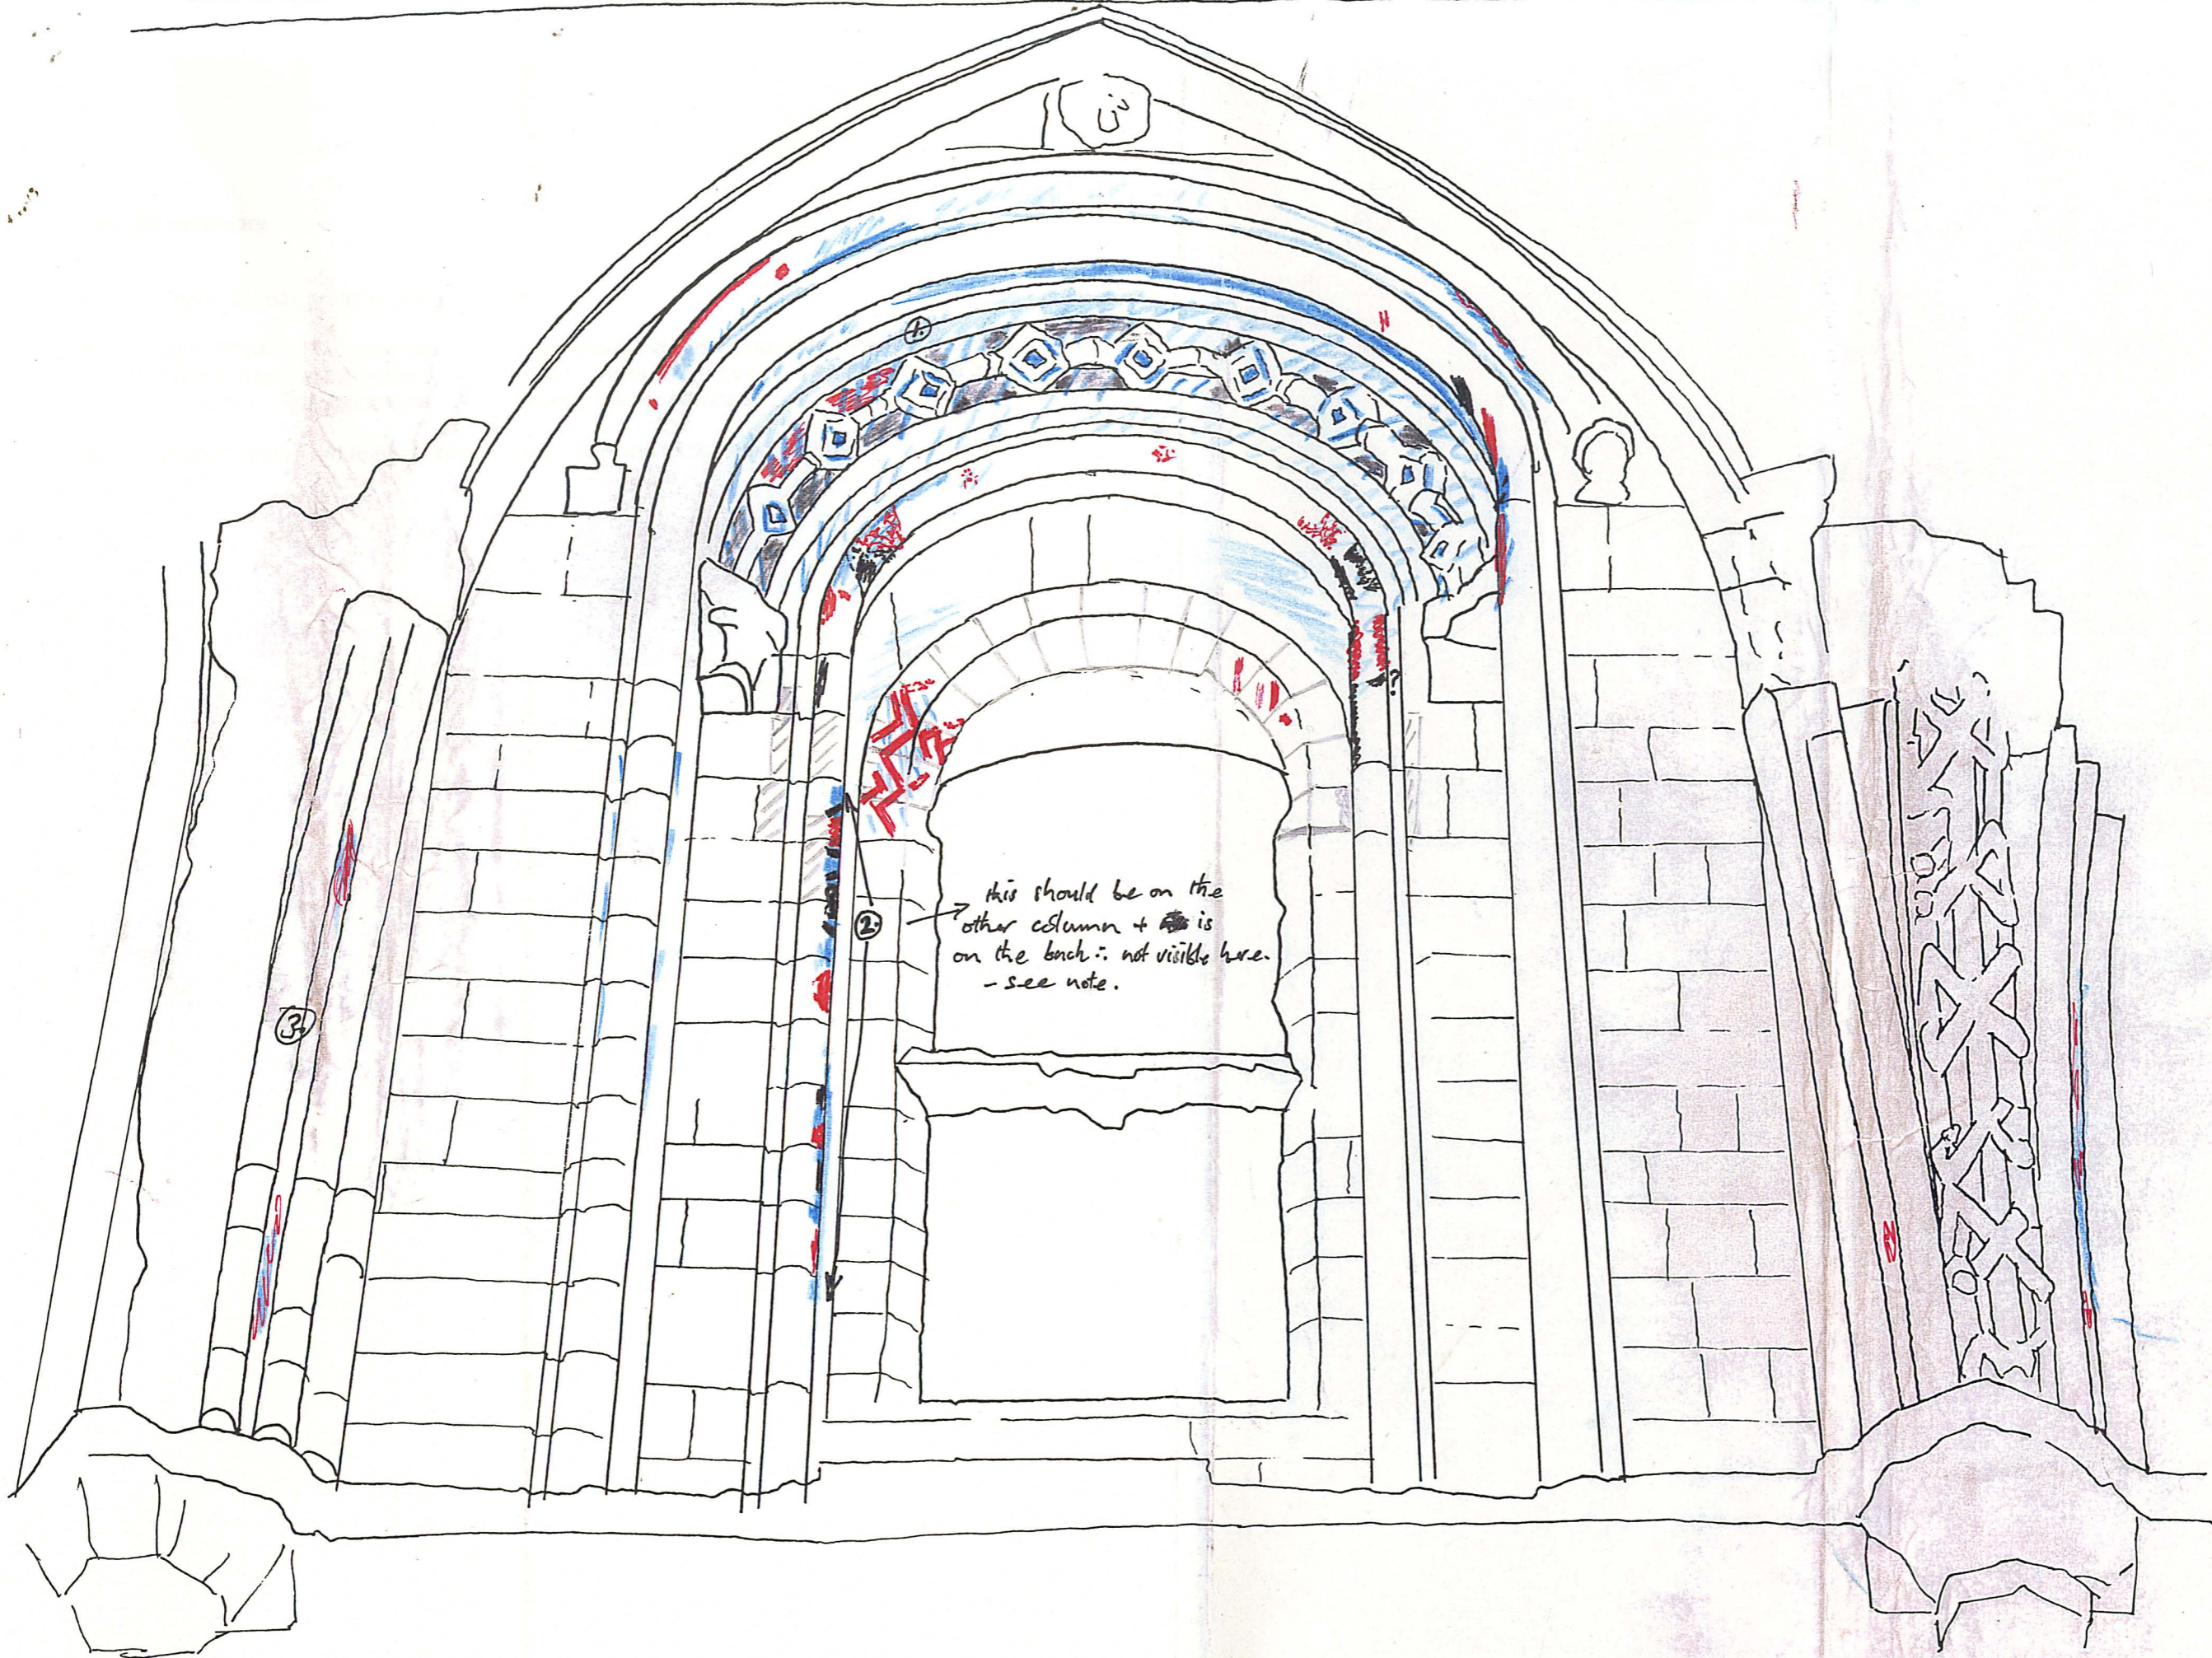
Bay 2N clerestory

→ this should be on the other column + is on the back ∴ not visible here. - see note.

③

②

1. This order has areas of pink overpaint.
2. **IMPORTANT:** The paint (red/black/white) shown here as being on the western attached shaft is in fact on the eastern attached shaft, and is also behind it rather than on the front as shown. The joints shown in the drawing are not accurate.
3. Probably more red and/or white survives under the thick black crust here.

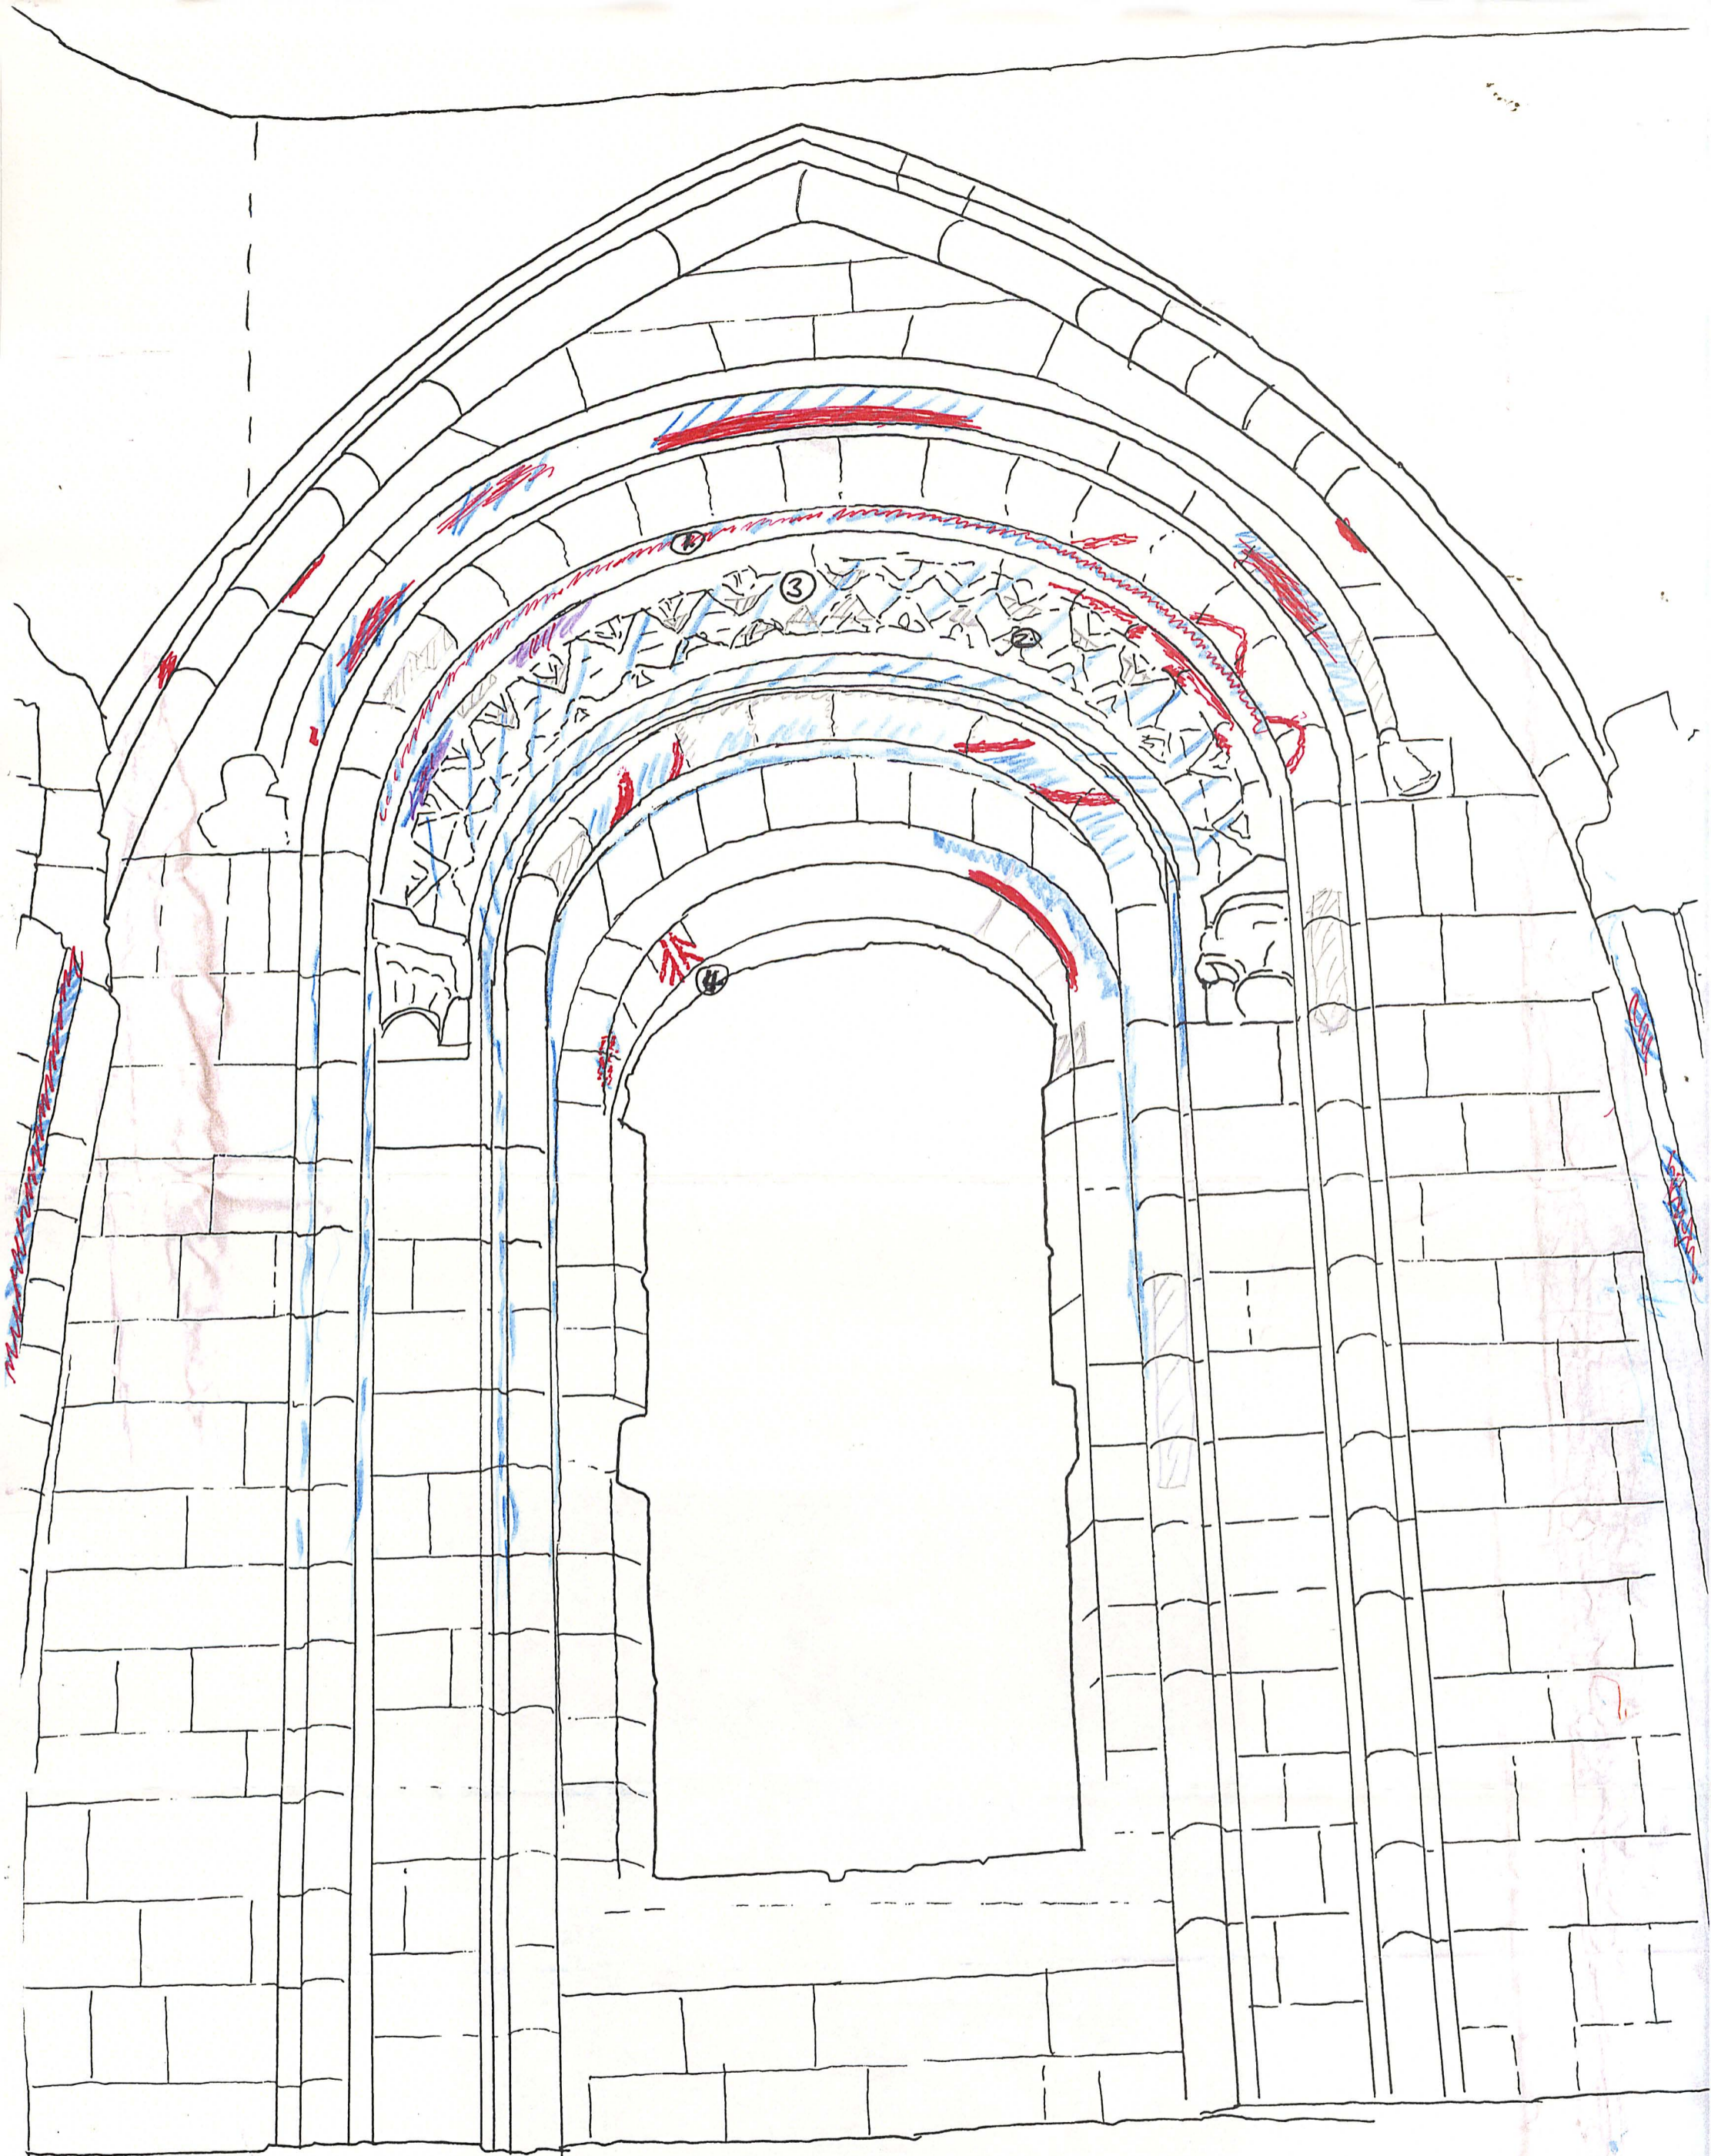
Bay 4N clerestory

1. Red with white over on flat face of small inner moulding (not shown on drawing).
2. Two ends of a copper pin (green only showing) here.
3. White over calcining throughout this chevron work.
4. This interpretation of the pattern was made only after long examination, and may not be very reliable – it exists only as a collection of dots and semi-lines of red.
