Glastonbury Abbey

The Lady Chapel

Polychrome Survey:

(2) The Clerestory

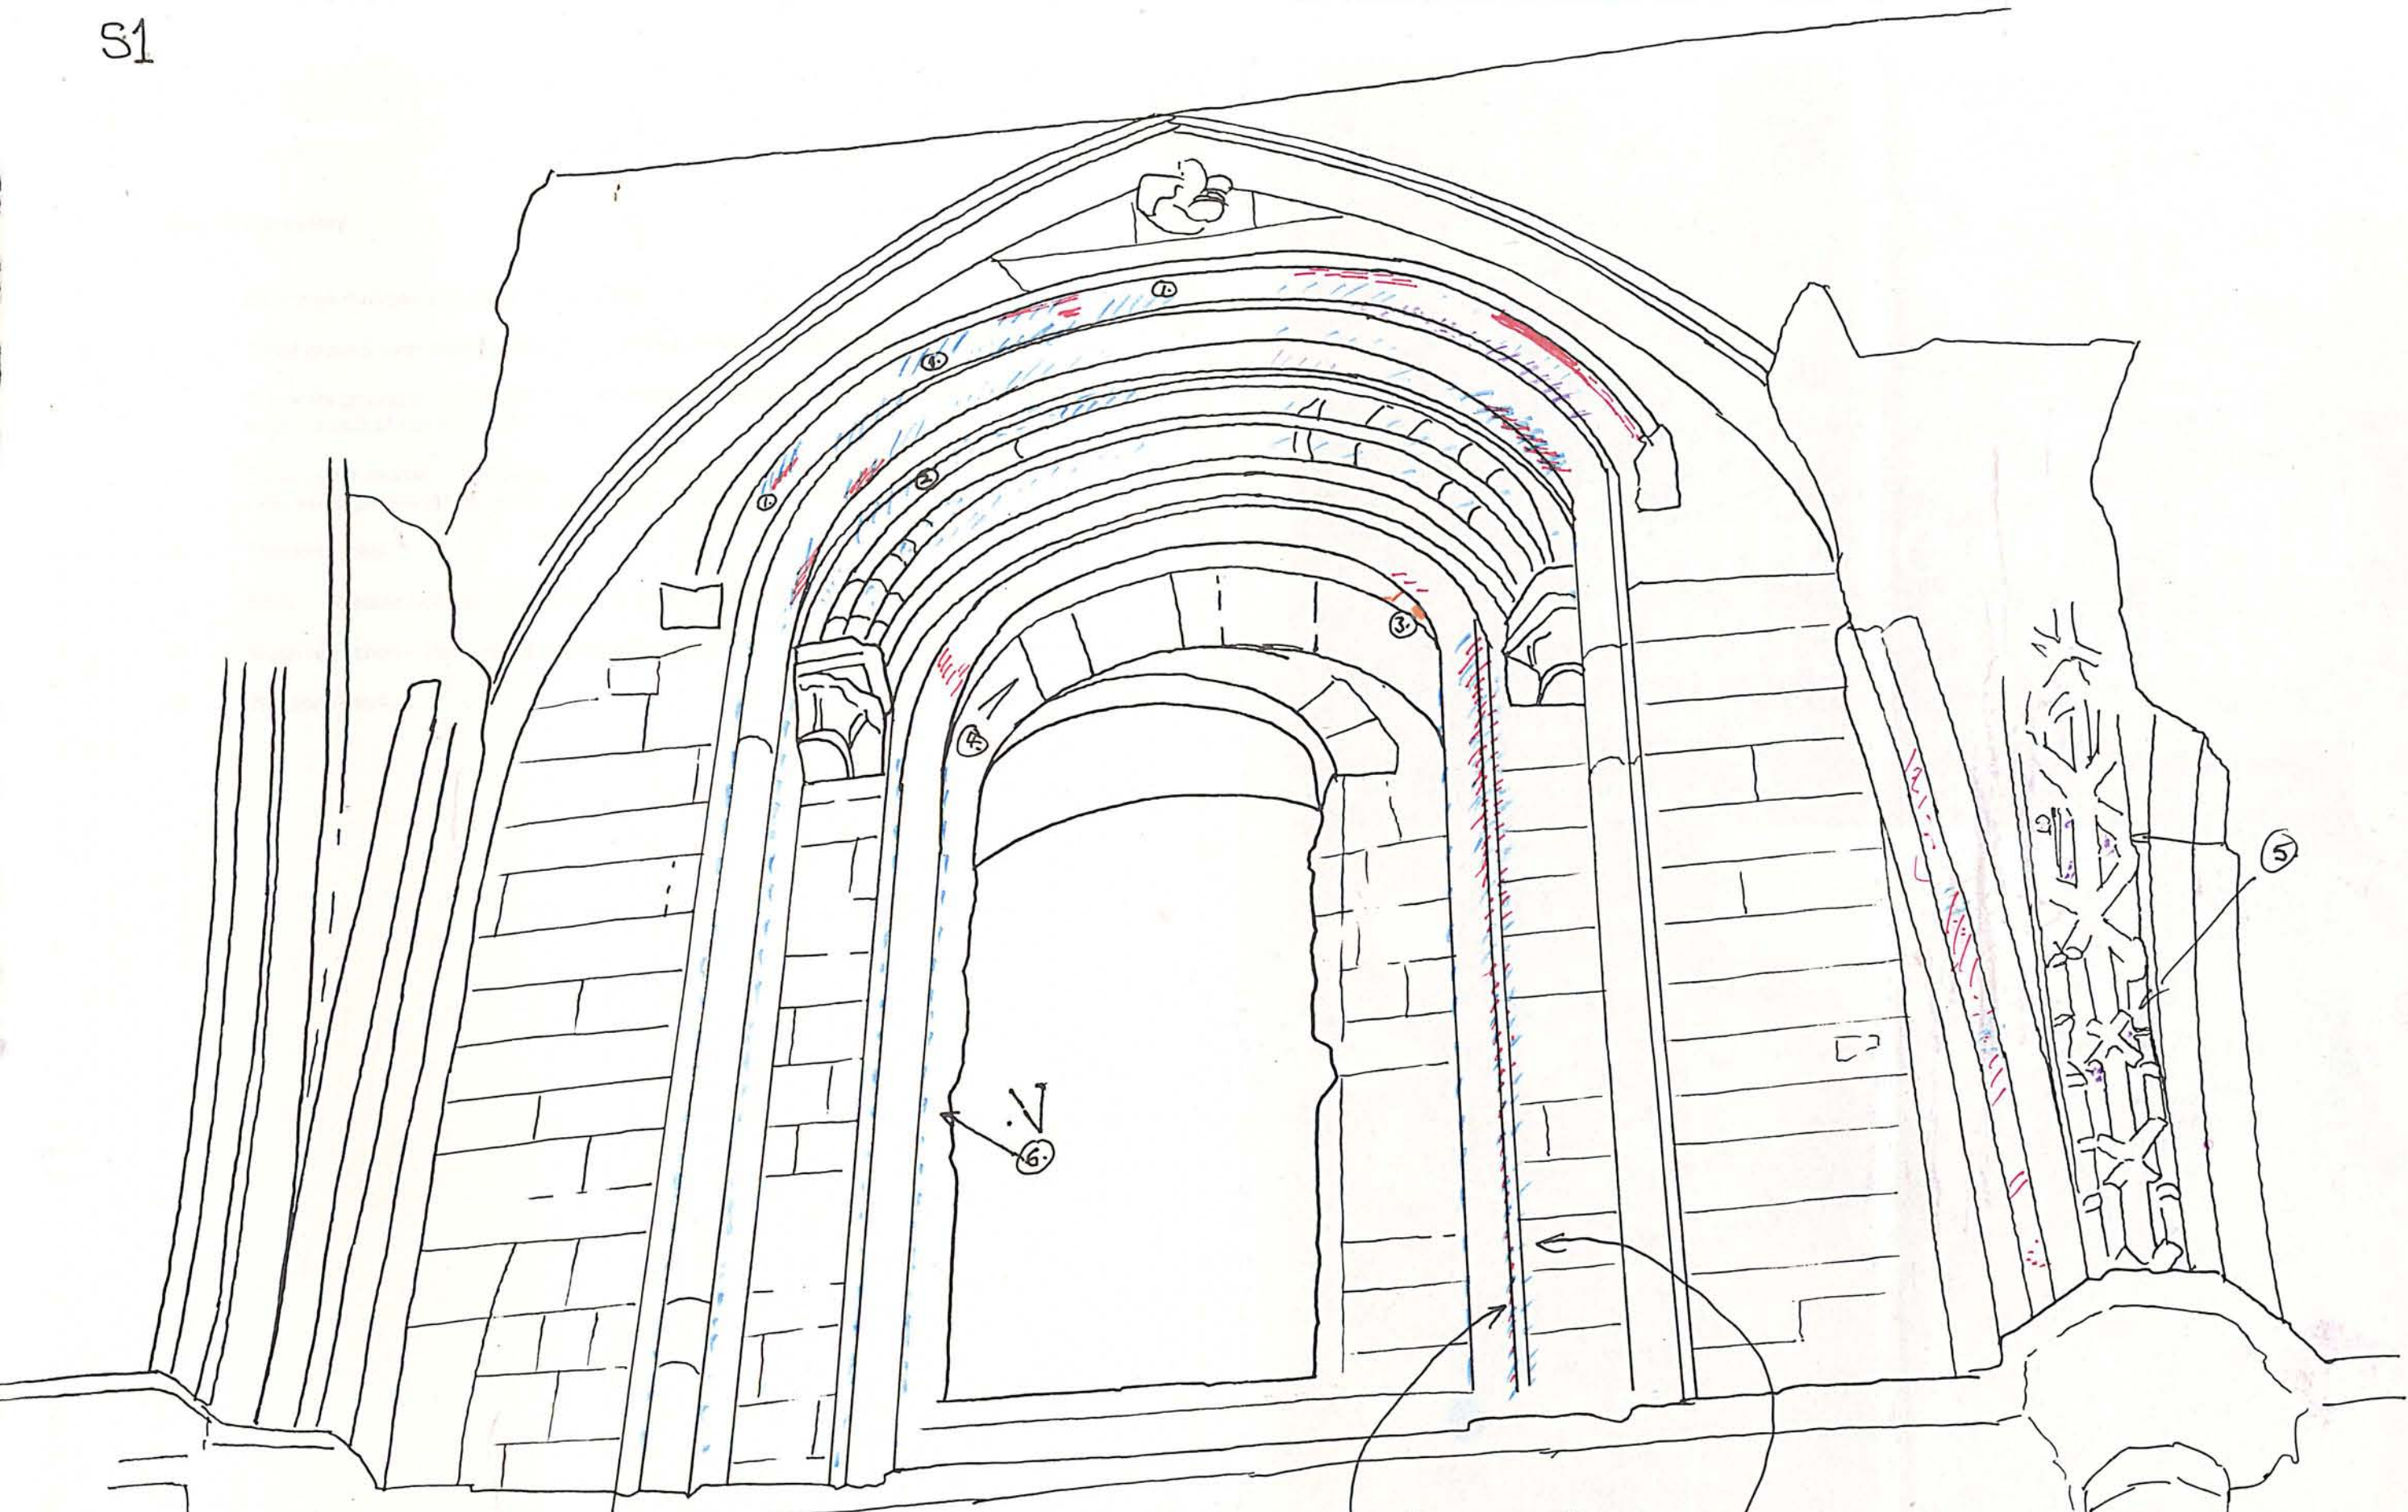
Bay 1S clerestory

important - mistake :
red with white | white only
over only on | on outside
inside of bead |
moulding

1. Later pink overpaint on some of this white.
2. White ground over calcining on this order and on next orders, including chevron work.

The white ground is only indicated on all orders of this head as most areas have some at least – much of this with pink overpaint.
3. Brown over mortar – ?old fixing. This in reveal and therefore not shown on drawing. Also white ground in this reveal; also spots and patches of red.
4. ?Masons mark.

Note: – possible hints of red on chevron work, but if so only dots over heavy calcining.
5. Much red lichen – these spots of red are suspect!
6. ?Masons mark.

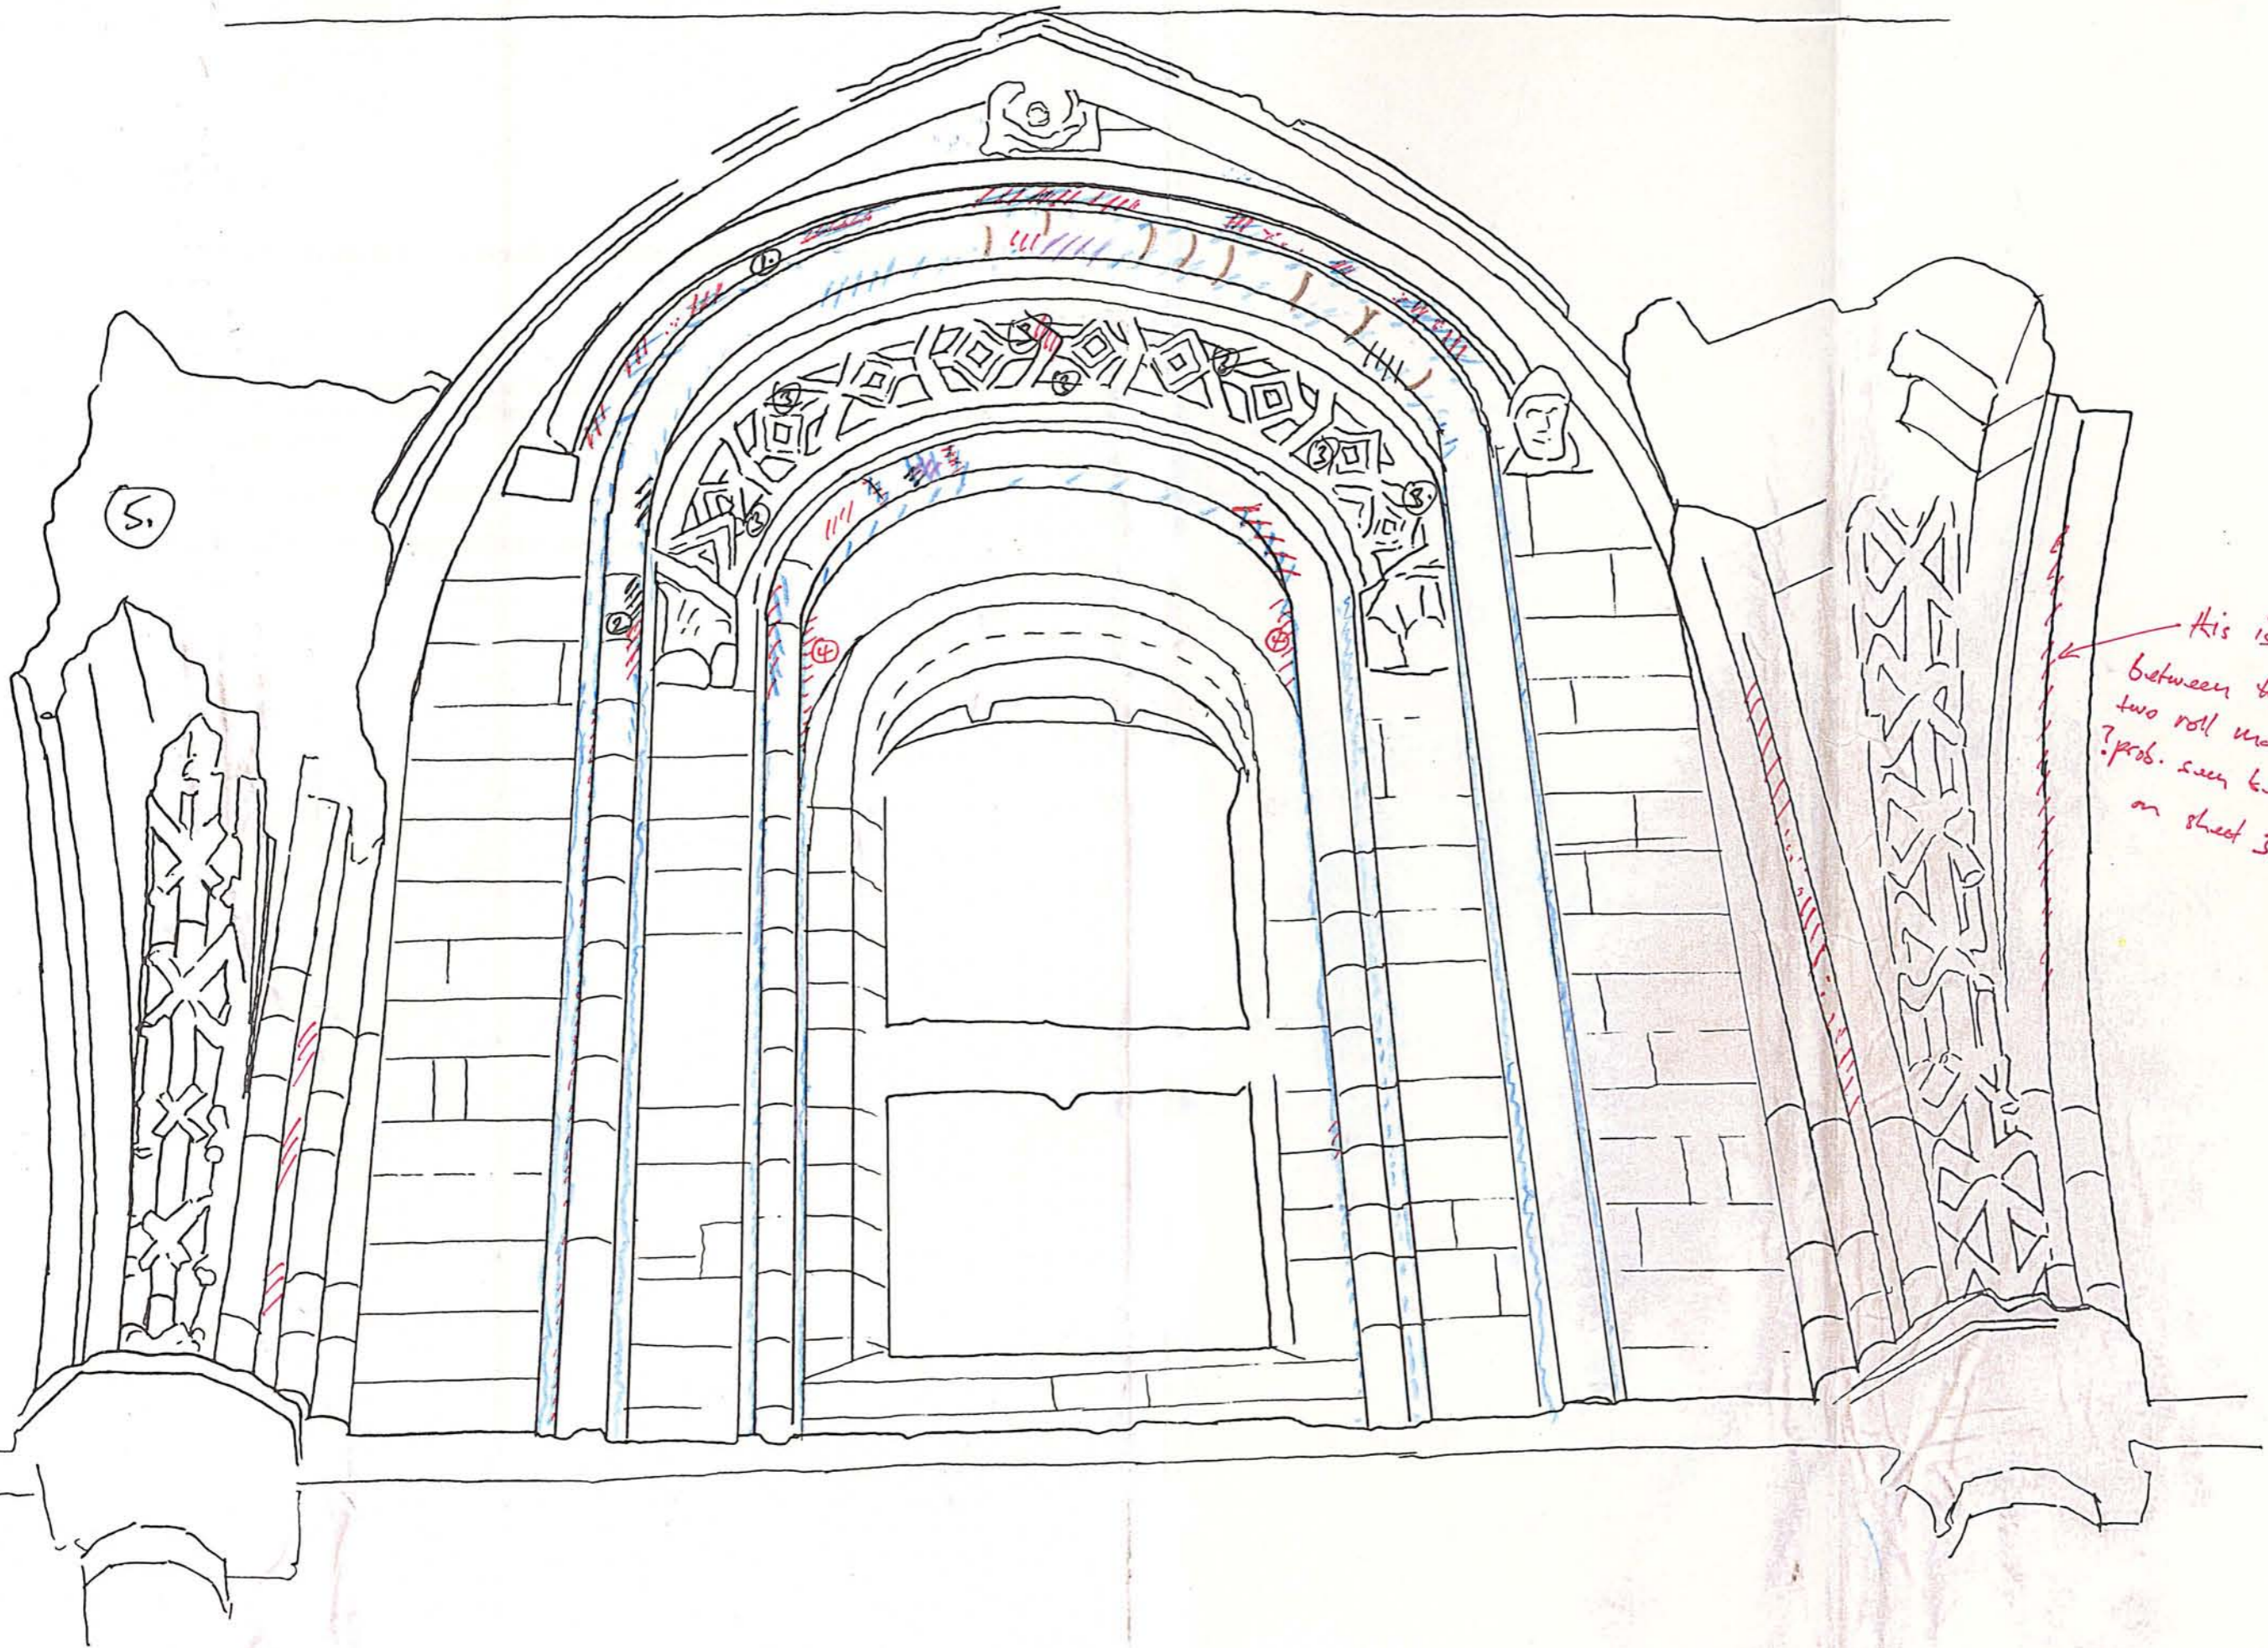
Bay 2S clerestory

This is
between the
two roll mouldings
? prob. seen better
on sheet 35

1. All the red on the vertical face of this moulding is a strong thick red with patchy white paint over it.
2. Red and black, both under white.
3. Patches and spots of white throughout this order – only the one patch of strong red is definite. There are also speckles thought to be calcining, but which could include or incorporate red paint.
4. The red here is on the edge of the reveal, which is not shown in the drawing.
5. Most of this vault springer assembly is shown in the drawing for 1S.

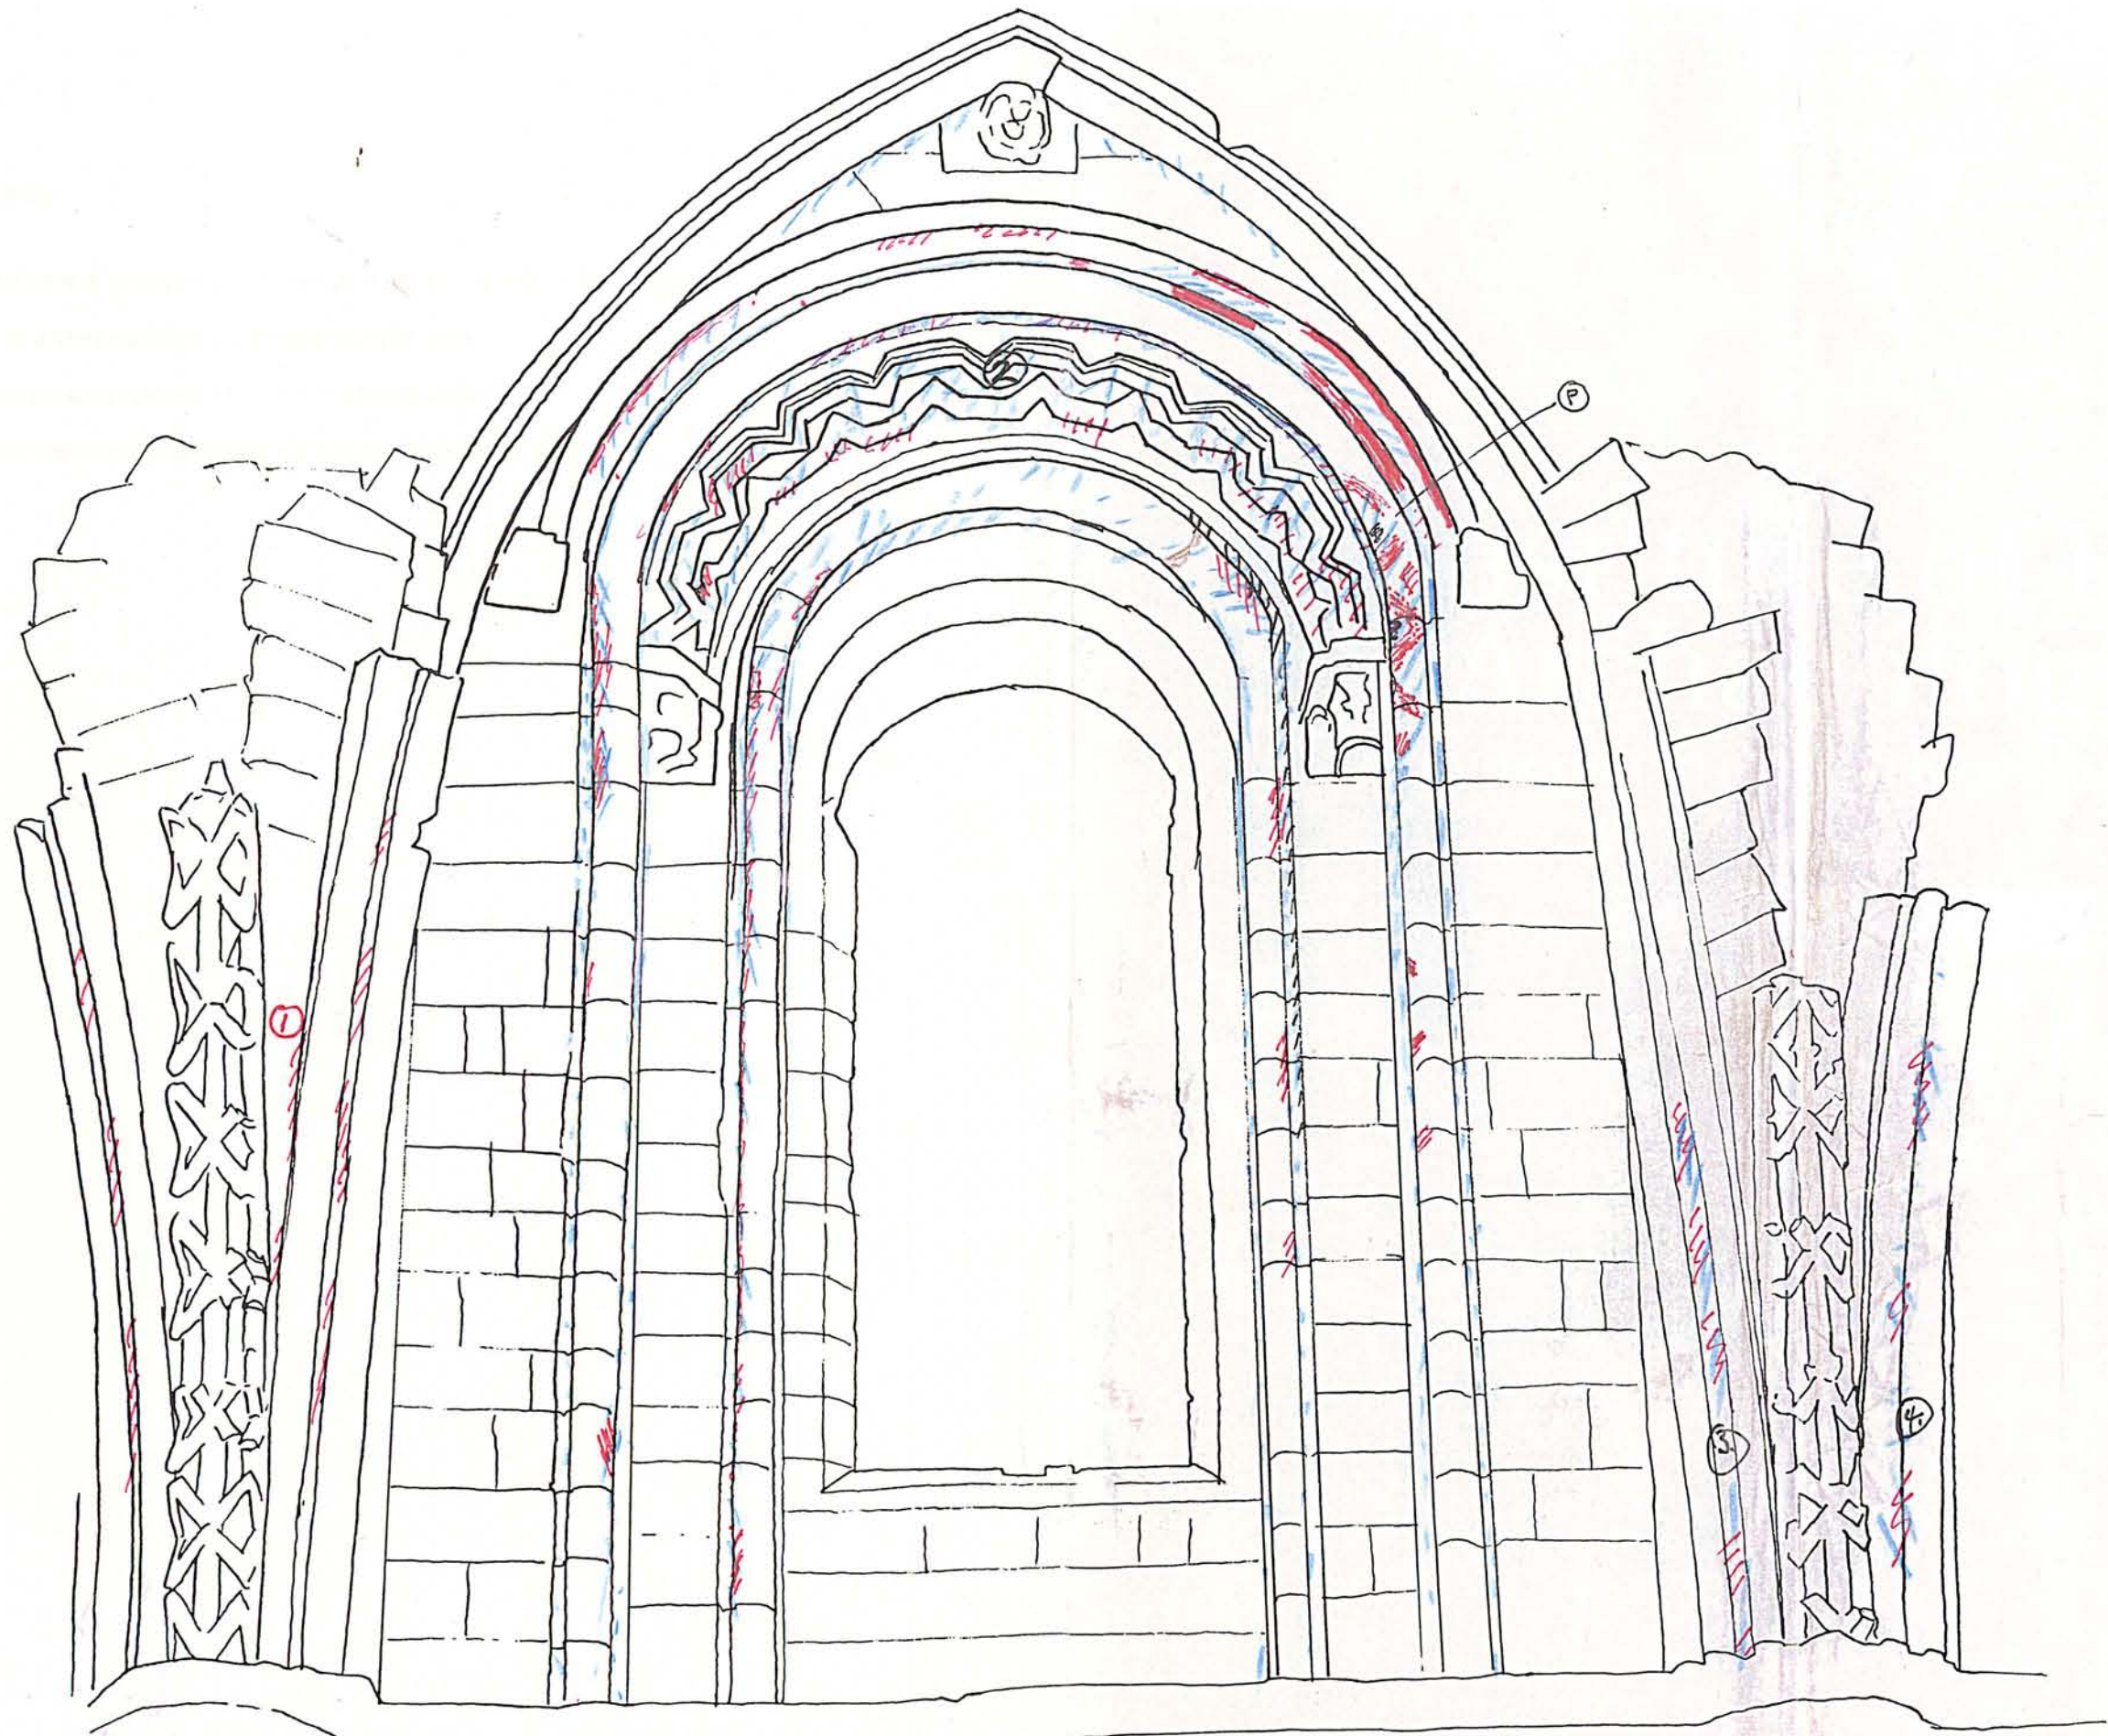
Bay 3S clerestory

1. The red here is on an inner face which is not fully shown in the drawing.
2. There is white over calcining throughout this order.
3. Located between the two main roll mouldings east.
4. Located between the two main roll mouldings west.

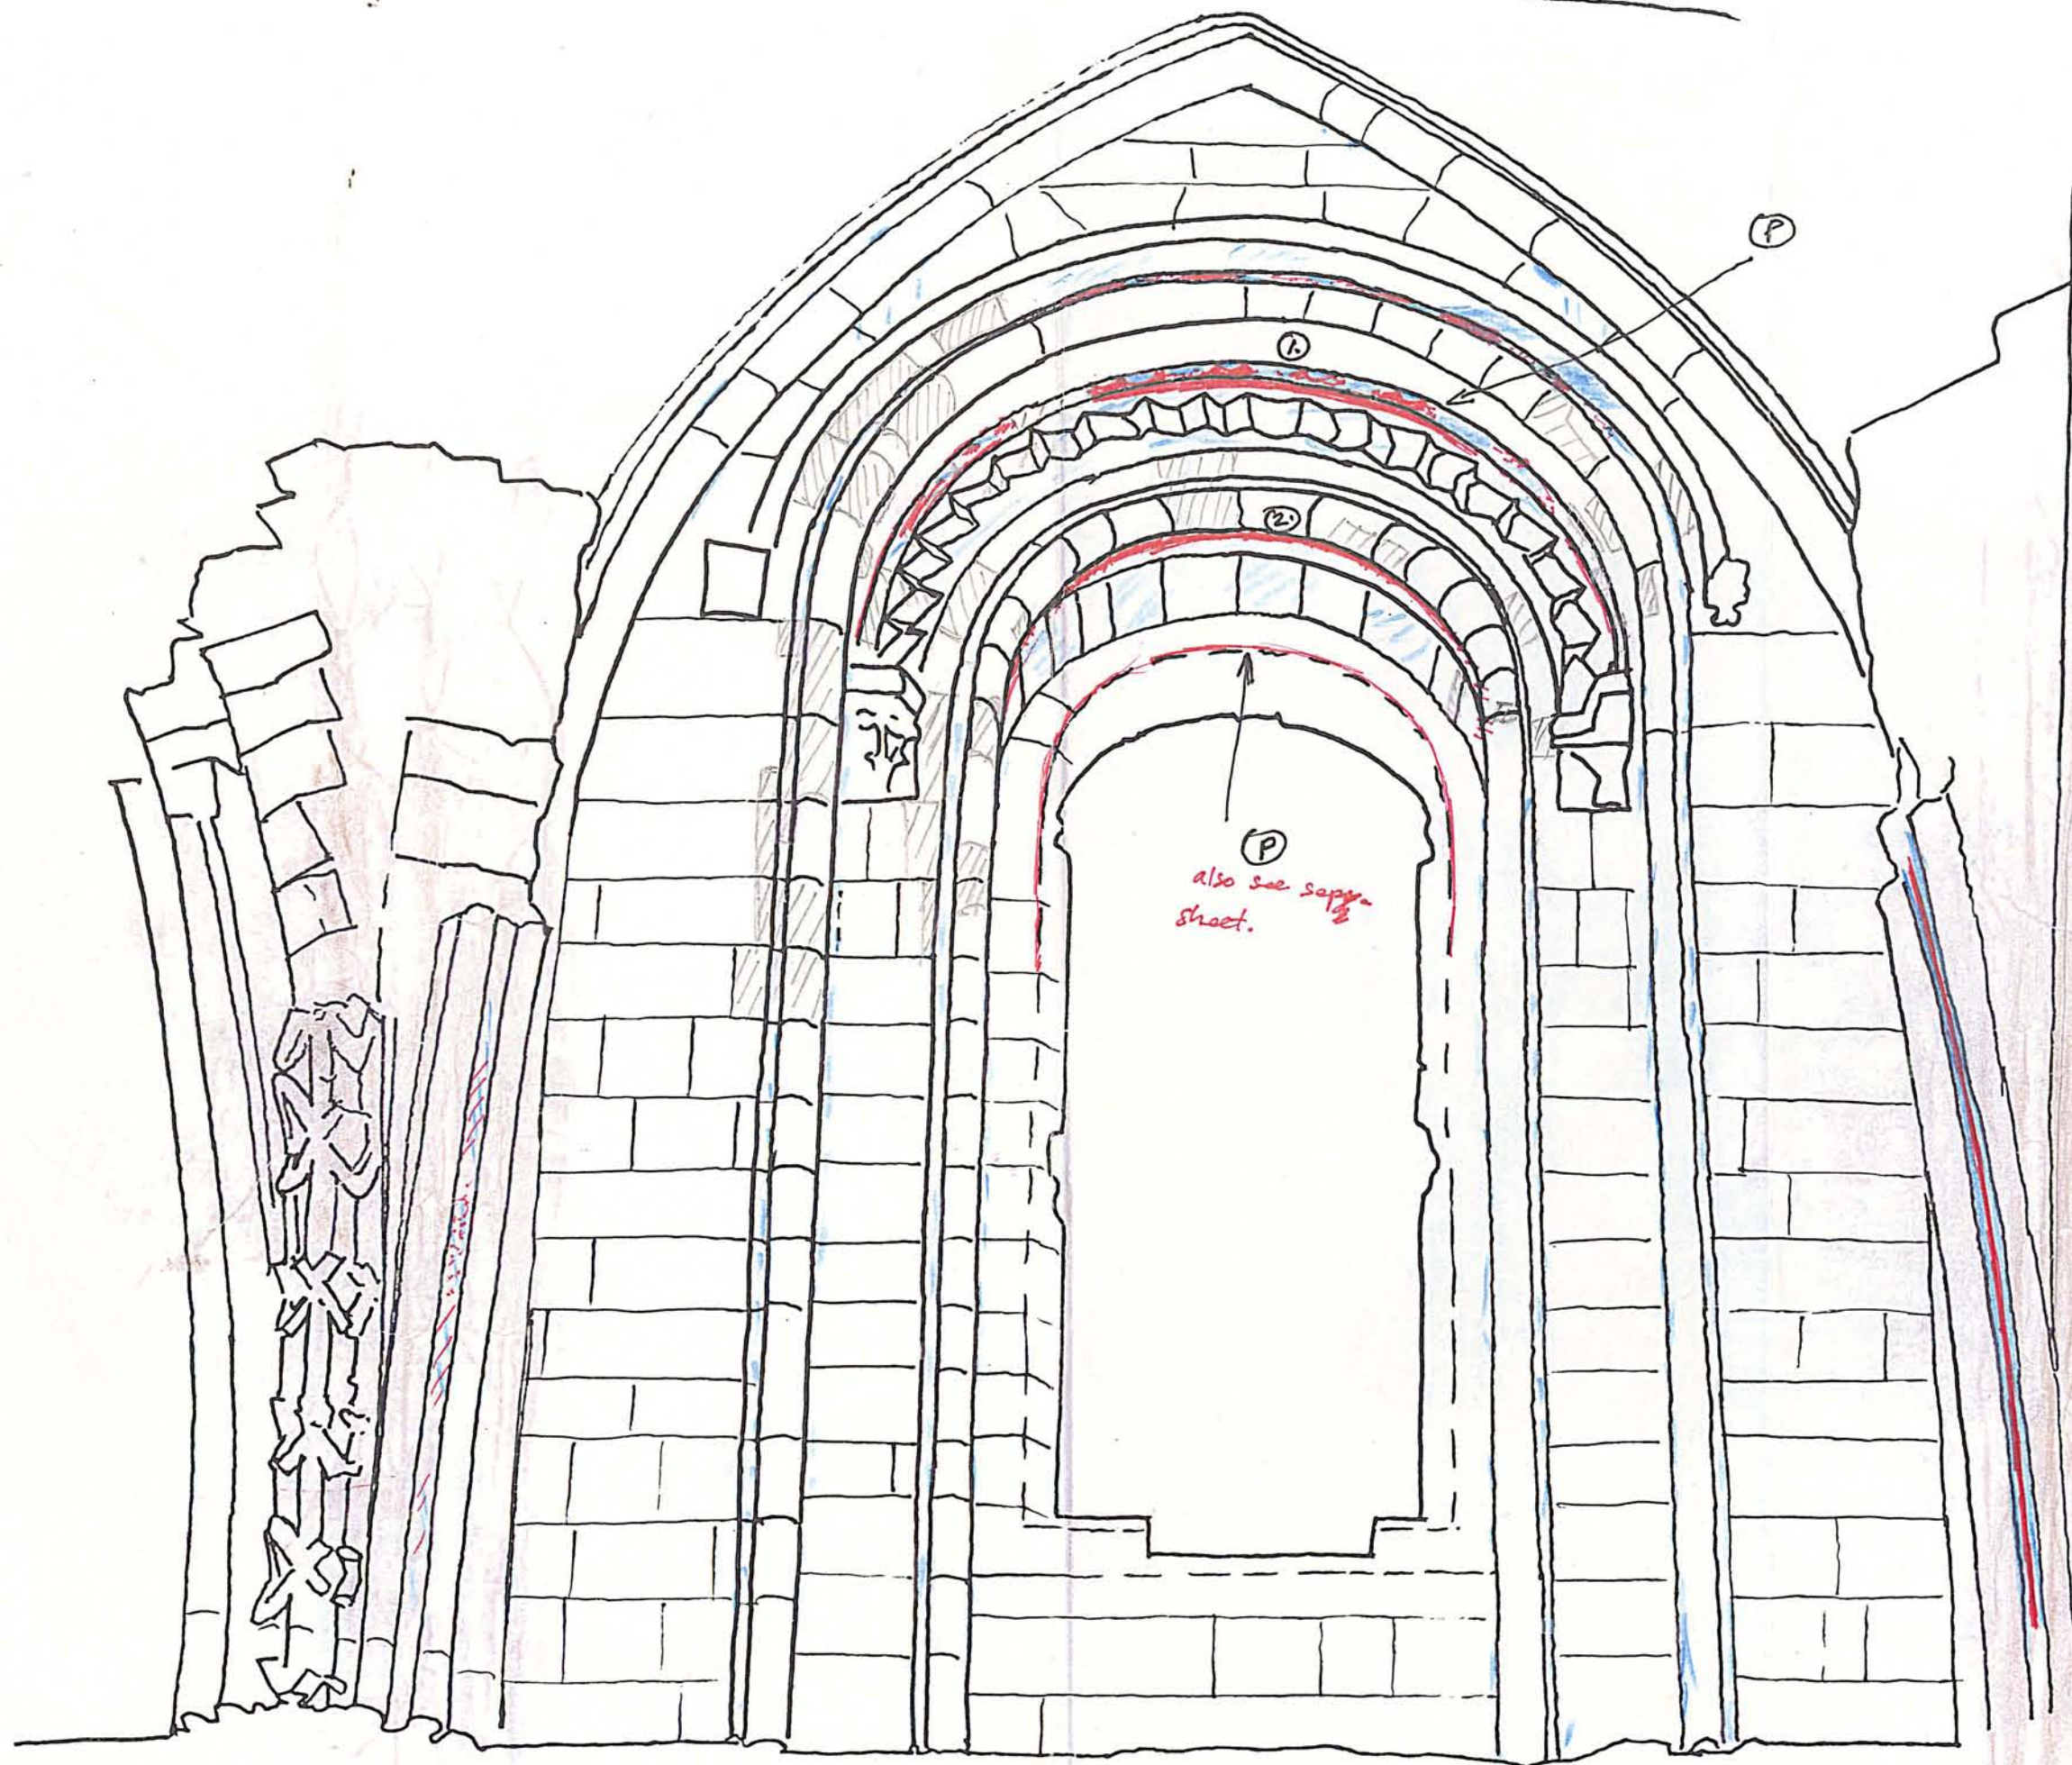
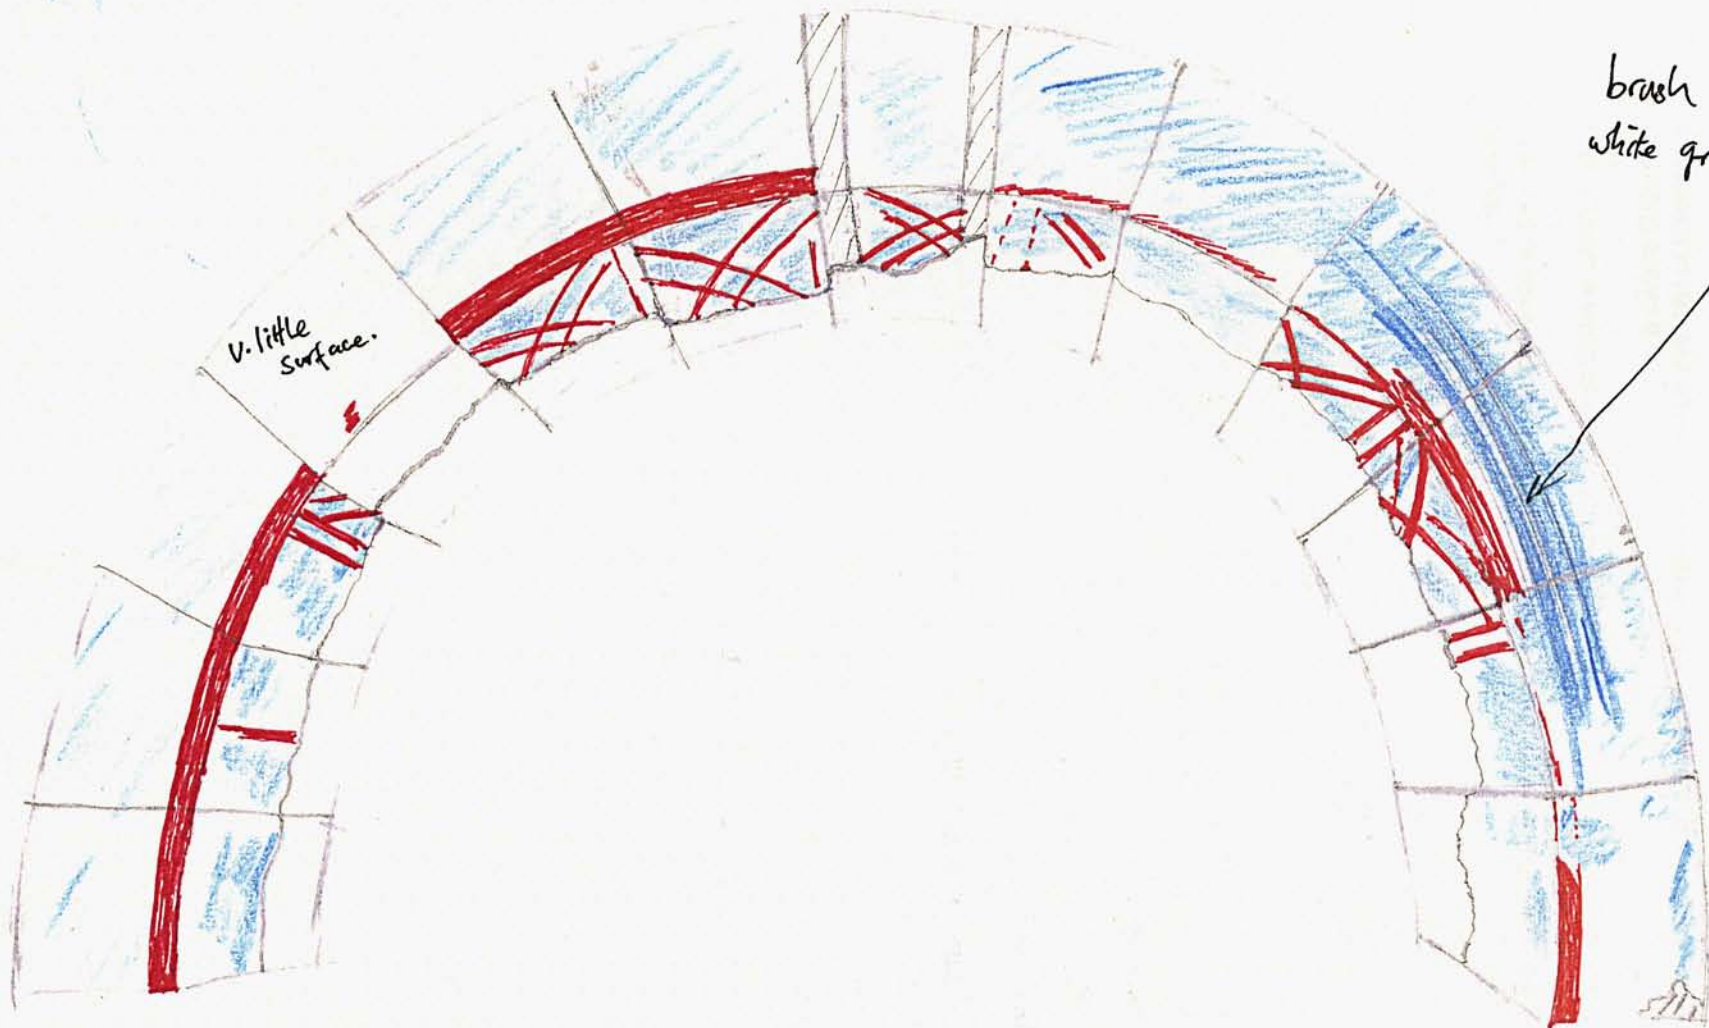
Bay 4S clerestory

v. little
surface.

brush marks in the
white ground run
thus.

1. Scalloping in red and white on complex moulding between the chevron work and the roll moulding above it.

It also bears a white overpaint/wash.

2. This red is covering the next chamfered moulding in from the roll – not shown in the drawing.

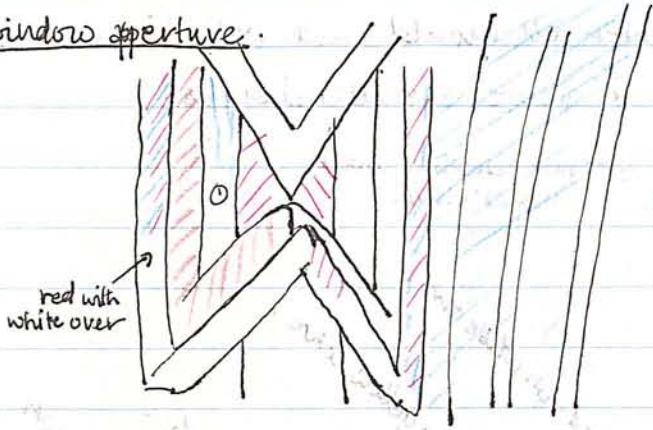
SW window aperture.

① white limewash with brownish colour over.

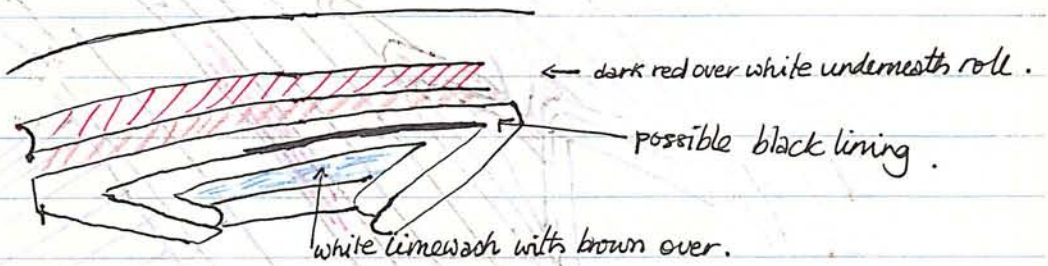
Inside orders of arch have white limewash; with traces of red over yellow ochre.

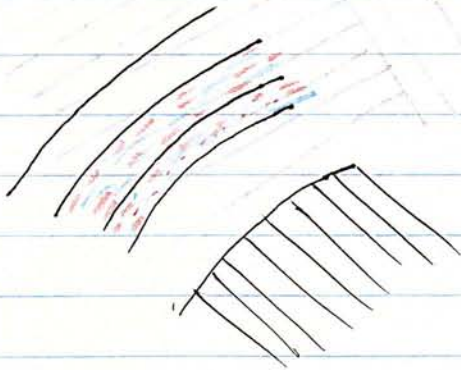
CENTRAL WINDOW

Thick dark red inside outer roll mould, with white limewash over.
Many traces of white in grooves & sheltered areas.

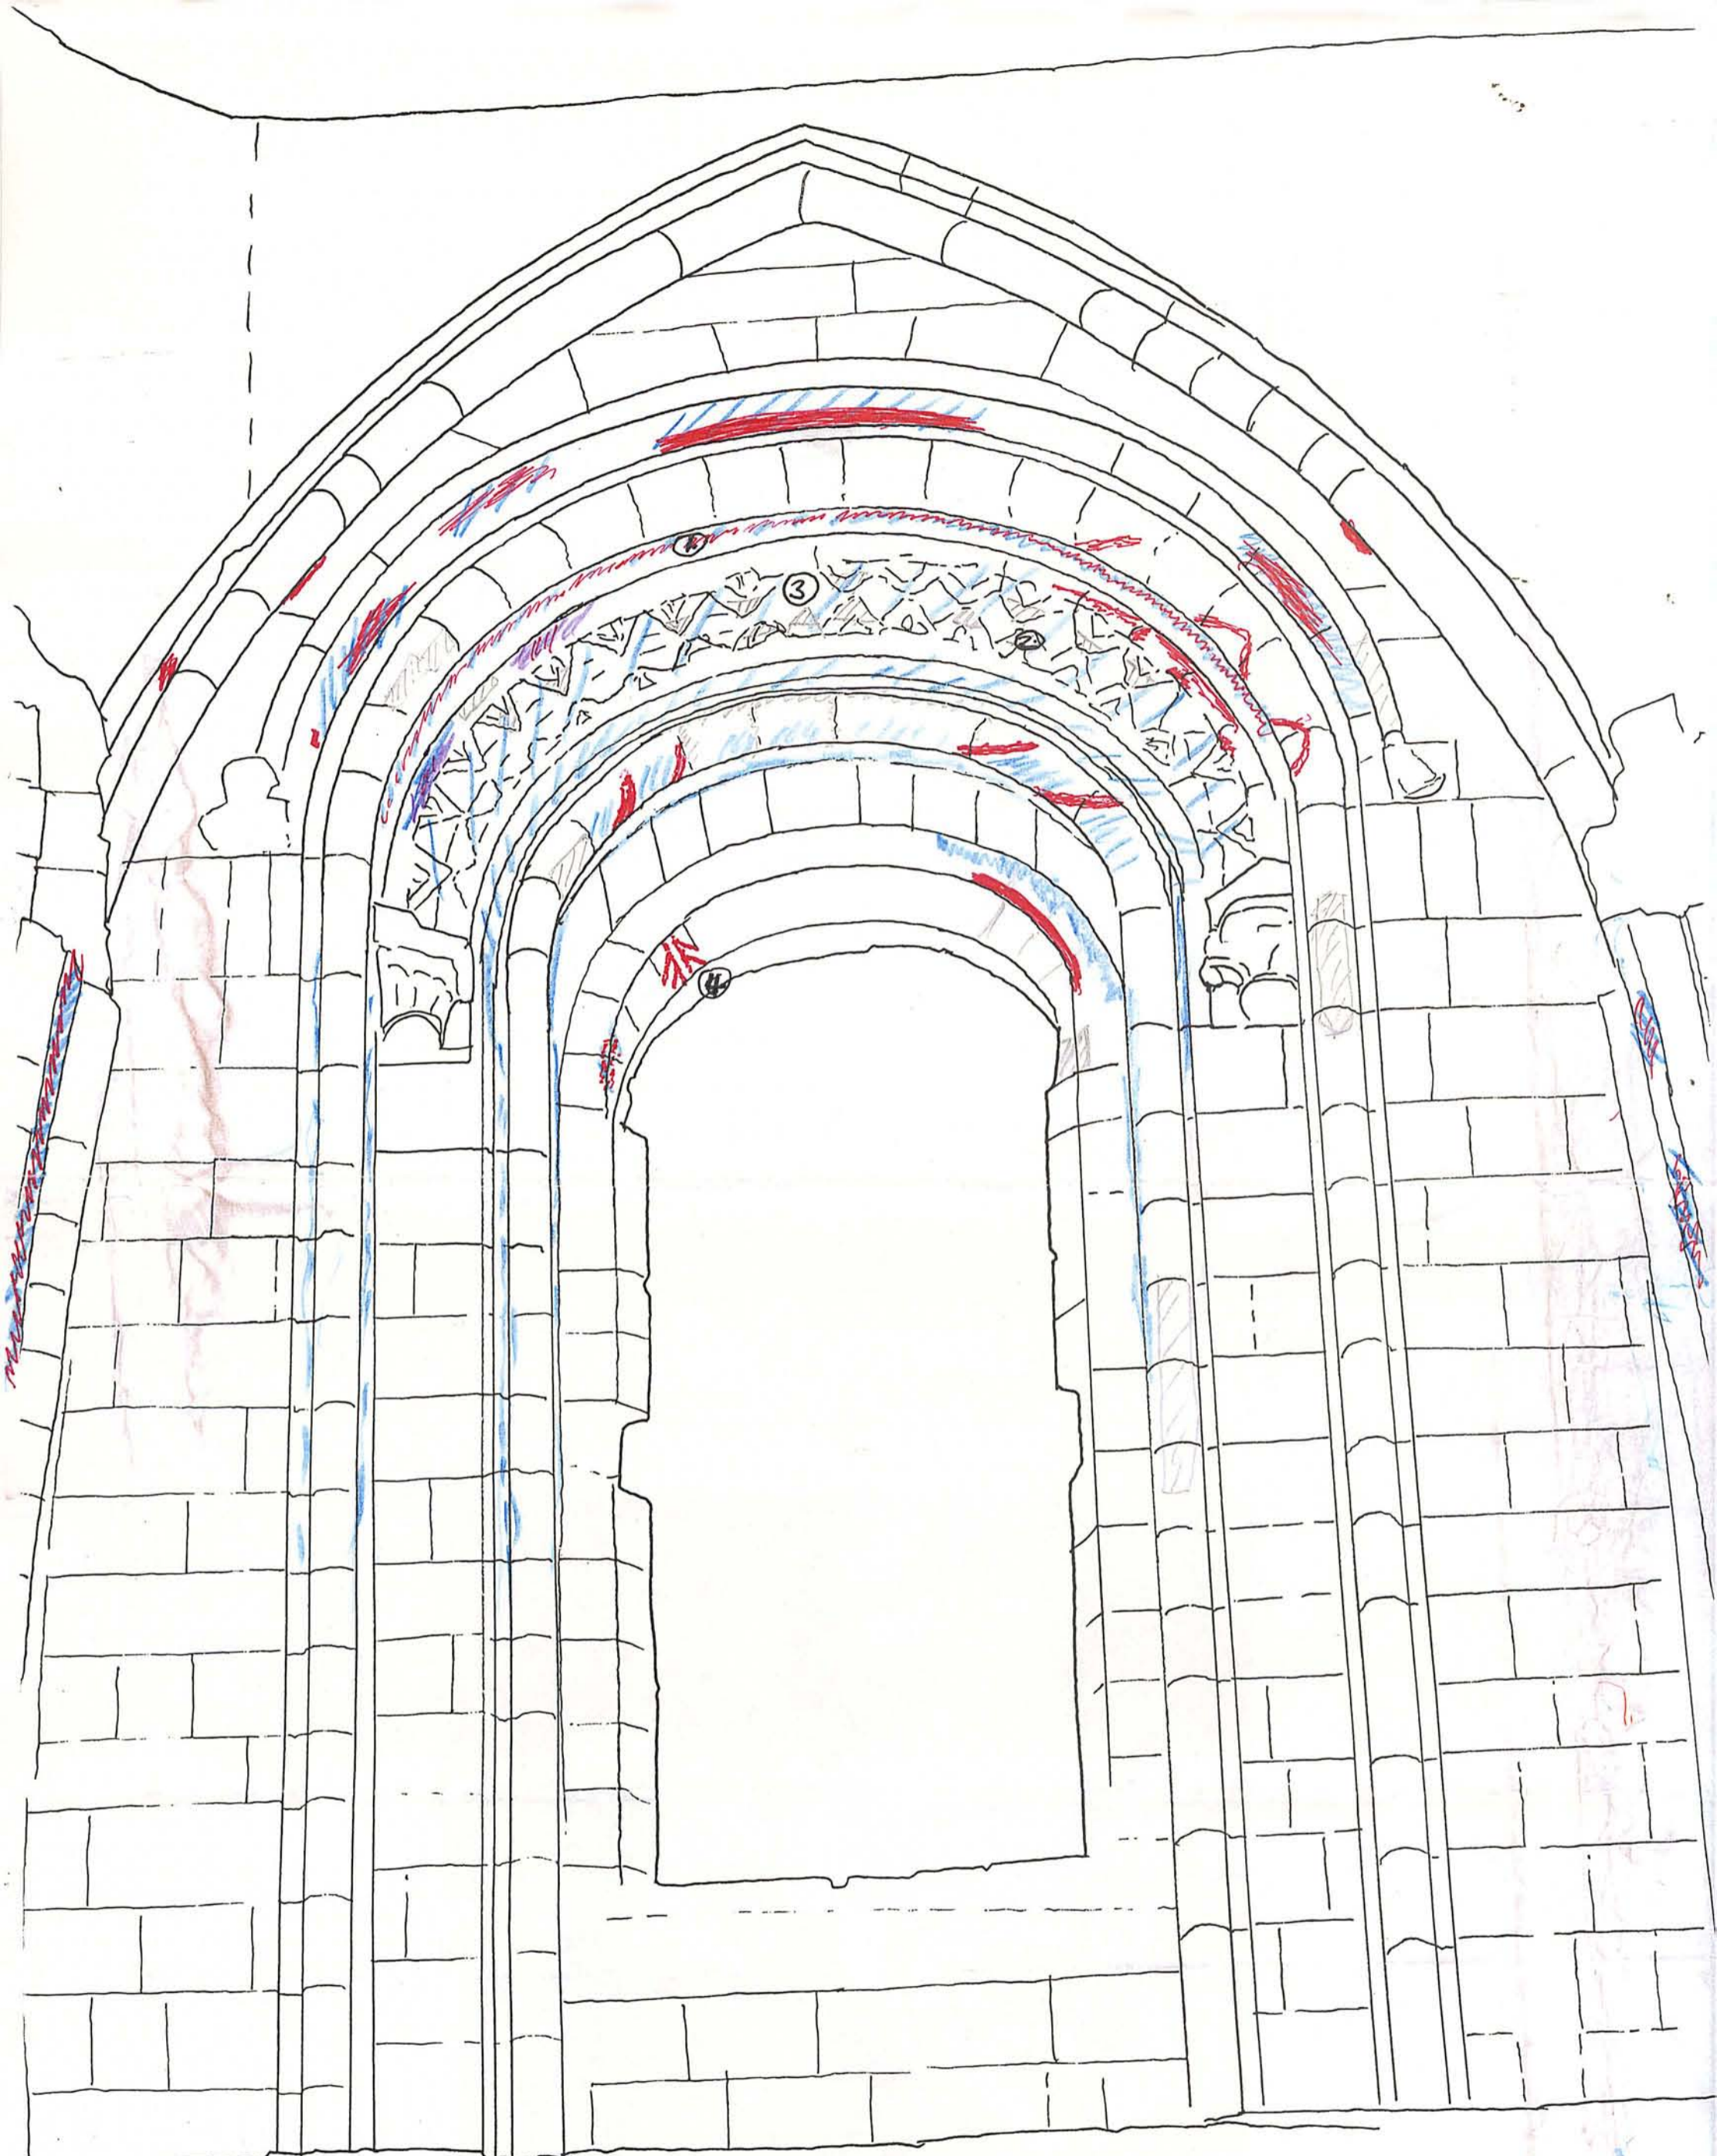
Bay 4N clerestory

1. Red with white over on flat face of small inner moulding (not shown on drawing).
2. Two ends of a copper pin (green only showing) here.
3. White over calcining throughout this chevron work.
4. This interpretation of the pattern was made only after long examination, and may not be very reliable – it exists only as a collection of dots and semi-lines of red.
