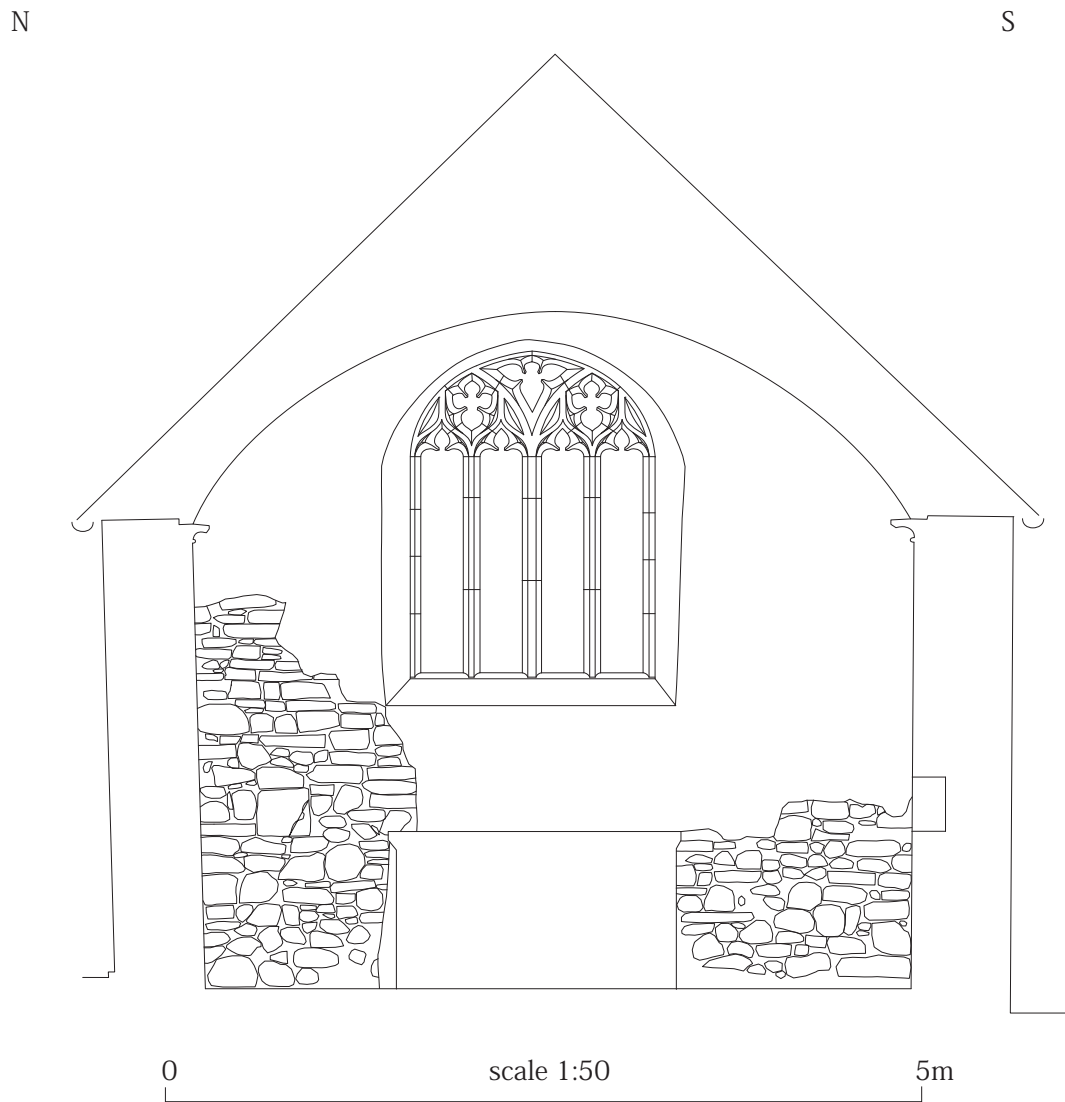
Fig. 11 Internal East elevation showing exposed stones plotted by corrected photography.
