**An Archaeological Investigation**  
**Adjacent to the**  
**Refectory Undercroft,**  
**Glastonbury Abbey**  
**Phase 2 works**

Carried out for the Trustees of Glastonbury Abbey

By  
**C. and N. Hollinrake Ltd.,**  
**Consultant Archaeologists**  
**12 Bove Town**  
**Glastonbury,**  
**Somerset BA6 8JE**  
**Tel/Fax: 01458 833332**

**Report Number 401**

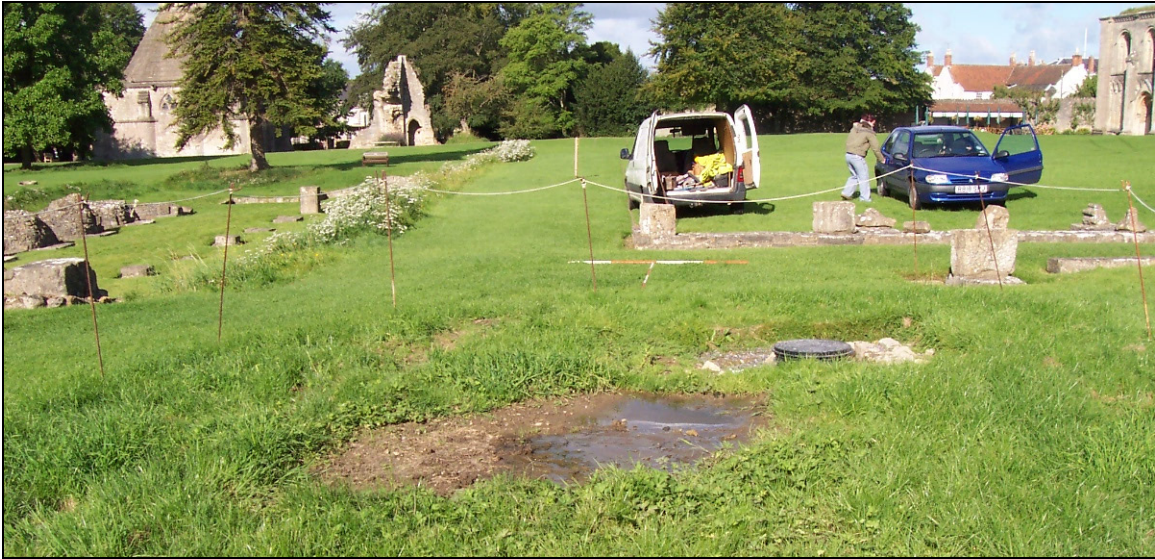
Photograph 1. Water from a broken pipe had killed the grass in a permanently saturated boggy patch. Ranging rods mark the centre lines of the excavatiuon trench. View from the east.

The boggy ground was seen to have been caused by a series of breaks along a 20<sup>th</sup> century, ceramic drain. Various sections of clay pipe had been either crushed, cracked or separated over a length of around 11 metres. In addition, part of the clay pipe line had been placed above some large blocks of Doulting stone, part of an unrecorded, W-E wall.

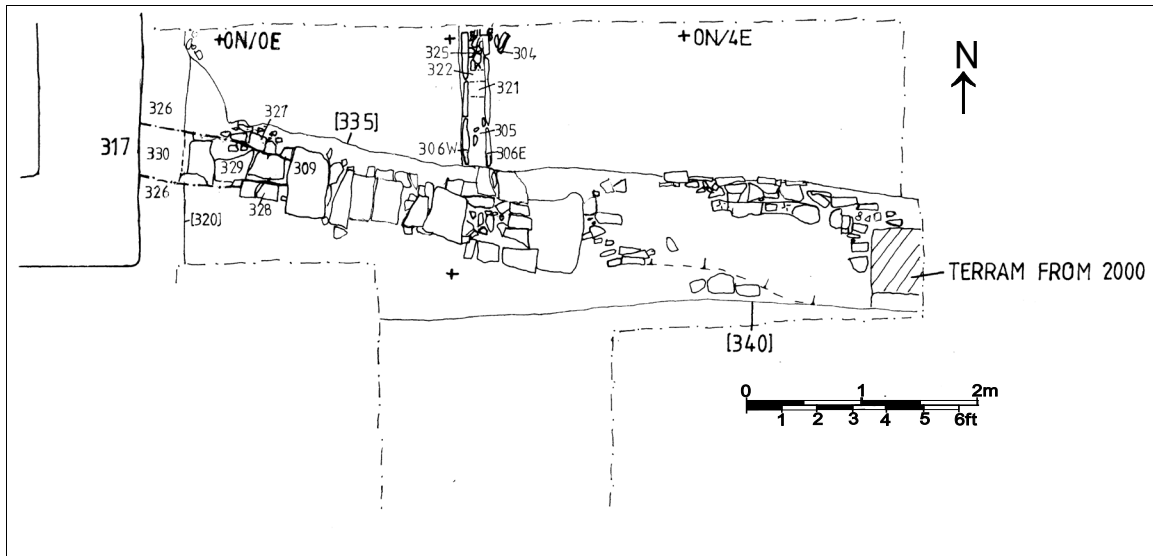
Figure 8. Plan of culvert U363.

The culvert had been removed further to the east, within cut [340], whether by FBB or others, and replaced by the ceramic land drain, probably during the early or mid-20<sup>th</sup> century. If the land drain had ever been present within the 2007 excavation area, it must have been removed at a later date.

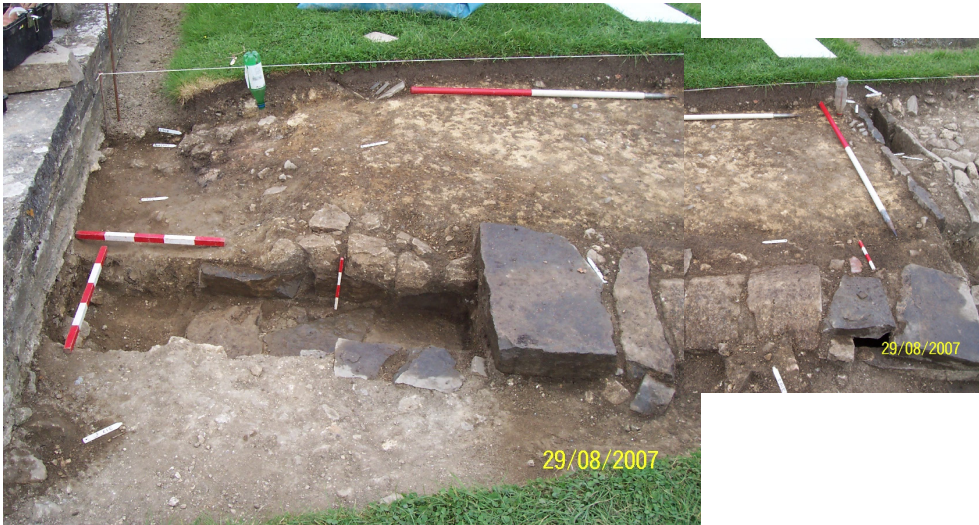
Photograph 7. Montage showing U363 looking North (capstones removed at the west end).

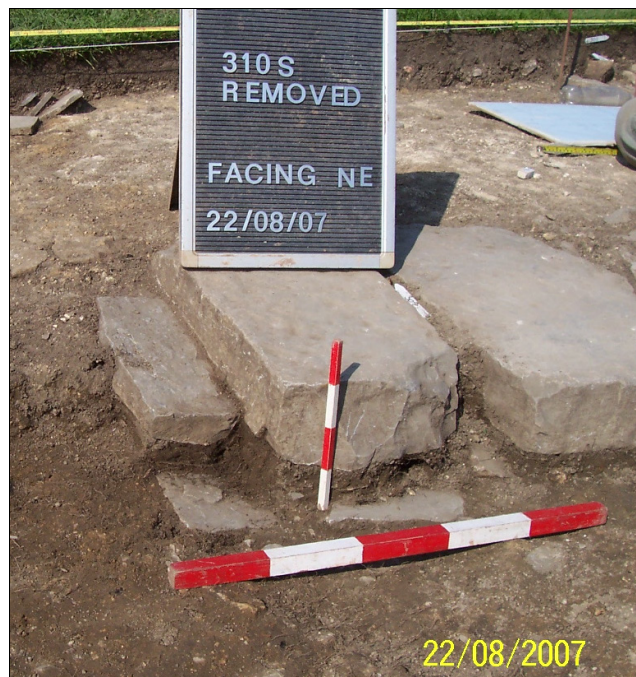
Photograph 8. Capstones **309** resting on clay.

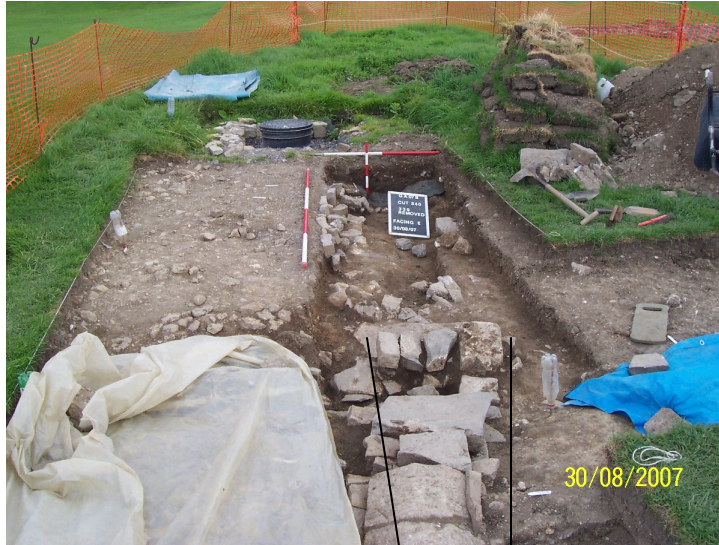
Photograph 9.  
Culvert **U363**  
showing robbing to  
the East. Looking E.

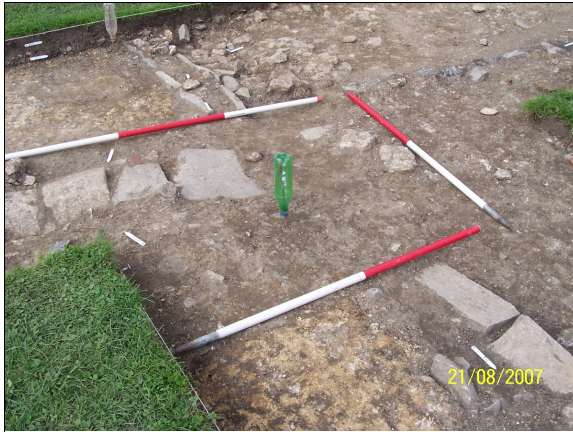
Photograph 12. **U362** at top of picture, U363 capstones on the left. The ranging rods mark the edges of an FBB trench. Small slabs to the bottom right cover **316**. Looking NW.

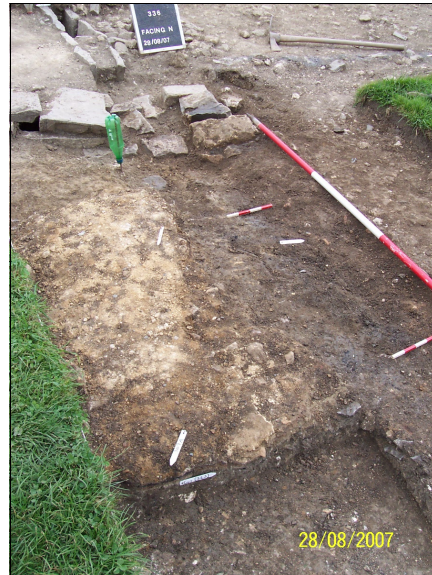
Photograph 13. Organic deposit **316** exposed. Looking NE.

| Context No. | Type | Description of Context | Interpretation |
|---|---|--|---|
| 316 | Deposit | Fairly loose, dark grey brown loamy clay. Contained c.6 x Lias slabs (average size = 160 x 60 x 440mm), moderate amounts of small to medium sized angular Lias & Tor Burr stones, occasional small charcoal lumps, mortar lumps, bone frags. Up to 15cm thick. Up to 75cm E-W. | Backfill. Disturbed area may be FBB excavation - where one would expect to see the continuation of drain U362. The Lias slabs within 316 are almost certainly re-deposited, drain side wall stones. |

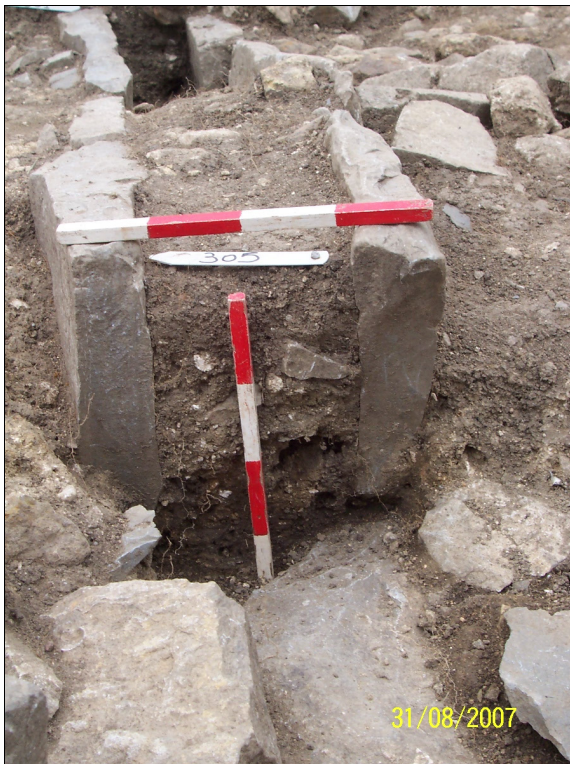
Photograph 18. Close view of S end of U362. Mortar 307 has flowed over the end stone (left edge of photograph).

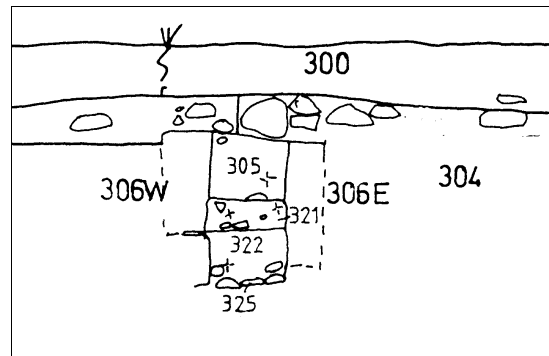
Figure 9. Section of U362 in the N baulk.

**6.6.3** The material composition of [321] might suggest that the increase in clay & mortar inclusions could be the result of an episode of construction or repair of the mortar floor layers immediately to the W (?during the 15<sup>th</sup> century rebuild).

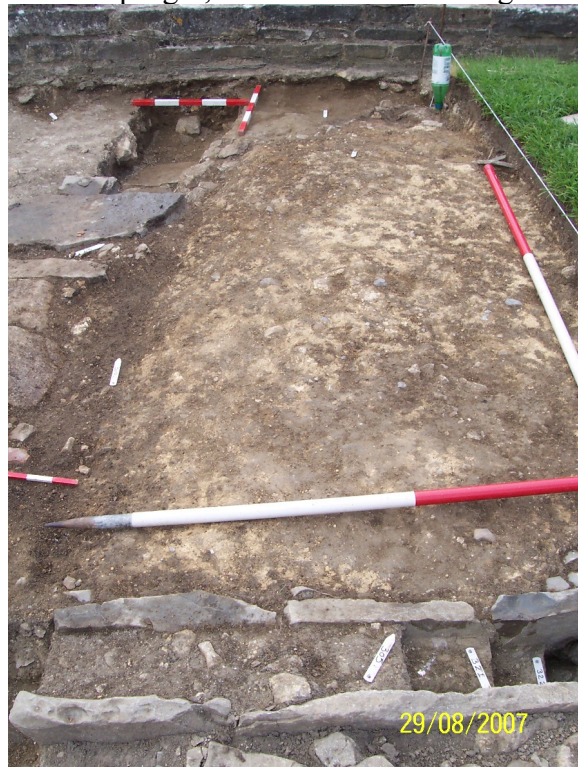
Photograph 20. General view of mortar bedding **307** and the stone drains. The mortar spread extends to the edge of drain **U362** at the bottom of the photograph and flows into the cut for culvert **U363** on the left, which can be seen passing below modern Cloister wall **317** at the top of the photograph. Looking West.

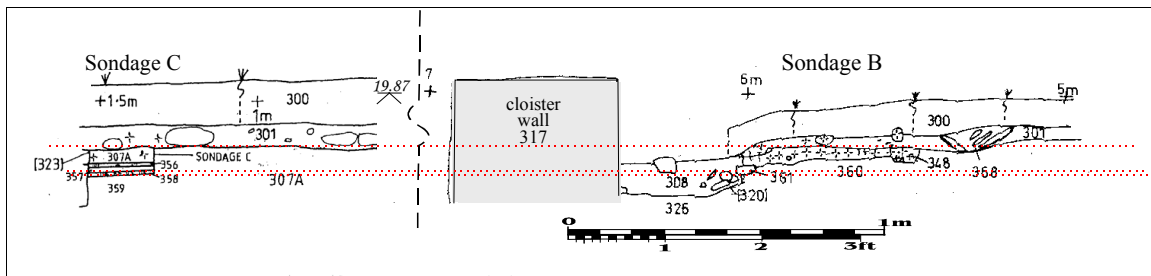
Figure 11 Layers and floors within Sondages B and C with height and layer lines

**7.12** The lowest mortar deposit in Sondage C – [366] / [334] – can be equated with the mortar deposit with the burnt surface in Sondage B – [360]. In Sondage C, [366] lay above dark, greyish-brown silty clay – context [367] – which predates the Cloisters.

**7.13** If the lowest mortar deposits represent the first, post Norman Conquest, Cloister floor of the early 13<sup>th</sup> century, then the charcoal deposits can probably be associated with the great fire of 1184 that destroyed the 12<sup>th</sup> century monastery.

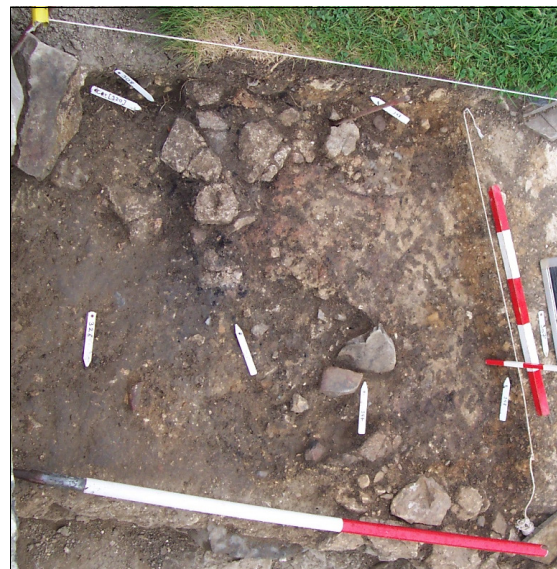
Photograph 23. Scorched surface **360**,  
below **351**, and stones **361**. Looking N.

In Sondage B, charcoal layer [351] lay above a burnt surface – [360] of a mortar deposit. The surface was burnt dark-grey, orange and red. The most severe burning was around a group of small, unworked stones – [361] - which had been burnt to a soft, grey colour with a heat-induced, crumbly texture.

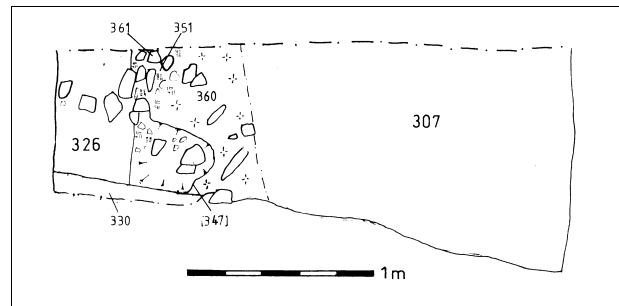
Figure 13. Plan of **360** and **361**.

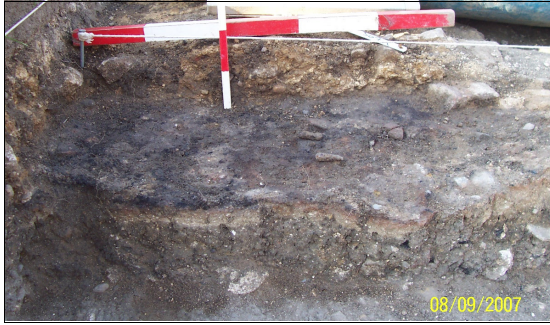
Photograph 27. Ash and charcoal layer **358** with nails.

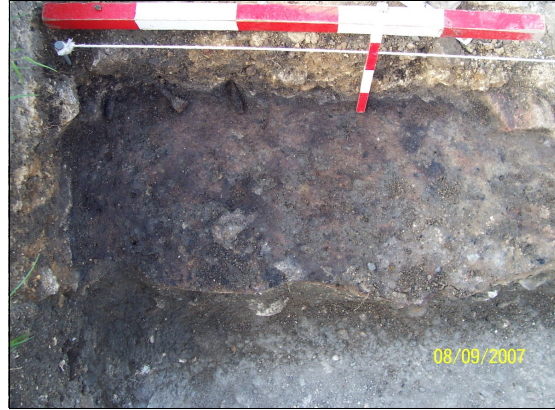
Photograph 28. Bird's-eye view of scorched surface **359** with nails on surface (below section).

**7.11** In Sondage C, the charcoal deposit lay above the hard surface of a mortar deposit – context [359] - that had been subjected to intense burning. The surface was burnt red and reddish-brown. Some iron nails were lying on this surface

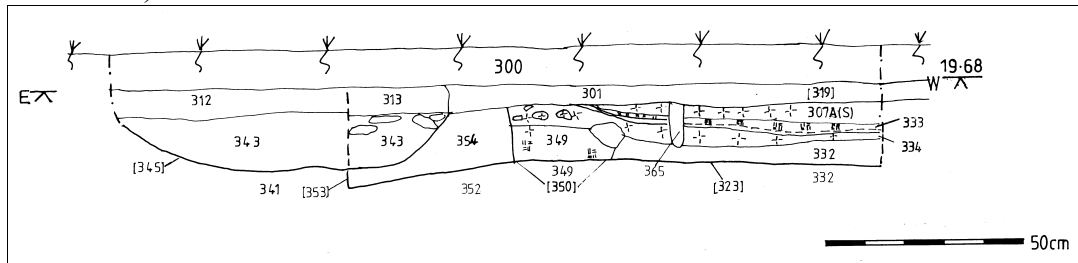
Figure 16. N facing (Composite) section of cuts [323] and [345]

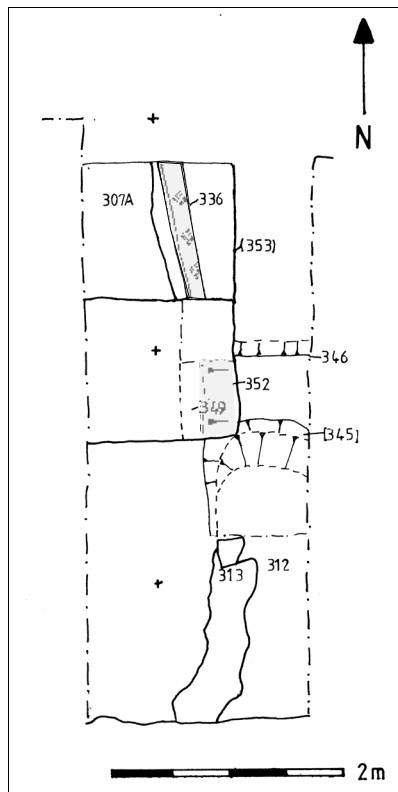
Figure 17. Gully 350 (fills shaded)

Cut [350] was filled by [349], buff-grey, silty clay. The feature was not excavated but finds were recovered during cleaning of the surface and of the section.

Theoretically, [350] should be cut by later stone lined drain [U362] and its southern continuation [316], ca.1m to the N. [U362] appears to, generally, take a similar line to [350]. If they were associated, however, the evidence has been destroyed by FBB trench cut [323].

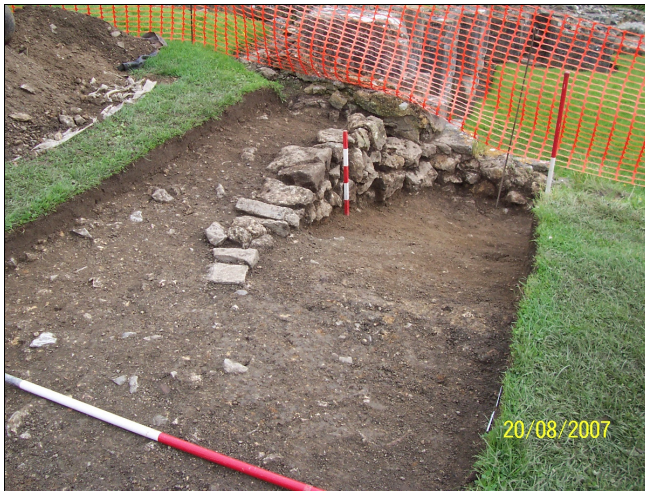
Photograph 31. Wall **313** and cut **319** looking S.

**8.6** Cut [345] might be associated with, or be a trench for, rough walling [313], to the south. **Wall [313]** consisted of up to three, random courses of rubble Lias stone. It was partly bonded by clay and lay above a thin soil on the surface of cut-away [314]. One sherd of 19<sup>th</sup> or 20<sup>th</sup> century blue transfer ware pottery was found within the wall, plus a very small, medieval sherd. Other finds from within the wall and from within the thin, soil below the wall, included modern bottle glass sherds, coal and animal bone fragments. [313] ran down the slope of [314] / [319] where it butted up to Undercroft wall [318]. Where these wall joined, they had been bonded together by a grey, charcoal flecked, lime cement of late-19<sup>th</sup> or early-20<sup>th</sup> century date.

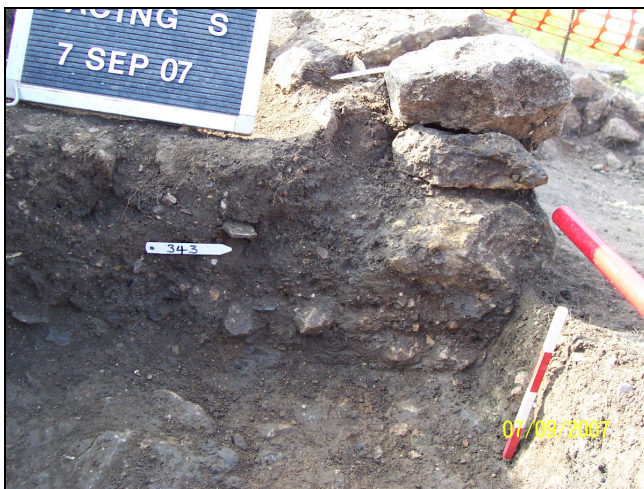
Photograph 33. Detail of section through wall **313**. Looking S

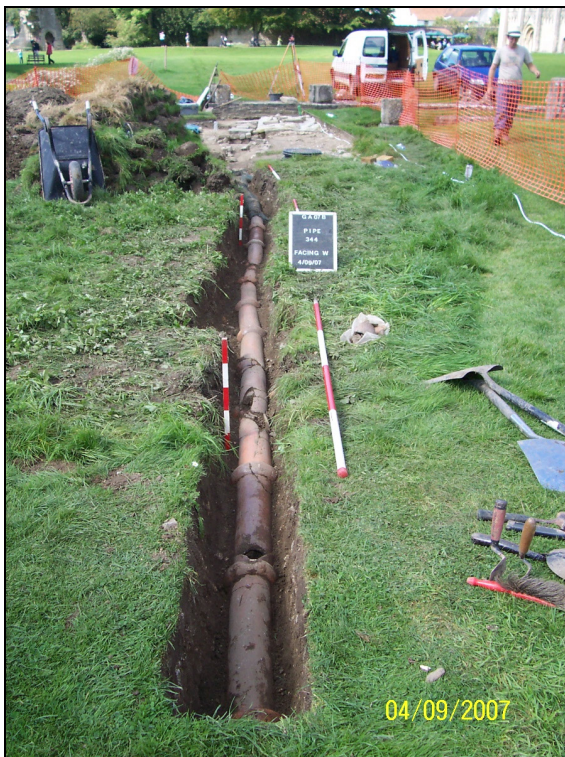
Photograph 34. Clay pipe drain looking W. Showing breaks and holes in the pipes.

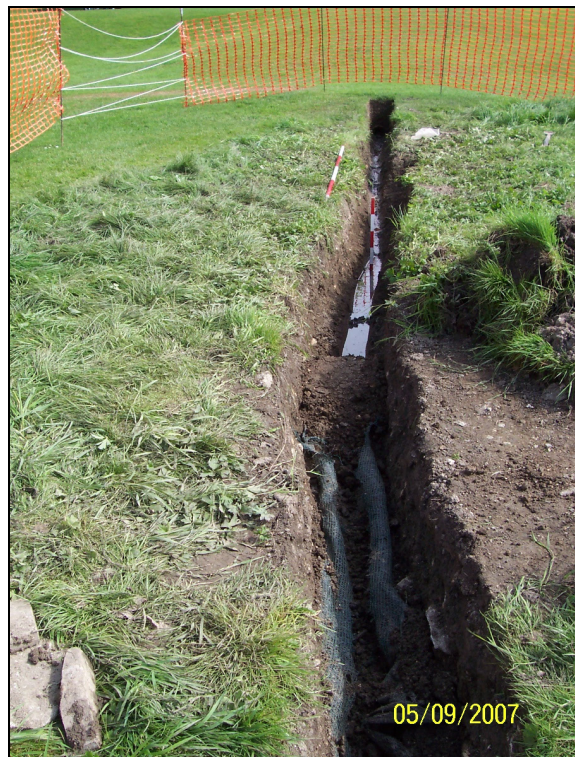
Photograph 35. Clay pipe drain trench looking E. The pipes have been removed and a small dam holds the water back from the trench.

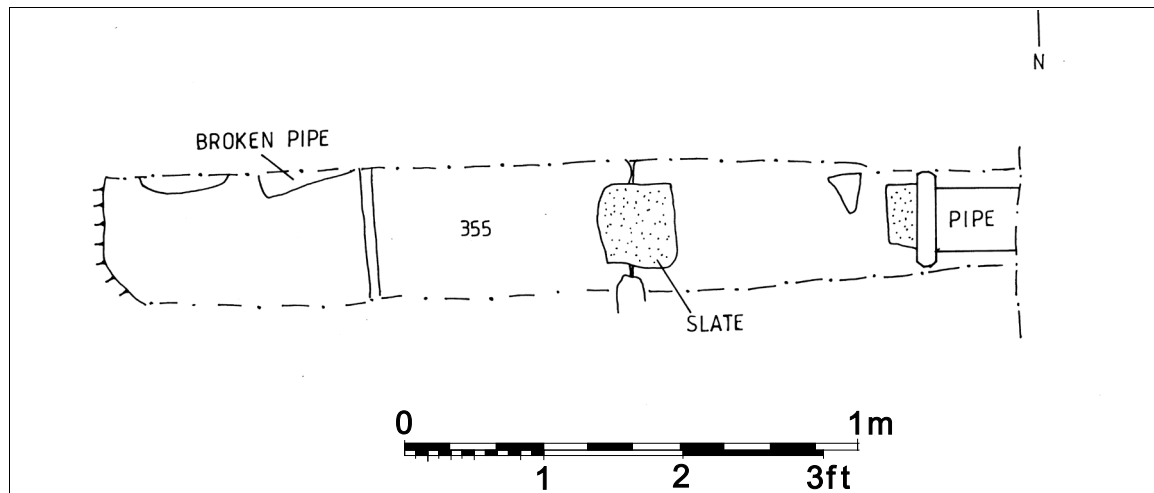
Figure 19. Wall [355] (ceramic drain pipes removed) north to top.

Fragments of roof slate had been placed over the joints between the stones. This probably took place when the pipes were laid above the wall.

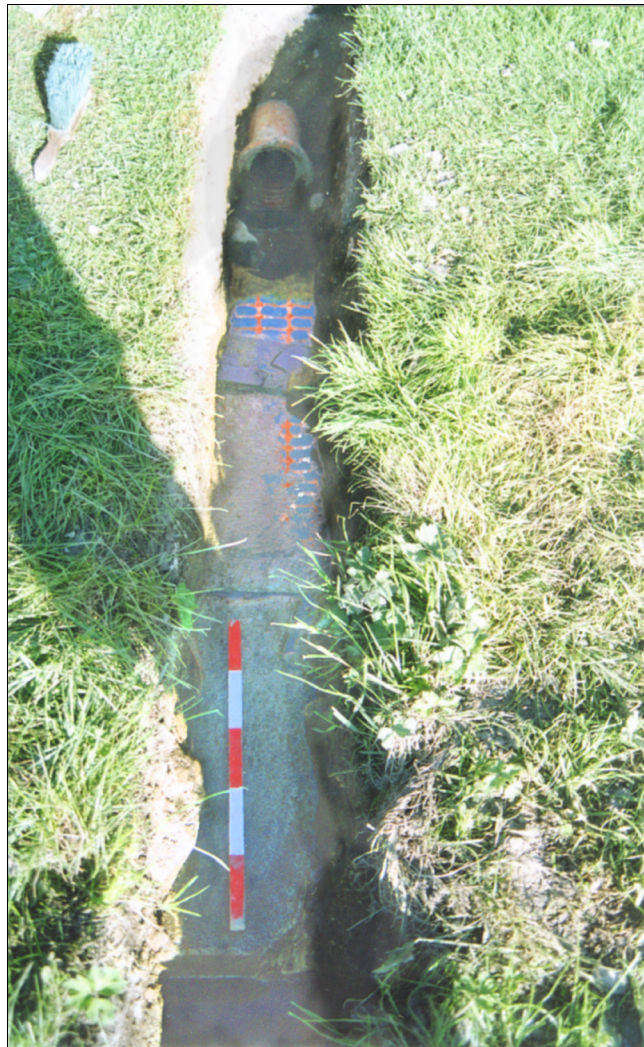
Photograph 36. A thin film of water flowing out of the open pipe, lies above the ashlar blocks of wall [355], reflecting the orange mesh, security fencing.

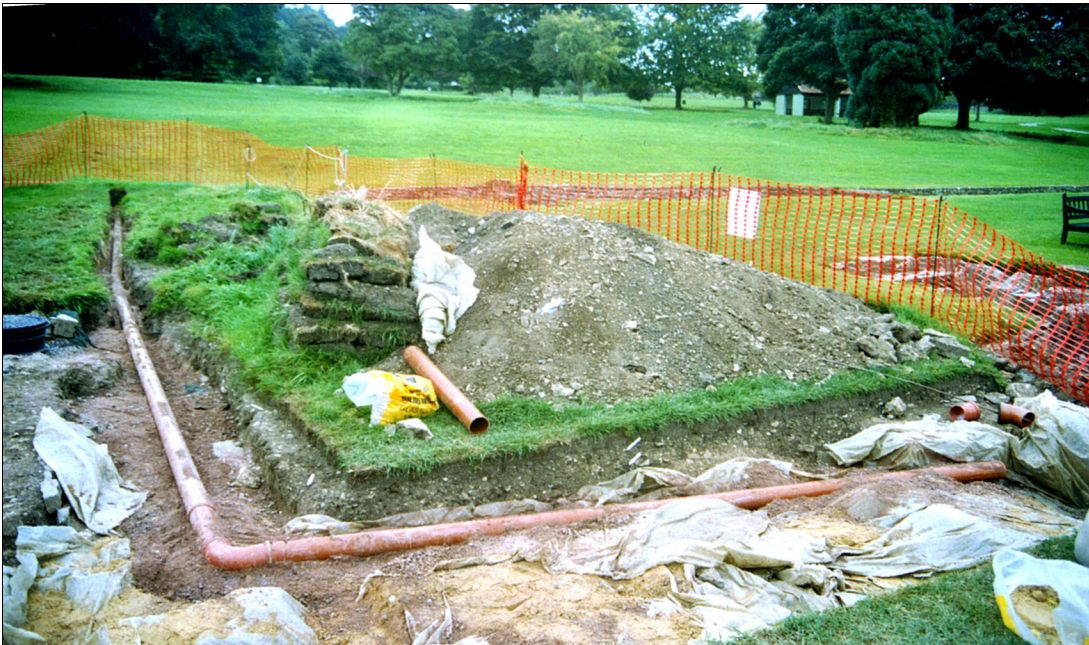
Photograph 39. The new plastic pipe installed. The archaeological layers are protected with plastic sheets and cushioned with sand. The new pipe is bedded on, and covered by, sand and gravel.

The pipe was then covered by sand and scalplings/gravel and stone dust, before backfilling with the excavated spoil.
