## **Summary**

*Archenfield Archaeology, in association with the Hereford Cathedral Archaeologist, Ron Shoesmith, was commissioned to undertake the monitoring of groundwork in the courtyard of the Bishop's Palace. The purpose was to increase the car parking capacity by reducing the lawn size and inserting new drainage, tarmac and kerbstones. As the area is of historical importance, it was considered that archaeological deposits could be present even at a shallow depth. The groundwork began on the 17<sup>th</sup> October 2005 and followed the specifications laid out in the plan by the architects, Hook Mason.*

*Work was interrupted by the discovery of a subterranean chamber made of stone and brick and a series of stone culverts. The exact purpose of the chamber is uncertain, it could be an 18<sup>th</sup> or 19<sup>th</sup> century ice house or simply an underground structure associated with drainage.*

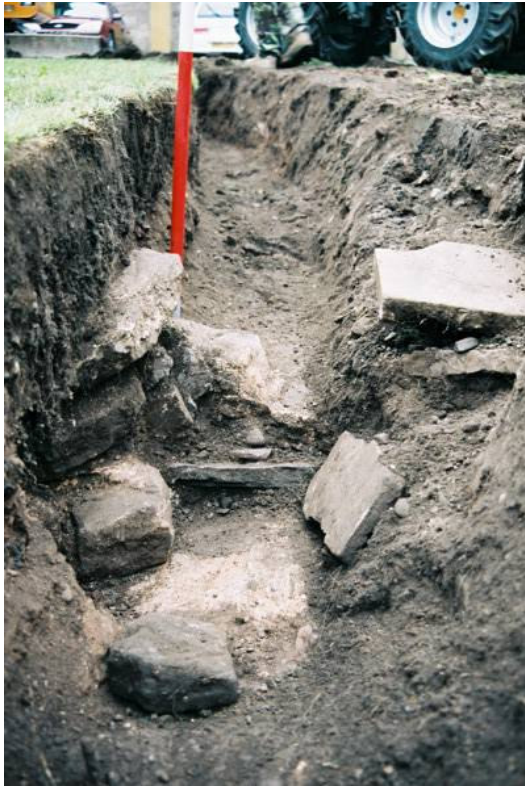
**Plate 1: (Above) Stone Culvert 8, looking west**

Turf and topsoil (1) overlay the excavated area. Beneath this was layer 2, a mixed deposit of variable depth that spread across the whole site containing medieval and post-medieval material. This layer was cut by several post-medieval features, the earliest being cuts 7 and 21 which contained stone culverts 8 and 22. These were revealed in the trench both to the north and south of the lawn and are probably lengths of the same culvert (Figure 2). The walls of this culvert were of stone and mortar and stone slabs formed the base and cap. It was probably used to drain rain water from the north range of the courtyard down towards the river bank. A few broken bottles were retrieved from the backfill (9) of the northern section which appear to be 18<sup>th</sup> century in date. Another culvert (14) was revealed to the west of the lawn and orientated north-east/south-west. An insufficient amount of this feature was revealed to determine if (or how) it related to the other culvert.

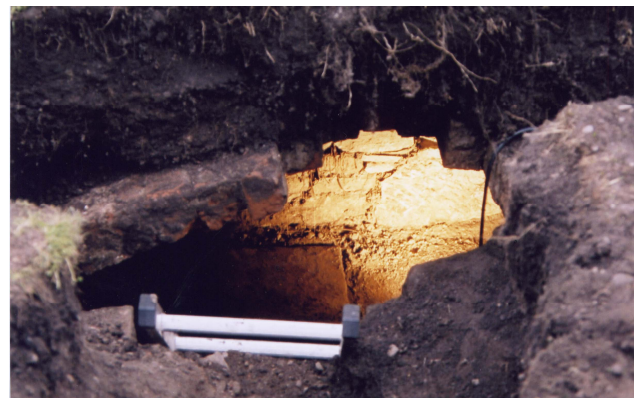
**Plate 3: The opening of chamber 11**

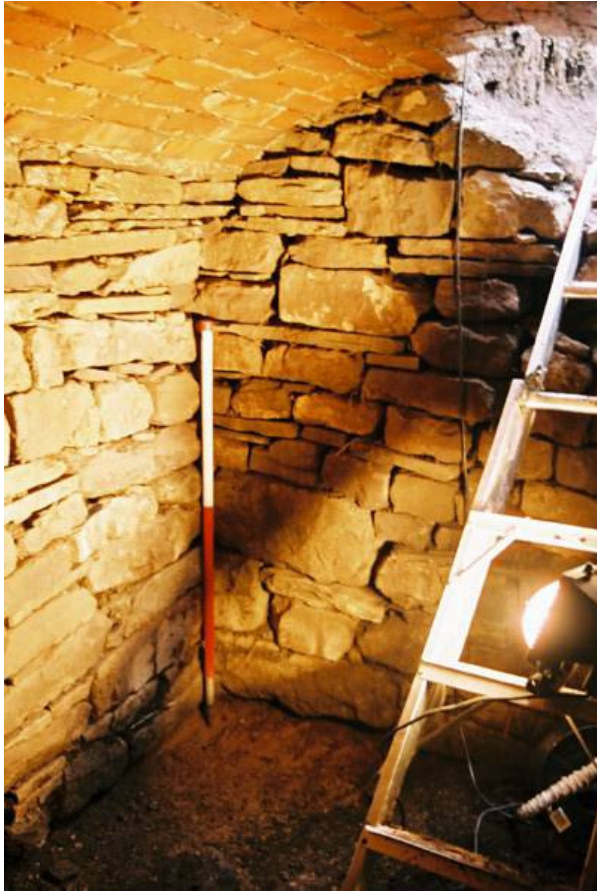
**Plate 4: The south-east corner of chamber 11**

The north-south culvert was divided by cut 12, which contained a subterranean chamber (11, see Plate 4) made of stone and brick. The walls were dry stone, and its internal measurements were 2.40 metres north-south and 1.60 metres east-west. The walls were roughly 250mm thick and 1.60 metres tall, and the stones were of varying size and shape, a few showing obvious signs of re-use. Several stones had evidence of mortar, of which a 351g sample was taken. The top courses of the walls were slabs forming a sill for an arched brick roof. The bricks did not have frogs, indicating that the construction was pre-1850. They had been laid with a stretcher bond on a north-south orientation. The roof was one course thick, ten bricks long, and twenty wide. The central north-south row was laid as headers. The bricks were cut and arranged to form a circular access hole at the centre, measuring roughly 600mm across. It had been blocked with concrete slabs at some time in the 20<sup>th</sup> century.

The culverts and the underground chamber appear to be 18<sup>th</sup> century in date. The re-used stones within the chamber walls, which included a single block of tufa (Plate 4), possibly originated from the chapel of St Katherine and St Mary Magdalene, which was demolished between 1737 and 1746, and/or the west end of the cathedral which collapsed in 1786. If this is the case then the structure would date from about this time.

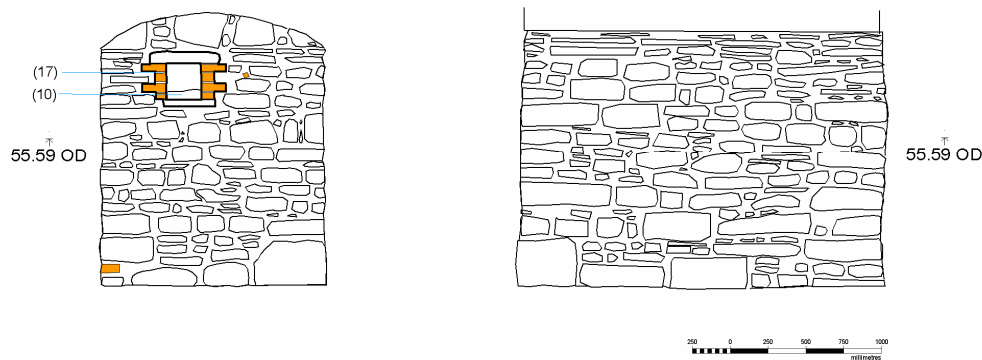
**Figure 9: The south-facing (left) and west-facing (right) walls of chamber 11. The bricks and brick fragments are indicated in orange.**

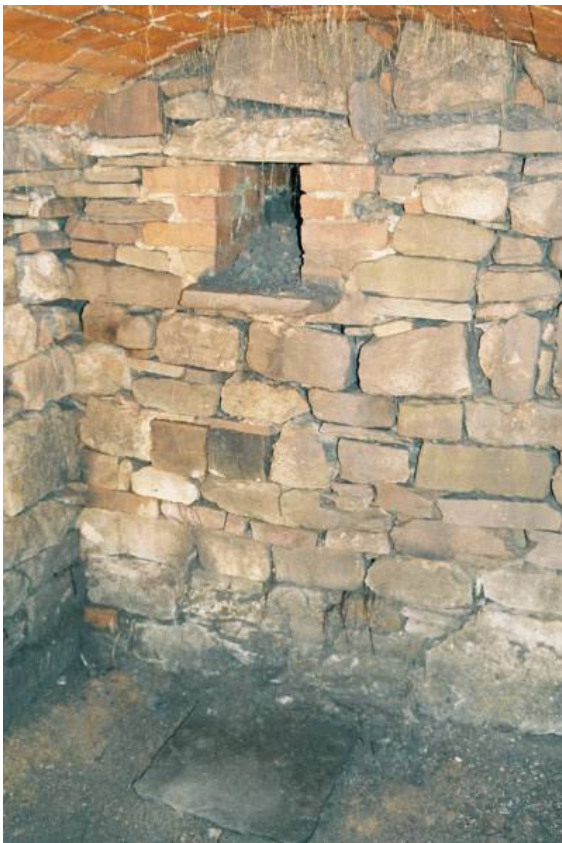
**Plate 7: The south-facing wall of chamber 11, showing culvert 17**

The north-facing wall showed no indication of culvert 22 which abutted its exterior side. The culvert protruding through the south-facing wall had been realigned to enter at a right angle with brick and mortar of the same type as that used in the arched roof. This brick and stone realigned culvert (17) was partially filled with a loose clay deposit (10).

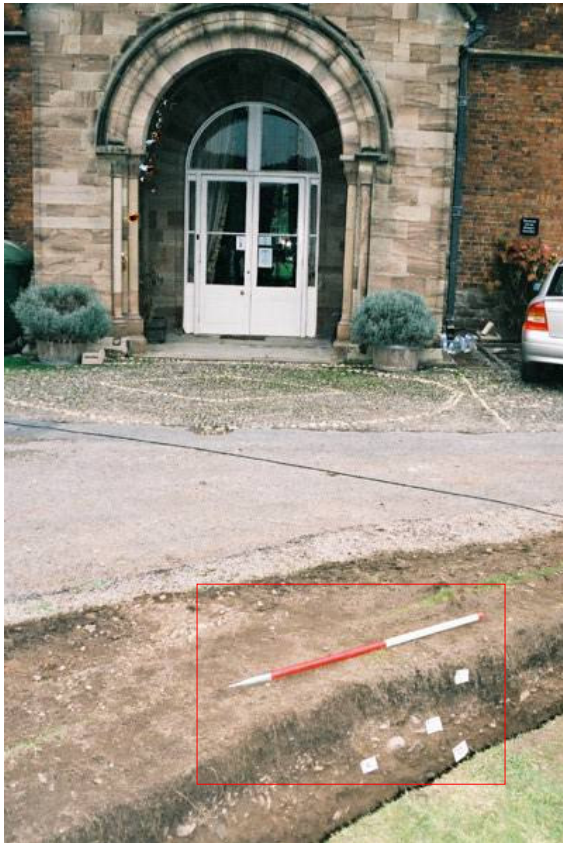
Layer 2 was cut by a further three features. The earliest was cut 6, which was filled with a metallised surface (5). It was revealed only in section approximately 100mm below the present surface and with a width of roughly 4 metres. It occurred in front of the main porch of the Bishop's Palace and it seems likely that it was a path that led to the entrance, although no datable evidence was recovered from the feature. The other two features were modern. Cut 3 was filled by a redundant lead water pipe (4), and cut 19 contained a service cable.

**Plate 8: The possible metallised surface (the pale band beneath the middle tag), visible in front of the main entrance to the Bishop's Palace**

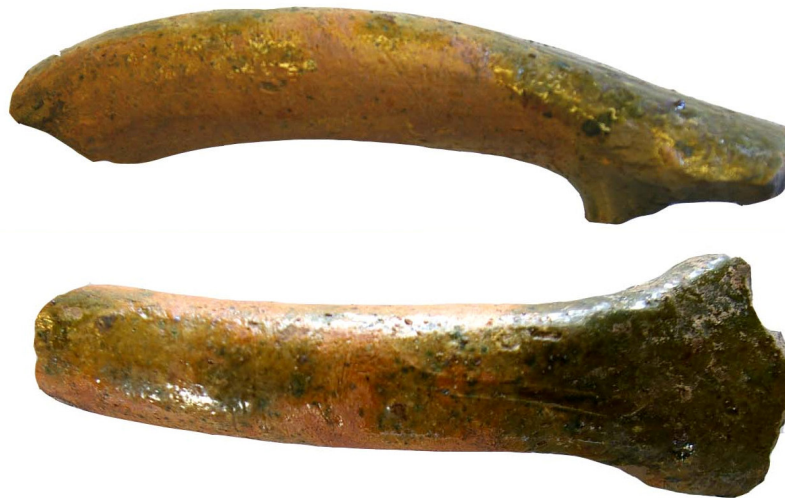
The medieval pitcher handle (Plate 9) was 130mm long, with a groove that was 3mm wide and 50mm long on the convex side, and was fabric A7b. The piece of medieval cup handle was 30mm long.

**Plate 10: The A7b pitcher handle from layer 2**

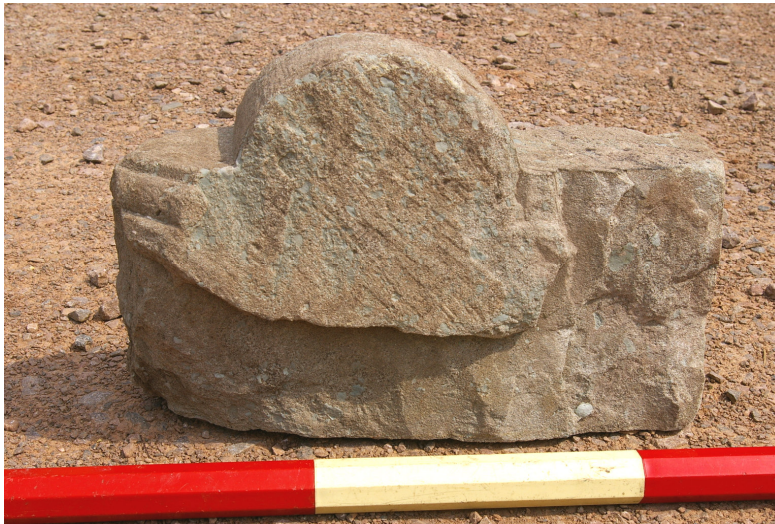
Several examples of re-used carved stone were present. The most ornate piece (Plates 11 and 12), which was dislodged by machining during the initial discovery, is archived with the other finds. It measures roughly 400mm in length, 250mm in height and 110mm in width. It was probably a part of an arch of an attached half column, and has the remains of a Norman style chevron design.

**Plate 11: The re-used Norman masonry. The block is roughly 400mm long.**

Two samples of mortar were taken. The first (104g) was taken from the brick roof of chamber 11. The second (351g) was a sample of the mortar that was attached to the re-used stones of the chamber, and further study might confirm the origins of the masonry.

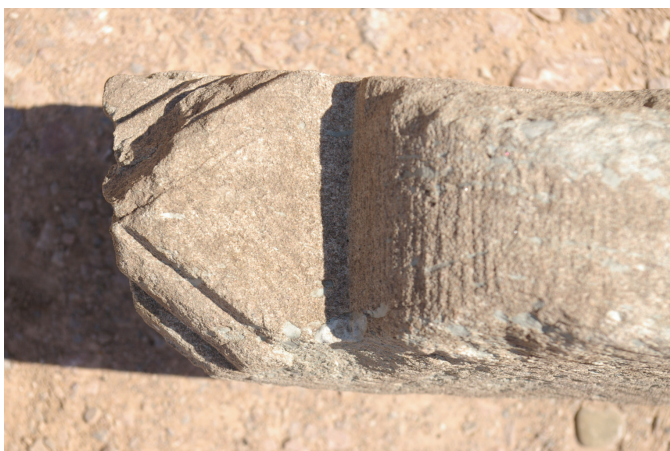
**Plate 12: The re-used Norman masonry, showing the chevron design**

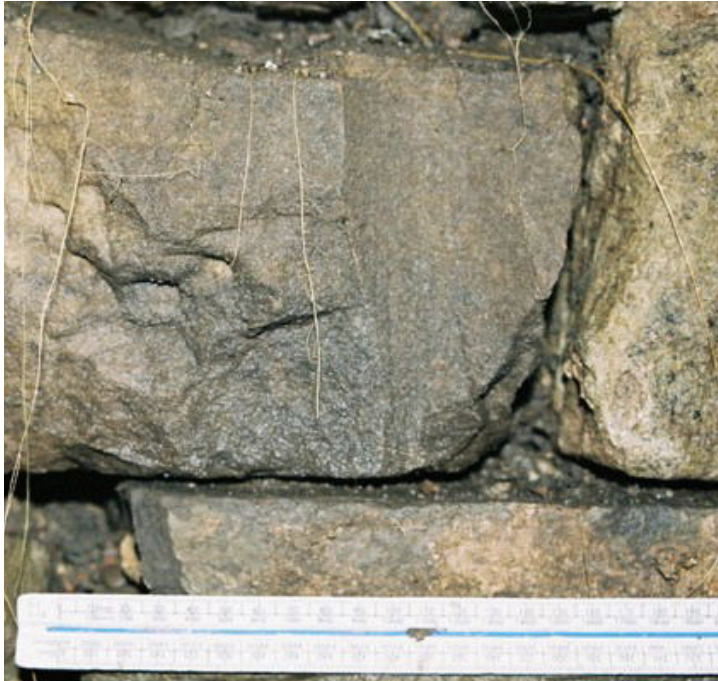
**Plate 13:** A stone in the north-facing wall of chamber 11 with a smooth, concave, semi-cylindrical carving. It is still *in situ*.

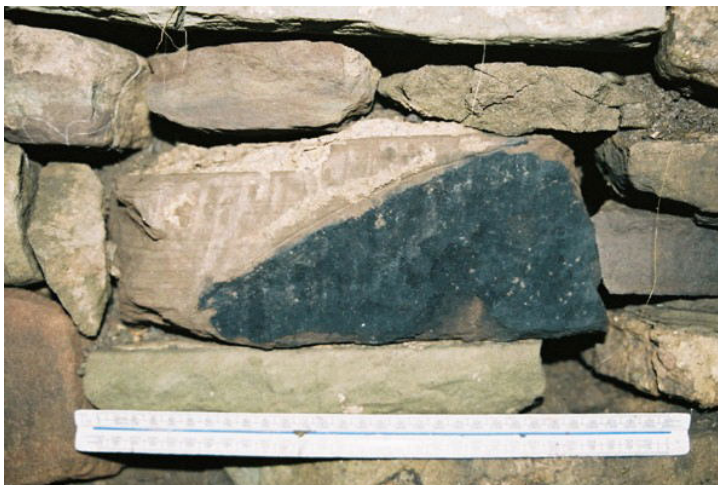
**Plate 14:** A stone in the west-facing wall of chamber 11, with a sooty deposit. It is about 250mm long, and is still *in situ*.
