Crown Inn Barns, Lea, Herefordshire
building recording and archaeological monitoring

Huw Sherlock & Robert Williams
2003

*Crown Inn Barns, Lea, Herefordshire: building recording and archaeological monitoring
2003*

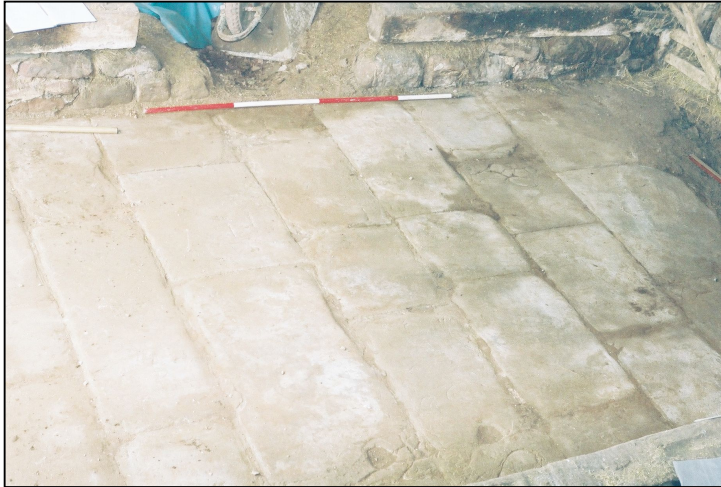
Plate 1: The threshing floor.

The floor of the threshing bay is covered with flagstones set in a deep 0.05 metre bed of lime mortar. These were large, long blocks of well-dressed stone and at the door entrances, long narrow stones were placed. These stones weren't weathered enough to be original and were therefore probably replaced at some stage (see Plate 1).
