Pound Farm, Kington, Herefordshire
archaeological building survey and monitoring

Daniel Lewis and RC Williams
2004

*Pound Farm, Kington, Herefordshire: archaeological building recording and monitoring
Report number 03/50*

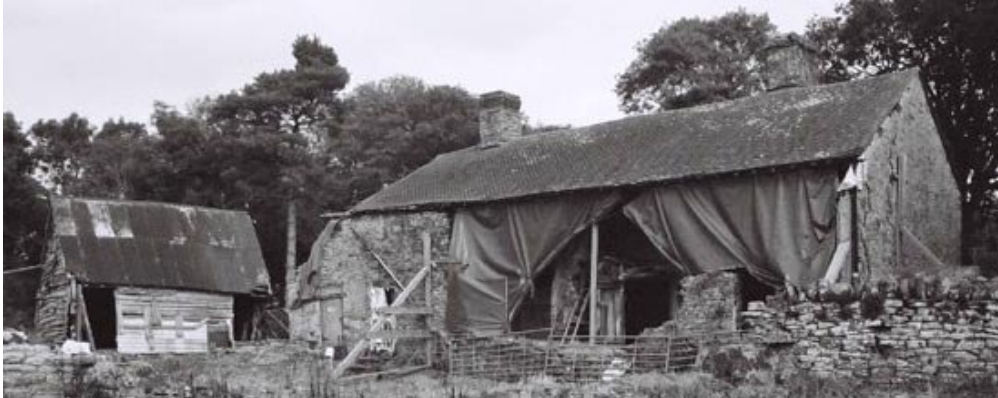
Plate 3: The west elevation of the house while under reconstruction

The west elevation of the house is in a poor state of repair due to collapse of some of the stonework. A photograph taken in 1937 by the RCHM shows the features of the wall.

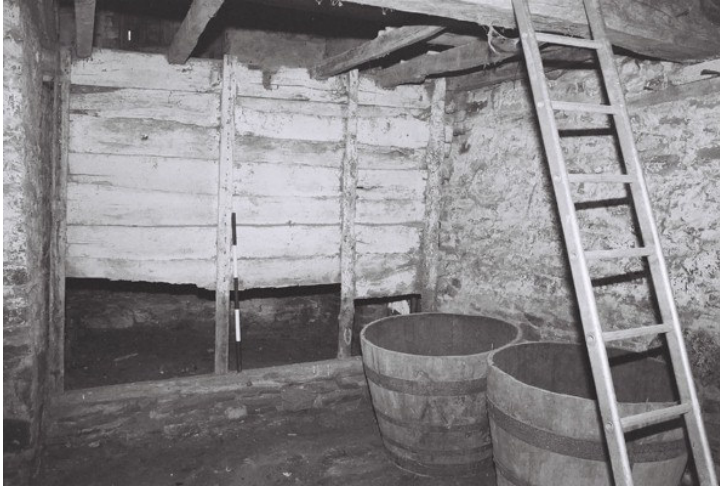
Plate 4: The stone, west wall of the cider house

A door leads to the cider house located in the last bay at the south end of the farmhouse. The bay was divided by a modern cross wall. The east half had been used as a store, with a granary on the second floor.

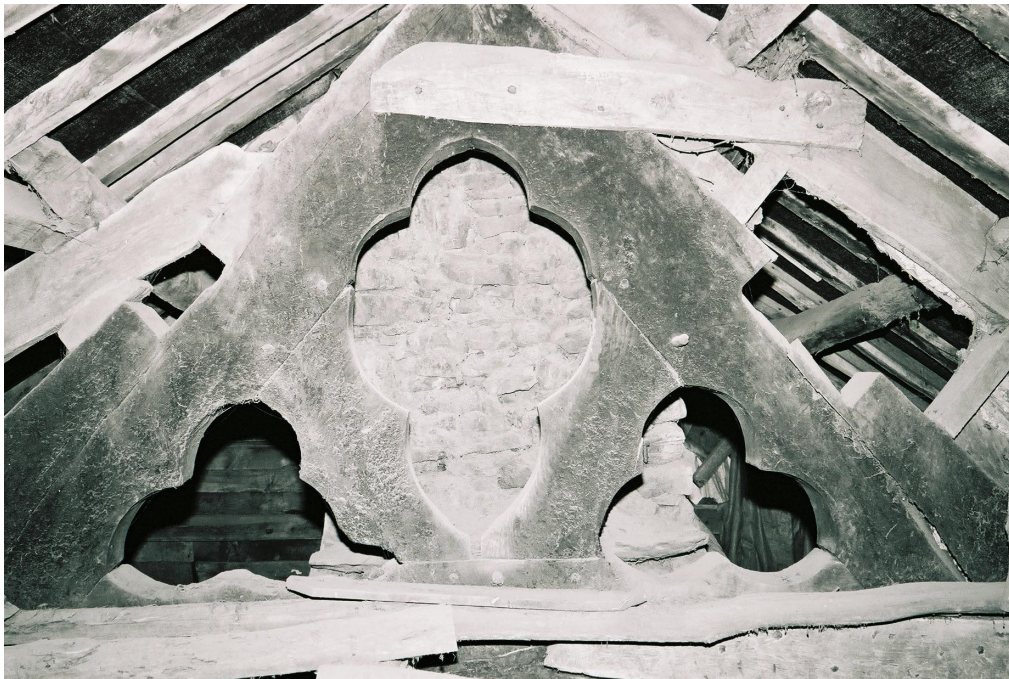
Plate 6: The decorated cruck (3) of the open hall

The open frame (cruck 3) has a central quatrefoil flanked by two trefoils above the collar. The moulding on the inside edge is chamfered on both sides and has a step with two more chamfers. Trefoil decoration is normally a feature found on the central cruck of a building.

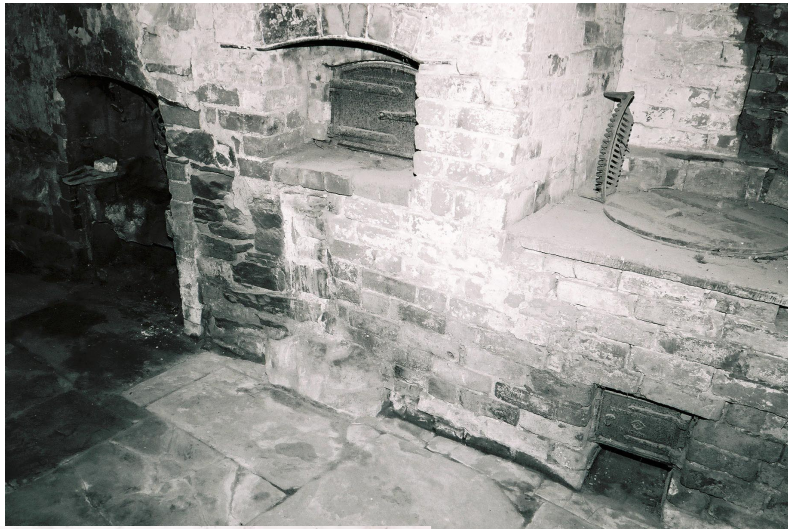
Plate 7: The baking oven and copper wash pot on the north side of the stack

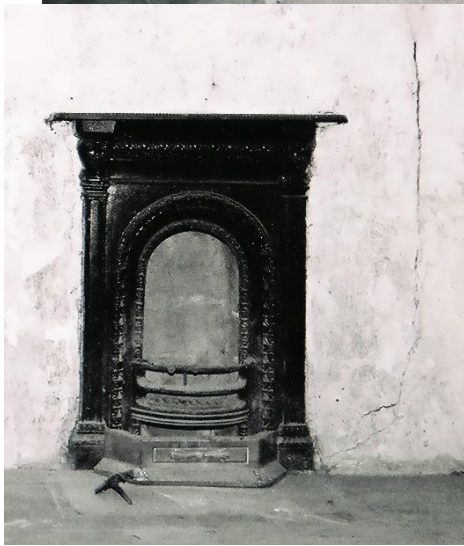
Plate 8: Fireplace in the bedroom

A new chimney stack was built on the south face of cruck 4, and a fireplace heated the new parlour and the bedroom directly above.

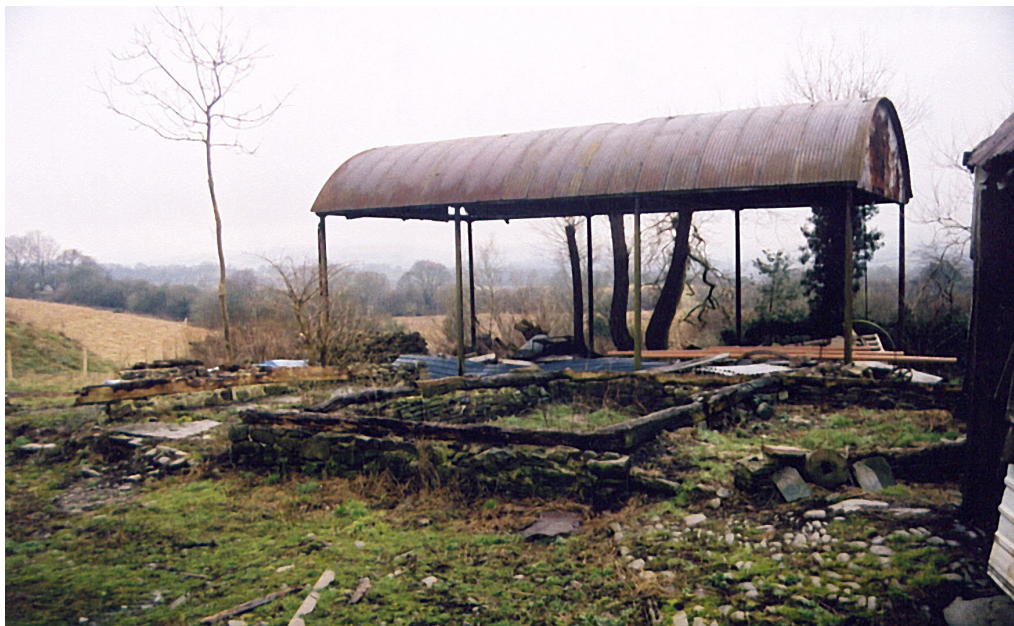
A typical Dutch barn with a curved metal roof of corrugated iron that is supported on cast iron posts, and probably dates to the late 19th-early 20th century.

Plate 9: The foundations of barn C with the Dutch barn in the background

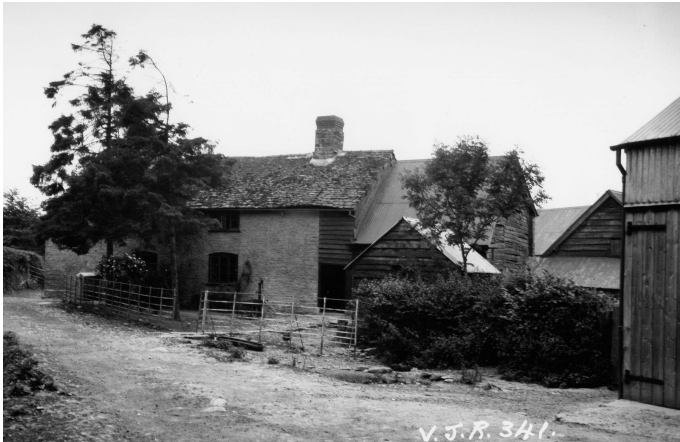
Only the stone footings remain. It was a square building (plate 10 & 11) that was still standing in the 1930's. The internal frame was probably of timber and was coated with weather boarding. The roof was of corrugated iron.

Plate 10: Building E in 1937. All that remains of the building are the stone foundations

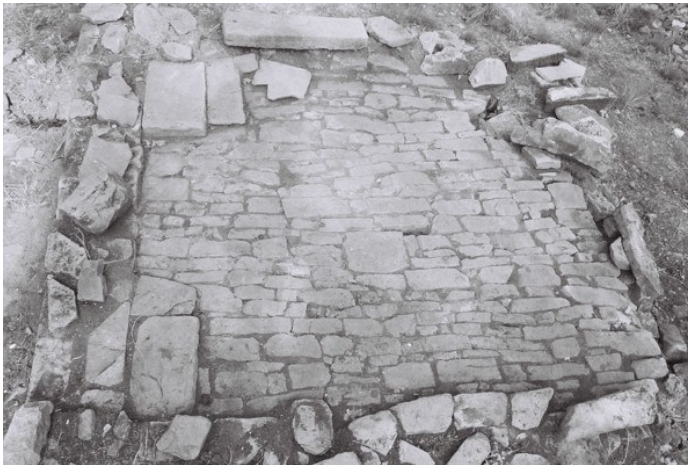
Plate 11: The stone foundation and floor of building E

The foundations showed no evidence of an entrance apart from possible steps on the north-west side.

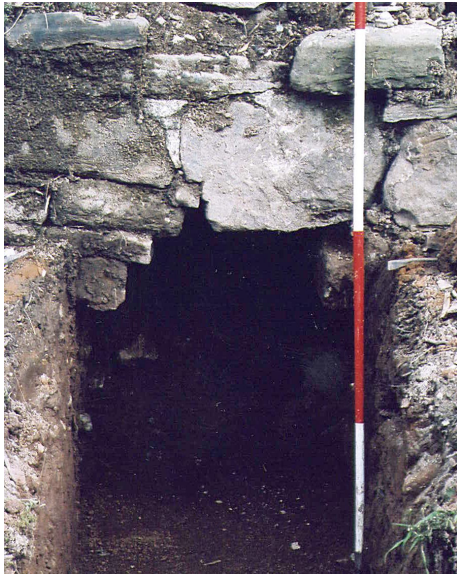
Plate 12: Example of pits dug for the underpinning of the walls

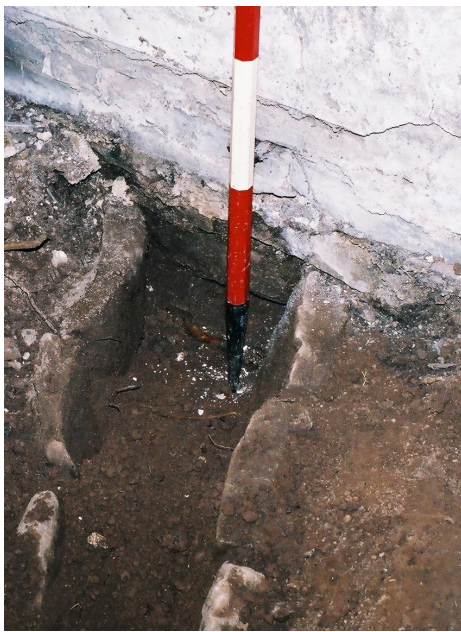
Plate 13: The stone lined drain within the house

The lowering of internal floor levels revealed archaeological features associated with the house, with some of the features possibly pre-dating the late standing walls. The lowering of the floor in the room south of the fireplace exposed a stone lined drain. The floor was laid on topsoil (1) with a thin skim of mortar (6). Below the mortar was a 0.20m thick layer of compact, red silty clay (7). The drain (2) was orientated north-east south-west and consisted of upright stones approx. 0.70-0.30m laid in two rows and capped by stone flags, possibly old roof tiles. The drain was approx. 0.30-0.40m deep with two fills. The upper fill (3) was of loose, well mixed rubble that was dark black and the lower fill (4) was compact beige silty clay.

The drain ran diagonally from the window to the door and at the north-east, appeared to be cut by the wall. Finds within the fill of the culvert consisted of 19th century pottery including some black slipware and clay pipe bowls, 3 with stamps, dating from 1660-1710.

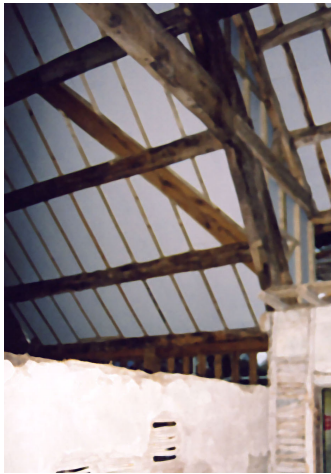
Plate 14: Passing wind brace in the restored roof at Pound farm

Something of a local tradition is possibly suggested by the wind-brace passing the three tiers of purlins. They are normally separated between the tiers. Other houses in the area with a similar passing brace feature include the cruck frame at Penros Court, Lyonshall, the Forge at Eardisley, Carter's Croft at Stapleton, and Black Hall at King's Pyon. It is possible that this could be a local tradition, but as there are a number of other houses in the area, including Great Quebb, Little Quebb, the two houses at Apostles, the Wren at Brilley, and Dairy Farm, Weobley, that follow a 'normal' cruck tradition, it may be possible that this type of wind brace is of a greater age (Tonkin 1973).
