Steen's Bridge Methodist Chapel, Docklow,
Herefordshire:
archaeological monitoring, recording and building
survey

Steen's Bridge Methodist Chapel, Docklow, Herefordshire: archaeological monitoring, recording and building survey
2003

Client: Ms D Camps, Chapel owner

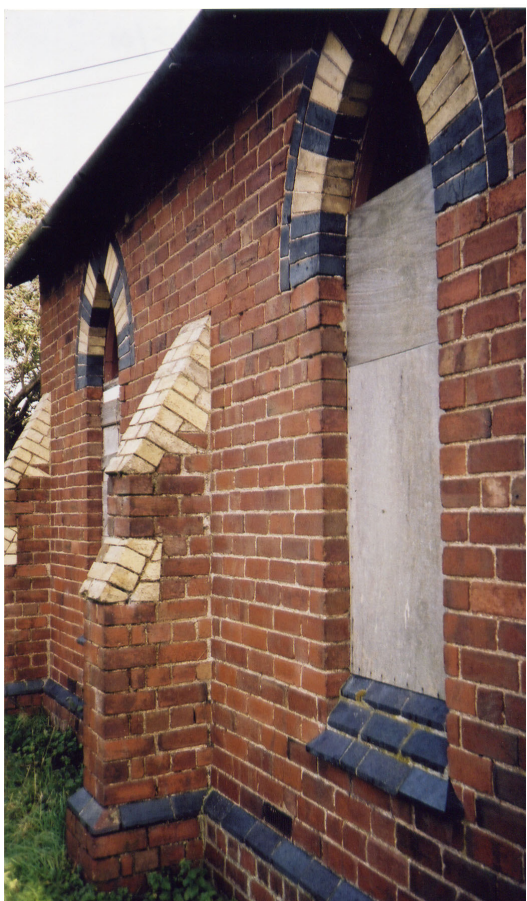
The chapel is built from brick, with a slate roof and ornamental ridge tiles. Around the upper portions of the buildings, and on the four wall buttresses on each side, various coloured bricks have been used to create patterns (plate 1).

Plate 1: Coloured stones used to decorate the windows and wall buttresses

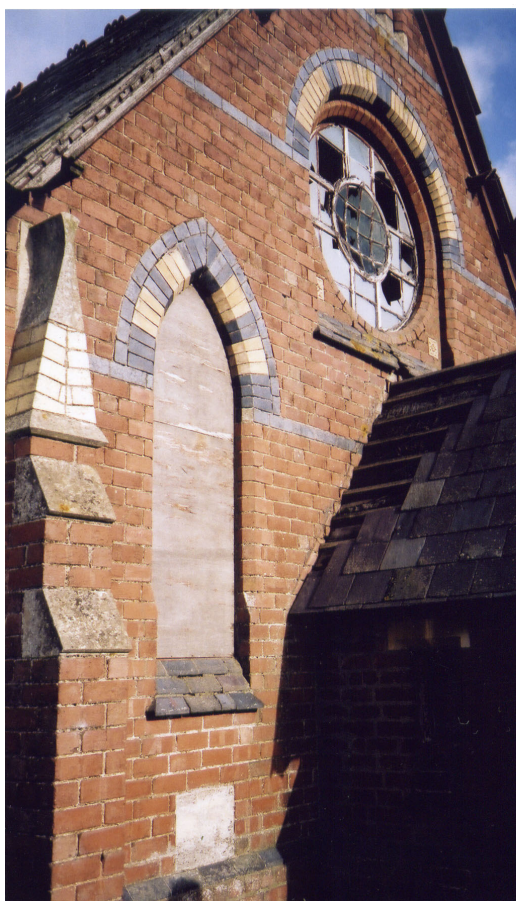
At the front of the chapel there is a roomy brick-built porch with narrow lancet windows on each side, also decorated with coloured bricks. Above this is a large circular window with some coloured glass (plate 2). Substantial barge boards under the gable end are of the same pattern as the porch. The chapel appears to be above average in the quality of construction; the circular window is an unusual feature for a local chapel. A photographic record of the building was made.

Plate 2: Large circular window above the entrance porch

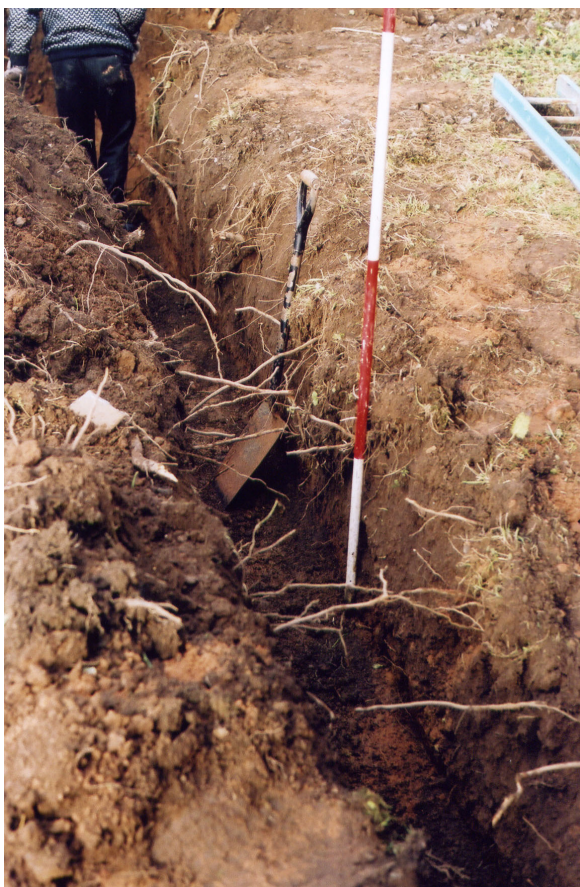
A service trench was excavated to a depth of 0.55 metres, running south-east to north-west from the western edge of the building (plate 3). 0.2-0.25 metres of topsoil lay over a neutral red-brown clay. No archaeological features were observed, and only one sherd of bone china was recovered.

Plate 3: Service trench

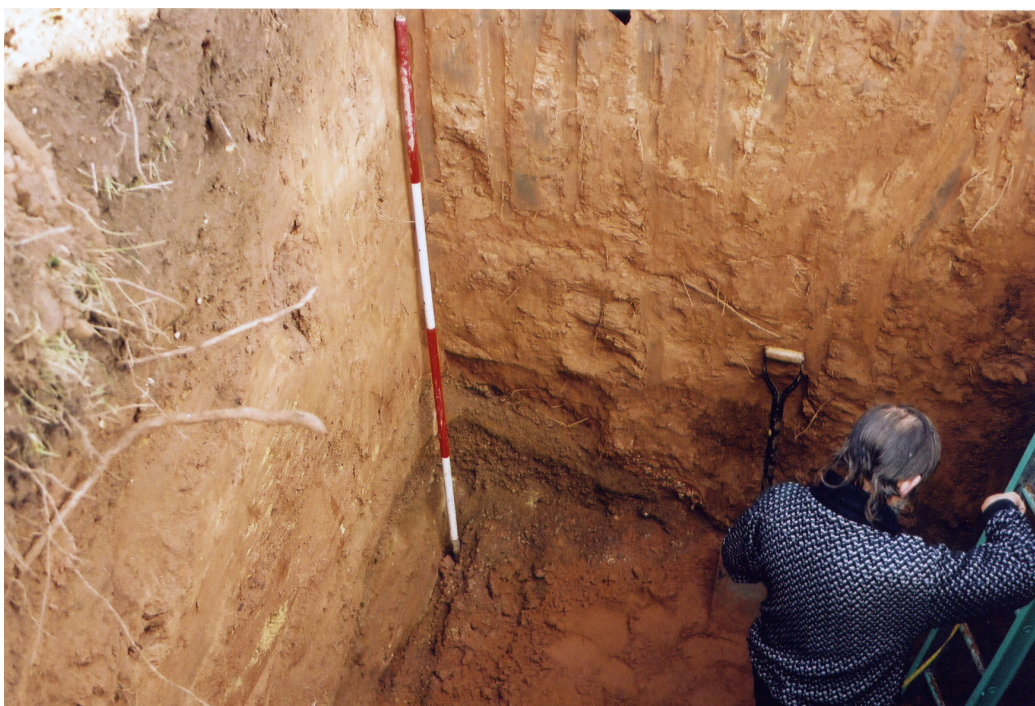
A septic tank pit was dug to a total depth of 2.9 metres (plate 4). A red-orange clay with patches of decayed sandstone lay beneath 0.2-0.25 metres of topsoil, with a patch of finer pea-gravel visible in the northern corner. No archaeological finds or features were observed.

Plate 4: Septic tank pit
