Choir House, King's School, Worcester:  
archaeological monitoring and building recording

Huw Sherlock and P J Pikes  
2005

*Choir House, King's School, Worcester : archaeological monitoring and building recording 2005*

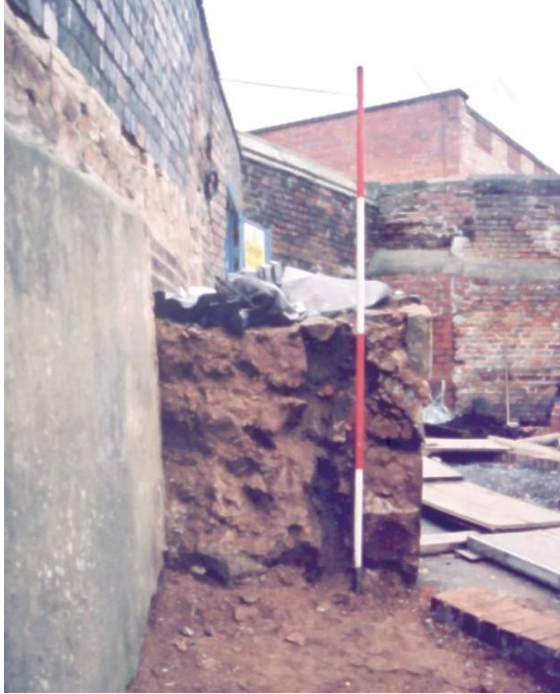
**Plate 2: Section of wall 36**

Wall 3 was a single row of ashlar deep and retained a bed of fine gravel (35). Removal of this gravel exposed an older sandstone and mortar wall (36) which appeared to have been re-faced by wall 3. A void between these two walls was filled with a brick and stone rubble (38). Wall 3 seems to be offset from the proposed original line of wall 3 by 1.10 metres and probably was simply a garden feature re-using the original sandstone blocks from the precinct wall.

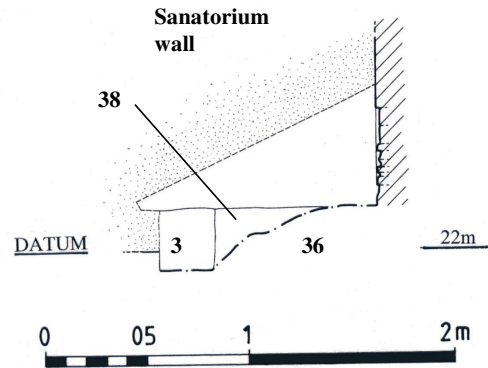
**Figure 15: Profile of wall 36 by the Sanatorium**

At the north-eastern end of wall 7, the southern wall of the Sanatorium had been laid directly onto 3, 36 and 38 without a foundation trench. Above wall 38 the Sanatorium butted wall 2.

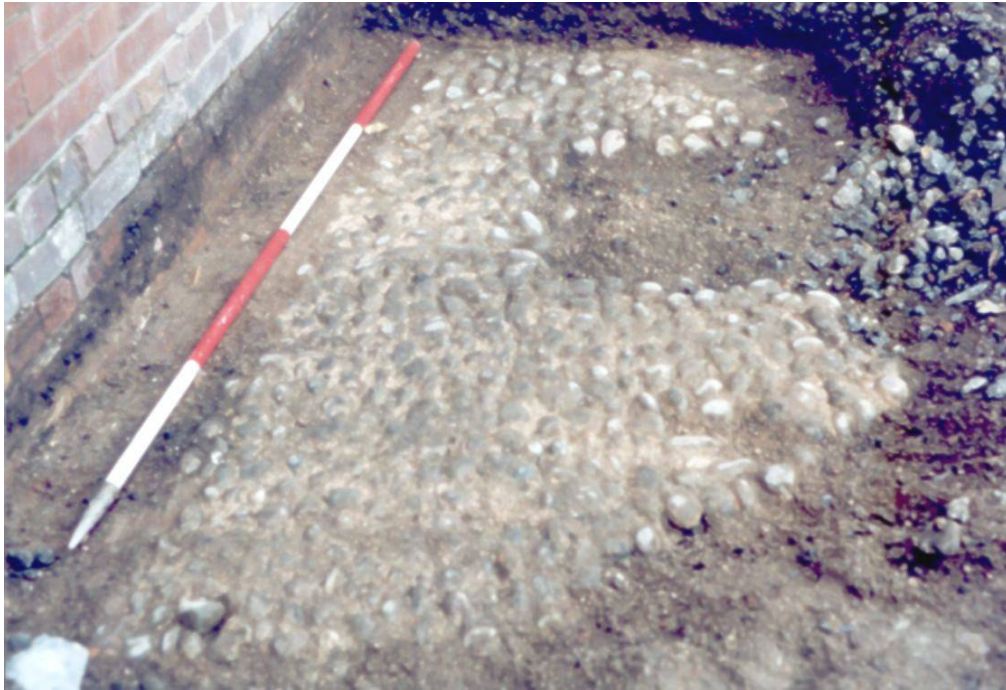
**Plate 3: Area of cobbles, 58, in trench K**

Trench K was an area opened up immediately to the east of the early 20<sup>th</sup> century block of Choir House (number 4 College Green) to investigate an area of cobbles visible below hardcore 6 in this area.

The cobbles (8) had been cut by the foundation trench of the eastern wall of the building. They were laid with a row of bricks running north-west to south-east at the northern surviving edge which measured 2.50 x 1.20 metres.
