101-106 St Owen's Street, Hereford:
archaeological monitoring

*101-106 St Owen's Street, Hereford: archaeological evaluation
2007*

Client: Mr D Marriott, land owner

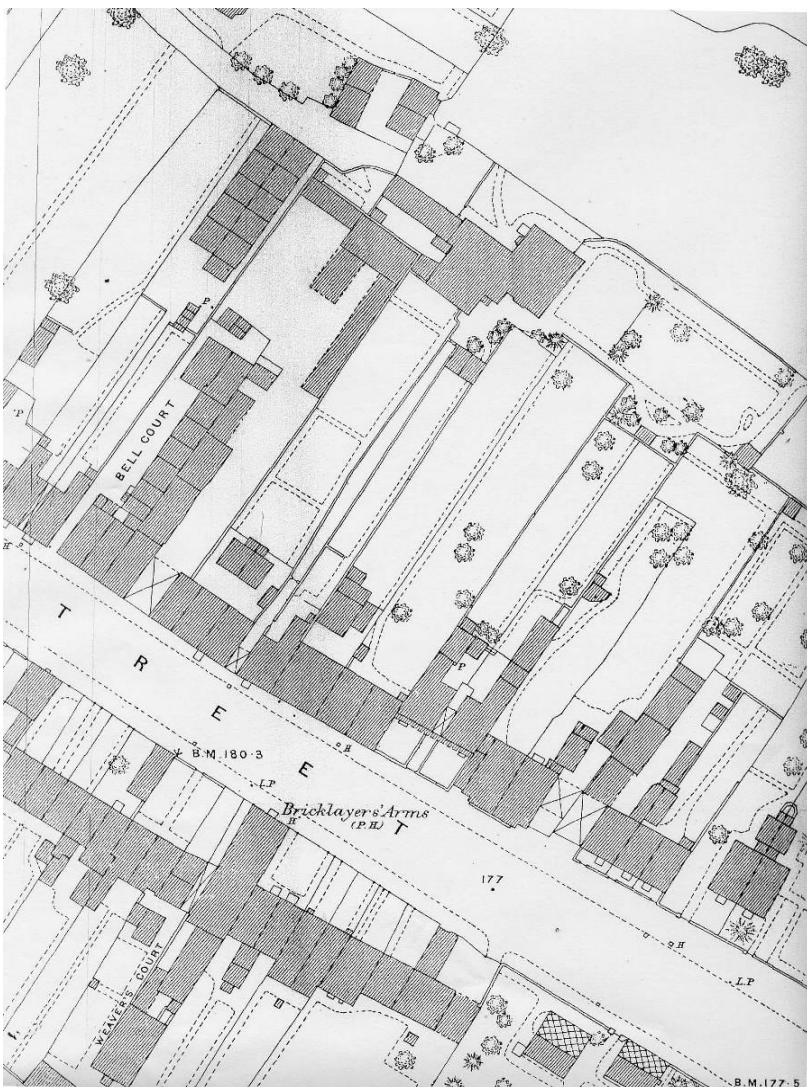
On the 1880s 1/500 OS map (Figure 3) a covered entrance (conventionally marked by a cross) leads behind Bell Court into a yard. By 1928 the yard and its buildings were the premises of Messrs Edmunds & Laurence, motor engineers. The site has an association with the motor trade of 90 years.

Figure 3: Extract from the 1886 1/500 OS map

No finds dating to earlier than the 16th century were found in this trench. The fact that the natural gravels were detected undisturbed at a high level across the centre of the trench may reflect the fact that the position of the trench coincides with an entrance way to the yard to the rear of buildings as shown on the 1886 1:500 OS map (see Figure 3).

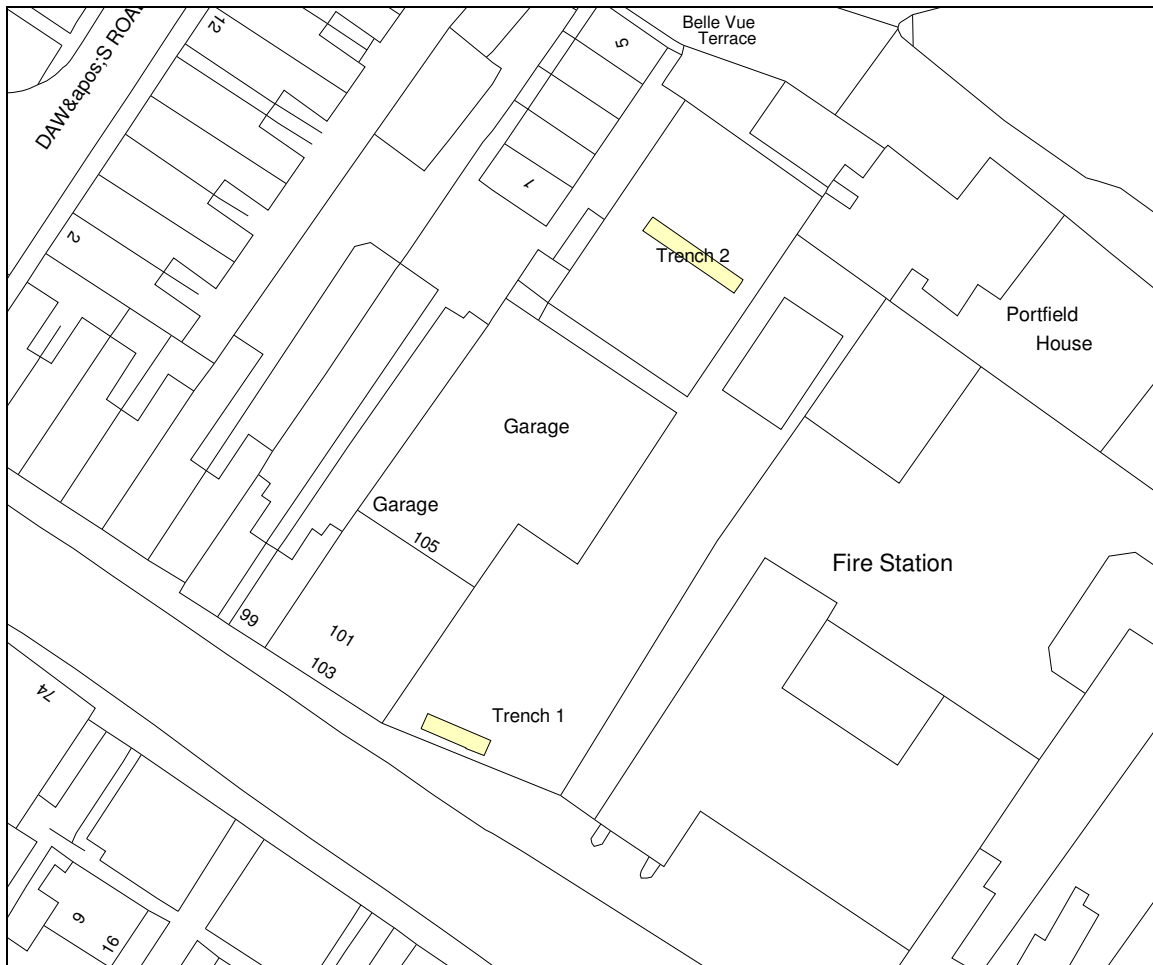
Figure 4: Trench location plan

Two trenches were excavated by means of a 2 ton tracked mini-excavator with a toothless bucket. Trench 1 was positioned as close as possible to the street frontage to assess whether evidence of medieval housing positioned along St Owen's Street had survived and to assess whether later post-medieval housing which had later occupied the site had cellars beneath the buildings. Trench 2 was oriented south-east/north-west and was positioned towards the rear of the property to assess the presence or absence of archaeological features associated with medieval urban use of garden plots.

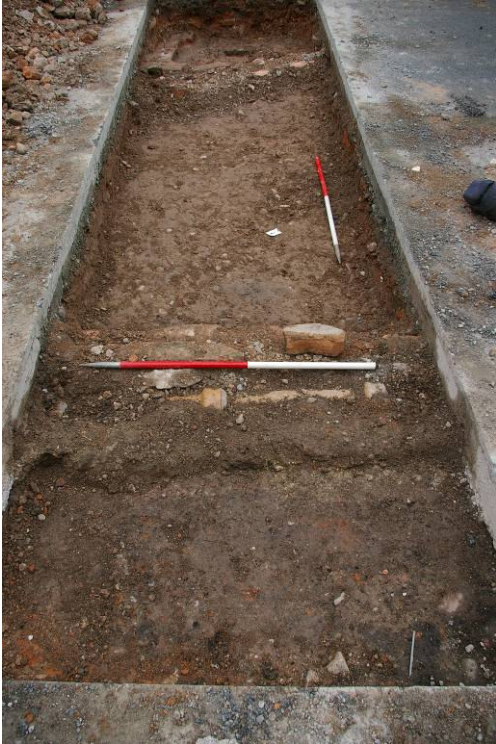
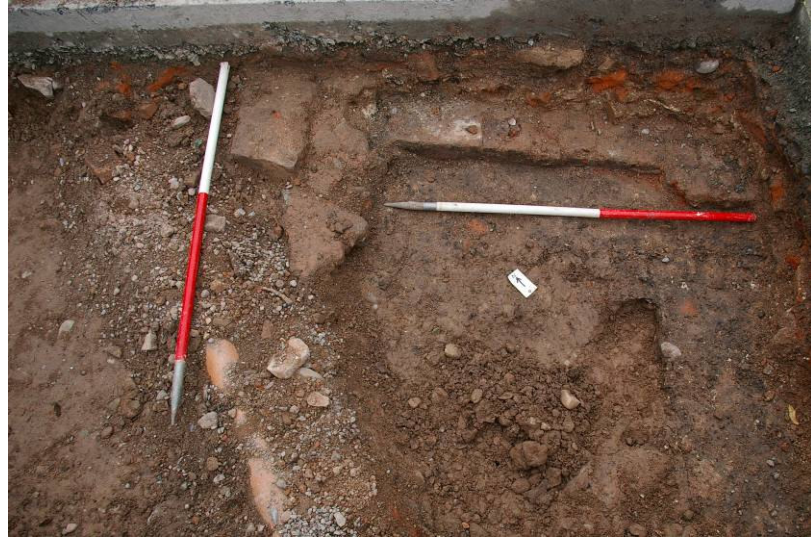
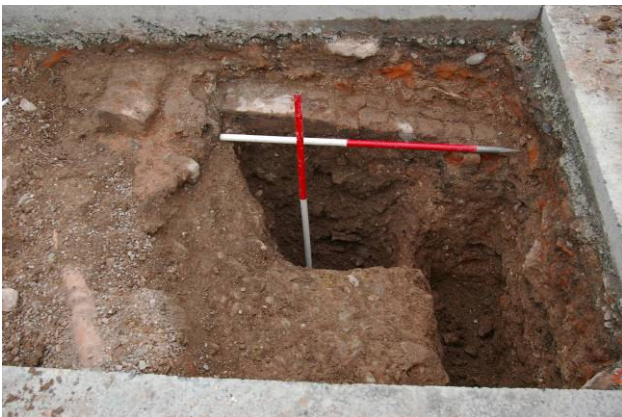
Figure 6: Trench 1; clockwise from top left; looking north-west along trench after cleaning; stone foundations (118); pit (125) and foundation cut (133) after excavation

Trench 1 was positioned along the St Owen's Street frontage and was oriented north-west/south-east. The modern ground surface consisted of tarmac (1) covering a skin of concrete (2). This was removed by machine and revealed a layer of dark, compact soil layer (103) containing frequent inclusions of crushed brick, tile and mortar. Beneath this layer at the north-western end of the trench a salt glazed waste pipe (104) ran across the trench from south-west/north-east, flanking the line of a modern brick foundation wall (105). Across the middle of the trench a layer of mixed clay and pebbles (122) was directly below the overburden and was in turn directly over the natural gravels (17). At the south-eastern end of the trench a series of brick sets (126) lying over a stone foundation (118) was found directly below the tarmac and make up layer, and below this lay a pit (125) containing 16th century and 17th century slip ware pottery, ceramic building material and decayed mortar. Flanking this, but separated from it, was a foundation cut (133), presumably for the return of a wall which had subsequently been robbed out.

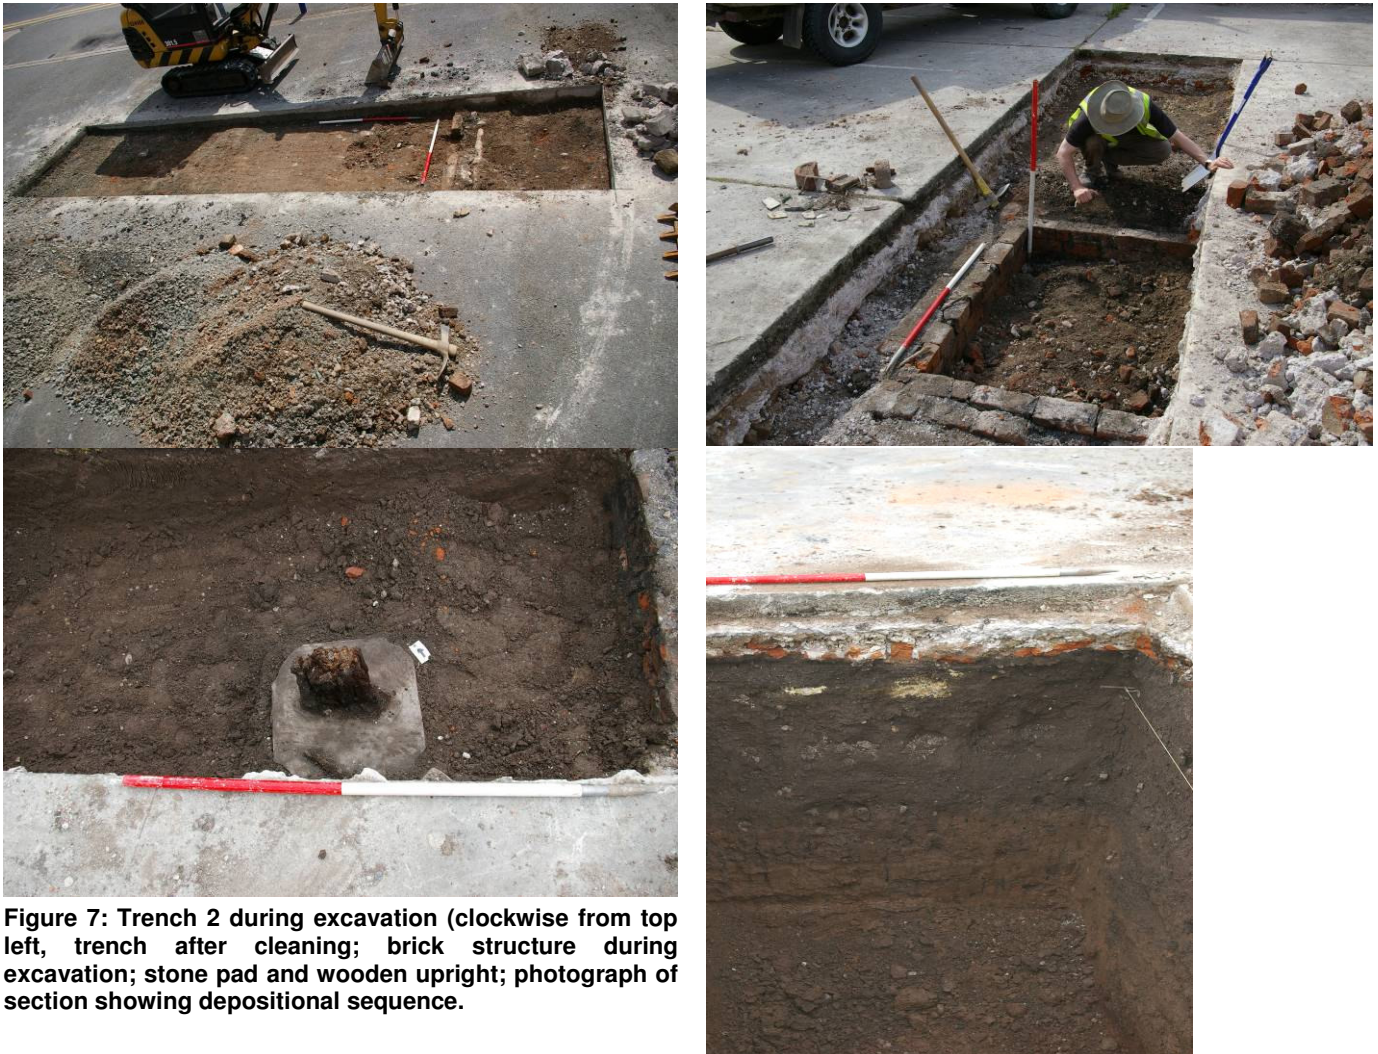
A skin of tarmac (1) lay over a double layer of concrete (210) which in turn covered a make-up layer consisting of crushed brick and hardcore. This overlay a layer of dark, friable soil (215); this was very humic and is consistent with a prolonged period of horticultural use. This in turn, lay over a mid red brown layer of very fine clay with silt and sand (216) which was undisturbed and lay directly over the natural gravels (17). A brick-lined pit was present which had truncated the deposits. Further to the south-west a brick-lined vehicle inspection pit (231) was present which had been backfilled with modern building rubble.

Two stone post pads on concrete bases (227 & 228) with the base of an upright wooden post still *in situ* was also uncovered. No finds pre-dating the 19th century were found in this trench.

Figure 7: Trench 2 during excavation (clockwise from top left, trench after cleaning; brick structure during excavation; stone pad and wooden upright; photograph of section showing depositional sequence.
