Nether Court Barn, Stoke Lacy, Herefordshire:
archaeological monitoring and building recording

*Nether Court Barn, Stoke Lacy, Herefordshire: archaeological monitoring and building recording
2003*

Client: Mr C Simmonds, land owner

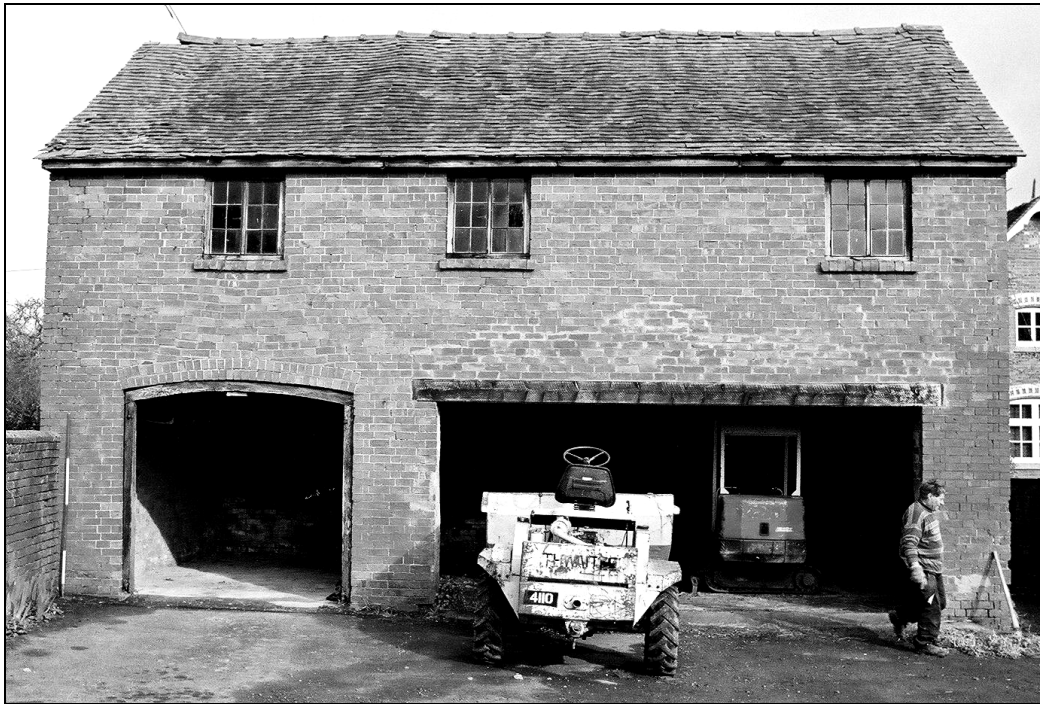
Plate 1: The southern elevation of the building

The building is of one storey and built in brick with a simple pitched roof covered in ceramic tiles. It is very similar in style to the adjacent hop kilns and other outbuildings, suggesting that it was constructed at the same time. The ground

floor was built as two unequal rooms, a cart shed/tack room and a stable. The western room still has the original brick arch headed doorway with wooden door surrounds, but the eastern room has had a new entrance inserted with a simple wooden lintel replacing the original doorway. The original position of the stable door can still be seen as a construction break (see plate 1). The upper storey has three unequally spaced casement windows with protruding lintels.

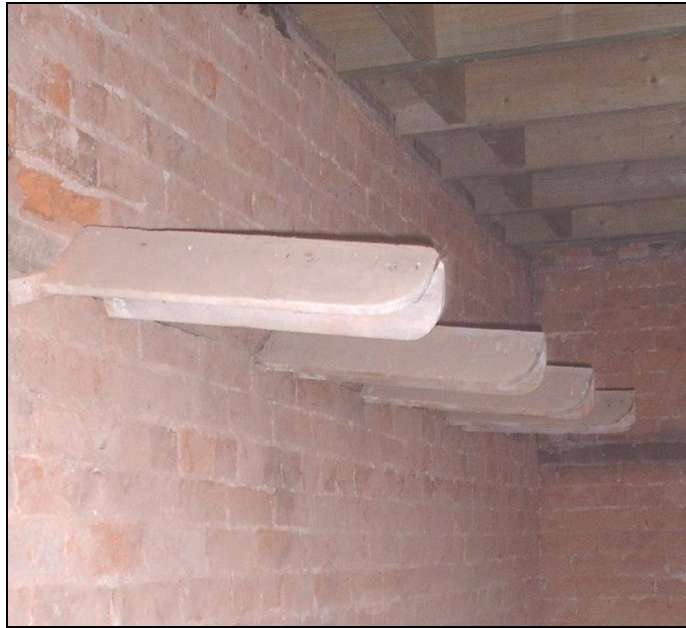
On the ground floor inside the western room attached to the western gable a series of wooden 'L' shaped supports survive. These were probably used to store saddles or other items of tack (see plate 2). The eastern gable end of the building has a door at first floor level was reached by a flight of external wooden steps. The floor of the first floor room had recently been replaced with new timbers and a hardboard floor.

Plate 2: The wooden supports probably used for storing saddles

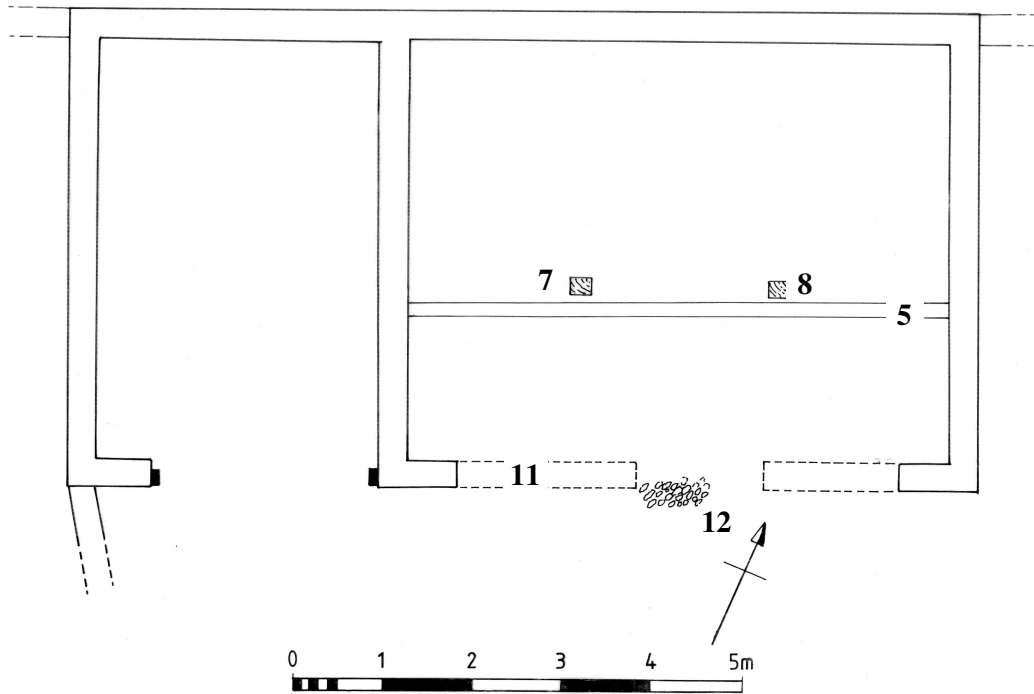
Figure 3: Ground plan showing the location of features recorded during the watching brief

The brick floor of the former stable was removed by hand (context 1). The bricks were hand made, had no frog and were 220 millimetres x 110 millimetres by 70 millimetres. The bricks were laid onto a lime mortar base which was 100 – 150 millimetres deep. A shallow gully was visible as a depression in the floor running north south across the width of the floor. Once the brick floor had been removed the underlying ground surface was examined for archaeological structures or deposits. This consisted of a deposit of mid brown silty clay with sand (context 3), which was 100 millimetres thick. This lay over a deposit of mid red clay (context 4). A brick lined drain (context 5) running north east – south west across the floor corresponding with the position of the gully visible in the brick floor above. This consisted of two rows of bricks (the same type as the floor was made from) laid on edge approximately 350 millimetres apart. Two pieces of roughly hewn tree trunk (contexts 7 & 8, see plate 3) had been buried to a depth of between 1 metre to 1.5 metres in the floor, apparently acting as supports for wooden partitions dividing the stable into separate stalls. The base of both these supports was very waterlogged. The position of the wooden supports corresponded with holes in the rear wall of the stable indicating where the partitions were fixed to the wall.

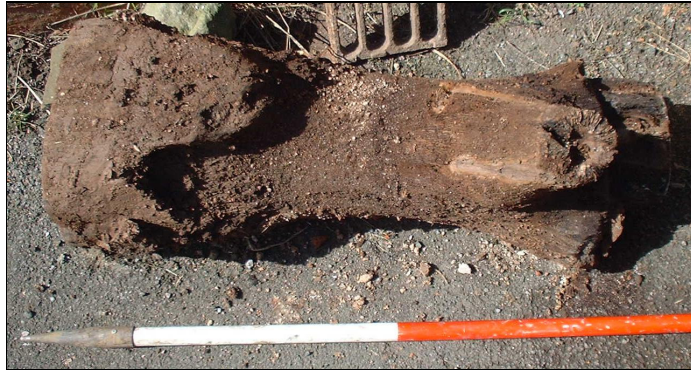
Plate 3: One of the two buried tree stumps (contexts 7&8)

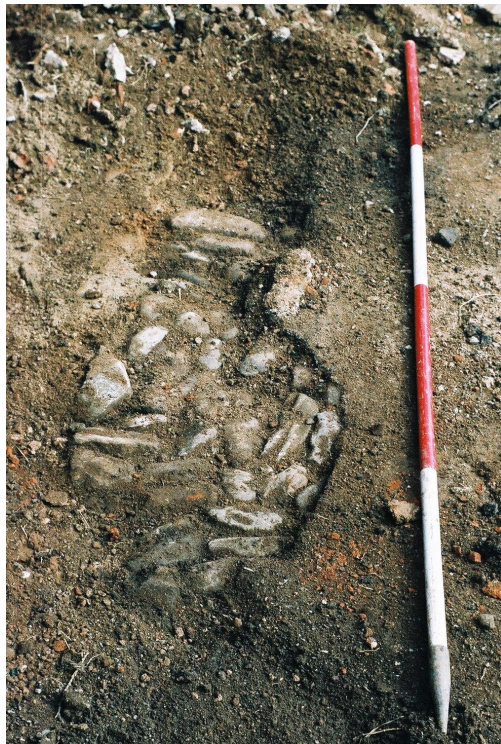
Some evidence relating to the original form of the building before the new doorway was inserted was observed. The original brick footings of the frontage of the building were clearly visible (context **11**), and showed that originally the stable had a single centrally placed doorway. A patch of cobbling (context **12**, see plate **4**) was still visible in front of the original position of the door. This appeared to continue beneath the tarmac yard surface.

Plate 4: The cobbles uncovered in front of the original doorway (context 12)
