4.0 Geological, historical and archaeological background

5.0 The buildings

Figure 2: The buildings from 42-52 Diglis Road

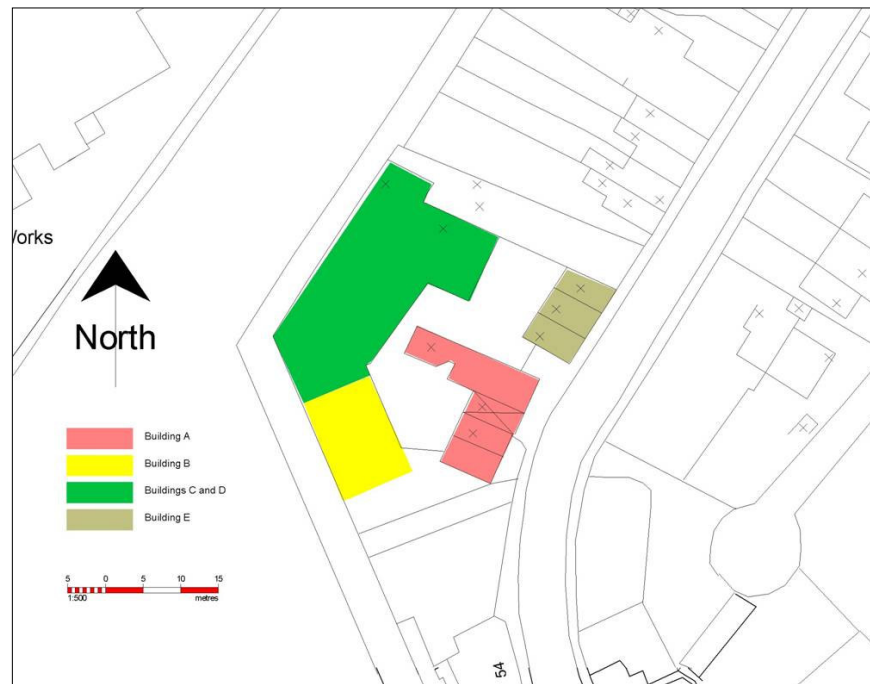
The area to the north is occupied by Building D and Building E (see Figure 2). Building D is largely built on virgin land but Building E occupies the site of three former dwellings, now single-storey garages (no's. 42 to 46). A substantial wall lies between this area and the former Court no 2. There are likely to be remnants of other buildings below ground (Figure 3).

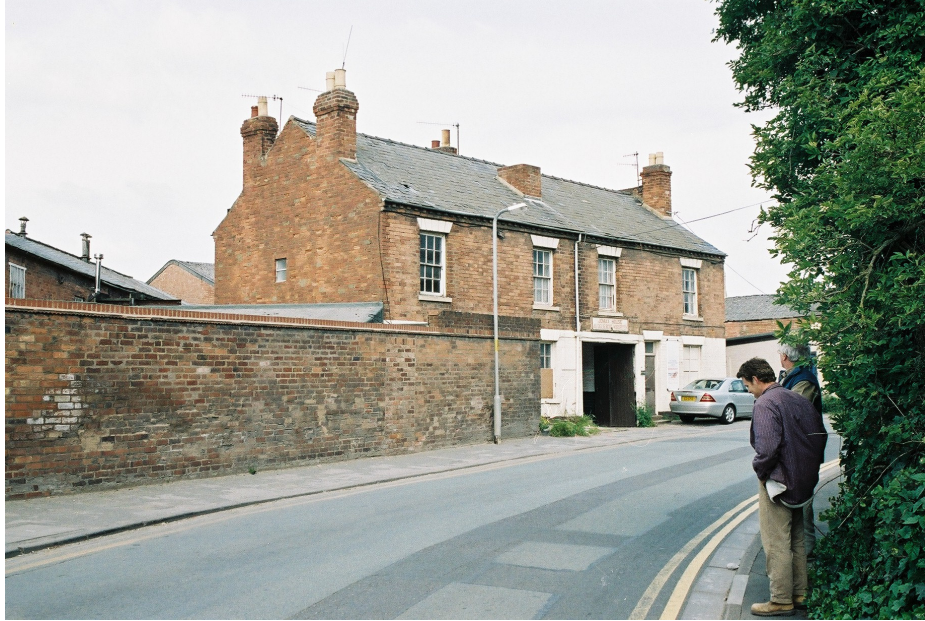
**Plate 1: Numbers 48 to 52 from the southeast. Number 48 lies to the left.
Note the ginnel between Numbers 50 and 52.**

Number 52 is separated from Numbers 48 and 50 by the ginnel (see Plate 1) and is considerably larger. It has, for instance, a more spacious hall and an open staircase with balusters. In addition it has a cellar and extends beyond the rear walls of Numbers 48 and 50 into the L at the rear. At a later stage an annex was built extending the L which terminated in the range running down to the canal. This was truncated after 1940, but together with the annex had catslide roofs which dropped towards the yard from the rear wall which formed the divide with Area 1. The annex is chamfered inwards to form a narrowing neck where it joined Number 52. The back wall viewed from Area 1 shows the building break where the annex was added (Plate 4). The annex contains the wash house for number 52.

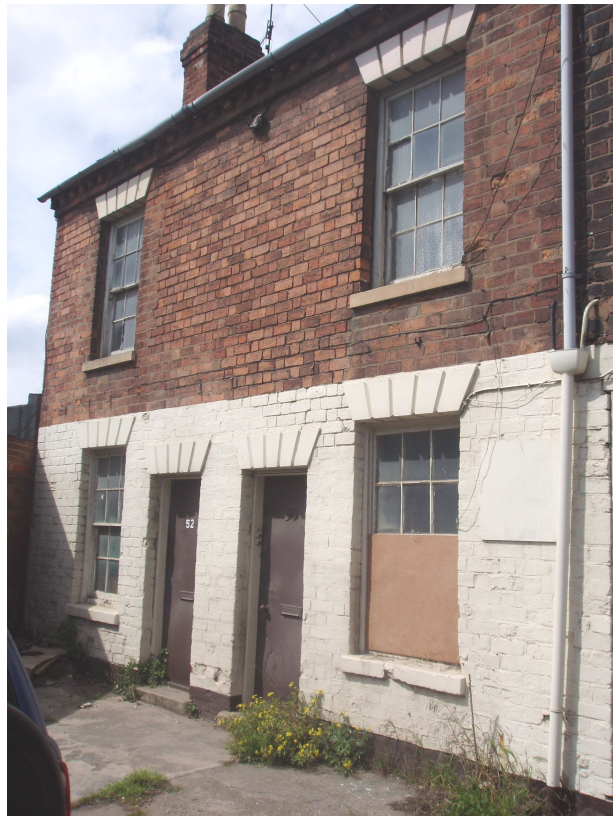
Plate 2: Numbers 48 and 50 Diglis Road

The front elevation has some architectural pretensions (Plate 2). A dentil course runs beneath the eaves. The front windows have sashes without horns and are of six lights in each, making twelve lights to each window. Above the ground floor doors and windows are stone segmented voissours with clear-cut arrises which give distinction to this elevation. Similar detail can be found in some of the double-fronted houses along Diglis Road but is unusual in such modest dwellings as no's. 48 to 52. The rear of no's. 48 and 50, being out of sight, lack this detail (Plate 3).

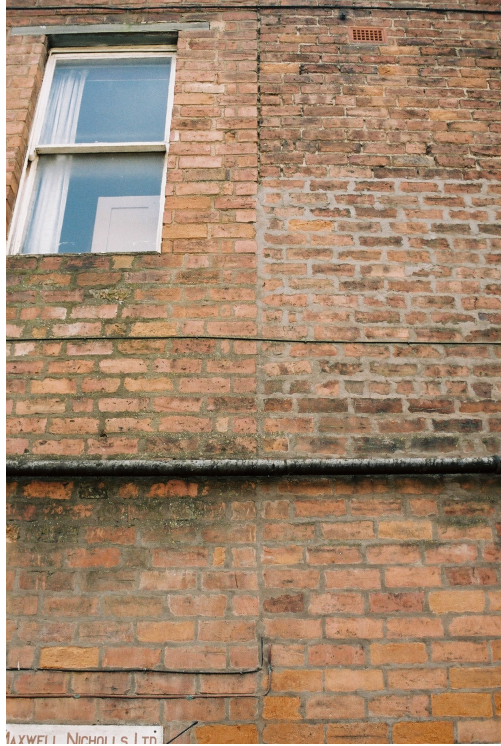
Plate 4: Building break between Number 52 and the annex (on the right)

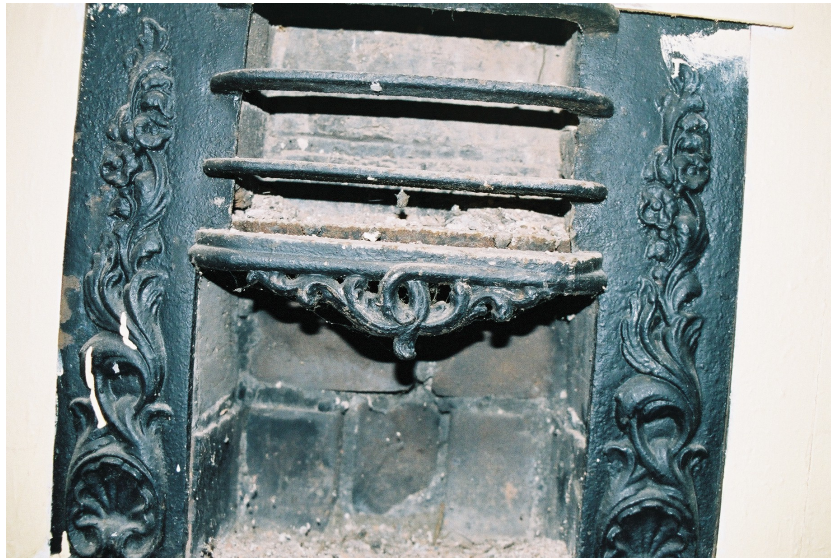
Within Numbers 48 and 50 there are some original features. These include early Victorian hob grates in the bedrooms (Plate 5) and a round-hooded fireplace in a living room.

Plate 5: Early Victorian hob fireplace in Number 48

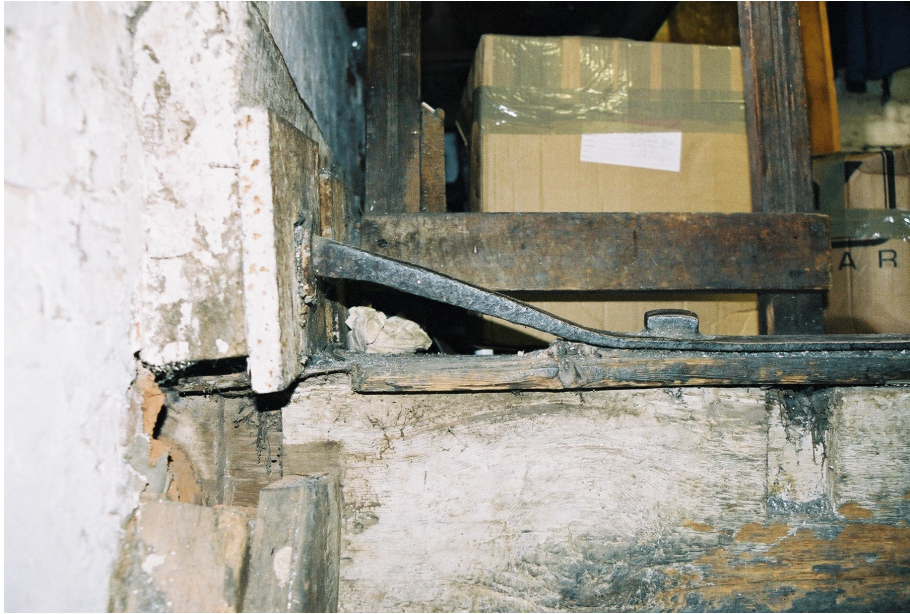
On the canal side, but outside the curtilage of Building B, lies the hand-operated crane. This is one of two marked on the OS map of 1928 around the inner basin and probably moved here after 1884 from elsewhere when its three points of anchorage were built into the wall of the building. Three wrought-iron strips for this were bolted internally and fixed by side plates against the wall (Plate 6).

Plate 6: One of three anchorages for the crane built into Building B. Note the spacing plate to the left.

The pull of the crane on the three internal anchorages has played havoc with the wall which is *in extremis*. In attempts to alleviate this consols and later, internal pilasters, were inserted. Transverse beams and open joists support the first floor. These too, and the weight they carried, exerted stress to the outer walls. Three (originally four) cast-iron pillars (Plate 9) set centrally along the lower floor helped support the upper floor and counteract the pull of the crane. The ground floor is raised slightly at the northwest end and here the original fourth pillar has been removed.

The modern accretions to be found in Buildings C and D do much to mar the complex and how these features might be handled invites sensitivity - they could obviously be cleared to returned the site to its original state as open land. Alternatively, considering the poor state of the canal front wall to Building B (which will undoubtedly need rebuilding) an extension in a similar material to this might be considered.

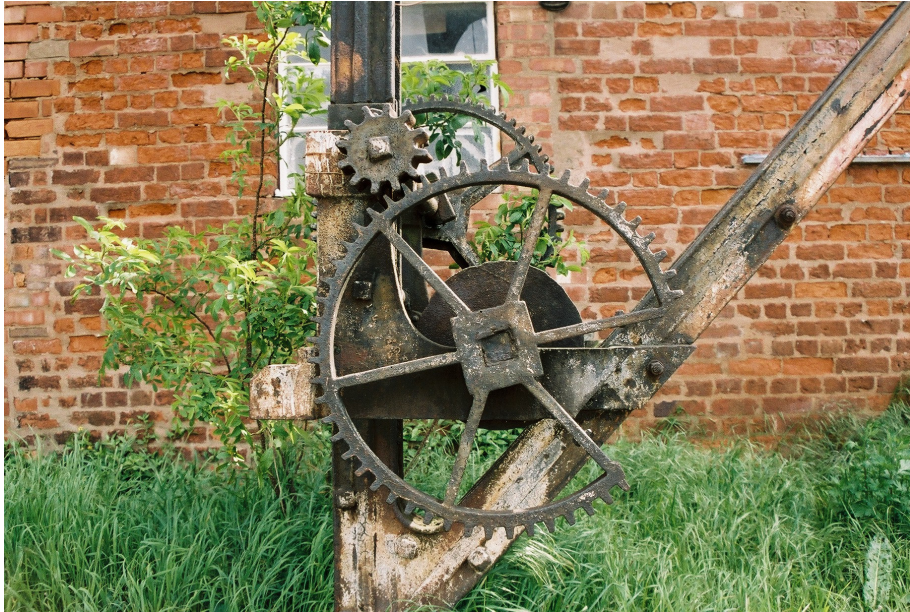
The crane is of primitive design with a combined wood and cast-iron jib (Plate 7) set on a fixed pivot. The axle is of square forged section but iron castings make up part of the jib, cogs and ratchet mechanism. It has no maker's mark and most of the nuts are square headed and hand forged – all this suggests that it was put together by a blacksmith from pre-cast parts. In basic form it appears to have been built around the time the canal was opened in 1815. It has a fixed reach limiting it to feeding the first or ground floor double doors of Building B from the canal (Plate 8).

Plate 7: The fixed-jib crane of around 1815

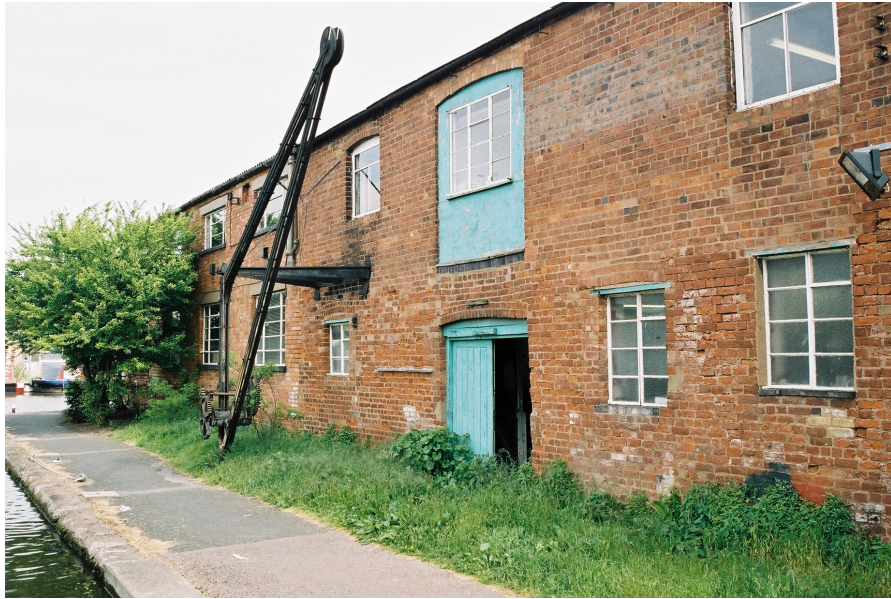
Plate 8: The canal front of Building B

The crane jib will only reach to the double doors on the two storeys of the building. Building C lies behind the crane. Note the mauld wall on Building B

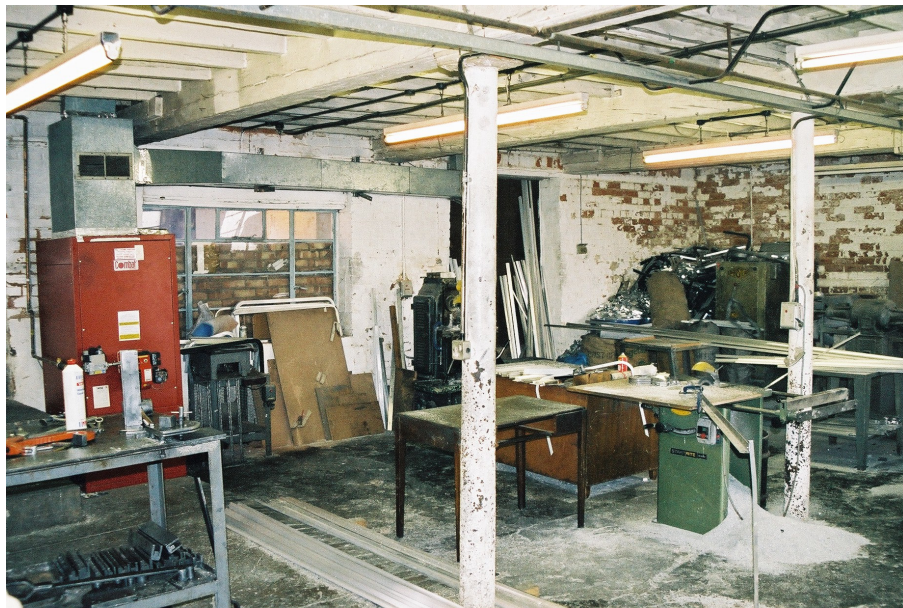
Plate 9: The ground floor of Building B showing cast-iron pillars

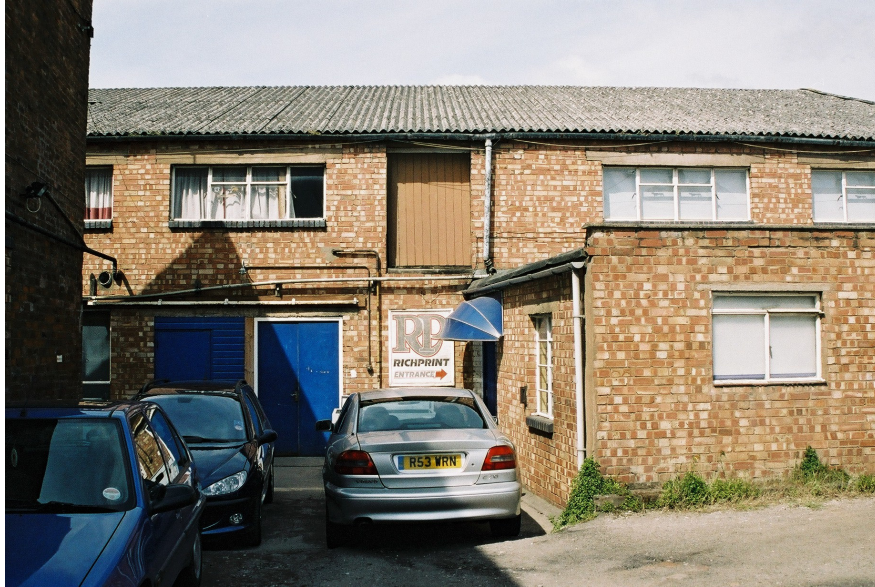
Plate 10: Building D from Diglis Road the annex to Number 52 on the left (Building A).

This post-1940 range lies mostly within Area 1 and extends across the virgin ground which lay between Building B and the wall with Court no. 2. However, a small part of the L-shaped arm would have been cleared to make way for it.

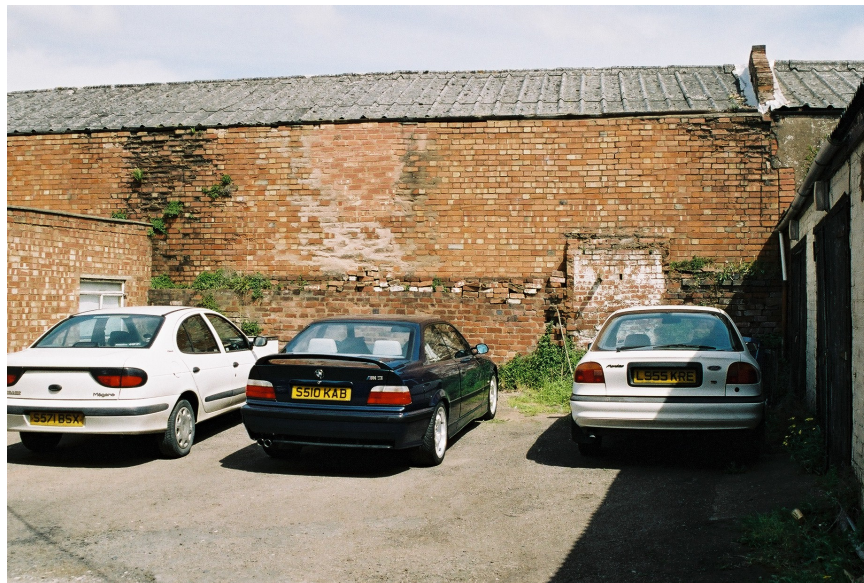
Plate 11: The site of the wash houses to Numbers 42 to 46

The wash houses are where the two cars on the left stand with the dividing wall between Area 1 and Court no. 2. The garages on the right stand on the site of the original three dwellings

There appears to be little that remains of the three dwellings which once stood here but their location was on the site of the present three garages. The three wash houses would have abutted onto the dividing wall between Area 1 and No. 2 Court (Plate 11).

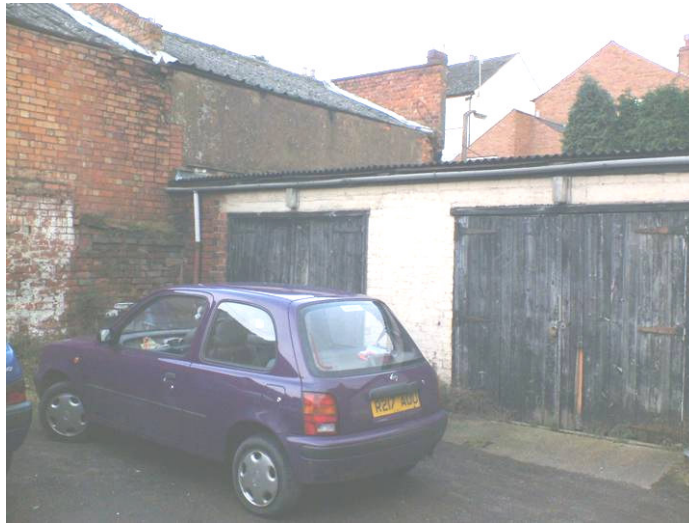
The garages to the north of building A are brick-built with a corrugated iron roof and have entrances from Diglis Road and the rear courtyard. The front of the building may once have been a working garage with two windows and garage doors on the east elevation facing the street, and a single door in the south elevation leading to possible office space. The rear of the building has 3 garages with wooden double doors.

Plate 12: The west elevation of building E and scars of the east-west brick wall

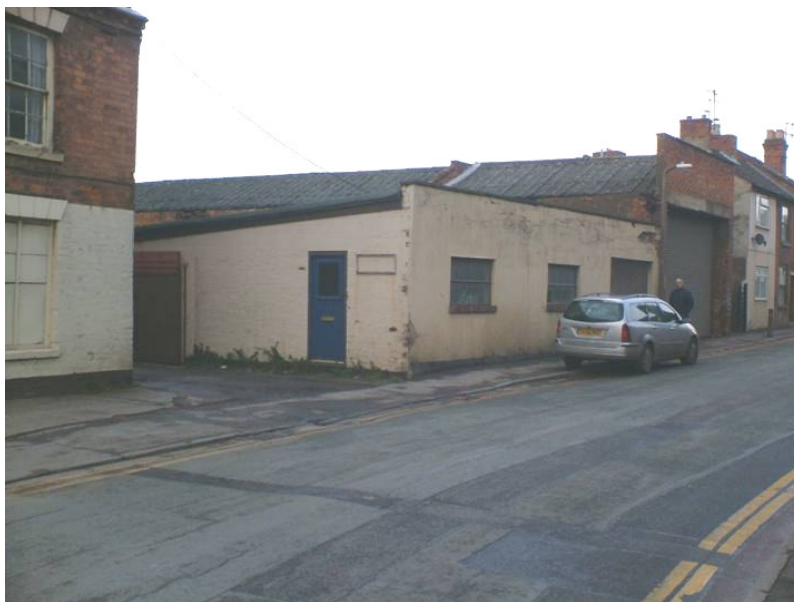
Plate 13: The front elevation of building E
