Morville Hall, Morville, Shropshire:  
an archaeological and historic landscape survey

*Morville Hall, Morville, Shropshire: archaeological and historic landscape survey  
2006*

Client: The National Trust

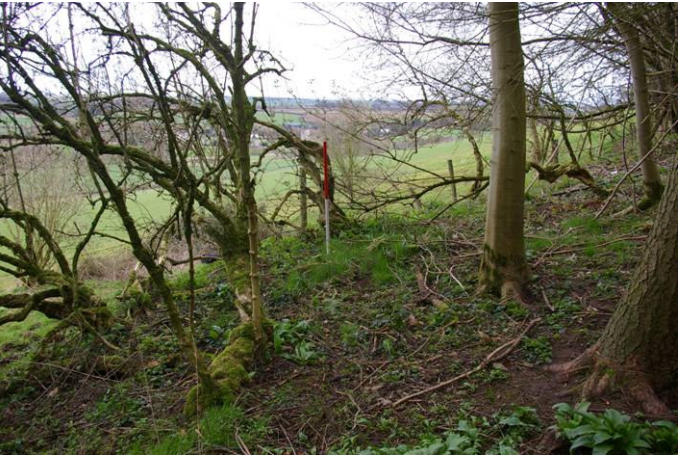
**Plate 30 – SMR No: 55607 – charcoal burning platform**

Charcoal burning platform approximately 7 metres in diameter and terraced into the hillside on its southern side and is on the north-facing hillside near the edge of the woodland. The

woodland edge has numerous coppiced hazel stools. The terrace is approximately 0.50 metres tall and dumped material forms the terrace. The soil inside the platform is much darker than surrounding soil and contains charcoal and burnt clay.

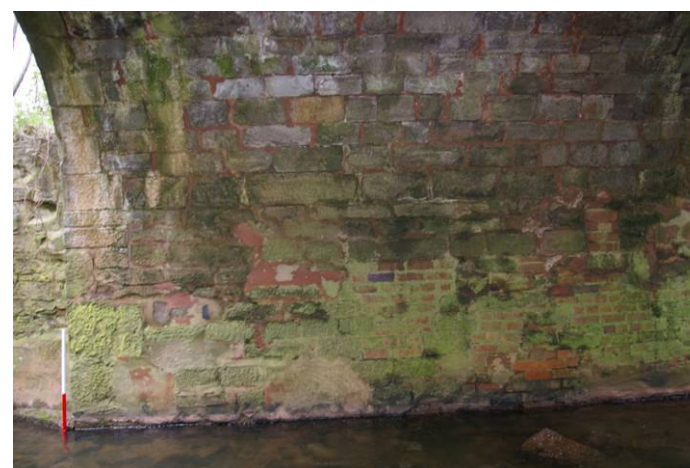
Plate 44 – SMR No: 55650 – stone bridge

An ashlar stone bridge approximately 10 metres high and 8 metres wide with an arch about six metres high and six metres wide. On the north and south-facing sides there are keystones and about 16 voussoirs. The bridge has been repaired internally with red brick. The bank on either side of the bridge has been revetted with stone walling. Stone pillars stand at each side of the bridge and on either side of the brook (four in total). On the south side, 0.50 metres above water level are iron hinges, indicating that originally there were gates on the bridge.

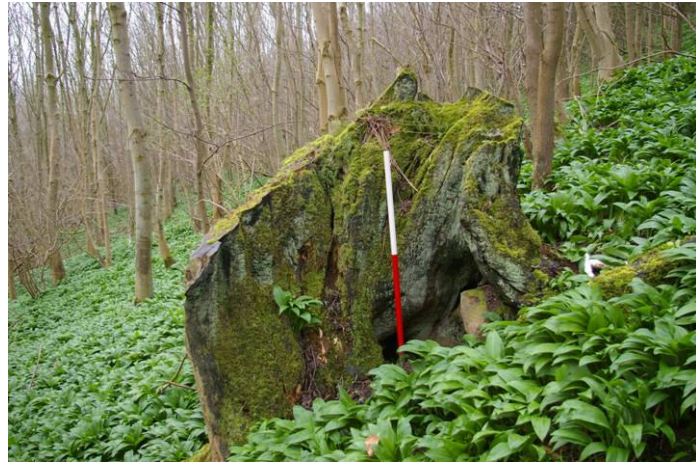
**Plate 48 – SMR No: 55600 – tree stump (possible yew)**

Half a tree stump (probably a yew) on the north-facing slope is all that remains of this tree which has been cut down and appears to have been burnt. The stump stands to a height of approximately 1.30 metres and is about 2 metres in diameter. There is a charred, moss covered branch lying to the south-west of the stump. The tree could have been part of an ornamental landscape.

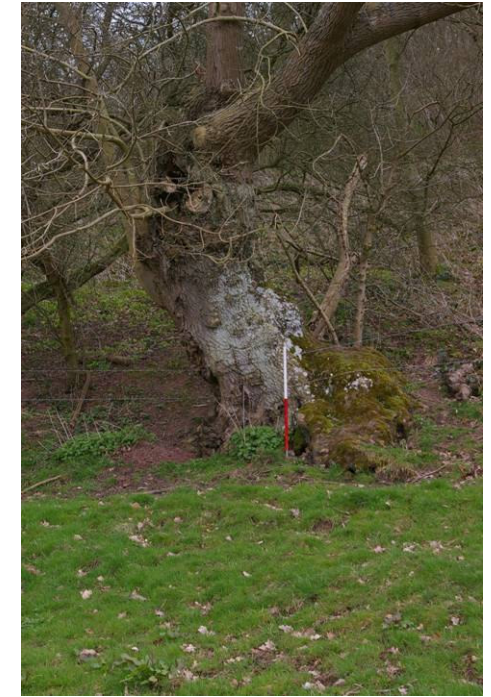
**Plate 51 – SMR No: 55620 – pollarded oak**

A pollarded oak growing against a fence roughly 1.50 metres in diameter and beginning to rot internally

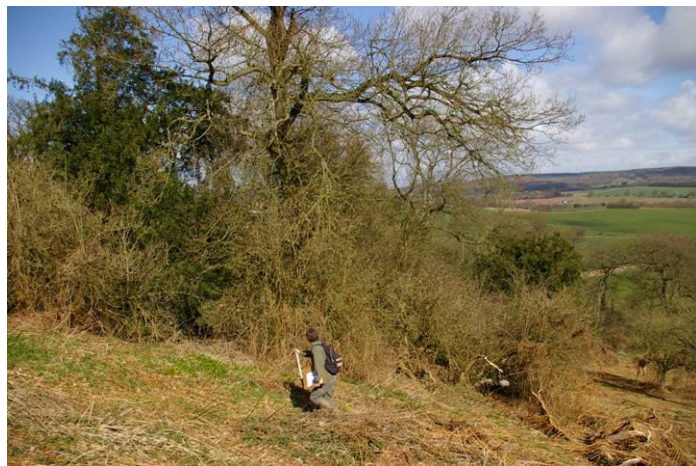
**Plate 52 – SMR No: 55633 – three yew trees**

There are three yew trees running along the edge of a stream gully known as 'Yewtree Dingle' which may represent a former parkland boundary. The trees are approximately 1 – 1.50 metres in diameter.

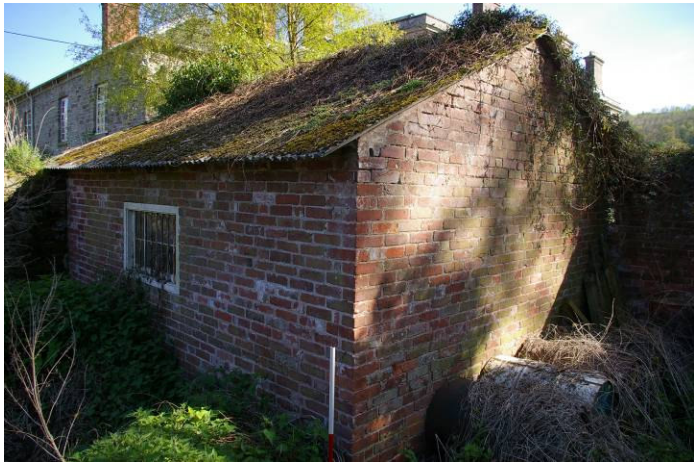
Plate 66 – SMR No: 55657 – kitchen garden structure

Lean-to brick structure attached to the southern wall of the kitchen garden. The structure has a central gabled doorway. It is constructed from bricks in a Flemish bond and is in excellent condition. The roof has terracotta tiles.

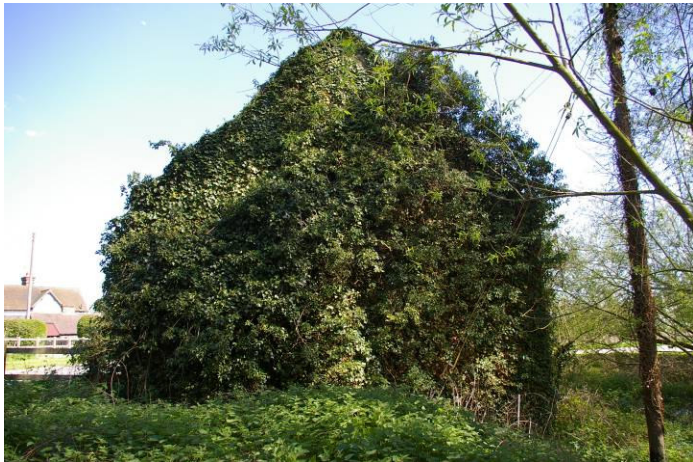
Plate 85 – SMR No: 55694 – the west elevation showing the vegetation that is causing damage to barn (55694)

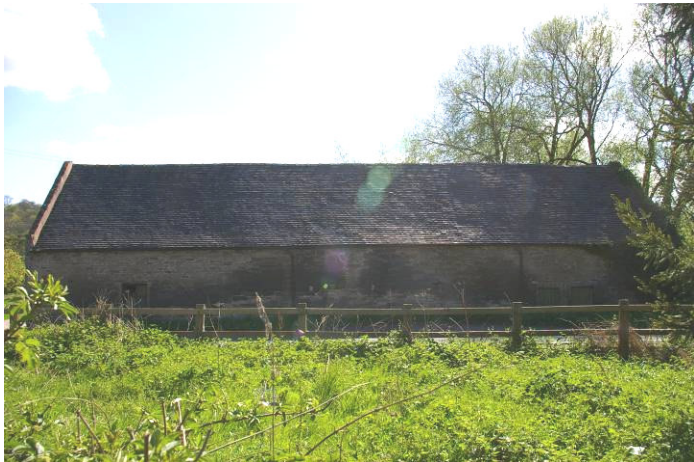
Plate 86 – SMR No: 55694 – the north elevation; the large blocked entranceway can be seen in the middle (55694)

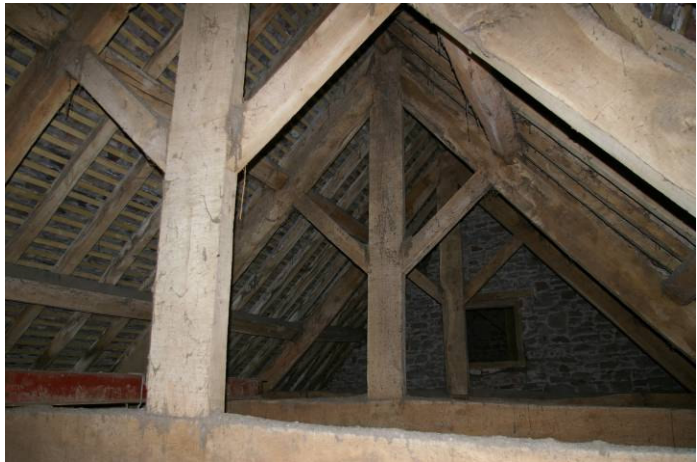
Plate 87 – SMR No: 55694 – the roof supported by king post trusses with angles struts (55694)

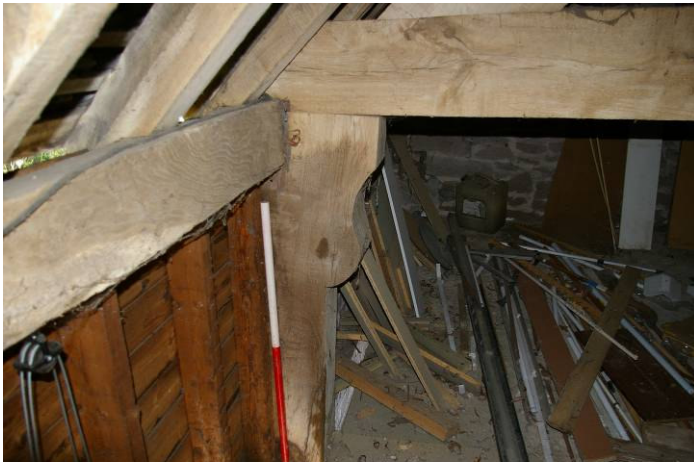
Plate 88 – SMR No: 55694 – the decorated jowel post (55694)
