project ref AA\_72

St Andrew's Churchyard, Allensmore,  
Herefordshire  
archaeological monitoring

*St Andrew's churchyard, Allensmore, Herefordshire: archaeological monitoring  
2004*

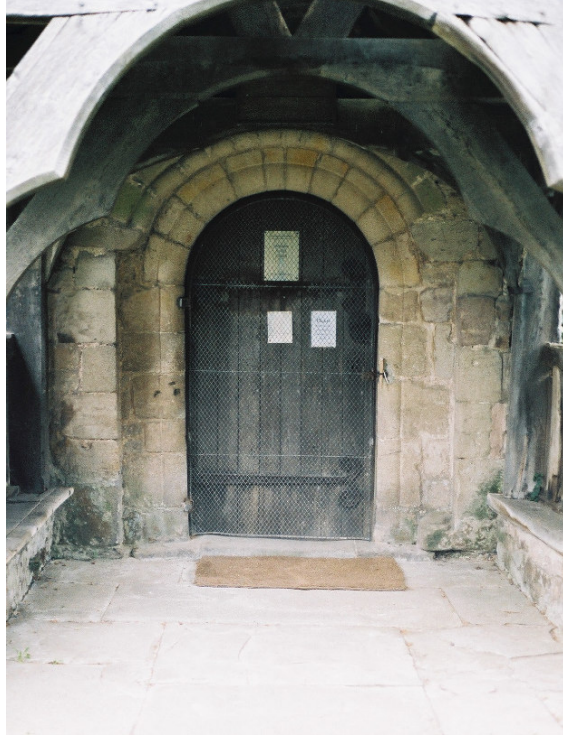
**Plate 1: The Norman doorway**

The earliest recorded detail is the western part of the south wall of the nave which contains the 12<sup>th</sup> century, or late Norman, doorway. This has a round head of two continuous moulded orders of which only the decayed base of the east outer shaft remains. In the churchyard to the south of the nave is a medieval preaching cross; the capital on top of the shaft originated from this doorway.

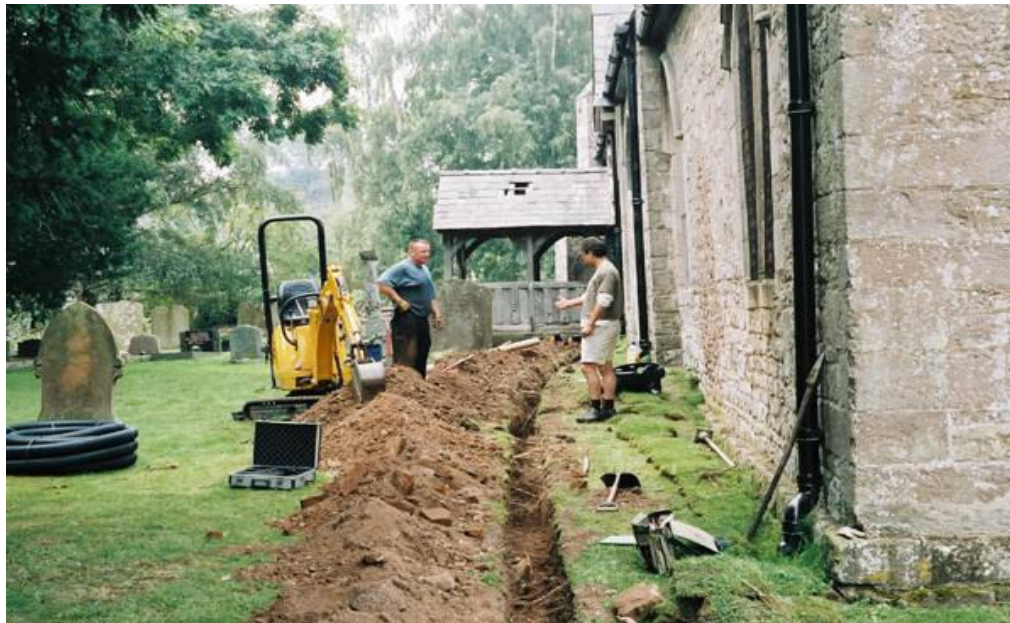
This 1 metre square hole was dug to a depth of 302.67m OD and cut through layers 1 and 2. In the south section of the east-west trench, just east of the manhole, was a small human skull (10) that was recorded but left *in-situ*. This probably would have belonged to an articulated burial that was orientated east-west and was at a depth of 303.27m OD. An iron coffin handle (SF 1) was also recovered from this area as well as some iron nails that were recorded but were left *in-situ*.

Plate 4: The south trench with the machine by the cut for the manhole

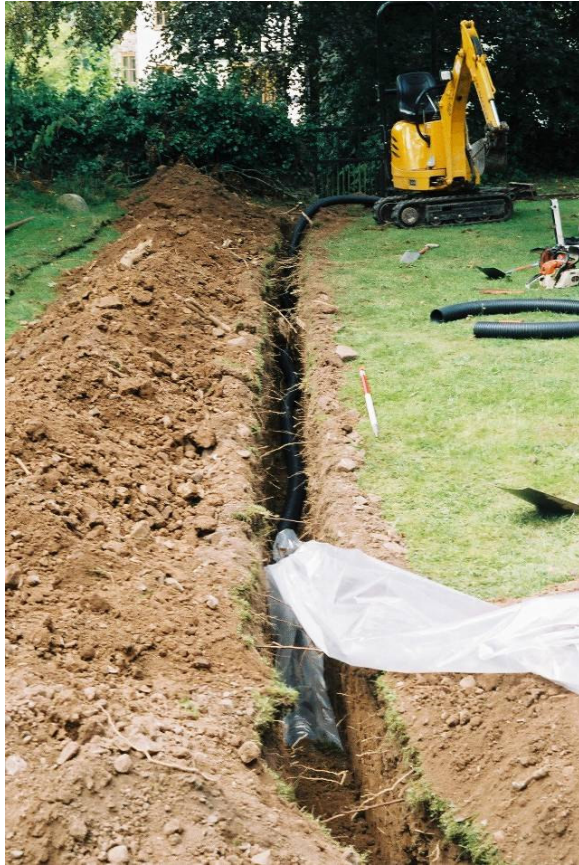
The trench was excavated to a depth of 302.67m OD at the north end and 303.00m OD at the south. The trench cut through layers 1 and 2.

It is likely that articulated human burials were disturbed during the excavation of this trench. Broken fragments of human bone were observed in 3 areas of the spoil, including fragments of skull, leg bones and arm bones. It is possibly that these bones were from articulated burials orientated east-west.

Due to the width of the trench (0.30m) it was difficult to observe any grave cuts within the sections.

**Plate 5: Trench heading south from the church**

It is possible that burials were disturbed in the trench running south from the church. At least one leg bone was observed in the east section, and bones were recovered from the spoil heap. However, the size of the trench, and given that disarticulated bones are common in graveyards, it is difficult to establish whether the bones were from articulated burials.

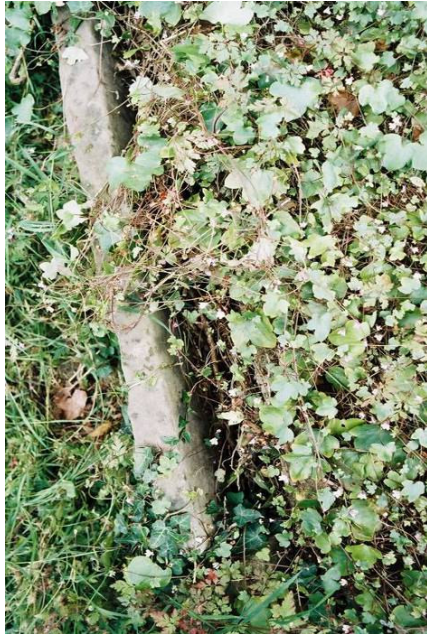
A gravestone was found that had possibly been reused in former work on the drainpipes, and a fragment of gravestone (figure 8) was recovered from the spoil heap. A reused gravestone can also be seen in the east boundary wall of the church.

**Plate 6: Re-used gravestone in the boundary wall to the east of the church**
