Archaeological Building Investigation and Recording,
Royal Worcester Porcelain Works,
Buildings A, B, C and H

August 2008

Client: Berkeley Homes (Oxford & Chiltern) Ltd

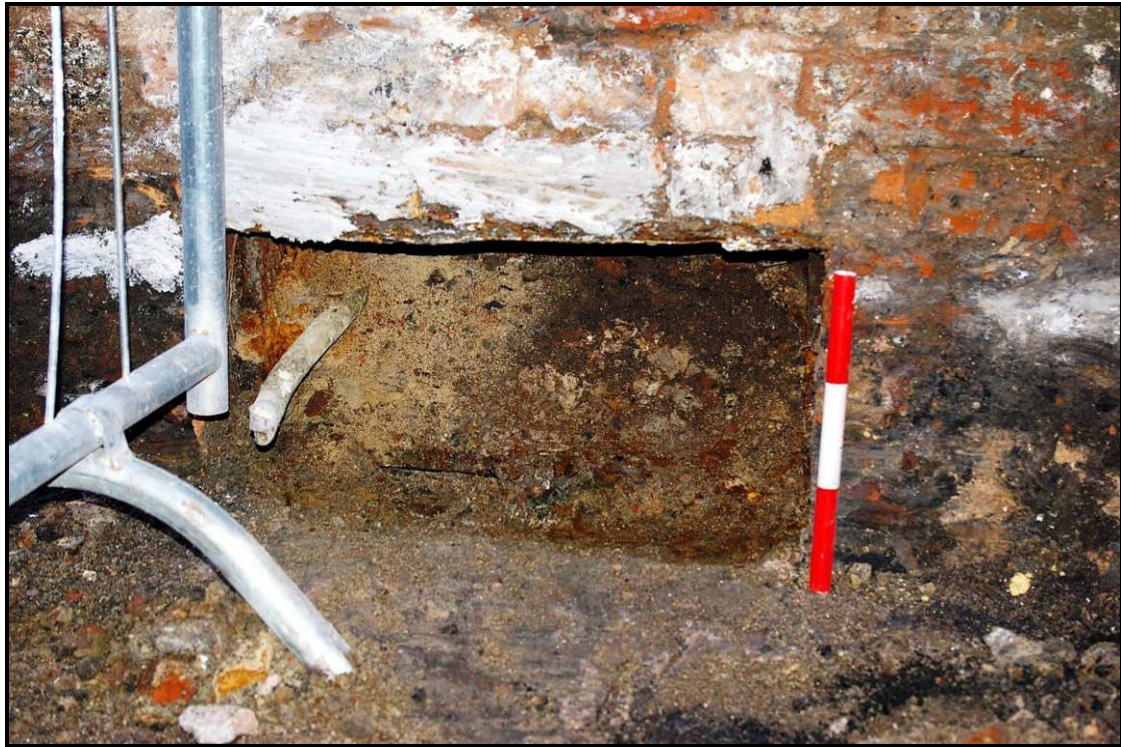
Figure 17: Cast-iron frame of former horizontal drive shaft

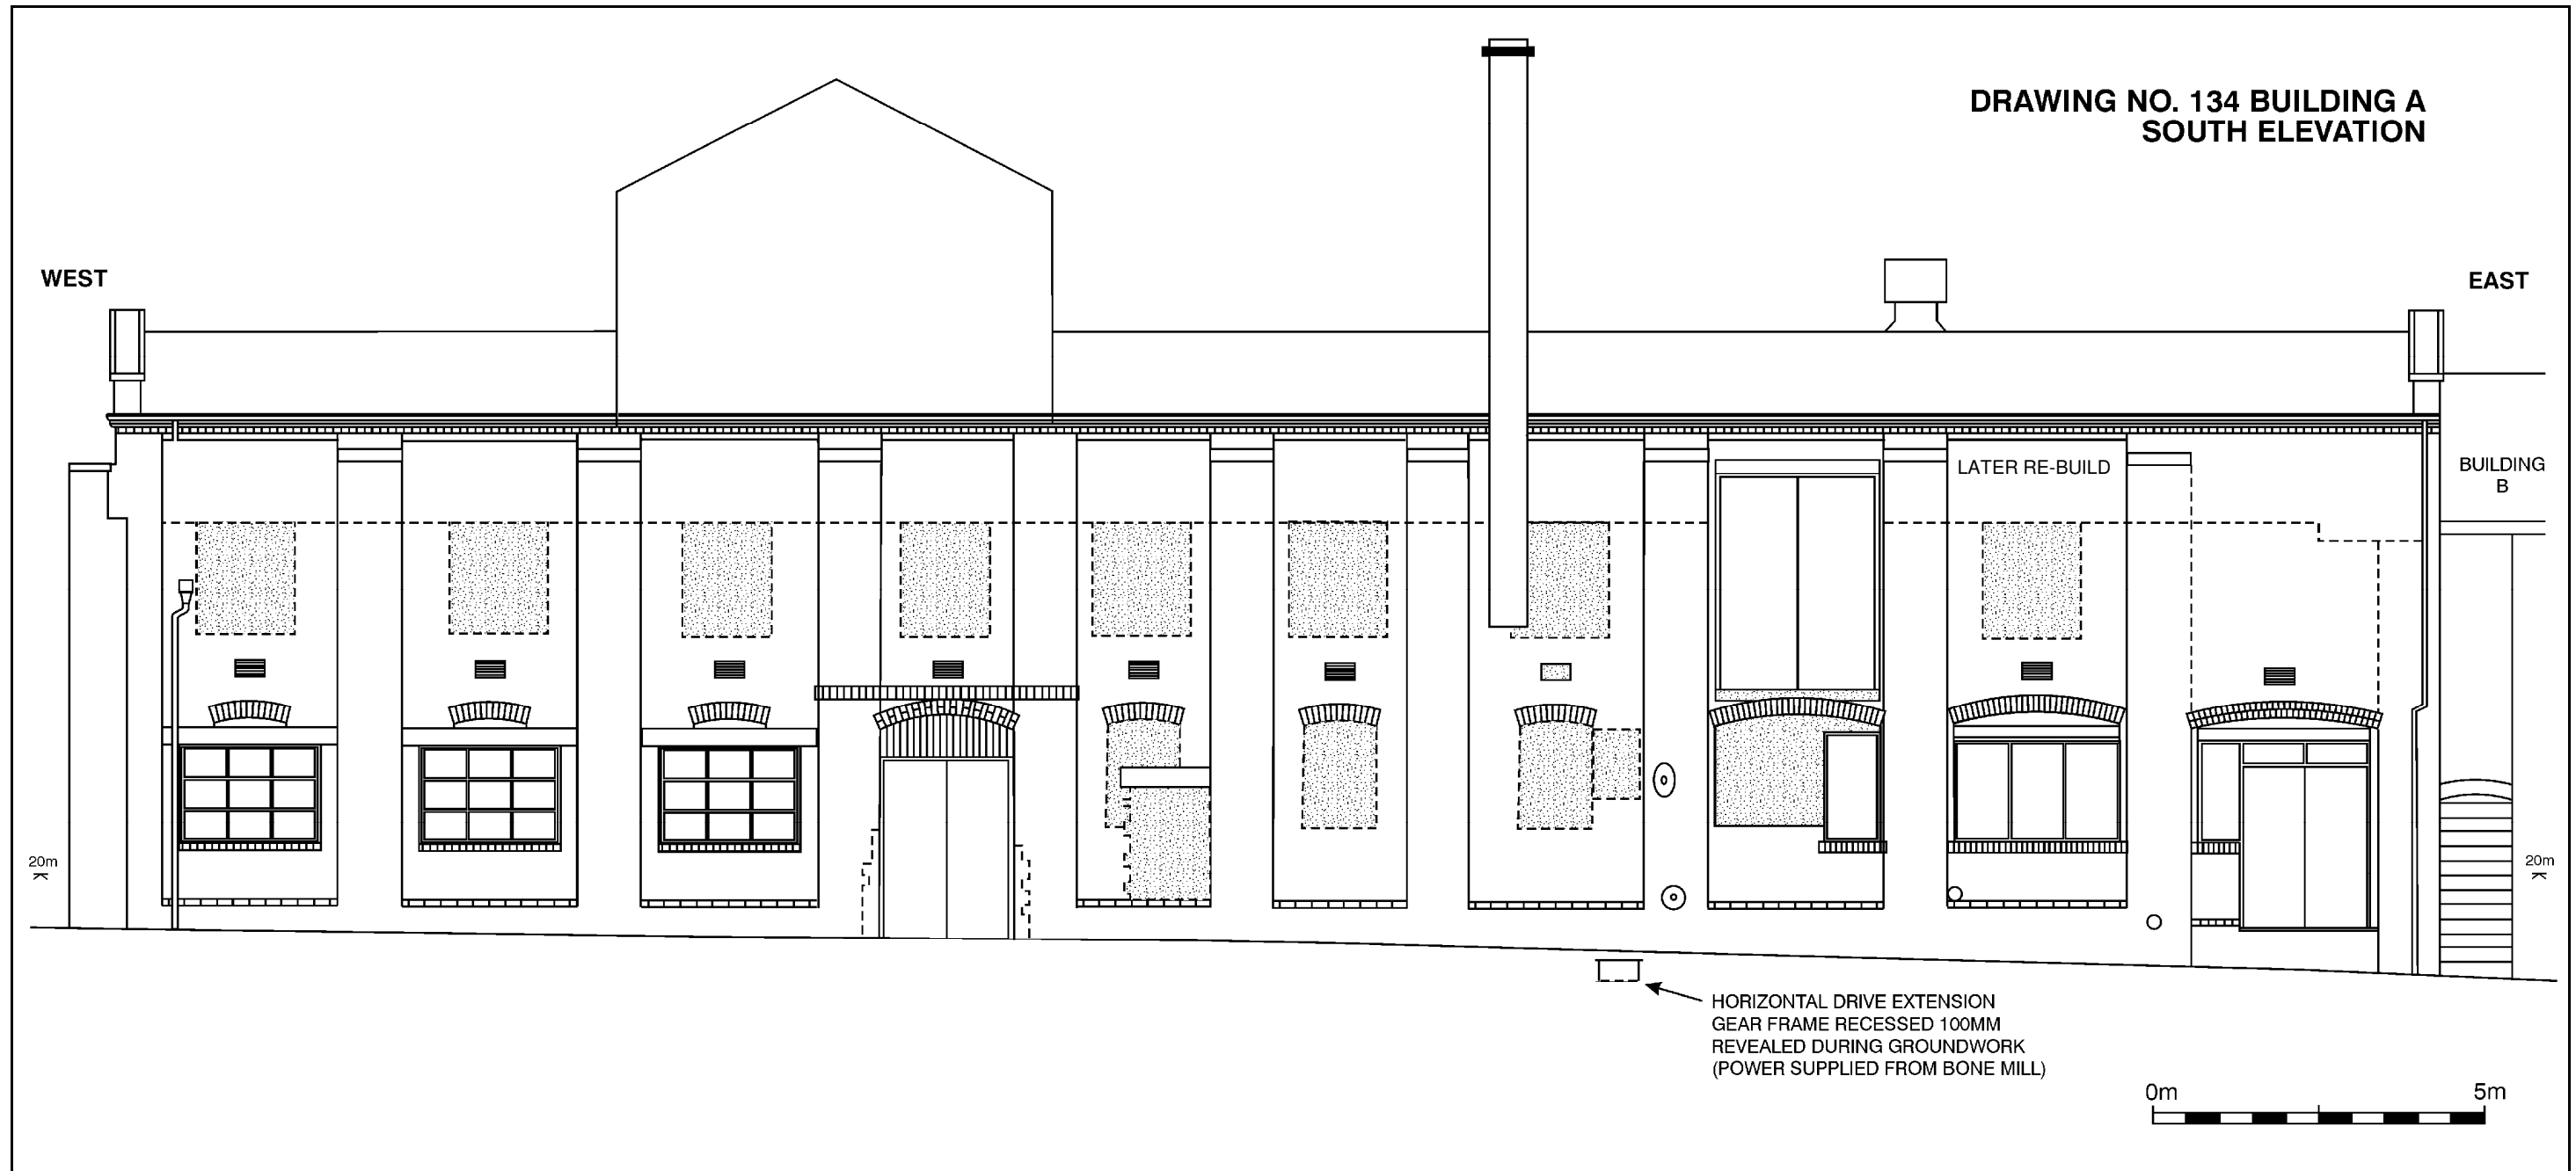
Figure 18: Survey drawing of the south elevation of Building A (scale 1:100)

The south elevation is similar to the north but is in a better condition. The majority of the ground floor is painted white, except for the three easternmost bays. The painted area was under a glazed canopy which covered the alleyway between this elevation and the north wall of the Bone Mill (Building D). The canopy was dismantled during the building survey as part of the overall demolition programme. On the western end there are three inserted steel-framed 'Crittall' type windows with flat concrete lintels and projecting sills made of reddish brown bricks laid to rowlock bond. There are three original window openings on the eastern end. These are larger than the others, occupying all of the space between the bay pilasters; one survives and the others have been altered. These large windows have segmental arched heads and blue engineering brick sills laid to rowlock bond of which only the second one from the east survives intact. The head of the easternmost window opening has two courses of bricks laid to rowlock bond and it is flush with the pilasters rather than with the recessed panel. The other two arched heads are made of a single course of bricks laid to soldier bond. The main doorway is situated in the fourth bay from the west which leads into a passageway through the building. There are further inserted openings on the fifth and seventh bay from the east, but they are blocked with later bricks. Four tie plates can be seen on the eastern side of the wall. During groundwork carried out on the alleyway mentioned above an opening was revealed below the plinth of the fourth bay from the east on this elevation. This opening has a cast-iron frame which was used to mount a horizontal drive shaft which would have been powered from the Engine House of the Bone Mill. A similar frame on the opposite wall of the Engine House was also exposed. The drive shaft would have been connected to a series of vertical and horizontal gears with further drive shafts in order to supply power to slip mixers in the Slip House.

The first floor has all the original window openings blocked with bricks and on the third bay from the east there is an inserted timber double door with a concrete threshold and an RSJ lintel. There is another RSJ at the top of the double door which runs north to south and is set on the wall of the opposite building (Building D). This RSJ would have been used to support a winch or similar device used to carry materials from the ground level. On the fourth bay from the east a chimney stack projects out by 1 metre. The stack is square sided (c. 700mm x 700mm) and is 9 metres tall. It is made of mid reddish brown bricks (9" x 4¹/₄" x 3") bonded with flush medium light pinkish beige lime mortar (up to 20mm thick) and laid to a mainly English bond with queen closers; the edges are reinforced with vertical metal plates. This chimney was demolished during the redevelopment work. The steel-framed cross-gabled structure projects upright from the eaves of the third and fourth bay from the west and the gable wall is made of mottled reddish/yellowish brown bricks (8³/₄" x 4¹/₄" x 3") bonded with cement (up to 20mm thick) and laid to Flemish Garden Wall bond. The later upper section of the wall is also visible on this elevation.

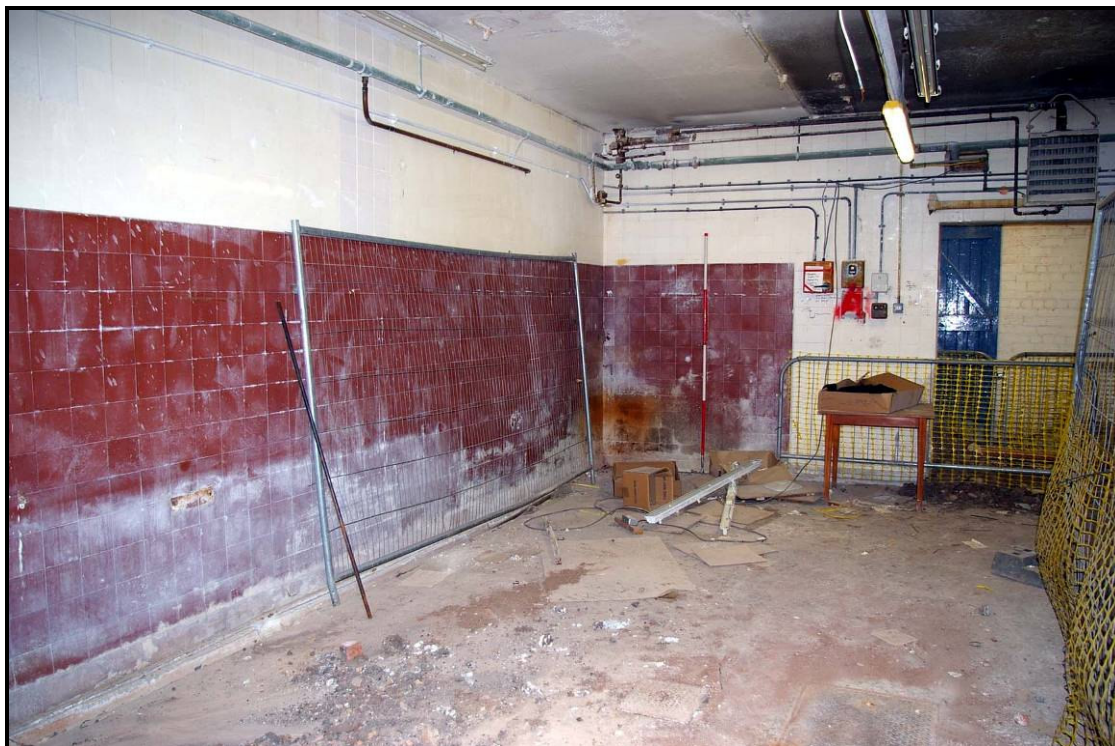
The central workshop measures 9 metres long (east/west), 8.5 metres wide (north/south) and is 3.42 metres high. It also has tiled walls, a concrete floor and a lath-and-plaster ceiling under iron joists orientated east/west supporting a series of vaulted concrete rows, although its western side has been mostly replaced with concrete encased within an RSJ structure. This ceiling replacement was the result of dismantling an original staircase to the first floor (see Figures 14 and 27 of the Appendix). The workshop is practically empty except for some tall wooden shelves. This workshop is accessed from an original doorway to the eastern workshop and also from a large later opening with a concrete lintel which leads to the passageway on the west wall.

Figure 29: The central workshop, looking west

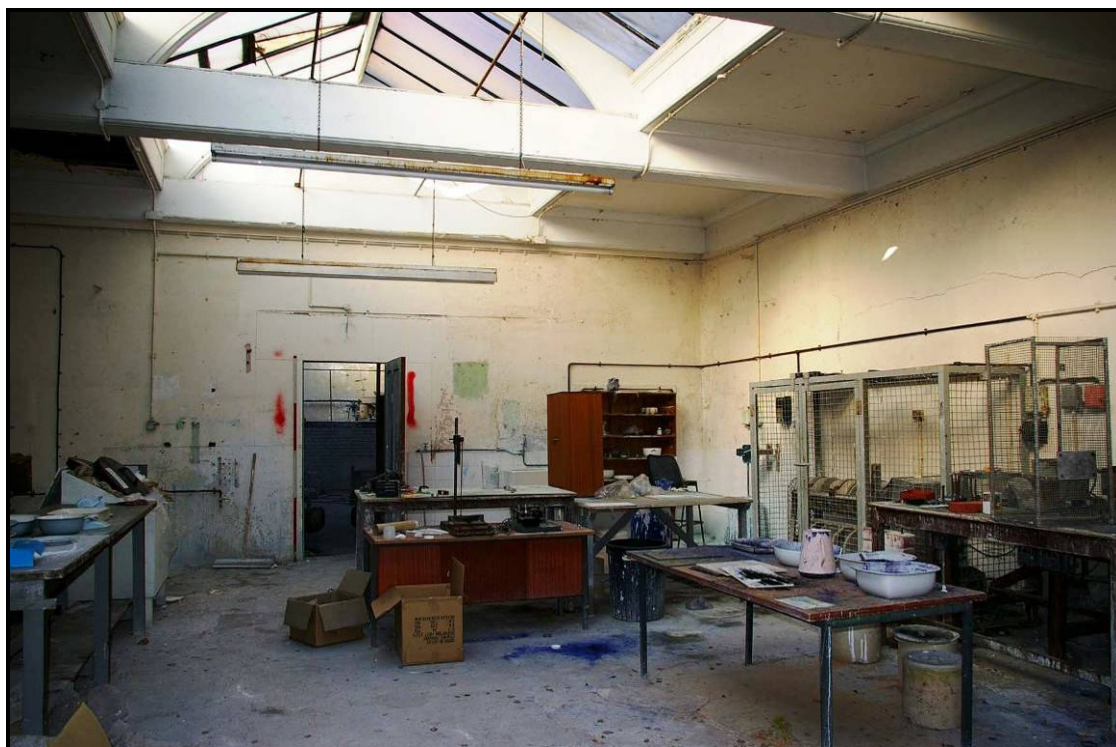
The central workshop is 9.5 metres long (east/west) and 8.5 metres wide (north/south). This is a laboratory which has several ovens, thermometers, testing equipment, gas burners, rotary machinery, large tables with slate tops, shelves with bowls and jars containing powdered and liquid products, and other apparatus. Some of the equipments are set on raised concrete plinths varying in height from 100 to 200mm. The plinth situated at the north-west corner has a sink and the walls around are covered with tiles up to 1 metre high. There is no sign of the chimney which projects out from this level as its flue opening is obscured by the current painted plaster. There is a doorway in the centre of the partition wall which links to the western workshop.

Figure 41: General view of the laboratory, looking west

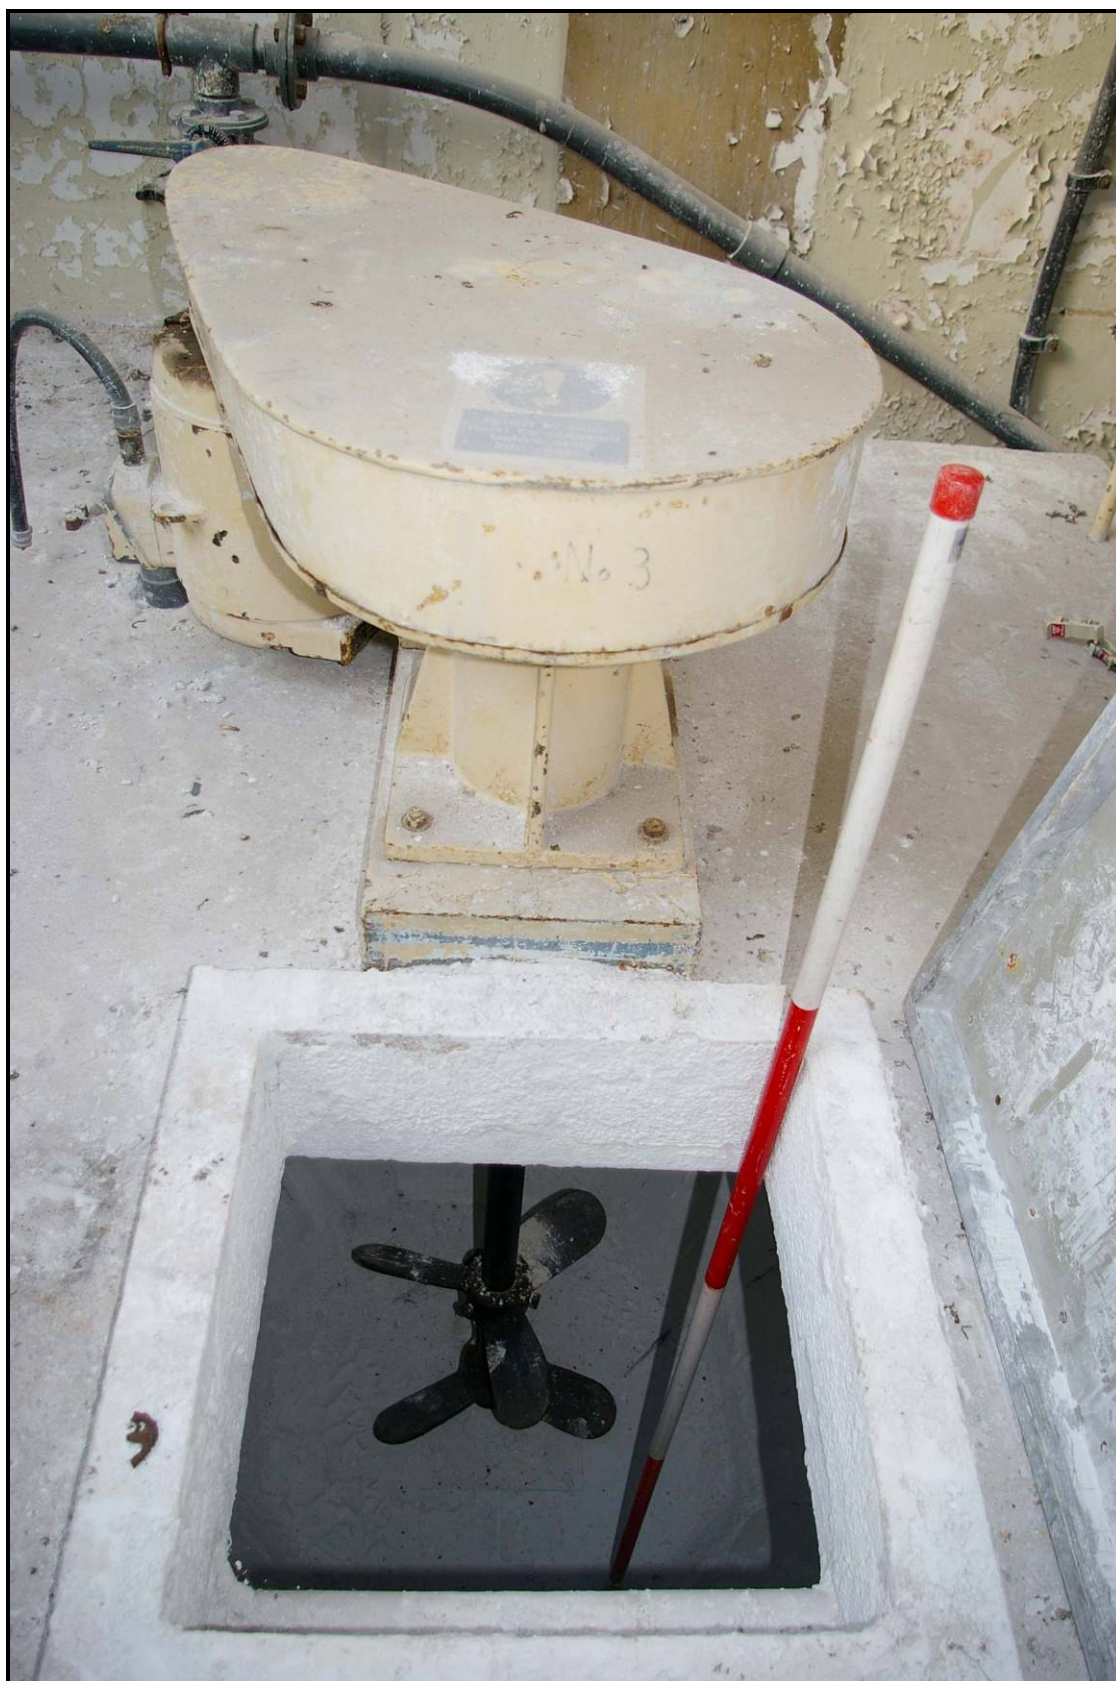
Figure 49: Detail of a slip blunger on the raised platform

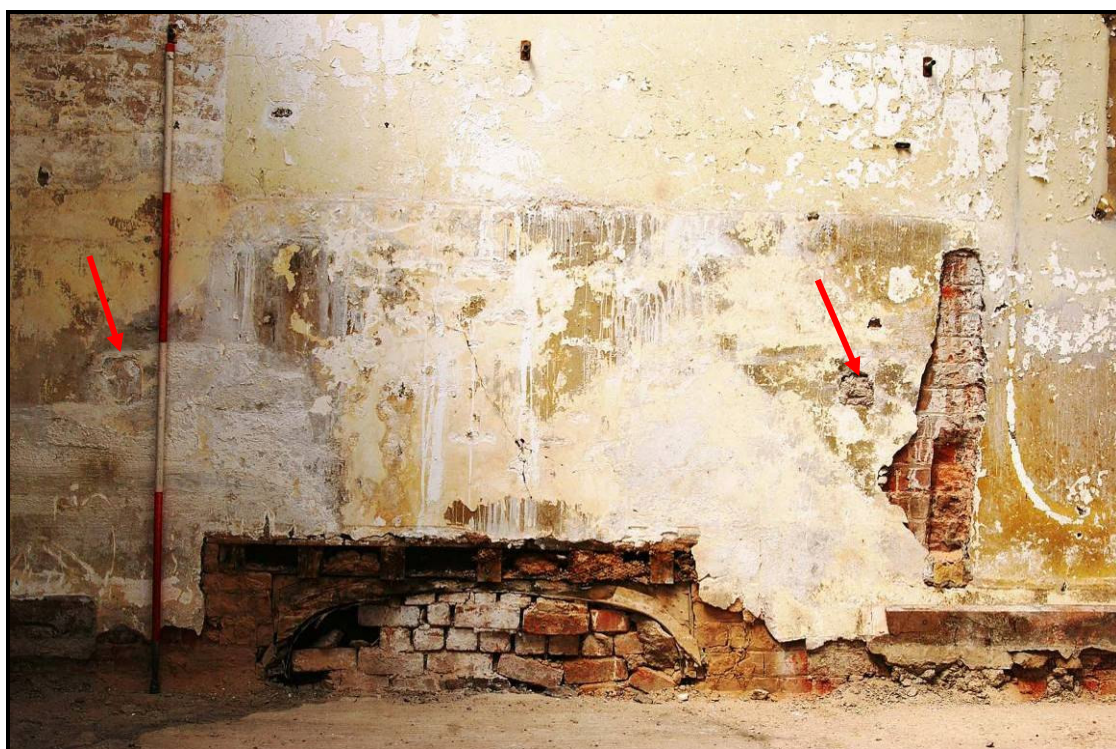
Figure 51: Archway and sockets for handrail (red arrows) of former staircase revealed after the dismantling of the raised platform on the west wall

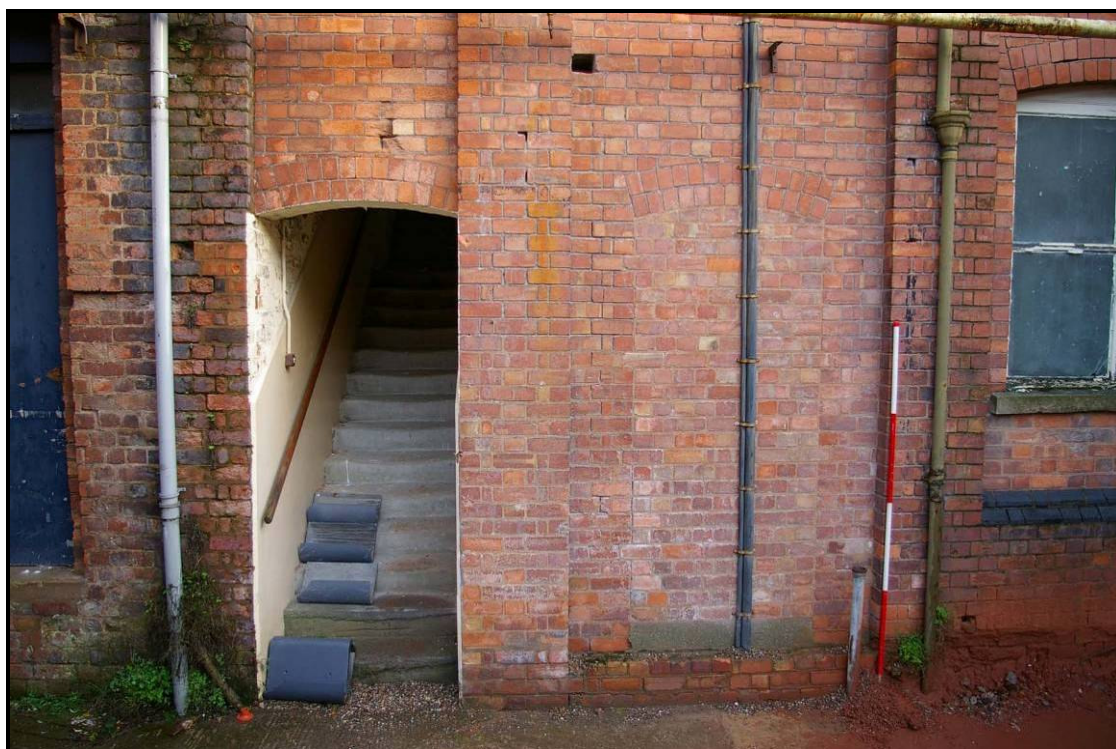
Figure 58: Staircase and blocked doorway on the south elevation of Building B

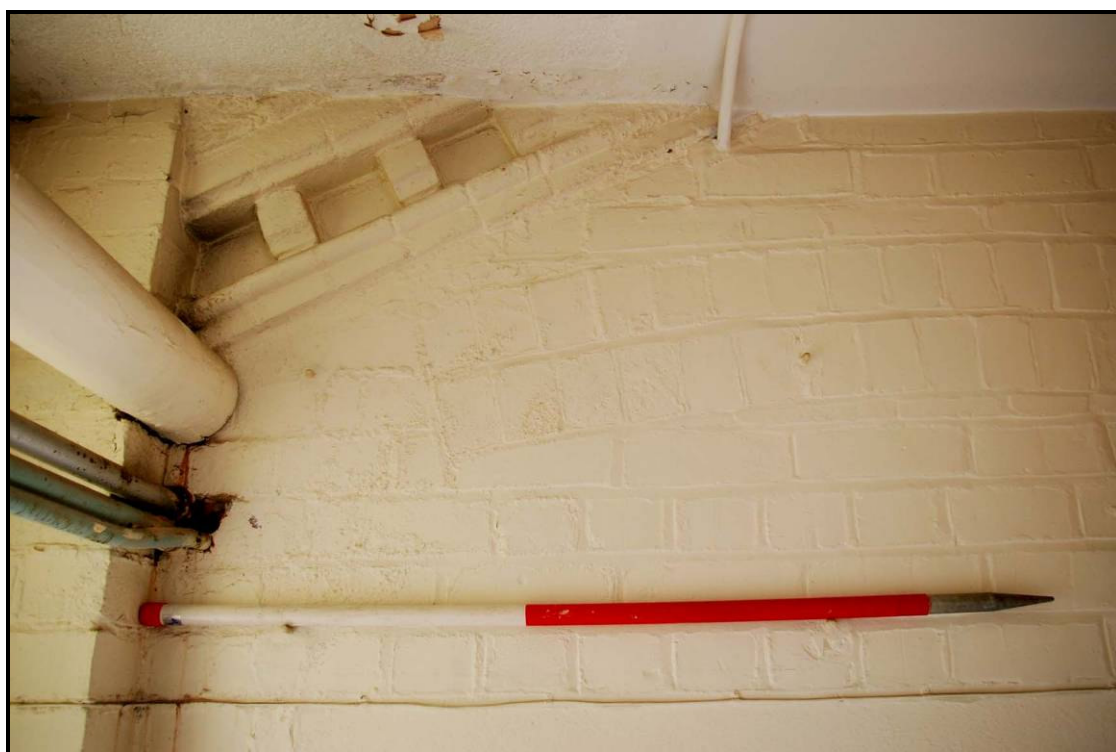
The coped eastern gable end is also largely obscured by the later Despatch Range (Building C1). This elevation is articulated by brick pilasters into three bays. Most of the ground floor wall has been removed but two segmental arched heads can be seen on the northern and southern bays above an inserted concrete bridging beam which is supported by a central brick pillar. On the first floor there are three window openings with segmental arched heads. These are blocked with bricks and painted white. The southern bay has surviving dentil decoration in the foot of the coping and an inserted doorway with a concrete lintel which leads to the adjacent Building C1 on the east. Most of the gable is not visible but it can be seen that it has lias coping stones and two ovolo moulding kneeler yellowish limestones at the top of the side pilasters. The survey drawing of this elevation shows a conjectured upper gable which is based on the visible features as well as the proposed 1890 architect's drawings of the Slip House Extension (Figure 59) and an early photograph taken around 1900 (Figure 54 of the Appendix).

Figure 64: Moulded dentilled brickwork on the first floor of the east elevation

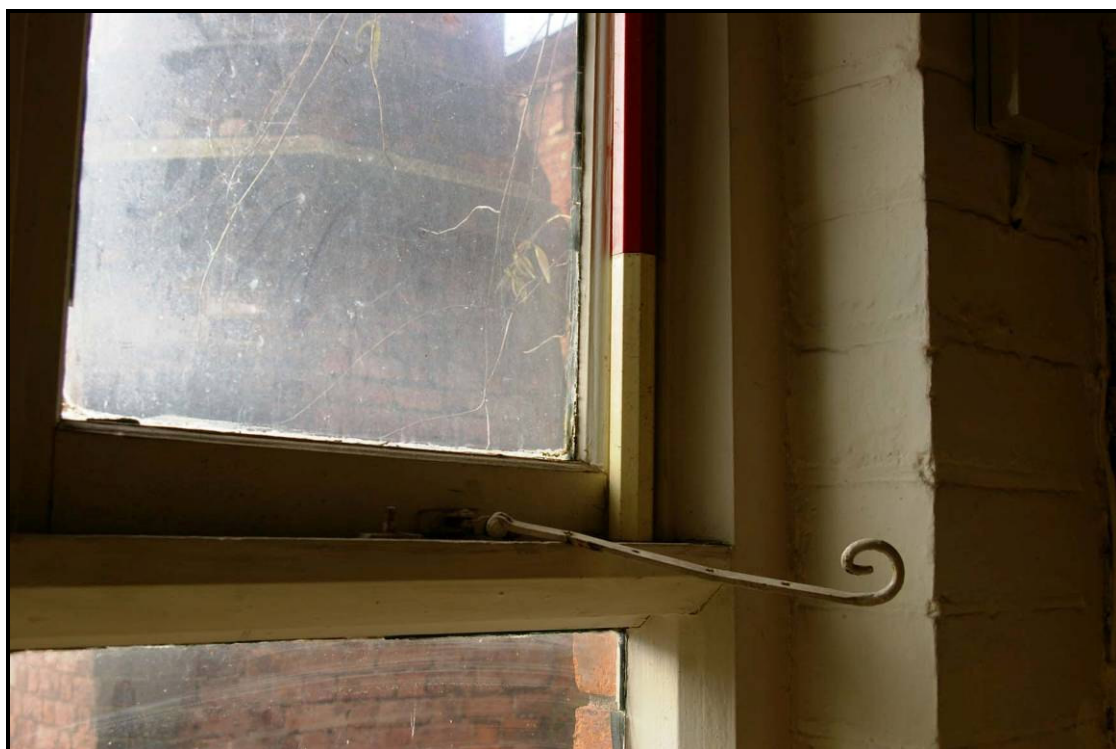
Figure 72: Detail of wrought-iron window stay with rat tail handle

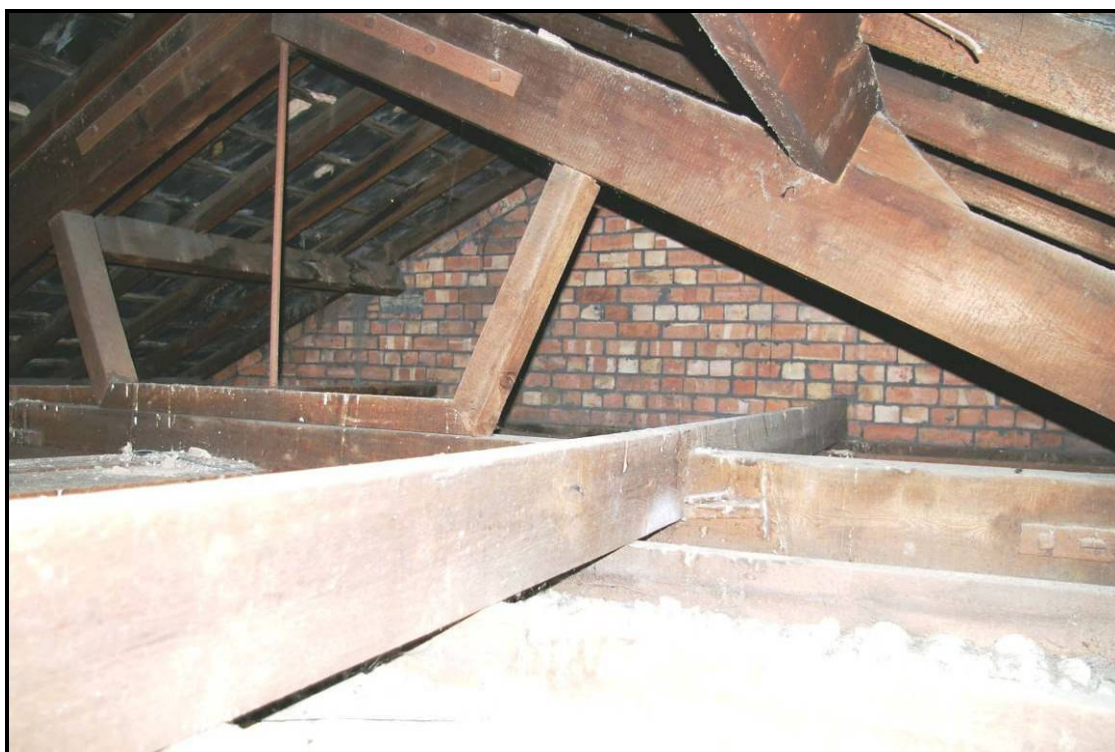
There is a metal ladder attached to the west wall which enables access to the loft from where the roof structure was surveyed. This consists of one upper king truss situated in the centre of the room (north/south) supported directly on the tops of timber posts on the inner face of the side walls. The posts have timber brackets acting as jowls. The truss is made of sawn timber with raking struts rising to the principal rafters from a straining sill over the collar. This arrangement is stiffened by a wrought-iron bolted suspension bar acting as a king strut. The principal rafters carry four tiers of trenched side purlins which are reinforced with wooden cleats. The upper ends of principal rafters are reinforced with metal straps. The area where lighter slates were identified on the south elevation has replaced battens confirming that there once was a sloping light-roof which was dismantled and covered with later slates.

Figure 77: Roof truss of Building B

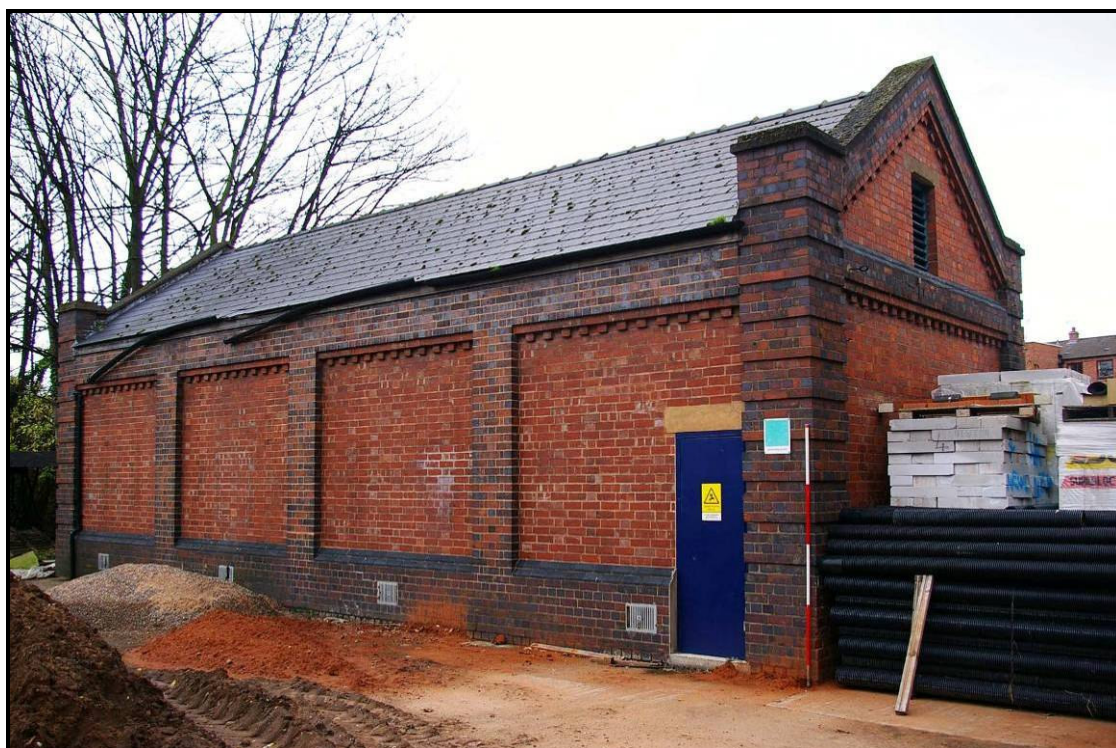
This elevation is of four bays which are divided by pilasters of which the south and north ends are rusticated. It has a continuous plinth decorated with two courses of blue engineering chamfered bricks laid to stretcher bond. The plinth is made of dark brown burnt bricks (9" x 4 1/4" x 3") bonded with flush beige lime mortar (up to 10mm thick) and laid to English bond. There are four rectangular metal vents set on each bay of the plinth. The recessed panels are made of reddish bricks laid to Flemish Garden Wall bond which are topped with simple dentilled work composed of an interrupted string brick course laid to header bond. The upper section is a simple cornice made with the same type of bricks as the plinths, as are the rusticated pilasters, although these are laid to English bond and topped with concrete coping slabs. The roof is made of cement-based slates with ridge tiles and has close eaves with PVC guttering. The verges have short parapets. On the southernmost bay there is a wooden doorway with a concrete lintel and raised threshold next to the pilaster.

Figure 79: West elevation of Building C

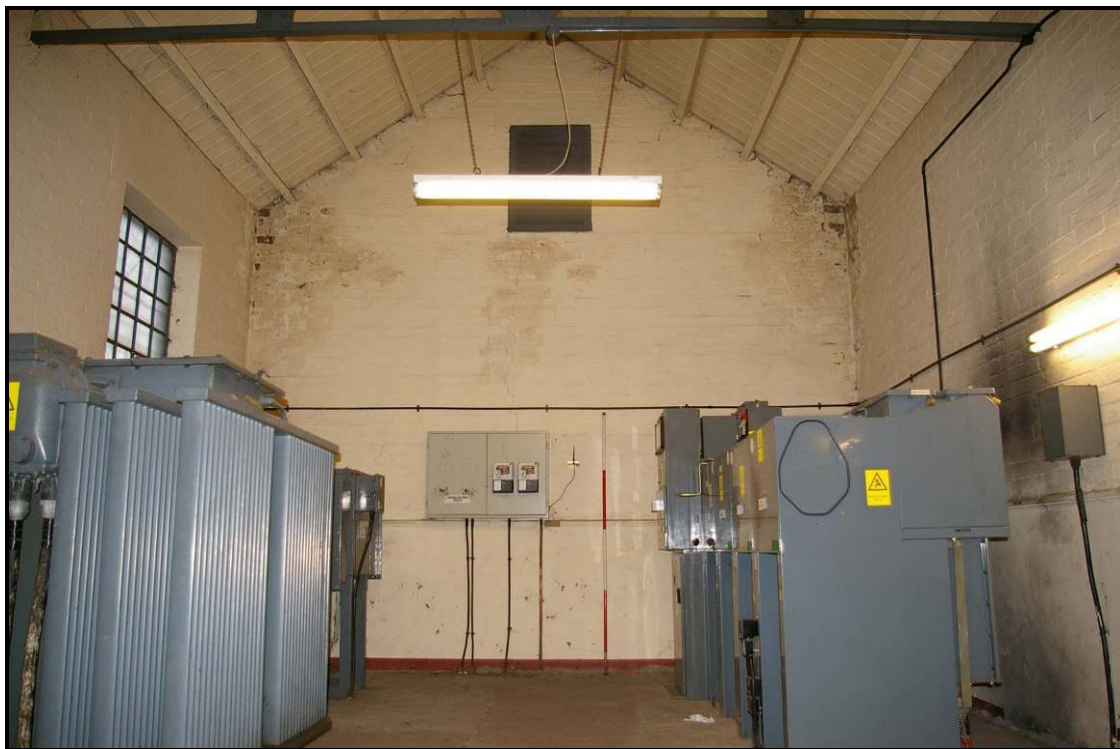
Figure 86: Electrical apparatus inside Building B, looking south

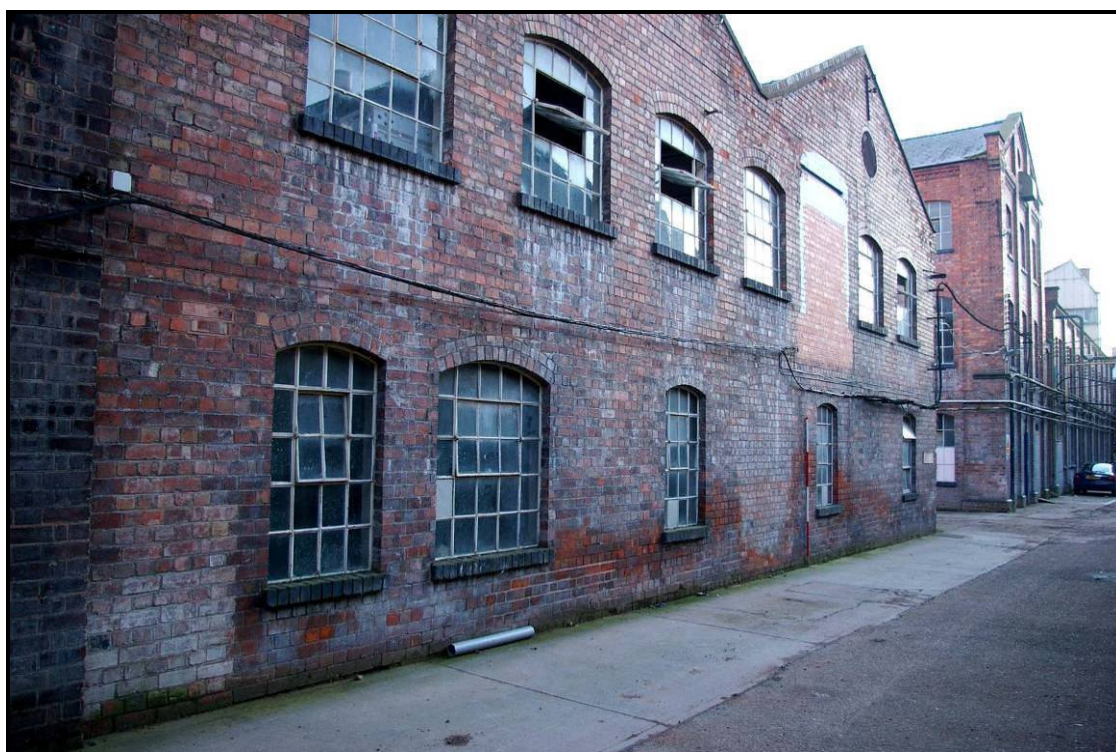
The main twin gabled elevation is of seven bays, expressed in the window pattern at first floor level. Interestingly, this bay division ignores the parallel roofs – the central window being directly under the valley between them. The windows of the first floor have cast-iron glazing, projecting blue engineering brick sills and segmental arched brick heads composed of two courses of bricks laid to rowlock bond. One of the first floor windows was dismantled and its opening was converted into the doorway of a later bridge and subsequently blocked. This window was re-inserted on the ground floor next to the northernmost window. The original windows of the ground floor do not match those of the first floor, except for the re-inserted one. These are smaller and their segmental arched heads are composed of one upper brick course laid to header bond and a lower laid to rowlock. There is a doorway in the centre of the ground floor which is blocked with bricks. Its original appearance can be seen on a 1935 architect's plan for Building F (see Figure 74 of the Appendix). The gables have brick-framed roundels containing ornate cast-iron vents although the southern one has been replaced by a lightweight metal grill cover. The coping is a string course of bricks and there is an ovolo moulding kneeler red sandstone forming a termination at the eave of the coping on the south end.

Figure 88: West elevation of Building H

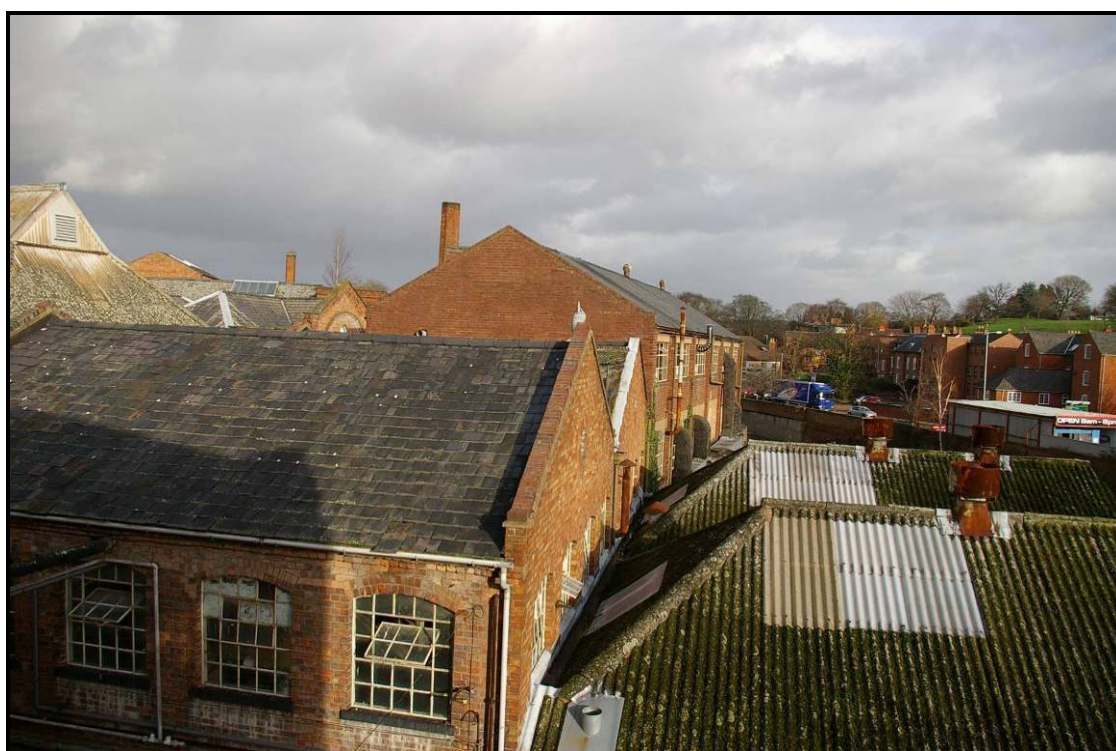
This elevation is partially obscured by the later Building I on the east. Much of the ground floor walling on this elevation has been removed to increase access to Building I. The walling has been replaced by RSJ beams supported by RSJ stanchions and brick pillars. The upper storey is of eight bays demarcated by its windows. This elevation, as opposed to the rest of the building, is made of bricks laid to Flemish Garden Wall bond rather than English bond, but there is no clear indication of construction breaks. The windows are the same type as those on the west elevation but their lowest rows have been blocked with later bricks. There are also roundels on both gables with vents, but the southern one is a replacement made of lightweight metal with similar decoration. There is a timber dormer with a cowl situated on the southern slope of the northern gable. This seems to be a later insertion which entailed replacing the original brick coping with lead flashing.

Figure 92: The east elevation of Building H butted by the hipped roof of Building I

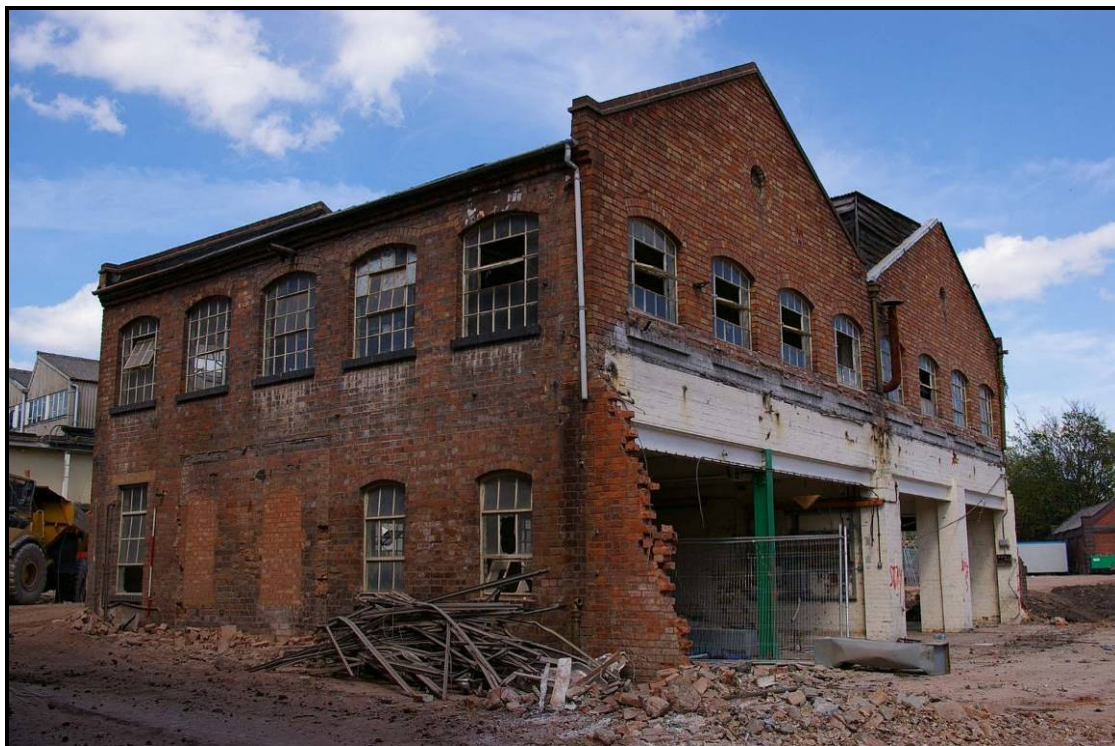
On the exposed south elevation there are five bays in all, topped by a plain brick eaves course. The first floor windows are larger than those on the ground floor. Only the two eastern ground floor windows survive intact; the two to the west have been blocked, and the westernmost one has been replaced by a later and larger window under a concrete lintel. Projecting from this elevation is a modern single storey brick block with a flat roof which was demolished prior to the survey. The roof is visible on this elevation and consists of natural slates topped with ridge tiles with parapets at both gable ends.

Figure 94: South and east elevations of Building H

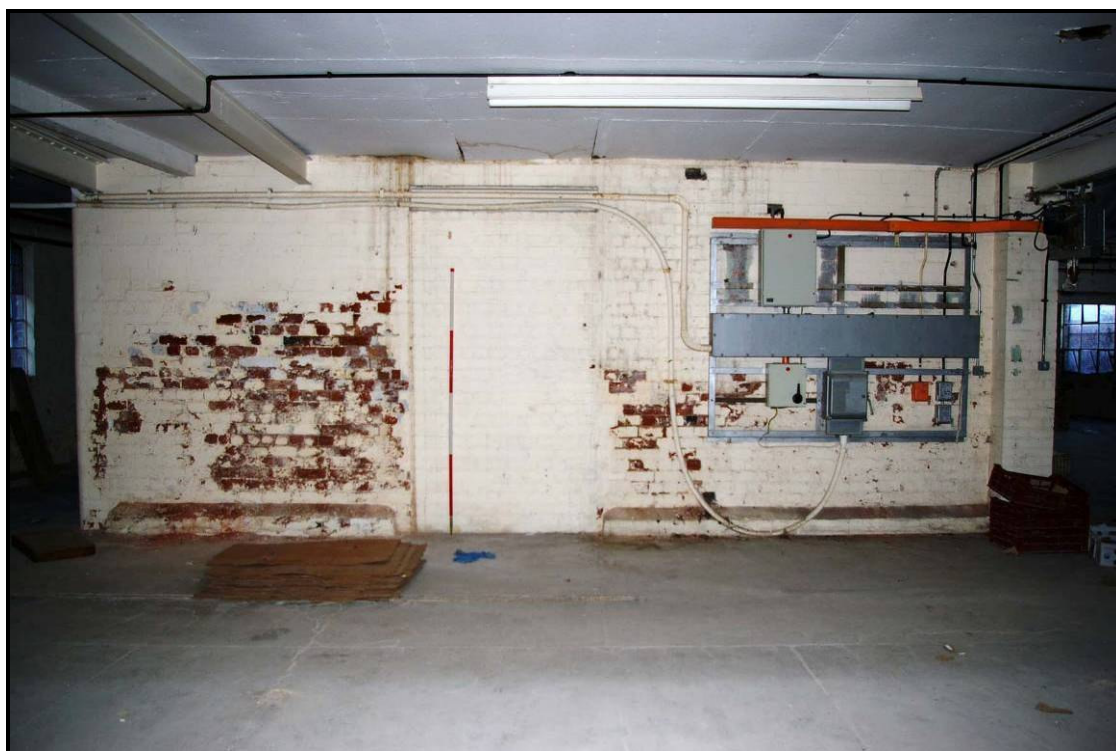
The interior of the ground floor has a single cross-wall but is otherwise an open space, and the removal of the north and east walls means that they are also open to the adjacent structures. It measures approximately 17.30 metres long (north/south), 10 metres wide (east/west) and is 3 metres high. It has painted brickwork, a concrete floor and a fibreboard ceiling under timber floor joists. There are several RSJ beams and stanchions which appear to be later insertions. These were probably inserted when a series of original partitions and staircase were dismantled as they are shown on the 1935 architect's plan for Building F next to Building H (see Figure 75 of the Appendix). The original windows of the south wall consist of nine rectangular lights set vertically (3 columns x 3 rows). Each has an opening with central pivotal hinges on the top row and a hopper opening at the bottom. The inserted window on the westernmost bay has a central opening with pivotal hinges (3 columns x 2 rows). The windows on the west wall are different from the ones on the south except for one situated on the southernmost bay which is identical to the original windows of the south wall. They consist of twenty rectangular lights set vertically (4 columns x 5 rows) on each cast-iron frame. They also have central openings with pivotal hinges. The re-inserted window is the same as the ones on the first floor which are described below. The partition wall is positioned in the centre of the floor and orientated east/west but it does not fully divide the floor into two spaces as the west end is 2.2 metres away from the west wall and has bullnose bricks on the edges. The partition wall has a central doorway which has been carefully blocked with bricks and a cement plinth throughout (230mm high). There is also a similar plinth along most of the west wall. This workshop is empty and thus has no clear signs of its later use.

Figure 99: Partition wall on the ground floor with blocked doorway, looking south
