Archaeological Building Investigation and Recording,  
Royal Worcester Porcelain Works,  
Buildings M, N, Q, R, S, Y and Z

September 2008

*Archaeological Building Investigation and Recording,  
Royal Worcester Porcelain Works,  
Buildings M, N, Q, R, S, Y and Z  
September 2008*

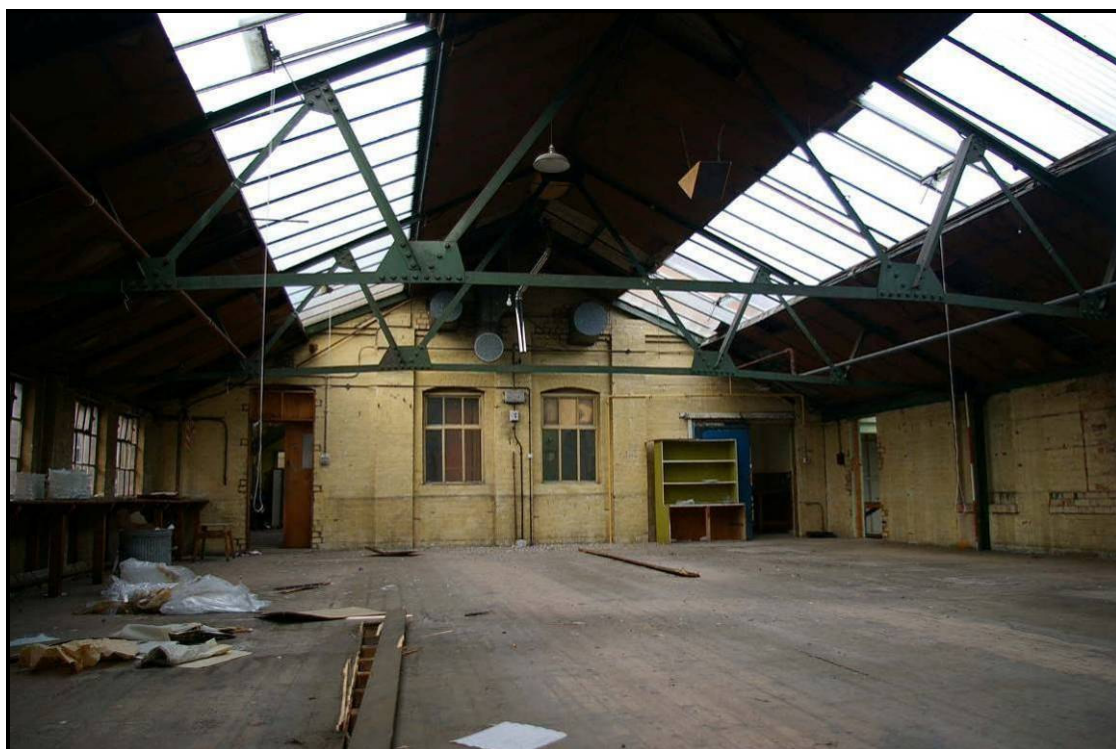
**Figure 3: East elevation of Building M, from Building N**

This gable facade is of four bays articulated by brick pilasters and topped by a simple cornice. The central bays are set more closely together than the outer ones. The ground floor has been considerably altered by the removal of the walls and the insertion of two steel stanchions and a steel beam supporting the upper storey. On the first floor there are original window openings with segmental arched heads in each bay. The southernmost has been converted into a doorway and the northernmost has been partially blocked with bricks and has an inserted timber sliding door with a concrete lintel. The window openings in the central bays have projecting brick sills. Most of the first floor wall is painted yellow as it became an internal wall when the upper storey of Building N was erected. The gable is topped by a cornice with simple dentilled brickwork laid to rowlock bond. There are two ovolo moulding kneeler greenish sandstones forming a termination at the eaves of the coping. On the gable panel there are two oculi which have been internally blocked with bricks and an original cast-iron vent between them.

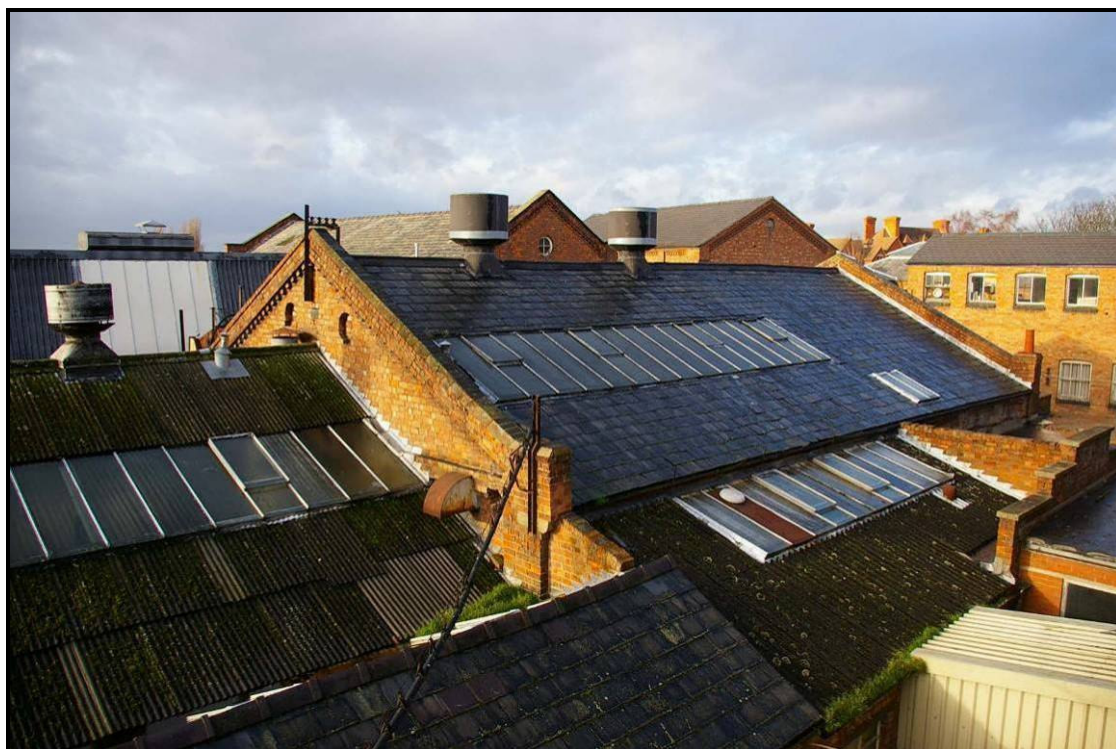
**Figure 4: Eastern gable of Building M, from Building K1**

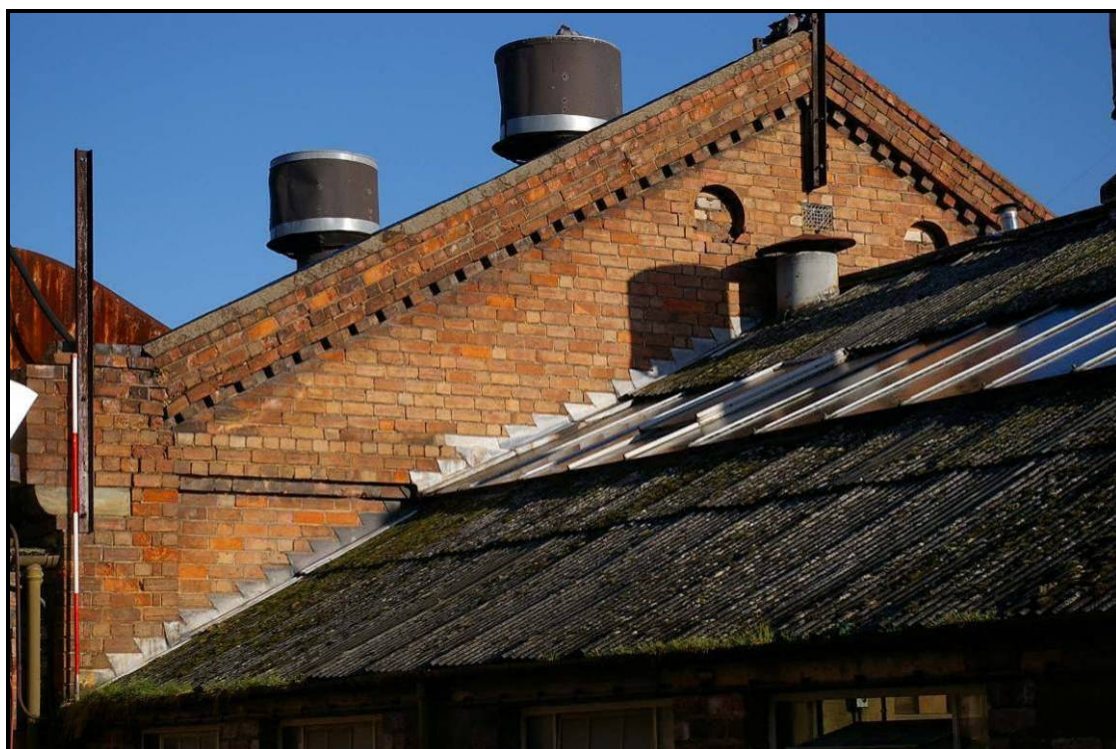
Figure 5: Detail of the eastern gable of Building M

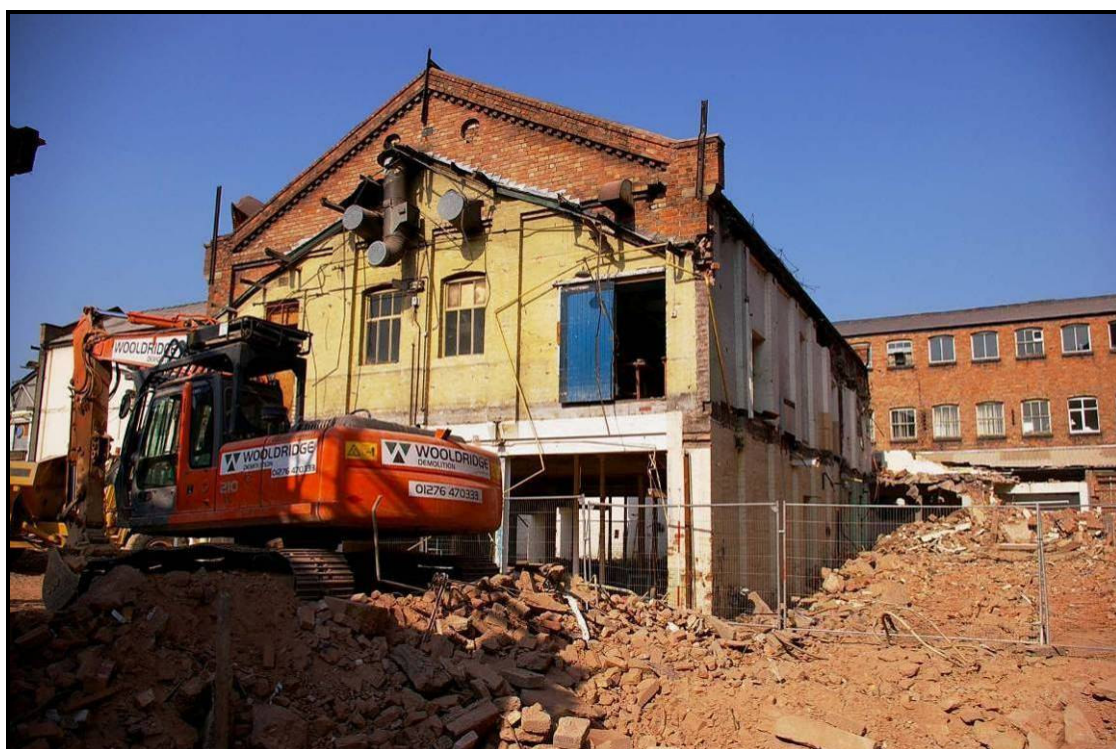
Figure 6: East elevation of Building M after demolition of surrounding buildings

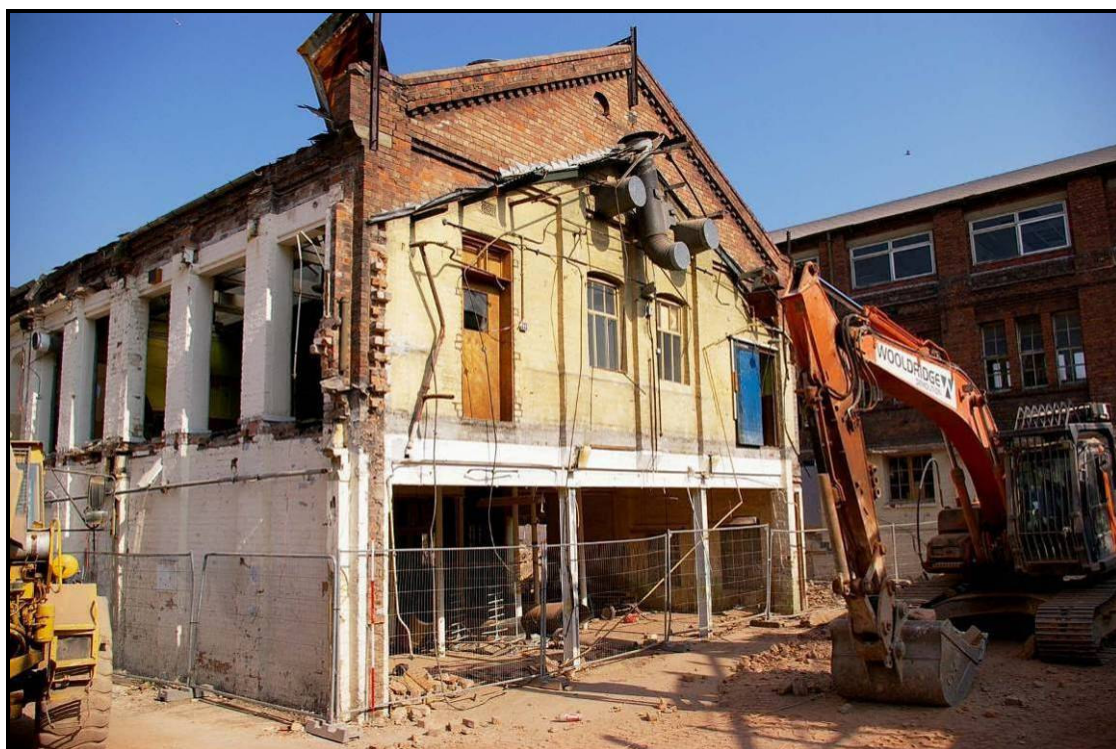
**Figure 7: East and south elevations of Building M**

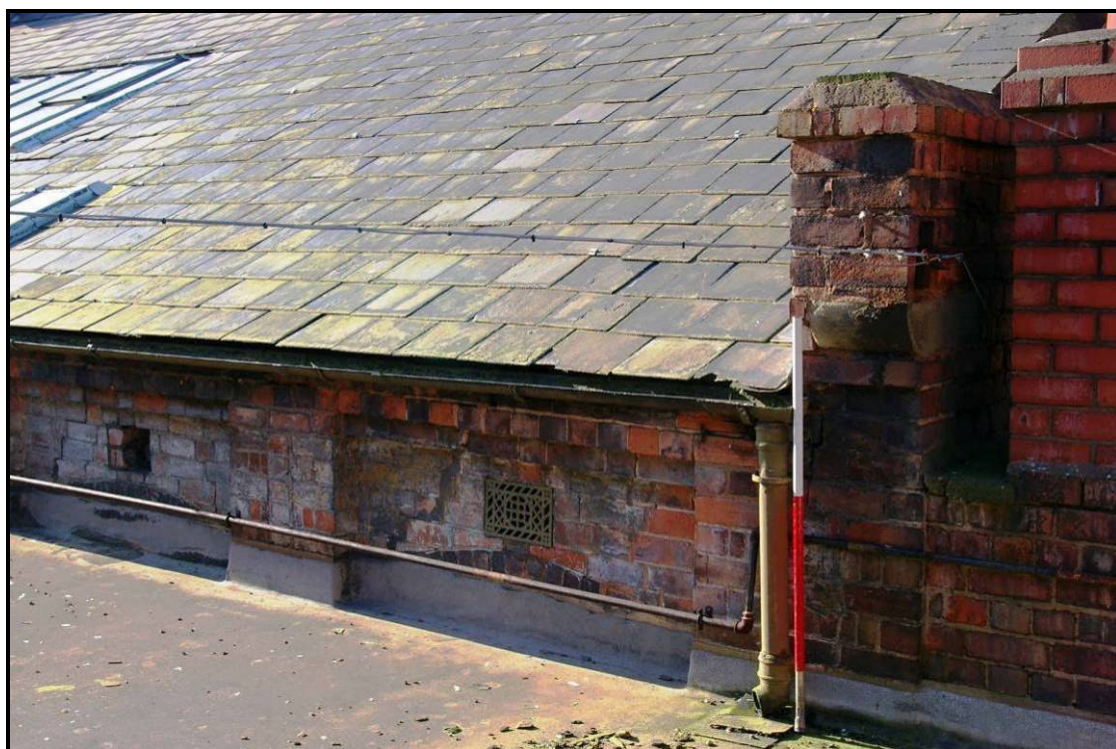
**Figure 11: Detail of kneeler stone on the west elevation of Building M**

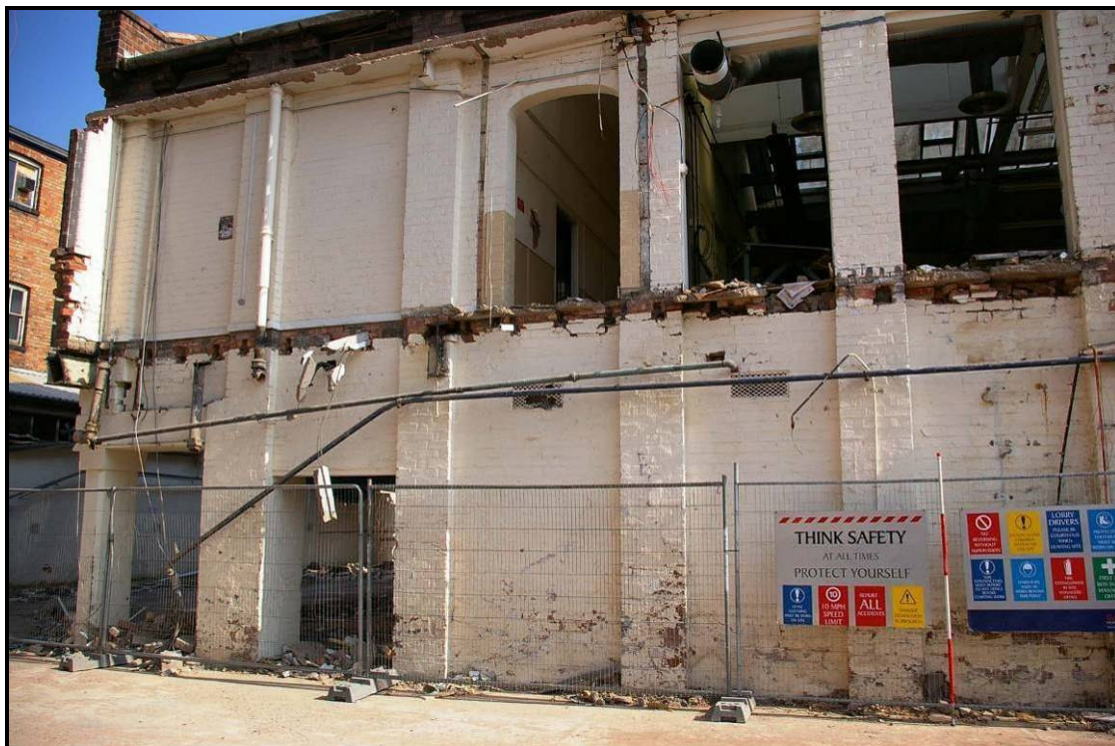
The south elevation is now a party wall between this range and the adjacent Building O. It has been considerably transformed and is currently painted white. The ground floor has been altered by the removal of the original window openings which were replaced by new brick panels. The two westernmost bays also have the original openings removed and replaced by large open doorways with RSJ lintels. The second of these bays from the west still has its segmental arched head over the lintel. The westernmost pillar has been replaced by a steel stanchion covered with cement; and second pillar from the west has been widened with bricks. There are two primary rectangular cast-iron vents on the third and fourth bays from the west. The first floor has also been largely modified and there are large open doorways with RSJ lintels in most bays except for the two westernmost bays which have been completely bricked-up. The third bay from the west has a wide segmental arched head made of bricks. There is a continuous simple cornice made of two brick string courses laid to rowlock bond. The pitched roof is made of natural slates topped with tile ridges in which two large metal cowls are set. It has close eaves with cast-iron guttering and both of the gables have parapets at their verges.

Figure 12: Western side of the south elevation of Building M

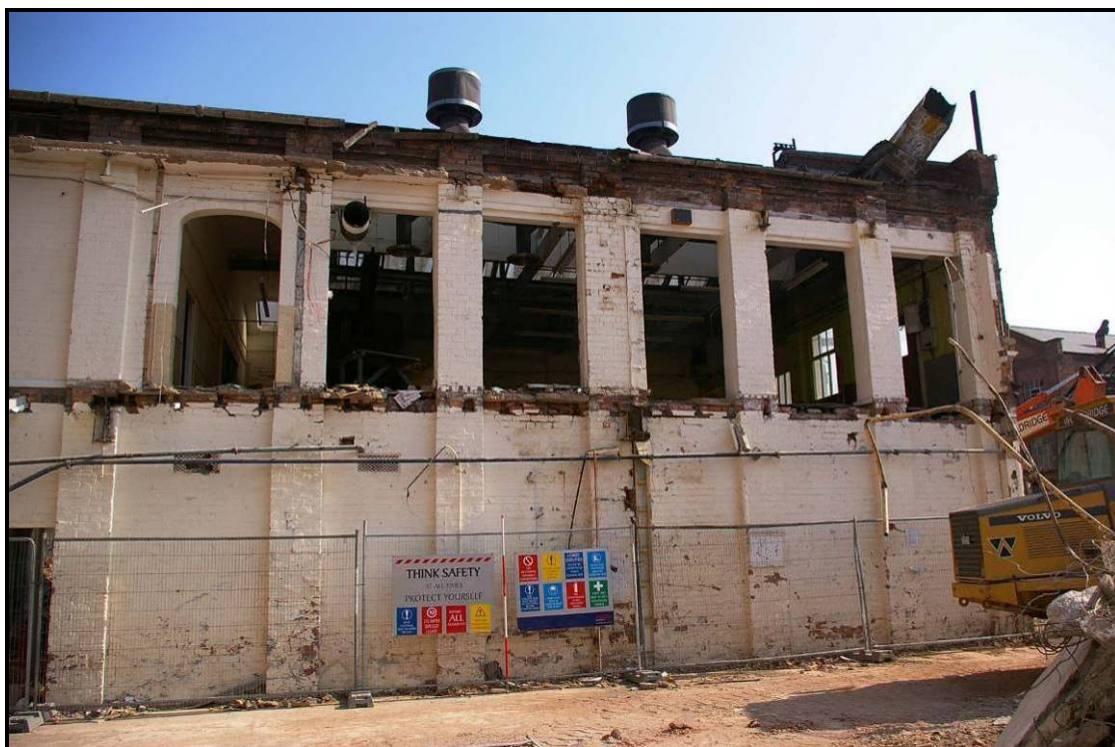
Figure 13: Central and eastern side of the south elevation of Building M

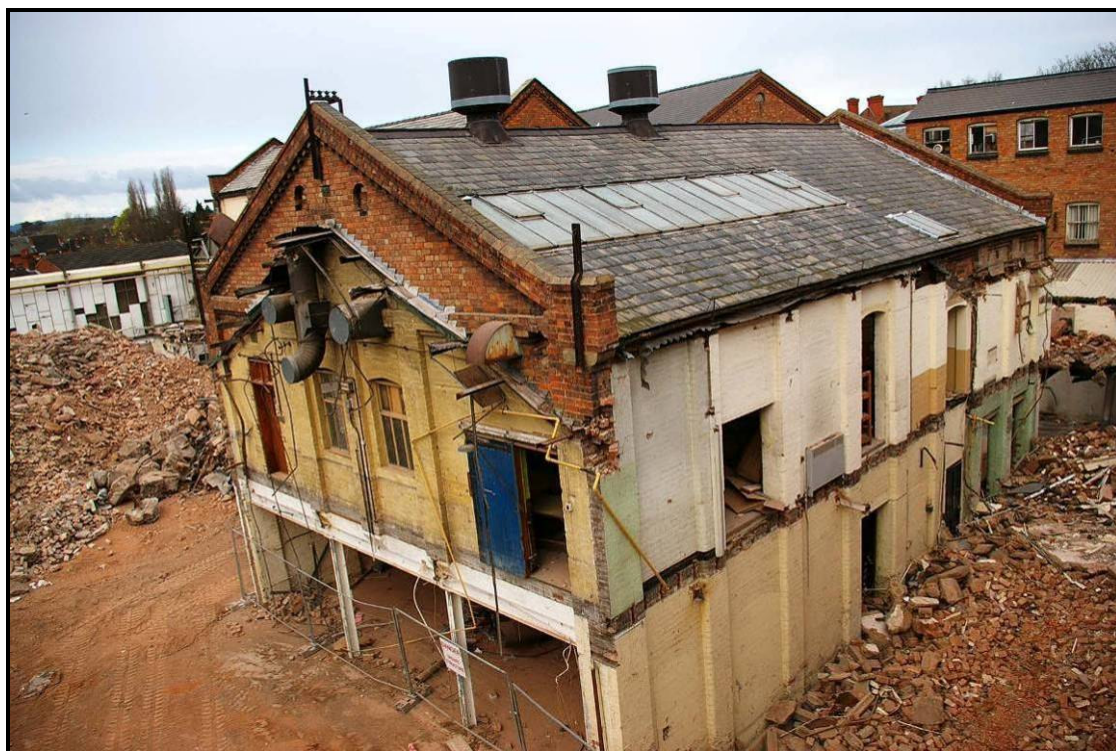
This elevation also has become a partition between the adjacent Buildings L and L1 and has suffered radical alterations. The windows have been blocked with bricks on both floors. Despite being painted some of the window heads can be still seen. On the ground floor there are later doorway openings with steel beams inserted on the two westernmost bays and on the fifth from the west. There is another doorway on the third bay from the west under an original window head. There is a segmental head on the second bay from the east which extends the whole width of the panel and might have formerly been a doorway instead of a window. This opening and the one on the easternmost bay are blocked with breeze blocks. Most of the first floor is heavily painted, however, four segmental arched heads of former windows have been identified on the four eastern bays. The second bay from the east has an inserted opening for a conveyor belt and the fourth from the east has a roller shutter under an original window head. The window opening on the third bay from the east has been converted into a doorway. On the westernmost bay there is a primary cast-iron vent still *in situ* over a window head.

Figure 14: North and east elevations of Building M

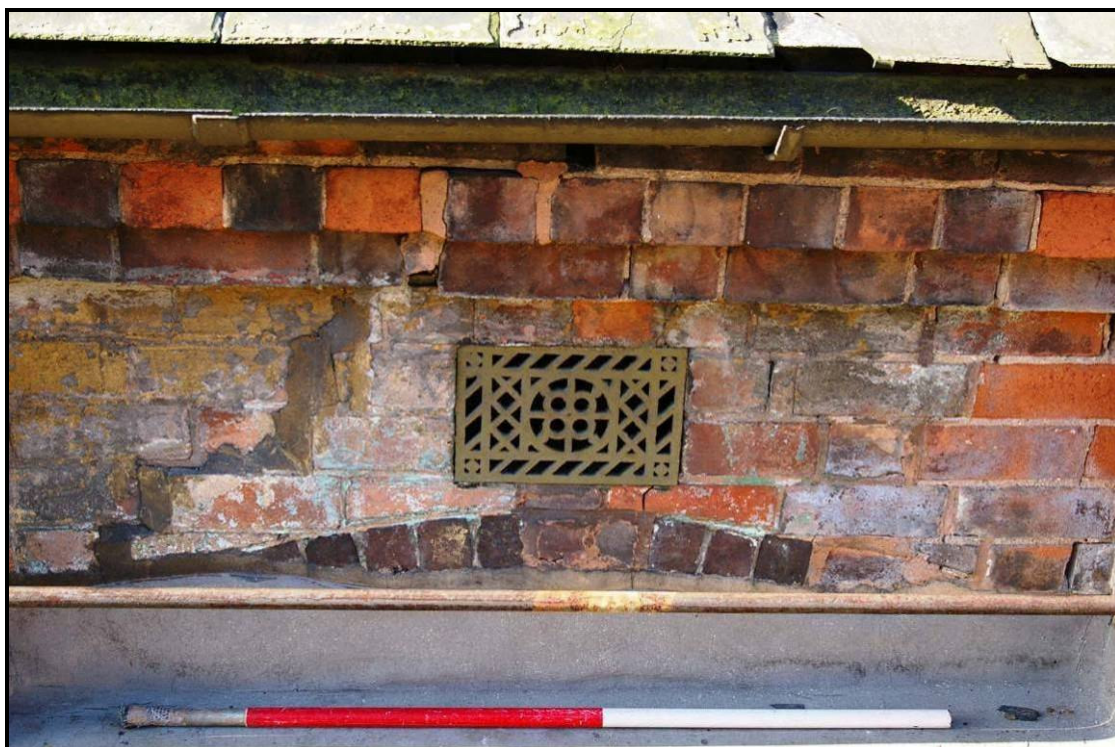
Figure 16: Detail of cast-iron vent on the north elevation of Building M

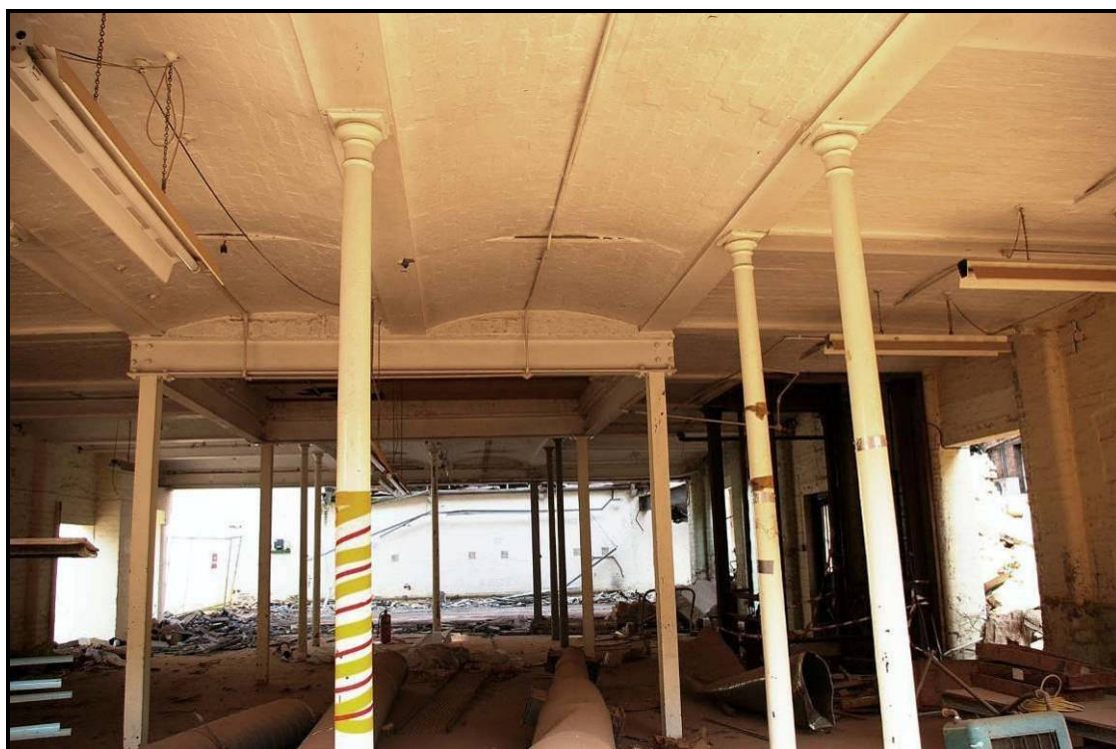
This floor is a large open workshop which measures 17.7 metres long (east/west), 11.5 metres wide (north/south) and 3.55 metres high. The interior is practically empty and has modern fluorescent lighting. A dumbwaiter linking this floor to the first is situated against the north wall on the fourth bay from the west. The eastern and western walls have been removed and replaced by two steel stanchions supporting a bridging beam on each side. These are opened to Building N on the east and Building P on the west. The northern and southern walls have also been considerably altered and their original openings are blocked with bricks. Later doorways, which have been already described on the north and south external elevations, lead to Building L on the north and Building O on the south. The workshop has painted brickwork, bullnose brick jambs on the internal pilasters, a concrete floor and a jack-arched ceiling. The ceiling structure consists of segmental brick vaults which spring from a series of steel girders positioned in accordance with the bays of both side and gable walls. The girders are supported by three rows of cast-iron columns aligned east/west, forming two central narrow bays (determined by the gable elevations) with parallel east/west segmental vaults and two wider side bays (determined by the side bays) with north/south transverse segmental vaults. The vaulted structure is reinforced with wrought-iron bars linking the transverse girders. There are in total ten cast-iron columns painted white which have Tuscan capitals and are 3.20 metres high. In the centre of the workshop there are four RSJ stanchions supporting a steel square structure with an asbestos soffit under a timber floor, which were inserted when a central chimney stack was removed in the late 1920s (see Appendix). On the north wall there are three surviving windows which are blocked externally. One of them was internally boarded up behind the hoist and is an original specimen made of a cast-iron frame with glazing bars. The other two are later replacements positioned on the first and second bays from the east. They have wooden frames and slender glazing bars with six lights each.

**Figure 18: Ground floor of Building M, looking west**

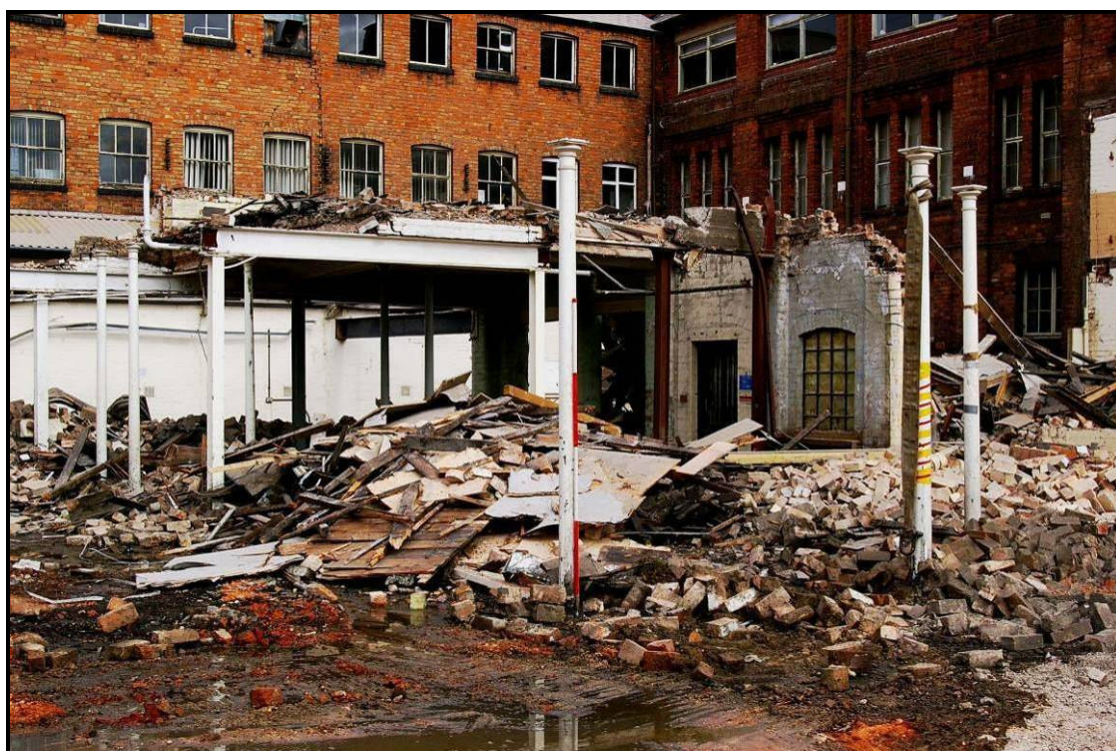
**Figure 21: Recovery of cast-iron columns during demolition, looking west**

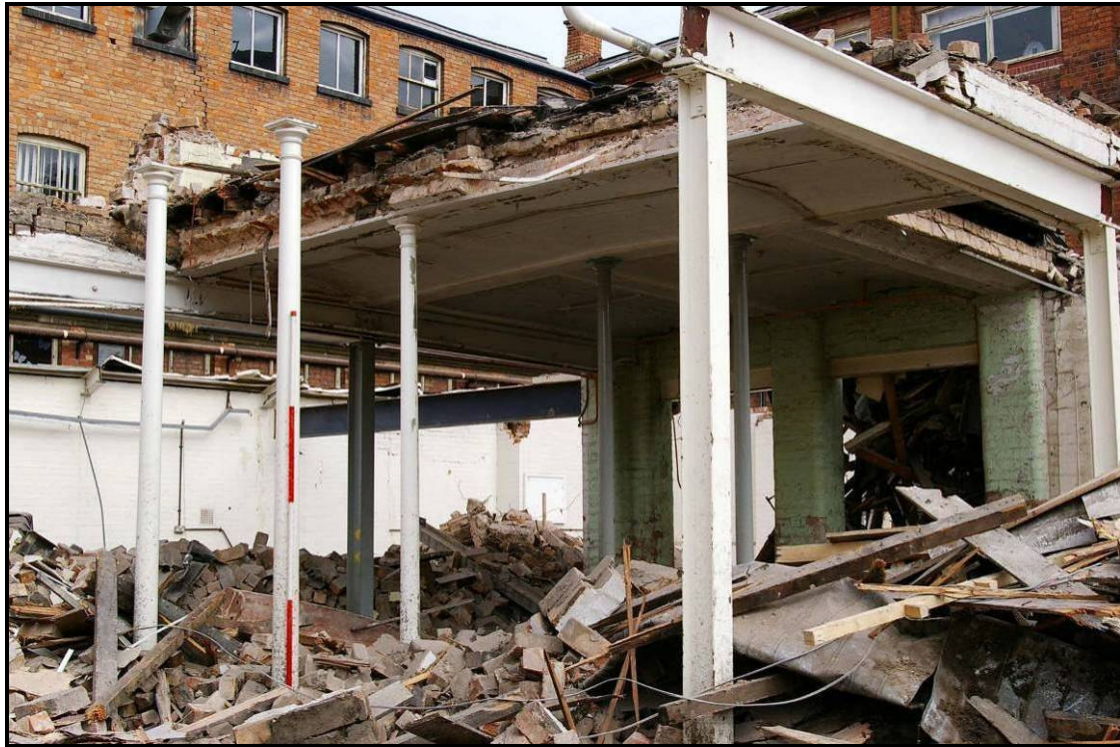
**Figure 22: Detail of jack-arched ceiling during demolition**

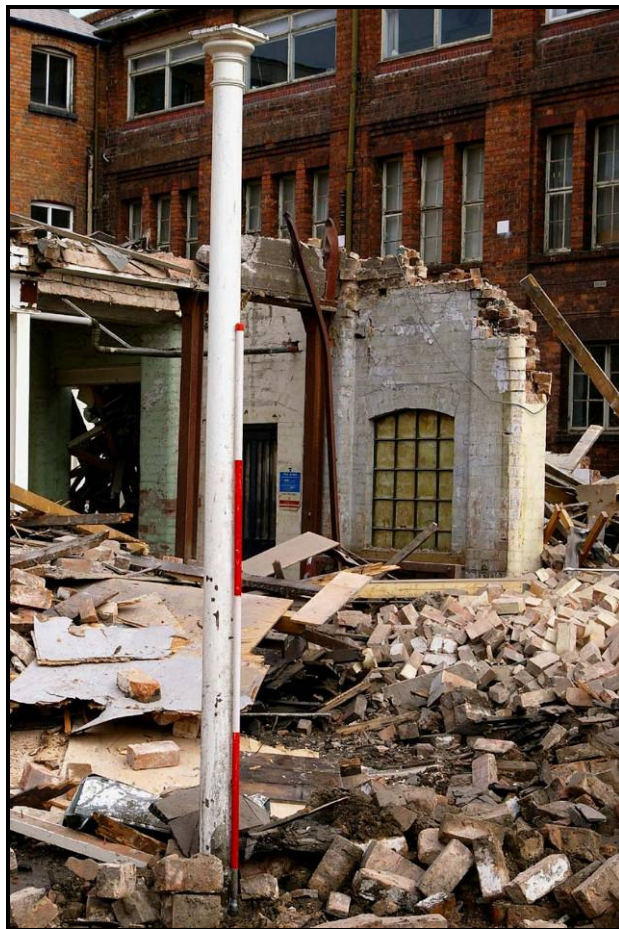
**Figure 23: Detail of cast-iron column**

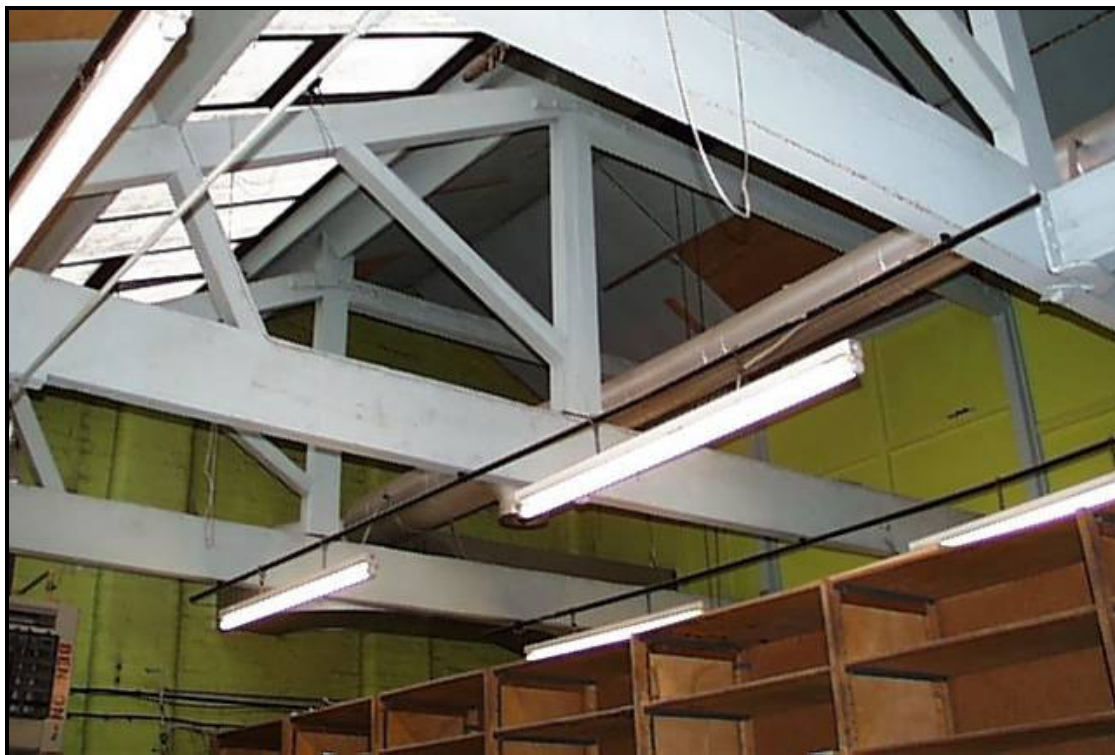
**Figure 25: Queen-post trusses on the first floor of Building M, looking east**

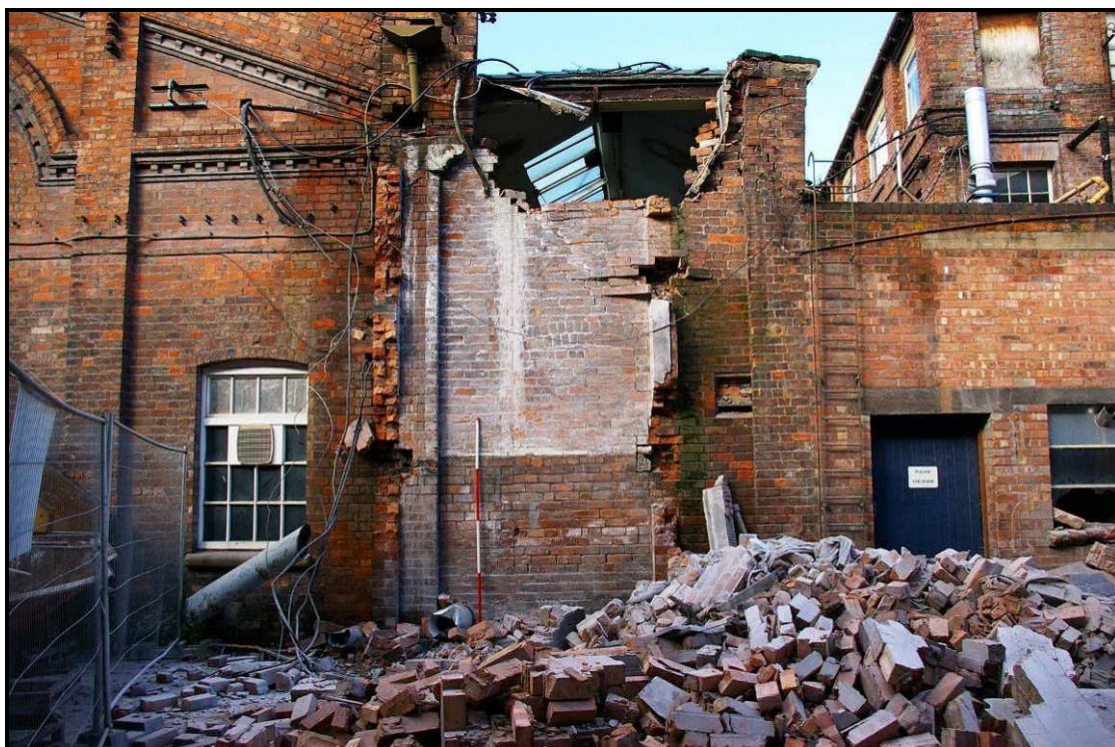
Figure 31: Blocked doorway of former lean-to of Building N revealed during its demolition

The main east elevation is a fairly elaborately decorated tripartite composition, with two ground-floor windows in the central section and one to each side. These have segmental arched heads and moulded brick sills. The southernmost window was dismantled during the survey. A dentilled brick cornice, interrupted by the bay pilasters, is taken up to a semi-circular lunette above the central pair of windows. The dentil work is repeated at the base of the fairly shallow-pitched coped gable. There are two *cyma reversa* kneeler sandstones forming a termination at the eaves of the coping. The upper section of the gable was raised in the 1940s and there is a distinct construction break between the original and the additional brickwork. There is small vent in the lunette set on an earlier oculus which is blocked with bricks. The pilasters have blue engineering chamfered brick plinths at ground floor level. The former lean-to structure is obscured by a projecting brick tower which contains a large extractor fan. Following its demolition, the remains of a doorway was revealed.

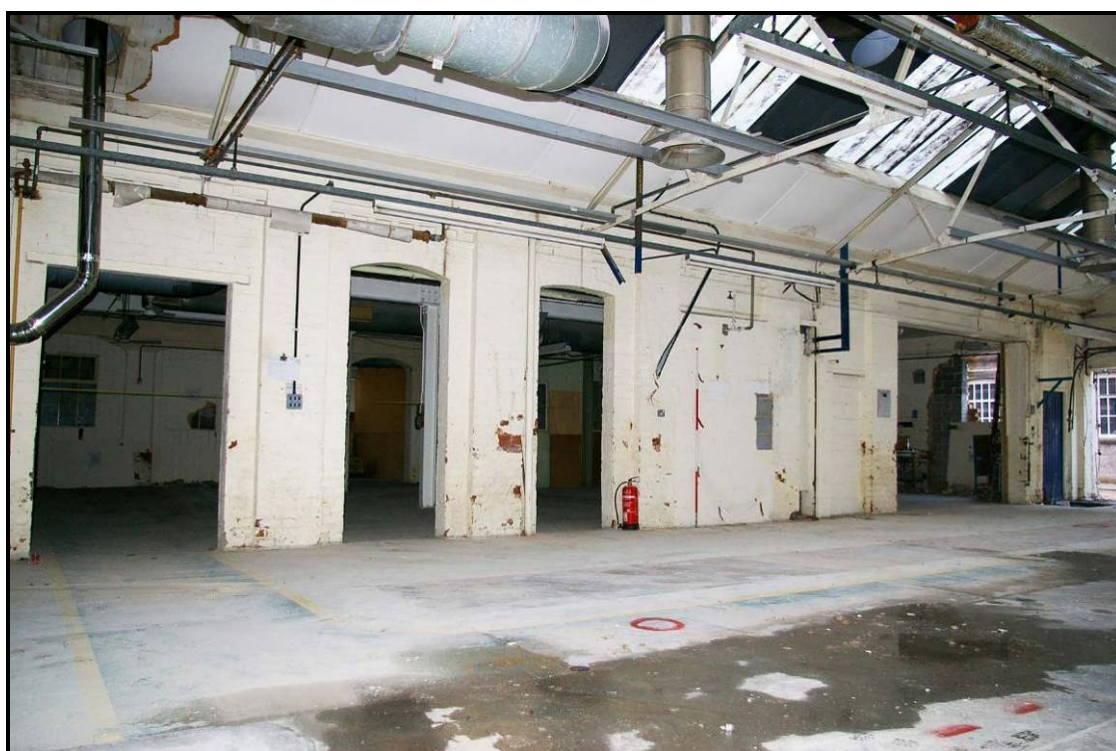
The south elevation has been considerably altered at ground-floor level with the insertion of later doorway openings. There are five arched heads of former window openings on the western side of the wall and above them the remnants of a dentilled cornice can be still seen. The bays are articulated by brick pilasters and there is a single inserted doorway with a steel lintel on the second and third from the east. The fourth and fifth bays from the east are blocked with breeze blocks. An earlier photograph taken inside the adjacent Building O shows the original windows of this elevation (Figure 35). The first floor was added later in the 1940s and is made of mid brownish red bricks (9½" x 4½" x 3½") bonded with orangey mortar and laid to stretcher bond. There are eight windows with concrete lintels and projecting sills. The roof is made of corrugated asbestos sheeting and has close eaves with cast-iron guttering and a parapet at the eastern verges of the gable wall.

Figure 33: South elevation of Building N, looking north-east

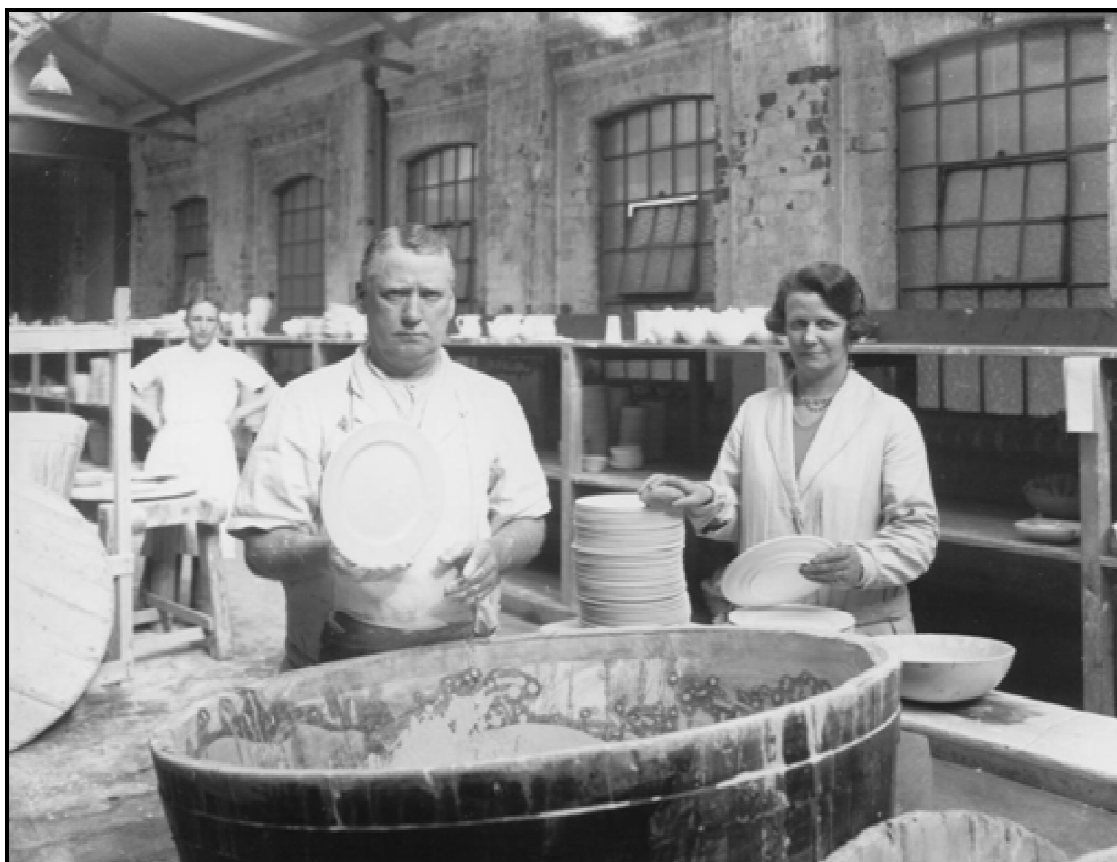
**Figure 35: South elevation around the mid 20th century with the original windows (WPM)**

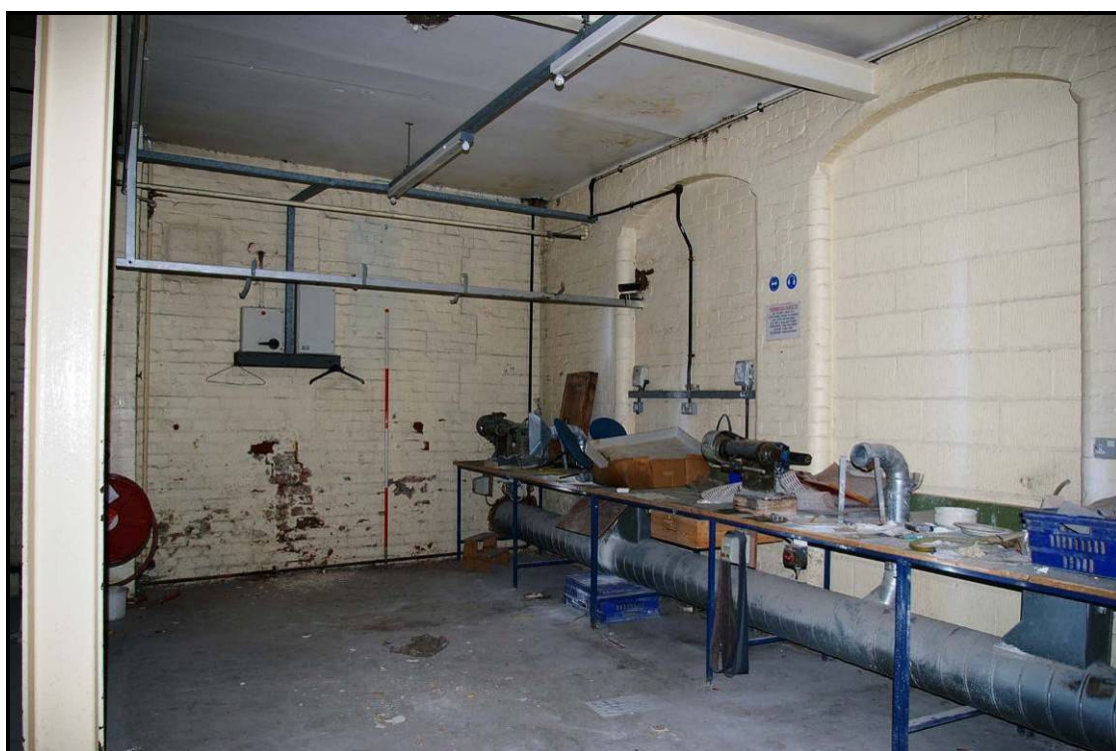
This elevation was originally a partition wall between the lean-to on the north and the main workshop. It is slightly shorter than the south elevation and thus it has seven bays rather than eight. The bays consist of wide doorway openings with segmental arched head and pillars with bullnose brick jambs. Most of them are blocked with bricks and breeze blocks except for the fourth and fifth bays from the east. The whole ground floor wall is painted cream. The first floor is a later addition to the original single-storey building and is now an interior wall of the southern side of Building L which is made of bricks (9¼" x 4¼" x 3") bonded with mid grey hard mortar and laid to Flemish Garden Wall bond. It has two small doorways on the eastern and western ends and five window openings with timber lintels which are blocked with bricks.

Figure 39: Eastern end of the south elevation of Building N

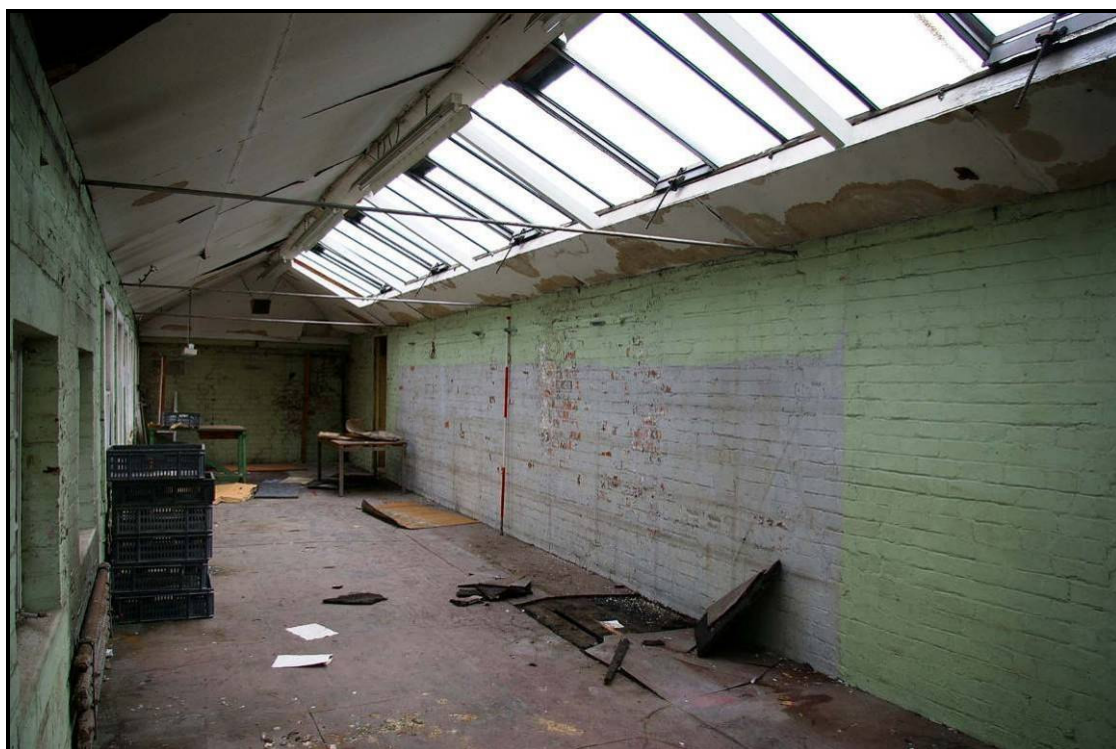
**Figure 42: The first floor of the north elevation with internal blocked windows**

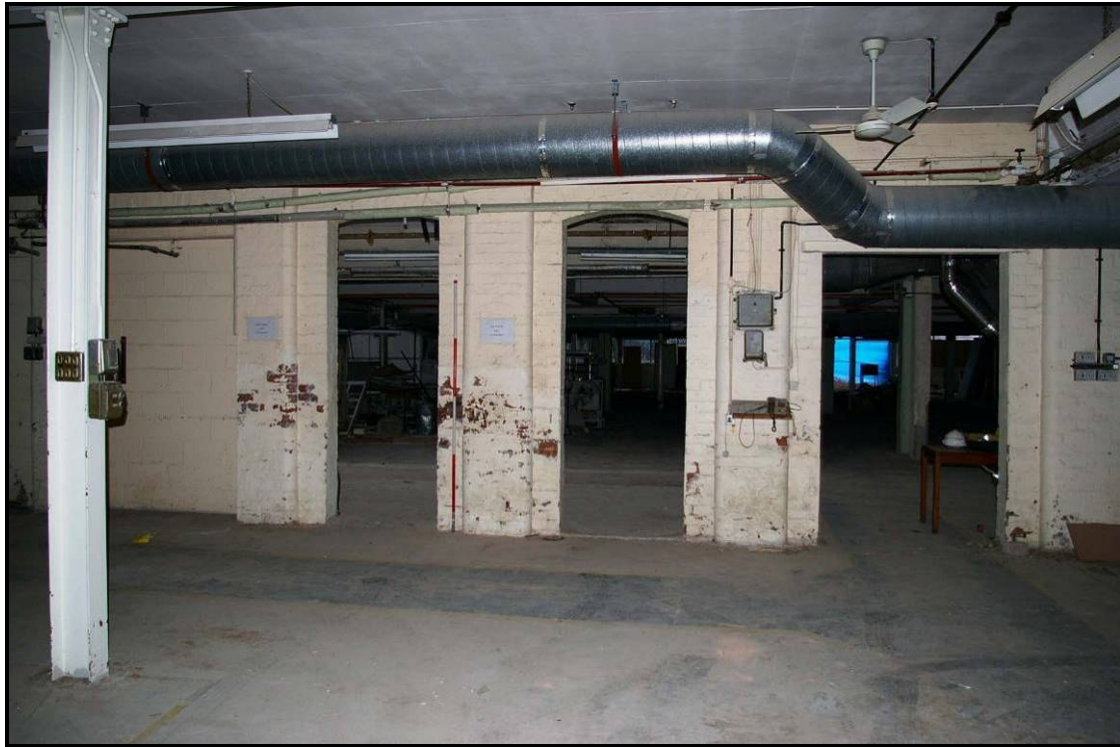
The northern lean-to structure has been considerably modified and its northern wall has been replaced by three RSJ stanchions supporting a wall of Building L. The only surviving remains are on the east wall which has a primary doorway blocked with bricks. The main workshop measures 17 metres long (east/west), 11.3 metres wide (north/south) and is 3.4 metres high. It has painted brickwork, a concrete floor with an U-shaped area covered with herringbone parquet flooring and a lath-and-plaster ceiling supported by a steel structure composed of four RSJ stanchions bearing two transverse RSJ beams. The brick pillars on the north and south walls have bullnose bricks. On the north wall there are three bays with tongue-and-groove panelling and the remains of window openings. The westernmost bay has a complete wooden window with six lights. These bays are blocked externally with breeze blocks. The east wall has four window openings with bullnose segmental arched heads and jambs, except for the northernmost bay which has straight jambs. The latter opening was formerly a doorway. There is a long worktop wooden table along the windows of the east wall.

**Figure 43: Ground floor of Building N, looking south**

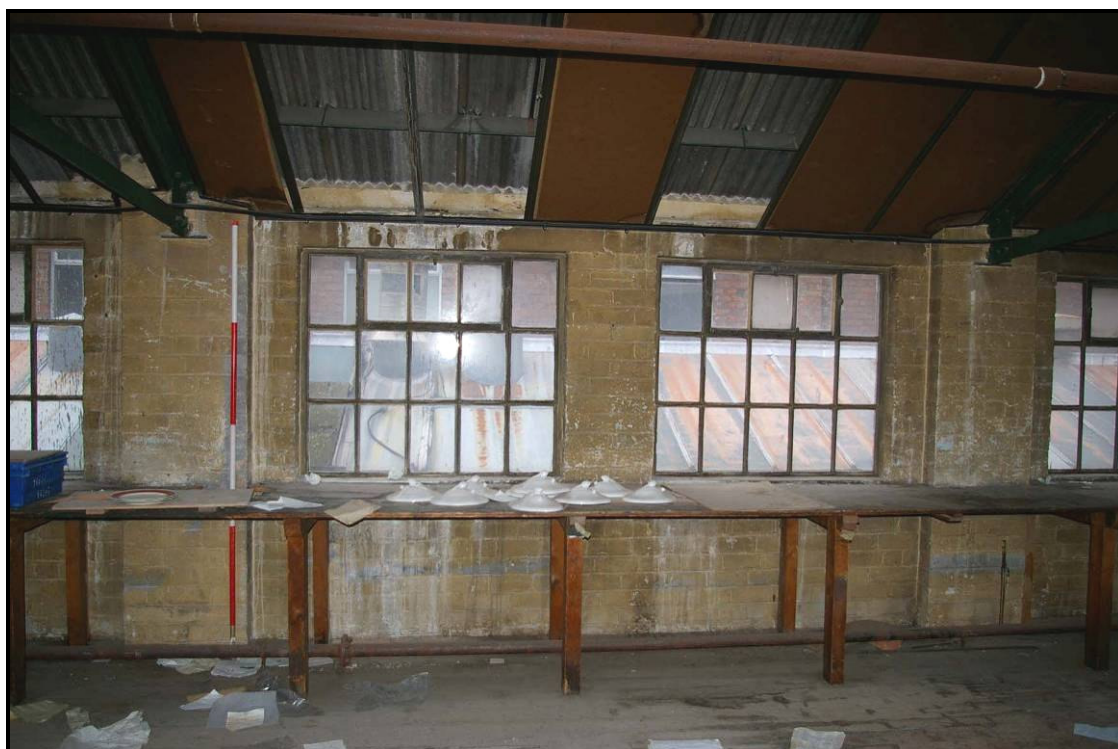
**Figure 49: Windows on the south wall of the first floor of Building N**

The first floor was added to the building in the 1940s and was built against the eastern gable end of Building M on the west and the first floor of the southern block of Building L on the north. Therefore, the south wall and the roof were the only additions to the first floor. Moreover, the eastern gable facade was slightly raised to accommodate the new roof structure. The south wall has eight 'Crittall-type' windows with fifteen rectangular lights set vertically (3 rows x 5 columns). Each has a central opening with pivotal central hinges on the top row. The windows light a long worktop table set against the wall. The inner side of the north wall is the exterior wall of the adjacent Building L and has five window openings with segmental arched heads and are blocked with bricks. Their projecting sills have been mostly removed but one of them partially survives. The east wall has an earlier oculus bricked up in which a later vent has been inserted. The northern kneeler stone can be seen from inside the first floor of Building L which was built against the original fabric of Building N. The floor is made of wooden boards and the roof structure consists of three lightweight steel trusses which stands 5.3 metres tall. The trusses are supported by brick pilasters on the south wall and steel stanchions butting against the north wall. The roof is covered with asbestos corrugated sheeting and two continuous central glazed skylights on each slope of the pitched roof.

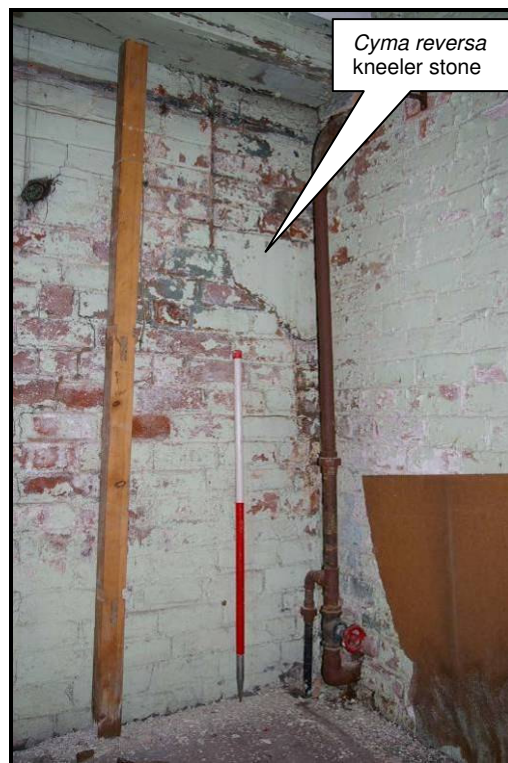
Figure 55: Kneeler stone inside Building L
