Archaeological Building Investigation and Recording,  
Royal Worcester Porcelain Works,  
Buildings M, N, Q, R, S, Y and Z

September 2008

*Archaeological Building Investigation and Recording,  
Royal Worcester Porcelain Works,  
Buildings M, N, Q, R, S, Y and Z  
September 2008*

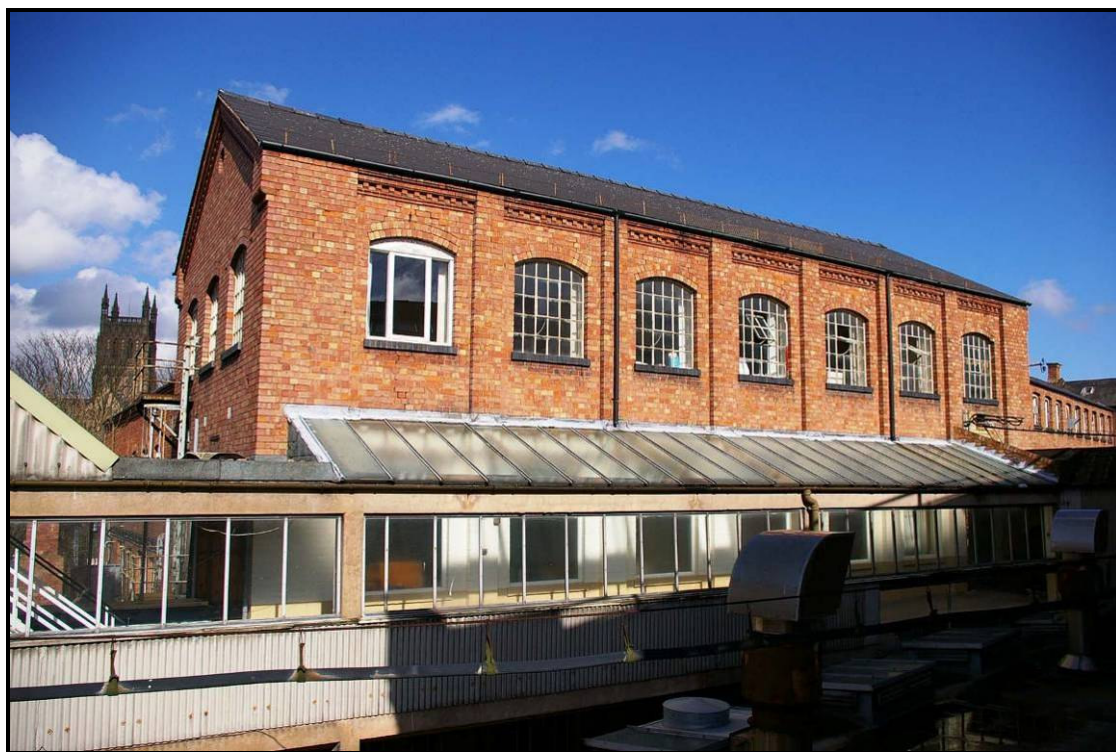
This side elevation is of seven bays articulated by brick pilasters which have plinths decorated with chamfered blue engineering bricks. Each of the recessed panels between the pilasters is topped by dentilled moulded brick cornices. This elevation has a glazed walkway/bridge built against the first-floor level which extends towards Building U on the south. There is a double timber door on the northernmost bay of the ground floor with flat chamfered brick jambs. In each bay there is a broad window opening with a segmental brick head and plain sills of engineering blue brick. Most of the window openings retain their original cast-iron multi-paned glazing, apart from the windows of the first-floor level which are later replacements. Moreover, the northernmost window opening on the first floor has an inserted doorway which leads to a later bridge. The southernmost bay of the second floor has also been altered by the insertion of a modern window. There are small rectangular vents above the segmental arched heads of the ground and first floors' windows. The pitched roof is made of natural slates topped with tile ridges. It has close eaves with cast-iron guttering and close verges.

Figure 57: East elevation of Building Q

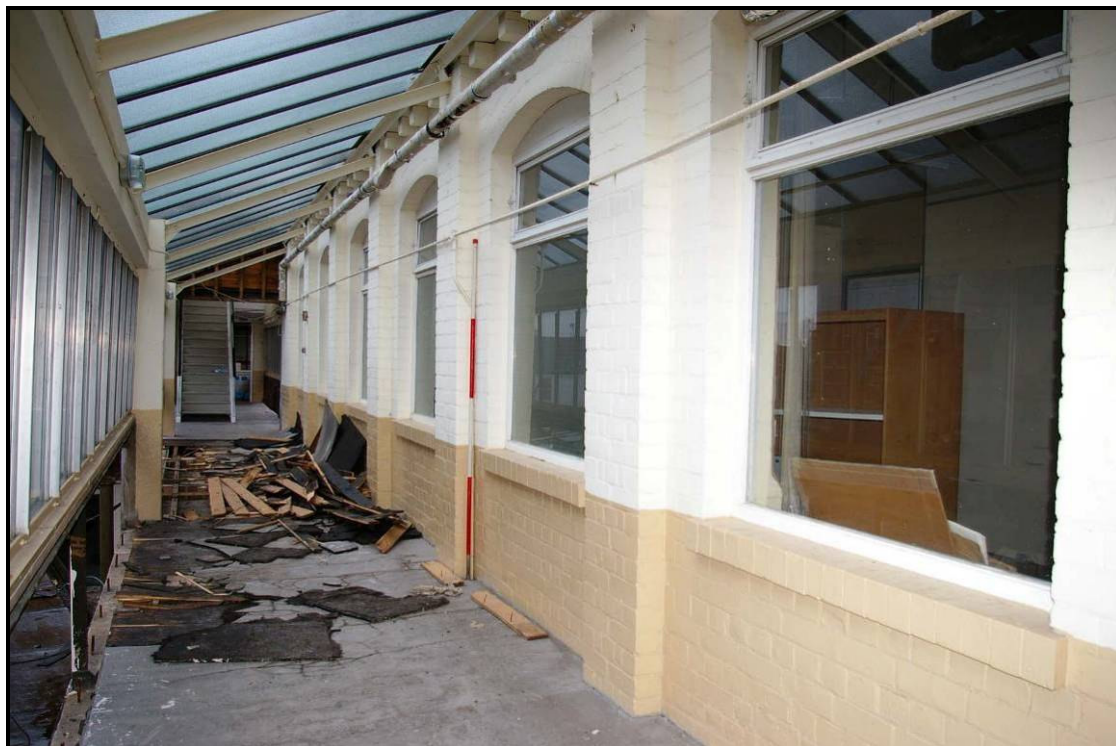
**Figure 58: Glazed bridge on the east elevation of Building Q, looking south towards Building U**

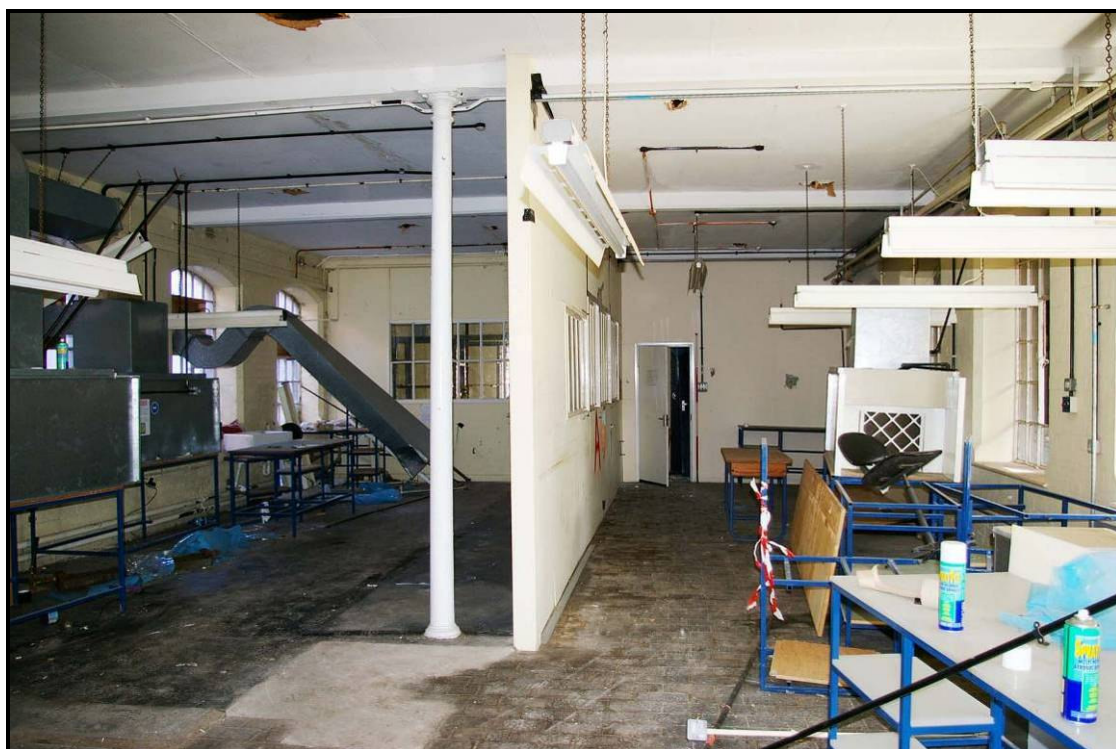
Figure 72: Ground floor of Building Q, looking north

This floor is accessed from the main double door through a step (140mm high) on the northernmost bay of the east wall and from the later inserted doors on both gable walls. This floor is an open workshop which measures 18 metres long (north/south), 7.65 metres wide (east/west) and is 3.35 metres high. In contrast to the external side walls, the interior consists of five bays demarcated by four cast-iron tapered columns with Tuscan capitals supporting transverse timber beams (east/west). The ceiling beams have narrow flat chamfered edges and plain chamfer stops. Most of the fenestration is original and made of cast-iron with thirty six rectangular lights set vertically (6 rows x 6 columns); on the central section is an opening (3 rows x 2 columns) with pivotal hinges. The inner windows' jambs and arched heads are flat chamfered with plain stops. The northern bay has a timber straight staircase set against the north wall which is enclosed with an asbestos boarding partition stud. There is another partially glazed stud wall orientated north/south forming separate working spaces. There is a small kitchen unit with a sink on the south-west corner. There are also some metal-framed worktop tables lit by modern fluorescent lighting. The workshop has painted brickwork, a brick floor and a plasterboard ceiling.

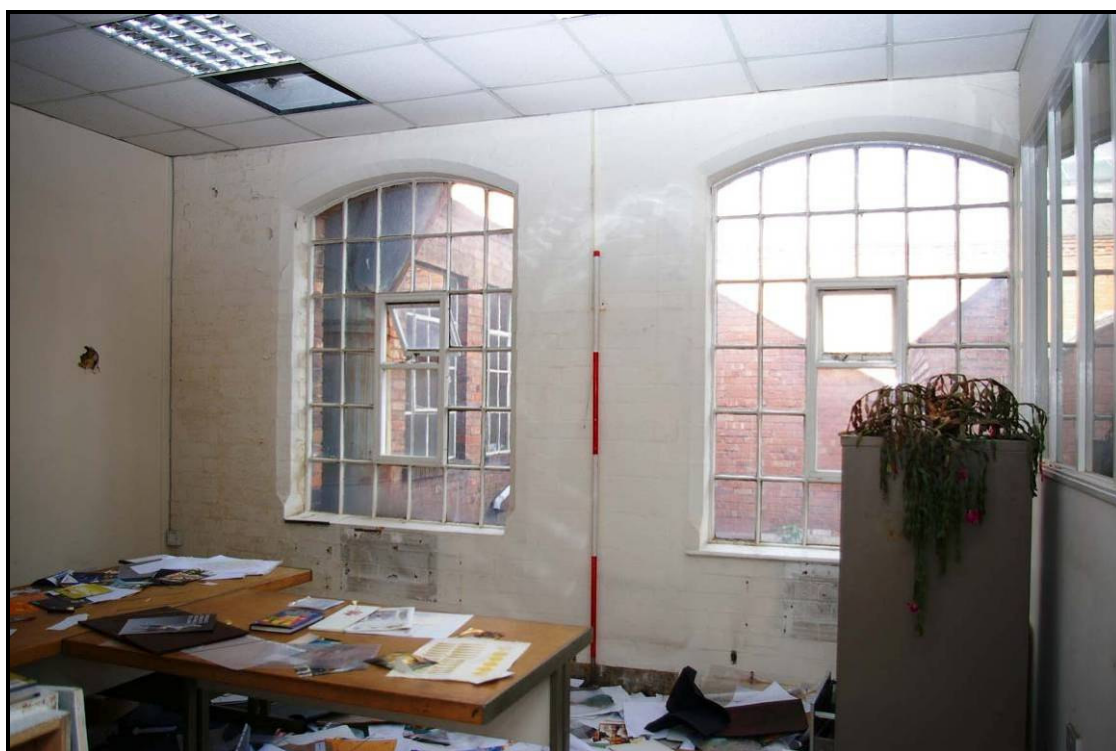
The first floor is very similar to the ground floor and has the same layout and internal dimensions except for its height which is 3.35 metres. It is accessed from its primary staircase on the northern bay, and also from three bridges inserted on the north, east and west walls. There is an office on the western side which is built with lightweight stud partitions and has a suspended ceiling (2.88 metres high). This floor is also fairly bare and there is furniture piled up at the southern end of the workshop. The bridge inserted on the west wall is a vast structure lit by six large cast-iron windows and has a screened office and a corridor. This structure is to be demolished. The majority of the fenestration is equal to that of the ground floor except for the windows on the east and south walls which are later replacements. These have wooden frames with two lights, of which the lower is a large frosted pane and the upper is a clear awning opening pane. The lower pane of the window on the westernmost bay of the south wall has been modified slightly in order to create a fire escape exit. The general fabrics of the entire first floor are the same as the lower level apart from the floor itself which is made of timber boards over joists.

Figure 78: Office on the first floor of Building Q, looking west

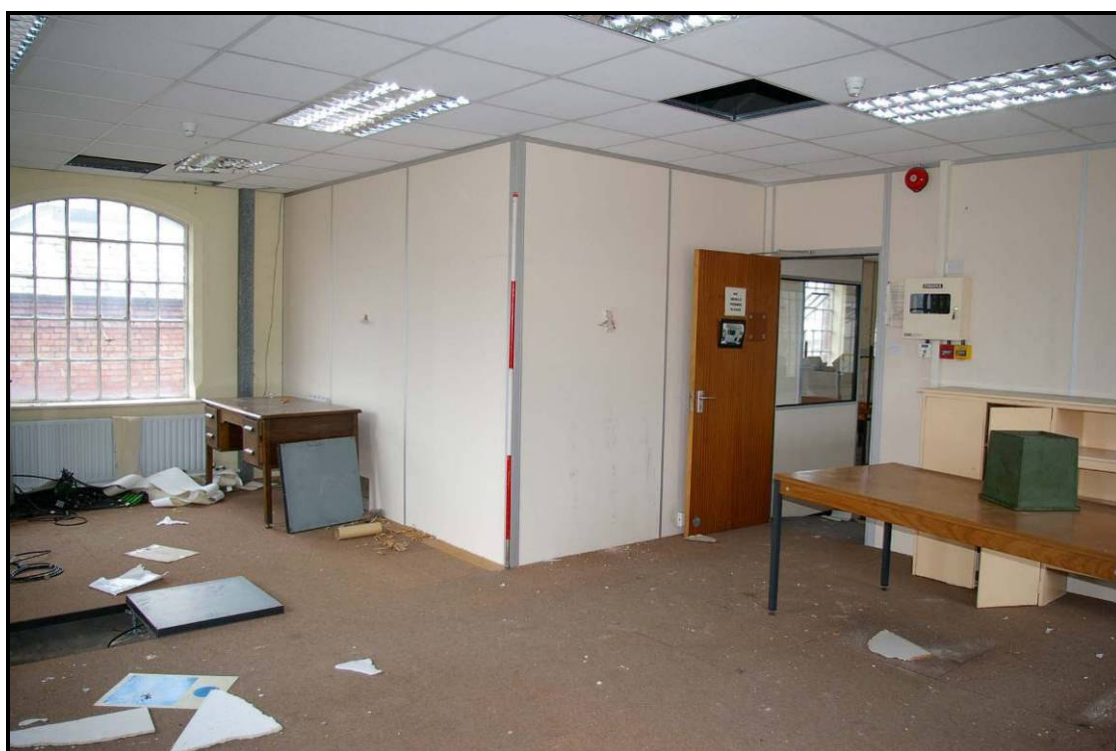
The second floor is also a large open workshop similar to the lower levels. It is accessed from the primary staircase on the northern bay. The floor has later lightweight partition studs on the southern end which enclosed a computer room. The walls and floor are identical to the first floor but the fenestration differs slightly as the windows are shorter with thirty lights (5 rows x 6 columns) with central pivotal openings composed of four lights. The entire floor is used as an office which has desks, office chairs, computers, filing cabinets, etc. There are radiators on the walls, window blinds and modern lighting set on a suspended ceiling (2.7 metres high). The original roof structure can be seen over the suspended ceiling which consists of four timber king-post trusses which carry two tiers of trenched side purlins (one on each principal). The common rafters are notched over a wall plate with their upper ends set on a ridge piece. The tie beams stand 3.13 metres high and the underside height of the ridge is 6.1 metres high. The primary ceiling is extant and is also visible over the suspending ceiling. This has boarded slopes to underside purlins and the central section is flat (4.3 metres high) and has several hatches.

Figure 86: Southern office on the second floor of Building Q, looking north-west

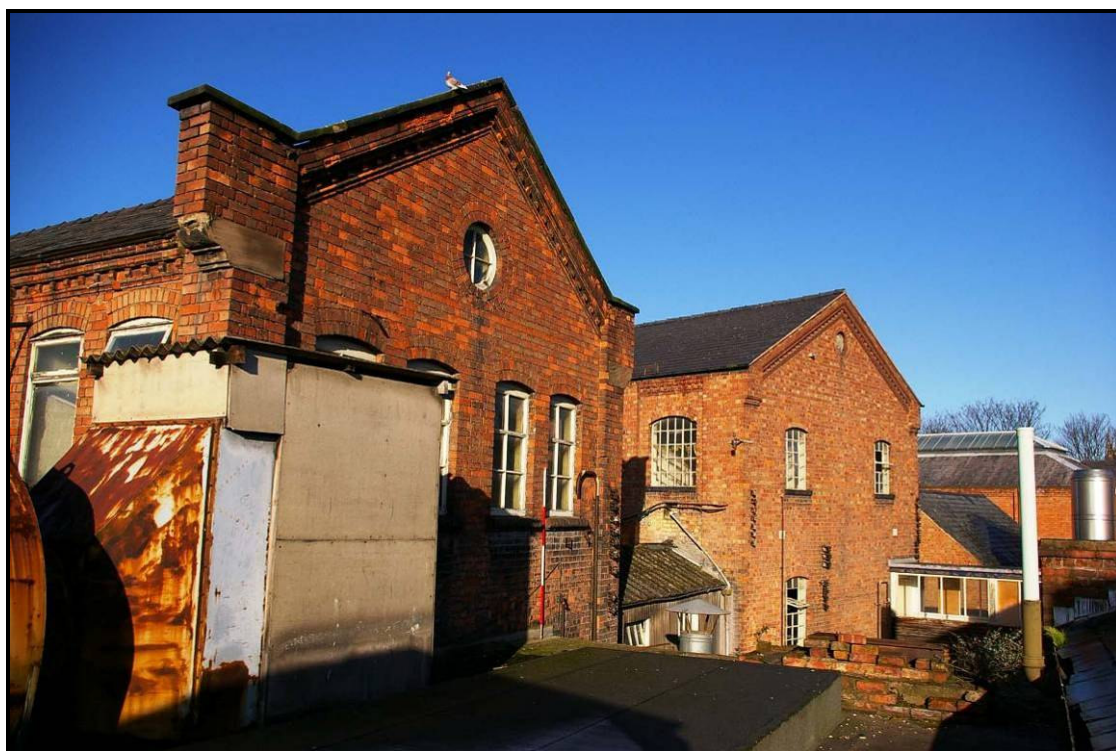
The northern gable elevation has four window openings at each level with segmental brick arched heads and moulded brick sills, but some have been blocked. The gable has a moulded dentilled cornice topped by coping lias stones. In the centre of the gable is a brick-framed glazed roundel. There are two *cyma reversa* moulded kneeler sandstones forming a termination at the eaves of the coping. The lower and most of the central section is butted by later structures belonging to Building O.

Figure 96: North elevation of Buildings R (left) and Q (right)

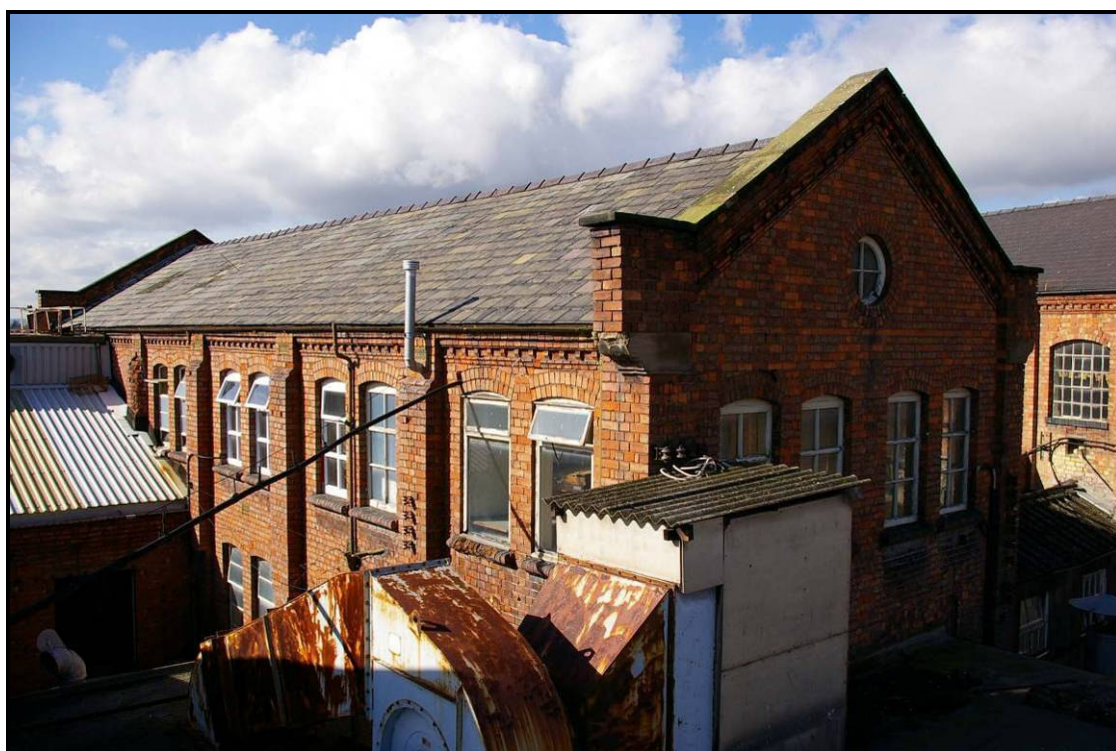
The east elevation consists of six bays articulated by brick pilasters corbelled out for the upper storey and terminating with two courses of chamfered bricks just before the eaves. The recessed panels are topped by ornately moulded dentilled cornices and have pairs of windows on each level. The ground-floor level has been substantially altered with the insertion of a large opening on the northern half. This consists of a steel stanchion with a fire protective covering supporting a large steel beam bearing the upper wall. Most of the window openings on the southern half of the entire elevation have been blocked with bricks. There are cast-iron vents on the uppermost section of the pilasters and on the recessed panels between storeys. The pitched roof is made of natural slates topped with tile ridges. It has close eaves with cast-iron guttering and both of the gables have parapets at their verges.

**Figure 103: East elevation of Building R**

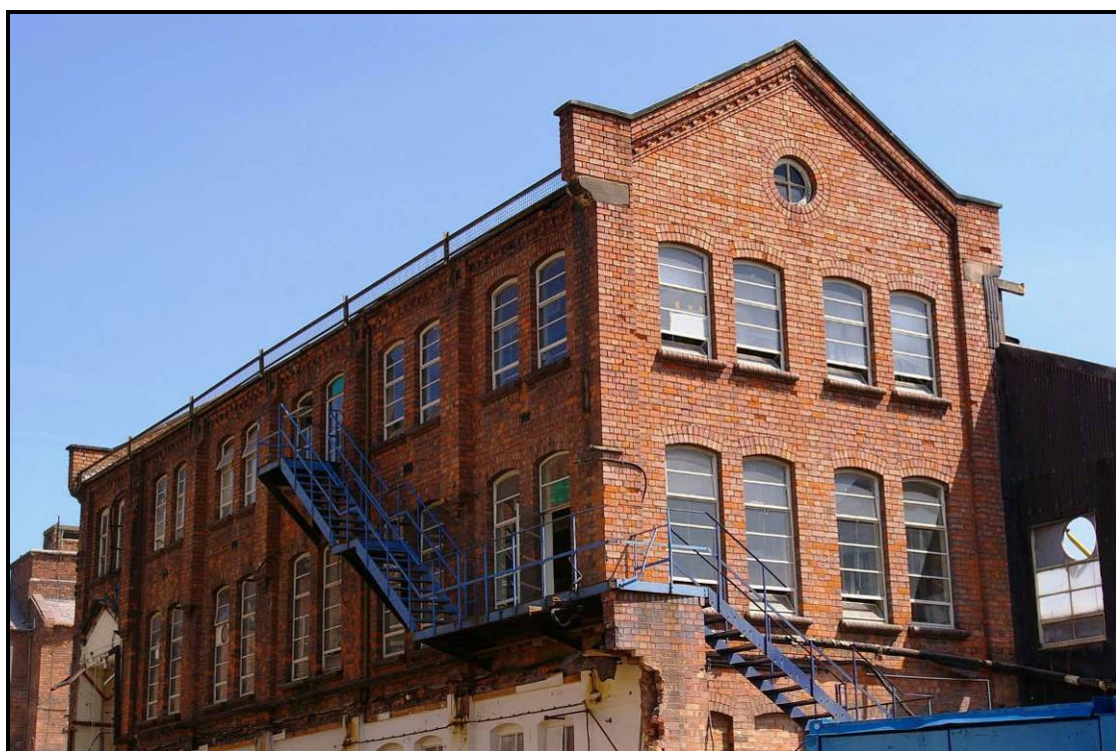
The ground-floor level of this elevation is obscured by Building P but the upper levels are visible. This side elevation has the same arrangement as the eastern one although its fenestration survives in both the first and second floors except for the ones on the northernmost bay of the first floor which has an inserted opening for a bridge. The ground floor is rendered, and has been modified with the insertion of openings on the second and third bay from the north. The fourth bay has a similar opening but is currently blocked with breeze blocks. The first bay is also altered and the windows are blocked apart from the lower rows of one of them. The pilasters have chamfered plinths and are also rendered. The roof has a long glazed skylight in the middle of the slope.

**Figure 111: West and south elevations of Building R**

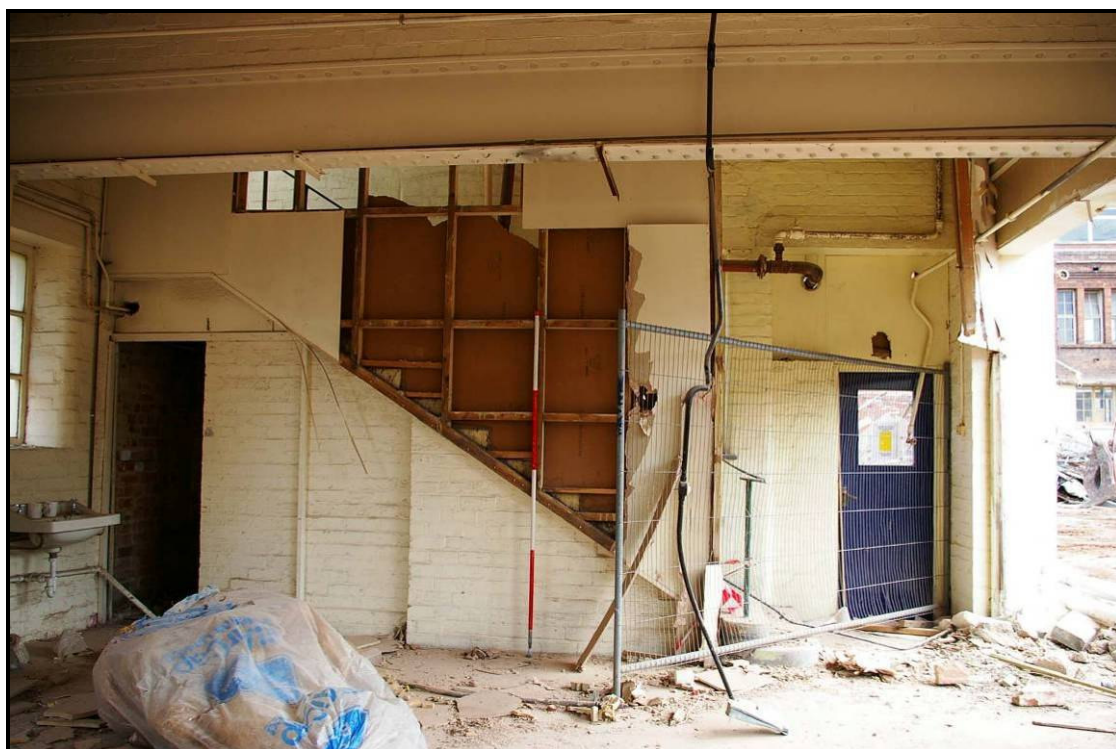
Figure 114: Ground floor of Building R showing inserted RSJ and stairwell, looking north

The ground floor is a large open room which measures 21.4 metres long (north/south), 6.2 metres wide and is 3.57 metres high. It has painted brickwork, a concrete floor and a plasterboard ceiling supported by four transverse timber beams with flat chamfered edges and plain chamfer stops. Most of the window openings have been removed or blocked. The surviving windows on the west, north and south walls have wooden frames with eight lights (4 rows x 2 columns). The top rows have pivotal openings with central hinges. Their inner jambs and arched heads are made of single bullnose bricks. There are inserted doorways and large openings on all walls but its primary doorway no longer exists. There is a riveted steel beam bearing the remains of a partition wall on the northernmost bay. An architect's plan for a new bridge towards Building Q in 1928 shows the partition wall with a doorway and the original staircase attached to it before it was moved against the north wall (see Figure 33 of the Appendix 1). The architect's drawing also indicates the positioning of the primary doorway on the northernmost bay on the east elevation. The present staircase is a dog-leg type, built with stone steps set between the north wall and an additional brick wall with lightweight studs covering the metal balustrade. There is a long electrical tunnel kiln on the southern side of the workshop.

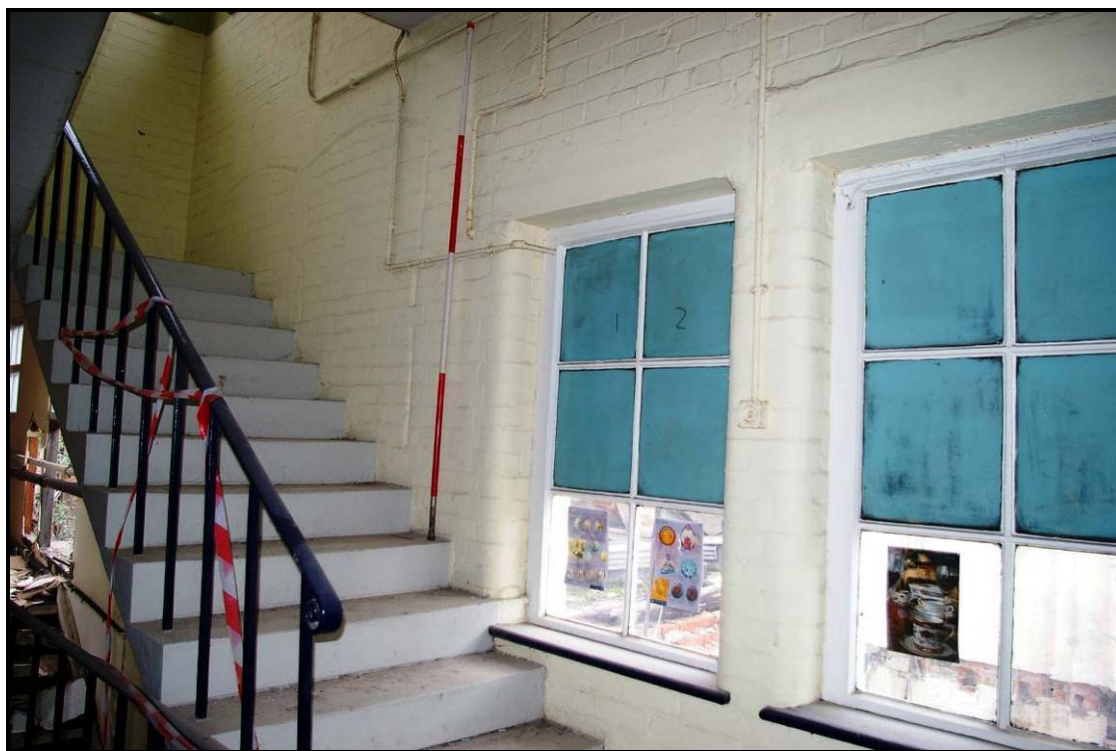
The first floor is very similar to the ground floor with the same layout and internal dimensions, except for the height which is 3.3 metres. It is accessed from the northern staircase which still has its original partition wall. This wall has its primary doorway blocked with bricks but there is an inserted doorway immediately to the eastern side of it. This floor is also accessed from the inserted bridges on the east and west walls. There is an office on the north-west corner built with lightweight studs, measuring 4.25 metres long (north/south) and 3.6 metres wide (east/west). The windows of the entire first floor are later replacements and consist of six rows of frosted lights within a steel frame. The lower rows are hopper openings and the two uppermost ones are pivotal openings with central hinges. The floor is made of timber boards covered with screed. Two of the ceiling beams have been replaced by RSJ beams. There are several long wooden shelves containing porcelain samples and design drawings.

Figure 119: Staircase on the first floor of Building R, looking north-west

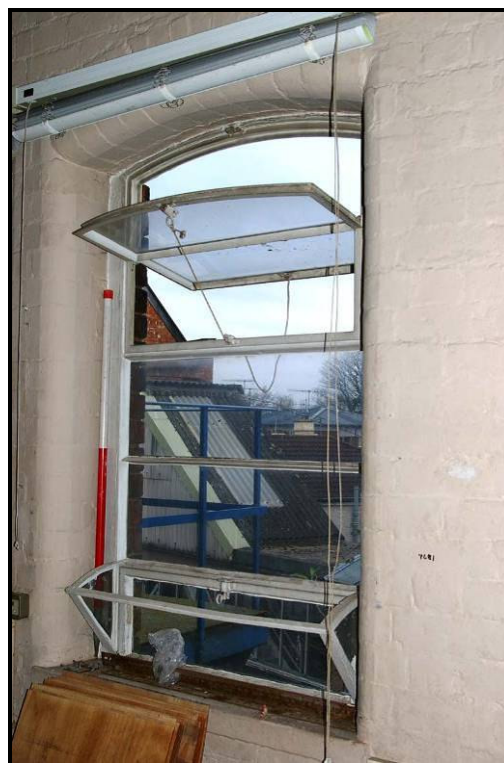
**Figure 135: Example of later window**

The majority of the windows are later replacements as those of the first floor but there are some on the north and east elevations which seem to be original. These have six lights (3 rows x 2 columns) within wooden frames. The upper rows are pivotal opening with central hinges. The floor is made of timber boards and the roof structure comprises five composite trusses. The principal rafters are of sawn timber with their ends housed in cast-iron shoes. From the upper shoe, a vertical wrought-iron suspension bolt drops to an interlocking and bolted junction that connects two further sections of wrought-iron that make up the tie beam and two wrought-iron raking struts. The principal rafters carry four tiers of trenched timber side purlins (two on each principal). The principal rafters have flat chamfered edges with plain stops. The ridge stands 5.22 metres high and the side walls 3.29 metres. On the western slope of the pitched roof there is a long glazed skylight.

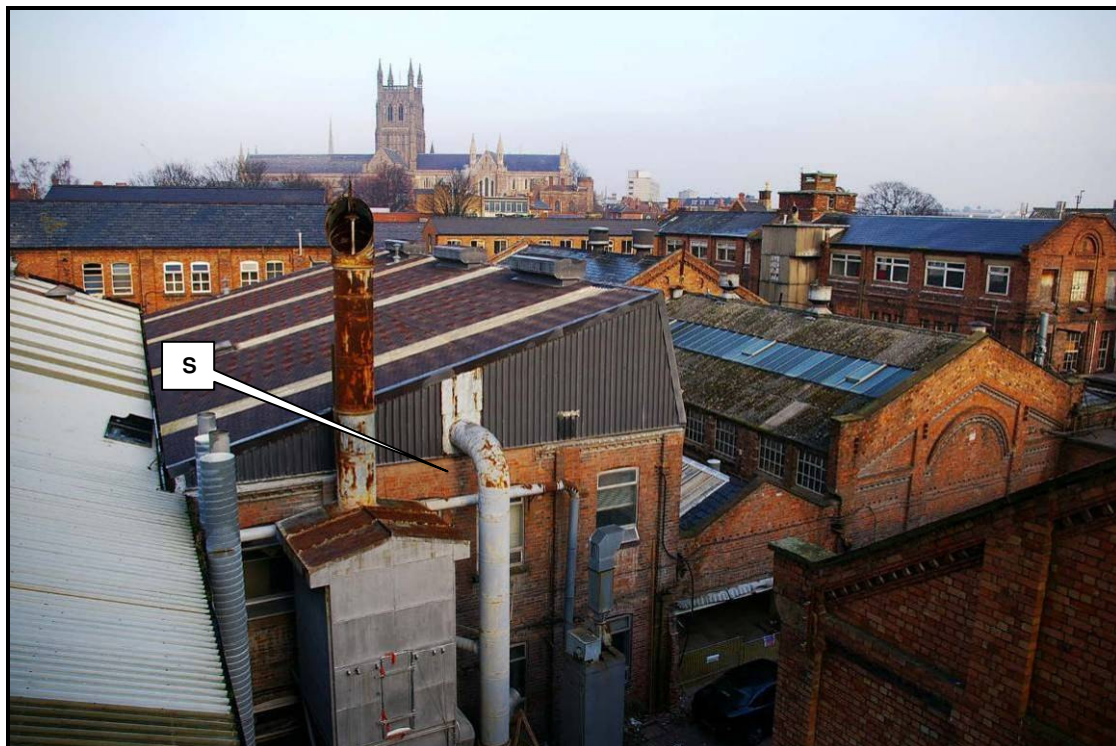
The main eastern elevation is of three bays articulated by pilasters with blue engineering chamfered basal plinths. The central bay is of double width with two window openings on each level and the side bays have single windows on both levels. A dentilled brick cornice, interrupted by the bay pilasters, is taken up to a semi-circular lunette above the central pair of windows but only its lower section survives as its original gable has been replaced by a north-light roof. The modern roof is made of metal sheeting and projects from the cornice and the base of the lunette. The window openings have segmental arched heads and moulded projecting sills except for the window on the first floor of the southernmost bay which has a later cement flush sill. The present windows are later replacements with aluminium frames. Part of the northernmost bay has been rebuilt, including the window sills which are blue engineering chamfered bricks. There are two cast-iron vents on the recessed panels and a fire insurance plate (Norwich Union) on one of the pilasters which is partially obscured by a primary drain pipe that extends beyond the top of the roof.

**Figure 140: Building S facing the central lane of the Works, viewed from Building W1**

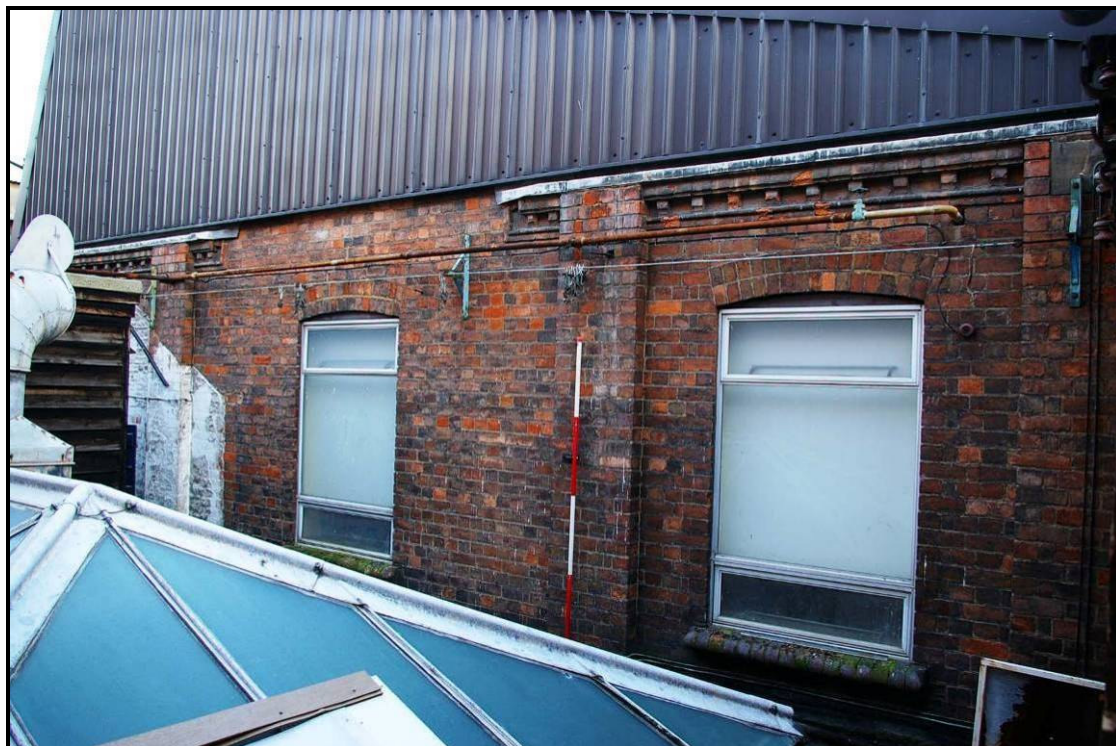
**Figure 145: West elevation of Building S**

The west elevation, facing towards Building R, is very similar to the eastern one, but is partially obscured by adjacent structures. The ground-floor level has been opened up linking it to the interior of a north/south wing of Building O. In contrast to the opposite gable wall only the central bay of the first-floor level has a single window in the middle of the recessed panel.

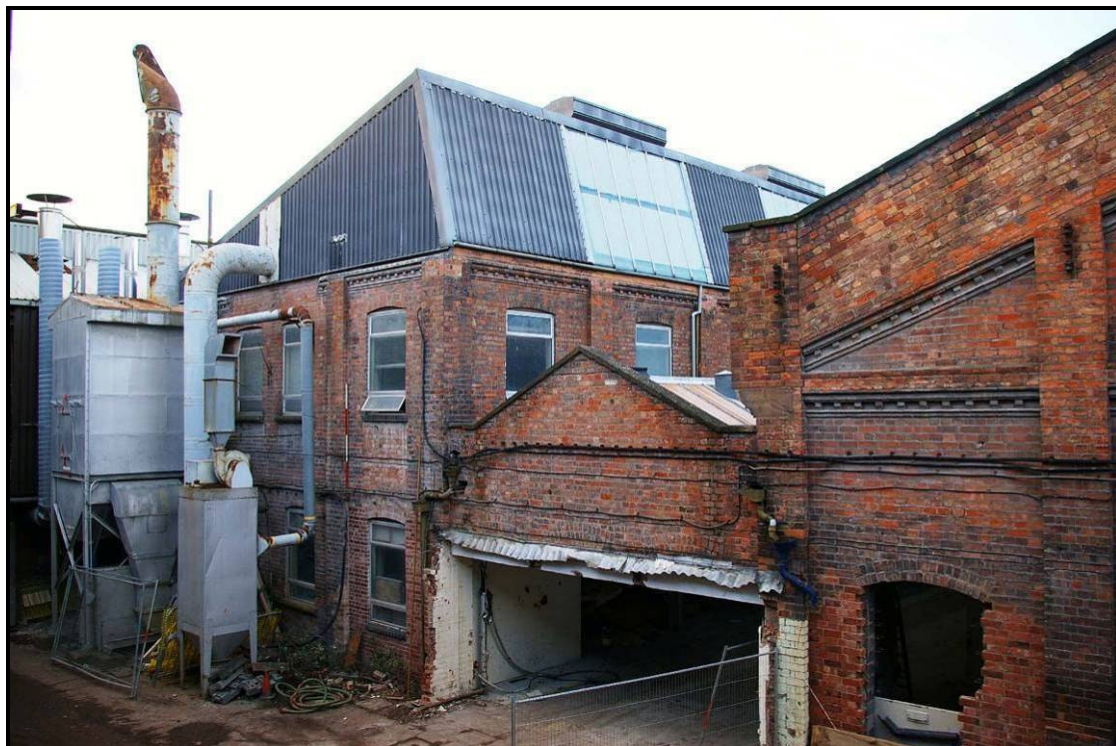
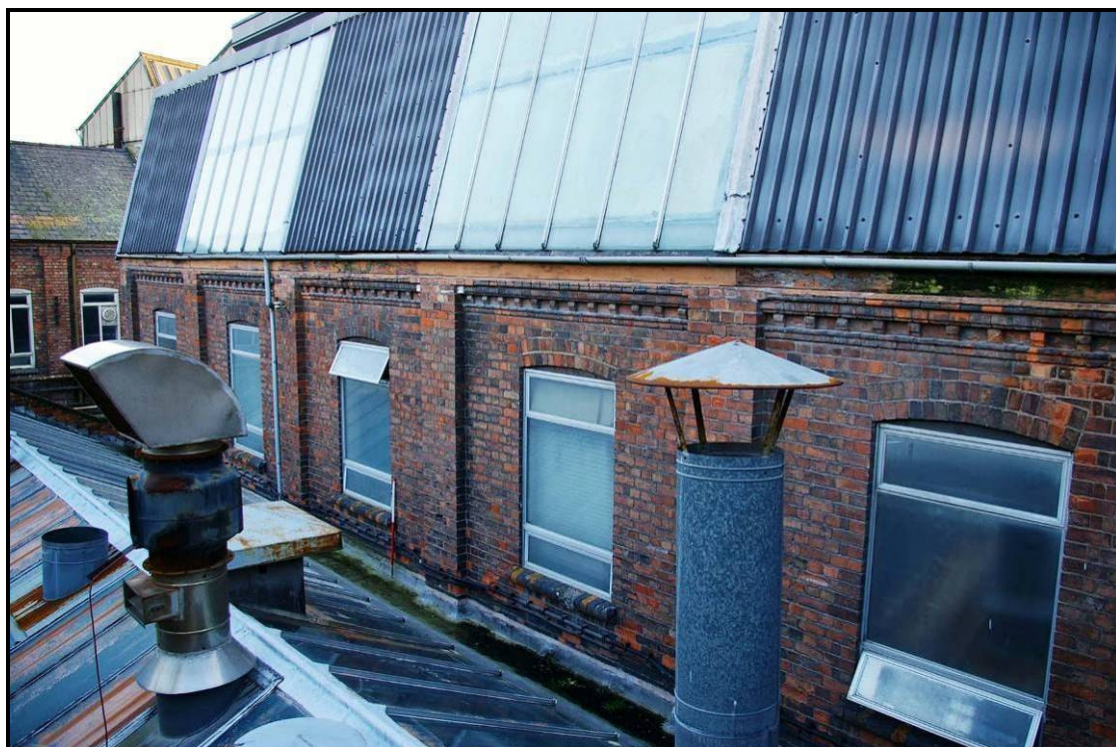
**Figure 146: North and east elevations of Building S**

The ground-floor level of this side elevation has been removed and is opened up to the adjacent Building O. The resultant opening has an RSJ structure, composed of girders supported by four stanchions, bearing the upper wall. The first-floor level is extant and consists of seven bays articulated by brick pilasters. Each of the recessed panels between the pilasters is topped by dentilled moulded brick cornices. There are window openings on each bay which are equivalent to the rest of the building. The windows on the first and second bay from the west have been blocked with bricks. On the first bay from the west there is an inserted doorway with a concrete lintel set on a bricked-up window. This doorway leads to a walkway on the roof of Building O. The metal roof has three large glazed skylights.

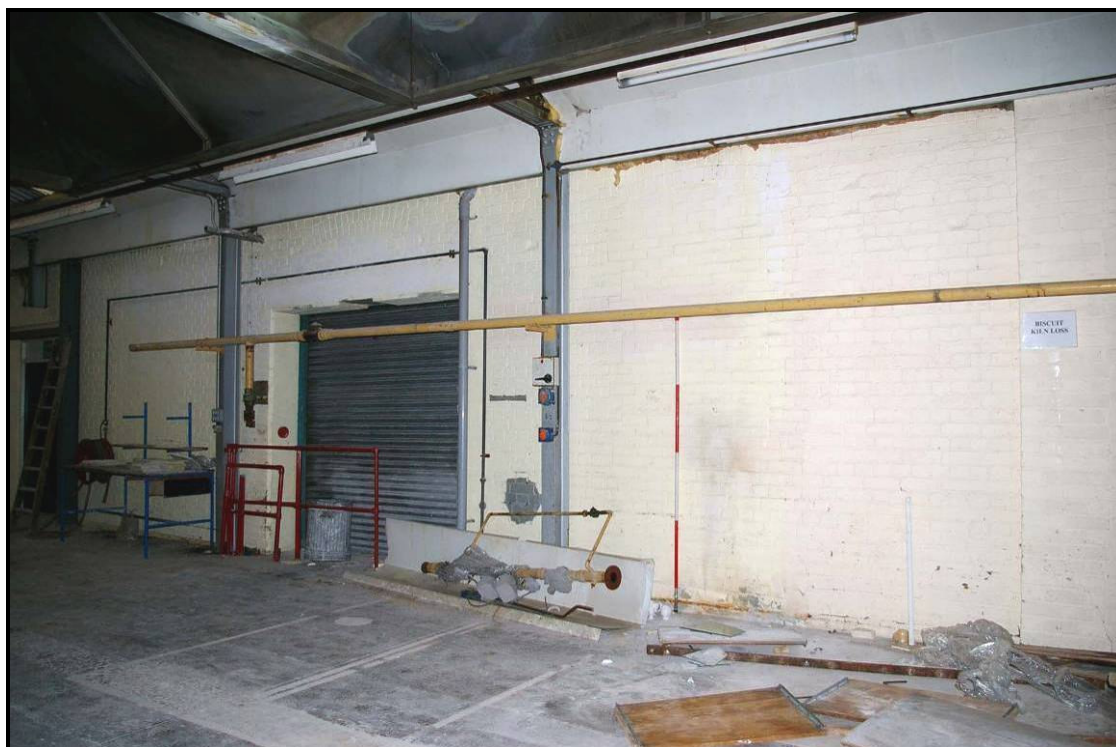
**Figure 149: Western side of the south elevation of Building S viewed from inside Building T**

The ground-floor level of the south elevation has also been removed and is opened up to the adjacent Building T. The resultant opening consists of an RSJ structure similar to that of the north elevation. The first-floor level is extant but was modified when it became a partition wall between the interior of Building S and the first floor of the attached Building T. As a result, all the windows have been blocked with bricks and three doorways were inserted on the recessed panels. One of these doorways is now blocked with bricks. The entire elevation is painted white.

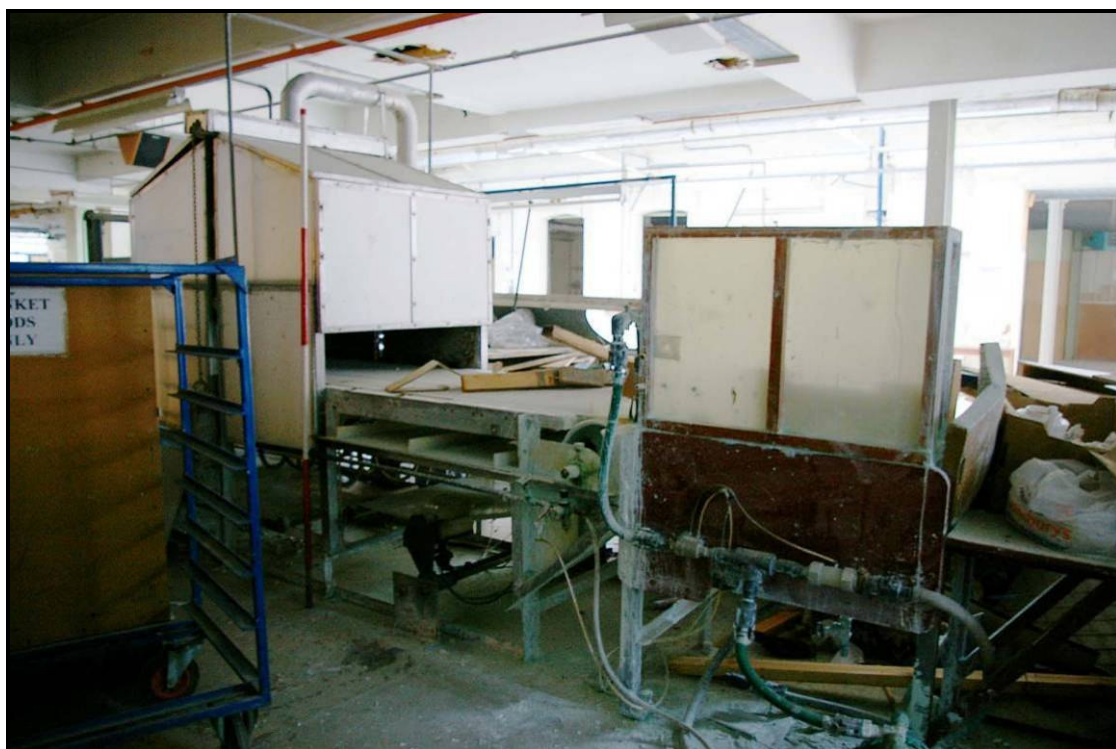
It is a single large workshop which measures approximately 24 metres long (east/west), 11 metres wide (north/south) and is 3 metres high. The interior has been radically altered and much of the original fabric has been lost, except for the east wall which has four window openings with bullnose brick jambs and arched heads. The windows are later replacements with aluminium frames. Each window has three lights of which the ones on the top and bottom rows are narrower than the central pane and have awning openings. The window on the southernmost bay is slightly different and only has two lights. The upper pane is a pivotal opening with central hinges. The workshop has a concrete floor and a plasterboard ceiling supported by an RSJ structure composed of four longitudinal beams, five transverse beams and fourteen stanchions with fire protective coverings. There is an east/west row of original cast-iron tapered columns with Tuscan capitals in close proximity to the south wall. On the southern side there is a lift made of bricks which is connected to the floor above. The workshop is fairly bare apart from some tables, trolleys and shelves.

Figure 151: Ground floor of Building S, looking north towards Building N

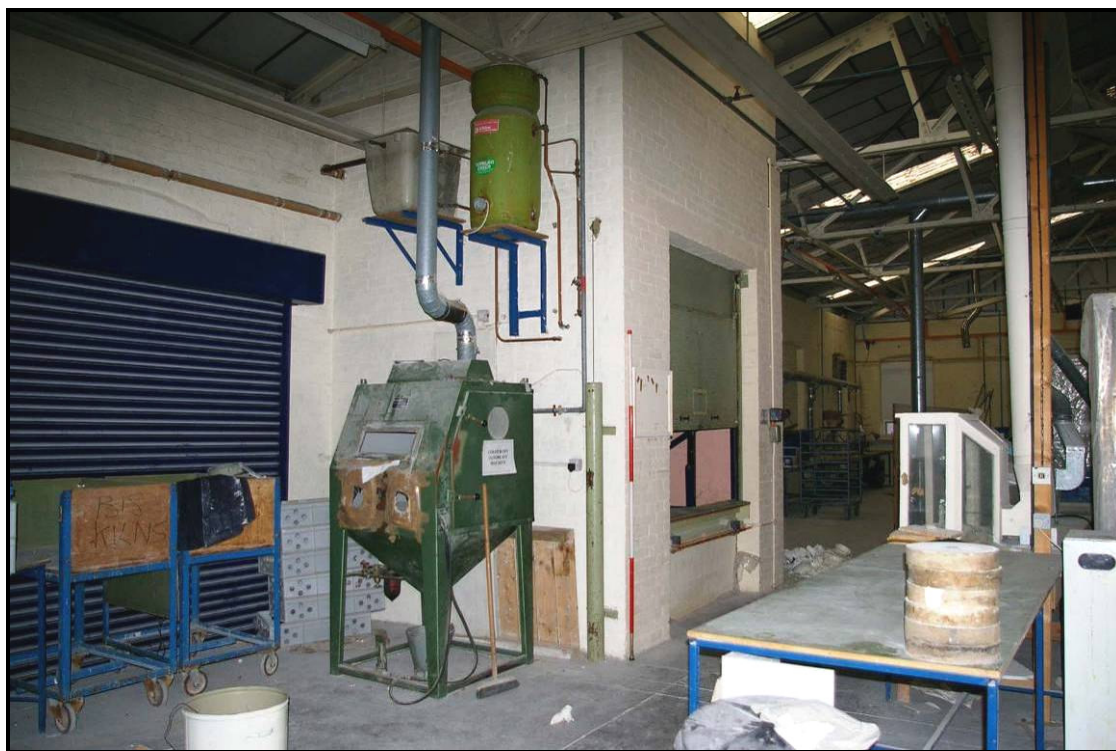
**Figure 156: Roller shutter and lift on the first floor of Building S, looking south-west**

The first floor is accessed from the adjacent Building T through several inserted doorways. This floor is also a large workshop with the same length and width. The interior has painted brickwork and a wooden floor covered with screed. The positioning of its original staircase was not identified, but it is possible that it may have been attached to the west wall, as the central bay of the first-floor level has only a single window which would have provided the space for it. The roof structure is composed of six lightweight steel asymmetric trusses which provide an approximate internal height of 7 metres. The side walls are 4.5 metres high. This floor survives better than the ground one and its plan is a better representation of the building's original footprint than at the lower level. The windows are the same as the ones on the ground floor and their openings also have inner jambs and segmental arched heads made of single bullnose bricks. The workshop has long worktop tables against the walls and a long double one running along the centre of the entire room.
