Archaeological Building Investigation and Recording,
Royal Worcester Porcelain Works, Building E: The
New Throwing House and Building G: The Finished
Goods Warehouse

July 2008

*Archaeological Building Investigation and Recording,
Royal Worcester Porcelain Works,
Building E: The New Throwing House and Building G:
The Finished Goods Warehouse
July 2008*

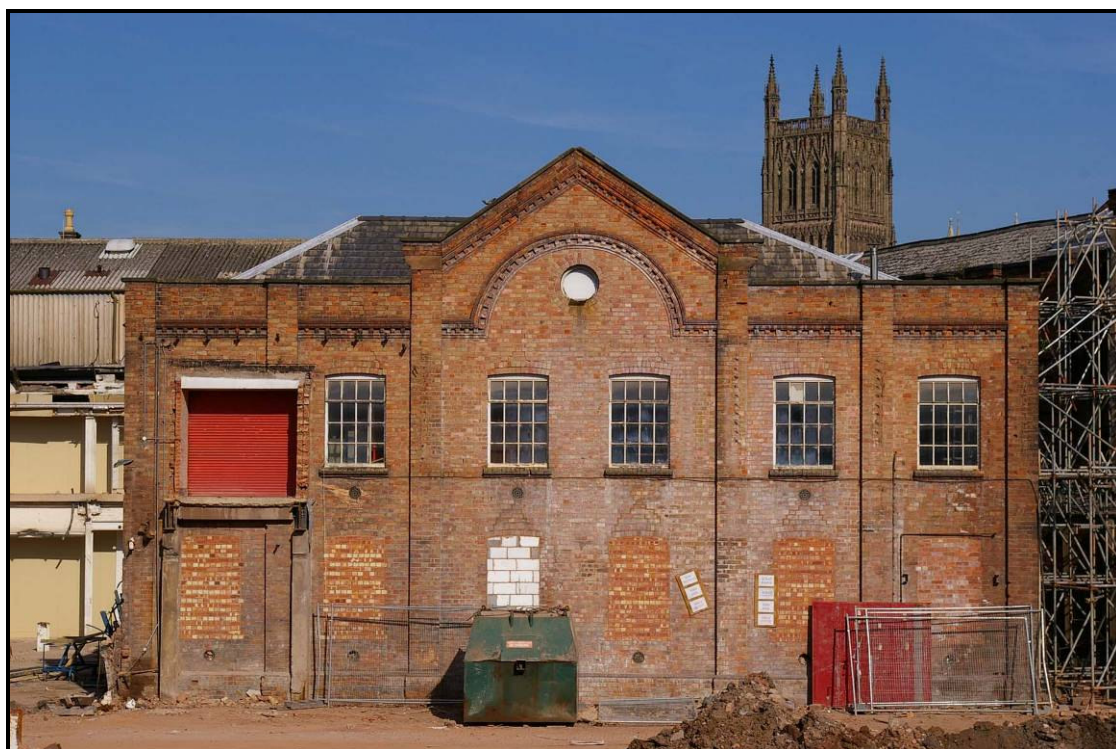
Figure 4: East elevation

The main eastern elevation is articulated by pilasters into five bays, the central bay of double width and topped by a raised coped gable reminiscent of churches of 13th century Lombardy. The plinths of the pilasters are decorated with chamfered blue engineering bricks. Each of the recessed brick panels between the pilasters is topped by dentilled moulded brick cornices. The dentilled brick cornice of the central bay is taken up to a semicircular lunette over a roundel which is currently blocked with a white translucent plastic sheet. The gable is also topped by similar cornice detailing at the base of its coping. There are two ovolo moulding kneeler red sandstones forming a termination at the eaves of the coping.

On this elevation there were originally six windows at each floor level, one in each of the side bays and two in the central bay. These have segmental brick heads and bold projecting moulded brick sills. The window openings of the ground floor have been blocked. One of them appears to have been converted into a doorway before it was blocked. The window openings on the first floor retained their original timber windows with slender glazing bars except for the southernmost which has a large opening leading to a bridge which was inserted to provide access to the opposite Building F. There are decorated cast-iron circular vents under the window sills. The ground floor is disfigured by an ugly modern steel-framed and steel-clad lean-to along its full width.

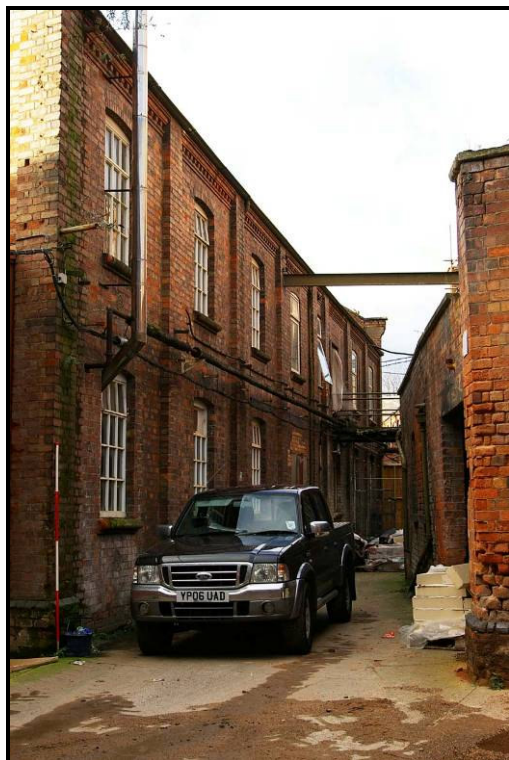
Figure 7: North elevation

The north elevation is of eight bays in all, including a narrow entrance bay just to the west of centre. The decorative details are identical to those on the eastern gable except for the lack of plinths on the pilasters. To the east of the narrow entrance bay a ground-floor window has been blocked and replaced by a doorway. Another window, in the second bay from the west, has been converted into a doorway but its upper section has been retained as a fanlight. On the first floor, some of the original windows have been replaced by modern simple types and a doorway has been inserted on the third bay from the west which leads to a concrete bridge which links it to the Bone Mill (Building D). The four bays on the east have circular cast-iron vents under the window sills.

The roof is visible on this elevation and is made of natural slates topped with tile ridges and lead flashing. It has close eaves with cast-iron guttering and both of the gables have tall parapets at their verges. The roof structure is in two separate parts corresponding to the different parts of the building. The wider eastern section is covered by a pair of parallel four-bay hipped roofs at right angles to the main coped gable of the eastern facade to Prince's Drive. The roof over the narrower western section is pitched and at right angles to the other section.

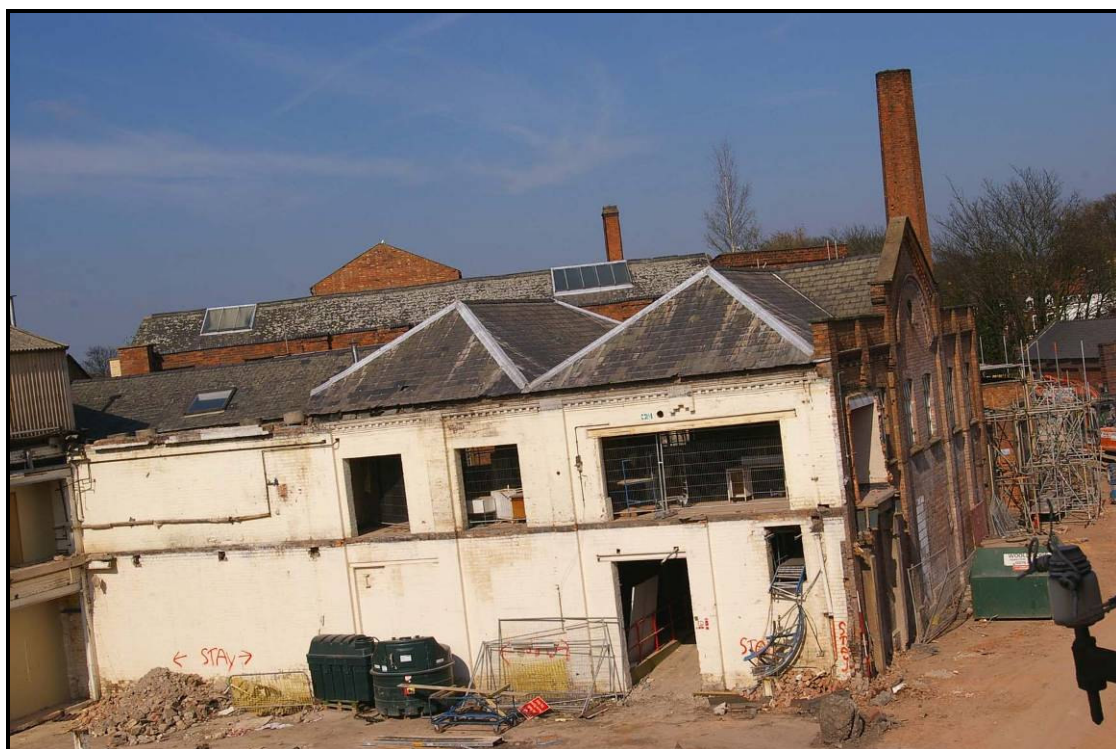
Figure 13: South elevation

The south elevation is now a party wall between this range and the adjacent Finished Goods Warehouse (Building G). Because of this, it has been considerably altered but survives better on the ground floor than it does at first-floor level, where original window openings have been removed and replaced by large open doorways with concrete lintels. The eastern half is original with four bays built in the same architectural style as the rest of the building. On the ground floor the windows have been blocked up with bricks and their sills have been removed, but some of the cast-iron vents survive. The first bay from the east has a small rectangular opening for a conveyor which took material from the adjacent Building G to the first floor, and the second bay has a large inserted doorway with an RSJ lintel. The remains of a cellar window are also visible here. The western half of the whole elevation is a simple painted brick wall of modern appearance. However, the westernmost end is an earlier wall of hand made bricks of variable size (mostly 9" x 4 1/4" x 2 1/2") bonded with flush orangey lime mortar (up to 22mm thick) and laid to fairly irregular Flemish bond. This wall has a blocked doorway on the ground floor and a blocked window with a timber lintel on the first floor. The wall exposed on this elevation is in fact an internal wall which has further windows inside. There are also two wall plates on each level and over them are scars of dismantled joists.

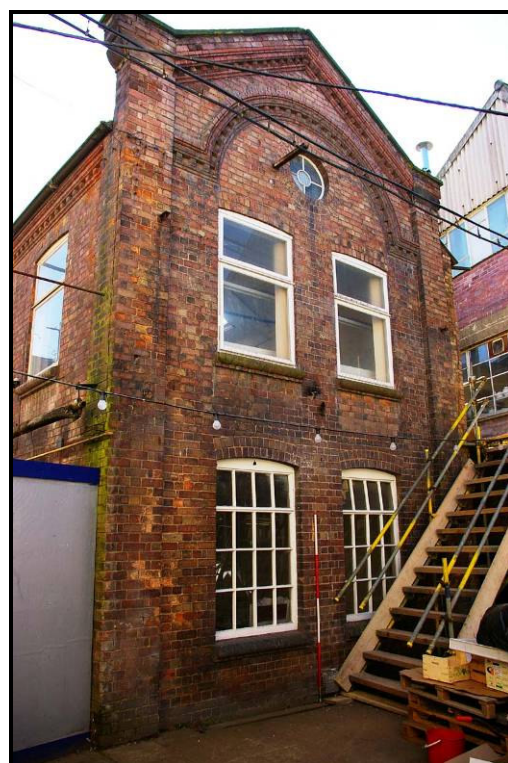
Figure 16: West elevation, from the ground

Because of the original shape of the building, its western gable is much narrower than its eastern gable. Architecturally, it is to all intents and purposes a deliberate repetition of the central bay of the main eastern facade. The windows of the first floor are modern replacements, whereas the ones on the ground floor are original. Underneath the sill of one of the upper windows there is a small area repaired with later brickwork. The roundel on the gable has its original fixed glazing with a cast-iron frame. The uppermost brick string course of the semicircular lunette is made of solid bricks whereas on the east elevation it is made of frog bricks. The later infilling of the 'cut-out' in the south-western part of the building has two large openings at each level with concrete lintels. The ground floor has a double timber door and the first floor has modern glazing. It has a flat roof covered with felt and two asbestos cowl.

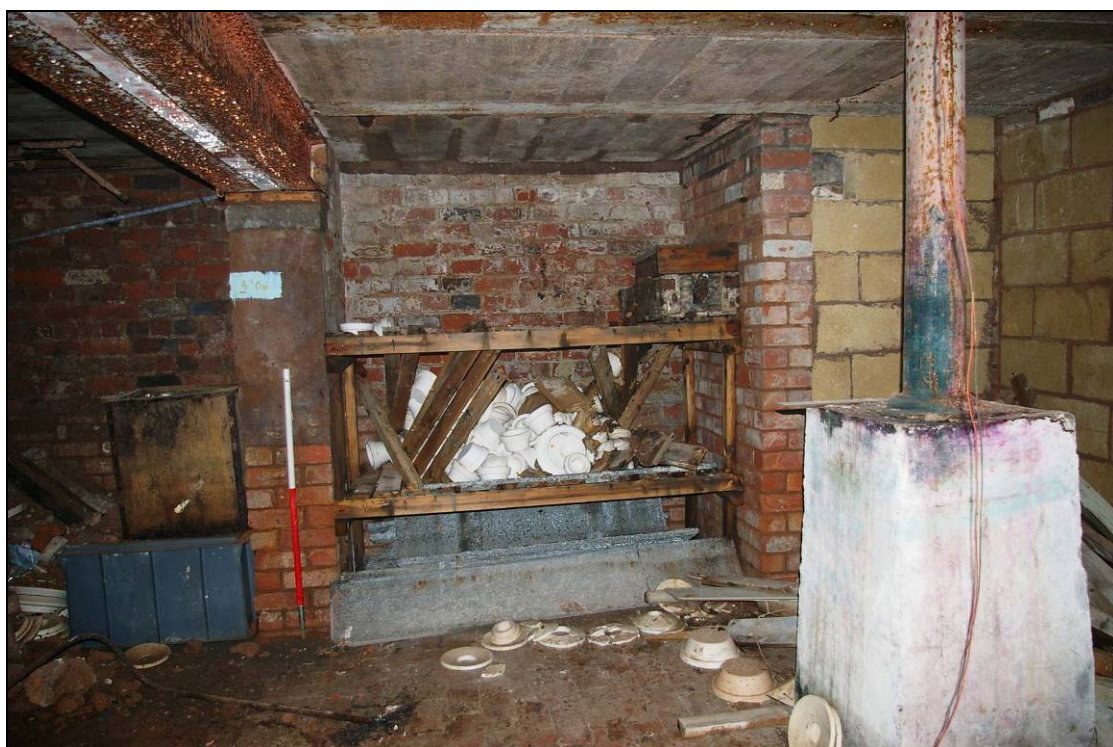
Figure 19: Inside the cellar, looking north

A small cellar was revealed during the current groundwork. The existence of this cellar was known as it is shown on the proposed plan of the 1877 architect's drawings, and the remnants of a window are visible on the south elevation. However, because its access was concealed its current condition was unknown. The cellar was found practically empty with some shelves and the staircase was concealed with breeze blocks and backfilled with ceramic material. The cellar is situated at the southern part of the building and has an overall dimension of 6.2 metres long (east/west), 6.05 metres wide (north/south) and 2.46 metres high. On the south-east corner there is a blocked window which is partially visible on the south elevation next to a doorway. The wall is made of bricks, the floor is also made of bricks laid on bed to stretcher bond (north/south) and the ceiling is composed of concrete and RSJ beams. There are two long brick piers supporting a large flitched riveted bridging RSJ beam (north/south). There is a tall concrete base for one of the cast-iron columns of the ground floor which is situated next to the bottom of the staircase. The staircase is straight (north/south) and consists of twelve steps made of bricks and two parallel brick walls.

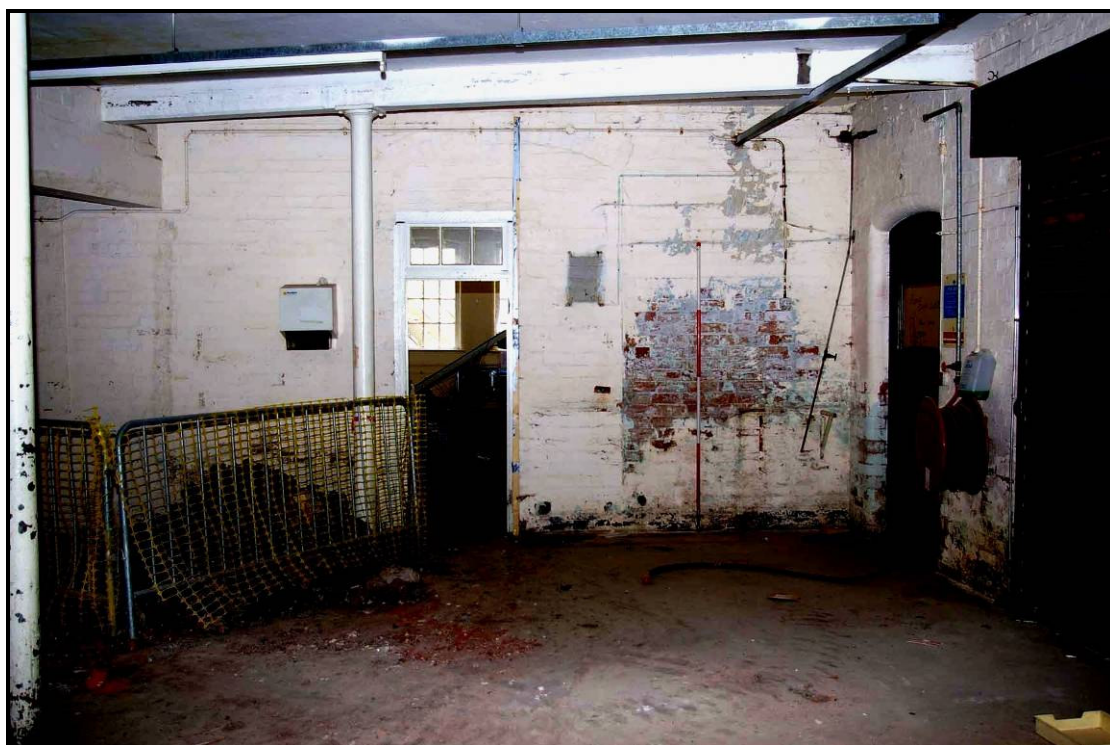
Figure 27: North-west room on the ground floor

The narrower western portion consists of a pair of full width spaces. The north-western room is fairly rectangular and measures c. 11.5 metres long (east/west), 5.5 metres wide (north/south) and 3.38 metres high. The north and west wall retains the original windows but the window on the central bay of the north wall has been converted into a door and only the upper section survives. The east wall has a central doorway set on an earlier doorway which is partially blocked. The former doorway has a segmental arched head made of two brick courses of which the lower is laid to header bond and the upper to rowlock bond. On the south wall there are four blocked-up openings and several areas of brickwork repairs. There are two timber bridging ceiling beams (north/south) with flat chamfered edges and plain chamfer stops set on the walls. The room has painted brickwork, a concrete floor and a lath-and-plaster ceiling. On the south-west corner of the ceiling the remains of a timber staircase can be seen.

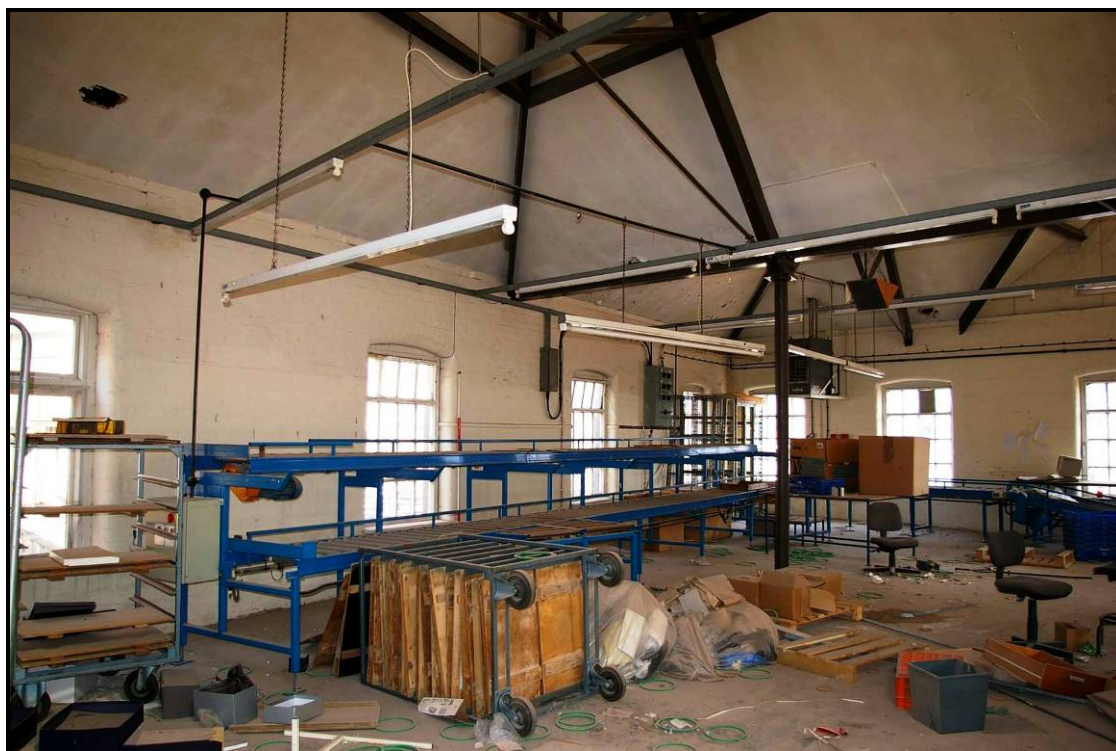
Figure 30: First floor, looking north-east

The first floor is accessed by way of a bridge over the alleyway on the north side and has a similar layout to the ground floor. In the wider eastern section, the space is interrupted only by four cast-iron columns under the valley between the two roof piles. The roof structure comprises six (three on each hipped roof) composite trusses set at c. 3.5 metre intervals (east/west). The principal rafters are made of sawn timber whose ends are housed in cast-iron shoes. From the upper shoe, a vertical wrought-iron suspension bolt drops to an interlocking and bolted junction that connects two further sections of wrought-iron that makes up the tie-beam and two wrought-iron raking struts. The principal rafters carry a single tier of trenched timber side purlins which are reinforced with wooden cleats. The principal rafters have bird's mouth joints at the ridge to carry a ridge piece over the upper cast-iron shoe. The common rafters are notched over the wall plate and the upper ends are set on the ridge piece. Both purlins and principal rafters have flat chamfered edges with plain chamfer stops.

There are original windows on the east walls, although the southernmost window has been converted into a bridge that leads to Building F. The north wall also has original windows but some of them have been replaced by modern types with awning openings. There is a metal conveyor set against the northern and eastern windows, some office desks and filing cabinets, and trolleys with wooden shelves. The floor is made of timber with boards set over joists aligned east/west and reinforced with Herringbone struttings. It has painted brickwork walls and a lath-and-plaster ceiling.

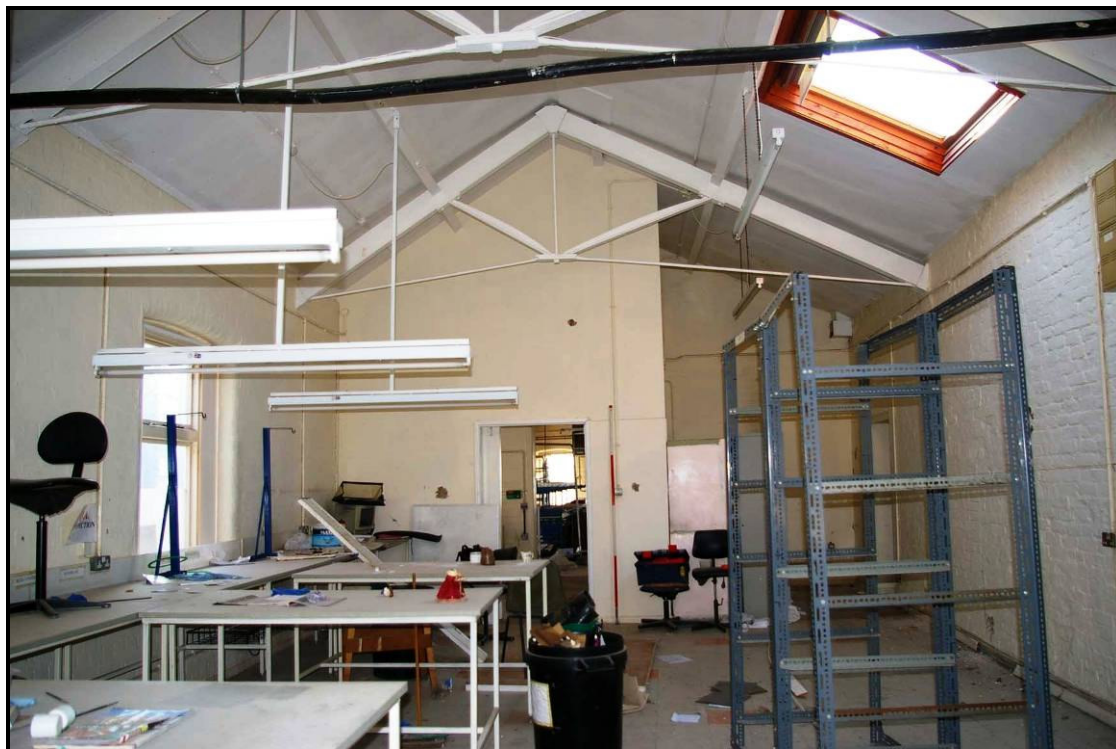
Figure 36: North-west room of the first floor

The narrower western portion consists of a pair of full width spaces. The north-western room is fairly rectangular and measures c. 11.5 metres long (east/west), 5.5 metres wide (north/south) and stands 4.95 metres to the apex of the principal rafters. The side walls measure 3.3 metres high. The roof structure is similar to the one in the main eastern room and consists of two trusses (north/south). There is one small skylight on the southern half-pitch. All the windows are later replacements which have wooden frames and two lights with awning openings. The room is currently accessed from the bridge on the north wall and from an inserted modern doorway on the west wall of the main room. On the south wall there are three window openings and a blocked-up doorway. The window openings have segmental arched heads made of a single course of bricks laid to header bond, and the doorway has a wooden lintel. There is also an inserted doorway on the eastern side of this wall which leads to the smaller south-western room. The floor, walls and ceiling are made of the same fabric as the main eastern room.

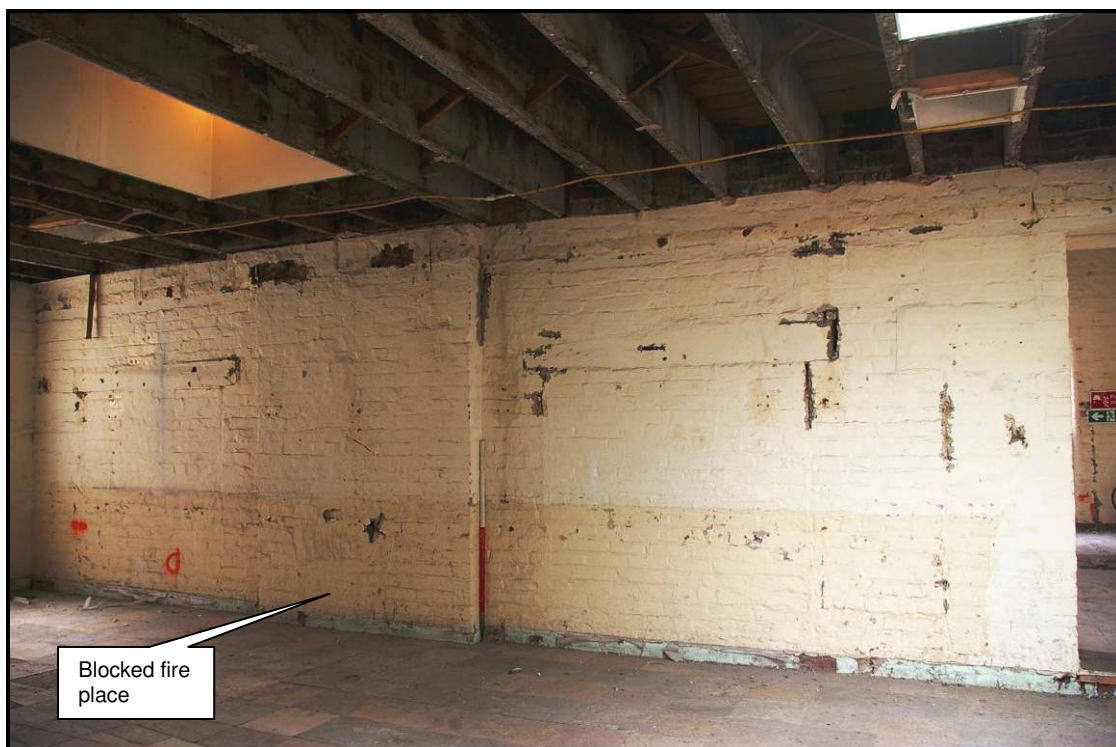
Figure 37: South elevation of partition wall

The south-western room is slightly trapezoidal and is divided into two spaces by a brick partition wall (north/south). Its overall dimensions are c. 4.5 metres long, 1.5 metres wide (west wall), 2.7 metres wide (east wall) and 2.4 metres high. It has painted brickwork, a timber floor and a plasterboard ceiling with two skylights. There are two inserted modern doorways on the east wall and an earlier window opening which is blocked with bricks. This window opening has a segmental arched head made of two brick courses of which the lower is laid to header bond and the upper to rowlock bond. The blocked window openings identified on the adjacent north-western room can be seen on the north wall of this small room. The blocked window openings have wooden lintels. There is also a small blocked-up fireplace in the centre of the wall which suggests that this side was once the interior of an earlier building. The fireplace opening has a segmental arched head made of bricks laid to soldier bond. The north and east walls are built with hand made bricks of variable size (mostly 9" x 4 1/4" x 2 1/2") bonded with flush orangey lime mortar (up to 22mm thick) and laid to

Flemish bond, although fairly irregular. These walls have a timber wall plate with dismantled joists of a former floor structure which confirms that this wall was the interior of an earlier building which would have been at least three storeys high.

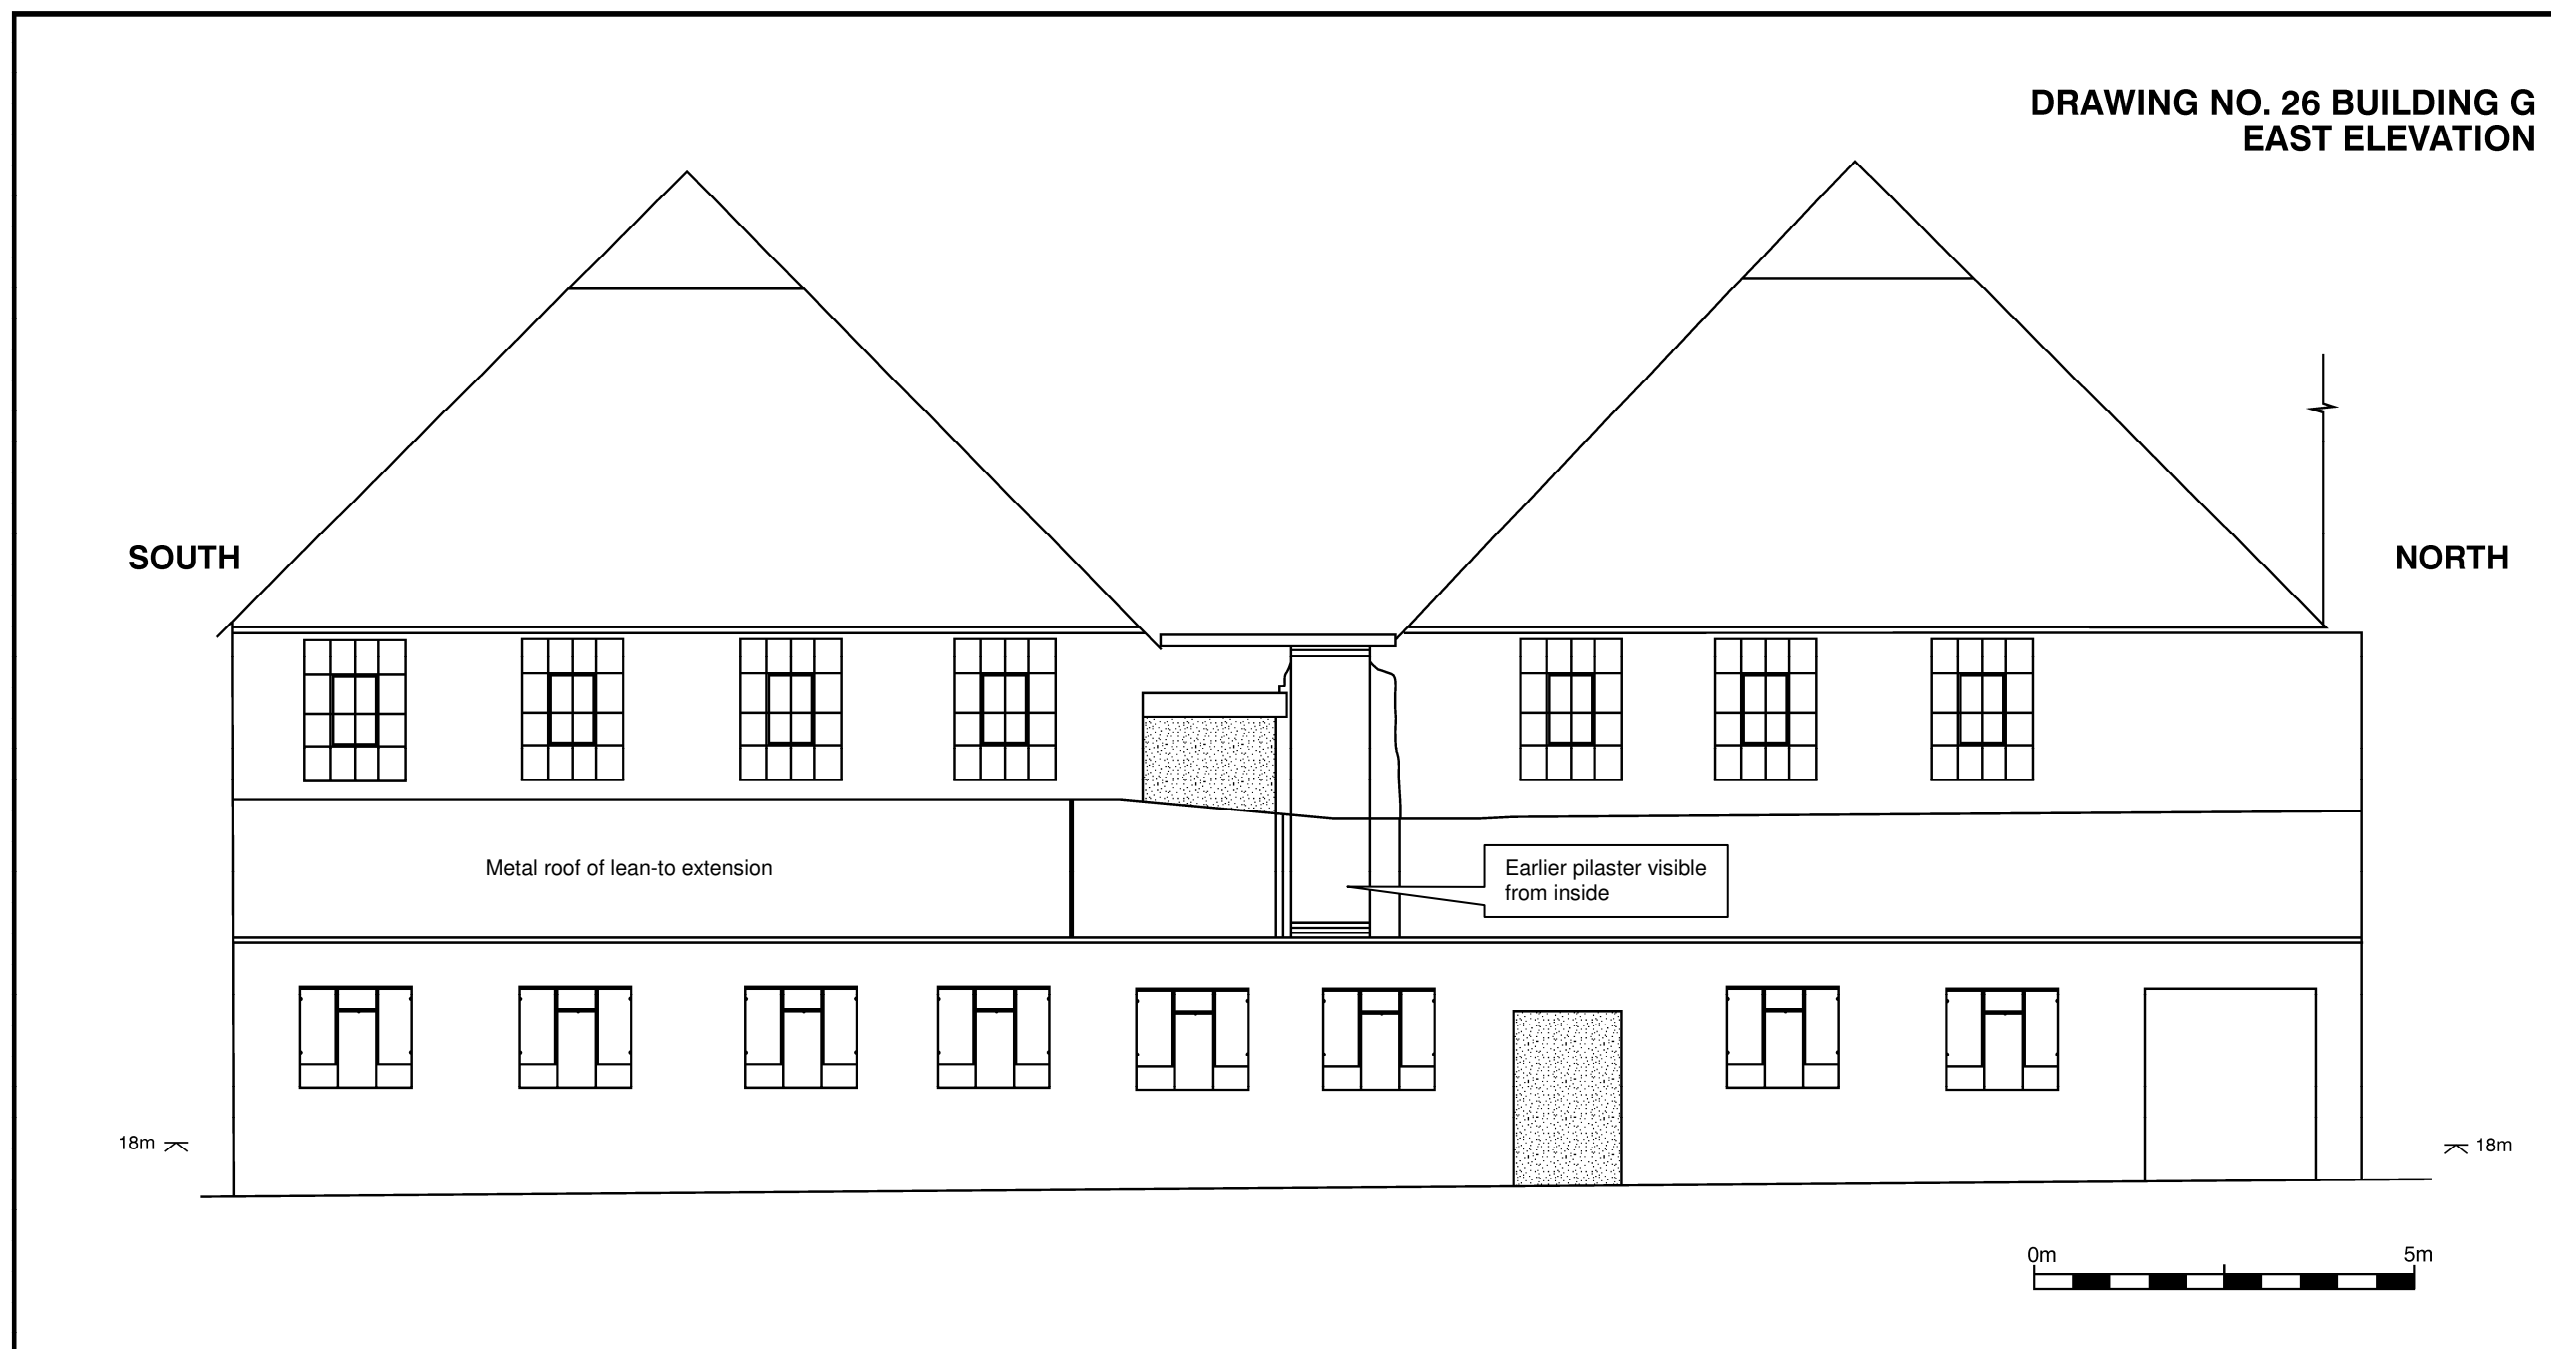
Figure 39: Survey drawing of the east elevation (scale 1:100)

The first floor of this elevation has nine bays divided into a pair of four bays under a double gablet roof and one bay in between them under a flat broad valley (east/west). The bays are demarcated by thin vertical steel stanchions with brick panels. The panels consist of a veneer of reddish brown bricks (9" x 4" x 3") laid to stretcher bond. Each bay has plain flat-headed window openings containing steel-framed windows except for the northernmost bay which is devoid of any window. The central bay has an inserted opening with a concrete lintel which is blocked with bricks. This opening once had a bridge leading to the opposite Building H. Immediately on the north side of this aperture there is the remnants of a pilaster made of mid brown bricks (8½" x 4¼" x 3") laid to English bond and topped with two flat chamfered courses of blue engineering bricks. The roof structure has two square galvanised metal louvre vents on each gablet and the hipped slopes are made of corrugated asbestos sheeting.

The ground floor has a later long and low brick lean-to extension with a series of plain flat-headed window openings containing steel-framed 'Crittall-type' windows and covered by a corrugated sheeted roof. It is of ten bays with windows in all apart from the northernmost which has a large doorway and the fourth (from the north) has a smaller doorway blocked with bricks. The wall is made of light reddish brown burnt bricks (8¾" x 4" x 2¾") laid to stretcher bond.

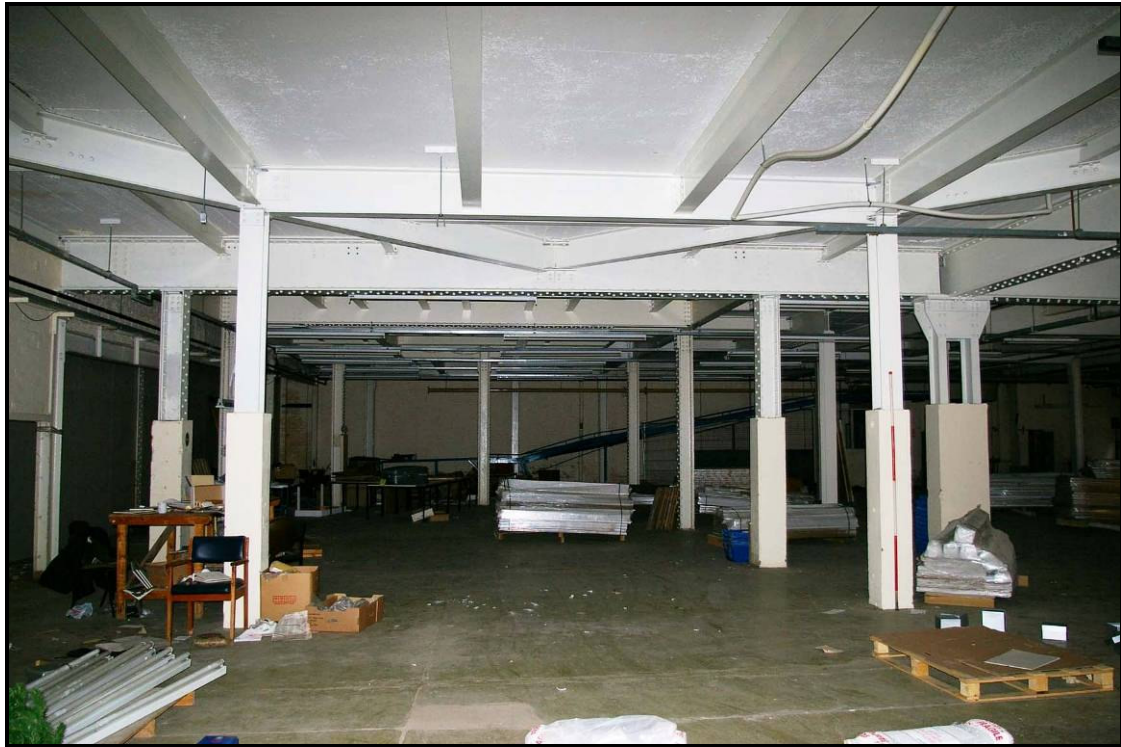
Figure 46: Ground floor, looking north

Internally there are large open spaces on this floor, interrupted only by the steel stanchions of the structural framing. The stanchions of the southern section have concrete casing around them. These are 1.8 metres high and are illustrated on the plan with black dots (Figure 47). There is an east/west conveyor along the northern wall which turns at a right angle to Building E. It has painted brickwork, a concrete floor and a concrete ceiling supported by the steel structure. It measures *c.* 27.5 metres long (north/south), 26 metres wide (east/west) and 3.3 metres high. The workshop is lit by seven steel-framed windows on the south wall which have twelve rectangular lights set vertically (4 columns x 4 rows) with a central pivotal opening, eight 'Crittall-type' windows on the east wall and three skylights on the flat roof of the central valley.

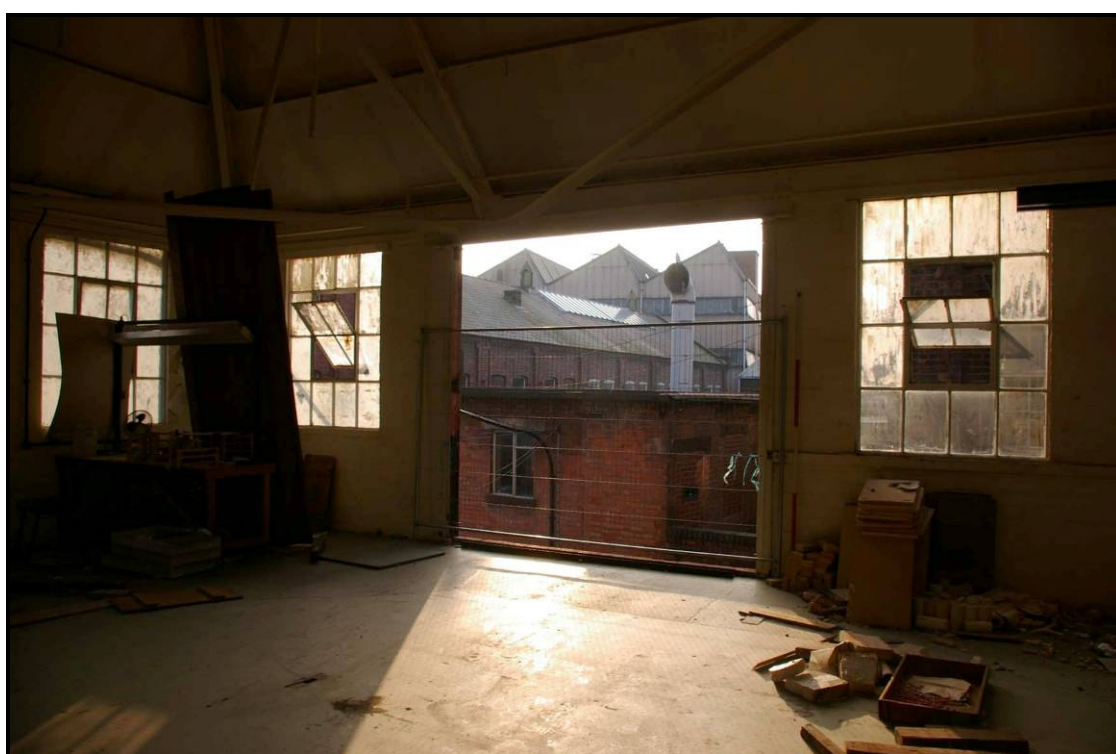
Figure 48: First floor of the southern block, looking towards Building W1

The first floor has a similar plan to the ground floor but without the eastern lean-to extension. It is a large workshop which is currently practically empty apart from some office desks and a long worktop table set against the eastern windows. Its overall dimensions are 27.5 metres long (north/south), 22 metres wide (east/west) and it stands 9 metres to the top of the apex of the roof. The side walls measure 3 metres high. The workshop is lit by six steel-framed windows on the south wall and seven on the east wall. These windows have twelve rectangular lights set vertically (4 columns x 4 rows) with a central pivotal opening. The southern roof structure has twelve skylights aligned east to west (6 on each side) and five tall cylindrical metal cowls on the southern half-pitch. The two roofs are supported on lightweight steel-framed trusses and the northern section has a suspended hipped ceiling.

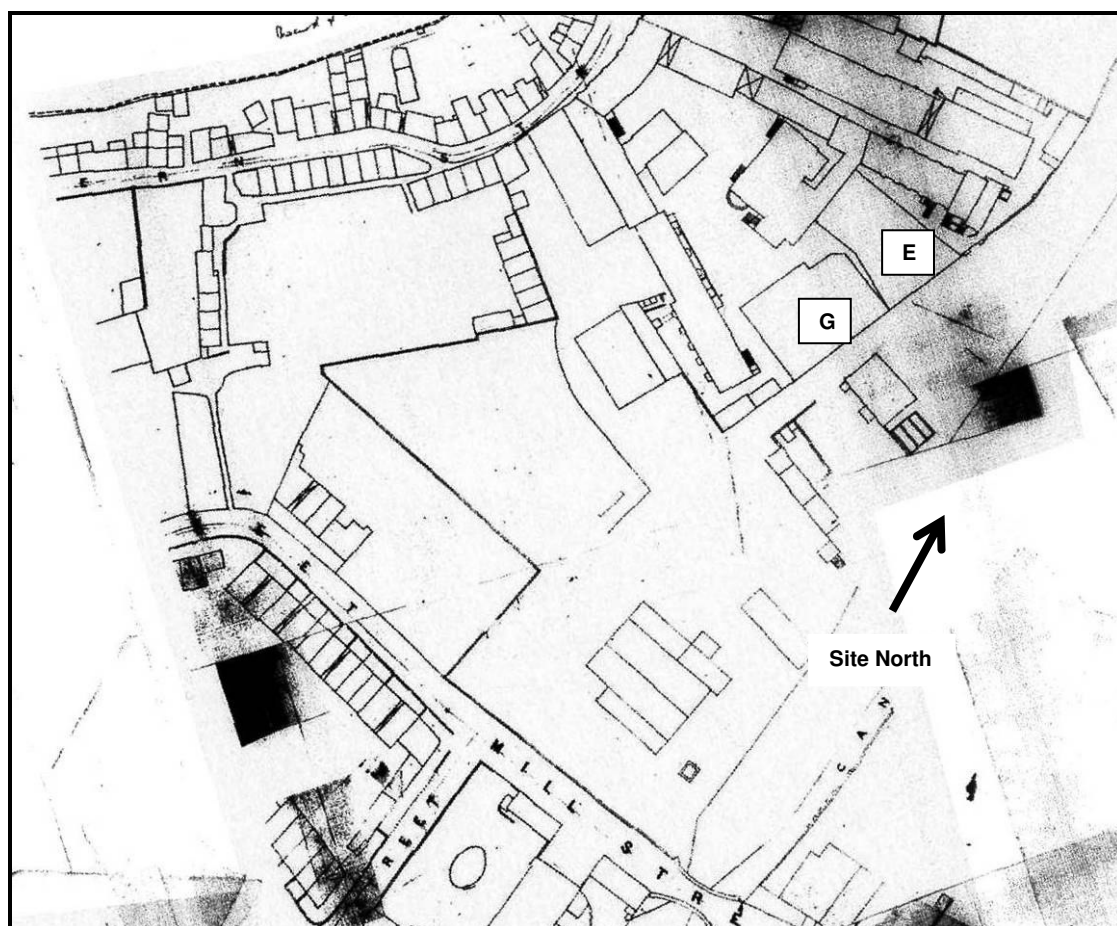
Figure 53: Board of Health plan of the Works in 1867 (WPM)

The land where Building G lies was acquired in 1854 (see Appendix) and its earliest construction consisted of two China and Biscuit Rooms, two Enamelling Kilns, one Parian Room, one Placing Room, one Back Lodge and a little room called Potting Shops which are depicted on the 1863 plan of the Works (Figure 52). The plan also shows Building E with further additions and modification from its previous phase, which is composed of several Glaze Kilns, two Press Rooms, one Placing Room and one Potting Shop. The north and east walls of the latter room (plot number 29) are extant with original window openings blocked-up. The morphology of Building G appears to have changed considerably shortly after as can be seen in the 1867 Board of Health plan of the Works (Figure 53). The building then is almost rectangular and is practically butting the south wall of Building E.

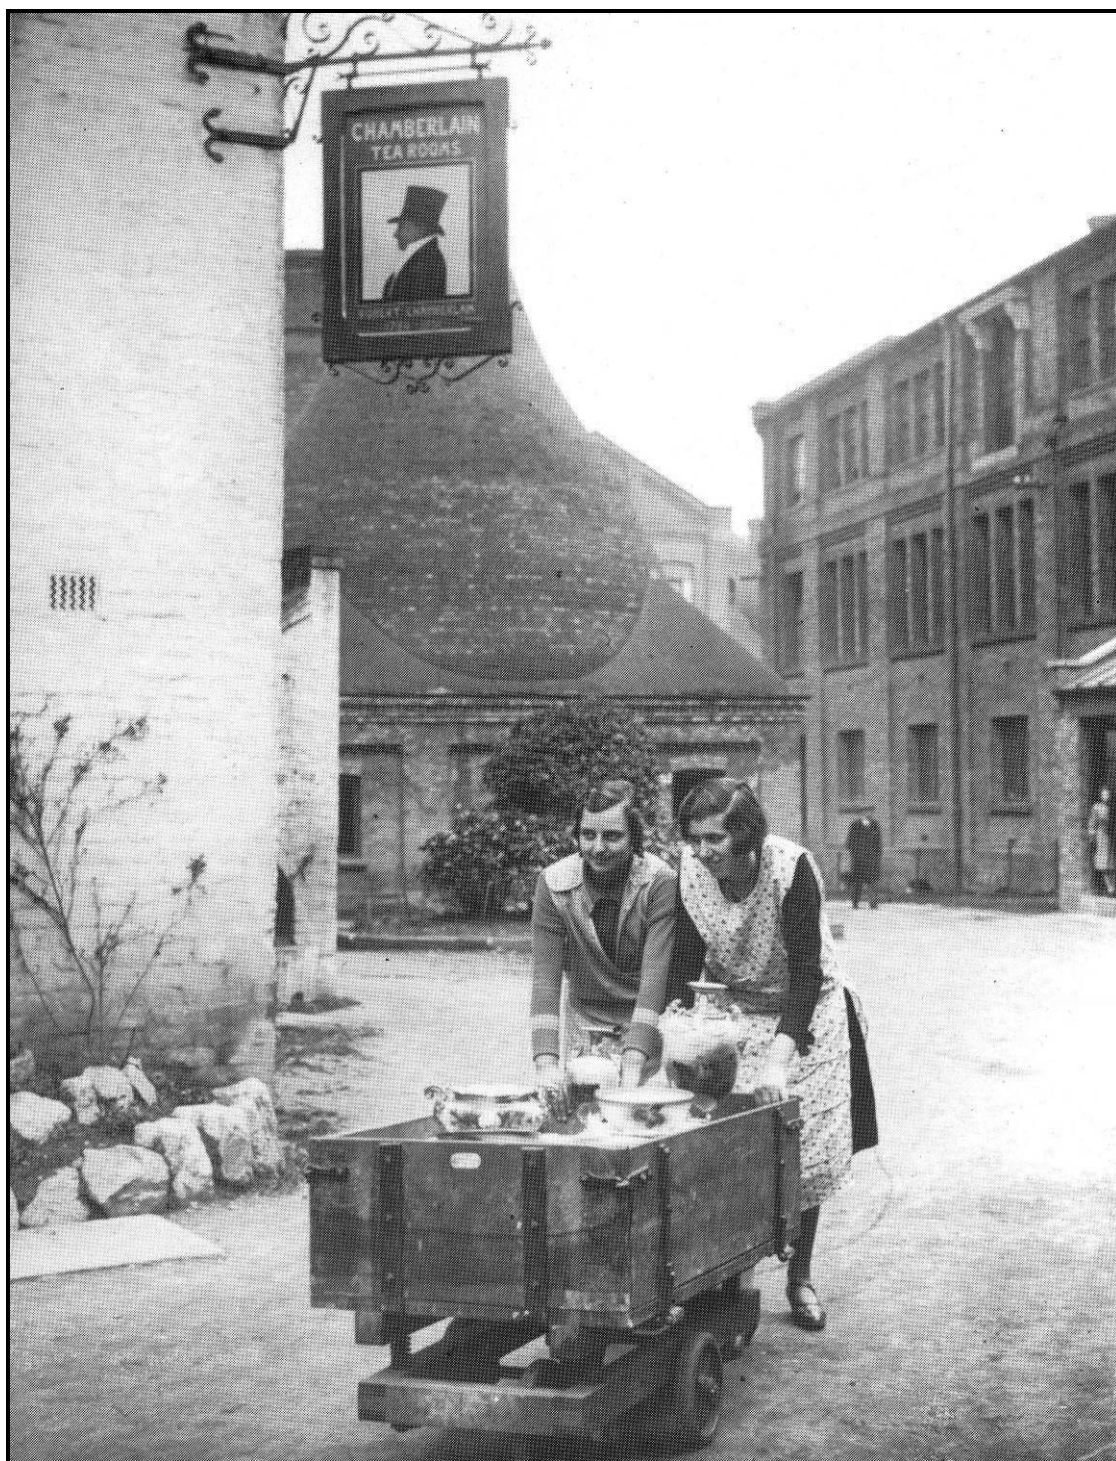
Figure 60: 1930s photograph showing a bottle kiln of Building G (WPM)

The 1928 Ordnance Survey map illustrates some developments on Building G (Figure 58). Indeed, the map shows that the northern block projects into the central lane of the Works. The projection is the result of a new and larger rectangular gas kiln. A 1934 architect's drawing shows the plan of Building G with the gas kiln on the north-west corner and the east elevation with the rectangular kiln structure on the north, a bottle kiln on the south and a gabled two-storey block in the middle (Figure 59). The gabled central building has three bays demarcated by brick pilasters of which one partially survives and is shown on the survey drawing of the east elevation (Figure 39). A photograph taken in the 1930s exhibits the south-west bottle kiln (Figure 60).

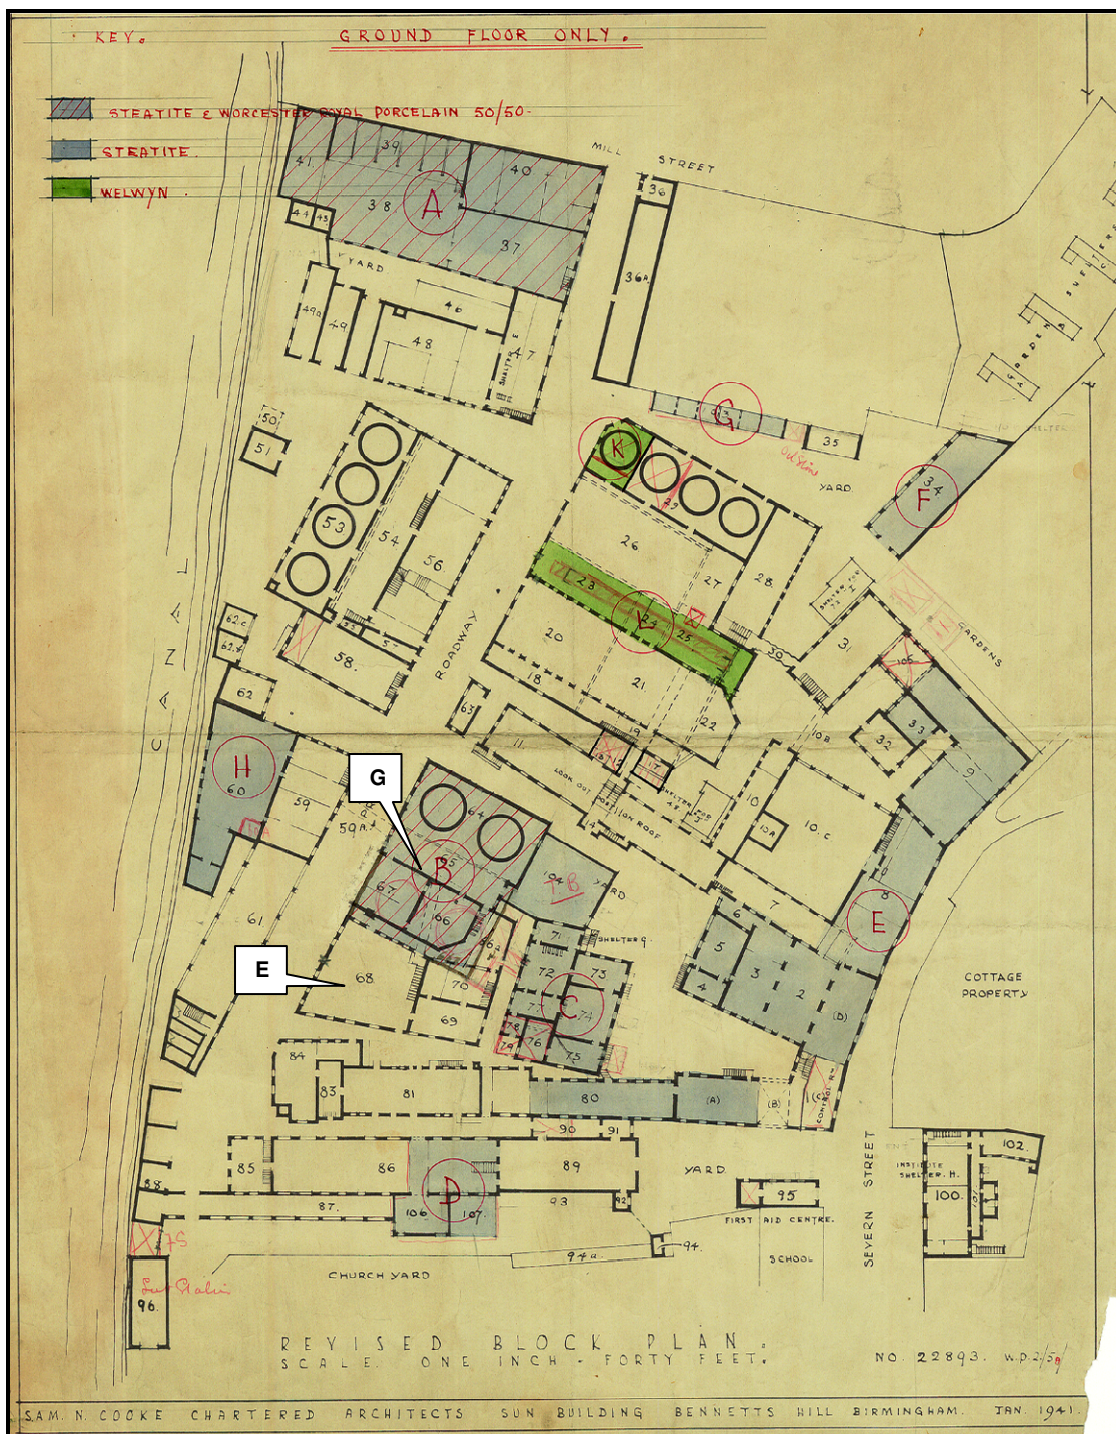
Figure 63: Later amendments drawn on the same plan (WPM)

Further reorganisation of the buildings appear to have occurred in the following years and are drawn over the 1941 architect's plan (Figure 63). The most noticeable change is the rebuilding of two bottle kilns on the northern block of Building G. The development involved building over the south-west room of Building E (plot number 70) and the east wall was flush with the lane without the former projection. A later plan of the Works exhibits the finished development of the new kilns on the northern block which would have been similar to the southern block with a steel frame over the bottle kilns (see Figure 11 of the Appendix).
