Archaeological Building Investigation and Recording, Royal Worcester Porcelain Works, Building J: The Gilding Shop

Revised version number 2 Issued 18/11/2008

Site name: Royal Worcester Porcelain Works

Location: Severn Street, Worcester, Worcestershire

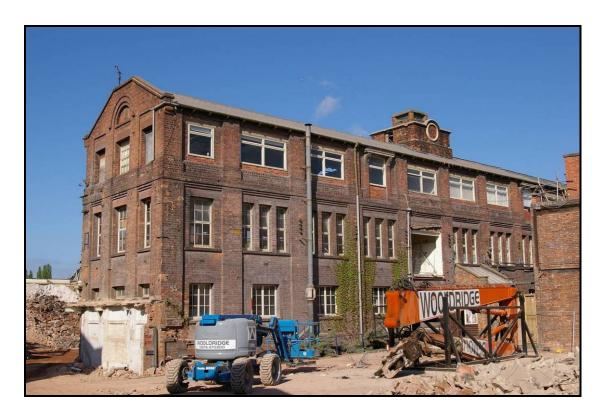
Figure 4: North elevation

The north elevation (Figures 4 and 38) is virtually symmetrical although the easternmost bay is narrower than the others. The bays are articulated by brick pilasters projecting upright from a plinth. The resultant recessed panels have plain brick cornices, and the continuous plinth is topped with a single course of chamfered bricks. Midway along the wall is a later lean-to porch for the main entrance, which leads directly into the hallway containing the main staircase (Figure 7). The porch has a mono pitch glazed roof and the half gables have concrete coping. The walls are built with mid orangey brown bricks (9" x 4½" x 3") bonded with medium coarse pinkish flush mortar up to 20mm thick and laid to Flemish Garden bond. The porch has a doorway with a flush concrete lintel and threshold in which a double timber door is set. The doors have three upper rectangular glazing panes. The porch has a small halfpitched (east/west) lean-to structure leading to the basement staircase made of the same fabric; and on the east, there is a shed attached to it which is made of timber boards topped with corrugated metal sheeting.

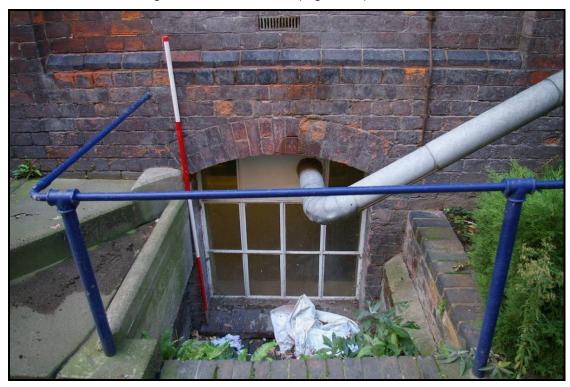
Figure 5: Basement window and light well

On this elevation the basement windows are lit by square light wells and they are made of cast iron topped with segmental brick heads (Figure 5). The easternmost window has been removed and the arched head has been re-inserted slightly further east and instead of having a window, there is an iron double door vent.

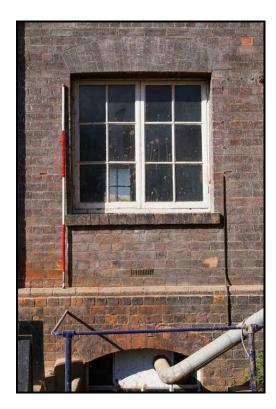
Figure 6: Ground floor window

The ground floor has encasement wooden windows with rubbed brick flat-arched heads and projecting brick sills (Figures 6, 21 and 22). The narrower eastern bay shows traces of an earlier external doorway, which consists of a flush green sandstone threshold set in the wall at the level of the plinth. The area between the threshold and the sill of the window above is blocked up with later bricks. An 1884

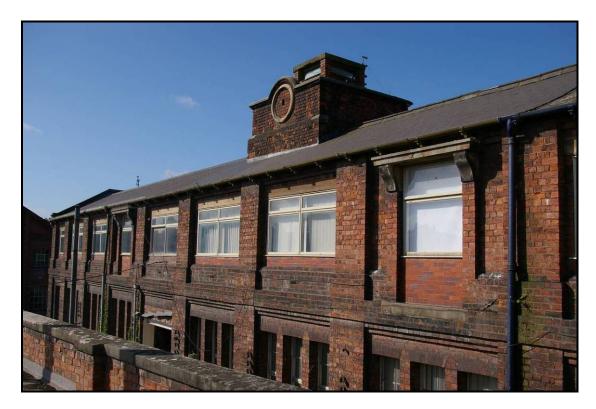
Figure 8: North elevation showing modern windows

At second floor level the windows have been replaced and are all modern. These have wooden frames and awning openings of which the upper ones are much shorter than the lower main ones. The windows have concrete lintels and, because they are smaller than the original windows, they have later brickwork supporting their sills. An earlier photograph reveals that some of the original windows were similar to the ones on the first floor (tripartite with mullions) but shorter (Figure 10). There were also two loading doorways of which the projecting canopies and flush thresholds still survive. The canopies are made of light yellowish limestone with cavetto moulding and supported by *cyma reversa* console brackets, and the thresholds are made of light greenish sandstone blocks (Figure 8).

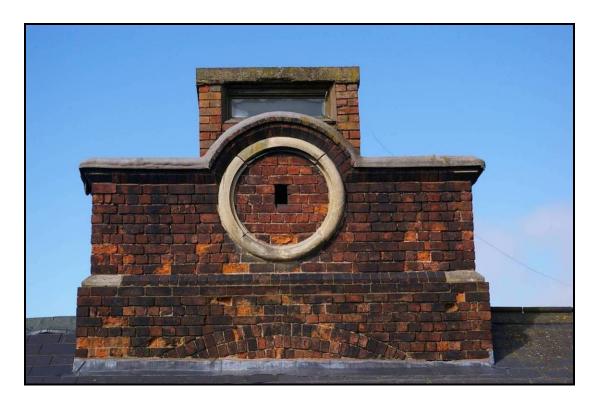
Figure 9: Clock tower

The roof is made of natural slate, but the flat top on the eastern section has a felt membrane. The roof has plain close eaves with cast iron guttering and the eastern verge has a parapet. At the junction of the two halves of the building is a projecting block of brickwork rising from the roof ridge which is the base of an earlier chimney which tops the platform part of this canted roof over the eastern section. The chimney base is made of bricks laid to English bond and has chamfered plinth and cornice reenforced with white limestone quoins. Lead flashing covers its flat roof. On this elevation there are the remnants of a former clock consisting of a circular limestone moulded edge (Figure 9). A later brick structure with small wooden windows was build on top of this chimney base. The historic research (see Appendix) identified it as being a look-out tower during the Second World War.

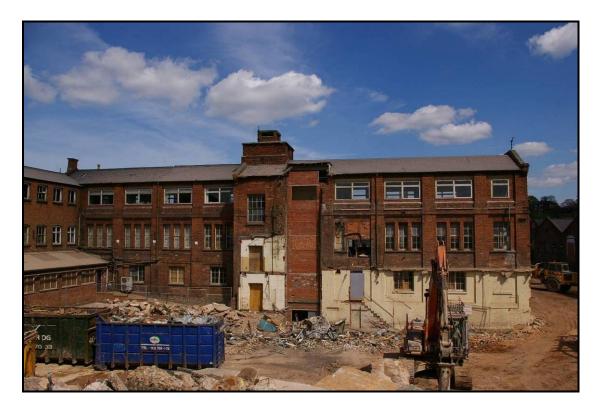
Figure 11: South elevation

The south elevation is similar to the north wall, except for large sash windows in the main stair hallway (Figures 11 and 39). However only the second floor's window survives intact, whereas the ground and first floors' former windows have later inserted doorways. These windows have flat-arched heads made of rubbed bricks the same as the ones on the ground floor. Also visible at the lower levels of the wall are more surviving and some blocked window openings. The lower level (basement and ground floor) is abutted by a later structure (Building L). The entire fifth bay (from east to west) was completely modified when a later lift was built against it (Figure 3). The lift was made of a steel structure with corrugated asbestos sheeting which was demolished as part of the re-development work.

(Figure 3). This entire bay was thus modified for such a purpose which can be seen after the removal of the lift took place as part of the demolition programme (Figure 11). An architect's plan of the basement dating to 1953 shows the insertion of the lift (Figure 51). This plan also exhibits additional alterations which consist of a small north/south staircase on the first bay (from the east) on the south wall that would have connected the basement to the adjacent building's ground floor and a much larger east/west staircase on the west wall. The former no longer exists and it has been blocked up, and the latter was not examined as it is beyond the study area.

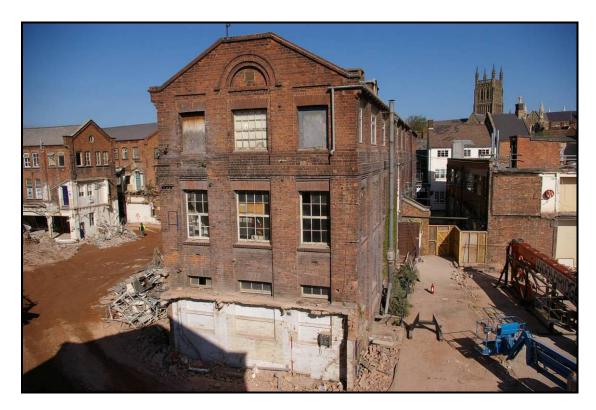
Figure 12: East elevation

The east elevation is of three bays and the panels between the pilasters are topped with the same plain brick cornices as on the side walls (Figures 12 and 40). The central bay is wider than the side ones. There are two blocked up windows on the basement level with flush concrete lintels, which are probably later insertion when the windows were blocked. The windows on the ground floor have flat arched-heads and projecting sills. These windows have been partially blocked up and only the upper sections survive, which have awning outwards openings. The windows on the first floor have flat rubbed-brick heads and projecting brick sills. The window on the southern bay has been modified with the insertion of a small encasement window in the lower section of the original window. This alteration was carried out to provide fire escape access. On the second floor the windows are similar to those on the first floor with flat rubbed-brick heads, but they are shorter and instead of having projecting sills, they have flush chamfered plinths. On the southern bay, the window has been removed and the opening is boarded up. This window was modified for fire escape

access in 1953 as it is shown on an architect drawing of the building (see figure 18 of the Appendix). The window on the northern bay has also been taken out and replaced by a later fire exit door accessed via a metal spiral staircase. The staircase was dismantled during the demolition work concurrent with the re-development of the site and is partially illustrated on the elevation (Figure 40). Above the central window, there is a square cast iron vent within a blank lunette with brick, topped by a semicircular drip mould. The gable has a flattened top with a coping made of two projecting courses of bricks, laid to header bond. There are two ovolo moulding kneeler red sandstones forming a termination at the eaves of the coping.

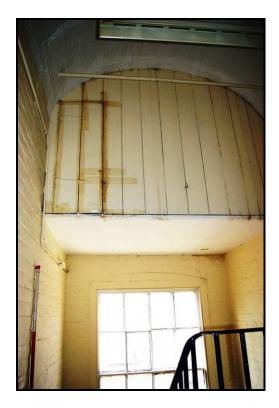
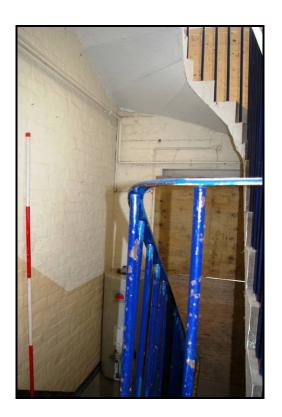
Figure 14: Cantilever staircase

The main entrance leads to a cantilever dog-leg staircase with winders (Figure 14). The steps are made of solid stone blocks and are in good condition. The wrought iron balustrade is simple but elegant with a moulded handrail and stick balusters. The ceiling of the stair hallway consists of a brick barrel vault, whose maximum height is 3.95 metres from a large stone landing (Figure 13). The central staircase leads to large workshops. The western ones are to be retained by Royal Worcester Porcelain Works, and thus are not described; and the eastern workshops are included below.

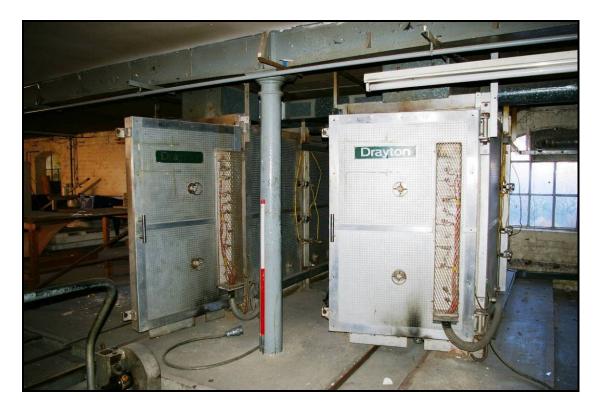
Figure 15: Basement floor

This floor is accessed from an external straight staircase situated immediately on the right-hand side of the main entrance (Figure 34). It is an open room with two kilns situated on the north-eastern side on a raised concrete platform, and a long worktop along the south wall. Internally it measures c. 18 metres long (east/west), 7.5 metres wide (north/south) and 2.5 metres high. There are central columns supporting cast iron I beams aligned east/west (Figures 14-17). Two of these columns are original and are made of cast iron with decorated Tuscan capitals. The other two are RSJ replacements. The room has painted brickwork, a concrete floor, and a lath-and-plaster ceiling. The north wall retains most of its original cast iron windows.

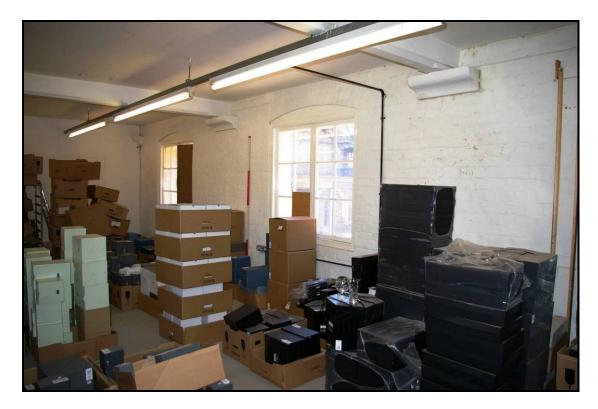
Figure 19: Ground floor, looking east

This floor is accessed from the main central stair hallway from the west, and from a later straight staircase on the south elevation that leads to an inserted doorway (Figure 35). This floor is an open large workshop, labelled 'Senior Painters' with a separate storage section at the east end whose partition is made of light-weight wooden boards. The floor measures c. 18 metres long (east/west), 7.5 metres wide (north/south) and 2.75 metres high. The internal five bays are divided by four (north/south) large scantling sawn timber beams, resting on $cyma\ reversa\ moulded\ limestone\ corbels\ on\ either\ side\ and\ supported\ by\ central\ timber\ posts. The beams and posts are flat chamfered with flat stops (Figure 19 – 22). The room has painted brickwork, a lath-and-plaster ceiling and the floor is covered with cement-based screed. A lift shaft opening on the south elevation is concealed with brickwork. Most of the original windows still survive, although the ones on the east elevation have been shorten and only two are present on the south wall.$

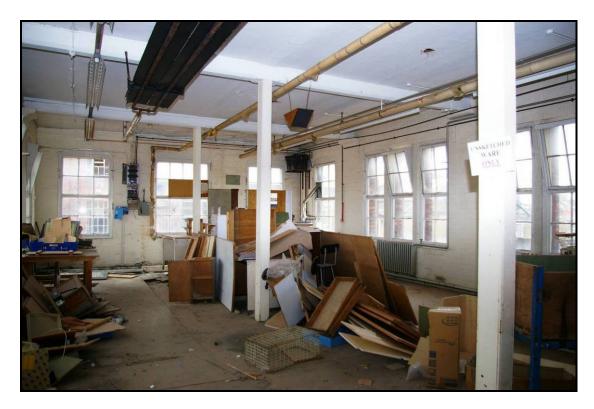
Figure 23: First floor, looking south-east

The same plan of one large open room is repeated on the first floor, except for its height which measures 3.65 metres (Figure 36). This floor has a similar ceiling structure but the central posts are thinner and taller, and instead of having flat chamfer stops, they have thin bead moulded corners (Figures 23, 24 and 26). Most of the original windows still survive although there are some later insertion such as a conveyor, linking material to the adjacent building, and a blocked up lift on the south wall. Another window has been removed and converted into a large bridge on the north elevation. The tripartite windows (described on the external elevations) have relieving arches at 3.20 metres from the floor level (Figure 25). The easternmost bay has plastic ceiling, the westernmost has hardboard, and the rest of the ceiling consists of lath-and-plaster. The workshop is practically empty with debris scattered and some large tables piled up. The wall has painted brickwork and the floor consists of cement-based screed possibly over wooden boards as early depictions and photographs reveal (Figures 28 and 29).

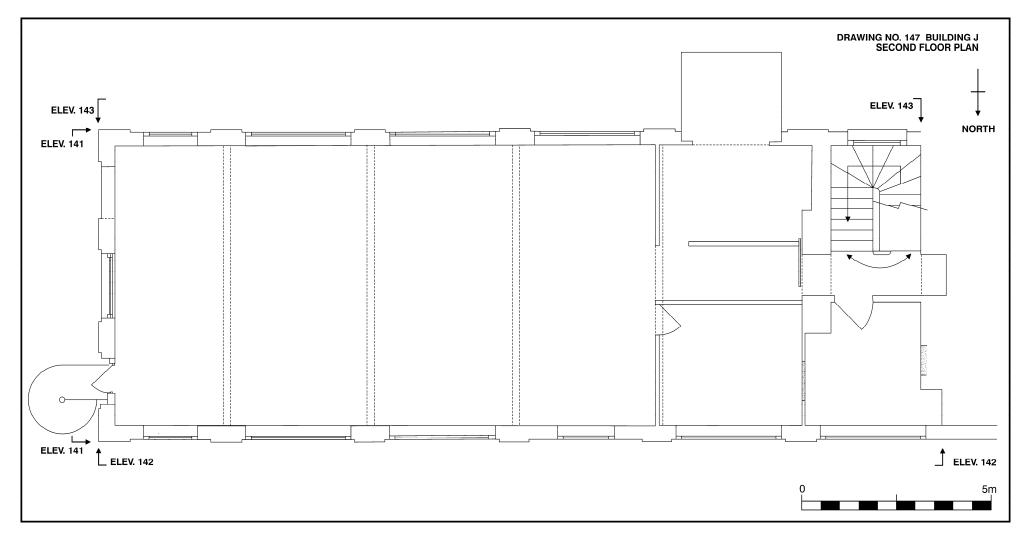
Figure 37: Second floor plan (scale 1:100)

This level was also originally an open large room, but it has small sub-divisions on the western end (Figure 37). These consist of two small rooms with a corridor between them, which are made of light-weight boards. The southern room has an opening for the inserted lift shaft on the south wall, and the northern room has a blocked up window on the west wall, which was joined to a small office on the central stair hallway. The majority of the workshop is empty, but the replaced modern windows and the decoration suggest that this floor was used lately as a large office (Figures 30 -32). The eastern side of the workshop has a suspended false ceiling and plasterboards over the east brick wall. The east wall has a fire escape door on the northern bay that leads to an external spiral staircase and on the southern bay, there is also a former fire escape door boarded up. The remaining wall has painted brickwork. The floor consists of tongue-and-groove boards covered with screed. The roof over the whole floor comprises five bays (all regular except the easternmost one which is narrower) demarcated by four composite kerb principal trusses which carry two tiers of purlins. The trusses consist of timber tie beams, truncated principal rafters topped by long collars, with raking struts rising to the kerb principals from either end of an additional straining sill on top of the tie beams. The whole arrangement is stiffened by wrought iron bolted suspension bars acting as gueen struts (Figure 33). The top timbers are 4.3 metres high and the main tie beams are 2.6 metres high. In the western section of the building (retained by Royal Worcester Porcelain Works), the trusses are timber king posts with wrought iron braces.

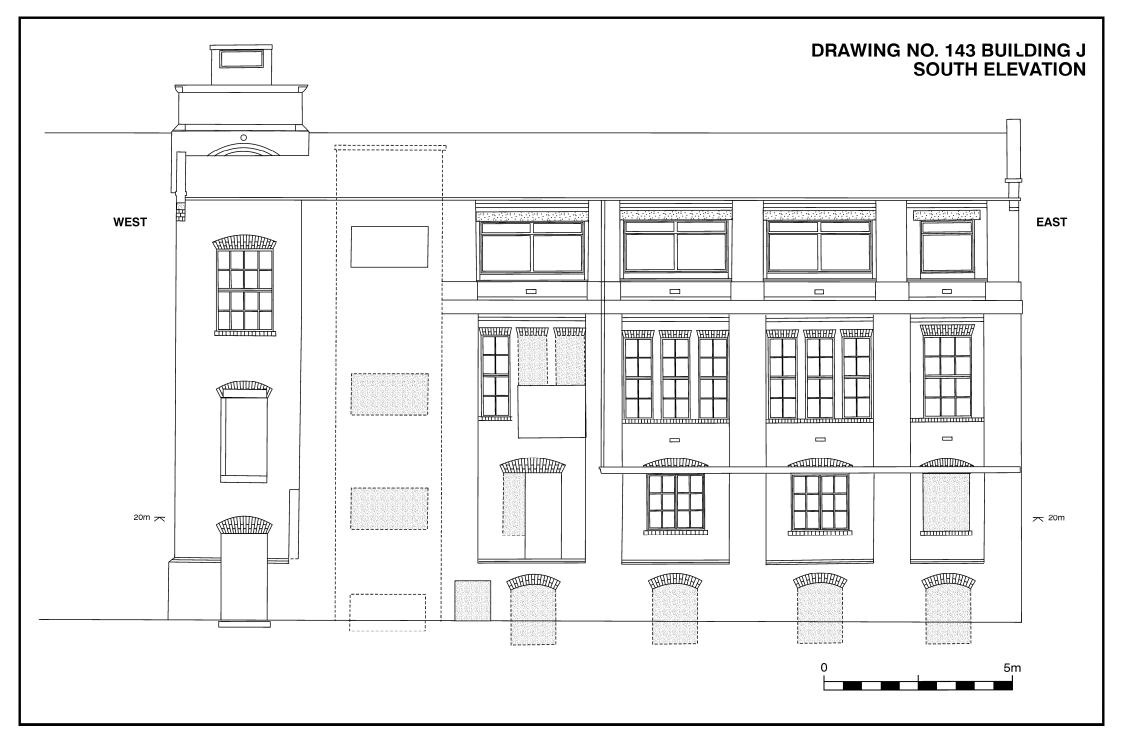
Figure 39: South elevation (scale 1:100)

In 1951 a new tunnel kiln structure was built against the eastern side of the south elevation of Building J. As a result, some of the windows on the basement and ground floors were removed and blocked up and the window on the fourth bay (from the east) of the ground floor was turned into a doorway which was accessed from a raised external staircase. Figure 50 shows the architect's proposal drawing with annotated instructions, including the removal of windows and insertion of walls, etc. Some of these later alterations can be seen today on the south elevation (Figure 39).

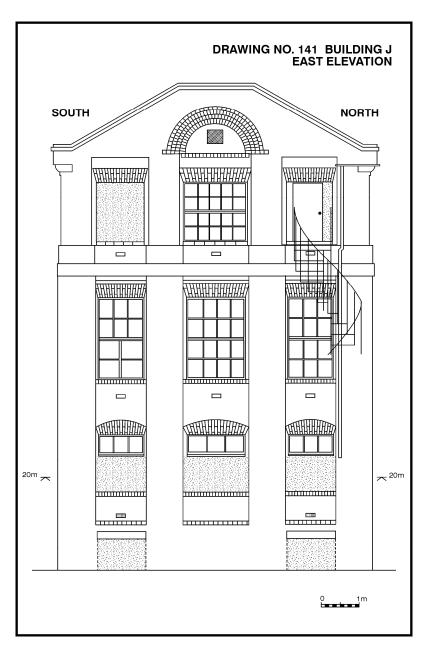
Figure 40: East elevation (scale 1:100)

A small two storey block was built in 1953 against the east elevation (see Appendix). Although that later building was not connected to Building J, part of its roof was used as a large landing for a fire escape staircase, which led to the second floor window on the south bay of the east elevation (see Figure 18 of the Appendix). This staircase was later on replaced by a galvanised metal spiral type, which enabled fire escape access from the second floor through an inserted door on the north bay of the east elevation. The spiral staircase was extant during the building recording but it has been dismantled as part of the demolition programme. The construction of this later building caused further alterations of the original windows, which were mostly blocked up at the lower level (see east elevation Figure 40).

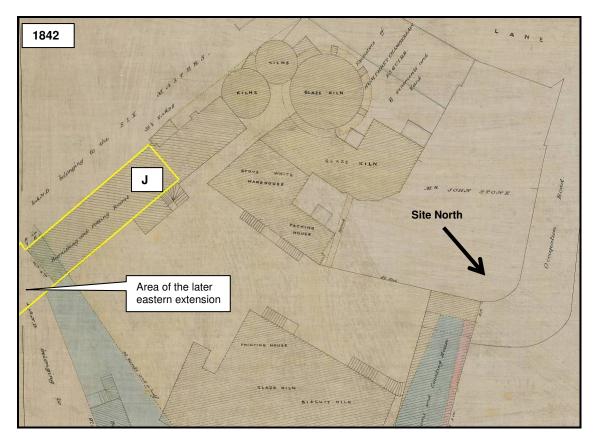
Figure 41: Plan of the Works in 1842, showing Building J before the eastern extension was built (WPM)

The earliest construction equated to the present building is the 'Burnishing and Potting Rooms' shown on a plan of the Works in 1842 and outlined in yellow in Figure 41. This building corresponds to the western side of the present Building J, but it is likely that the former structure was significantly modified as the present outer shell of the building does not show any indication of construction breaks between the original western side and the later eastern extension. Moreover, the 1842 plan shows the width of the building being 15ft and 6" which is 4.72 metres, but the present western side is 6.5 metres wide. Although the plan has slight inaccuracies in relation to later plans of the Works, the dimensions stated above are actually written on the drawing, which suggests plausible measurements. Therefore, the early building might have been rebuilt considerably and its foundation (or part of it) was utilised to support the present structure. It is not known how many storeys this building had, but the external quarter-turn staircase shown on the north-west corner of the building suggests that it might have been at least two storeys high. Indeed, external access to the upper floors of the factory's buildings was very common in the early days. A good example of this is exhibited in a contemporary illustration of the former 1840s 'Printing House and Glaze and Biscuit Kilns' (later Chamberlain Tea Rooms) situated opposite to Building J (Figure 42).

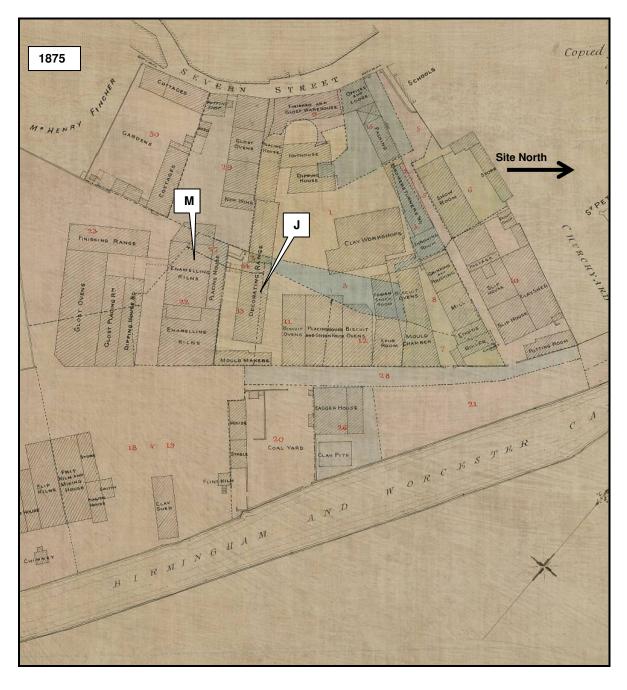
Figure 45: Plan of the Works in 1875 showing Building J (WPM)

In 1875, the name of the building changed to the 'Decorating Range' as seen in a plan of the Works (Figure 45). The building was used as gilding, painting and decorating studios. The only development identified from the 1875 plan is the addition of a bridge in the middle of the south elevation connecting the 'Placing House and Enamelling Kilns' (Building M). This bridge appears to have been built against the first floor window of the staircase bay and thus the window itself was converted into a doorway which is still visible on the south elevation.

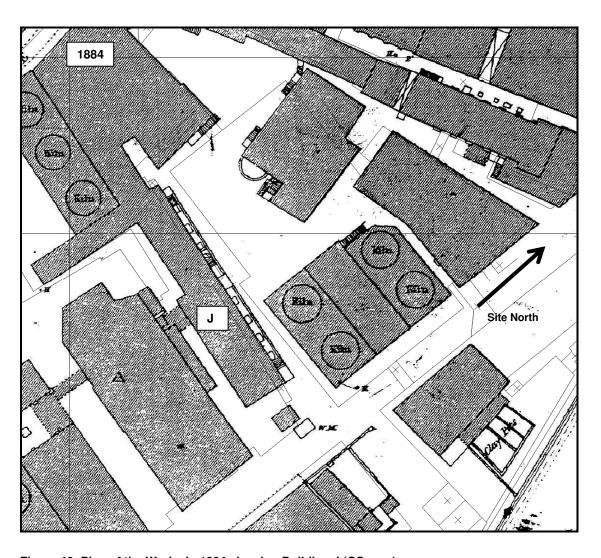
Figure 46: Plan of the Works in 1884 showing Building J (OS map)

Ordnance Survey plan shows an external staircase situated exactly where the door's remains are, confirming its former existence (Figure 46).

An Ordnance Survey map of 1884 shows the Works in more detail. The extract selected below (Figure 46) shows also the bridge mentioned in the above section. On the north elevation of the building, there are light wells for the basement windows, which currently exist. There is also an external staircase next to the main entrance that leads to the basement floor, which is currently enclosed with a later porch lean-to structure. The plan also illustrates a further external staircase near the north-east corner. This staircase no longer survives but there are visible traces of it described in the building analysis and shown on the north elevation (Figure 38). These series of features might have existed before the production of the Ordnance Survey map, but the previous plans did not show them. However, this 1884 plan certainly exhibits details that are attributed to the current fabric. Moreover, the Appendix includes a photograph of the Works taken before 1884 which shows Building J with the eastern flat roof and gable and the western pitched top as it is currently (except for a central chimney which was removed later). The roof structure as its present state is also shown on a drawing by James Callowhill around 1881 (Figure 47).

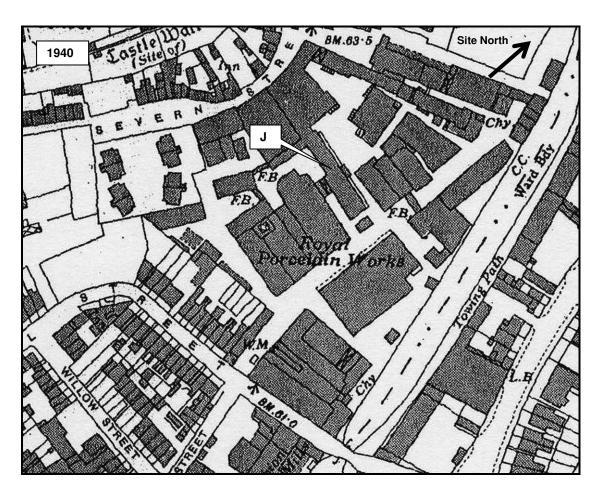
Figure 48: Plan of the Works in 1940 showing Building J (OS map)

The 1940 Ordnance Survey map shows the additional porch (Figure 48). Before or during the Second World War a central chimney stack, shown on early illustrations (Figures 43 and 47) and photographs included in the Appendix, was removed and its base converted into a look-out tower. This look-out is shown on the 1941 plan of the Works (Figure 49) and is still extant. The access to the look-out tower was through a small doorway which is situated on its eastern wall. This doorway would have been accessed from the second floor, but the opening on the ceiling is blocked up.
