Land at New Place Farm, Pulborough, West Sussex - Archaeological Evaluation Report Barratt Redrow Southern Counties

Report to:	Barratt Redrow Southern Counties
Report Title:	Land at New Place Farm, Pulborough, West Sussex RH20 1AT - Archaeological Evaluation Report
Version:	V1.1
Issue Date:	December, 2025
Report Ref:	23077
Prepared by:	Cura Terrae: Unit 4, Prisma Park, Berrington Way, Wade Road, Basingstoke, RG24 8GT. 01256 224 588
Originated By:	<i>Lucie Collett</i>
	Lucie Collett
	Senior Archaeology Supervisor
Reviewed By:	<i>Finlay Wood</i>
	Finlay Wood
	Archaeology Project Officer
Approved By:	<i>Oliver Good</i>
	Oliver Good
	Practice Area Lead – Historic Environment

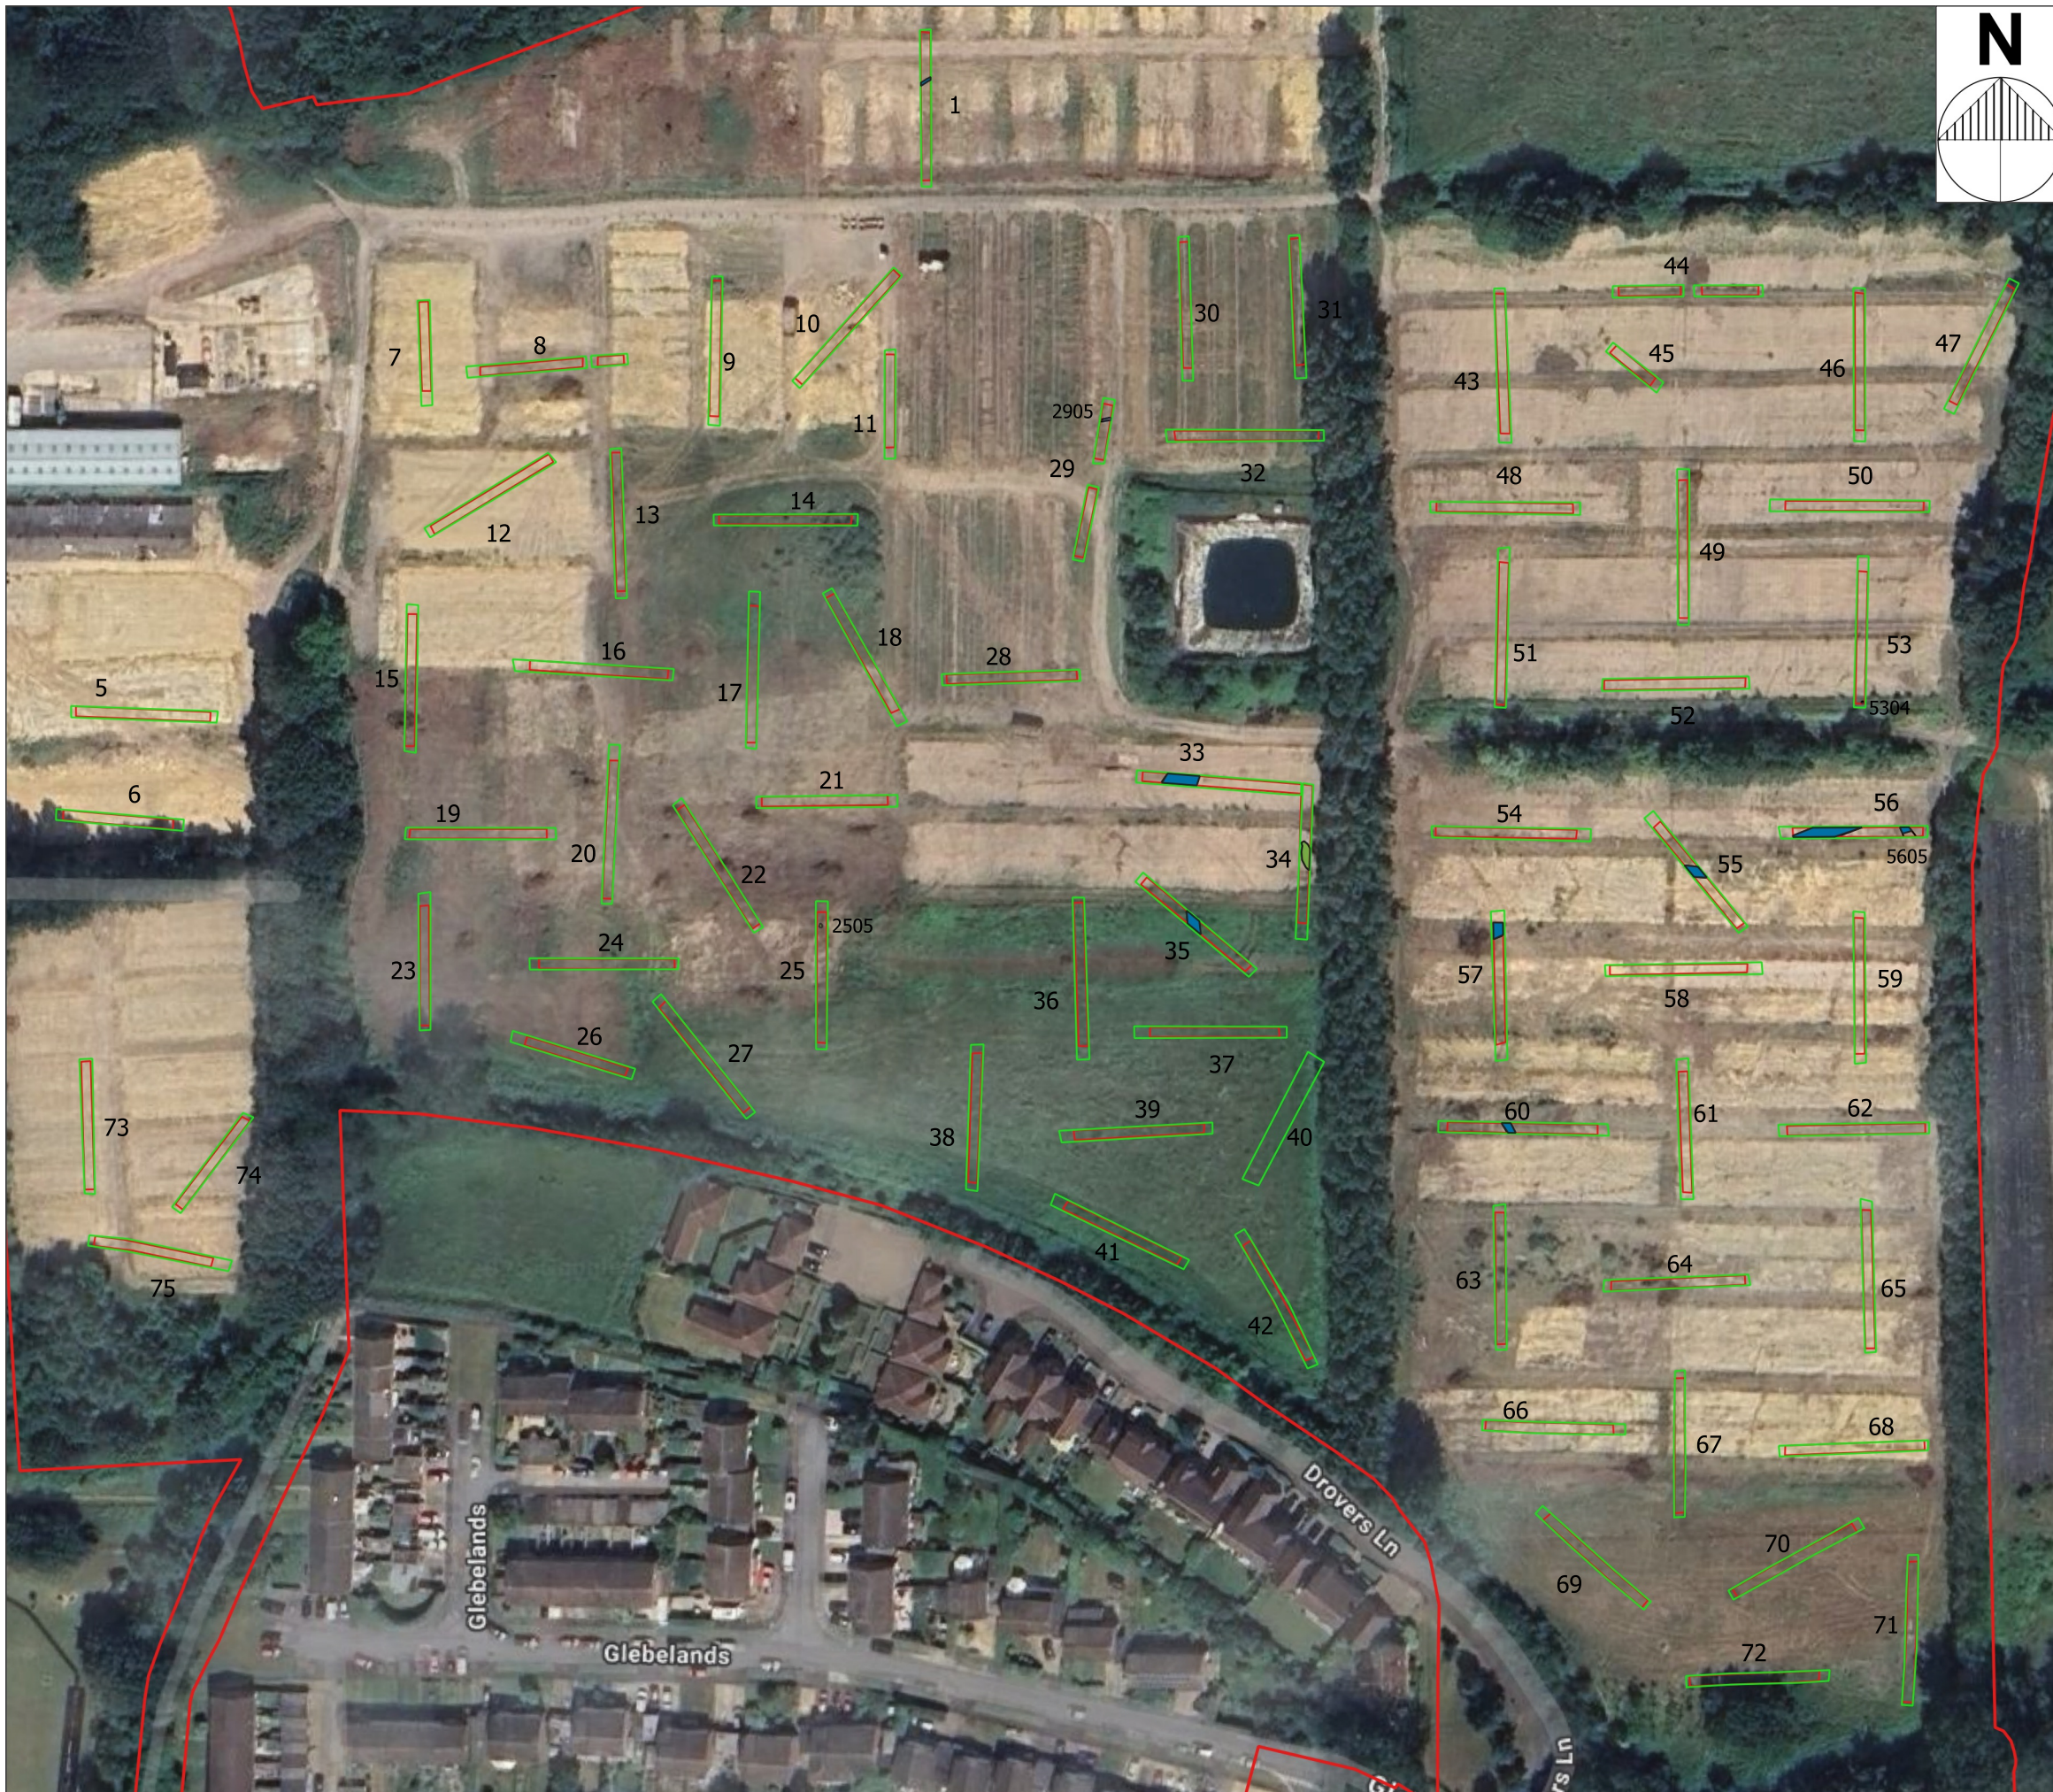
Figure 2
Trench results overlaid on satellite image

- Site Boundary
- Trench Top
- Trench Bottom
- Archaeological Feature
- Rooting
- Modern Feature

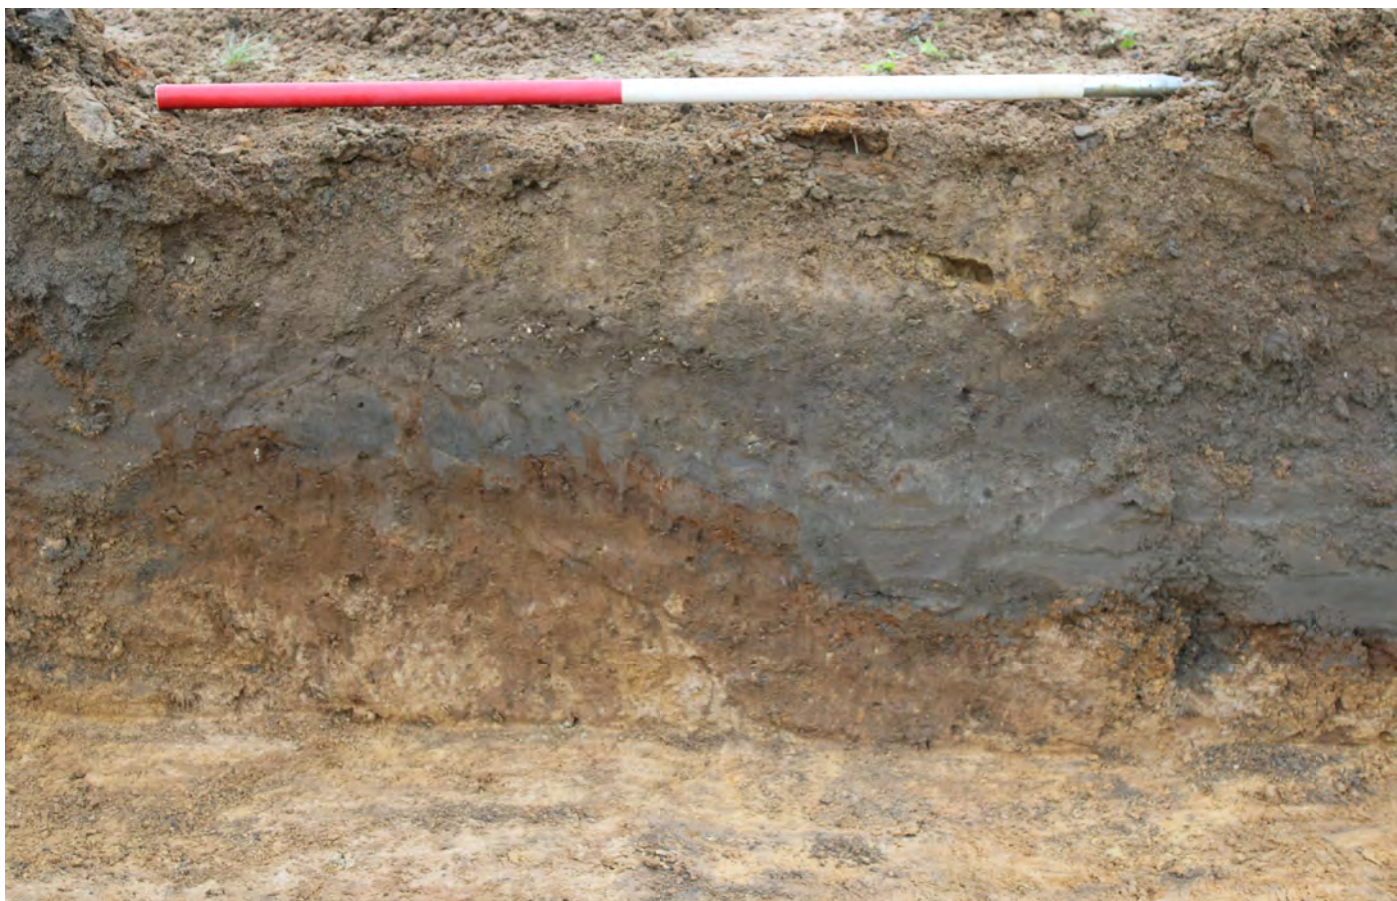
Plate 7

Trench 5, representative section looking north.

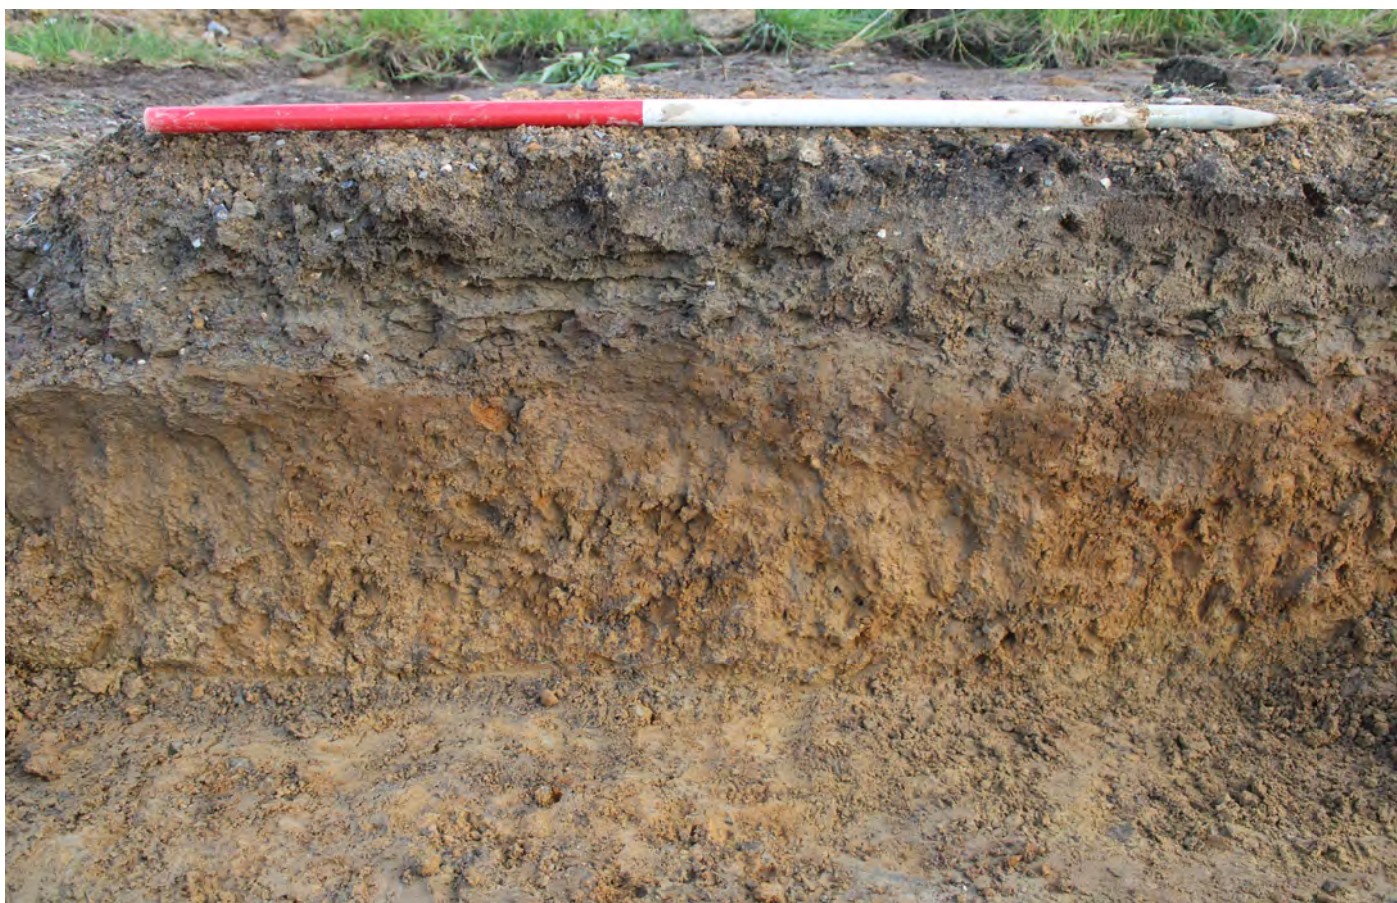
Plate 8

Trench 13, representative section looking southwest.

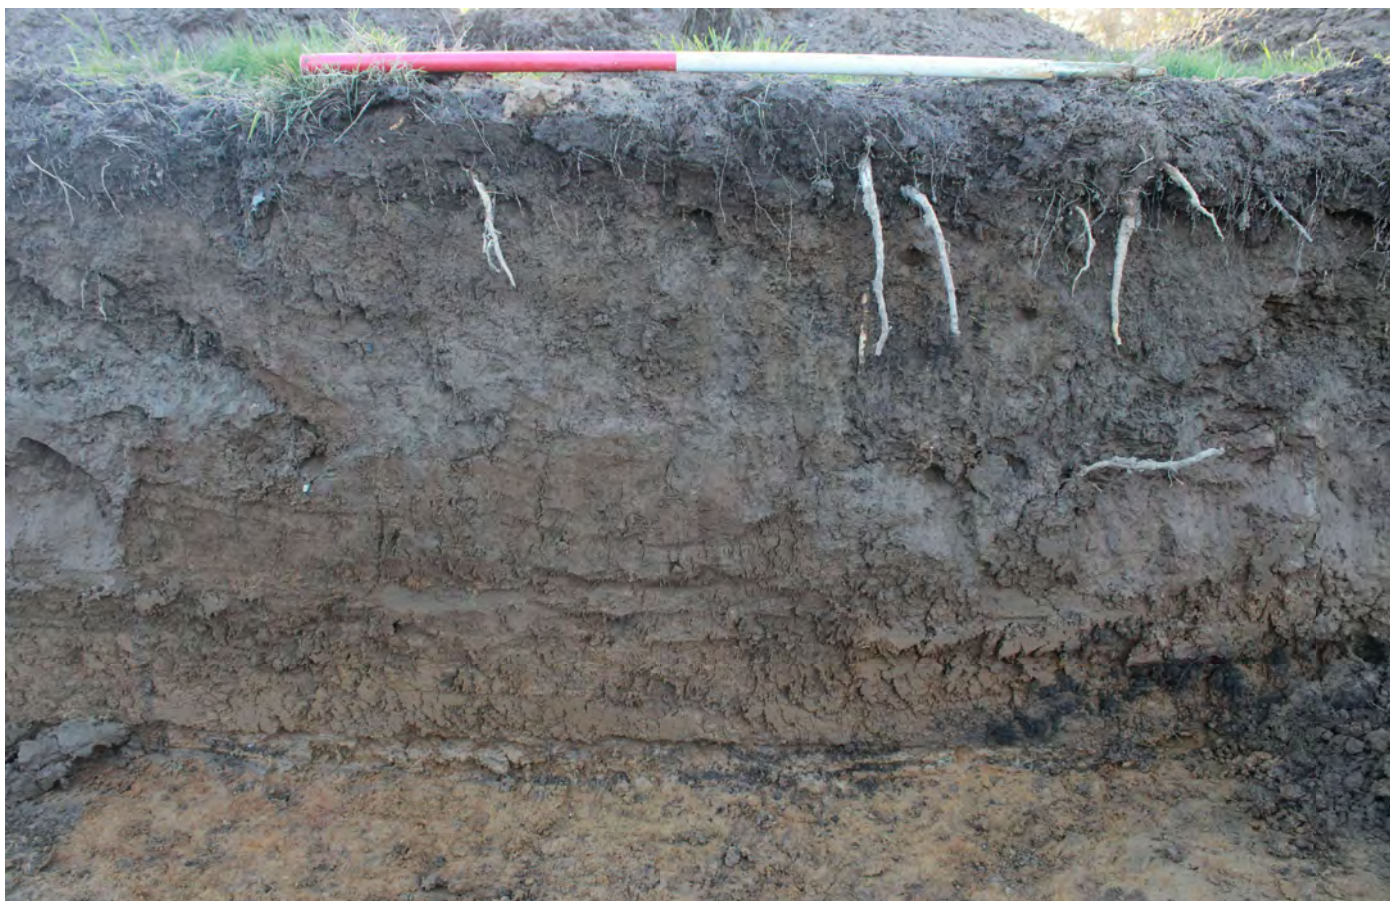
Plate 9

Trench 27, representative section looking southwest.

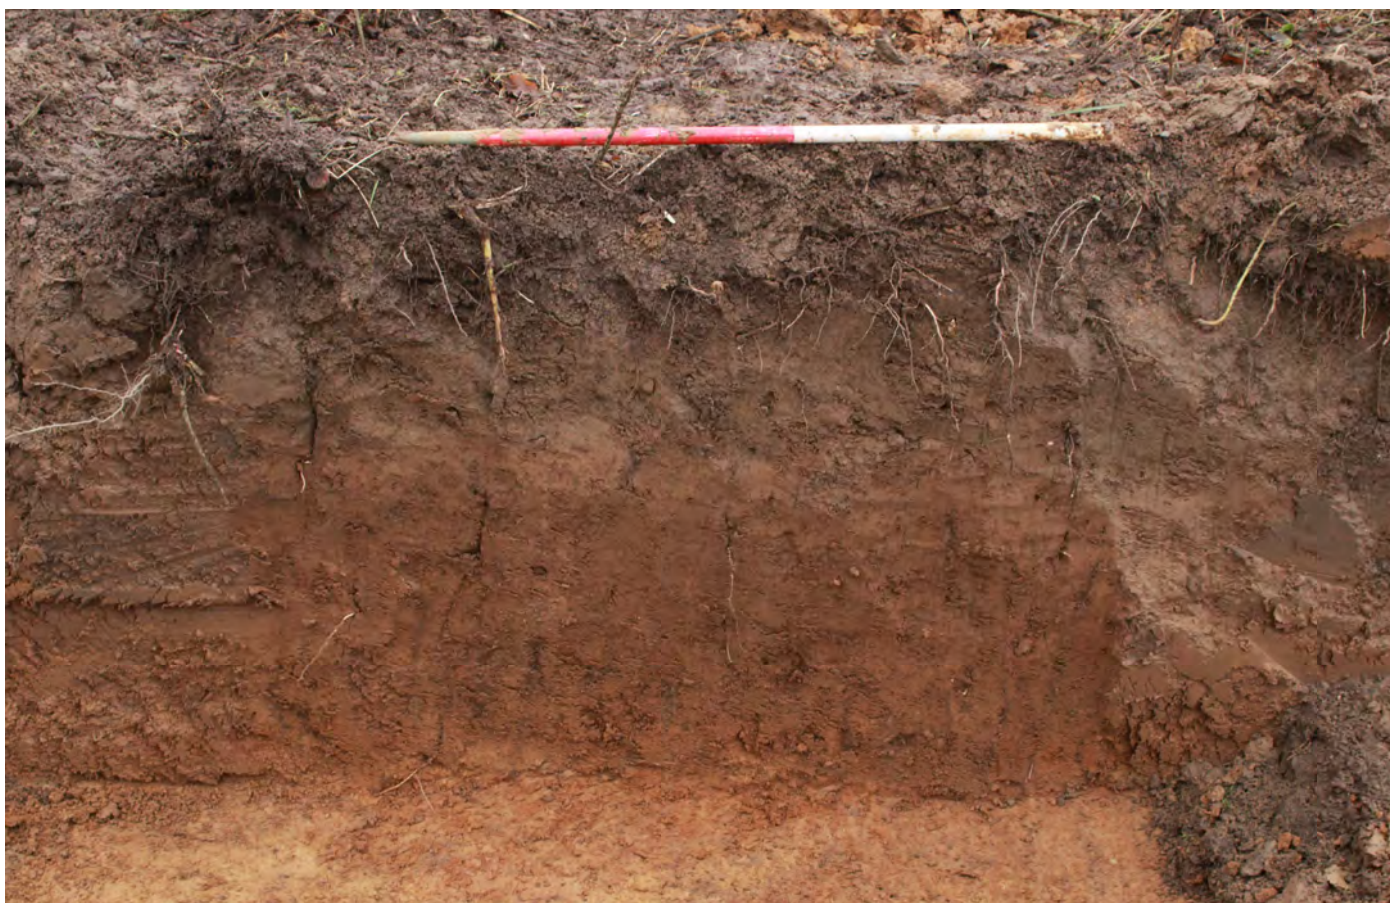
Plate 10

Trench 42, representative section looking south.

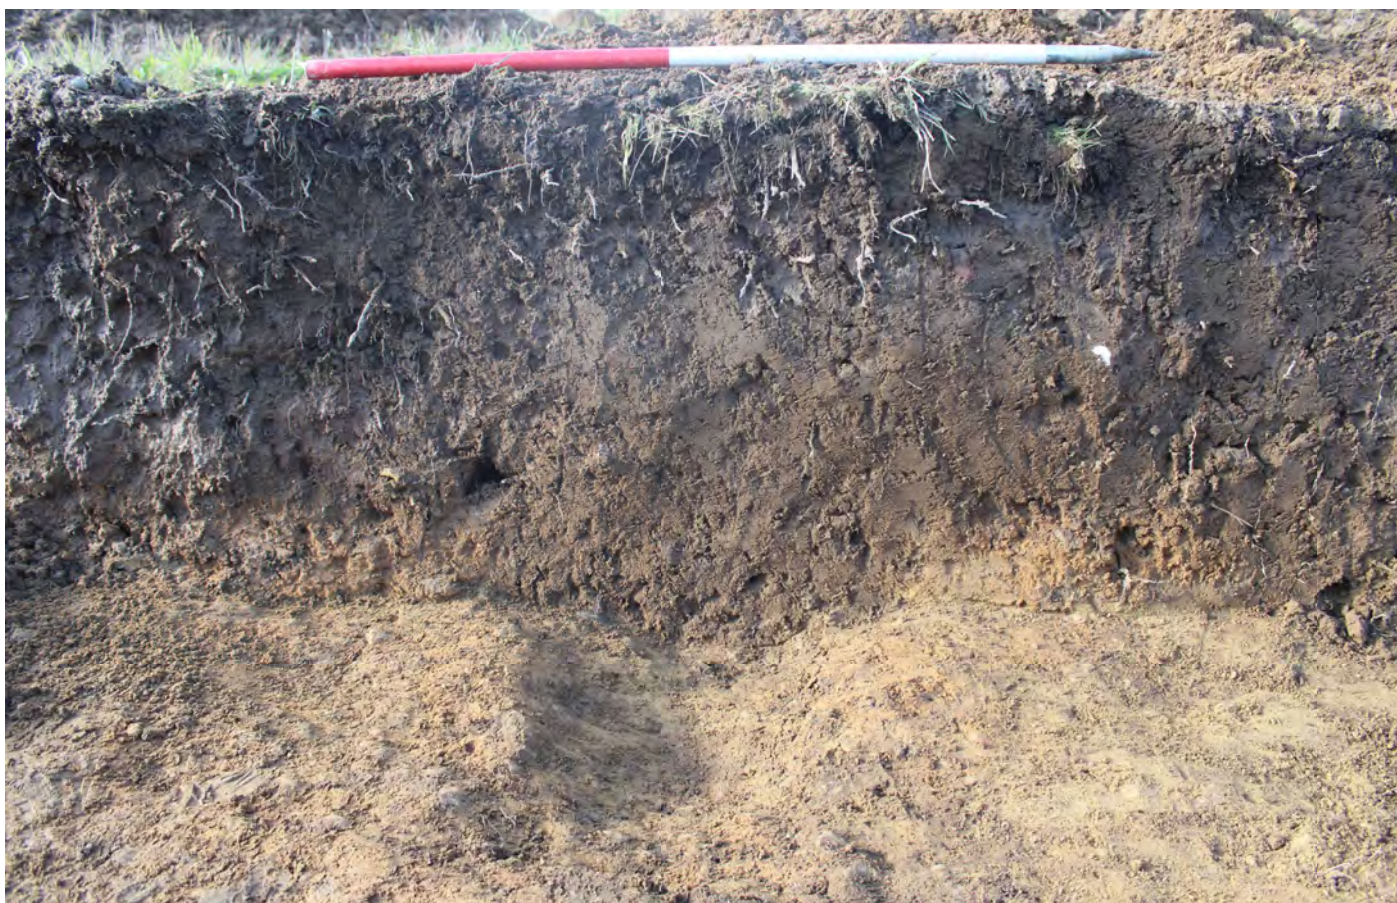
Plate 12

- 5.4.4 Trench 29 was located in the centre of the Site, oriented from north to south. The trench contained one shallow ditch (Plate 12).
- 5.4.5 The natural geology (2903) was found at a maximum depth of 0.50m below the modern ground surface.

- 5.4.6 Ditch [2905] was located at the northern end of the trench, on an east to west alignment. It measured 0.8m wide and 0.25m deep, and extended across the whole width of the trench. It was not observed in any of the trenches on either side. It contained one naturally silted fill (2904), near identical to the overlying subsoil (2902), that comprised a loose, mid greyish brown clayey silt. No finds were retrieved.

- 5.4.7 Given the loose quality of the fill, its similarities with the subsoil above, and the presence of multiple pipes crossing through trench 29 on the same alignment, it is likely that this ditch is a modern cut for a service associated with the plant nursery that has since been removed and infilled with subsoil-rich material.

Ditch 2905, looking west.

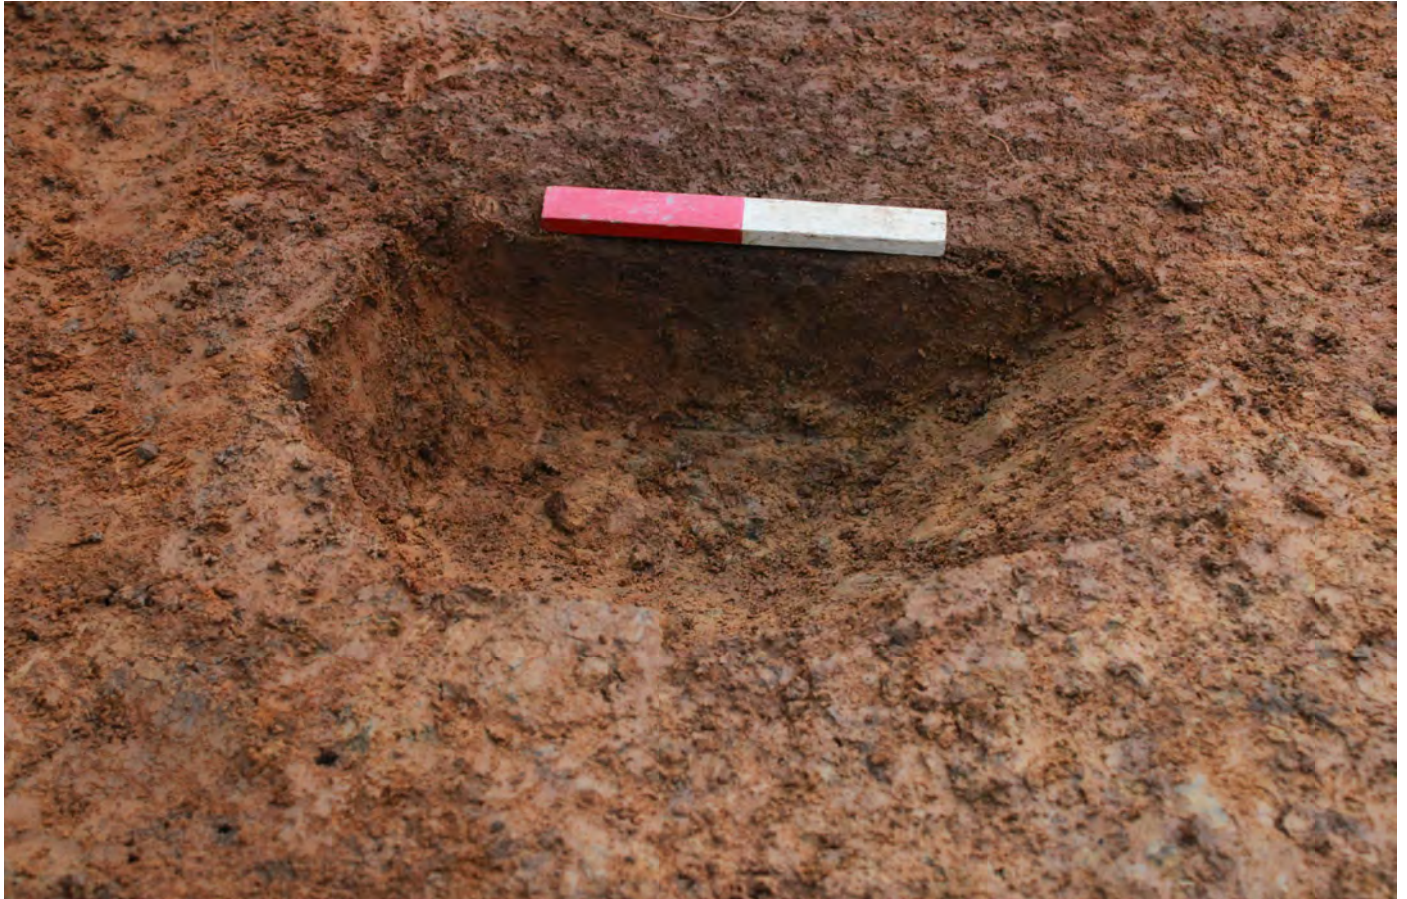
Plate 13

- 5.4.8 Trench 53 was located in the northeastern field, oriented north to south. The trench contained one small pit (Plate 13).
- 5.4.9 The natural geology (5303) was found at a maximum depth of 0.70m below the modern ground surface.
- 5.4.10 Pit [5304] was located at the southern end of the trench and measured 0.30m in diameter and 0.11m deep. It contained one naturally silted fill (5305) comprising a light orangey brown silty clay. No finds

Pit 5304, looking south.
