# **REPORT ON AN ARCHAEOLOGICAL SCHEME OF WORKS: BURTON ROAD, MELTON MOWBRAY, LEICESTERSHIRE**

Planning Reference: 09/00860/FUL  
NGR: SK 7531 1883  
AAL Site Code: MEMO 10  
Leicestershire Museums Accession Number: X.A92.2010  
OASIS Reference Number: allenarc1-100330

By  
Allen Archaeology Limited  
Report Number 2011028

May 2011

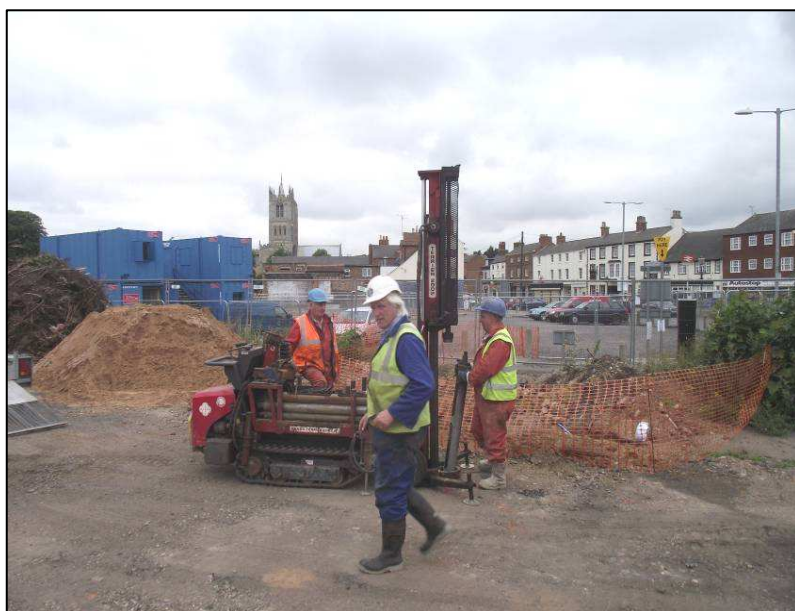
**Plate 2:** North facing shot showing auger survey in progress

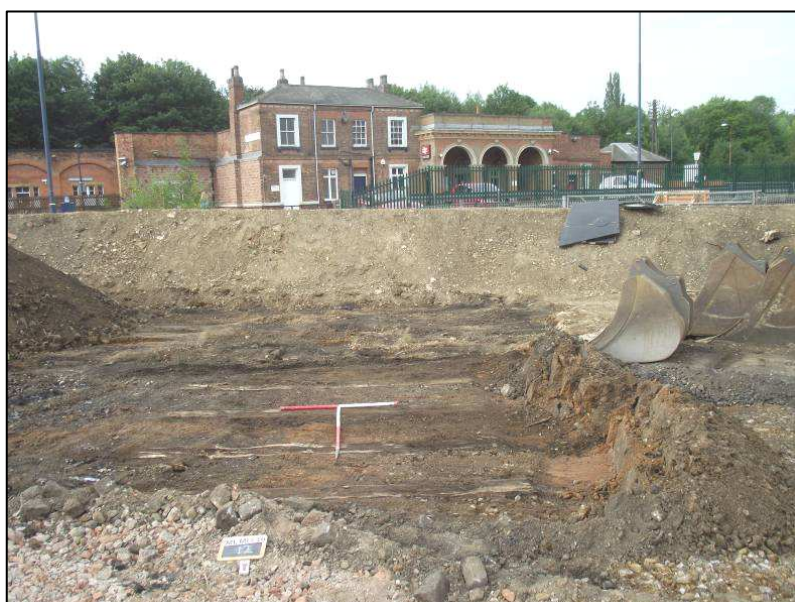
**Plate 3:** Sleepers for former railway service line revealed during stripping, looking south towards train station

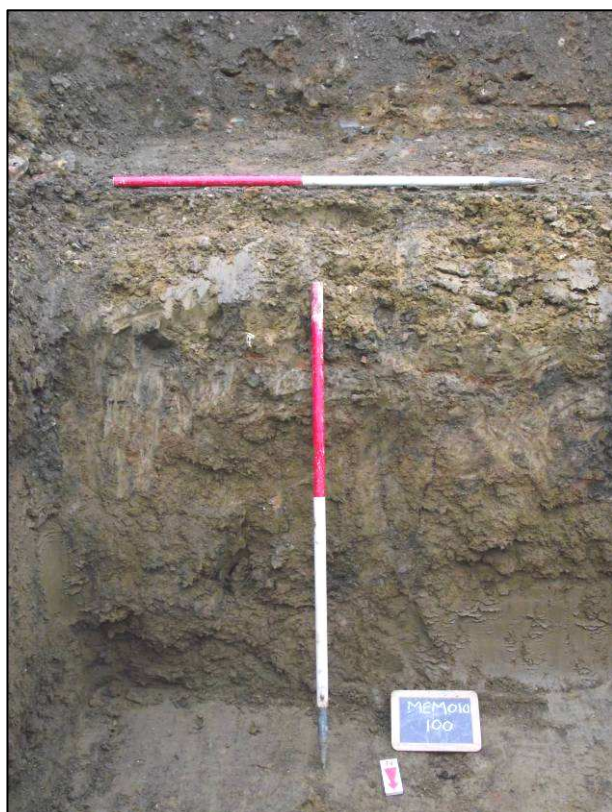
**Plate 4:** Representative section showing stratigraphy recorded in deep drainage excavations. Looking south

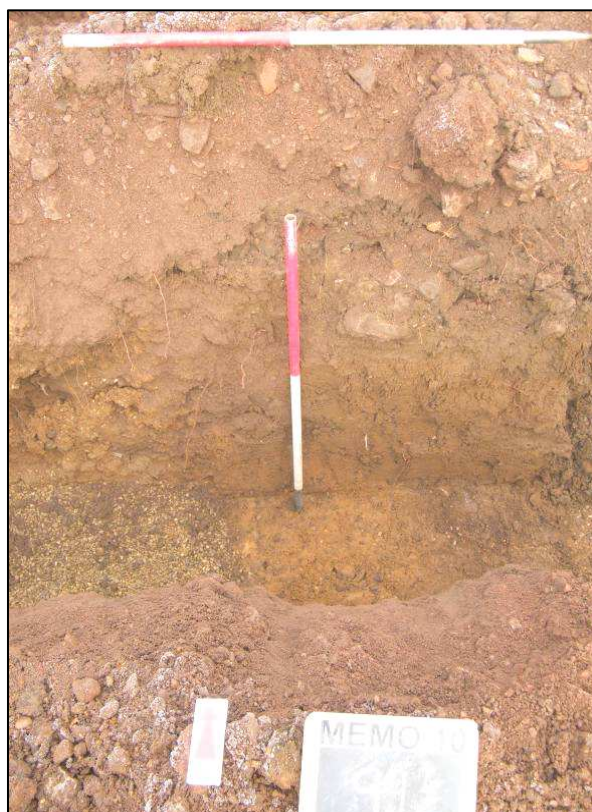
**Plate 5:** South facing section through pit [166], looking north

- 7.4 A large cut feature [166] observed in the northernmost run of the drainage excavations, is thought to be a large pit of pre-modern date. The feature's extent was such that while the eastern edge was visible within the excavations, it extended beyond their limit in all other directions, and as such was in excess of 2m x 2.5m in extent. A second large pit was also encountered by the auger survey to the south-west. It is possible that these pits represent features similar to a large pit identified by the preceding evaluation. This was thought likely to represent a quarry pit of post-medieval date. A worn fragment of Staffordshire Salt-Glazed pottery dating to c.1765 to 1775, suggested that the feature could have been contemporary with the construction of the nearby Melton Canal, built between 1791 and 1795, and was perhaps excavated to provide additional sand, gravel, or cobbles for the construction works.

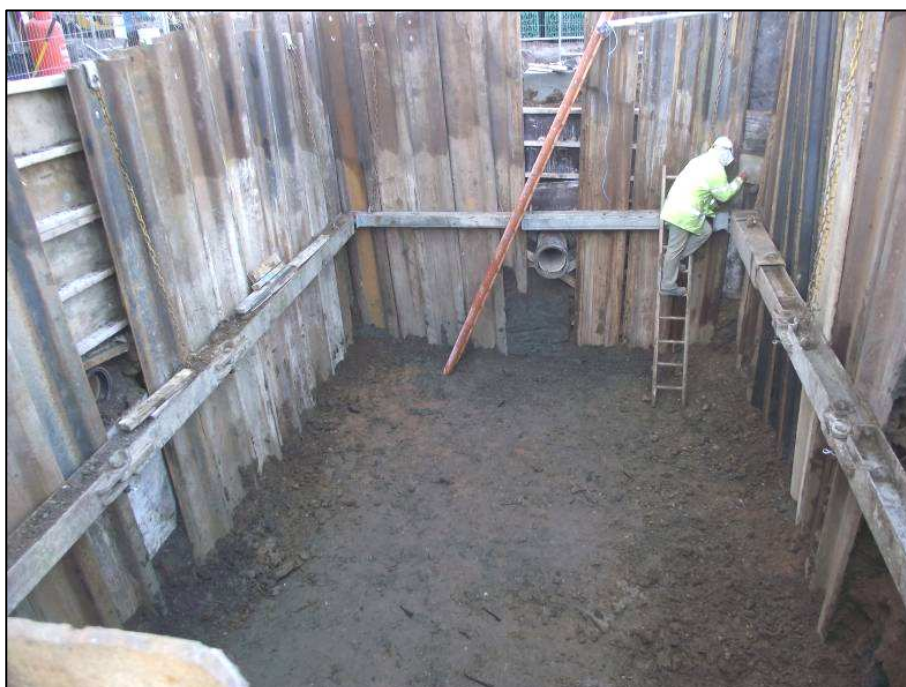
**Plate 6:** West facing shot showing work at deepest limit of excavations in storm drain to the north of the new building

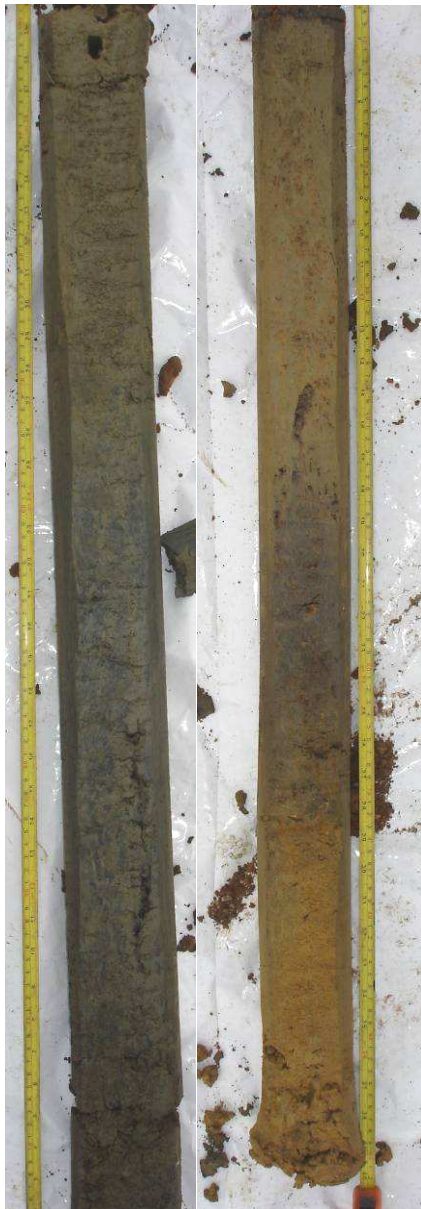
T1/BH7/core 2    T1/BH7/core 3

**Fig. 3 (overleaf):** Alluvial clays in Transect 1, BH7 between 2 and 4m depth. The lower yellowish brown deposits of core 3 are 'natural' clayey sands and gravels, with dark grey sandy silty clays above suggesting sediments from the small stream channel to the south.

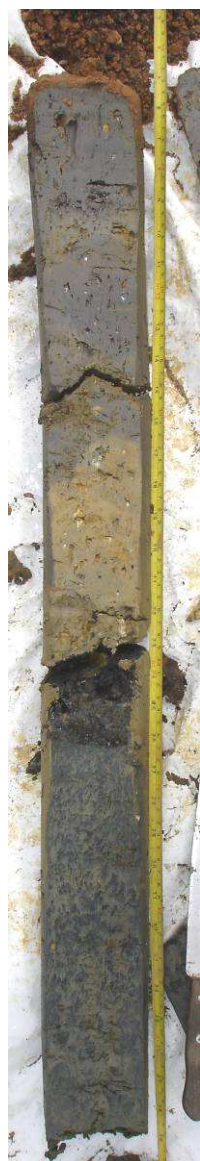
T2/BH2/core 5

**Fig. 5.** The black silts at 4.28-4.74m depth in BH2 of Transect 2.

BH2 is similarly disturbed and clearly dug out in the past to a depth of over 4.5m. Brick is recorded to 3.85m depth in a mixed sandy clay with grits and stones, clearly a dumped deposit. At the base of the sequence in this borehole is a 0.46m depth of black silt (Fig. 5). This deposit has formed in a still water environment with sufficient oxygen for the organics to partially break down and be responsible for the black staining in the sediment. This is a deposit more typical of a moat, pond or canal than a stream or river channel and the location of the borehole adjacent to the probable course of the Melton Canal suggests that this borehole may have cored through the canal deposits and its later infilling or associated excavations. In BH1 of Transect 2 the third core came up empty, having probably been

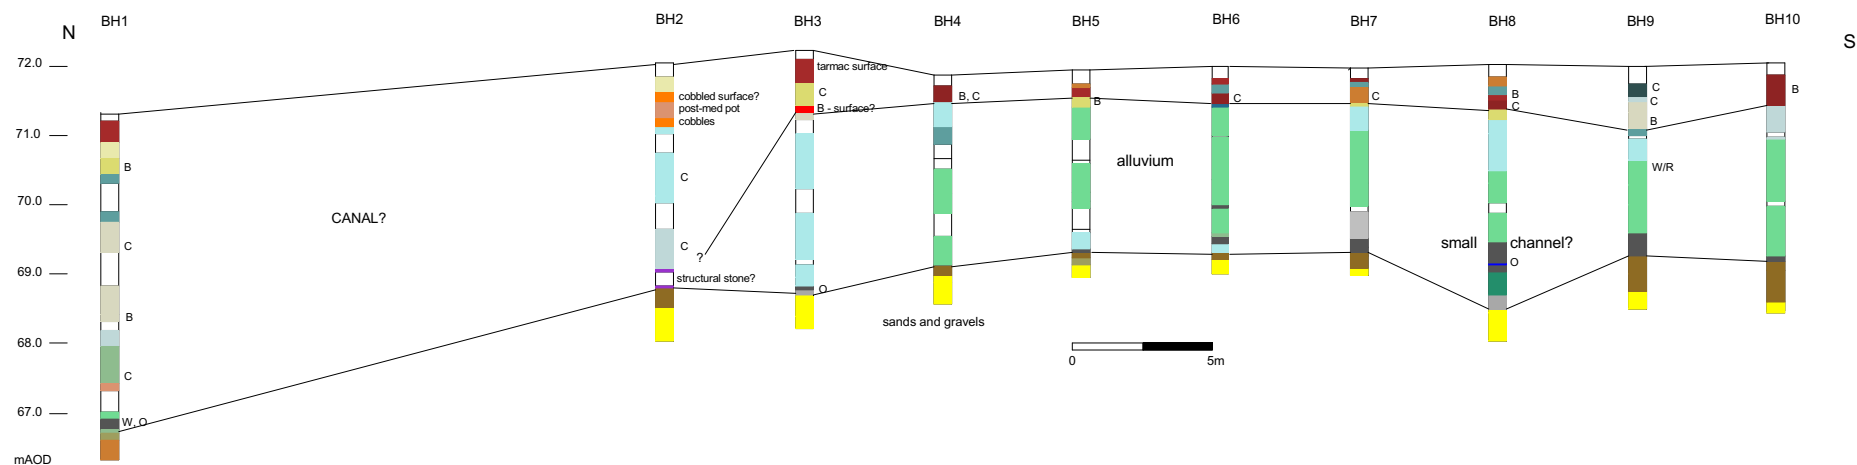
Melton Mowbray, Transect 1

**Fig. 6 Reconstructed section based upon the boreholes along Transect 1**

The two northern boreholes, BH1 and BH2, illustrate a different pattern. Archaeological debris, including brick, coal, possible structural stone and wood occurs throughout the cores to a depth of 3.9m in BH1 and 2.95m in BH2 (Fig. 6).

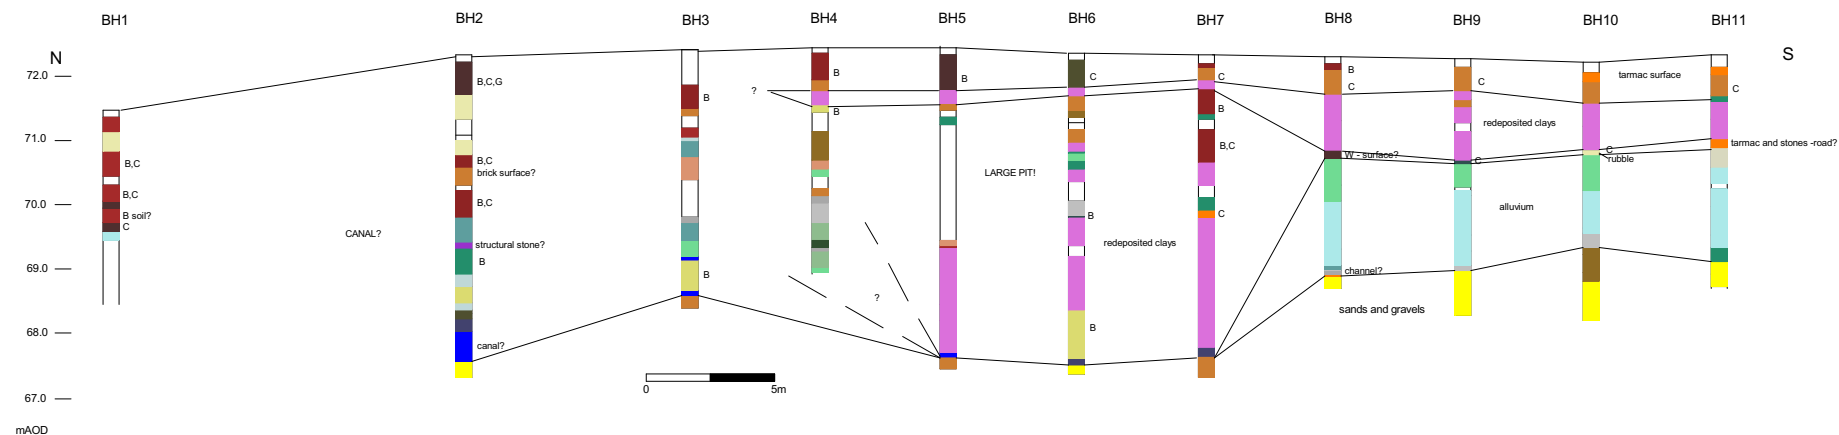
Melton Mowbary - Transect 2

**Fig. 7 Reconstructed section based upon the boreholes along Transect 2**
