ARCHAEOLOGICAL WATCHING BRIEF REPORT:

PASTURE WHARF CHIMNEY, BARTON-UPON-HUMBER NORTH LINCOLNSHIRE

By Allen Archaeology Limited Report Number 2011070

October 2011

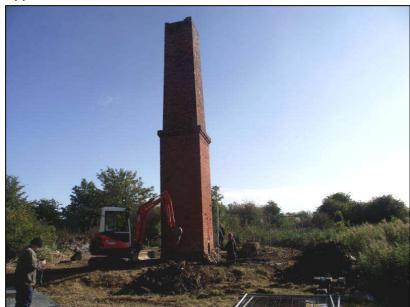
Plate 1: General view of the site during the groundworks, looking west-southwest

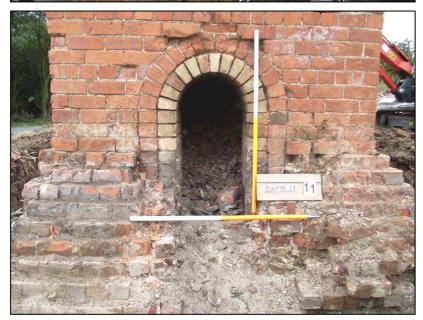
- 6.2 The chimney foundation consisted of nine courses of brickwork, each stepped out by half a brick width from the course above, with a total width of c.3.3m. The full size of the semi-circular arched opening on the north elevation was exposed, measuring c.0.9m in height and 0.4m in width. A gap the same width as the opening had been cut through the brick foundations in front of this opening, suggesting that a flue probably ran into the chimney below ground level.

Plate 2: General view of the chimney opening and the foundation. North elevation, looking south

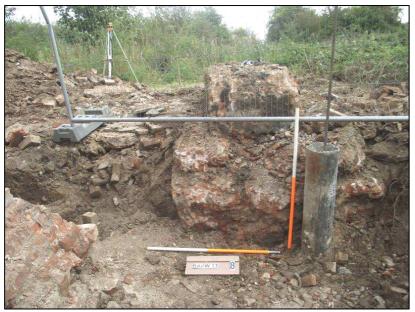
- 7.2 The concrete foundation 004 and brick floor 005 are likely to be associated with a demolished building which once incorporated the chimney (AAL 2009). The concrete foundation is particularly substantial and may represent a pad to support some machinery within the building, rather than representing a wall footing. The overburden sealing brick floor 005 and slumping down around the foundation is likely to be associated with the demolition and removal of structures surrounding the chimney in the 1970s.

Plate 3: Brick foundation 004, looking west

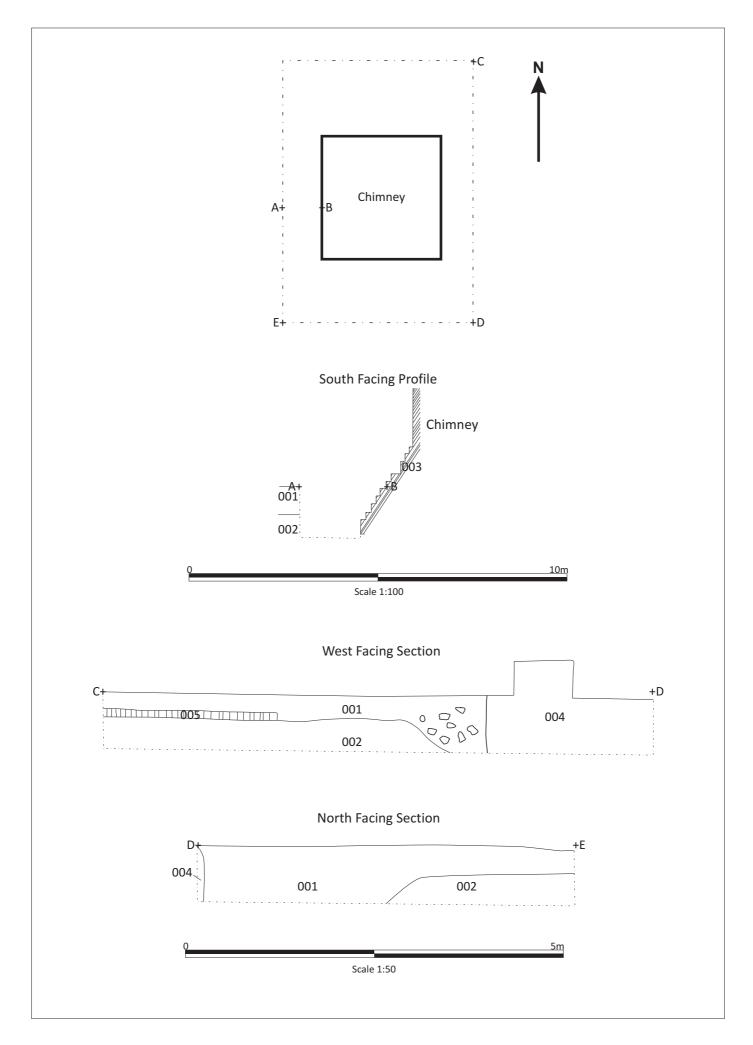
- 6.1 The trench around the chimney was excavated to a depth of c.0.7m. The uppermost layer removed consisted of a c.0.2m 0.7m thick overburden 001. The layer was a mix of very loose mid brown clayey silt, with abundant brick and tile. To the west and north this layer gradually slumped down towards a concrete foundation 004 which had a width of c.2m and was visible above the ground surface. The overburden 001 also sealed an un-bonded brick surface or floor 005 on the west side of the chimney. The brick floor sealed reddish brown clay 002 and the foundation and brick chimney 003 cut through this natural geology.

Figure 3: Plan and profile drawing at scale 1.100 and sections at scale 1:50

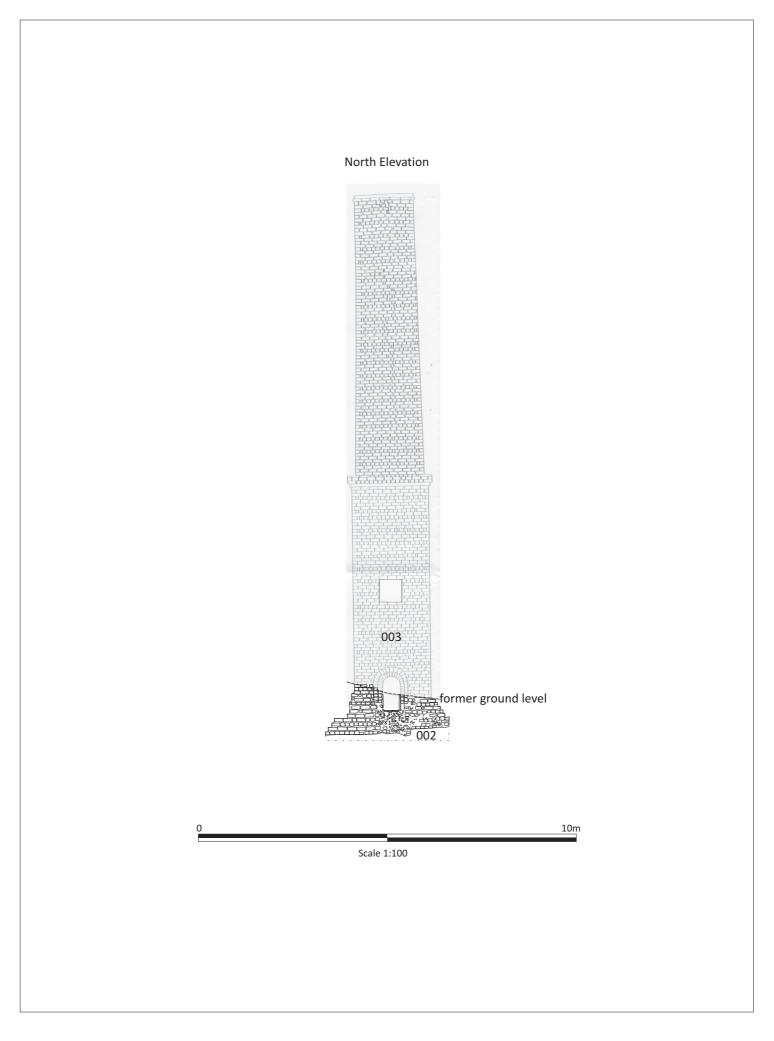
- 4.6 The chimney itself is a square, brick-built structure with an English Garden Wall Bond. It measures approximately 2m square at the base, with a height of approximately 13.25m. The lower portion of the chimney has parallel vertical sides to a height of approximately 5.5m, above which the upper portion of the chimney tapers slightly from a width of c.1.8m to c.1.55m. The two components of the chimney are divided by a prominent string course, comprising a protruding lower stretcher course, over which another stretcher course and two header courses protrude slightly further out from the face of the brickwork.

Figure 4: Amended elevation of chimney at scale 1:100 (based on survey by Surveyline Geomatics UK Limited, drawing reference SL2205/2)
