**ARCHAEOLOGICAL WATCHING BRIEF REPORT:  
23 HILL VIEW, BUCKLAND, HERTFORDSHIRE**

Planning Reference: 3/11/0150/FP  
NGR: TL 35575 33770  
AAL Site Code: BUCK 12  
OASIS Reference Number: allenarc1-128701

By  
Allen Archaeology Limited  
Report Number 2012051

June 2012

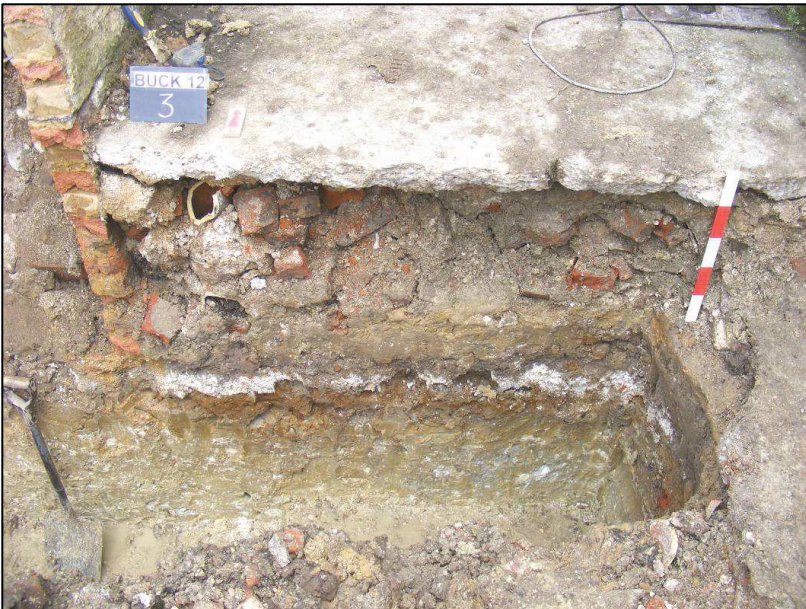
**Plate 2:** Wall of existing store to left of shot with demolition deposit 09 overlying a sequence of dumps, including chalk rubble spread 03, looking north. Scale is 0.5m

- 6.1 The uppermost deposit in the western half of the site consisted of a modern concrete surface 10/18, which sealed a dump of brick rubble and other modern building materials, 09. This layer appears to have been dumped during construction of the existing house and store building, as it abutted the wall of the store to the west. Layer 09 sealed a sequence of dumped deposits comprising clayey sand 02, chalk rubble spread 03, clayey sand 04 and sandy clay 05. Layer 04 produced three fragments of ceramic building material (CBM); two of 16<sup>th</sup> – 18<sup>th</sup> century date and one of 18<sup>th</sup> – 20<sup>th</sup> century date.

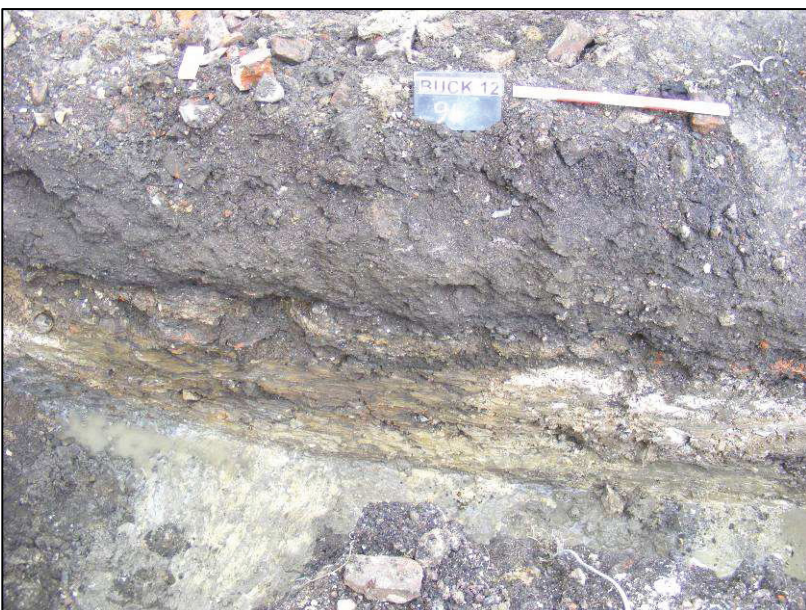
**Plate 3:** Pit [25] cutting chalk rubble spread 30 and underlying pit or ditch [21], looking south-south-east. Scale is 0.5m

- 6.3 Approximately 2m east of pit [11] the topsoil sealed a larger pit [25] with moderately steep sides and a concave base. It contained four distinct dump deposits, 26 – 29, with a single mid 17<sup>th</sup> - 18<sup>th</sup> century pottery sherd and one brick fragment of 16<sup>th</sup> – 18<sup>th</sup> century date recovered from its secondary deposit 27.

- 6.4 Layer 30 sealed two steep sided pits or ditches [21] and [23]. Both had diffuse edges and contained similar fills of blueish grey silty clays, 22 and 24 respectively. Fill 22 produced a single 17<sup>th</sup> – 18<sup>th</sup> century blackware pottery sherd and a fragment of cattle skull.

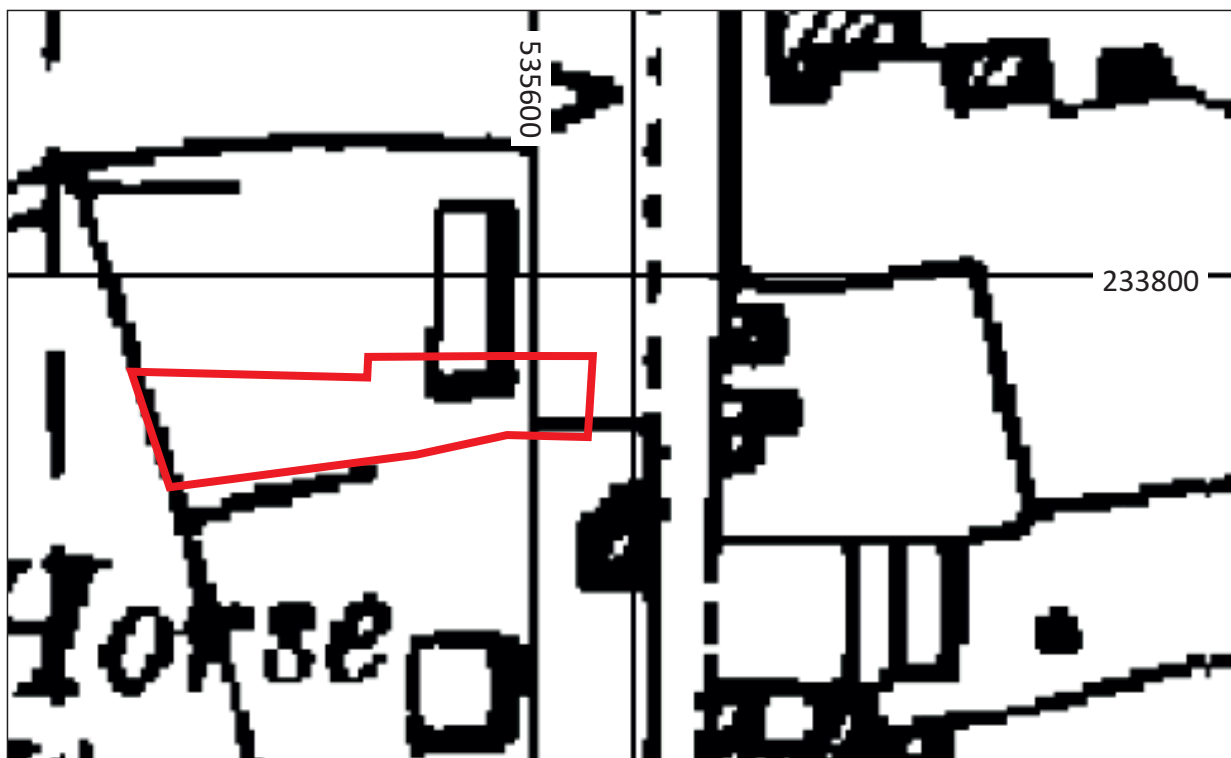
Figure 5: Ordnance Survey maps from 1878 and 1960 with the site outlined in red

- 4.7 The 1878 First Edition Ordnance Survey map (Figure 5) shows that the development site was formerly occupied by several buildings and yards, the date of which are unknown. A smithy lay to the south, partly under the present buildings of numbers 22 and 22b Hill View.

- 7.2 Historic Ordnance Survey mapping of the area (Figure 5) shows a range of what appear to be farm buildings along the southern boundary of the site and along the road frontage to the east. These are shown from the time of the 1878 map, but had been cleared by the time of the 1960 map that shows the existing building on the site. It seems probable that the chalk rubble spread may be the remains of a former yard surface associated with the farm buildings, with the overlying dumps of material and the later pits [11] and [25] reflecting the demolition and levelling of the site and subsequent construction of the existing buildings in the mid 20<sup>th</sup>
