## PHOTOGRAPHIC SURVEY REPORT:

### OXFORD HALL, OXFORD STREET, LINCOLN

By  
Allen Archaeology Limited  
Report Number 2012070

August 2012

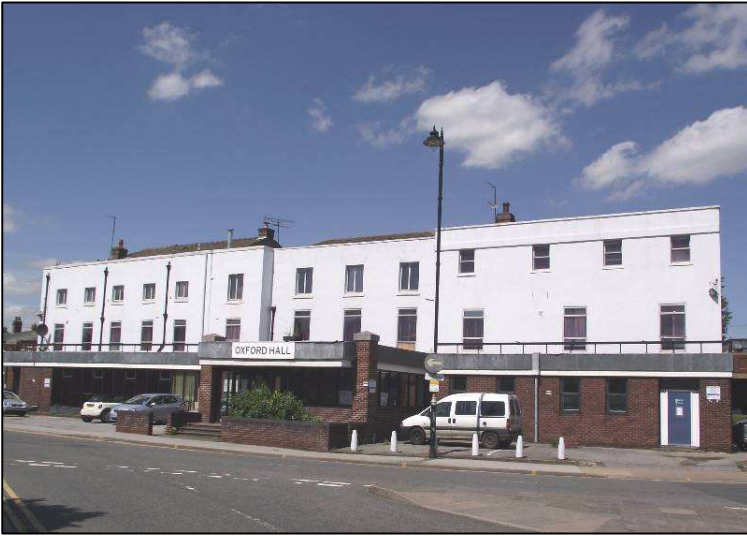
**Plate 1 (Shot 75):** South elevation of Oxford Hall, looking north

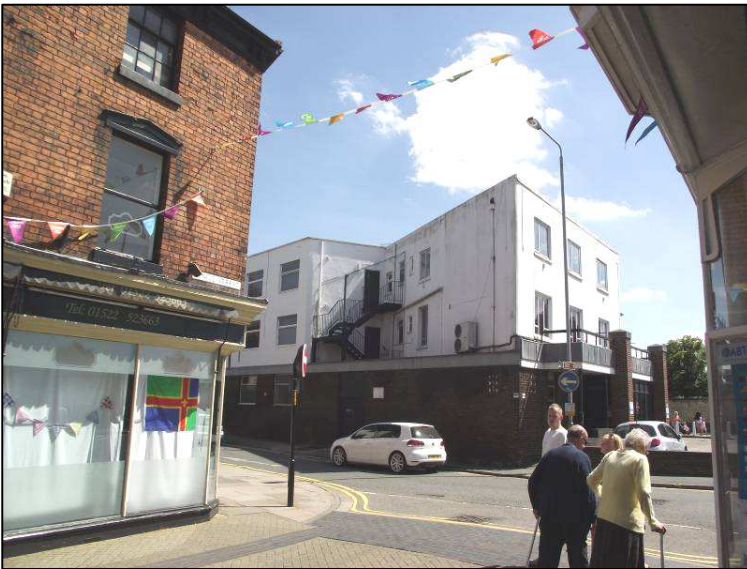
**Plate 2 (Shot 80):** East and north elevations, looking southeast

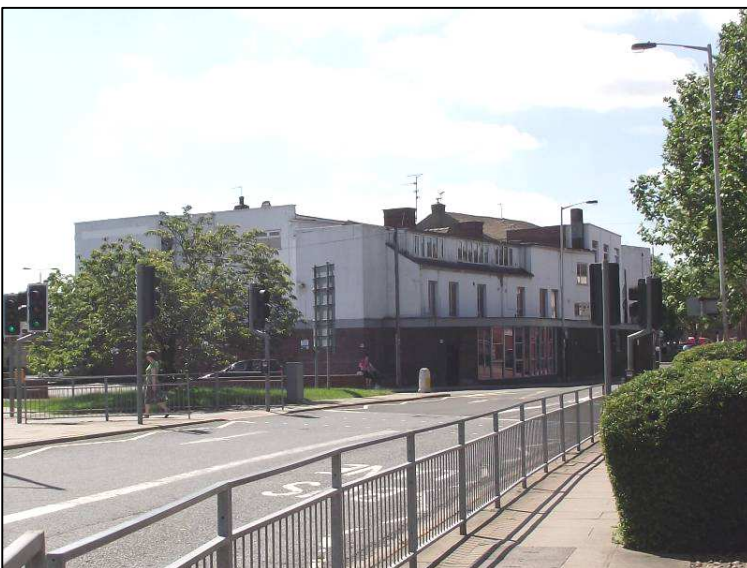
**Plate 3 (Shot 81):** North and west elevations, looking west-southwest

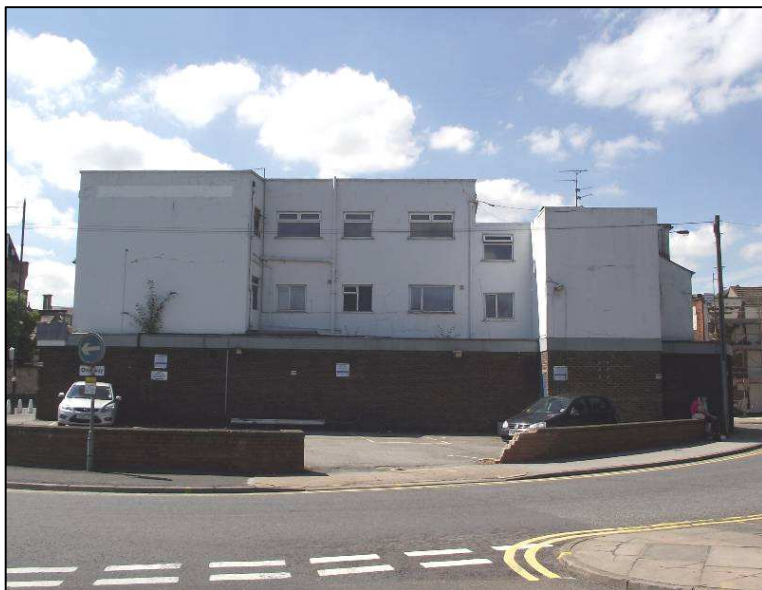
**Plate 4 (Shot 82):** West elevation, looking east

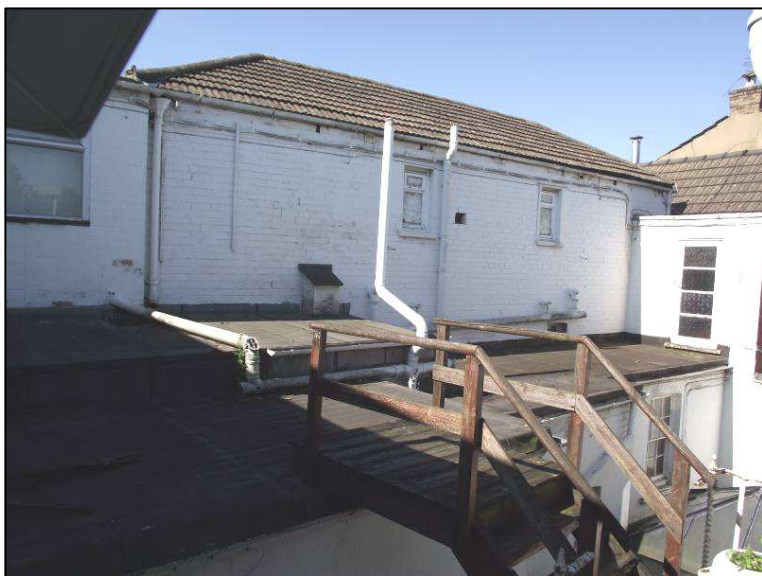
- 6.1.2 Most of the outer façades have been rendered and/or painted white. However, a late 20<sup>th</sup> century unpainted brick extension in stretcher bond, with a flat roof, protrudes at ground floor level around the entire building, with a porch on the south elevation over the main entrance (Plates 1-4). The building has a mixed array of vertically sliding sash windows, small hopper windows and side and top opening casements, with panorama windows on the south-west and north-east corners of the building at ground floor level.
- 6.1.3 The roof structure is concealed by a low parapet running around the entire building. However, the later extensions to the building generally have flat roofs whereas the earlier parts of the building fronting St. Mary's Street to the south and Norman Street to the north have double pitched and hipped roofs covered by modern concrete tiles (Plates 5-7).

**Plate 5 (Shot 5):** Original north elevation of 5 Norman Place taken from second floor, looking southwest

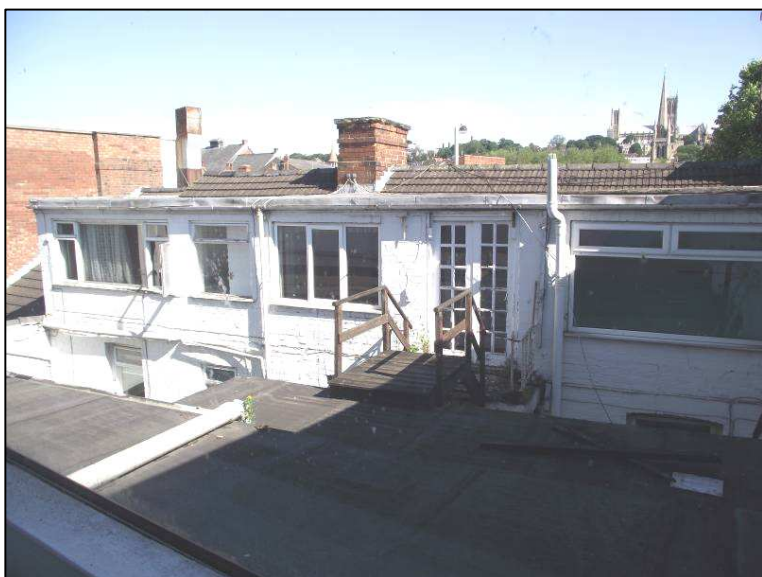
**Plate 6 (Shot 9):** South elevation of range fronting onto Norman Street, taken from second floor, looking north-west. Note intervening flat roof extensions

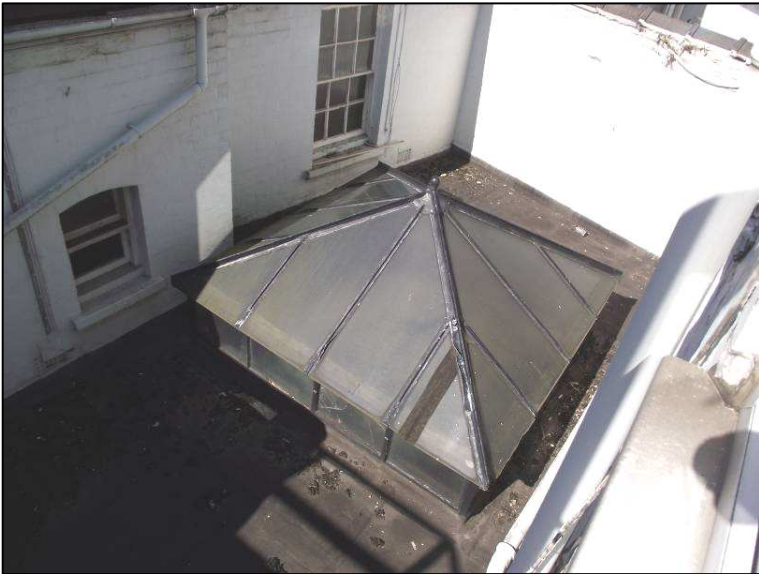
**Plate 7 (Shot 8):** View of skylight in ground floor flat roof extension, looking south-west

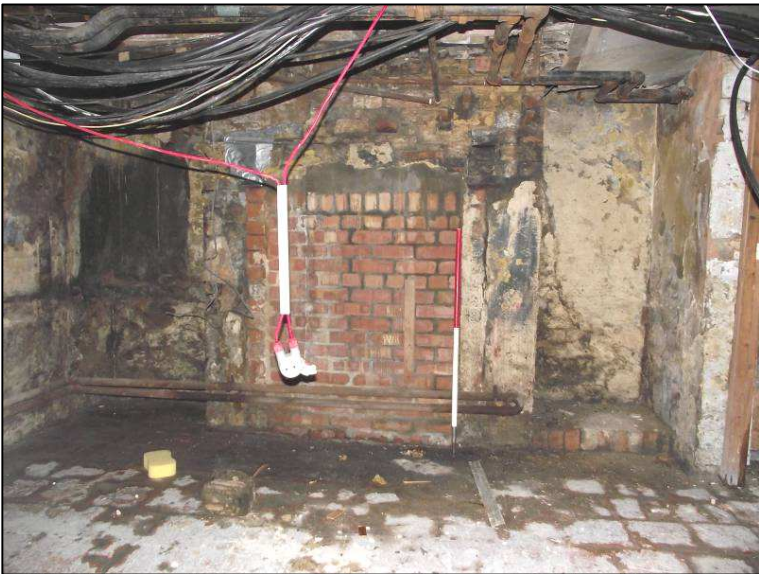
- 6.2.1 The basement does not extend under the entire complex but is restricted to the older parts of the building i.e. the southern frontage facing Oxford Street and the northern frontage facing Norman Street. Much of the original fabric of the basement is still visible; indeed the basement is the only area that has not been extensively obscured and altered by later development. Most of the floors in the basement have been rendered with concrete in recent years but some areas of original quarry tile flooring remain visible (Plate 8).

**Plate 8 (Shot 62):** Bricked up fireplace and quarry tile floor in the basement, looking east-southeast. Scale is 1m

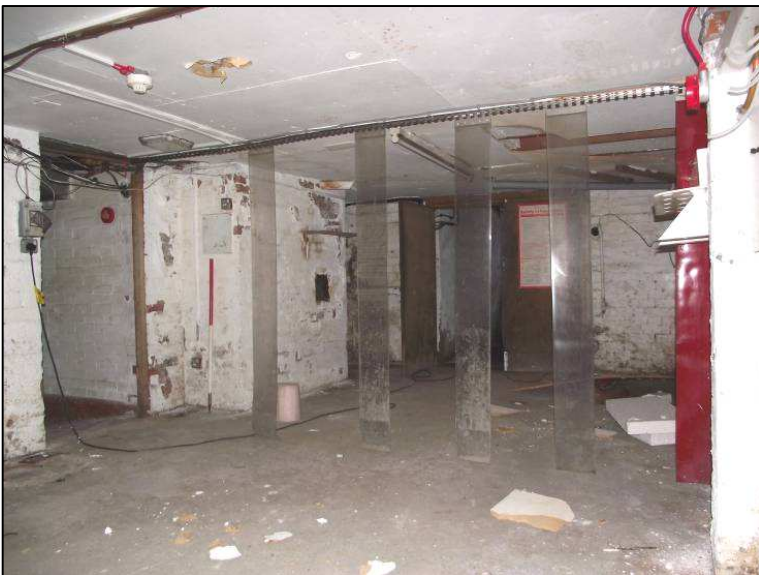
- 6.2.2 In the south-west corner of the basement is a former beer cellar (Plate 9) with an original access ramp to a hatch visible externally and covered with steel double doors (Plate 10). To the north is a second access leading to the Buttery Bar and Grill on the floor above.

**Plate 9 (Shot 45):** Basement under the Buttery Bar, looking south-southeast. Scale is 1m

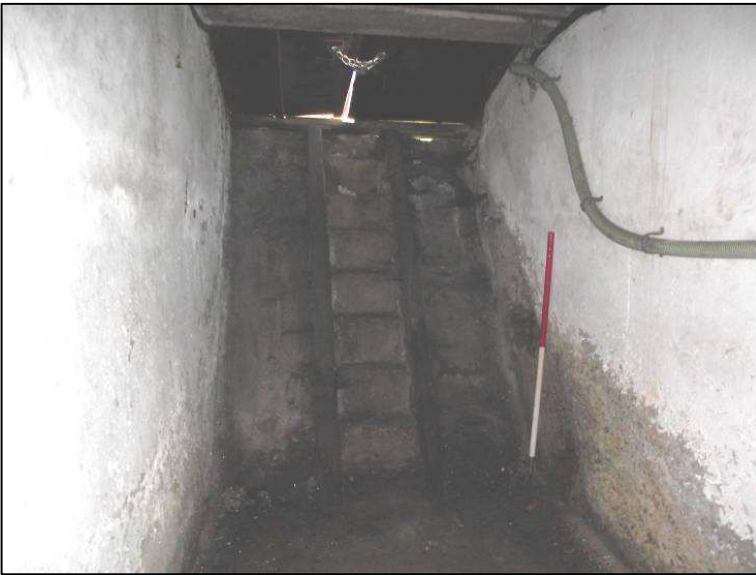
**Plate 10 (Shot 46):** Basement access to beer cellar from St. Mary's Street, looking south-southwest. Scale is 1m

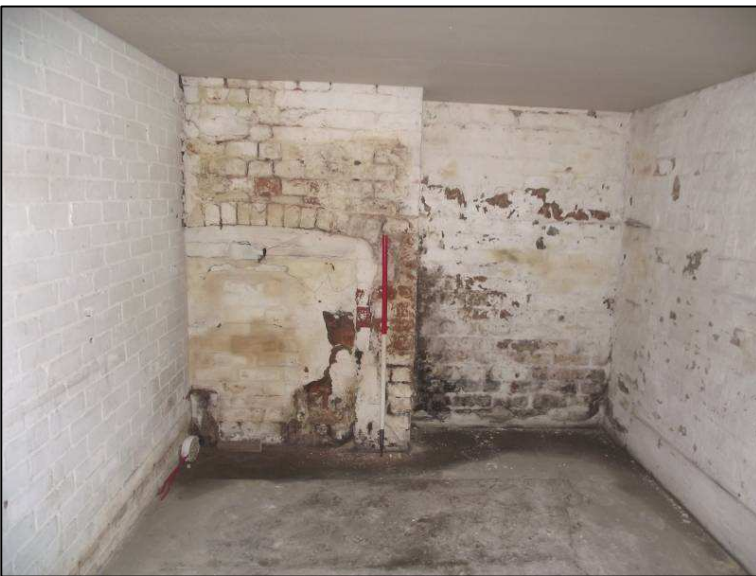
- 6.2.3 A corridor runs eastwards from this beer cellar. It is flanked by further general purpose stores to the north and south, as well as a boiler room with sunken floor and a room containing a large steel oil tank. East of the room containing the oil tank is a staircase to a blocked opening that formerly led to the foyer above. North of this, a bricked up fireplace was noted, partially obscured by a brick partition between two storage areas (Plate 11). Another large bricked up fireplace was noted to the west beneath the former bar.

**Plate 11 (Shot 56):** Bricked up fireplace partially obscured by later partition, looking north-northeast. Scale is 1m

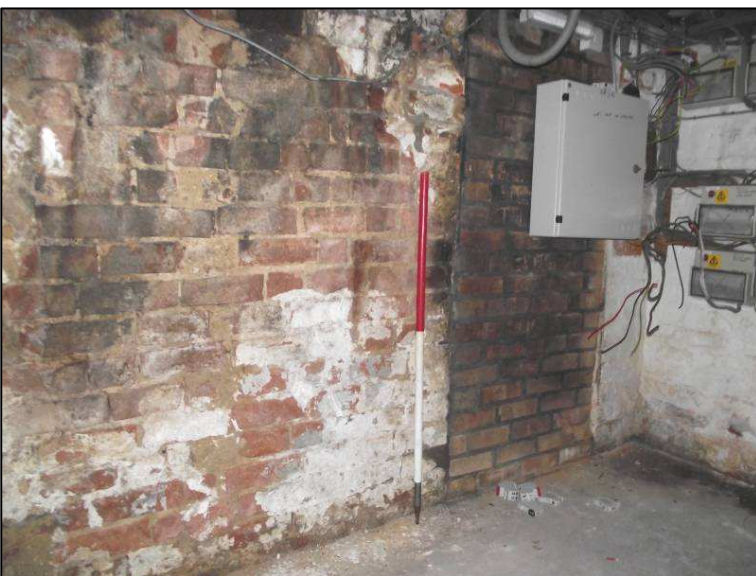
- 6.2.4 Further beer cellars at the east end of the basement have a trapdoor and stairs from the overlying lounge and an access from St. Mary's Street to the south. An opening between the two easternmost stores has been bricked up (Plate 12). A probable coal chute is located in the north-west corner of this storage area (Plate 13).

**Plate 12 (Shot 61):** Bricked up opening between easternmost store rooms, looking south-west. Scale is 1m

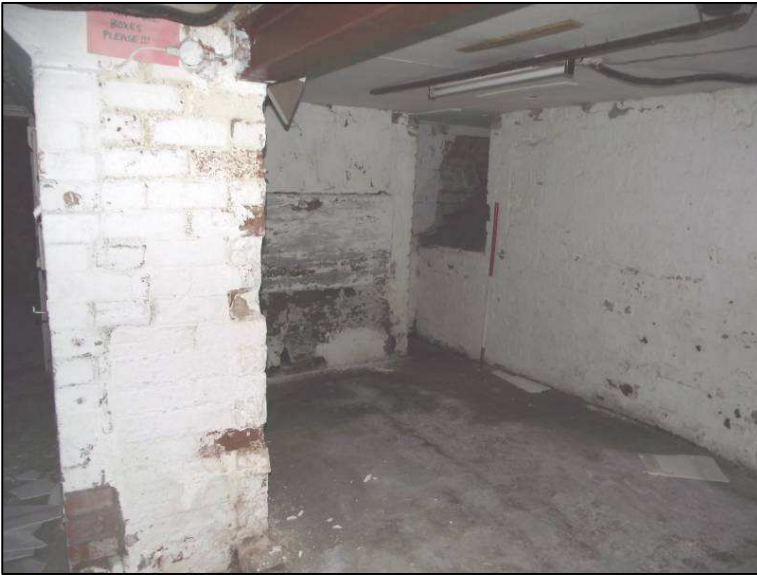
**Plate 13 (Shot 57):** Storage area with coal chute in the corner, looking north-west. Scale is 1m

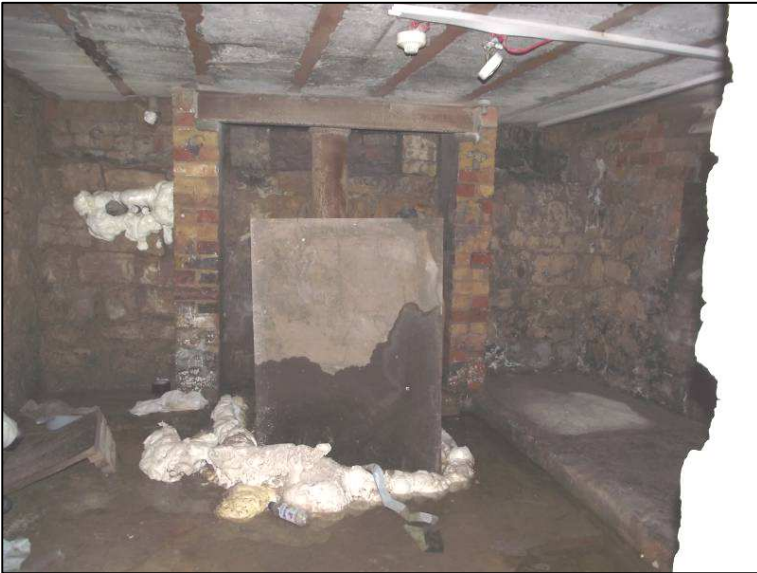
- 6.2.5 A separate basement area under the building fronting Norman Street functioned as storage areas for the kitchen situated above. The westernmost part retained a brick surround, possibly for a former boiler, with a metal pipe extending through to the floor above and a coal chute on the north elevation. The sunken floor in this area had flooded, which limited further access. The south, west and north walls incorporated limestone walling, possibly components of an earlier cellar (Plate 14). The remainder of the cellar comprised general purpose storage areas, with a number of arched brick alcoves.

**Plate 14 (Shot 66):** Possible former boiler room at west end of basement below the kitchen. Also note the earlier limestone walling, looking west-northwest.

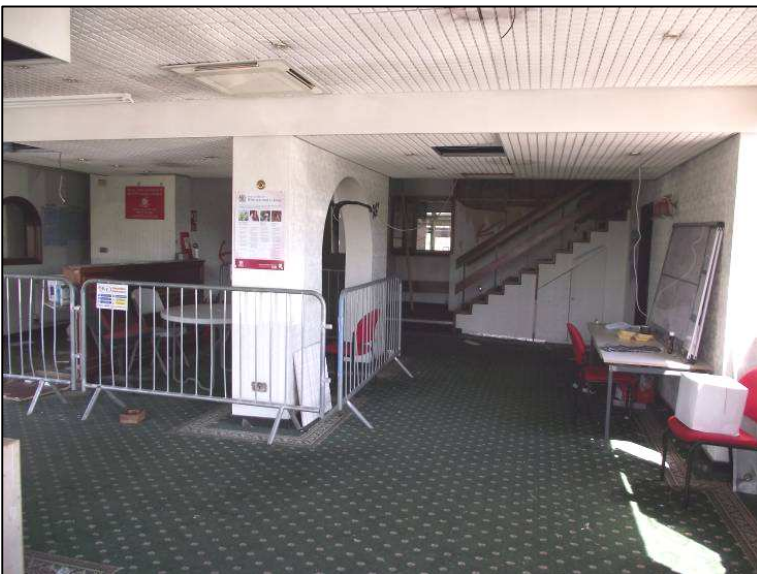
- 6.3.1 The ground floor is generally characterised by modern fixtures and fittings throughout. The main entrance on the south elevation opens into a foyer and reception area with a staircase to the first floor and openings to the east and west (Plate 15). To the north steps lead up into a hallway from which a corridor extends to the west with rooms off to the north and south, including the Abbey Room lounge, offices, a toilet block and at the west end the Buttery Bar and Grill. The toilets and other facilities had been removed from the toilet block, exposing bare brickwork (Plate 16). Black staining of the wall indicated the location of a former chimney stack directly over the blocked fireplace in the basement (Plate 11).

**Plate 15 (Shot 32):** Modern foyer with reception to the left and main access to first floor in the background, looking north-northwest

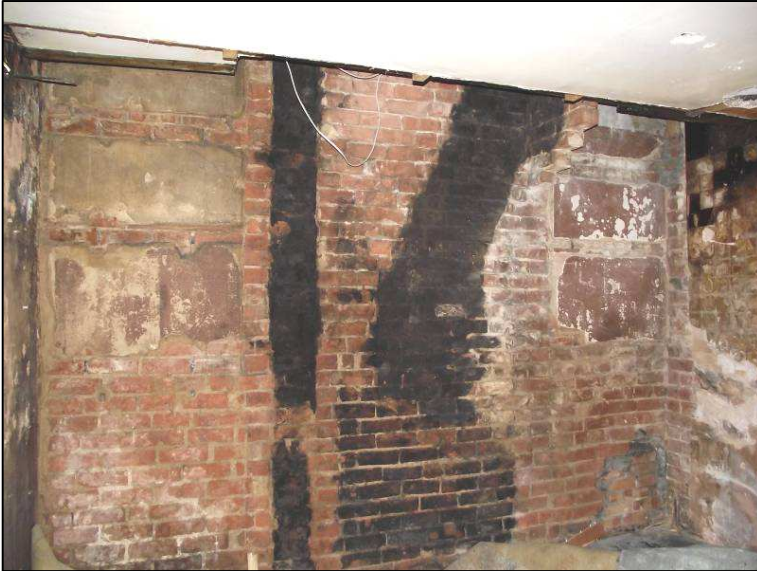
**Plate 16 (Shot 42):** View of location of former chimney breast on ground floor, (situated above fireplace in Plate 11), looking east-southeast.

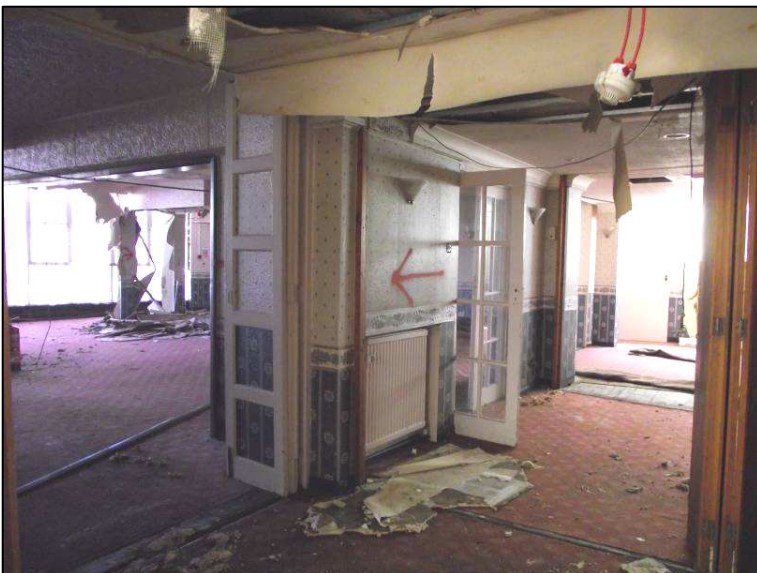
- 6.3.2 A corridor from the north-west corner of the hallway runs broadly northwards to the kitchen block, and at the north-east corner of the hallway is the main entrance to the dining rooms in the north-east corner of the building (Plate 17).

**Plate 17 (Shot 39):** Dining rooms in northeast portion of ground floor, looking east- northeast

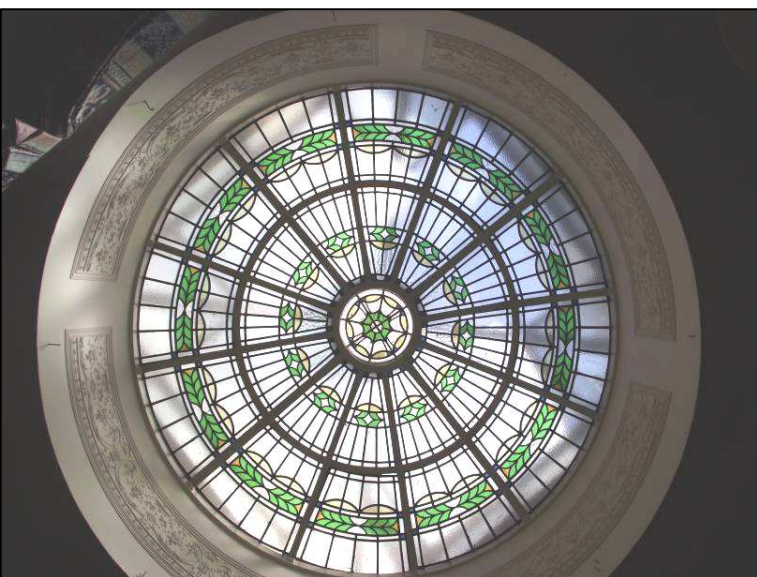
- 6.3.3 In the southwest corner of the dining rooms is a circular domed roof light in 1930s art deco style. The window itself has a geometric design incorporating painted glass, with a moulded plasterwork surround with highly decorative panels in relief (Plate 18).

**Plate 18 (Shot 37):** Domed roof light in dining room

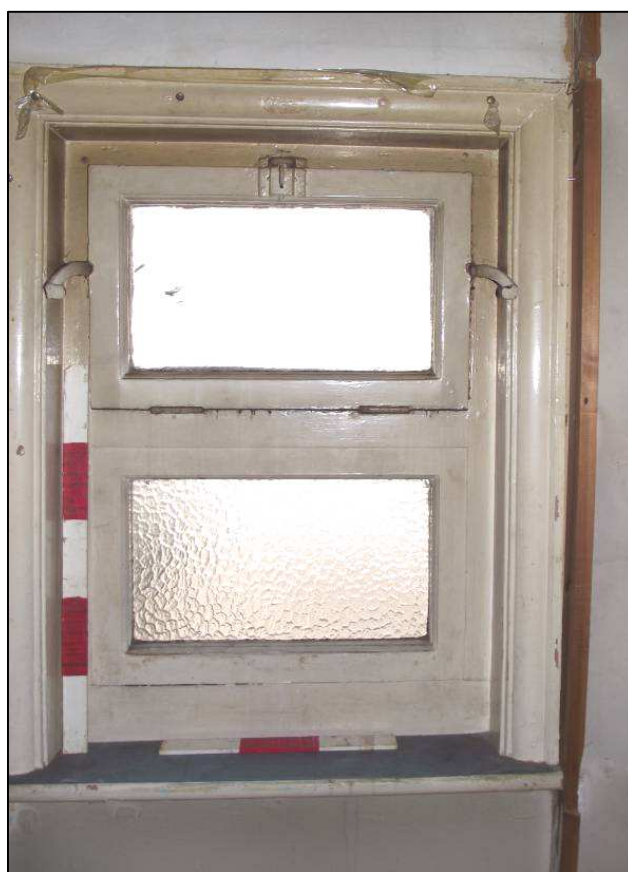
- 6.4.1 On the first floor, much of the 1960s redevelopment of the buildings and the subsequent conversion to student accommodation in 2004 had removed or concealed earlier features (Plate 20). The entire floor was given over to 26 bedrooms with en-suite bathrooms, as well as a number of small stores and connecting corridors. A number of sash windows and hopper windows with original frames of probable late 19<sup>th</sup> to early 20<sup>th</sup> century date did survive in situ however, such as a small hopper window with a fixed bottom light of frosted glass located in the north elevation of the former 5 Norman Place (Plate 21), and a sash window in the north elevation of the former 4 Norman Place (Plate 22).

**Plate 21 (Shot 25):** Small hopper window in storage area on first floor, looking north-northeast. Scales are 0.5m and 0.3m

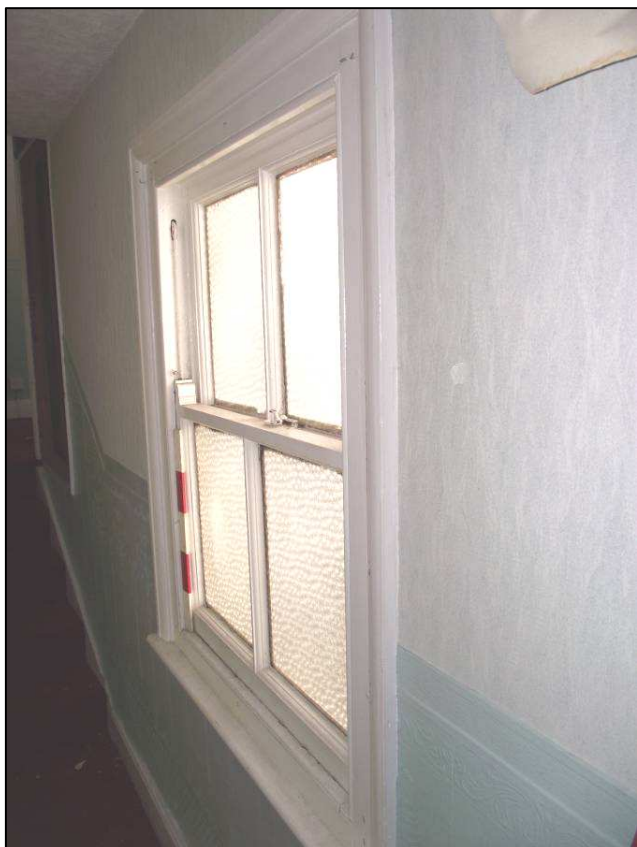
**Plate 22 (Shot 30):** Sash window on first floor, looking west-southwest. Scale is 0.5m

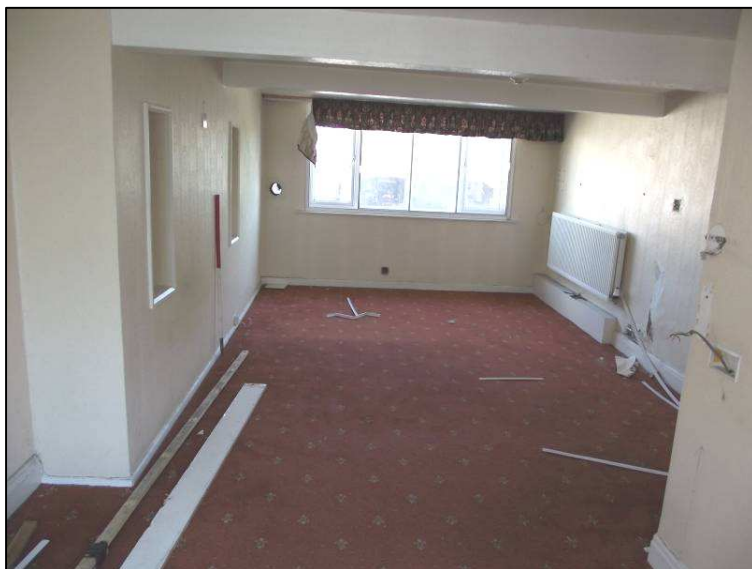
- 6.5.1 As with the previous two floors later work has disguised or destroyed most of the original features. This floor again comprised a series of en-suite bedrooms which had been modernised throughout, with a larger manager's flat in the northeast corner of the building (Plate 23).
- 6.5.2 The south range of the building had two small dog leg staircases with half landings between the first and second floors, each with slender turned balusters and plain wooden hand rail (Plate 24). In the south-west end of the south range was a third, wider dog-leg staircase with half landing with wooden panels and square newel posts.

**Plate 23 (Shot 4):** Representative shot of the managers flat on second floor, looking north. Scale is 1m
