**ARCHAEOLOGICAL WATCHING BRIEF REPORT:
BADGERS, BUNNY LANE, SHERFIELD ENGLISH, WILTSHIRE**

Planning Reference: S/2012/0231
NGR: SU 27430 24121
AAL Site Code: SEBB 12
OASIS Reference Number: allenarc1-133782

By
Allen Archaeology Limited
Report Number 2012103

November 2012

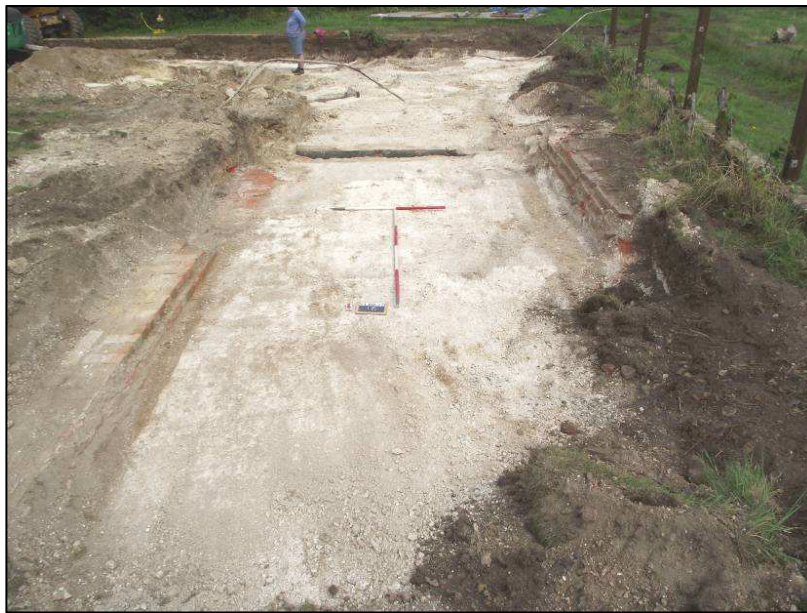
- 6.4 An east – west aligned cut for a brick-lined and stone capped culvert [119] ran across the southern part of the site. It was sealed by 102 and was vertically cut into the natural geology 116. Directly to its south were two north – south aligned brick walls 120 and 121 bonded with mortar, their relationship with 102 is uncertain.

Plate 1: General view looking north, with walls 120 and 121 in foreground and culvert 119 in middle distance. Scales are 2m and 1m

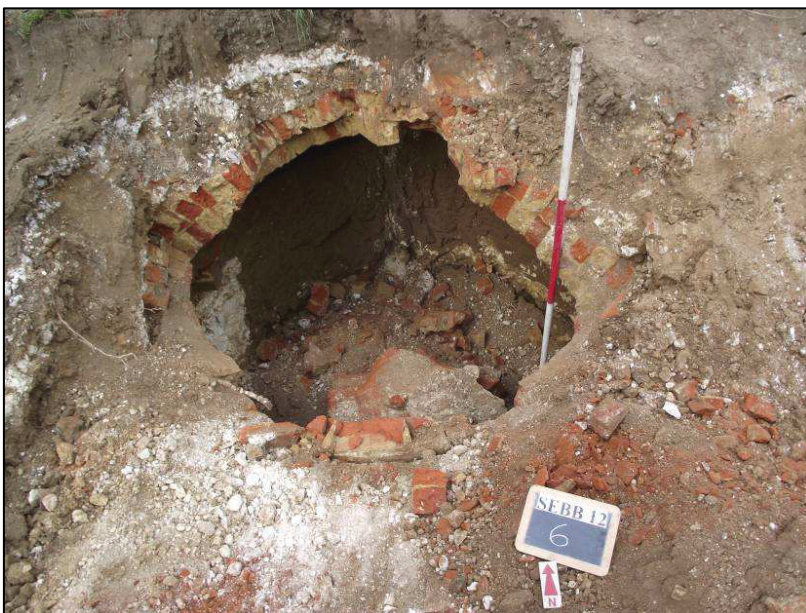
- 7.4 The 1896 and 1901 Ordnance Survey maps indicate several pumps (indicated by an italicised letter 'P') in an east – west alignment across the farmstead. One of these is likely to explain the brick cistern 126, which was lined with mortar to improve water retention, and would have been located within the former crewyard. The smaller brick built circular feature 122 was not lined with mortar, and its presence within the area of one of the buildings, with a connecting drain, suggests a function as a soakaway is more likely.

Plate 2: Brick soakaway 122, looking north. Scale is 2m

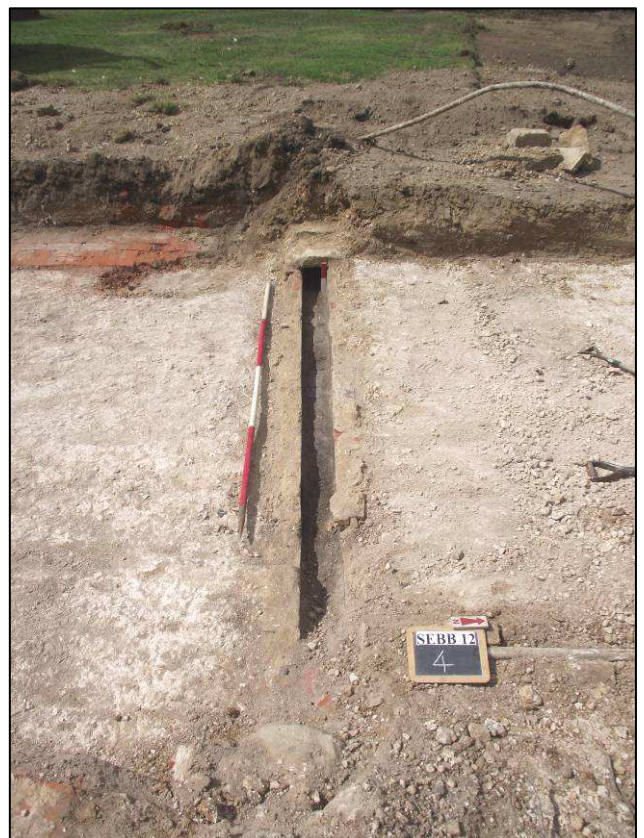
Plate 3: Culvert 119, looking west. Scale is 2m

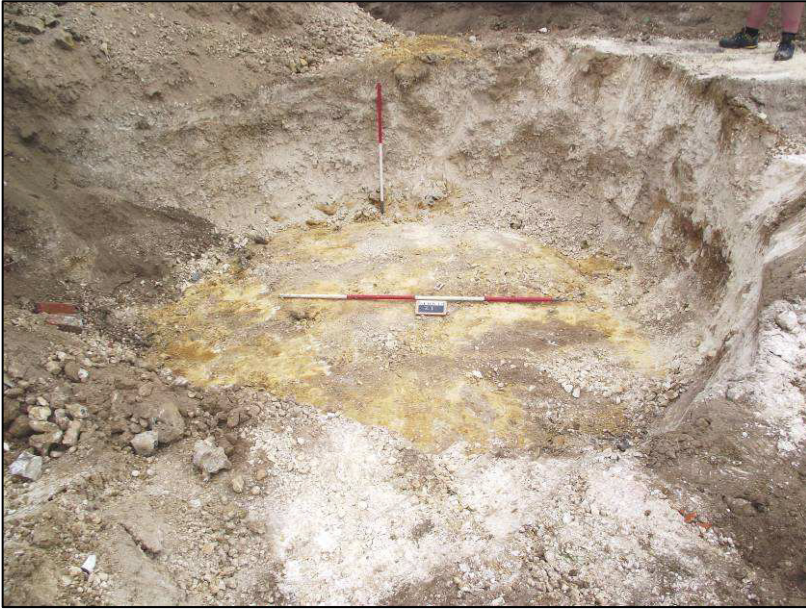
- 6.7 Wall 114 of the same brick building sealed another sub-circular quarry pit [124] which had been backfilled with redeposited natural 125.

Plate 4: Quarry pit [124], looking northwest. Scales are 2m and 1m

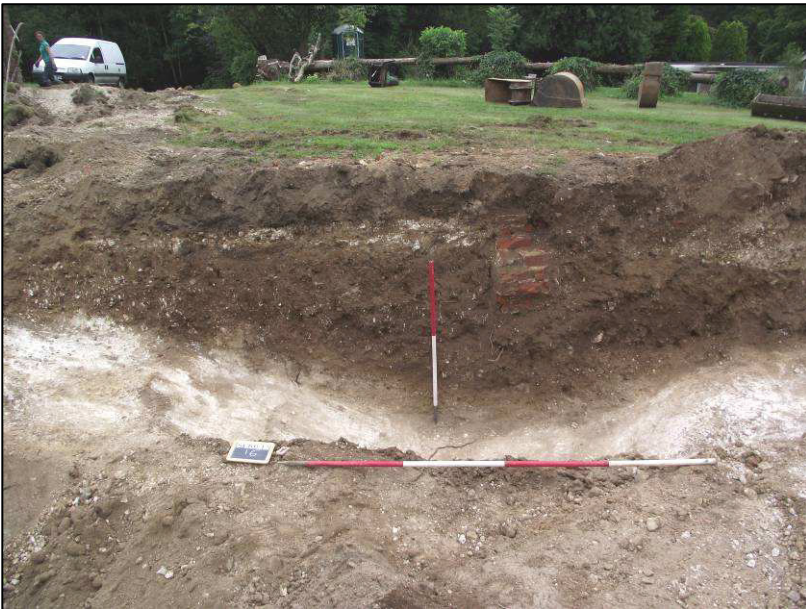
- 6.6 Below wall foundation 103 an elongated cut for a possible quarry pit [128] was recorded cutting into the natural geology. It contained two undated natural silting deposits 108 and 109, sealed by a backfill 107 of compact mid dark grey brown sandy silt with chalk and CBM fragments, occasional slate and rare clinker.

Plate 5: Quarry pit [128], looking south. Also note remains of wall 103. Scales are 2m and 1m
