ARCHAEOLOGICAL EVALUATION REPORT:

TRIAL TRENCHING ON LAND OFF SEINE LANE, ENDERBY, LEICESTERSHIRE

Planning Application: 12/08231/1/OX NGR: SP 5287 9946 AAL Site Code: ENSL 13

Allen Archaeology Limited Report Number AAL 2013026

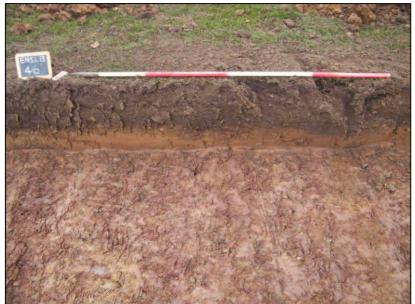
Plate 2: Representative section of Trench 16, showing the general site sequence of topsoil subsoil and natural clay, looking southeast. Scale is 2m

6.1.1 Trenches 1, 2, 3, 5, 10, 13, 15, 16, 17 and 19 contained no archaeological features. In all these trenches the sequence was the same with topsoil varying between 0.3m and 0.4m in

thickness overlying an intermittent light yellow brown silty clay subsoil up to 0.2m thick. This overlay the natural geology which consisted of a variable pink/red/brown clay with patches of gravel and sand.

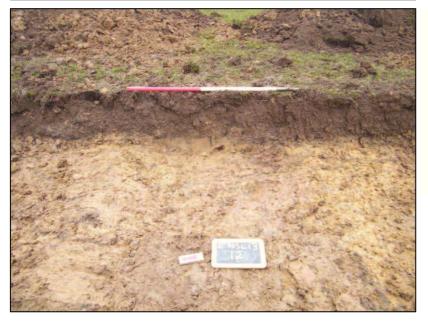
Plate 3: West facing section of furrow [605] in Trench 6, looking east. Scale is 1m

- 6.3.1 Trench 6 contained a furrow [605] which was 1m wide and 0.15m deep and running in a northeast to southwest direction, towards the north end of the trench.

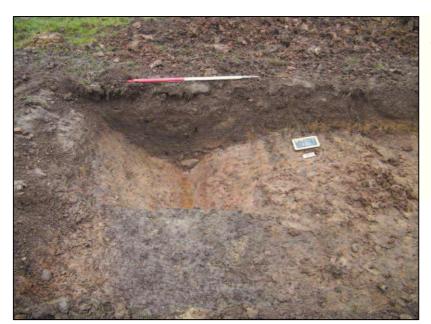
Plate 4: East facing section of field boundary [609] in Trench 6, looking west. Scale is 1m

- 6.3.2 At the southern end of Trench 6 was a ditch, [609] which ran in an east-northeast to west-southwest direction and corresponds with the course of a field boundary marked on early Ordnance Survey mapping and also identified during the geophysical survey (AAL 2012c). The ditch was 1.1m wide and 0.56m deep and showed signs of being recut by ditch [612] indicating periodic maintenance. A remnant of the primary silting of ditch [609], 610, contained creamware and whitewares dating from the 19th to 20th centuries. The silting of recut [612], 613, also contained pottery dating from the 19th to 20th centuries, a fragment of chemist bottle and a clay pipe stem dating from the 19th century. This ditch was also recorded in Trench 7 as cut [703].

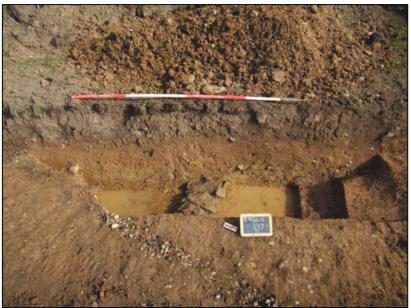
Plate 5: Southwest facing section of culvert 712 and watercourse [708] in Trench 7, showing stepped southern edge, looking northeast. Scale is 2m

- 6.4.2 Towards the southern end of Trench 7 was a broad linear feature [708] which was also observed in Trenches 8, 9 and 11 (cuts [803], [903] and [1107] respectively) and corresponds with a sinous linear anomaly running the width of the site in the geophysical survey (AAL 2012c). The nature of the feature suggests that it represents a natural watercourse that has been managed and controlled over time. [708] was c.3.7m wide and 0.6m deep although the northern edge was obscured by a land drain. The southern edge had a stepped profile, which suggests that the watercourse was maintained to a certain degree. Two silting deposits were identified, 710 and 711, which both consisted of silty clays and were devoid of finds. The silting deposits had only partially filled the channel before the insertion of a culvert 712 which

was contained with a vertical construction cut [714], backfilled with silty clay 713. The culvert was built of stone and consisted of two rows of flanking stones capped with larger flat stones and measured 0.4m wide and 0.15m high. This was sealed by a further silting event 709, which contained an 18th to 19th century sherd of pottery, window glass and a fragment of slag.

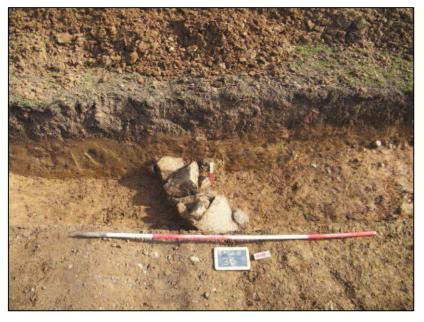
Plate 6: West facing section of culvert 907 and watercourse [903] in Trench 9, looking east. Scales are 2m and 0.2m

6.6.1 The channel observed in Trenches 7 and 8 also continued into Trench 9 as [903] where it was the only feature exposed. Here the channel was 5m wide and 0.45m deep and also contained two silting deposits, 908 and 904, which had again partially silted the channel before the stone culvert 907 was inserted. Fill 904 contained a single sherd of late 18th to 19th century creamware. The stone culvert was contained within steep sided cut [905] and was again constructed of two rows of stone capped with larger stones. A section through the culvert revealed that it was partially filled by a silty clay 909 which was only 0.03m thick, the remainder of the culvert being void in this section. The culvert construction cut was backfilled with clayey silt 906 and the whole sequence sealed by a later silting event 910. Environmental samples taken from both the primary and secondary silting of the channel, 908 and 904, recovered little other than occasional charcoal, small pieces of coal and black porous and tarry residues (see Appendix 5).

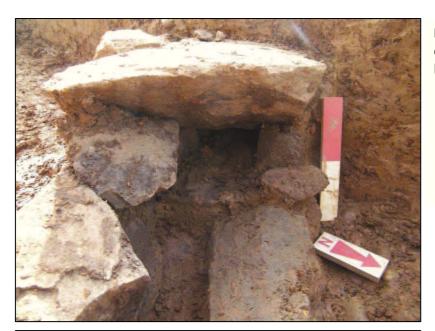
Plate 7: Northeast facing section of culvert 907 in Trench 9, looking southwest. Scale is 0.2m

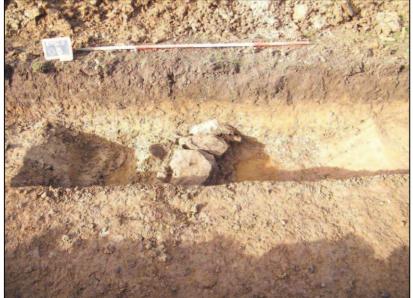
Plate 8: East facing section of culvert 1106 and recut watercourse [1103 and [1107] in Trench 11, looking west. Scale is 2m

6.7.1 The channel continued into Trench 11. Here, the original watercourse [1107] was 4.6m wide and only 0.14m deep before being recut to make a deeper, narrower channel [1103] which was 2.8m wide and 0.4m deep. Channel [1103] contained 2 silting deposits, 1104 and 1112, which was cut by construction cut [1105] for the insertion of stone culvert 1106. The culvert was again constructed of two rows of stone capped with larger stones and in this case was completely silted up with dark yellow brown clayey silt 1108. The culvert construction was backfilled with clayey silt 1110.

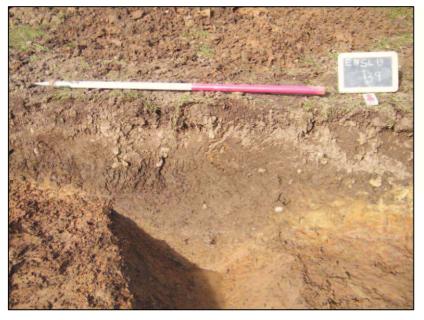
Plate 9: South facing section of field boundary [1203] in Trench 12, looking north. Scale is 2m

6.8.1 Trench 12 contained a single linear feature towards the western end of the Trench [1203]. The linear was 0.8m wide, 0.4m deep and ran in a north-northeast to south-southwest direction. It was filled with two fills 1204 and 1205 which both represent natural silting. This ditch is almost certainly a continuation of ditch [807] and can be equated with a field boundary marked on early Ordnance Survey mapping, and also identified in the geophysical survey.

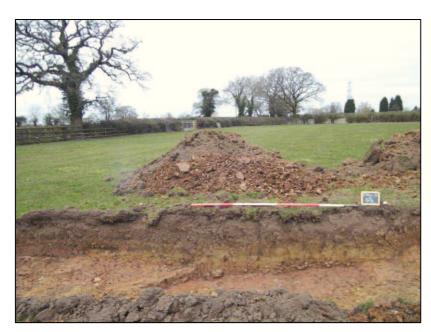
Plate 10: Southeast facing section of watercourse [1803] in Trench 18, looking northwest. Scale is 2m

- 6.10.1At the western end of Trench 18 a broad shallow linear was observed, [1803], which was recorded in the geophysical survey as a faint irregular linear anomaly. The feature was 3.8m wide, 0.4m deep and ran from the northwest to the southeast. The base of the feature consisted of a 0.05m to 0.15m thick layer of well sorted water-worn pebbles 1804 which was overlain by a yellowy grey clay silting deposit 1805, which was 0.3m thick. The pebbles had become impressed into the underlying natural 1802 and are likely to have been imported by natural alluvial processes indicating that this feature may have been a watercourse. Deposit 1805 contained a single sherd of pottery dating from the mid 16th to 18th century.
- 6.10.2Two further features were investigated in Trench 18, [1806] and [1808] which proved to be a tree throw and an animal burrow.

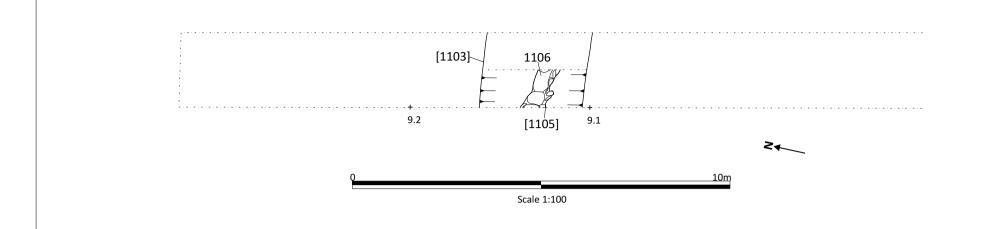
Figure 9: Plan and sections of Trench 11

6.7.2 A linear band of gravel corresponding with a geophysical anomaly was observed towards the southern end of Trench 11 and proved to be natural, likely representing a former spring or stream bed. A similar band of gravel was investigated in Trench 16, 1603, which also proved to be natural.
