ARCHAEOLOGICAL WATCHING BRIEF REPORT:

LAND OFF MANOR DRIVE, PASTON, PETERBOROUGH, CAMBRIDGESHIRE

Planning Reference: 11/01981/FUL
NGR: TF 1931 0328
AAL Site Code: PAMD 13
OASIS Reference Number: allenarc1-147766

By
Allen Archaeology Limited
Report Number 2013034

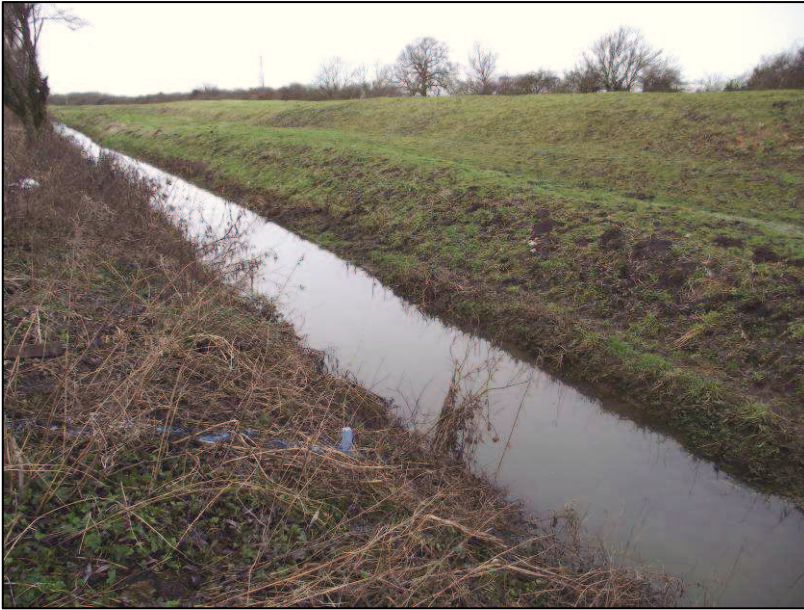
Plate 1: General shot of the Car Dyke, showing the end of the drainage trench marked out in blue, looking northwest

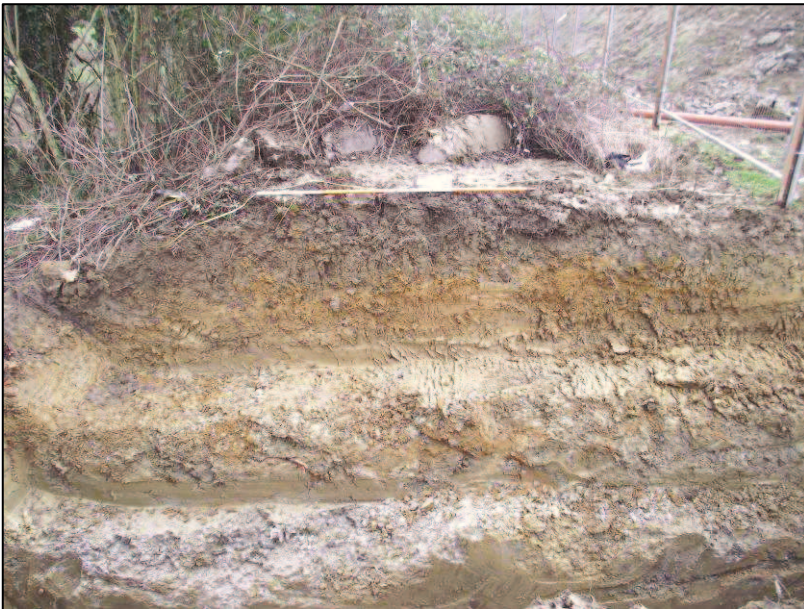
Plate 2: View of the section through the bank, looking east, showing topsoil layers 008 and 009, over bank deposits 006 and 007. Scale is 2m

- 6.5 Overlying this was a layer of yellow brown clay silt, 007, the upper limits of which merged into the overlying orange yellow clay 006. These layers extended across the whole area of the excavated trench and were up to 1.75m thick, thinning towards the northern end of the site. These layers formed the bulk of the bank deposits and appear to consist mainly of re-deposited clays.

- 6.6 The uppermost deposits in the sequence consisted of a heavily root disturbed silty deposit, 009, overlain by topsoil, 008.
- 6.7 Towards the southern end of the excavated trench, a portion of the bank deposits had been truncated by machine prior to monitoring. At the south end of the trench, a steep sided cut for a modern manhole was observed, [003], cutting through bank layer 007, and sealed by a dump of modern made ground 004.

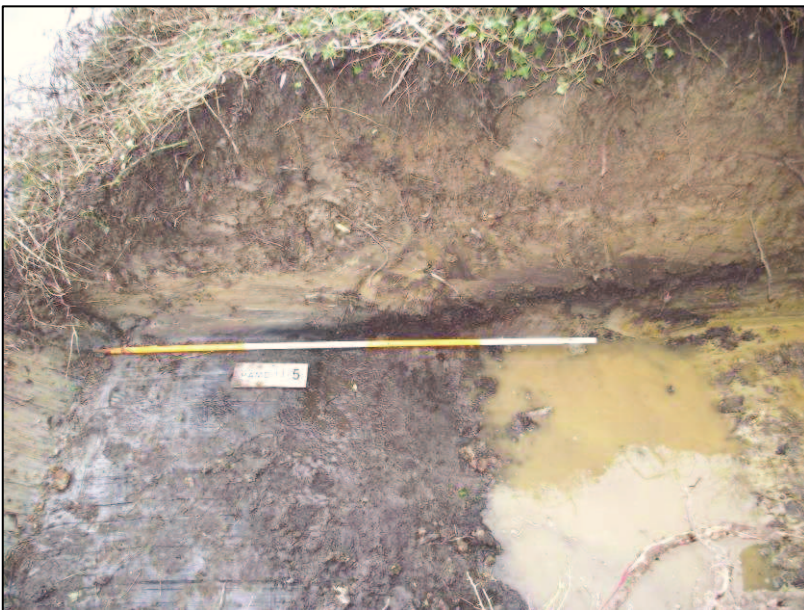
Plate 3: View of the peat layer 011, looking east. Scale is 2m

- 6.4 Partly overlying the peat, and also restricted to the northern end of the trench, was a 0.2m thick layer of silty clay with organic inclusions, 011. This again was sampled for environmental evidence, although proved to be too disturbed by modern root intrusion to be of archaeological interest.

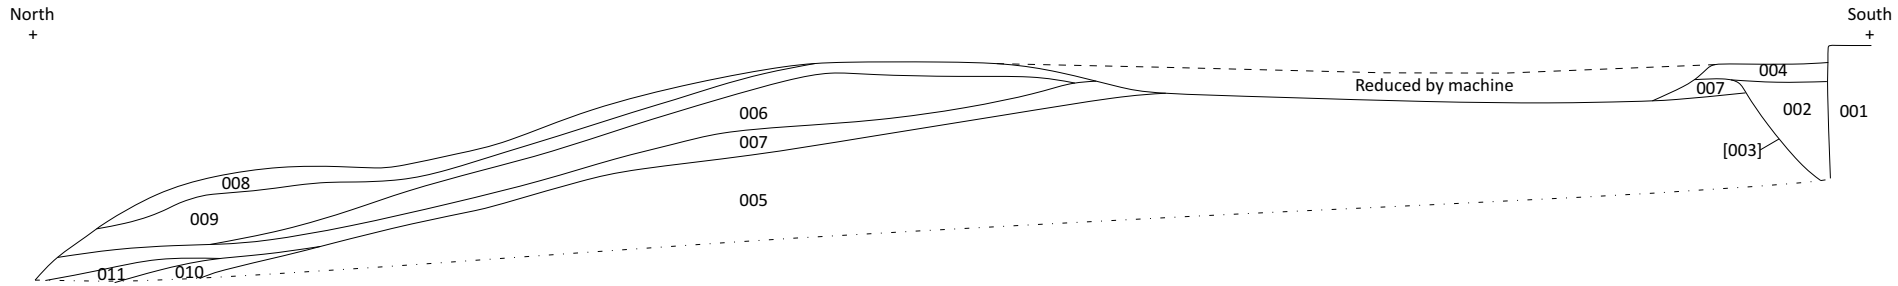
Figure 3: West facing section of the drainage trench

West Facing Section

- 6.1 The works revealed a sequence of deposits representative of ditch upcast and make-up deposits forming the southern bank of the Car Dyke.
- 6.2 The natural geology 005, consisted of a very dark grey/brown clay with a laminated structure and was observed at a depth varying between 0.5m and 1.7m below the existing ground level. The natural surfaced sloped downwards from south to north.
- 6.3 The earliest deposit sealing the natural was a peat layer, 010, which was 0.25m thick and occurred only in the northern end of the trench, adjacent to the existing dyke. This layer directly overlay the natural and was sealed by a sequence of bank deposits, and as such it had

- 7.1 The excavation revealed a sequence of deposits relating to the bank on the southern side of the Car Dyke. In this area the bank is made up of a number of dumped clay deposits to form a low wide bank rather than a high narrow bank as observed on the northern side of the existing dyke. The bank survived to a maximum height of 1.7m high from the natural ground level at its highest and extended for a distance of 20m from the watercourse. It is probable that the bank here has been levelled to a certain extent and is of similar dimensions to that observed at Thurlby, which had also been partially flattened (Simmons and Cope-Faulkner 2004, 68).
- 7.2 Although a number of soil horizons were exposed that appeared to predate the Car Dyke, the extent of modern root intrusion limited the archaeological potential and significance of these deposits.
