HISTORIC BUILDING SURVEY REPORT:
PROSPECT FARM, ALKBOROUGH, NORTH LINCOLNSHIRE

Planning Application: PA/2012/1253
NGR: SE 88282 22013
AAL Site Code: ALPF 13
OASIS ID: allenarc1-149230
North Lincolnshire Museum Site Code: AKAS

Report prepared for
Keigar Homes Limited

By
Allen Archaeology Limited
Report Number 2013045

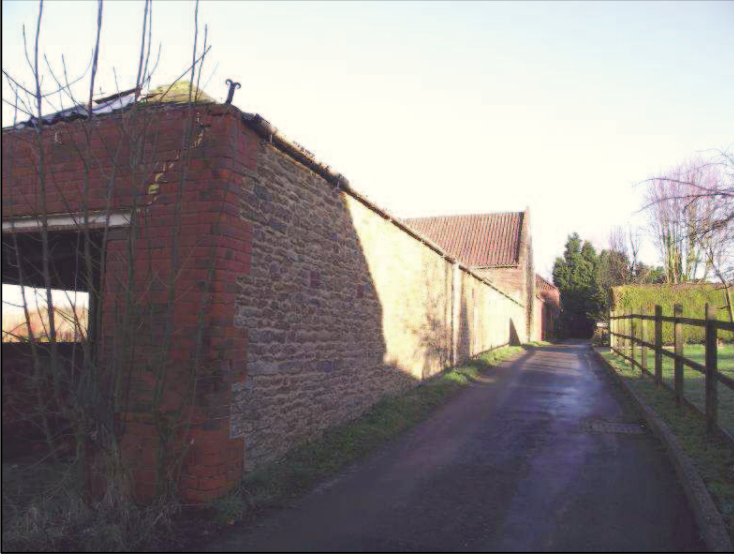
Plate 1 (Shot 2): Southeast elevation of B1, looking north. Scale is 2m

- 6.1.2 The southeast elevation appears to be original and is built in coursed stone, except for a number of bricked up ventilation holes and brick dressings to the northeastern corner. The southwest and northwest elevations are later additions in an irregular brick bond comprising three courses of stretchers followed by a course comprising paired headers separated by between one and five stretchers. Bullnose bricks have been used on the southeast and southwest corners (Plates 1 – 3).

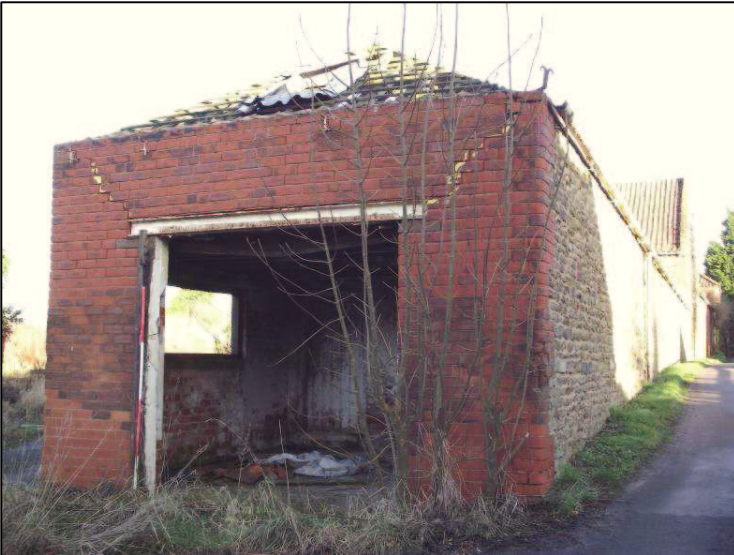
Plate 2 (Shot 3): Southwest elevation of B1, looking north. Scale is 2m

- 6.1.4 Cell B1.1 has lately been converted for use as a garage with a large opening with a steel lintel in the southwest elevation (Plate 2). It has a concrete floor and the walls showed traces of render and paint.

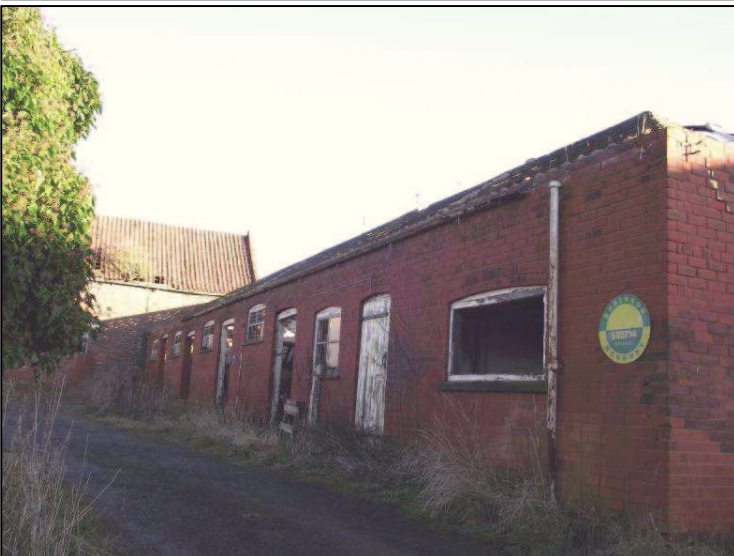
Plate 3 (Shot 4): Northwest elevation of B1, looking north-northeast. Scale is 2m

- 6.1.3 The barn is divided into six cells, all but two appear to have been used for housing livestock. The majority of openings have segmental arches with four fixed lights in louvered windows. All but one door has been removed, which was a simple wooden plank door with strap hinges (Plates 3 and 4).

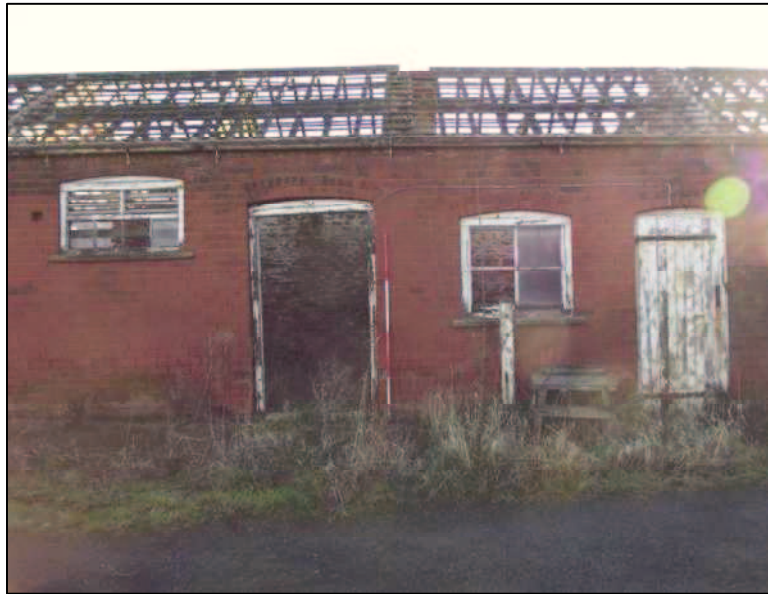
Plate 4 (Shot 5): Representative shot of B1 openings and windows, looking east-southeast. Scale is 2m

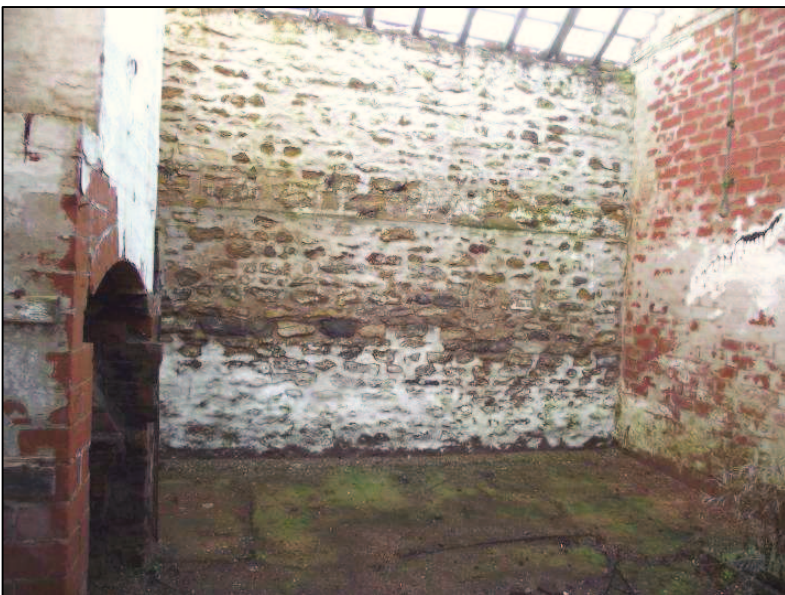
Plate 5 (Shot 8): Interior view of B1.2, looking east-southeast

- 6.1.5 Cell B1.2 contains a brick fireplace indicating it may have been used as a tack room, and rest room for farm labourers. There are two openings into cell B1.1, one at ground floor level and one at first floor level. The floor is of concrete and the walls show remnants of lime wash (Plates 5 and 6).

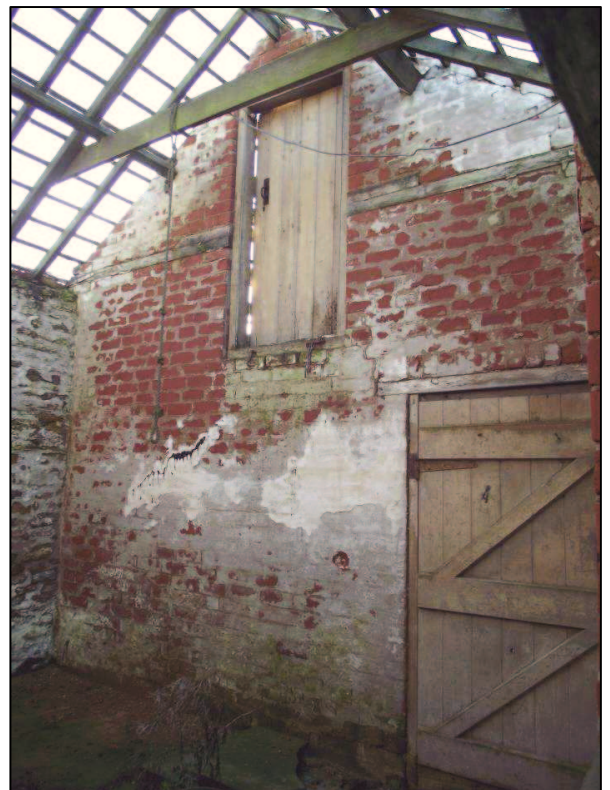
Plate 6 (Shot 6): Northeast elevation of Barn 1.2, looking southeast

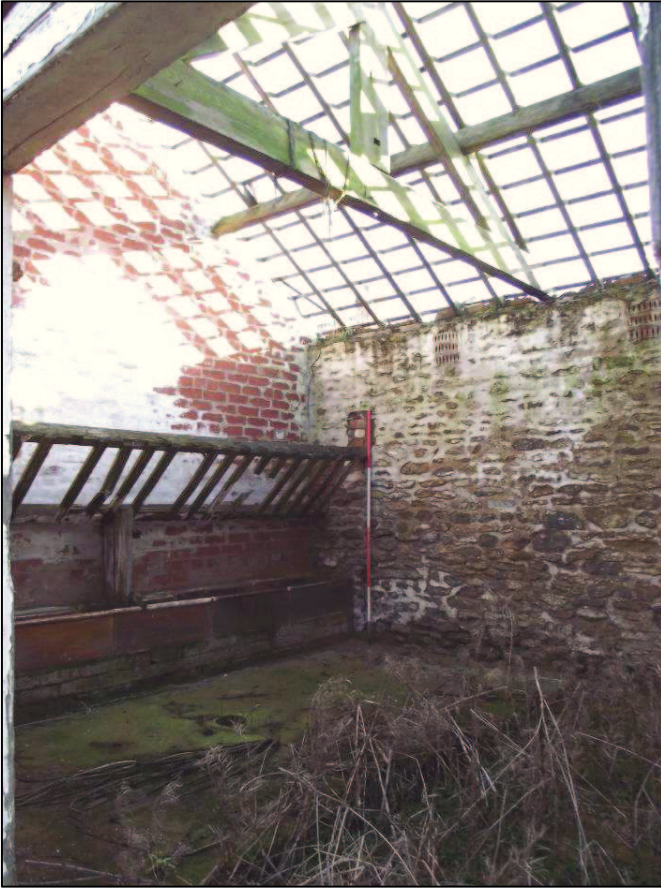
Plate 7 (Shot 9): Interior view of B1.3, looking northeast. Scale is 2m

- 6.1.6 Cells B1.3, B1.4 and B1.5 all have raised concrete floors over an earlier brick floor and ceramic feeding troughs, several of which are stamped 'Wilcock & Co.' This Leeds based company was active from c.1858, changing its name to The Burmantofts Company in 1888, thus providing a mid to late 19th century date for the troughs (<http://www.studiopottery.com/cgi-bin/mp.cgi?item=315>) Wooden hayracks are fitted above the troughs in B1.3 and B1.5. A low opening has been formed in the partition wall between B1.5 and B1.6 to allow the passage of animals (Plates 7 – 9).

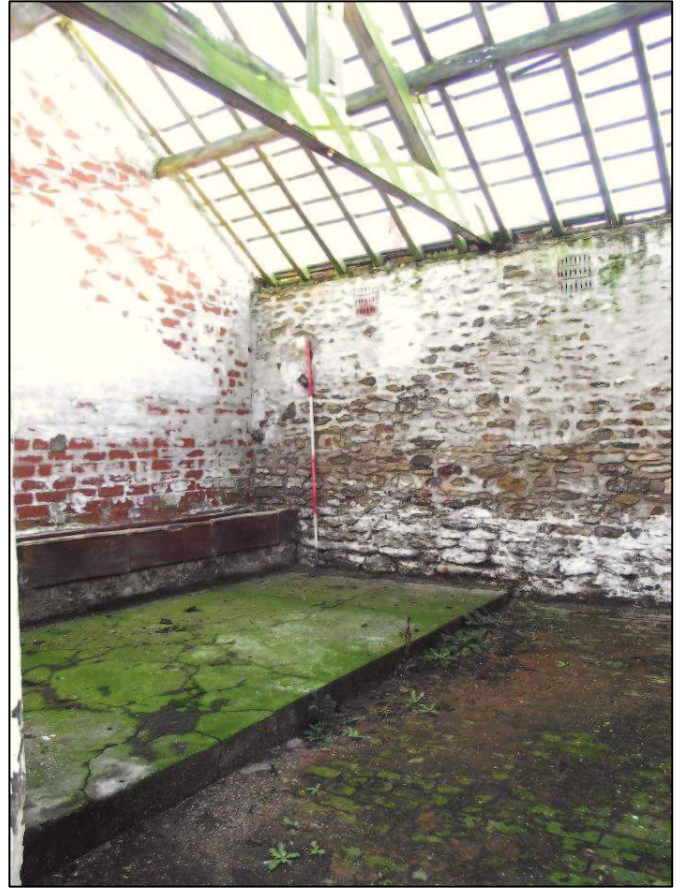
Plate 8 (Shot 10): Interior view of B1.4, looking northeast. Scale is 2m

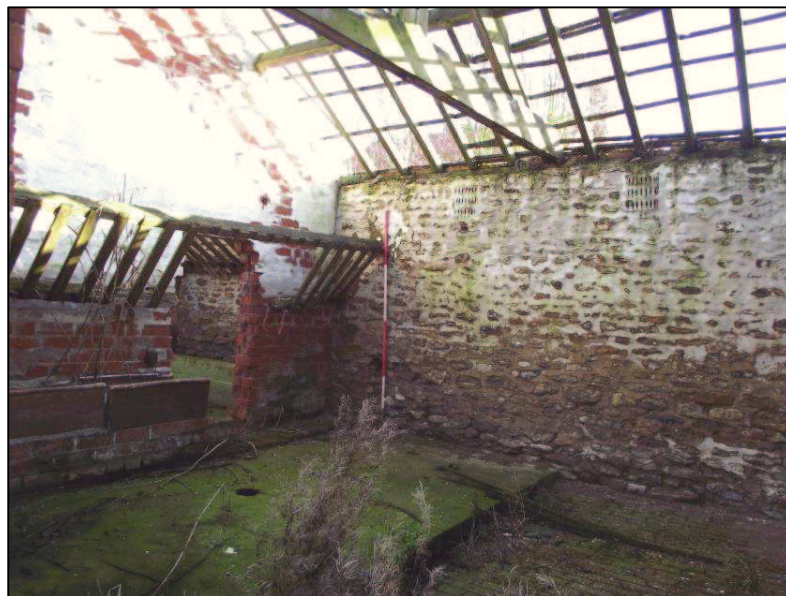
Plate 9 (Shot 11): Interior view of B1.5, looking northeast. Scale is 2m

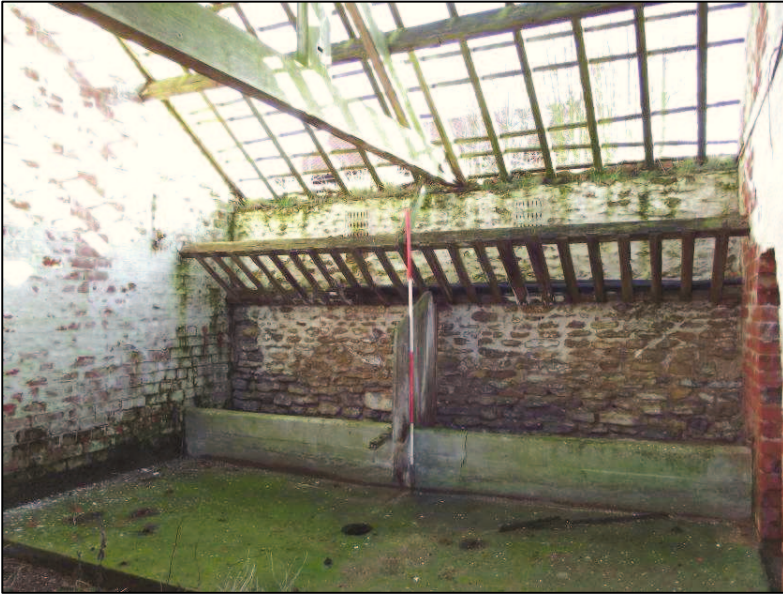
Plate 10 (Shot 12): Interior view of B1.6, looking east. Scale is 2m

- 6.1.7 Cell B1.6 also contains a feeding trough however it was made of concrete with a wooden partition (Plate 10).

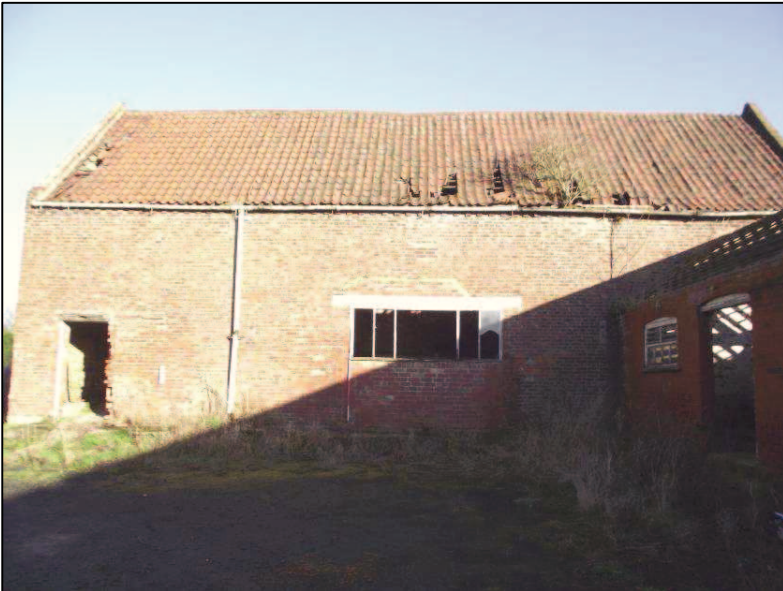
Plate 11 (Shot 13): Southwest elevation of B2, looking north-northeast. Scale is 2m

- 6.2.2 The southwest elevation is in English Garden Wall Bond with a dentil course below the eaves and is probably a later repair to the barn, the remainder of which is stone built (Plate 11). The large square opening in the centre of the elevation has been bricked up and an elongated window fitted. This opening corresponds with a second also infilled opening on the opposing elevation which allowed a throughflow of air over a central threshing floor to help carry away the chaff during manual threshing. A smaller doorway is present towards the west end of the southwest elevation.

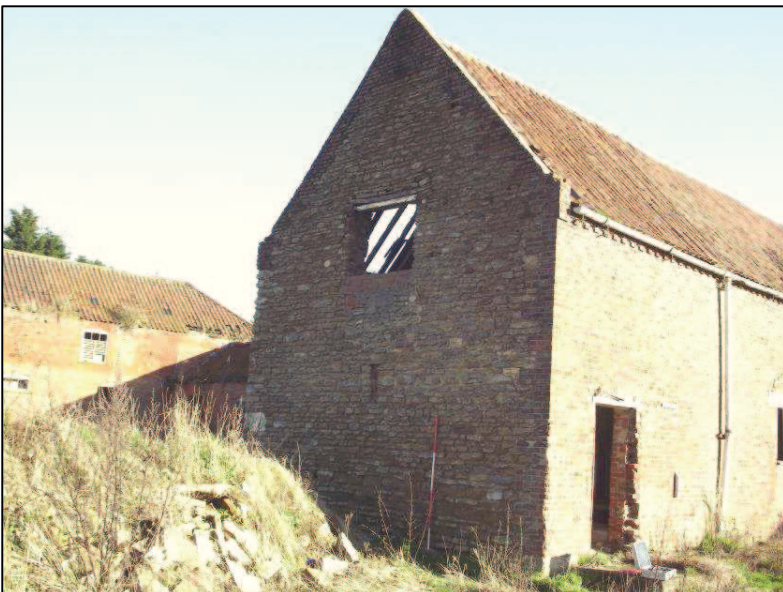
Plate 12 (Shot 17): Northwest elevation of B2, looking northeast. Scale is 2m.

- 6.2.3 The northwest elevation has a pitching hole partially infilled with bricks and stone, with a bricked up ventilation slit at ground floor level, and brick tumbling at the eaves (Plate 12).

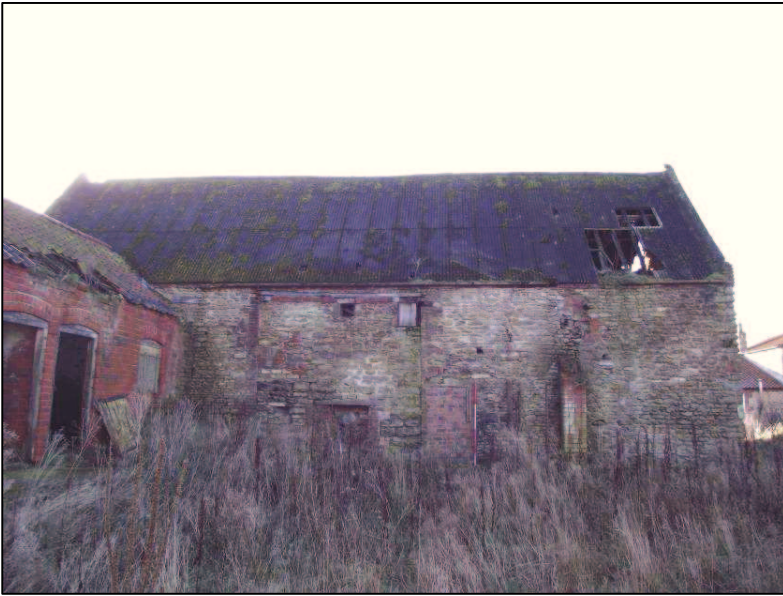
Plate 13 (Shot 19): Northeast elevation of B2, looking southwest. Scale is 2m

- 6.2.4 The large blocked opening on the northeast elevation has brick dressings, within which is a smaller infilled opening, also with brick dressings. At the top of the large infilled opening are two small square openings of uncertain function, and there is another bricked up opening adjacent to the west. The elevation also displays a brick buttress with bullnose bricks which is a remnant of a demolished farm building or covered yard (Plate 13). This corresponds with a similar buttress and roof scar on the opposing elevation of Barn 4 to the north (see 6.4.2 below).

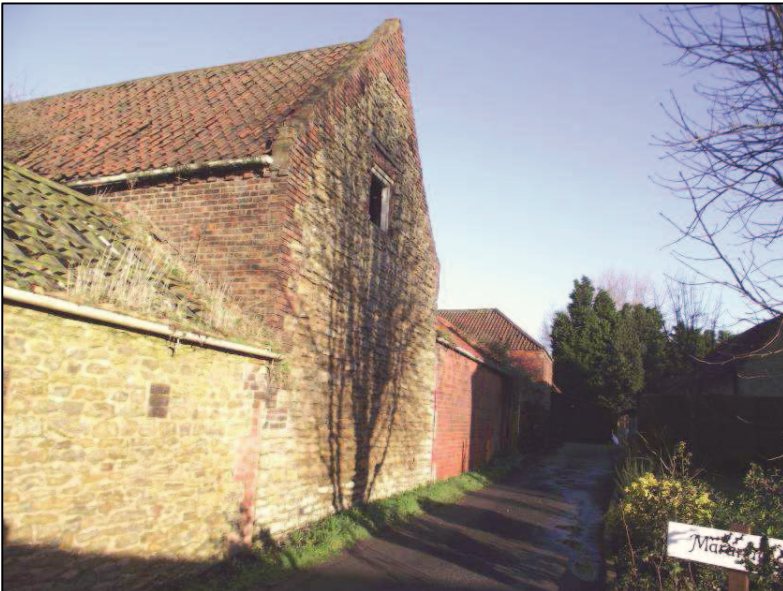
Plate 14 (Shot 1): Southeast elevation of B2 and B3, looking north. Scale is 2m

- 6.2.5 The southeast elevation has a square pitching hole with a lintel and flat brick arch, with brick dressings, brick tumbling at the eaves and an area of brick repair at the apex of the roof (Plate 14).

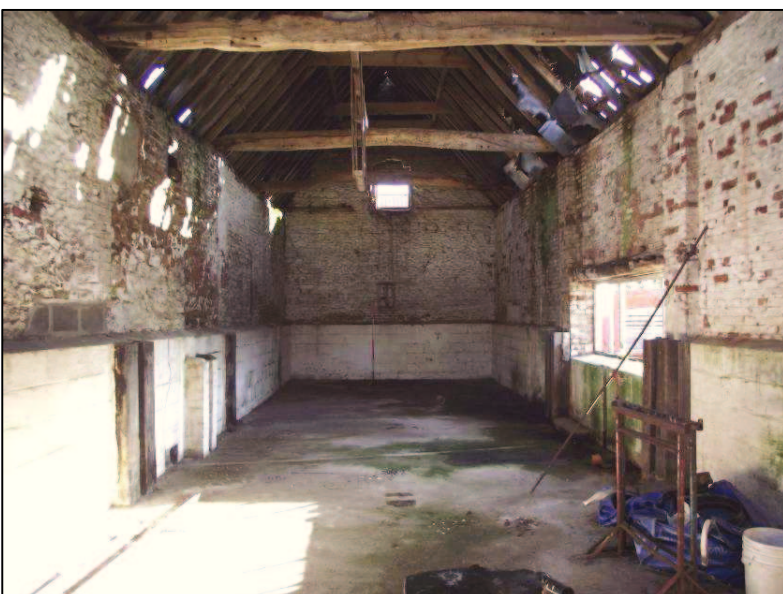
Plate 15 (Shot 14): Interior view of B2, looking east-southeast. Scale is 2m

- 6.2.6 The threshing barn has a clasped purlin roof which is a later addition. The notched timber beams resting on the wall plates may be original however. The walls were painted and a reinforcing breeze block runs along all but the northwest elevation (Plate 15).

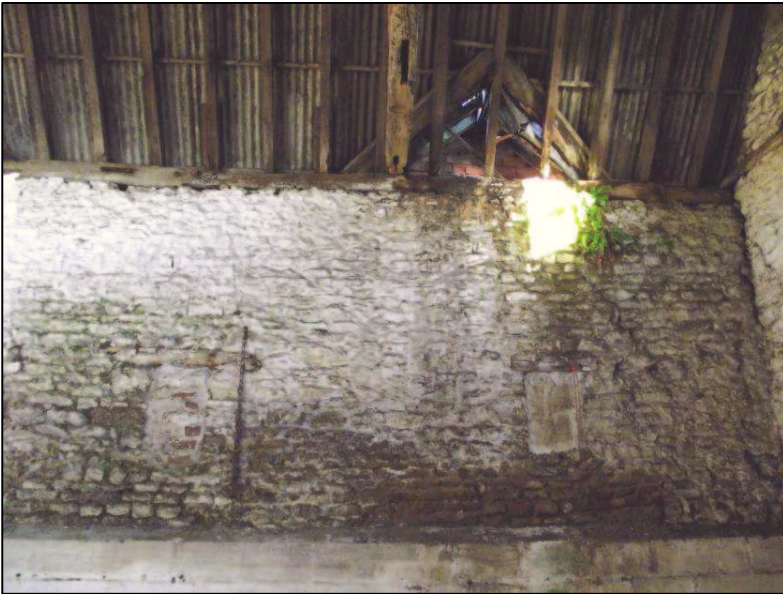
Plate 16 (Shot 16): Blocked up openings on northeast elevation, also showing the adjoining B3, looking northeast

- 6.2.7 The northwest elevation shows two blocked up openings likely to be ventilation slits, above which the adjoining roof of Barn 3 can be seen (Plate 16).

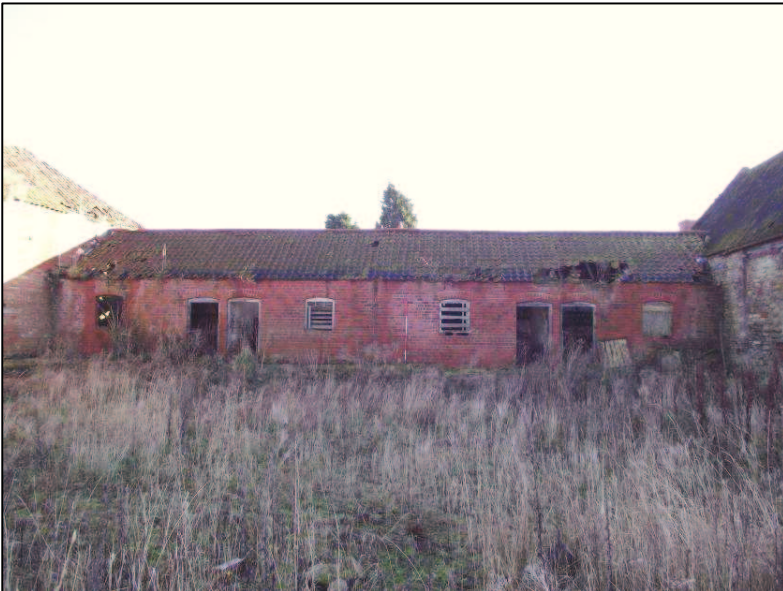
Plate 17 (Shot 20): Northwest elevation of B3, looking east-southeast. Scale is 2m

- 6.3.1 Barn 3 is aligned north-northeast to south-southwest and measures 4.5m x 20m, and is very similar in style to Barn 1, built in an English Garden Wall Bond brickwork with three courses of stretchers to each course of headers. The double pitched gabled roof is covered in S-shaped ceramic pantiles and the four doorways and four windows in the northwest elevation all have segmental brick arches (Plate 17).
- 6.3.2 The building has a king post roof with trenched purlins, and is subdivided into four cells, the layouts of which are very similar to those of Barn 1. All four had a stepped concrete floor, and B3.3 had a central drainage channel. The brick and ceramic feeding troughs had up to four tethering rings for livestock with wooden hayracks fitted above. There was a small opening for livestock formed in the partition wall between B3.3 and B3.4 (Plates 18 – 22).

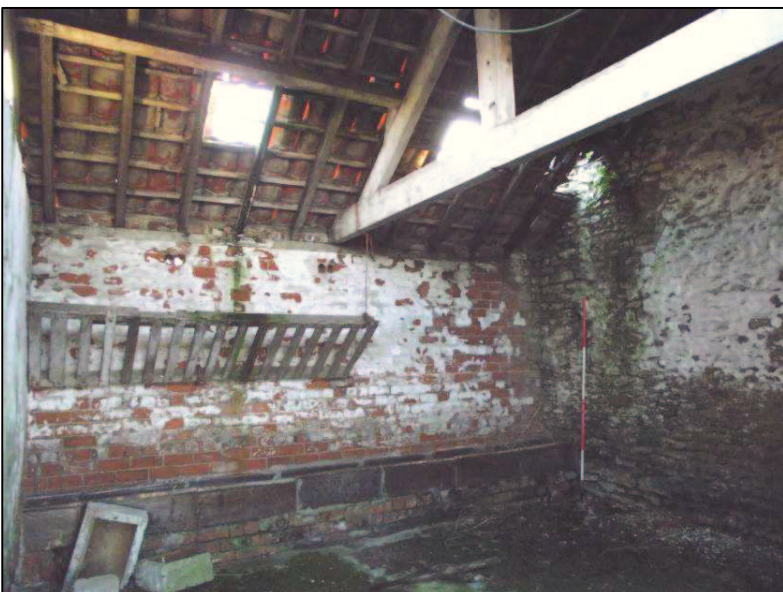
Plate 18 (Shot 21): Interior view of B3.1, looking southeast. Scale is 2m

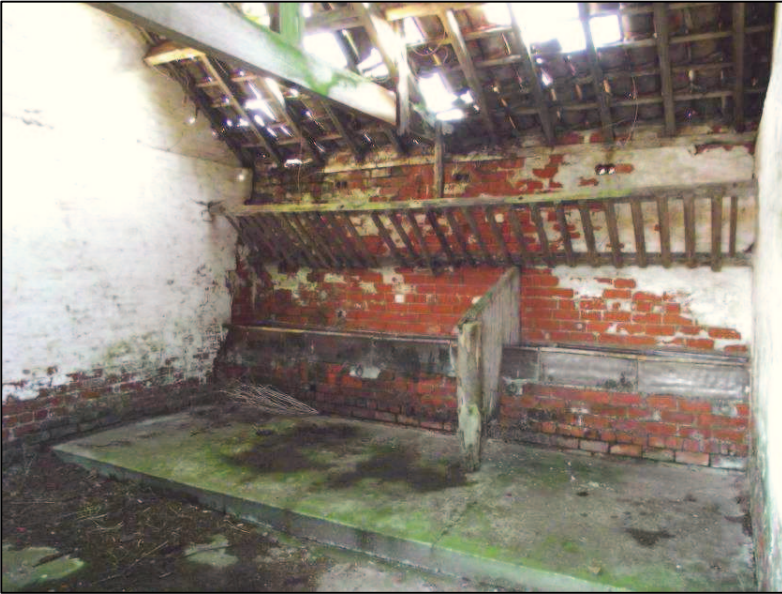
Plate 19 (Shot 22): Interior view of B3.2, looking northeast

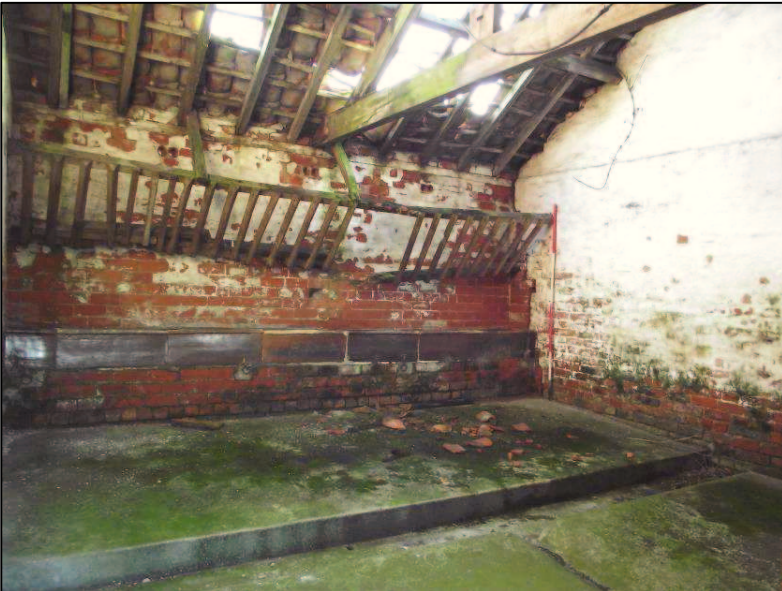
Plate 20 (Shot 23): Interior view of B3.3, looking southeast. Scale is 2m

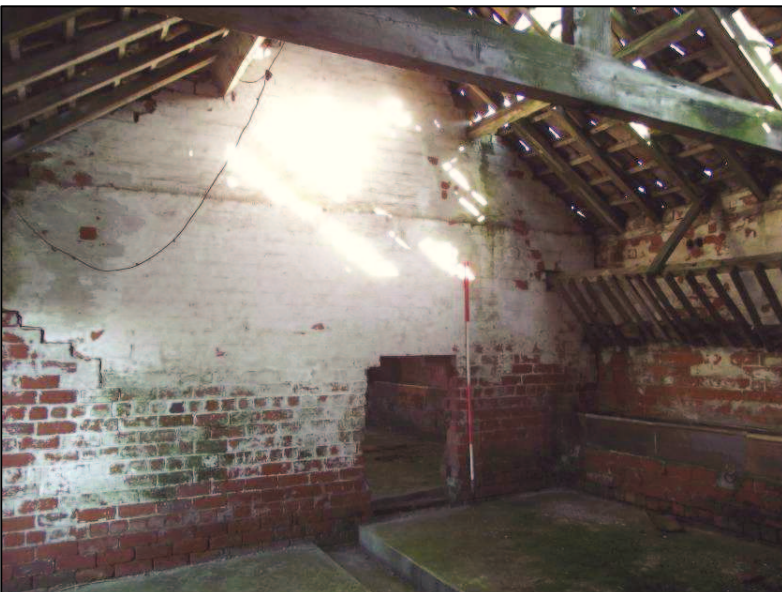
Plate 21 (Shot 24): Interior view of B3.3 with opening formed to B.3.4, looking northeast. Scale is 2m

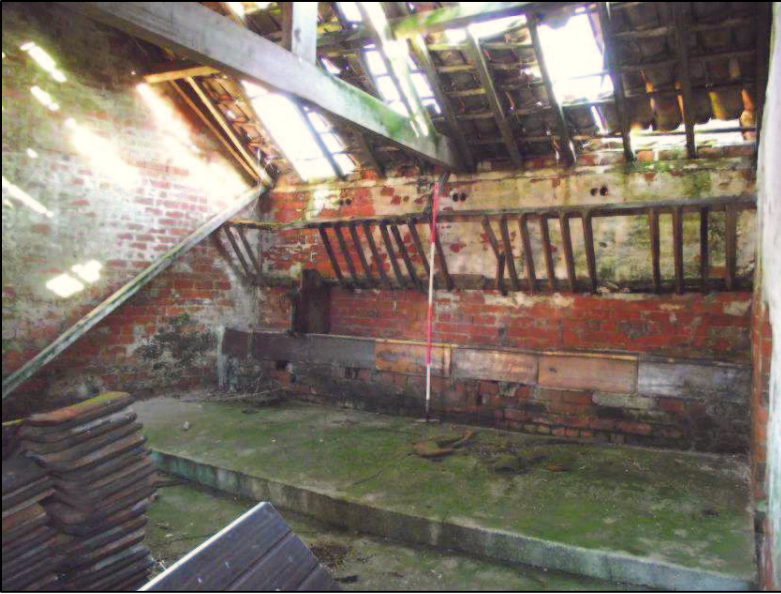
Plate 22 (Shot 25): Interior view of B3.4, looking east. Scale is 2m

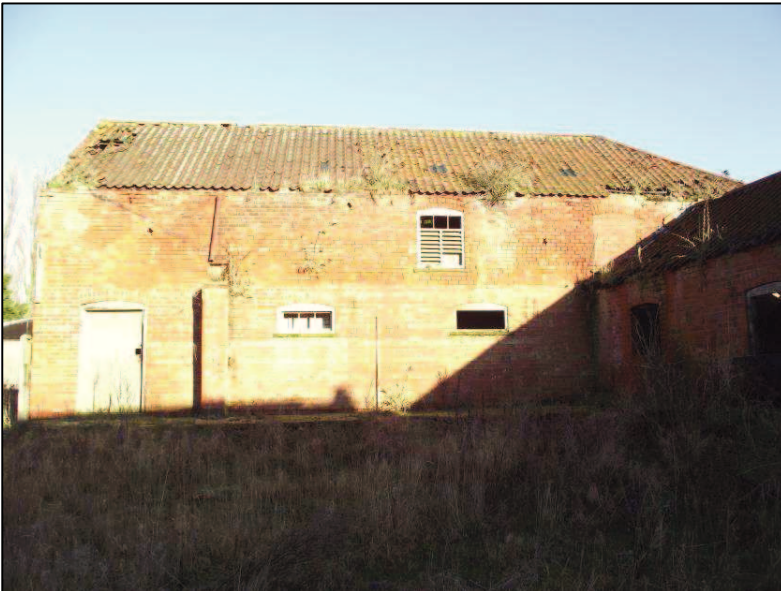
Plate 23 (Shot 26): Southwest elevation of B4, looking north-northeast. Scale is 2m

- 6.4.2 The brickwork on the ground floor of the southwest elevation appears later in date than the first floor, and a similar brickwork has been used to block one of the two openings on the first floor. This blocked opening is partially covered by the roof of Barn 3 and it is possible that the opening was blocked immediately prior to its construction. A roof scar and brick buttress on this elevation correspond with the buttress on the opposite elevation of Barn 2 (Plate 23 and see 6.2.4 above). The ground floor had two small windows and a single door opening, all with segmental arches, with a louvered window on the first floor.

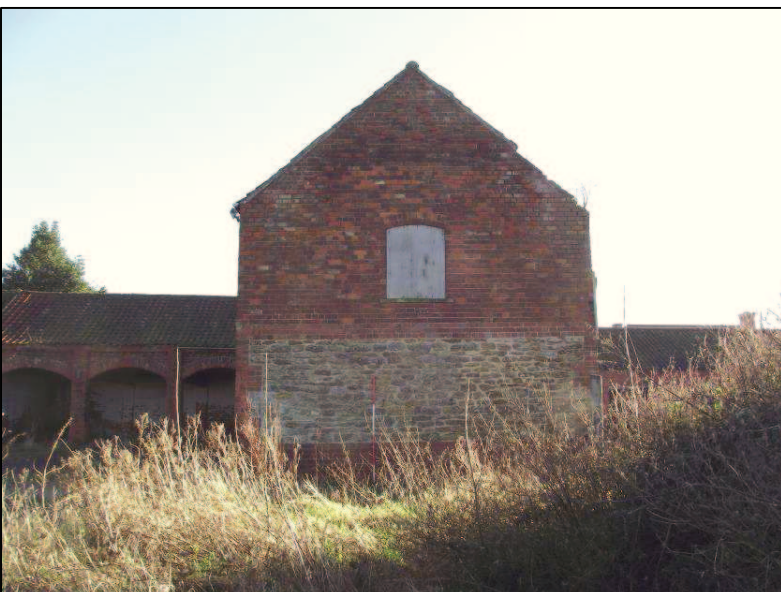
Plate 24 (Shot 27): Northwest elevation of B4, looking northeast. Scale is 2m

- 6.4.3 The northwest gable has a single opening; a boarded up pitching hole below a segmental arch (Plate 24).
- 6.4.4 The northeast elevation has a single doorway and two louver windows on the first floor, one of which is within the roof space of the adjacent Barn 5. It is likely that there would originally have been steps leading up to the doorway, however there were no trace of these during the survey.

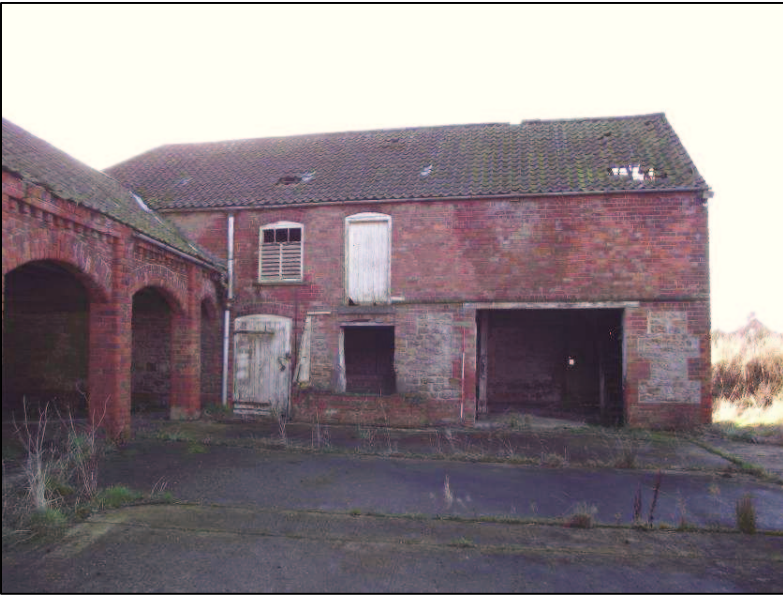
Plate 25 (Shot 28): Northeast elevation of B4, looking northeast. Scale is 2m

- 6.4.5 The ground floor had a single blocked window within Barn 5, a plank and batten door with strap hinges, a square window opening, and large square opening wide enough to fit a cart (Plate 25). All but this final opening had segmental arches above.

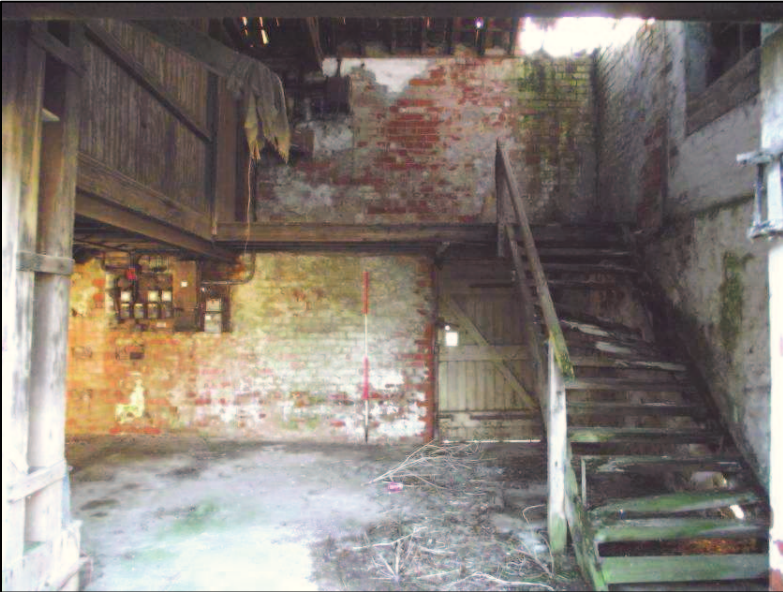
Plate 26 (Shot 33): Southwest elevation and stairs leading to the loft, looking southwest. Scale is 2m

- 6.4.6 The interior of the granary had been subdivided to accommodate grain processing machinery. A brick silo was connected to the smaller square opening on the northwest elevation and adjacent to this was a chain conveyor with connections to the above loft. There was a derelict wooden staircase to the loft, although it was not safe to access the upper floor during the site visit (Plates 26 and 27).

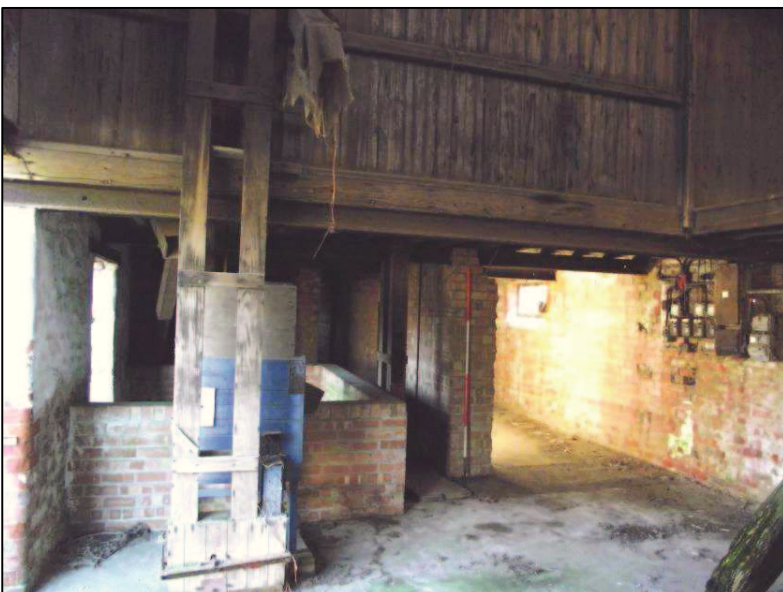
Plate 27 (Shot 29): Interior view of B4, looking southeast. Scale is 2m

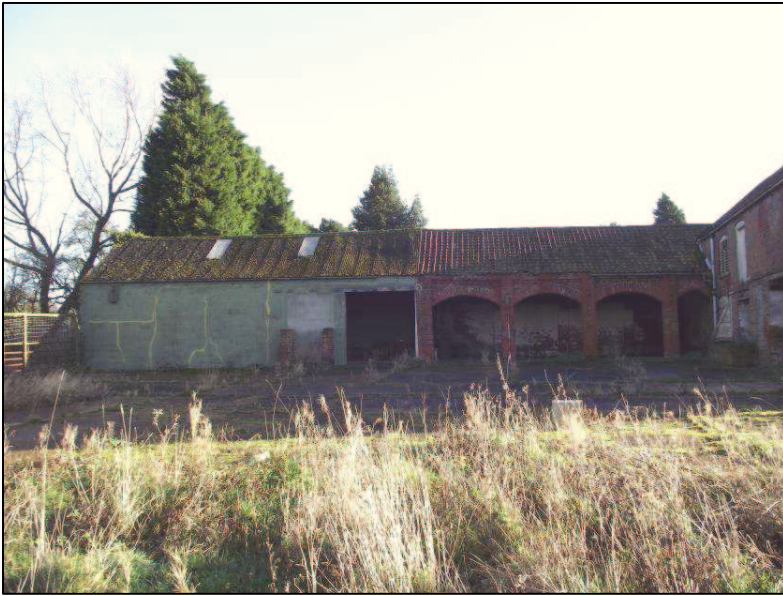
Plate 28 (Shot 34): Northwest elevation of B5, looking southeast. Scale is 2m

- 6.5.1 Barn 5 comprised a cart shed B5.1, measuring 6m x 12m and a later shed B5.2 to the northeast measuring 6m x 13m. The cart shed is a four bay building in English Garden Wall bonded bricks with a double pitched gabled roof covered with S-shaped ceramic pantiles and a dentile cornice. The cartshed has three large arched openings and a smaller opening at the east end, all with brick segmental arches on pillars with bullnose bricks at the corners (Plates 28 – 30).

- 6.5.3 The abutting shed B5.2 was mainly built of breeze blocks apart from the northeast elevation, which was in brick. There were two large square openings, one in the northwest elevation and one in the northeast elevation. Two brick pillars to support a fuel tank were situated next to the opening on the northwest elevation. The double pitched gabled roof was covered in corrugated asbestos sheets (Plates 28 and 32).

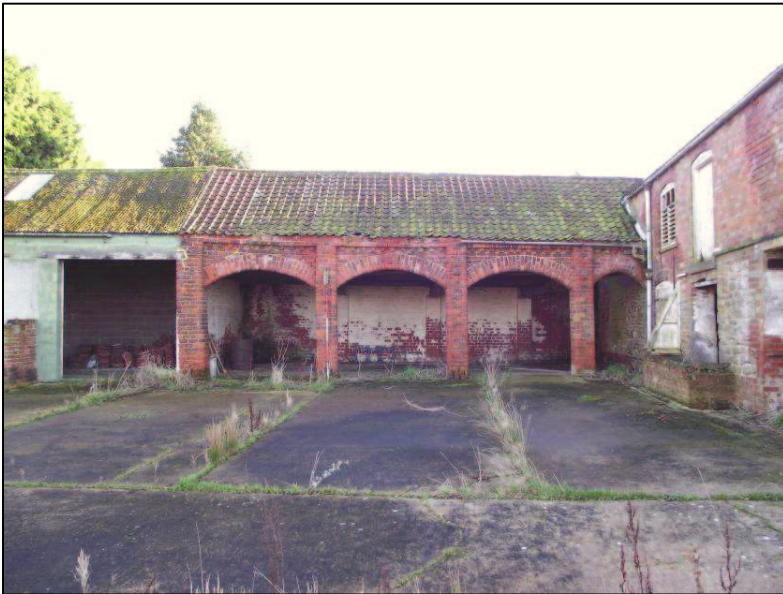
Plate 29 (Shot 35): Northwest elevation of B5.1, looking southeast. Scale is 2m

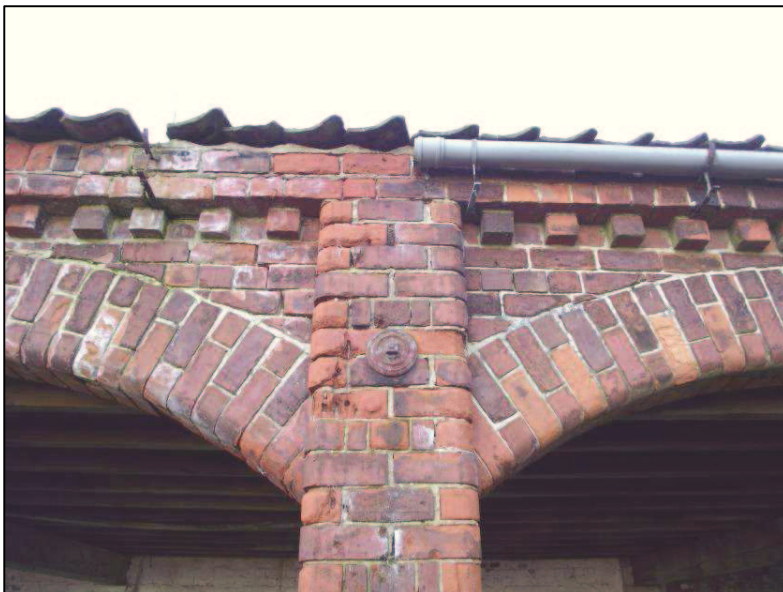
Plate 30 (Shot 41): Representative detail shot of dentilation, pillar and arches, looking southeast

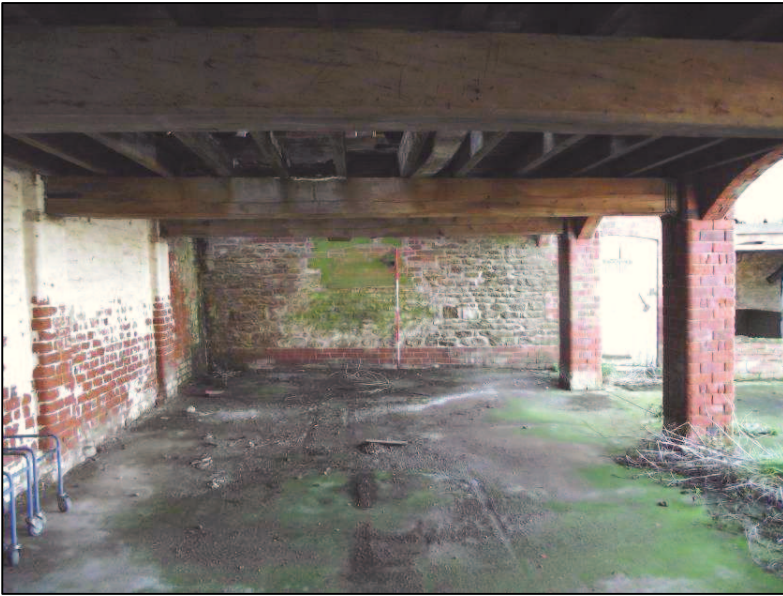
Plate 31 (Shot 36): Interior view of B5.1, looking south-southwest. Scale is 2m

- 6.5.2 The adjacent concrete yard surface has been extended into the cart shed and above was a loft space which could be accessed from the granary, but was again unsafe to enter (Plate 31). There was another opening into the loft space in the northeast elevation (Plate 33).

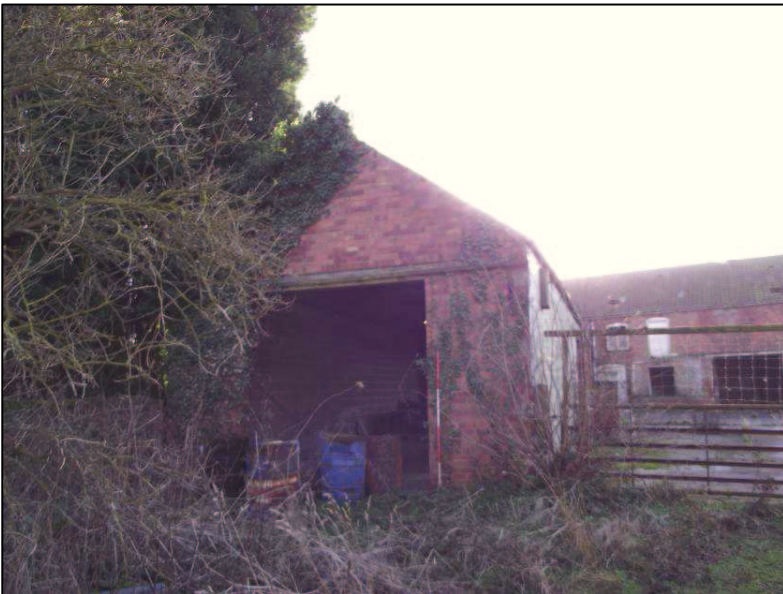
Plate 32 (Shot 40): Northeast elevation of B5, looking south-southwest. Scale is 2m

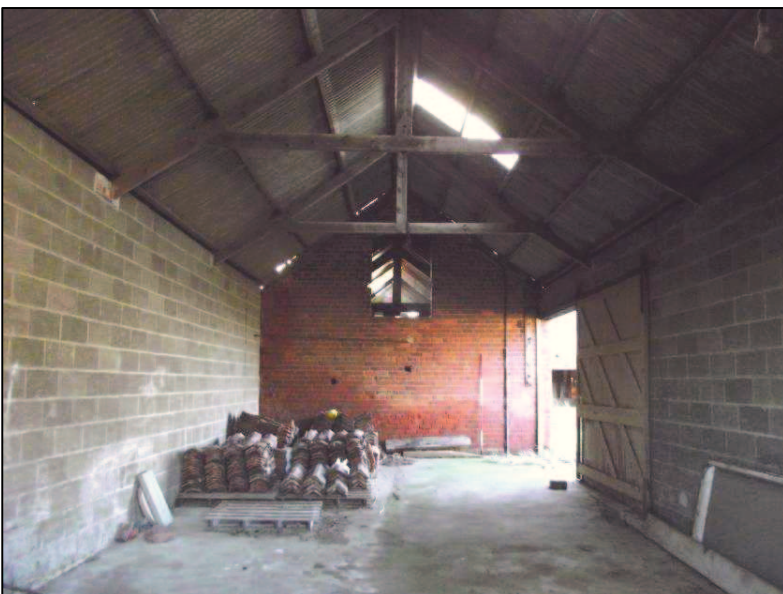
Plate 33 (Shot 39): Interior view of B5.2, looking south-southwest. Scale is 2m

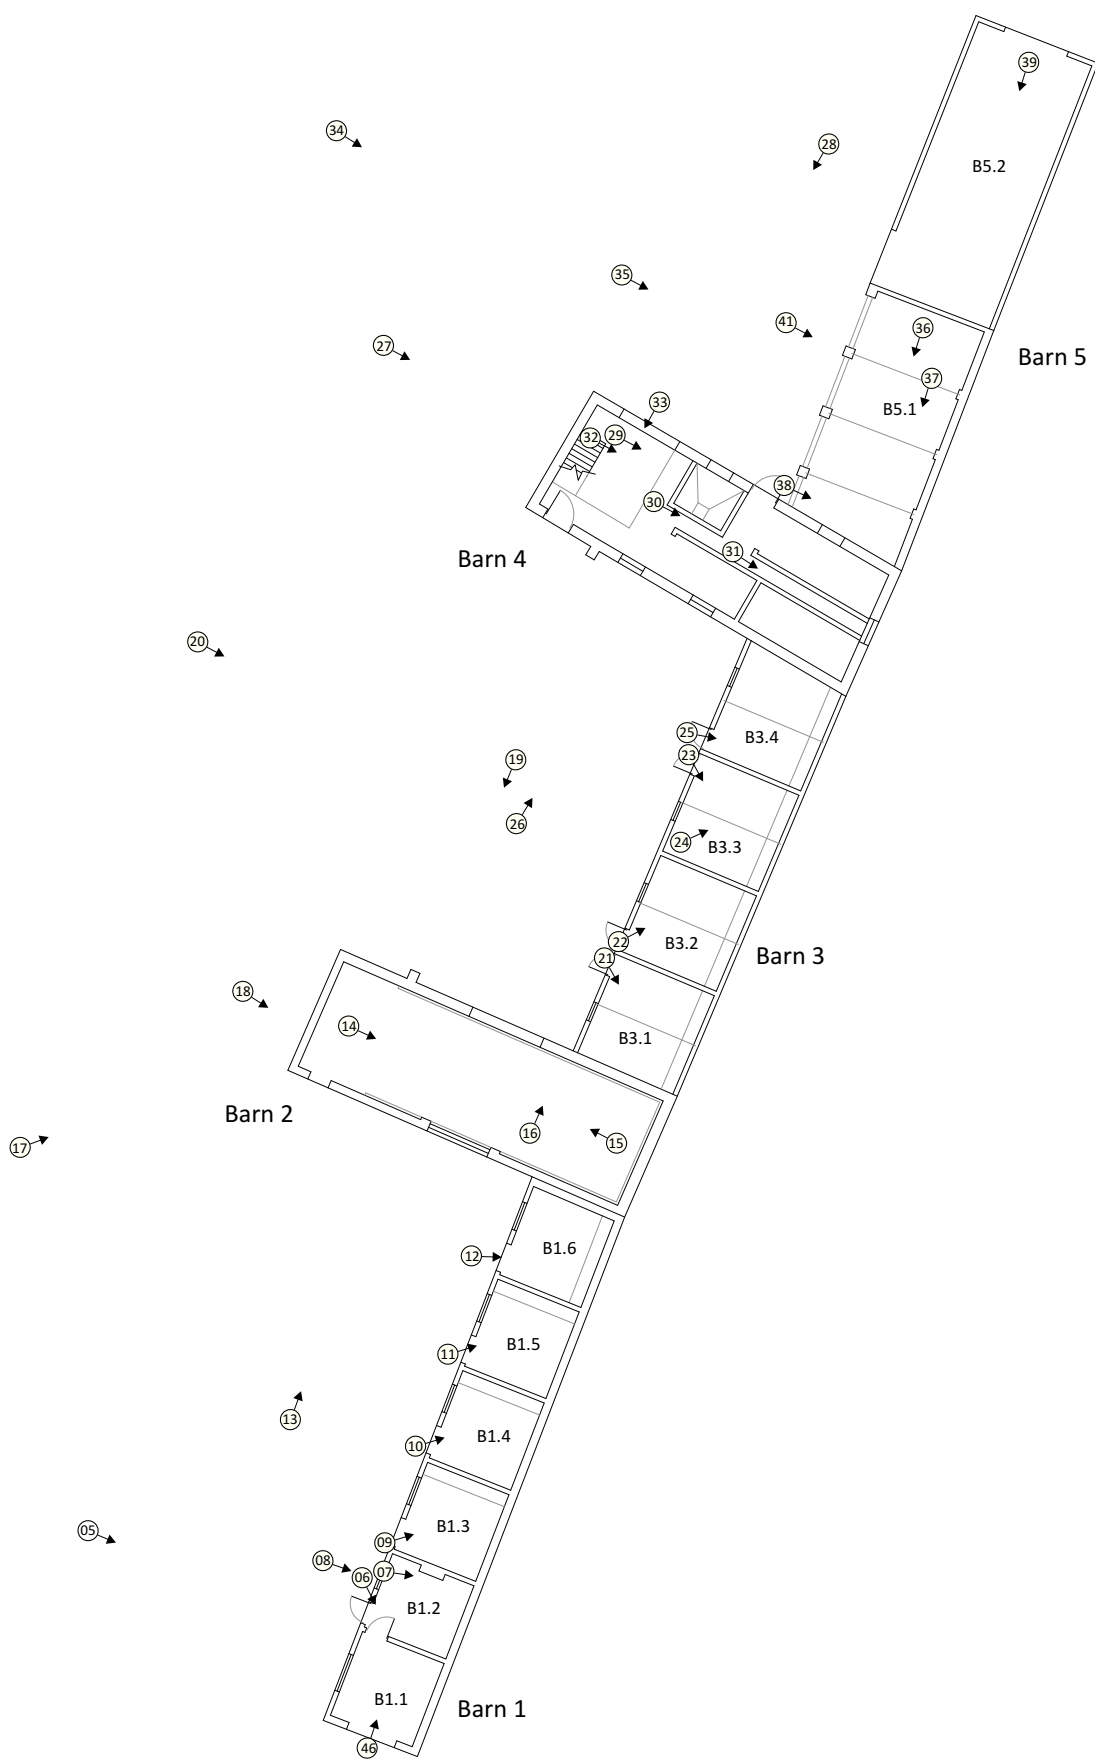
Figure 3: Existing ground floor plan showing location and direction of photographs taken during the building survey
(Base plan provided by Keigar Homes)
