HISTORIC BUILDING SURVEY REPORT:
HUTTS FARM, ELLASTONE, STAFFORDSHIRE

Planning Application: P/2012/01103
NGR: SK 12700 44400
AAL Site Code: ELLA 13
OASIS ID: allenarc1-149662

By
Allen Archaeology Limited
Report Number 2013048

May 2013

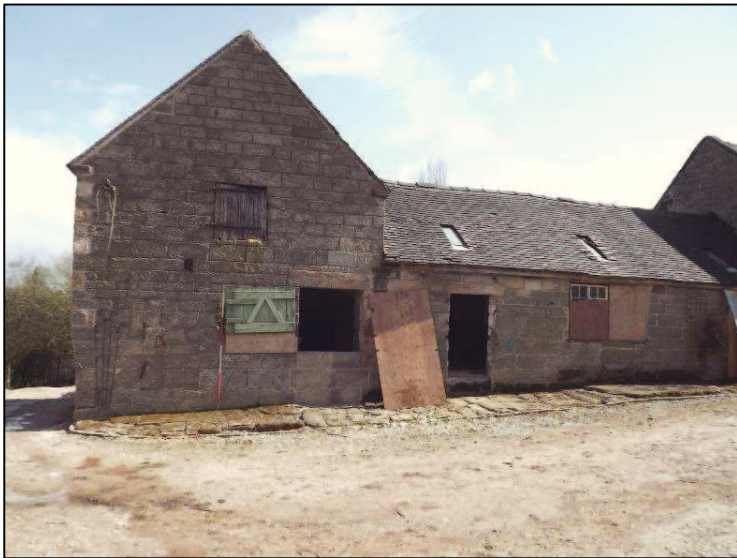
- 6.1.1 Barn A is square in plan and measures c.7 x 7m. It is a two storey ashlar stone structure with stone cornice at the eaves, returning at the gables. The double pitched gabled roof is covered in plain ceramic tiles with two new roof lights facing northwest (Plates 1 - 4).

Plate 1 (Shot 1): Southwest elevation of Barn A. Scale is 2m

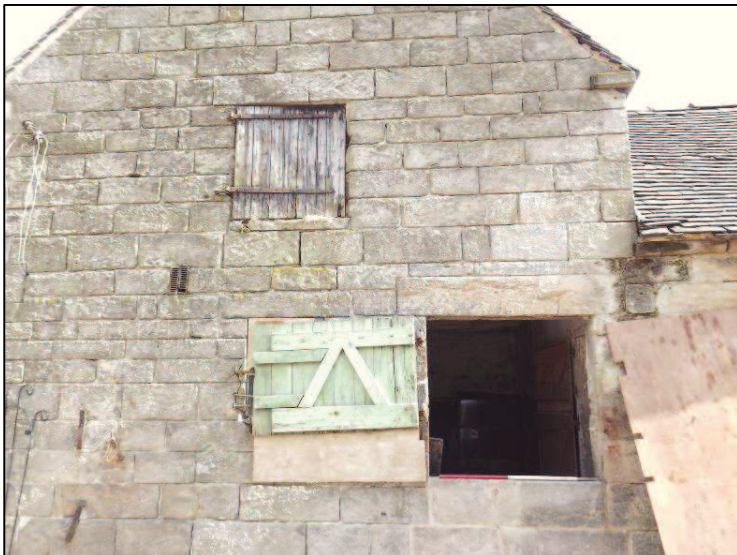
- 6.1.2 The southwest elevation has three square openings: a loft pitching hole just below eaves level with a wooden door on 18th century style spearhead shaped strap hinges; a small boarded up window opening directly below, and a later square window with stone lintel on the southwest corner, formed from infilling the lower part of a doorway (Plate 2).

Plate 2 (Shot 3): Openings on the southwest elevation, looking northeast. Scale is 1m

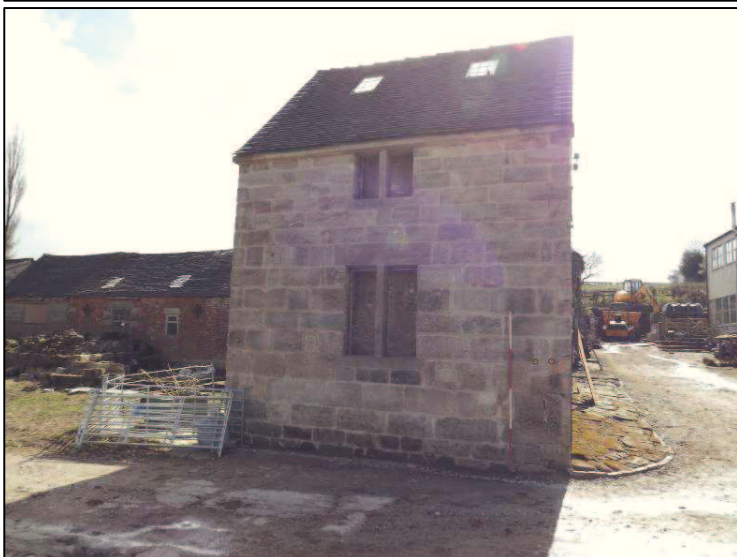
- 6.1.3 The entire northwest elevation has been recently rebuilt, with the addition of two mullioned windows on ground and first floor (Plate 3).
- 6.1.4 The northeast elevation also has a mullioned window on the first floor although the mullion is probably a later addition, bisecting a former pitching hole. The square window at ground floor level is again likely to be a partially infilled doorway (Plate 4).

Plate 3 (Shot 6): New northwest elevation, looking southeast. Scale is 2m

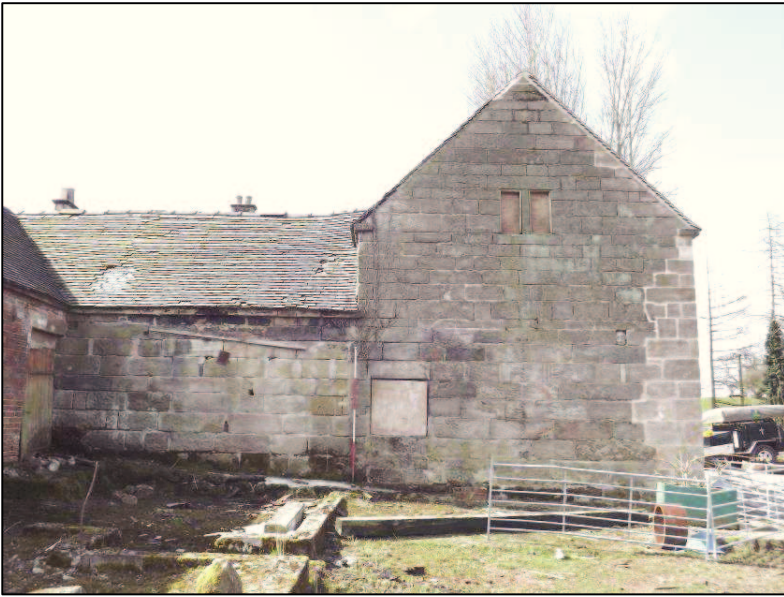
Plate 4 (Shot 7): Northeast elevation of Barns A and B, looking southwest. Scale is 2m

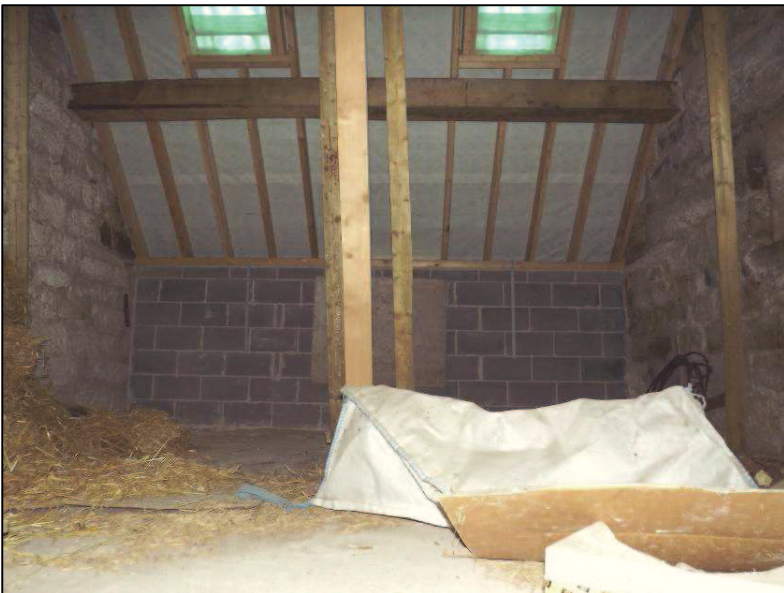
- 6.1.5 The interior walls of A1 are rendered and painted; it has a concrete floor and wooden lintels above all openings apart from that on the northeast elevation. A small section of the ceiling was exposed, which showed cob above thin wooden laths (Plate 7). The entirety of newly erected northwest elevation is in breeze blocks. The roof structure comprises common rafters resting on the back of the purlins (Plate 8).

Plate 8 (Shot 52): Loft space A2, looking northwest

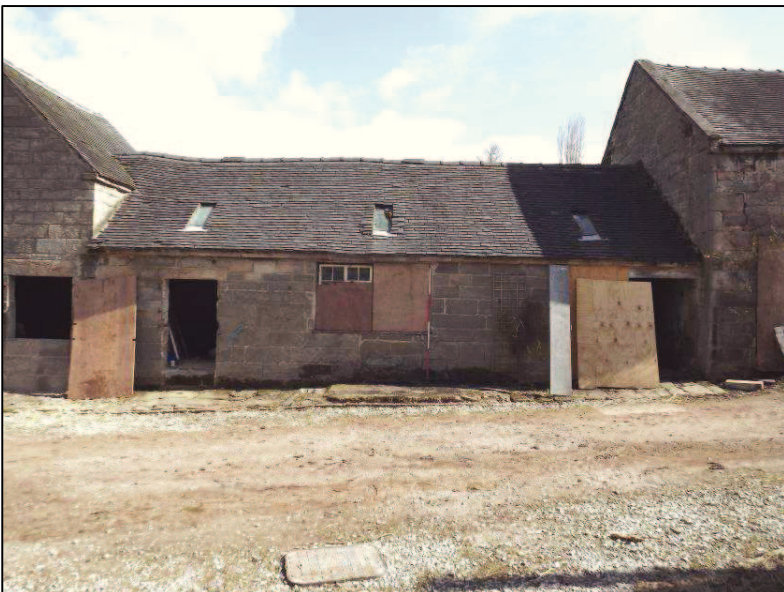
- 6.2.1 Barn B, aligned northwest to southeast, measures c.7m x 17m and is a later addition keyed in between Barn A and Barn D. The double pitched gabled roof is covered in plain ceramic tiles and has three new roof lights facing southwest. The southwest elevation has a small doorway at the northwest end and a larger doorway at the southeast end. In between is a largely boarded up window beneath which there is evidence for the infilling of the lower part of a former doorway (Plate 9).

Plate 9 (Shot 2): Southwest elevation of Barn B, looking northeast. Scale is 2m

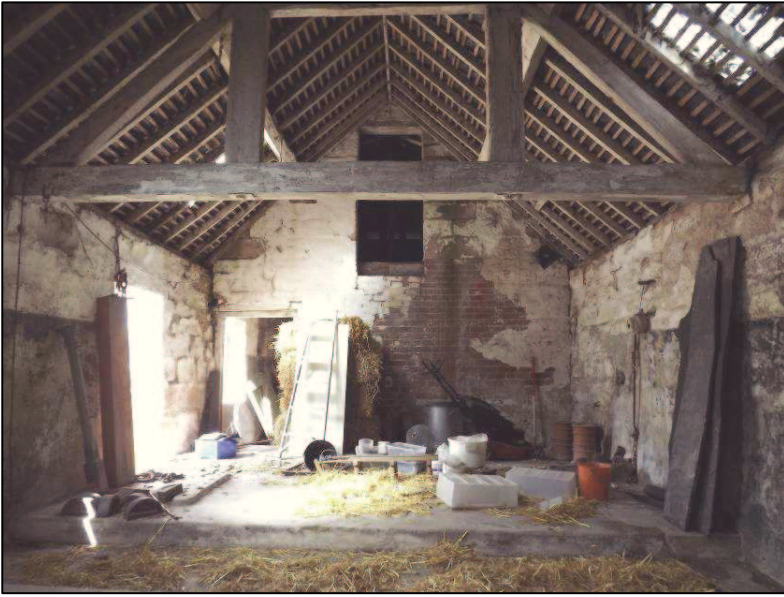
- 6.2.2 A partially rendered brick wall forms the partition between Barn A and Barn B, and has a doorway into the loft above Barn A (Plate 10).
- 6.2.3 The interior walls of Barn B have all been rendered and painted and it has a concrete floor with drainage channels running northeast to southwest that continue into Barn C. The barn has a queen post roof with principal purlins trenched into the back of the rafters. At the pitch there is a ridge plank, which tended to replace the ridge beam in the 18th and 19th centuries (Harris 2003) (Plates 10 and 11).

Plate 10 (Shot 27): Interior view of Barn B, looking northwest. Scale is 1m

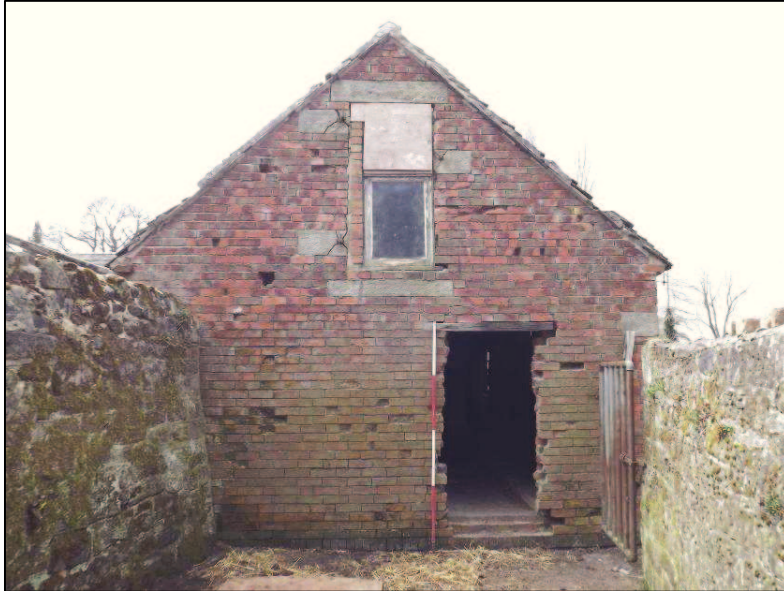
- 6.3.3 The first floor window on the northeast elevation has partially been used to block up a doorway with jamb stones, stone lintel and sill. A doorway with wooden lintel has been added at ground floor level which opens into an enclosed yard or animal pen (Plate 17).

Plate 17 (Shot 13): Northeast elevation of Barn C, looking southwest. Scale is 2m

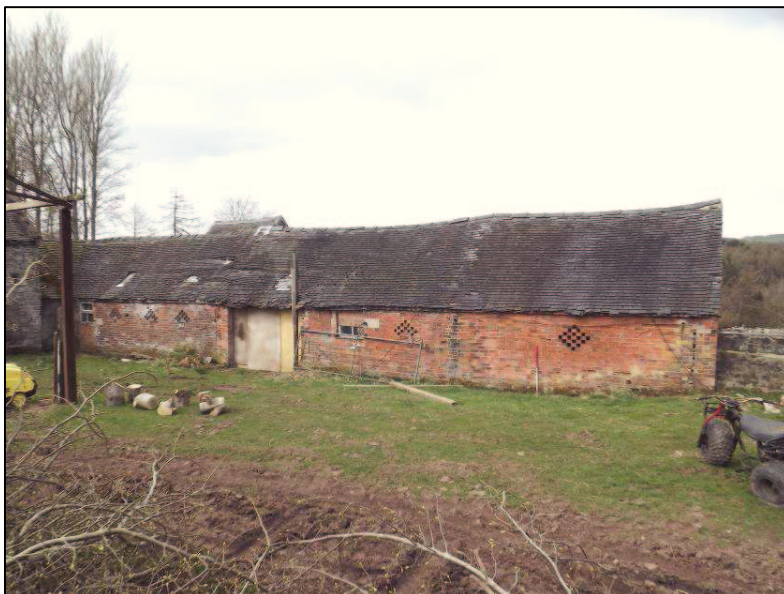
- 6.3.4 The southeast elevation also displays a series of boarded and blocked up openings (Plate 18). At the centre of the elevation is a large opening into C2, which has been partially bricked up on its southwest side (Plate 19). Directly north of the opening is a square window that has been fitted in an earlier doorway (Plate 20), with another square window in a partially bricked up doorway to the southwest, again with stone jambs.

Plate 18 (Shot 14): Southeast elevation of Barn C, looking west. Scale is 1m

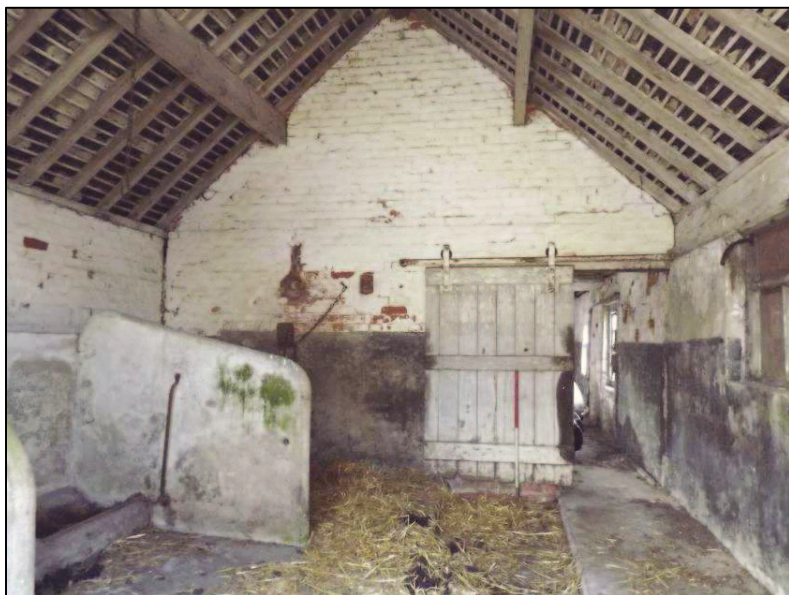
- 6.3.7 As with the access between C1 and C2, the access between C2 and C3 has been made narrower, with the brick infill again extending across the channel in the floor. Concrete stalls in C3 are later additions which do not abut the southeast elevation (Plate 26).

Plate 26 (Shot 35): Interior of Barn C3, looking southwest. Scale is 1m

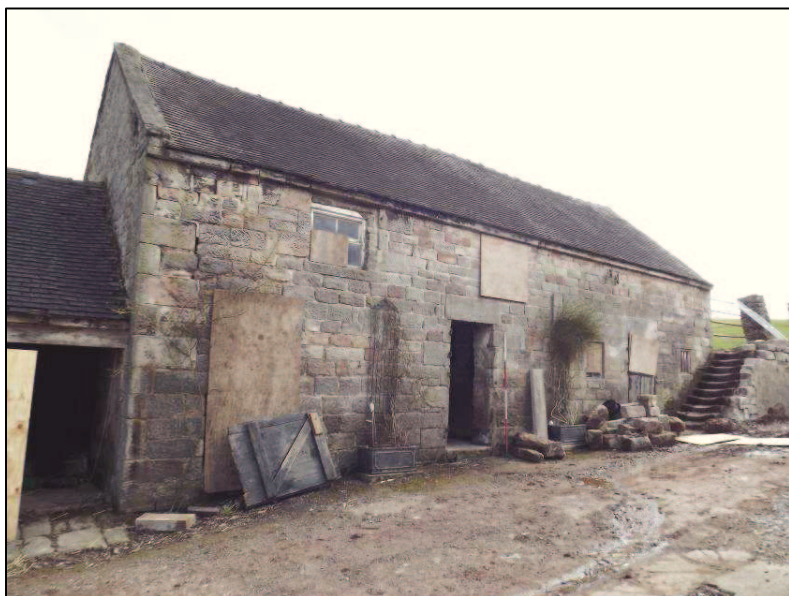
- 6.4.1 Barn D is c.19m x 8m and aligned northwest to southeast. It is again built in ashlar with a double pitched gabled roof with plain tiles, a stone cornice returning at the gables and coping on the northwest gable. The southwest elevation has three doorways with large stone lintels, the northernmost one being boarded up, with two square windows with fixed lights at first floor level and two small windows on the ground floor (Plate 27). A flight of well worn stone

steps lead up the side of the barn. It was also noted that the stone in the northwest end of the elevation was somewhat less weathered, possibly indicating a recent rebuilding.

Plate 27 (Shot 4): Southwest elevation of Barn D, looking east-northeast

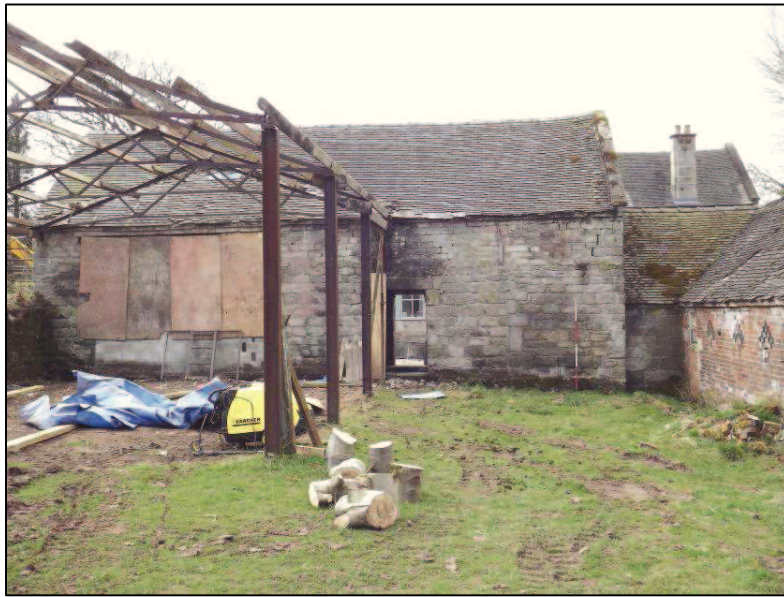
- 6.4.2 Breeze blocks on the northeast elevation infill a former wide opening with a small doorway to the northwest. Approximately two metres northwest of the smaller doorway are a number of large jamb stones indicating the position of a much larger opening that probably incorporated the existing small doorway (Plate 28).

Plate 28 (Shot 16): Northeast elevation of Barn D, looking southwest. Scale is 2m

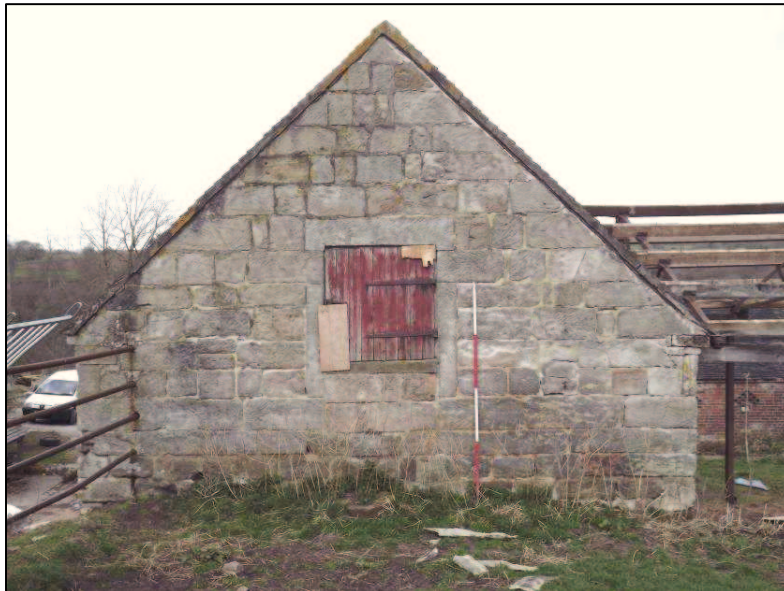
- 6.4.3 The southeast elevation has a pitching hole with a wooden door on 18th century style strap hinges. The opening has been fitted into the upper part of a former doorway (Plate 29).

Plate 29 (Shot 19): Southeast elevation of Barn D, looking northwest

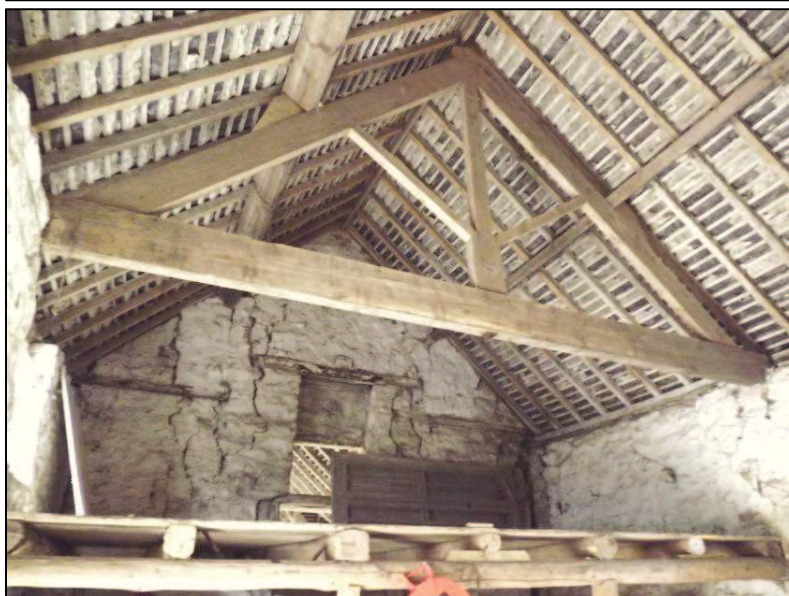
- 6.4.4 The northwest cell of Barn D has been divided with a brick partition, with a loft above the northwestern part, D1, resting on wooden supports extending from the brick partition. The walls in D1 and D2 are painted and the floor is of concrete (Plates 30 – 32).

- 6.4.5 The king post roof structure of Barn D appears to be a later repair to the building, the relatively fresh condition of the wood suggesting a later 20th century date (Plate 32). Behind the truss the through purlin is held in place by a wooden chuck and the king post is bolted to the tie beam. Stylistically the roof is very much in keeping with local traditions, with around half of Staffordshire farm buildings built up to 1880 having a king post roof (Wade-Martins 1991).

Plate 32 (Shot 48): Loft space above Barn D1, looking northwest

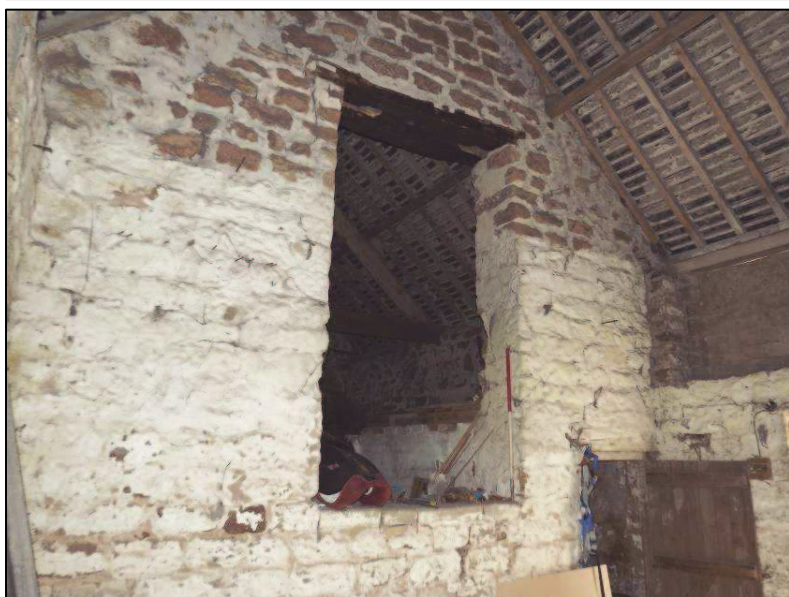
- 6.4.6 A raised doorway leads from D2 into a small storage room D3 (Plate 33), which may have been a former cornhole. Cornholes developed in Staffordshire in the mid 18th century and were usually built of brick. It was found in threshing barns where it stored the grain prior to winnowing (Peters 1969, 1981), although if so this may be a relatively late example of such a feature.

Plate 33 (Shot 39): Opening in partition wall between D2 and D4, looking south. Scale is 1m

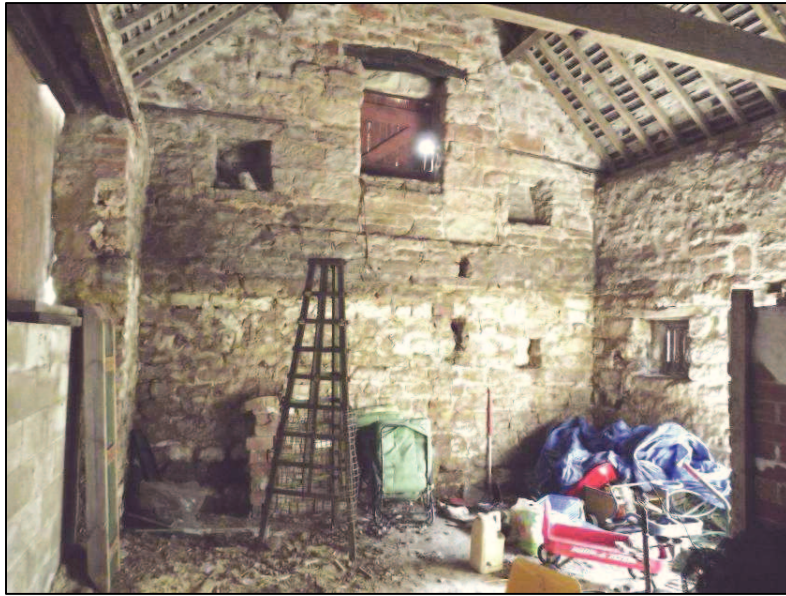
- 6.4.7 The southeast elevation of D4 has two square ventilation holes on either side of the pitching hole, which have been infilled (Plate 34).
- 6.4.8 Most of the floor of Barn D was covered in concrete apart from a patch in front of the doorway which had been laid with rectangular cut stones (Plate 36).

Plate 34 (Shot 42): Interior view of Barn D4, looking south. Scale is 1m

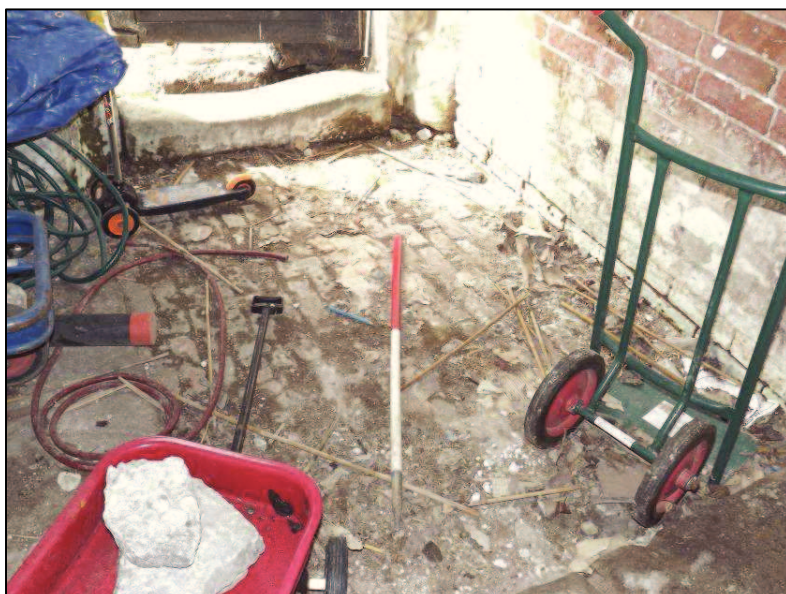
Plate 36 (Shot 47): Floor of D4, looking west. Scale is 1m.
