ARCHAEOLOGICAL WATCHING BRIEF REPORT:

LAND OFF FOSSE ROAD, FARNDON, NOTTINGHAMSHIRE

Planning Reference: 10/01605/FUL NGR: SK 476719 350952 Site Code: FAFR 12 OASIS Reference Number: allenarc1-156614

By Allen Archaeology Limited Report Number 2013115

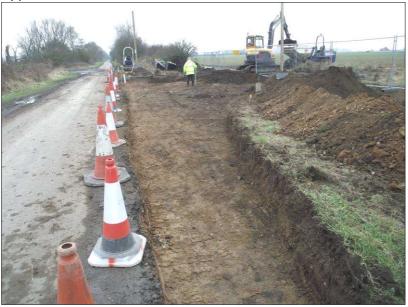
Plate 1: General view of groundworks at site entrance, looking southwest

- 6.1 At the site entrance, approximately 1m from the road, a water main, 05, was uncovered running roughly northeast to southwest. Parallel to this, and 5.6m from the edge of the road, a cable trench was excavated revealing a 0.4m thick layer of topsoil/ploughsoil 01 overlying natural deposit 02, which was a light brown clayey silt.

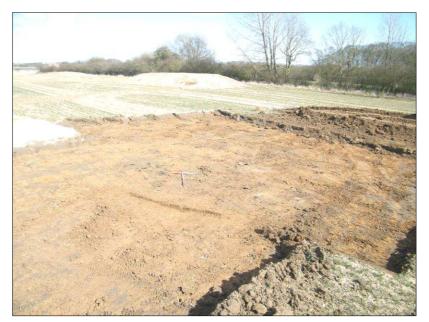
Plate 3: Stripped area of crane hardstanding, looking north-northwest. Scales are 1m

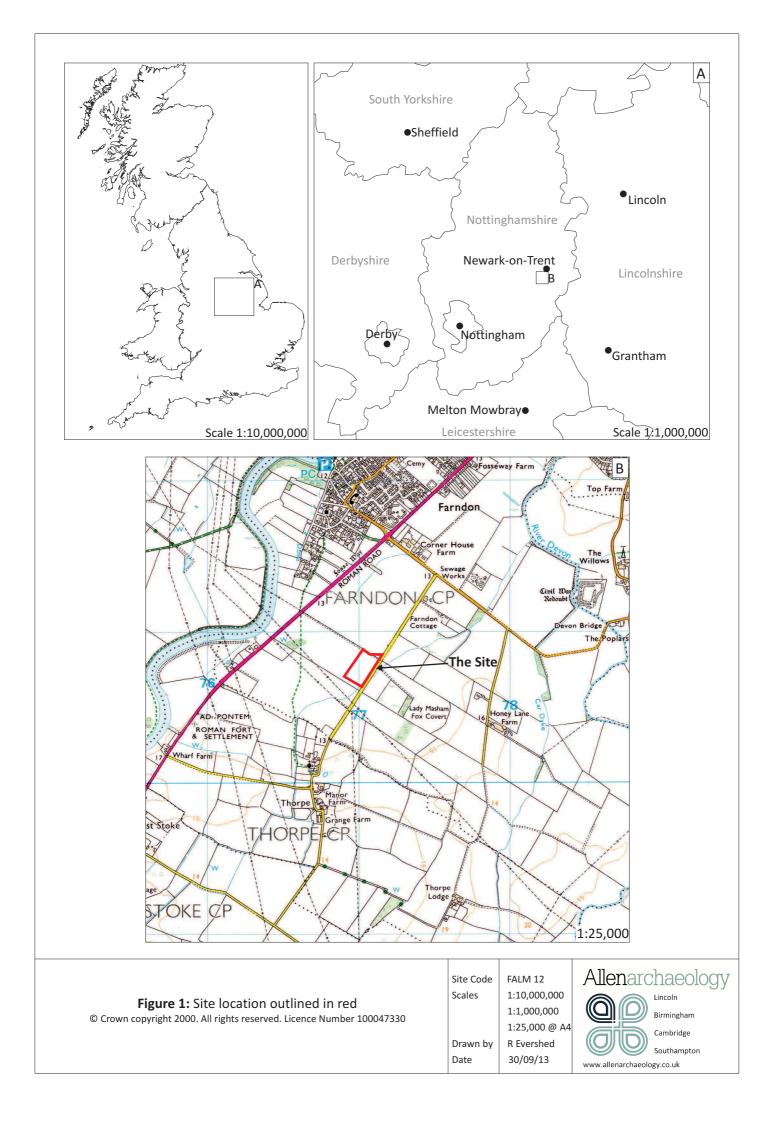
- Figure 1: Site location outlined in red
- Figure 2: Site location also showing the location of sections in Figure 3
- Figure 3: Sections shown on Figure 2

- 2.1 Farndon is situated c.3.1km southwest of Newark, within the administrative district of Newark and Sherwood (Figure 1). The site is 1.19km south-southwest of the core of the village and 0.6km southeast of the Fosse Road. The site centres on NGR SK 476719 350952 and lies at a height of approximately 13m above Ordnance Datum.
- 2.2 The site lies on a bedrock geology of Edwalton Member mudstone, with superficial geology of Holme Pierrepont sand and gravel (http://mapapps.bgs.ac.uk/geologyofbritain/home.html).
