HERITAGE IMPACT ASSESSMENT:
HISTORIC BUILDING SURVEY AND TRIAL TRENCHING
AT WILLOW FARM, HIBALDSTOW, NORTH LINCOLNSHIRE

NGR: SE 9805 0247
Planning Reference: Pre-Planning
AAL Site Code: HIWI 13
North Lincolnshire Museum Site Code: HTTP
Oasis Reference: allenarc1-159708

Report prepared for Keigar Homes Limited

By
Allen Archaeology Limited
Report Number 2013113

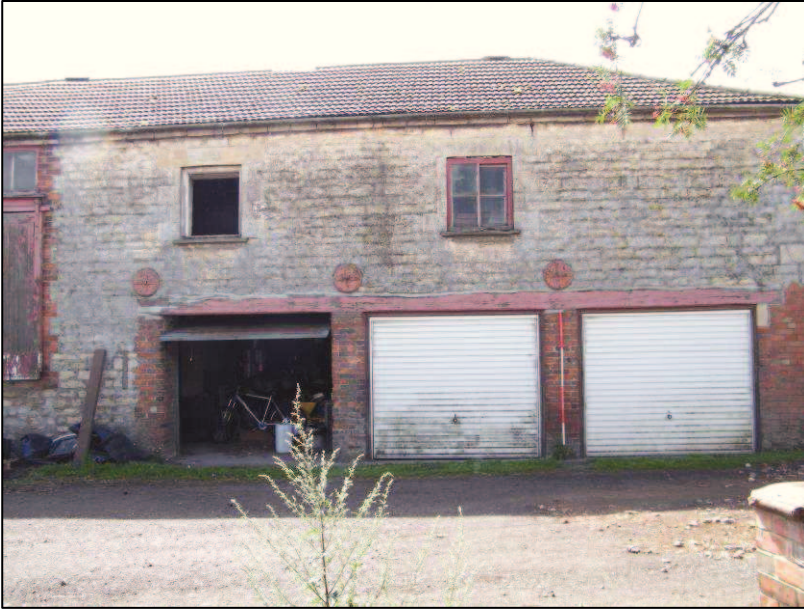
Plate 3 (Shot 4): Mid section of the north elevation of Building A showing brick dressings around openings, looking south-southwest. Scale is 2m

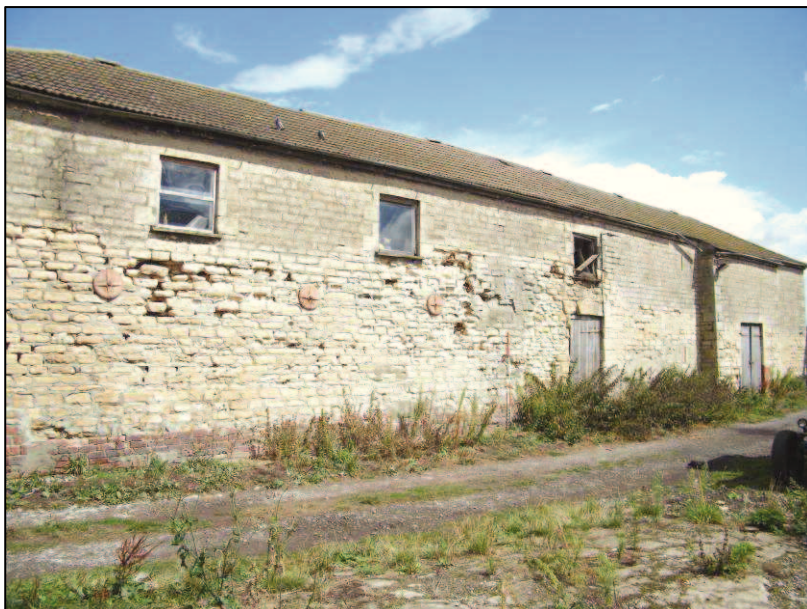
- 6.1.4 The west elevation is mainly in stone but with occasional brick and cement repairs, for example where brick has replaced the stone quoins on the lower part of the northwest corner. Both the west and south elevations display patches of heavily weathered stonework (Plates 6 and 7).

Plate 6 (Shot 10): West elevation of Building A, looking east southeast. Scale is 2m

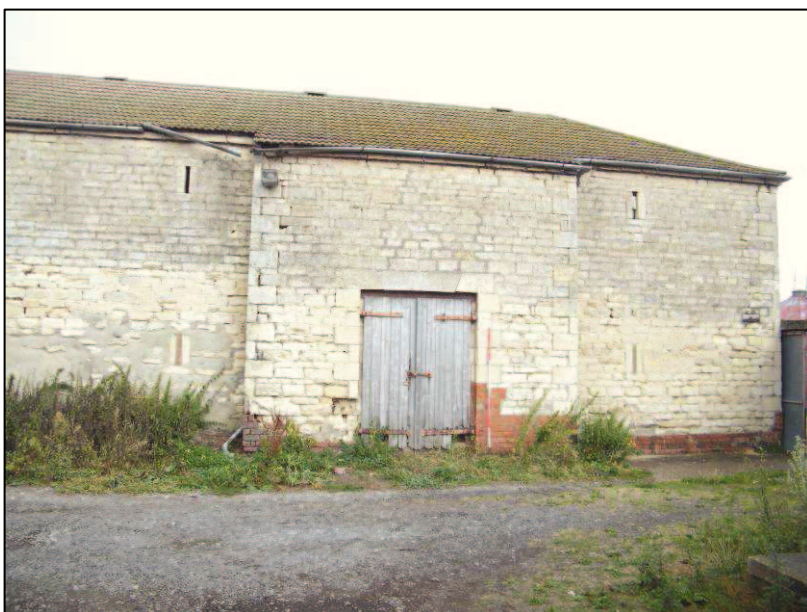
Plate 7 (Shot 11): South elevation of Building A, looking northeast. Scale is 2m

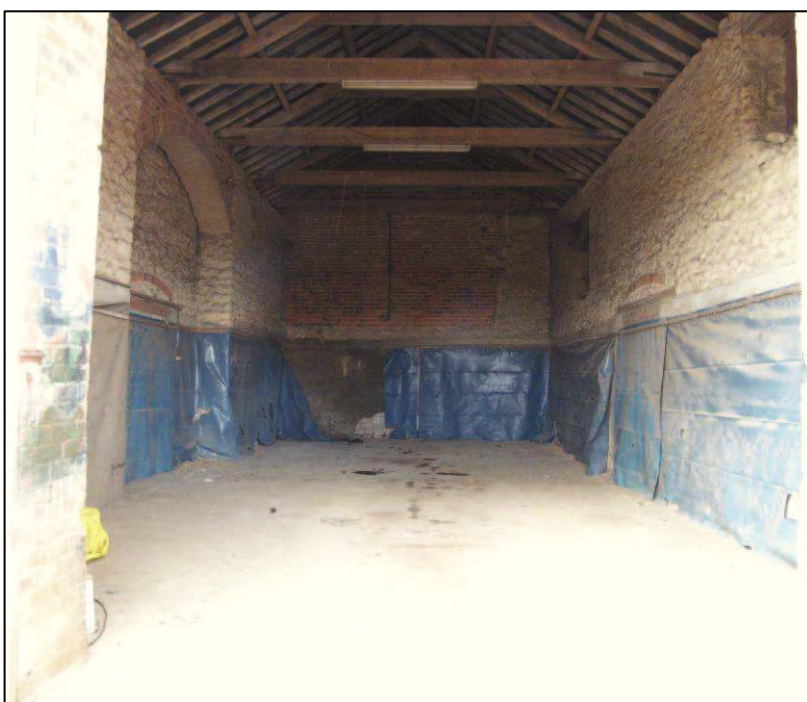
- 6.1.5 All openings (doors, ventilation slits and pitching holes) on the south elevation appear to be original features with stone dressings, although glass has been fitted in two of the three pitching holes on the first floor. The lower part of this elevation has throughout been repaired with bricks (Plate 7). A square-cut bay or porch has been built at the southeast end of the elevation, possibly built to extend a threshing floor (Plate 8).

Plate 8 (Shot 14): Square-cut bay in the threshing barn of Building A, looking northeast. Scale is 2m.

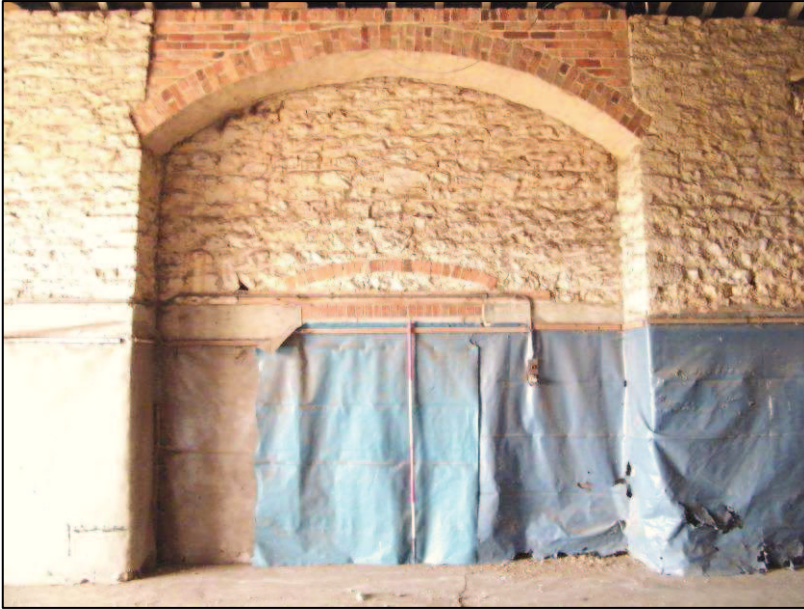
- 6.1.7 The east end of Building A comprises a threshing barn which has the characteristic two large opposing doors to the north and south, both of which have segmental brick arches with stone infill (Plate 9). The interior of the threshing barn measures approximately 12.5m x 5.4m, and has a modern concrete floor, removing any trace of an earlier threshing floor. Although a large part of the interior walls had been covered with plastic it was noticeable that a large part of the partition wall to the east and also the upper part of the west elevation has been repaired with bricks. A later brick arch has been built into the southern porch, which probably replaced an earlier stone arch or possibly a wooden lintel (Plate 10).

Plate 9 (Shot 16): Interior view of the threshing barn in Building A, looking west-northwest. Scale is 2m

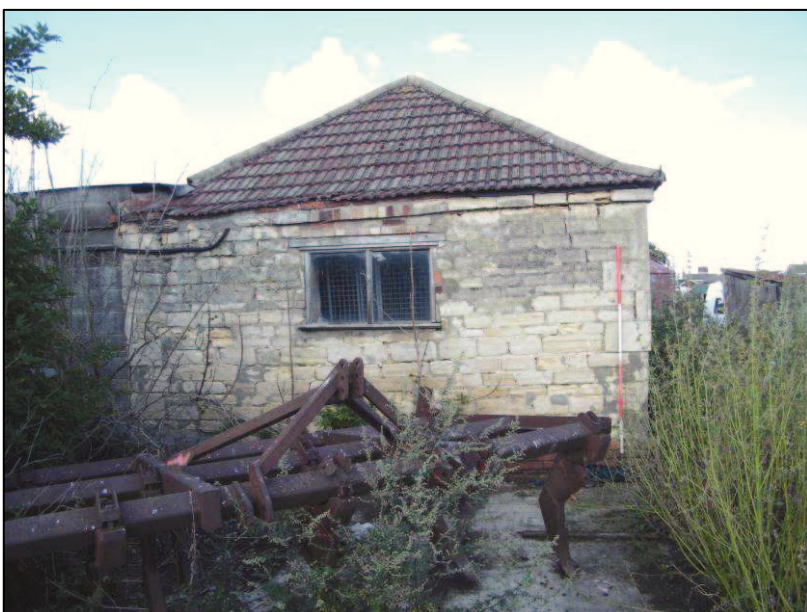
Plate 19 (Shot 37): East elevation of Building B showing blocked up door, looking west-northwest

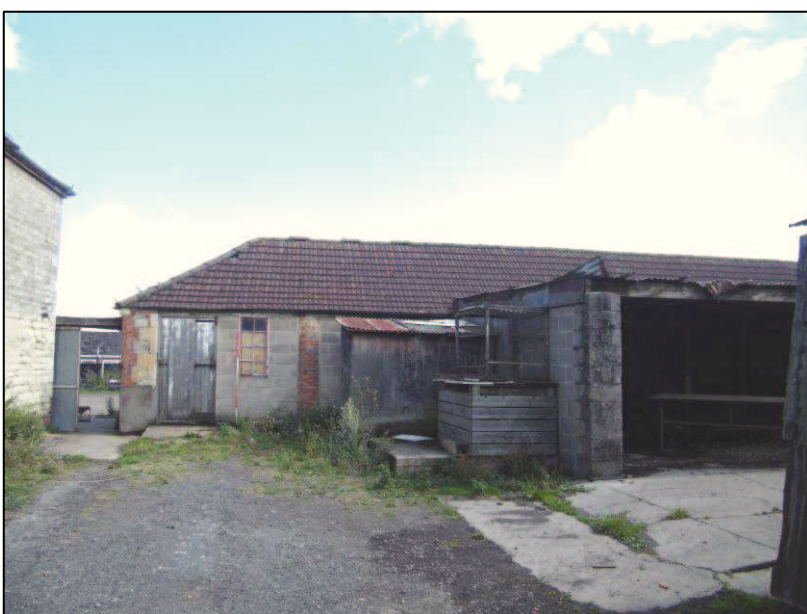
6.2.3 On the southern elevation there was evidence for recent repair works, and a later window had been fitted (Plate 20).

Plate 20 (Shot 39): South elevation of Building B, looking north-northeast. Scale is 2m

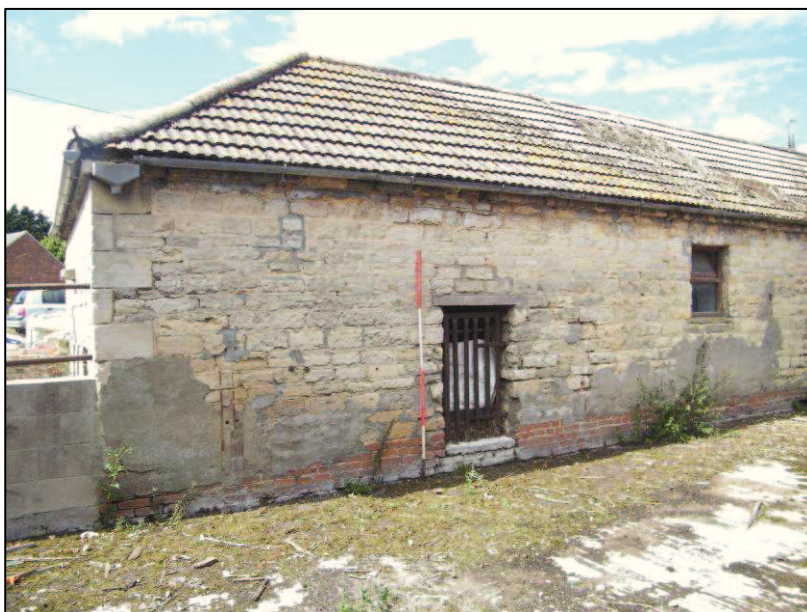
Plate 27 (Shot 50): Representative shot of a door converted into a window, east elevation of Building C, looking west-northwest. Scale is 2m

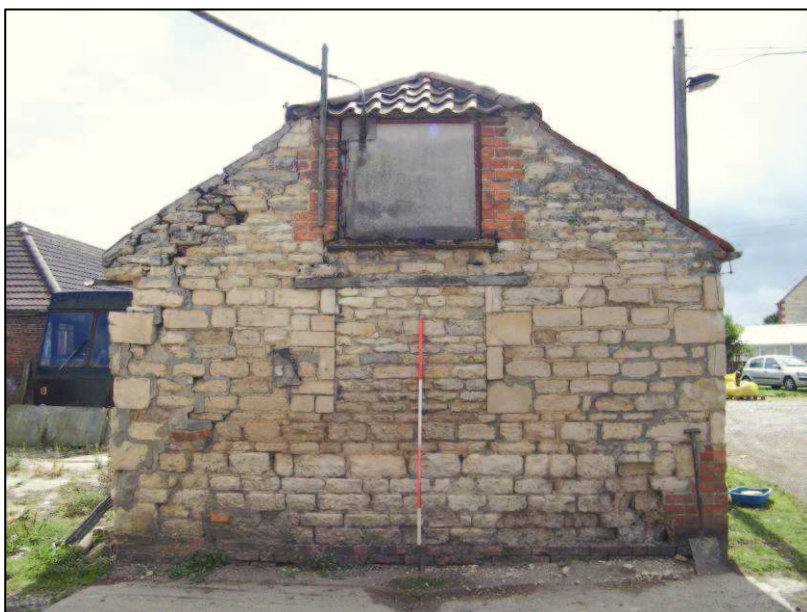
- 6.3.1 Building C was located southwest of Building A, aligned roughly north – south and measured approximately 5.1m x 22.4m. The building again comprised dressed and coursed limestone blocks, with ventilation slits, stone quoins and stone dressings and occasional brick repairs to the lower walls. The roof was gabled to the south and half gabled to the north with pantiles to the west and concrete tiles to the east (Plates 26 – 32). There were several stable doors on the east and west elevations, the majority of which had been partially blocked up and converted into windows (Plate 27). A possibly original metal gate had been left *in situ* on an opening at the southeast end of the building (Plate 28).

Plate 28 (Shot 52): Southern end of on the east elevation of Building C, looking west northwest, looking north. Scale is 2m

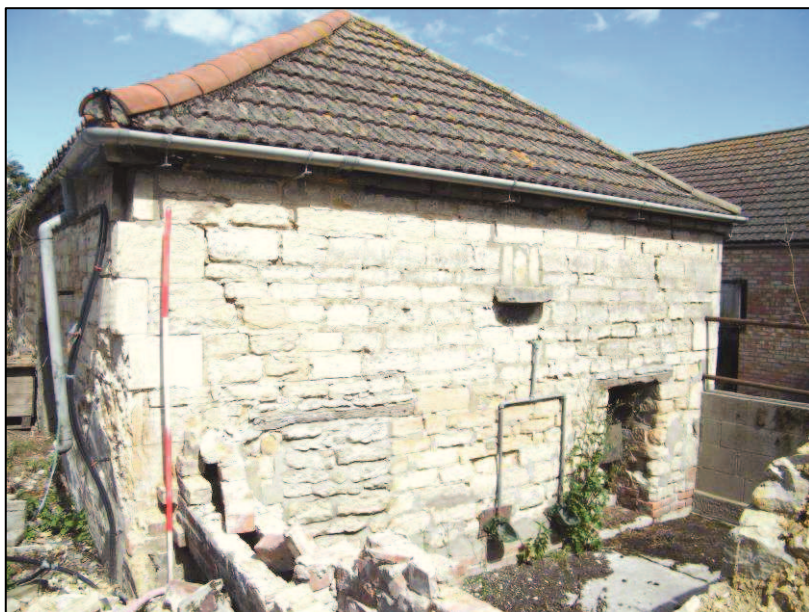
Plate 31 (Shot 59): South end of west elevation of Building C showing exposed rubble core, looking east northeast. Scale is 2m

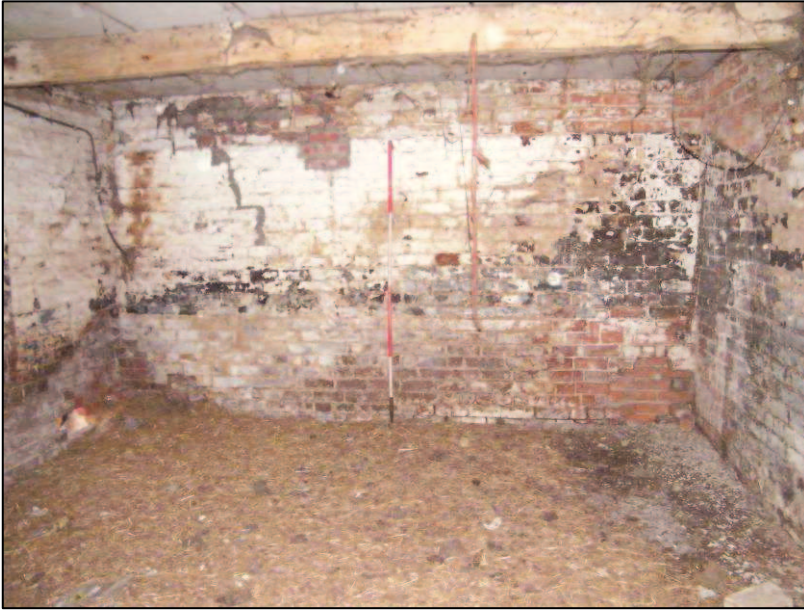
Plate 42 (Shot 75): Bricked up door in the north elevation of Building D, looking north-northeast. Scale is 2m

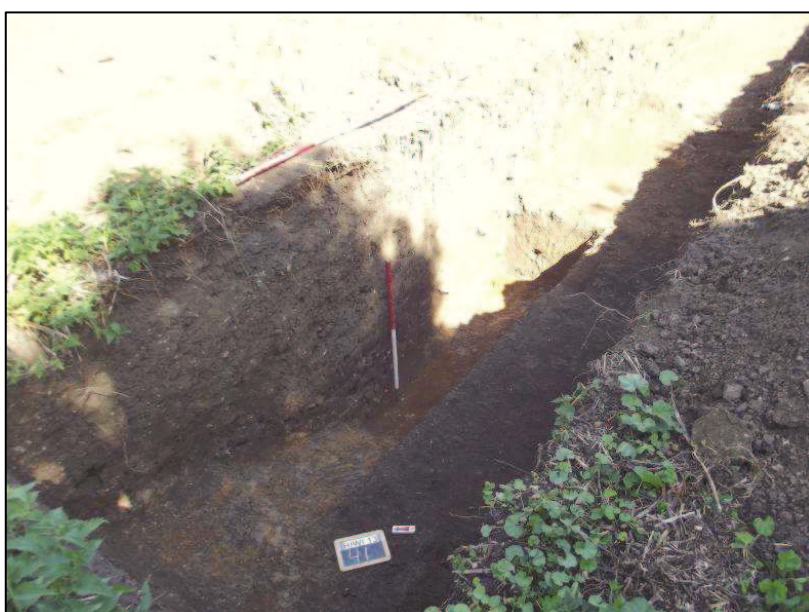
- 8.2.2 At the west end of the trench was a roughly north – south aligned ditch [204], measuring 2.8m wide and 0.78m deep. A single 12th – 13th century pottery sherd and two fragments of middle Iron Age pottery were recovered from the fill, as well as a small group of animal bone. A soil sample contained a small quantity of cereal grains and weed seeds, as well as frequent charcoal and other burnt material. It cut through an earlier northeast to southwest aligned ditch, [206], the northern edge of which was beyond the limit of excavation. Sixteen fragments of animal bone and two sherds of Romano-British greyware were recovered from the fill, 207. A soil sample contained small quantities of cereal grains, along with moderate quantities of charcoal and other burnt organic material.

Plate 51: Southwest facing section of feature [204] and ditch [206], looking northeast. Scales are 2m and 1m

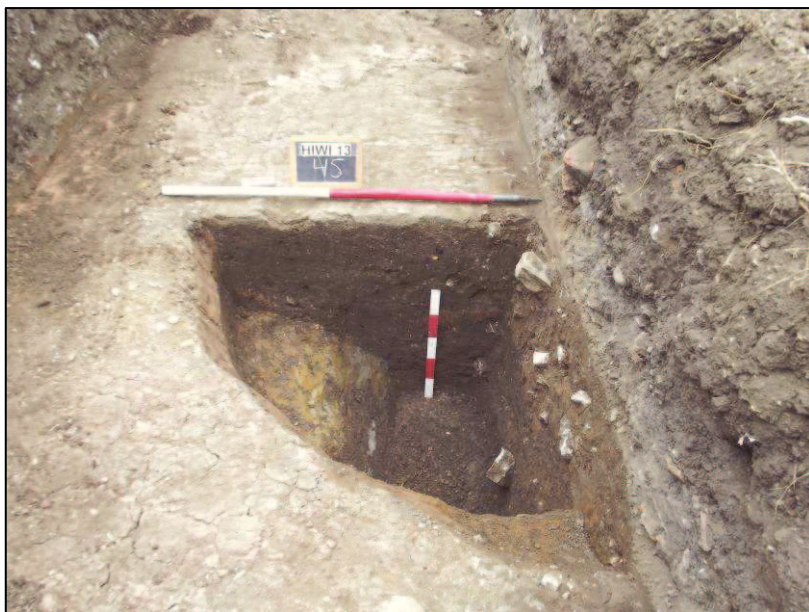
- 8.2.3 Further to the east there was a 2.3m wide pit or ditch terminus [208]. Due to the depth of the feature and the sealing overburden, this feature could not be safely bottomed. The feature contained two distinct silting deposits, 209 and 210, each of which contained two sherds of Roman pottery. The primary fill 209 was sampled for environmental evidence and contained sparse cereal grains and a moderate quantity of burnt organics.

Plate 52: East facing section of [208], looking west. Scales are 1m and 0.5m

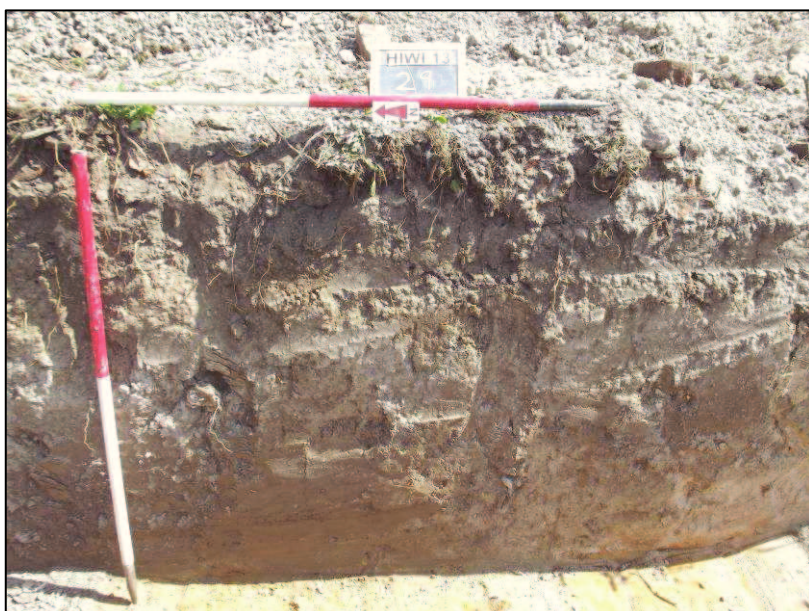
8.3.1 Trench 3 was devoid of archaeological features. Sealed by yard surface 300, a former topsoil 301 was exposed, beneath which was a 0.77m thick pale grey silty sand, 302. This was interpreted on site as a flood deposit, although the source of this flooding is unclear, and it may represent silting occurring within a slight natural hollow. A single retouched flint flake of possible Neolithic date was found in this deposit along with two fragments of Roman tile and a Roman greyware pottery fragment. At the base of the sequence was the natural geology 303 of glacial till.

Plate 53: West facing representative section of Trench 3, looking east. Scales are 1m

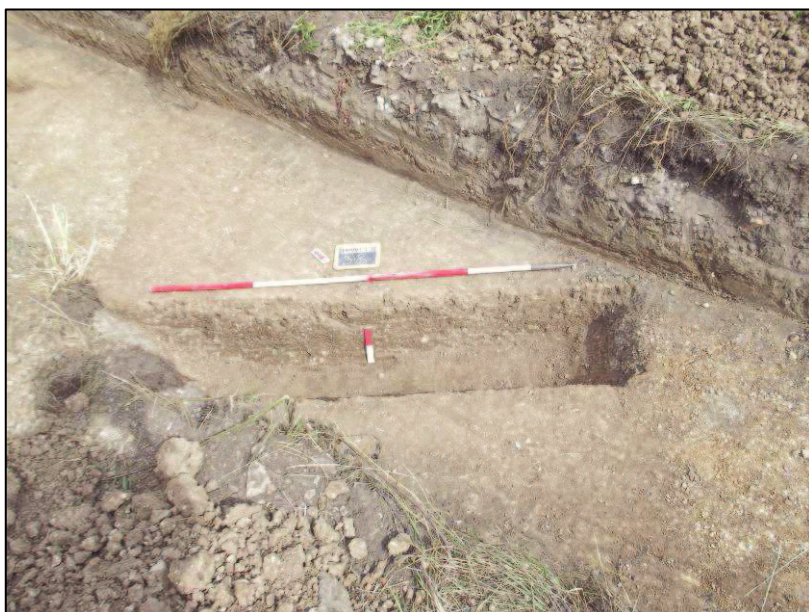
8.4.2 Ditch [403] measured 2.4m wide and 0.4m deep, and contained a single natural silting deposit 404. Finds from this feature comprised five middle Iron Age pottery sherds, and five fragments of animal bone. A soil sample from the feature produced a moderate quantity of charcoal and other burnt organic material, and also contained a snail assemblage indicative of an overgrown partially wooded environment, with damp conditions in the base of the ditch. To its north, ditch [405] had a shallow bowl shaped profile and measured 1.28m wide 0.16m deep. It produced a single sherd of middle Iron Age pottery and one small piece of fuel ash slag. A soil sample from fill 406 was submitted for processing and also contained moderate quantities of charcoal and burnt organics, although the snail assemblage suggested more open country environment in the vicinity of the feature.

Plate 54: Southwest facing section of ditch [403], looking northeast. Scales are 2m and 0.2m
