**HISTORIC BUILDING SURVEY AND
ARCHAEOLOGICAL EVALUATION BY TRIAL TRENCHING:
SITE ADJACENT TO 11 CROSS GREEN, WICKEN, ELY, CAMBRIDGESHIRE**

NGR: TL 57120 70571
Planning Reference: 10/00491/FUL & 10/00492/CAC
AAL Site Code: WICK13
CHER event no: ECB4031
Oasis Reference: allenarc1-160860

Report prepared for Cambridge Design and Build

By
Allen Archaeology Limited
Report Number 2013125

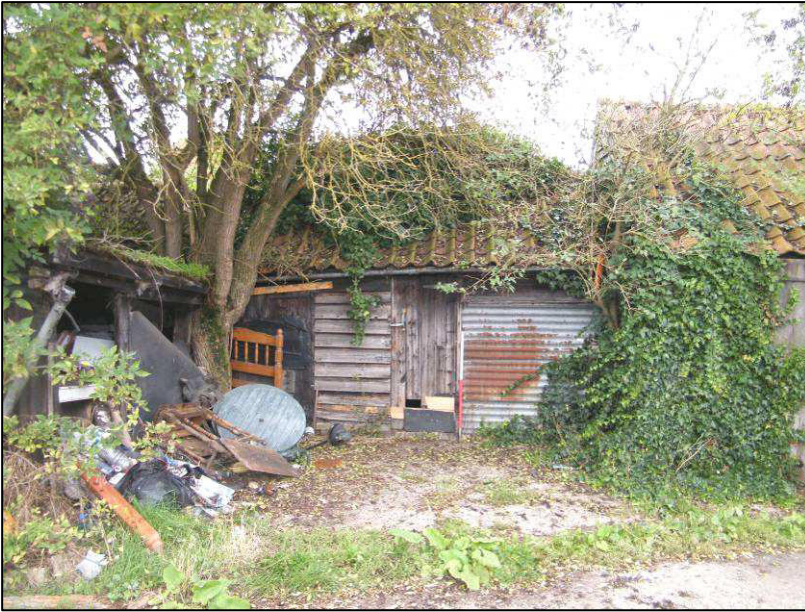
Plate 1 (Shot 14): South elevation of Building A, looking north. Scale is 1m

- 6.1.1 Building A comprises a single storey wooden framed structure (Plate 1) built against a brick and flint banded wall which forms the northern boundary of the site (Plate 2). It has a hipped roof of ceramic pantiles. This building measures 7.72m by 3.16m with a crude wooden lean to measuring 3.48m by 3.84m, built onto the southern elevation. The lean to is in the process of collapse and is supported by a tree growing against and partially through its structure.
- 6.1.2 The wall which forms the northern elevation is constructed from a mix of machine made bricks, and coursed flint rubble, and is likely to predate the extant structure, although the upper courses of brickwork are likely to represent a later repair.
- 6.1.3 The building retains a plank and batten style door in the south elevation, which resembles those of the later 19th century and may be a reused piece.

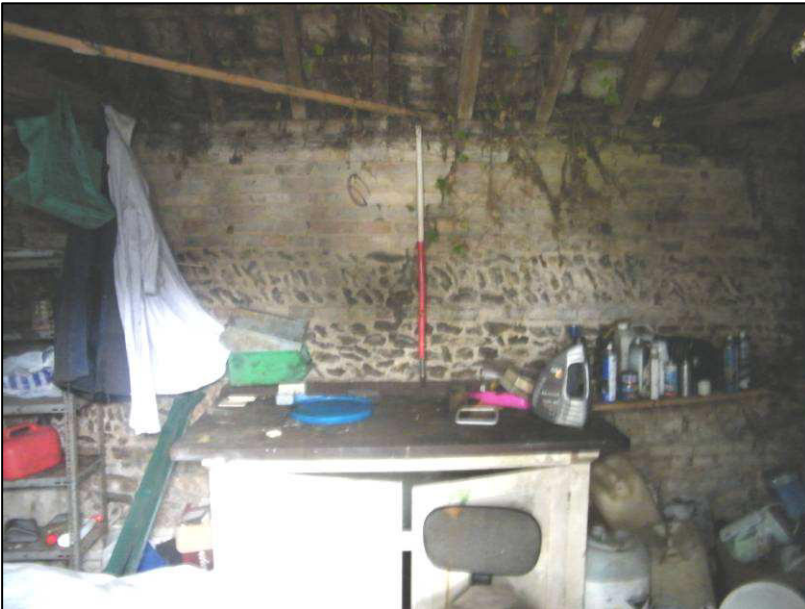
Plate 2 (Shot 39): Interior of Building A, looking north, showing brick and flint banded wall, which predates building. Scale is 1m

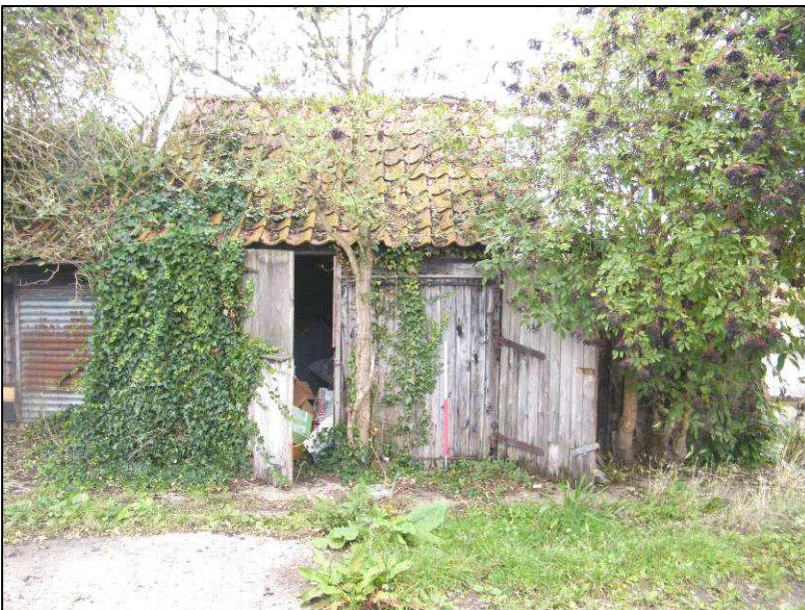
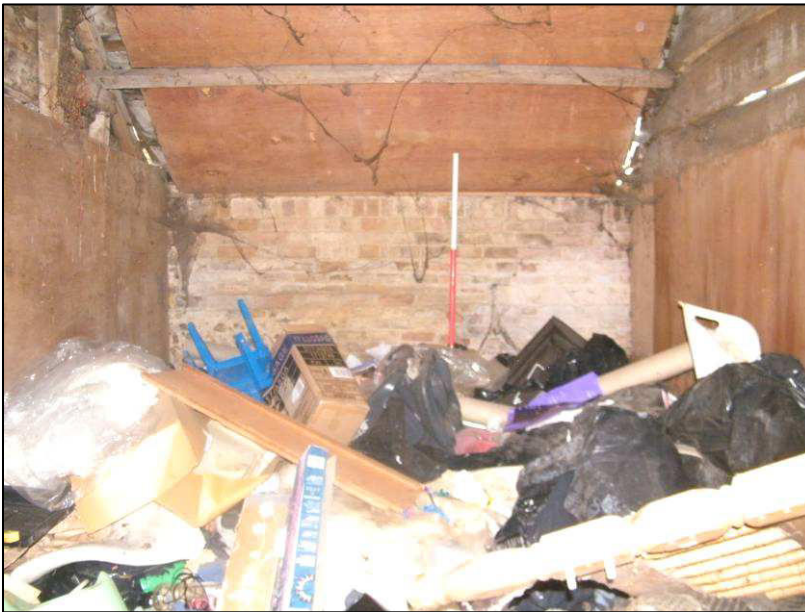
Plate 3 (Shot 15): South elevation of Building B. Scale is 1m

Plate 4 (Shot 36): Interior of Building B, looking north. Scale is 1m

- 6.2.1 Building B comprises a single storey wooden framed, weather-boarded structure, with a gabled pantile roof, and measures 5.96 by 3.8m (Plates 3 and 4). It is attached to the east end of Building A and was also built up against the brick and flint wall that forms the northern site boundary. The eastern end of the roof had collapsed and this part of the building was not safe to enter.
- 6.2.2 The remaining part of the building has plywood panels affixed to the internal walls and ceiling and has a stable door in the south elevation. A plank and batten door forms the opening in the damaged portion of the building to the east. The building contained large quantities of assorted household waste.

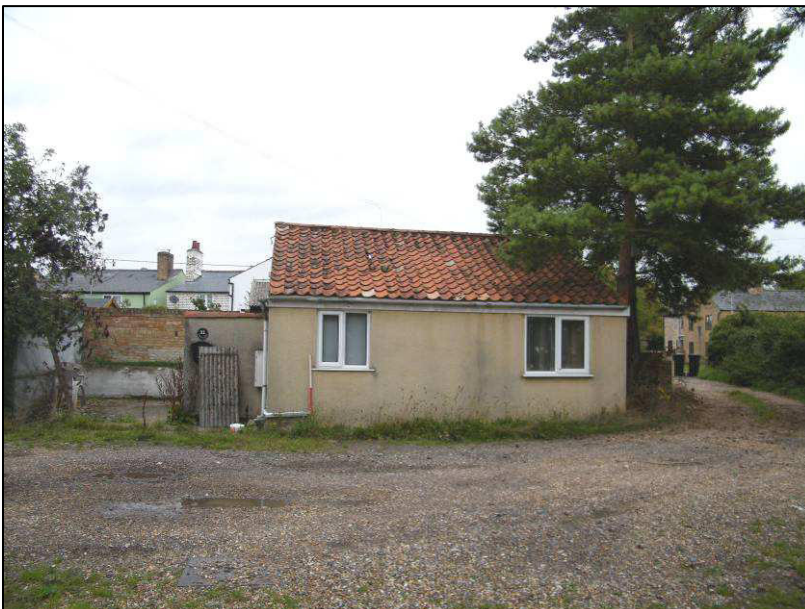
Plate 5 (Shot 19): South elevation of building C. Scale is 1m

- 6.3.1 Building C comprises a single storey dwelling measuring 6.07m by 5.22m and retains an external sign marking it as '11 The Flat'. This building appears to have been built against the northern wall previously noted, with cement rendered external walls. The roof is gabled and uses the same style of pantiles as in Buildings A and B (Plate 5).

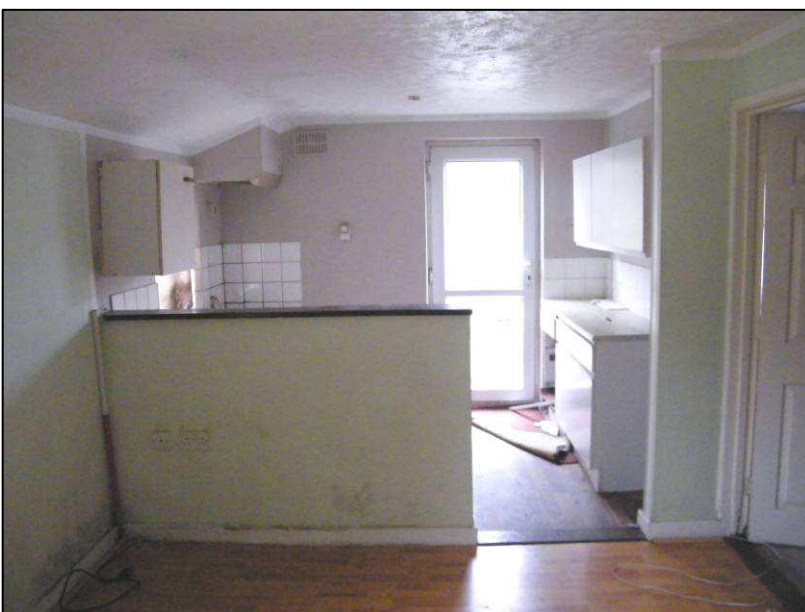
Plate 6 (Shot 23): Kitchen/diner area in Building C, looking west. Scale is 1m

- 6.3.2 Internally, the building contains a bedroom, bathroom and kitchen/diner area, separated by modern stud walling. Fixtures and fittings are all modern in date including double-glazed PVC windows and external door. The walls and ceiling are faced with painted plaster-board and no historic features were identified (Plate 6).

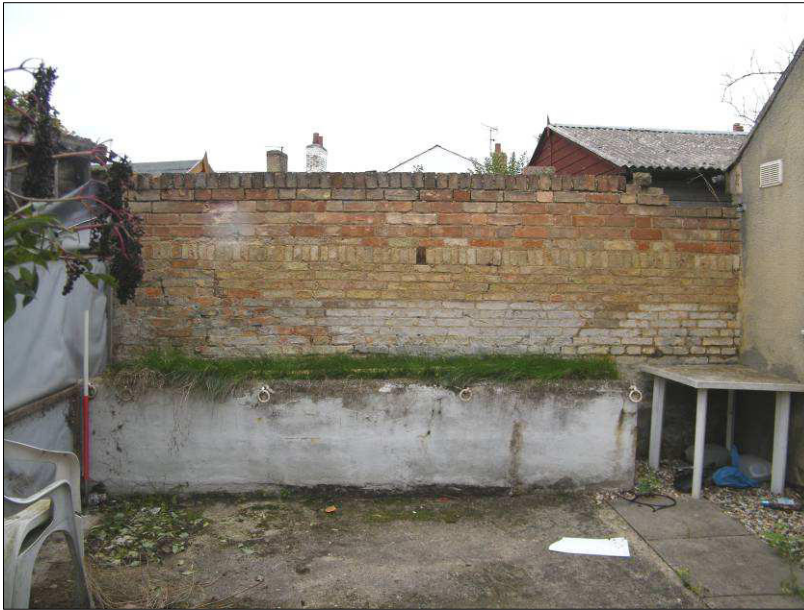
Plate 7 (Shot 17): Feeding trough between Buildings C and D, looking north. Scale is 1m

- 6.3.3 Externally, a whitewashed concrete feeding trough with attached tethering rings was positioned against the east – west aligned boundary wall between Buildings B and C (Plate 7). It is probable that this is a feature associated with a former animal shed. A short stretch of rendered wall extending from the west elevation of Building C may be a surviving part of the south wall of this former building (Plate 5). The boundary wall in this area is entirely in brick and has clearly been raised in height.

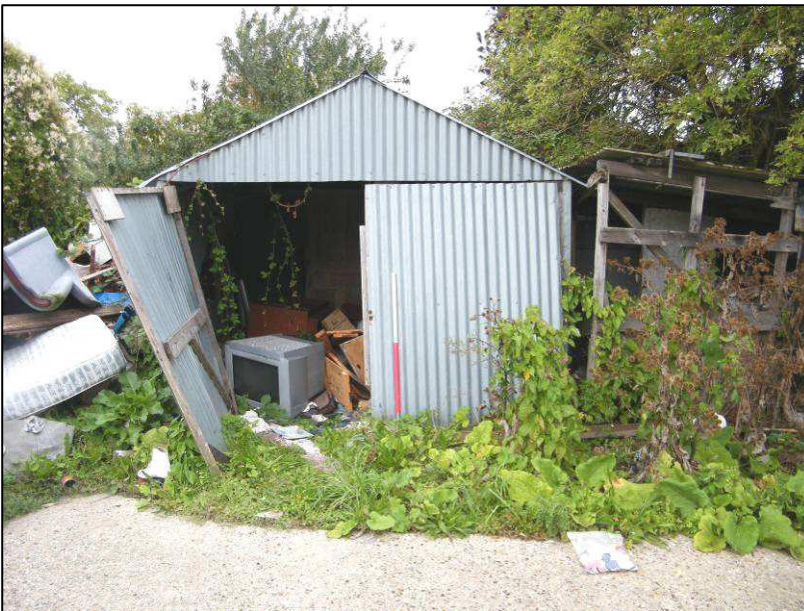
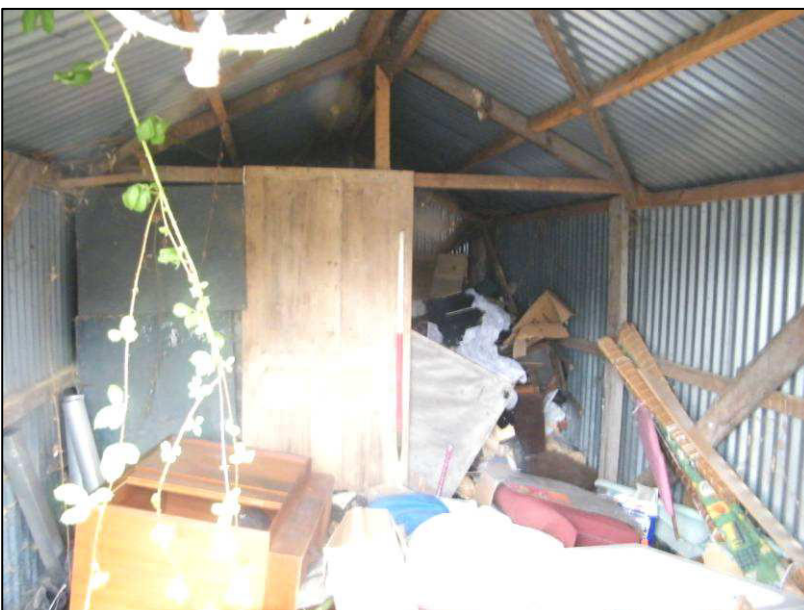
Plate 8 (Shot 11): South elevation of Building D, looking north. Scale is 1m

Plate 9 (Shot 47): Interior of Building D, looking north. Scale is 1m

- 6.4.1 Building D was constructed of corrugated steel sheets fastened to a simple wooden frame (Plates 8 and 9) with a crudely constructed door formed from two corrugated steel sheets. This structure is located in a similar position to a building shown on the 1st Edition Ordnance Survey; however this structure is clearly of a more recent date.

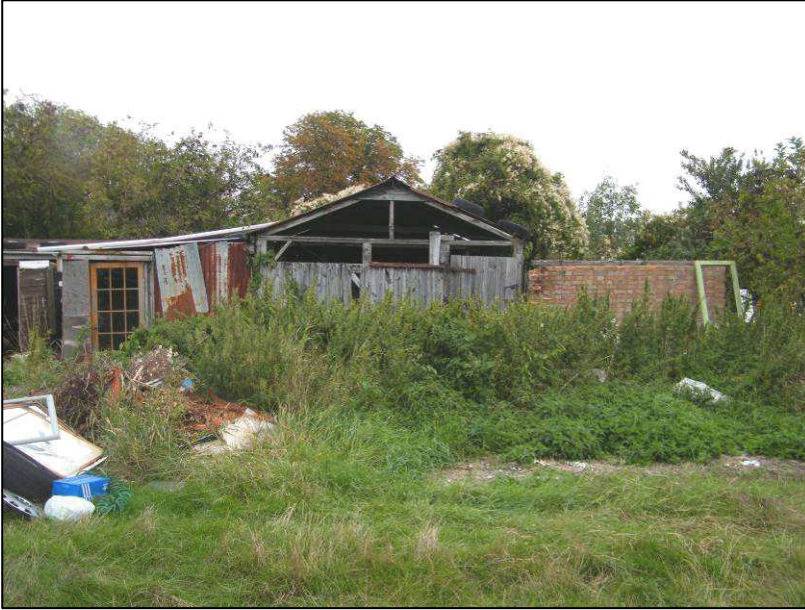
Plate 10 (Shot 9): Buildings E and F, looking north.

- 6.5.1 Building E comprises a north – south aligned single storey wooden framed and weather boarded structure, which measured c.20m long by 5.5m wide. This building was in a poor state of repair and had a double pitched gabled roof of badly corroded corrugated sheets. The south elevation had a wooden plank and batten door, with another similar example on the eastern side. The west elevation was abutted by Building F, while the eastern elevation was derelict and open to the elements (Plate 10).
- 6.5.2 This building was not noted on the 1958-59 Ordnance Survey mapping and first appears on the map of 1973, suggesting a likely construction date of 1960-1972.

- 6.6.1 Building F is a lean to structure positioned against the west elevation of Building E and measures c.16m by 4m. This building was formed from an ad-hoc assembly of corrugated sheeting affixed to a wooden frame on a concrete base and as with Building E, first appears on the 1973 mapping (Plate 10). An additional structure was once attached to the eastern side based on the 1970s mapping, however all that now remains is a short stretch of east – west aligned brick wall.

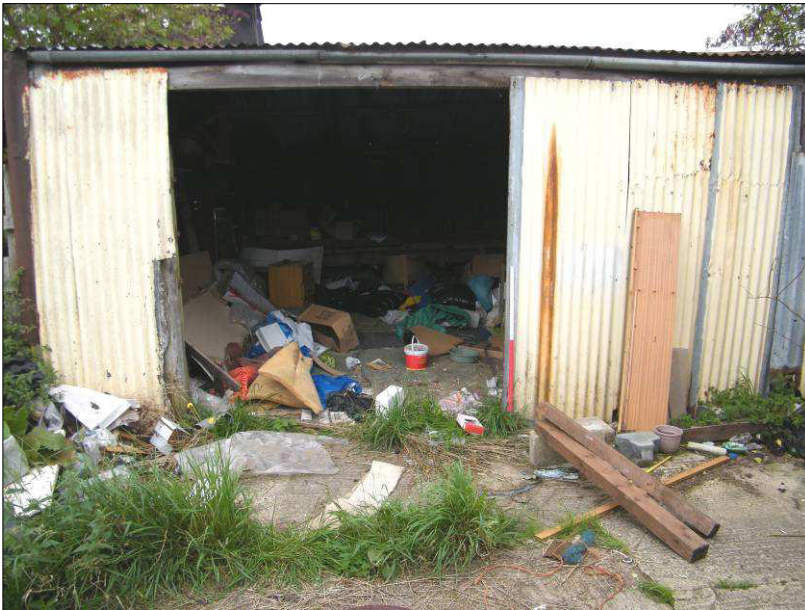
Plate 11 (Shot 5): Building G, looking west. Scale is 1m.

- 6.7.1 Building G is a free-standing single storey shed formed from corrugated sheets affixed to a simple wooden on a concrete base with a low gabled roof, also formed from corrugated sheets fixed to a timber frame (Plate 11). This structure measured approximately 7.5m square and first appears on the 1973 map.

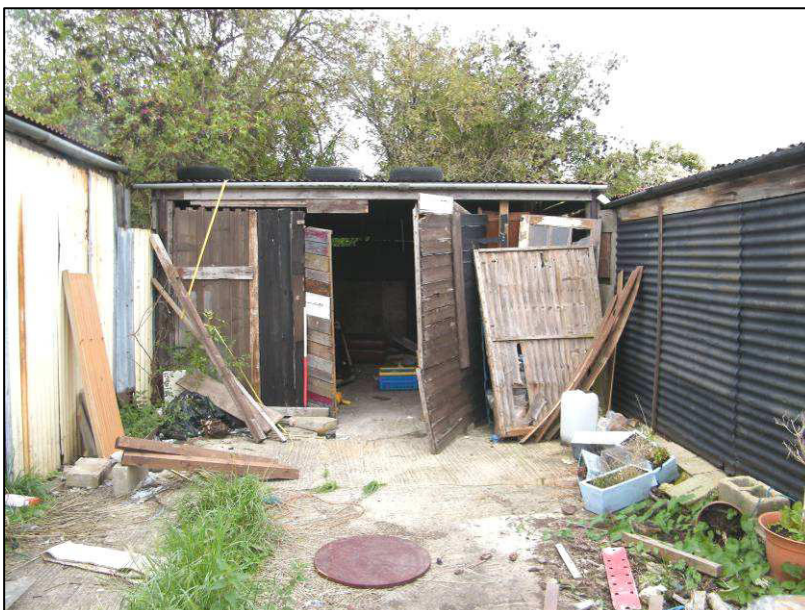
Plate 12 (Shot 6): South elevation of Building H, looking north, with Building G to the left of the shot and Building F to the right. Scale is 1m

- 6.8.1 Building H is a free-standing shed built on a concrete base with weather-boarded sides and a flat roof formed from corrugated sheets (Plate 12). This building measured approximately 7m by 5.5m and first appears on the 1973 mapping.

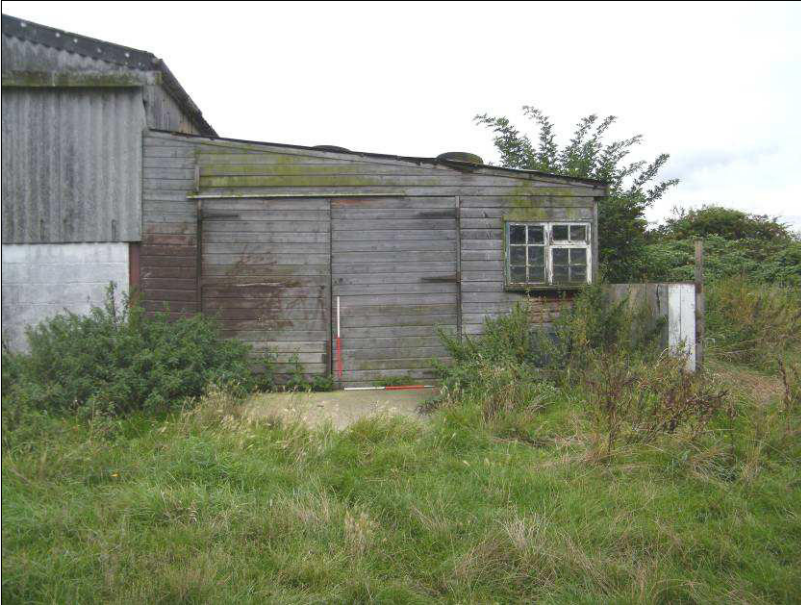
Plate 13 (Shot 2): Building I, looking south. Scales are both 1m

- 6.9.1 Building I is a lean to structure with mono pitched roof, formed from a wooden frame and weather boarding, abutting the western side of Building J and measuring approximately 23m by 7.8m (Plate 13). In the north elevation is a double door of two weather-boarded panels and a window with small top hung casement and thin wooden glazing bars.
- 6.9.2 This structure first appears on the 1973 mapping and was probably ancillary storage for the associated agricultural Building J.

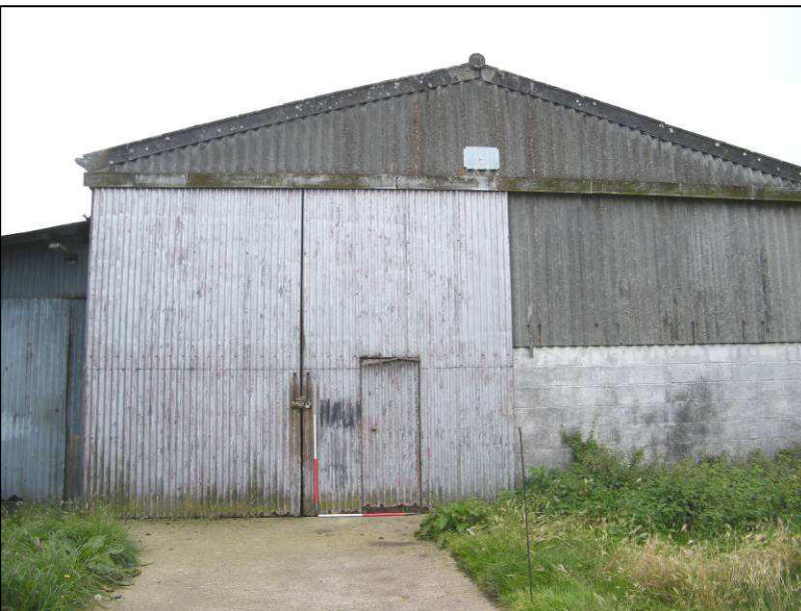
Plate 14 (Shot 3): Building J, looking south. Scales are both 1m

- 6.10.1 Building J is a large modern agricultural barn measuring approximately 23m by 11m and formed from breeze block lower walls with corrugated sheet upper walls, presumably attached to an internal steel frame (Plate 14) and built on a concrete base. It has a double pitched gabled roof. Two large corrugated sheet panel doors were located on the northern elevation sufficient to allow access for large agricultural machinery. A small access or wicket door had been cut into the main door to allow pedestrian access.
- 6.10.2 This building is modern in date, again first appearing on the 1973 map.

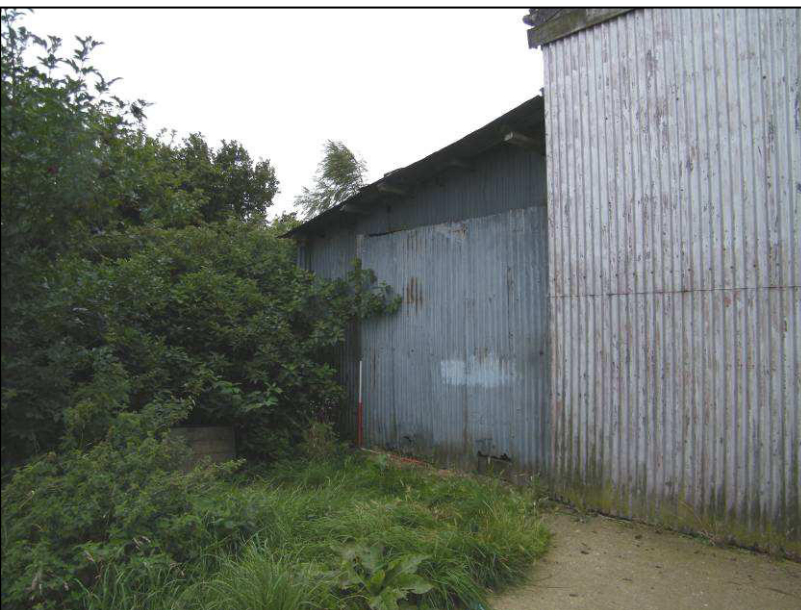
Plate 15 (Shot 4): Building K, looking southeast. Scales are both 1m

- 6.11.1 Building K is another mono-pitched lean to structure built against the east side of Building J, and measures 22m by 6m. This structure was constructed of corrugated sheets attached to an internal frame (Plate 15). No entrance was noted, which may suggest an internal access from Building J.
- 6.11.2 As with previous buildings on this side of the site, this structure first appears on the 1973 mapping.

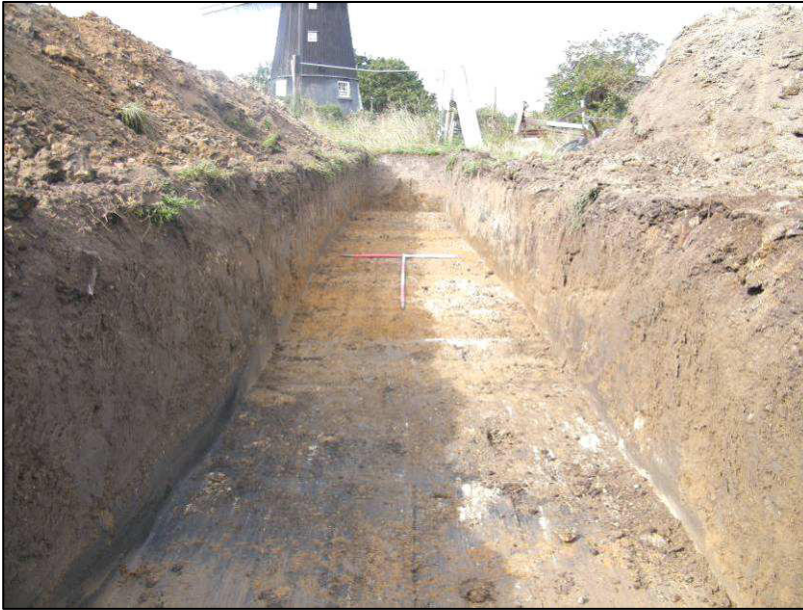
Plate 16: Trench 1 looking west.
Scales are 2m and 1m

- 8.1.1 Trench 1 was aligned east – west in the southern part of the site. The uppermost deposit was a greyish brown silty clay topsoil 100, 0.3m thick, overlying made ground or levelling layer 101, which was also 0.3m thick. This layer sealed a north – south aligned ditch [103], which measured 1.19m wide by 0.52m deep, with a concave profile and was filled by a dumped deposit of dark grey silty clay 102.

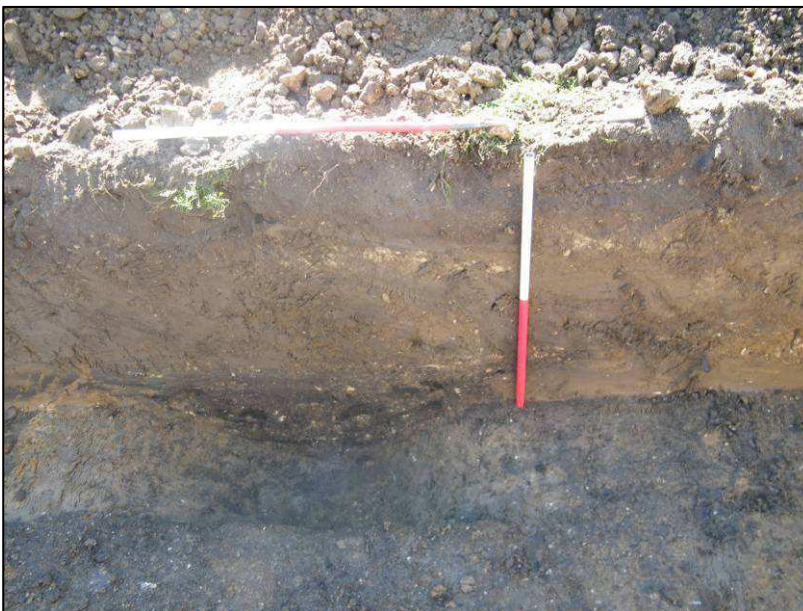
Plate 17: South facing section of
ditch [103], looking north. Scales
are both 1m

- 8.1.2 Pottery dating from the 12th century AD and a single fragment of animal bone was recovered from the ditch. Environmental sampling indicated the presence of moderate densities of cereal grains indicative of burnt crop processing or storage waste, although the presence of moderate densities of charcoal and small amounts of other food detritus suggests this may represent crop processing waste burnt as fuel on a domestic hearth.

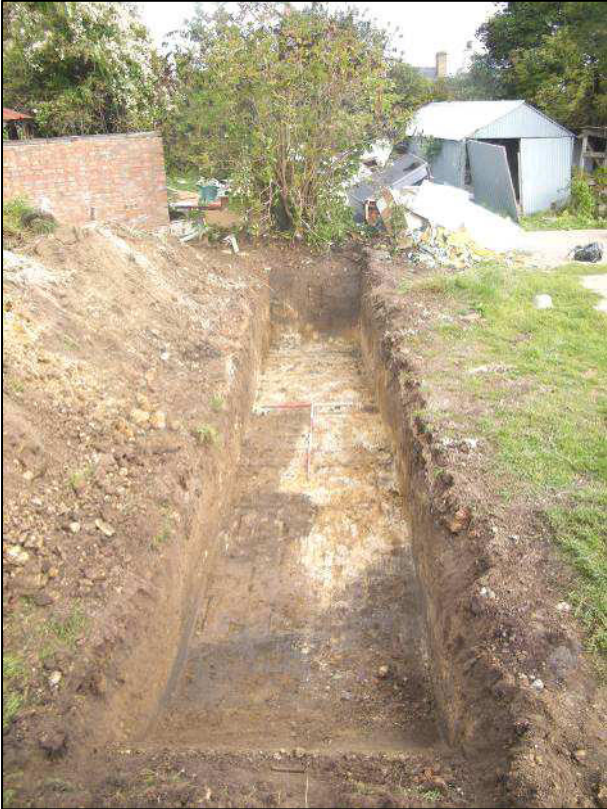
Plate 18: Trench 2 looking north. Scales are 2m and 1m

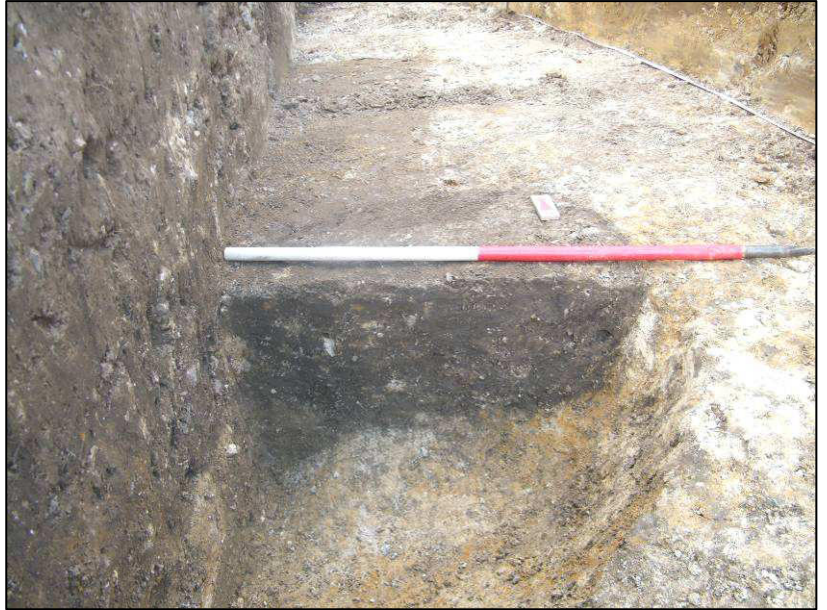
Plate 19: South facing section of Pit [208]. Ditch [206] extends to the northeast. Scale is 1m. Looking north

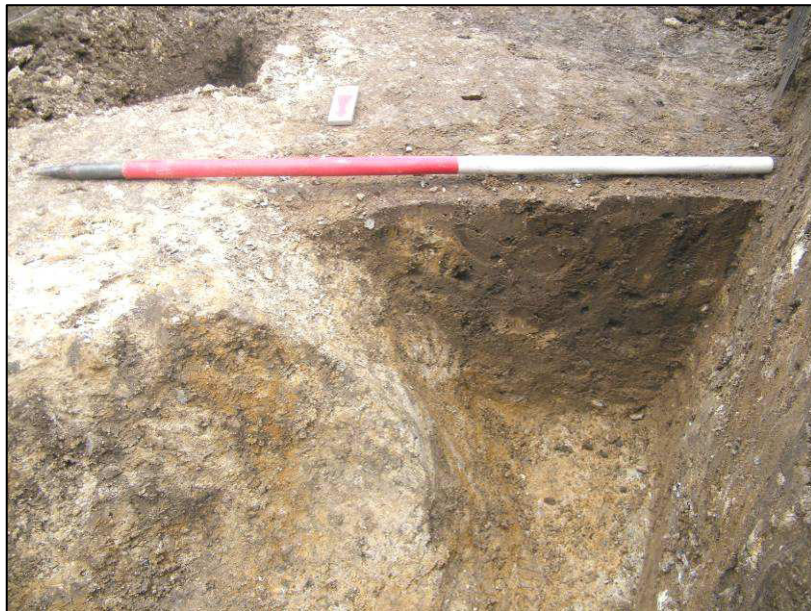
Plate 20: North facing section of ditch [212], looking south. Scale is 1m

- 8.2.7 A vertically sided northeast to southwest aligned modern feature truncated ditch [212]. The feature was not fully excavated or recorded after modern material including plastic and recent waste was noted in the fill. This feature does not extend into Trench 1 and is probably an isolated pit or backfilled trench relating to the former farmyard.
