ARCHAEOLOGICAL WATCHING BRIEF REPORT:

HOE CHURCH HALL, HOE, NORFOLK

Planning Reference: 3PL/2012/1346/F NGR: TF 9969 1644 Site Code: HOCH 13

By Allen Archaeology Limited Report Number AAL2013135

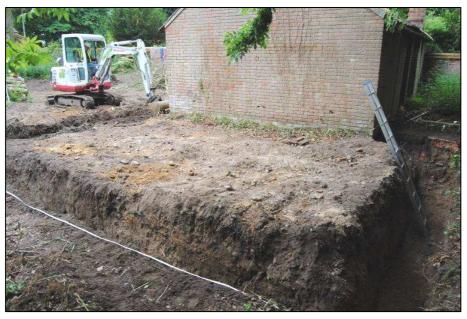
Plate 1: General working shot, showing the excavation of the foundation footings for the church hall extension. Looking southwest

- 6.1 The excavations for the footings of the church hall extension were undertaken using a tracked 360° mini excavator. The footings were 0.80m wide and 1.60m deep.
- 6.2 In general, 0.40m of topsoil, 03, overlay the natural geology of grey silty sand, 08, and yellow orange sand, 09.
- 6.3 In the eastern length of the footings, the topsoil overlay the remnants of a path which consisted of dark orange brown sandy gravel and fragments of brick, 05 and 07, with an underlying levelling layer of light grey brown clay, 06.

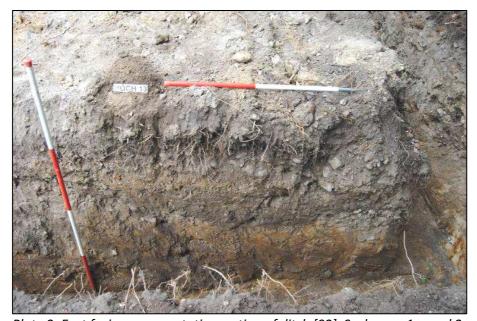
Plate 2: East facing representative section of ditch [02]. Scales are 1m and 2m

- 6.4 This sealed the only cut feature recorded on the site, a ditch [02], which was 0.30m deep, and had silted up with an undated greyish brown silty sand 01.
- 6.5 An area measuring 3.60m by 4.30m was excavated for the insertion of a septic tank. Here, 0.4m of topsoil was removed and this overlay a 0.10m thick layer of re-deposited natural, 10. This in turn sealed a 0.3m thick layer of buried topsoil, 11, which overlay the natural geology, 09. No archaeological features were observed and no finds were recovered.
- 6.6 Excavations for the associated pipe trenches were between 0.40m and 0.50m deep and only revealed topsoil 03.

- 7.1 The watching brief revealed a single undated ditch which ran in a roughly east west direction. Although the feature is undated, is likely that it relates to the medieval and post-medieval activity that has previously been identified to the north and west of the site. It is also possible that the ditch may relate to features associated with Hoe Hall and its surrounding landscaped park.
- 7.2 The remainder of the watching brief revealed no further archaeologically significant features, suggesting that this area was not extensively occupied in the medieval and post-medieval periods.

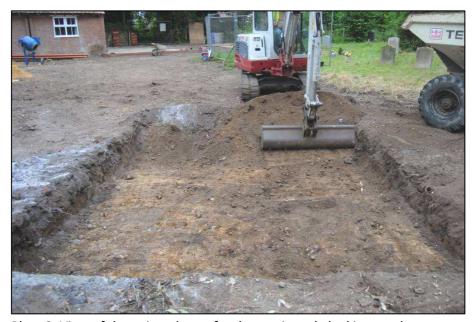
Plate 3: View of the stripped area for the septic tank, looking north
