ARCHAEOLOGICAL WATCHING BRIEF:

GAINSTHORPE ROAD DRAINAGE SCHEME, GAINSTHORPE, NORTH LINCOLNSHIRE

By
Allen Archaeology Limited
Report Number AAL2014046

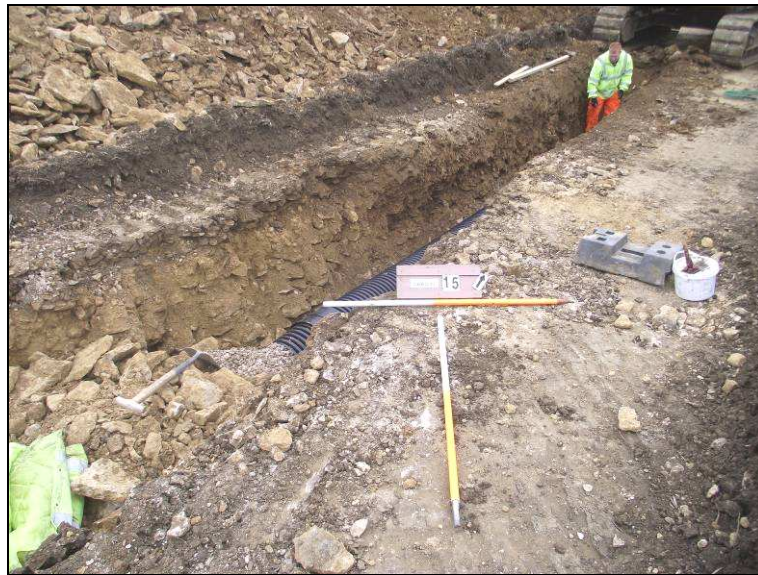
Plate 1: Northwest facing section of trench showing feature [015]. 1m and 2m scales

- 6.1 A limestone brash, 004, 007, 013 and 016, over solid limestone, 010, with occasional patches of sand, 012, formed the natural geological deposits across much of the trench at a depth of 0.40m-0.60m below the existing ground surface.
- 6.2 A substantial feature, [015], which measured approximately 8m wide and 1m deep, was encountered approximately 135m from the south end of the trench. Due to the narrow width of the trench the orientation of the feature was unclear and it may have been a pit or hollow

rather than a linear ditch. It contained a single undated fill, 014 of light to mid brown clayey silt.

- 6.3 A compact clayey silt, 006 and 011, which measured an average of 0.15m thick, intermittently sealed the geological deposits and also sealed cut feature [015], and may have been the remains of a buried soil layer or former ground surface. No finds were recovered from the deposit however and as such its date and origin is unclear.
- 6.4 At the southern end of the trench two clay-rich layers, 008 and 009, with a combined thickness of 0.70m overlay the buried soil 006/011, adjacent to an extant ditch. The deposits are almost certainly alluvial in origin and probably relate to flooding episodes related to the adjacent ditch. Both of the layers were undated.
- 6.5 The uppermost deposit encountered in the trench was a 0.25m thick layer of ploughsoil 002 which formed the modern ground surface.

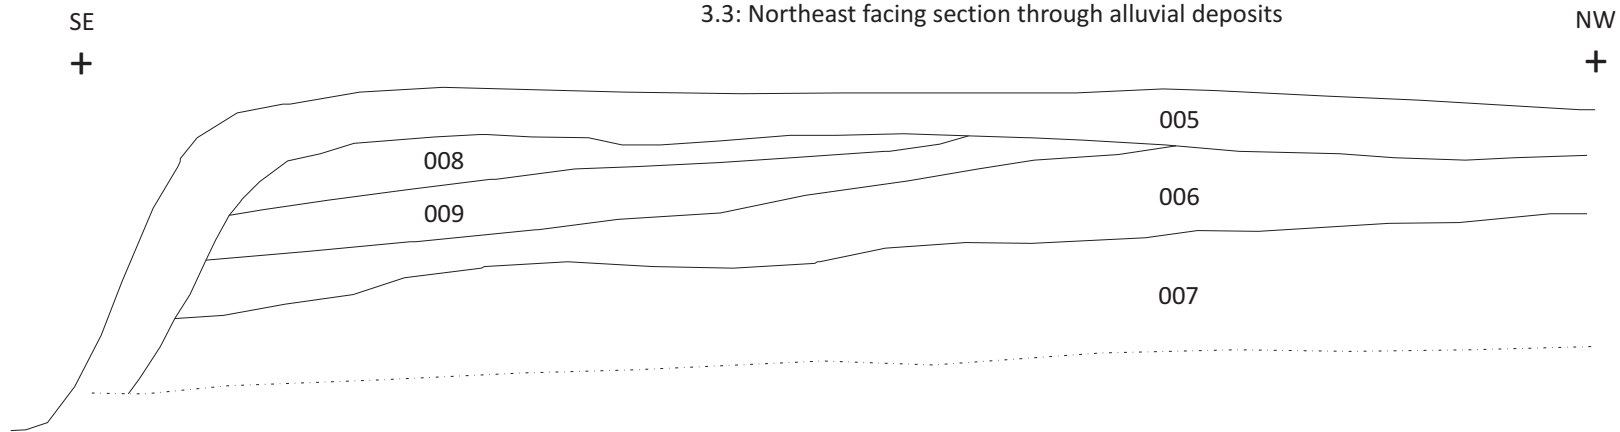
Figure 3: Selected sections, located on Figure 2
