HISTORIC BUILDING SURVEY REPORT:
THE WELLINGTON ARMS, ANDOVER ROAD, NEWBURY, BERKSHIRE

Planning Reference: 14/00305/FULD
NGR: SU 4694 6643
AAL Site Code: NEAR 14
OASIS Reference Number: allenarc1-179183

By
Allen Archaeology Limited
Report Number AAL2014053

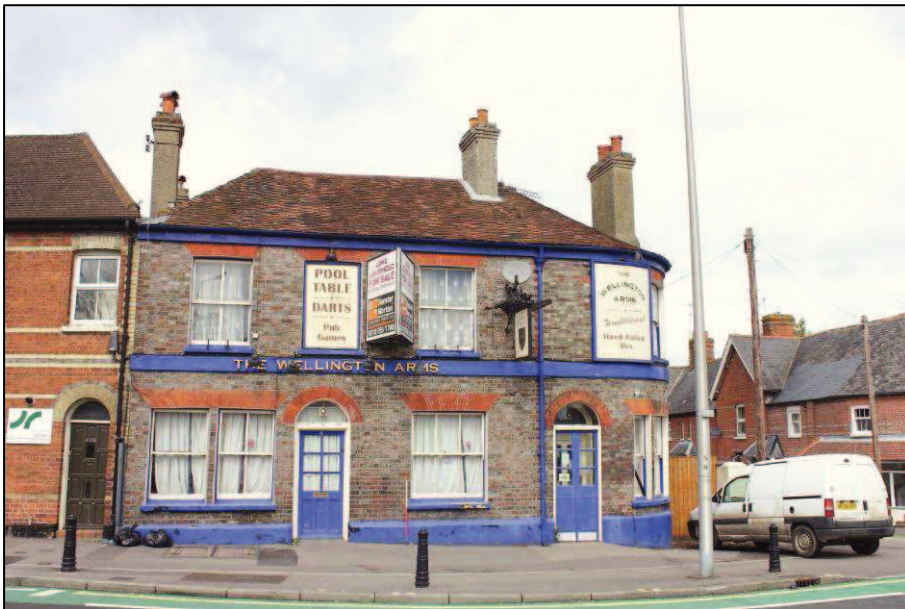
*Plate 2 (Shot 118):
Southeast elevation,
looking northwest,
1m scale*

- 6.2 The existing structure follows the alignment of Andover Road, with a curved façade to the northeast facing the junction of Andover Road and Derby Road. It is likely to be of an early to mid 19th century date, first shown on mapping dating to 1841 (WA 2013). The front of the pub is built in red and grey brick in a Flemish bond with a hipped roof in plain tiles. There are three rendered brick chimney stacks; one external chimney at each gable and an internal stack protruding through the roof, slightly offset from the ridge (Plate 2).

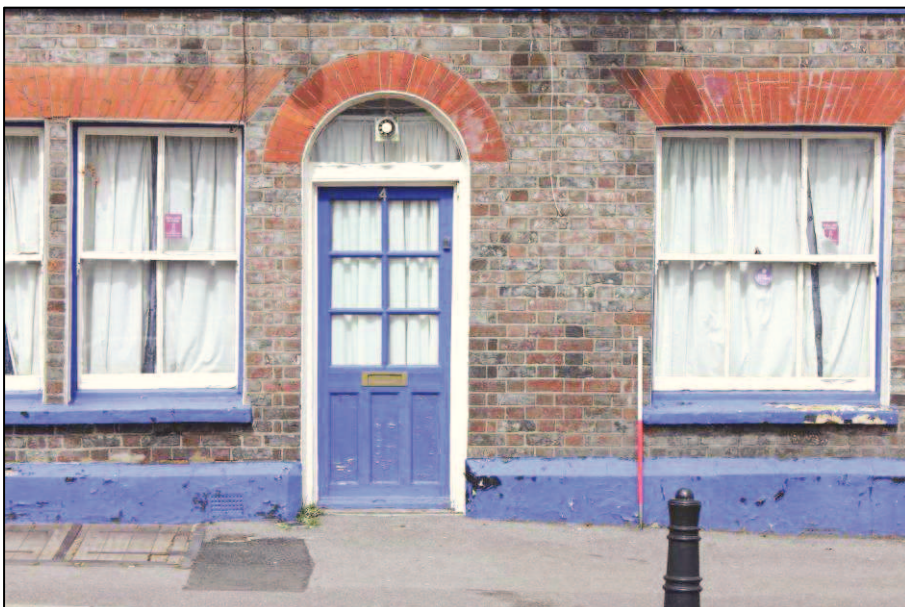
*Plate 3 (Shot 120):
Representative shot of
ground floor doors
and windows, looking
northwest. 1m scale*

- 6.3 The frontage of the pub has a rendered plinth, and a rendered string course divides the ground floor and first floor, with another rendered string course below the eaves. There are two glazed wood panelled doorways on the southeast elevation, each with simple semi circular fanlights and gauged brick arches. This elevation has three ground floor vertically sliding sash windows with red brick cambered arches (Plates 2 and 3). There also used to be three similar windows on the first floor although the central example has been bricked up (Plate 4).

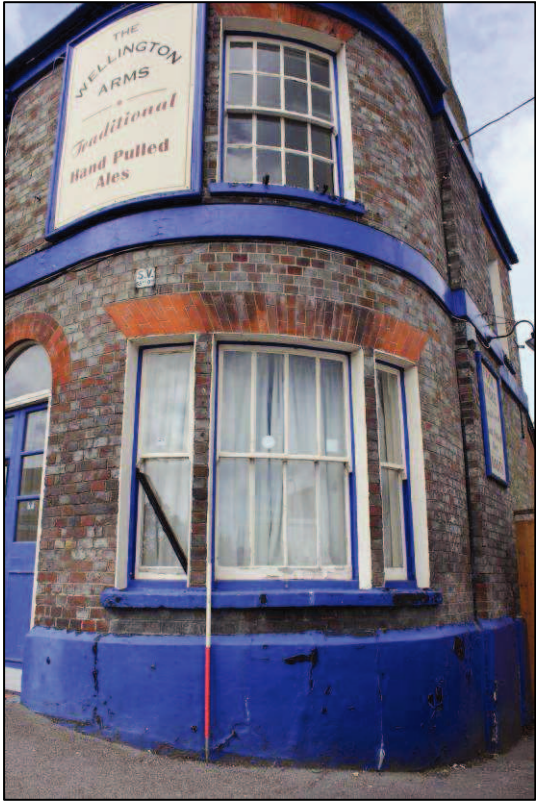
Plate 5 (Shot 123): Northeast corner of pub, looking southwest, 1m scale

- 6.4 The curved northeast façade is built using a header bond, with sash windows at ground floor and first floor level (Plate 5). The first floor window is bowed to reflect the curvature of the wall and is probably original whereas the ground floor windows are flat and may be replacements.

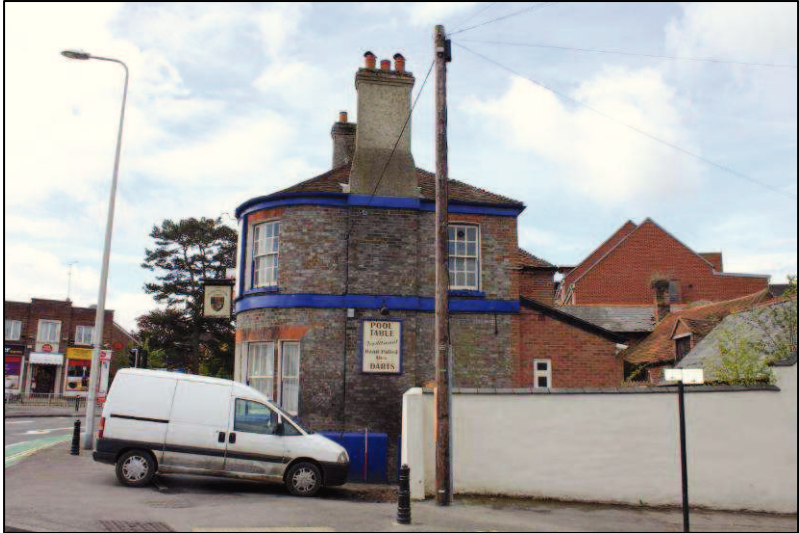
Plate 6 (Shot 116): Northeast elevation, looking southwest, 1m scale

- 6.5 There is an external chimney stack on the northeast elevation with another sash window to its west at first floor level (Plate 6). There is significant evidence for later repair along the northwest corner of this elevation.

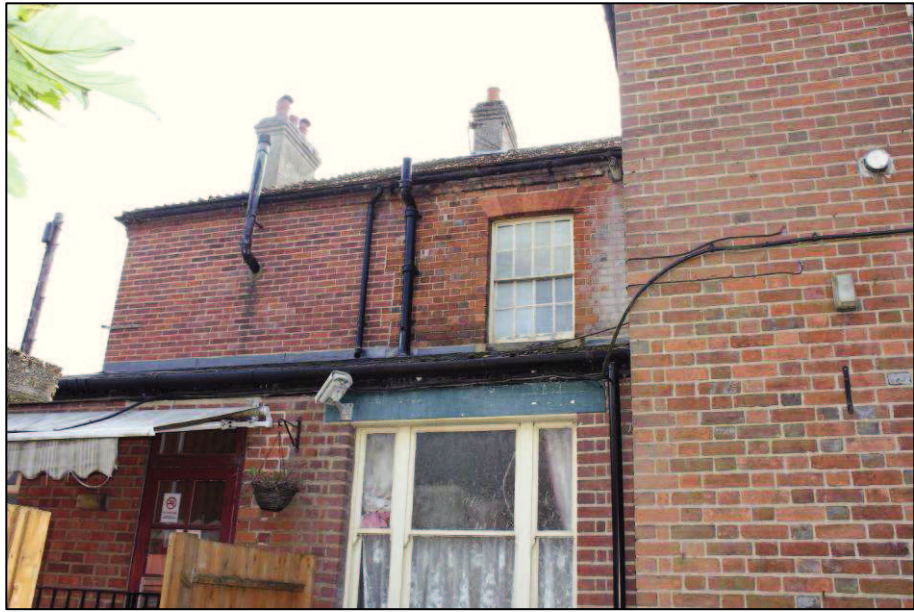
Plate 7 (Shot 110): Northwest elevation showing later rusticated brick repair, looking east

- 6.6 The northwest elevation also shows extensive 20th century repairs to the brickwork at first floor level, with only its southern half being original. There is a single sash window with small panes at first floor level which corresponds in style with those on the northeast elevation (Plate 7).

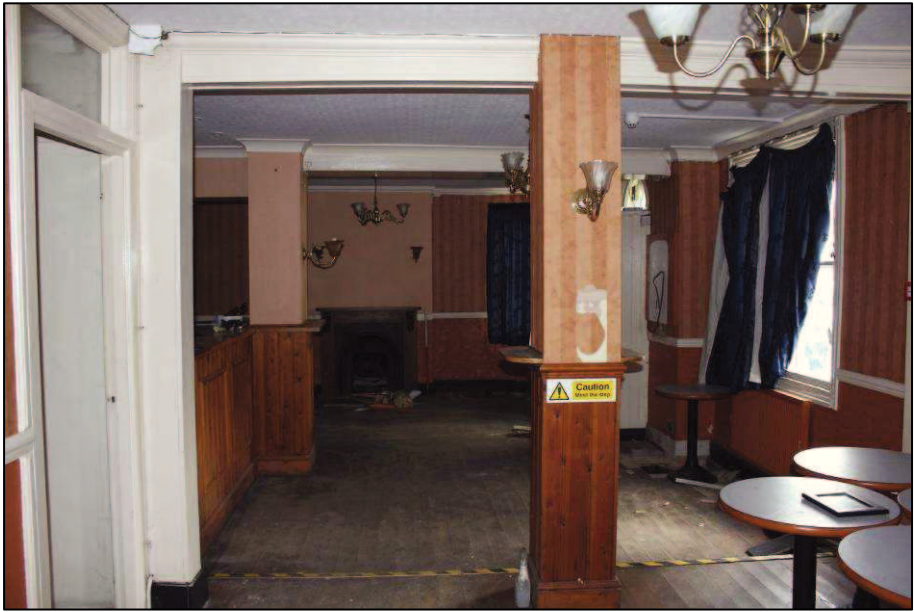
Plate 9 (Shot 12): Pub area on ground floor, looking northeast, 1m scale

- 6.7 The ground floor of the pub contains the lounge and bar area, and has modern décor, fixtures and fittings throughout. Two pillars offer extra support to the open plan form, which is likely to be a relatively recent alteration (Plates 8 and 9). The fireplace in the southwest chimney stack is disused and has been timber clad. The cast iron fireplace with wooden surround on the northeast elevation is a probable 20th century addition (Plate 10). The exact date of the skirting boards, dado rails and covings are unknown, but appear to be a mix of 19th-20th century dates.

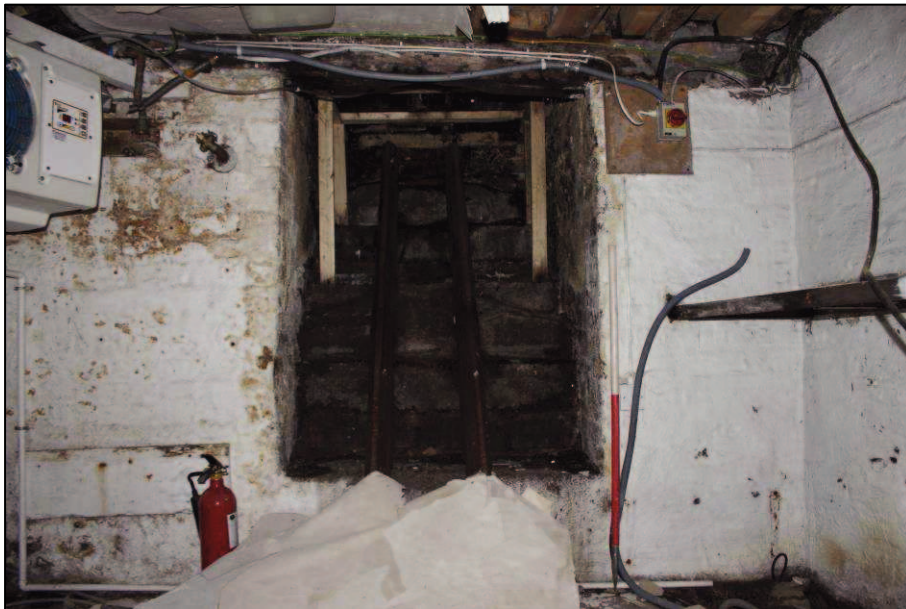
*Plate 11 (Shot 46):
Cellar access to
Andover Road, looking
east-southeast, 1m
scale*

- 6.8 The cellar is accessible via stairs located southwest of the bar. There is a delivery entrance in the cellar accessible via an opening on Andover Road (Plate 11). The base of the chimney breast is vaulted with a rubbed brick arch, not an uncommon feature in buildings of this date. In the northwest elevation is a vaulted recess, likely to be a barrel store (Plate 13). Modern draught equipment covers most of the northeast elevation.

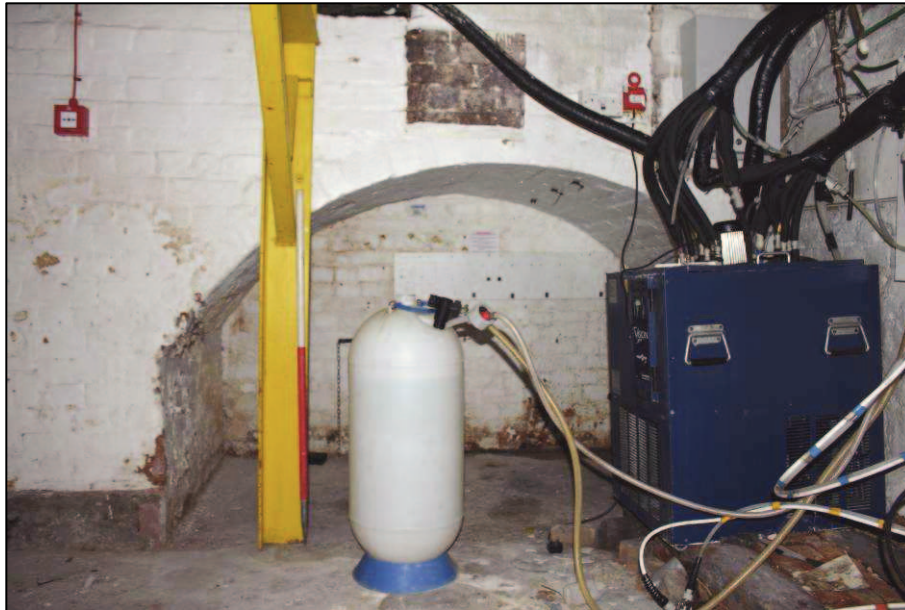
*Plate 13 (Shot 49):
Vaulted storage cell
on the northwest
elevation, 1m scale*

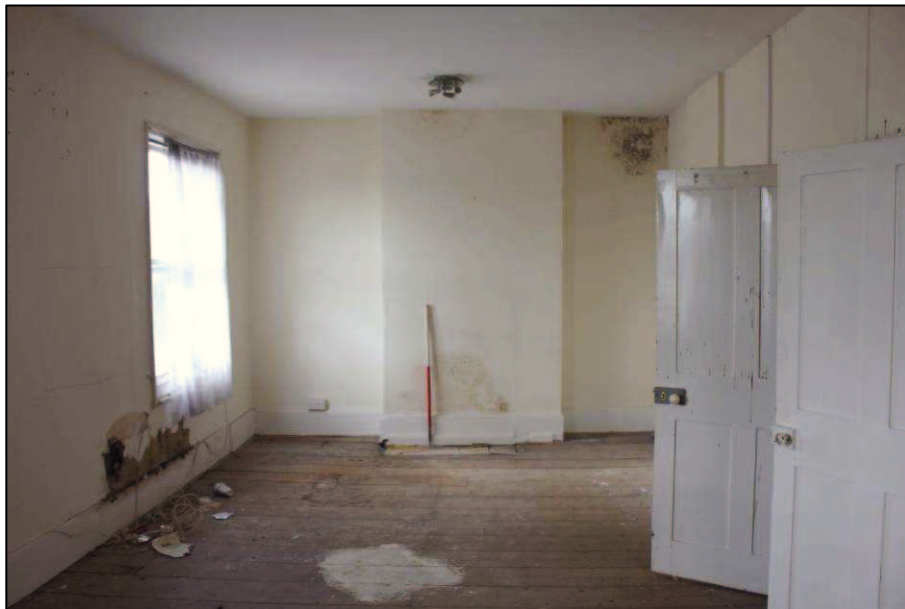
*Plate 14 (Shot 25):
Living space on first
floor looking towards
blocked up fireplace
on the southwest
elevation, 1m scale*

to the building. The first floor has been converted into a self contained flat but would originally have been occupied by the publican and his family. The closely spaced doors into the main room suggest that the space was probably two rooms originally, and a partition wall has been removed, as in the pub itself below. Both fireplaces on the first floor are disused and have been blocked up. The wooden floor is likely to be original. (Plates 14 and 15).

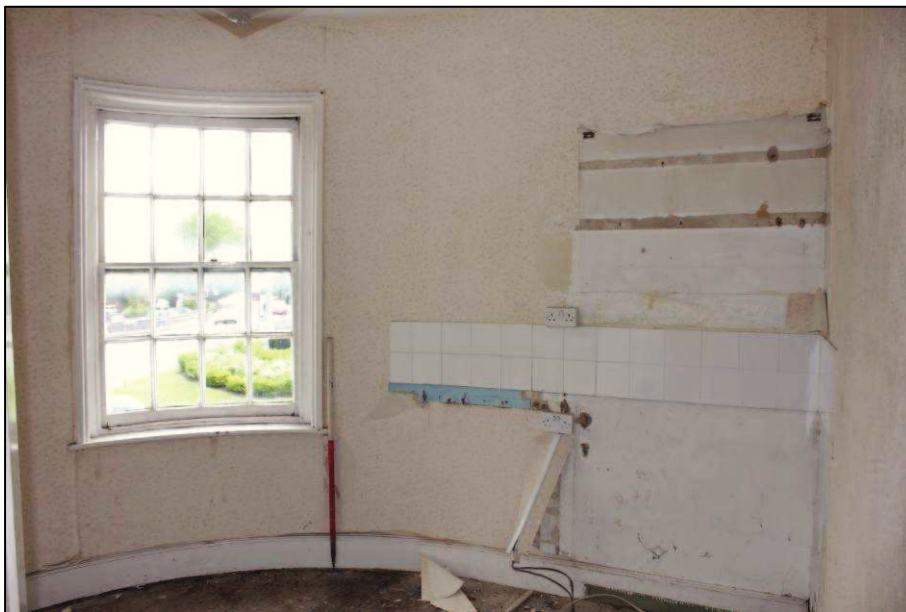
Plate 18 (Shot 31): First floor kitchen, looking northeast. 1m scale

- 6.10 Across the corridor there is a cupboard space with rounded corner wall, and adjacent toilet (Plate 16). At the north end of the corridor is a converted bathroom and kitchen, both later additions but with the original wooden plank floor (Plates 17 - 19).
- 6.11 The original kingpost roof structure appears to be intact although the central truss has the added support of diagonal bracing struts at its apex (Plate 20). The trenched purlins are held in place by cleats.

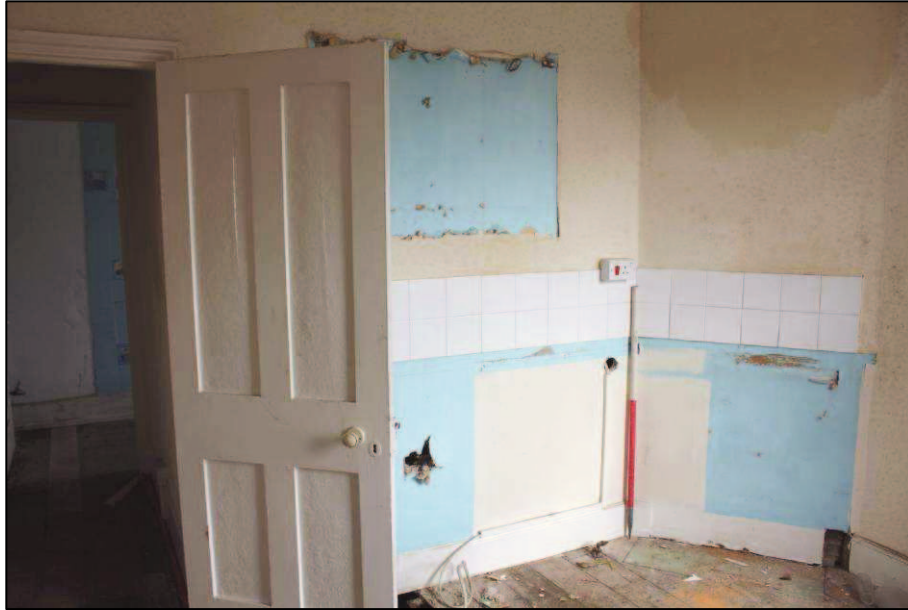
*Plate 19 (Shot 34):
General view of the
kitchen, looking
northwest, 1m scale*

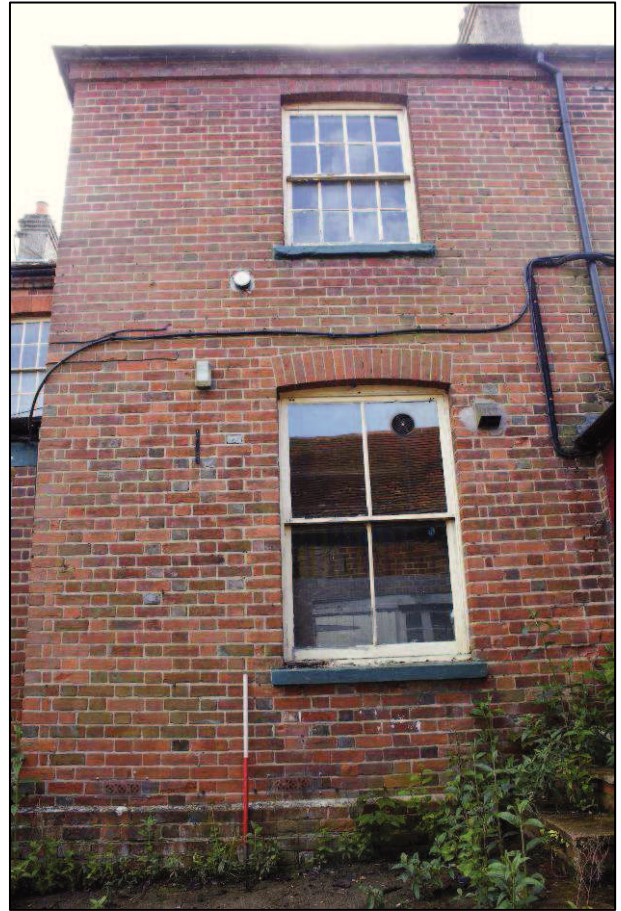
Plate 21 (Shot 101): Two storey extension southwest of the main pub, looking east southeast, 1m scale

- 6.12 Southwest of the main pub is a two storey red brick extension in Flemish Bond, with a patch of Dutch Bond on the first floor northwest elevation (Plate 21). It is first visible on the 1880 Ordnance Survey map, and therefore dates to the latter half of the 19th century. Just as with the main pub, the structure sits on a projecting plinth, although it is in this instance bare brickwork rather than rendered plinth. On the northwest elevation just above the plinth are Edwardian style air bricks which allow for airflow beneath the floorboards.

- 6.13 On the first floor is a sash window of the same style as those found on the main pub building but in this instance with a segmental rubbed brick arch. The ground floor sash window also has a segmental arch but the glazing is of later style with larger panes. The extension has a hipped roof of plain ceramic tiles with a rendered brick chimney stack protruding at the west side of the roof (Plates 21 and 22).

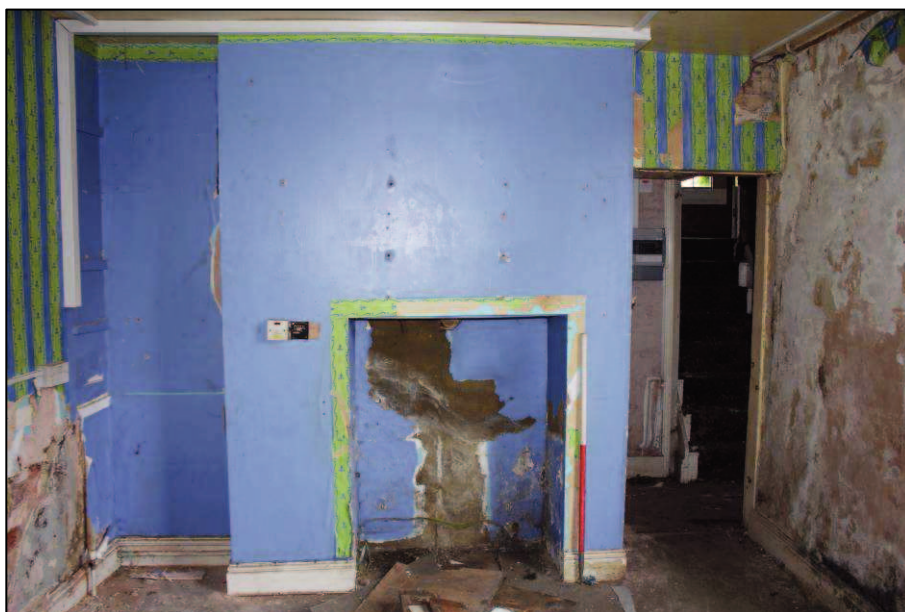
*Plate 24 (Shot 17):
Disused fireplace in
the back room,
looking southwest, 1m
scale*

- 6.14 There are two rooms within this structure, one on each floor. The ground floor room acts as a back room to the pub and has a disused fireplace (Plates 23 and 24). The first floor room is likely to have of late functioned as a bedroom. There was no sign of a chimney breast or fireplace in this room, but repairs to the floorboards suggest the location of a possible former fireplace in the southwest elevation.

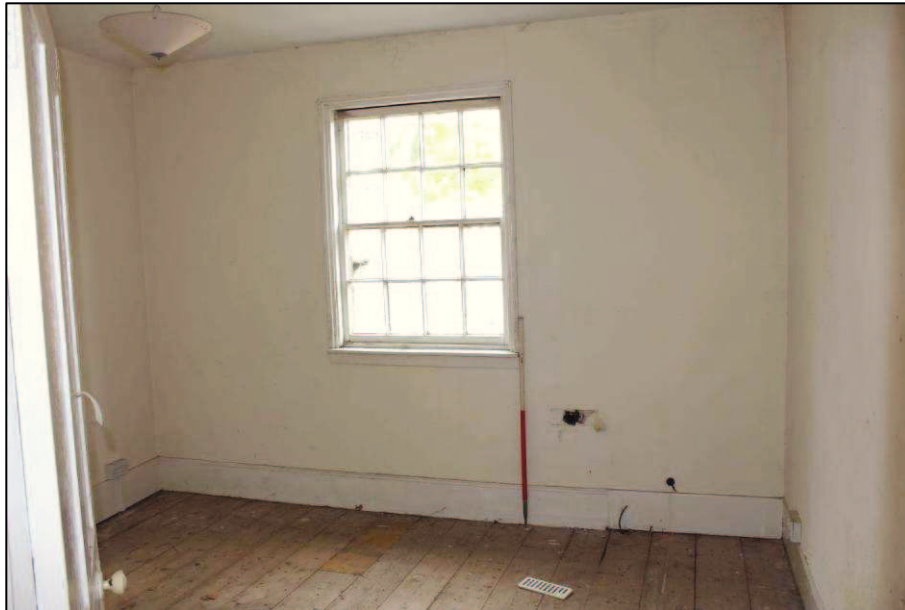
*Plate 25 (Shot 22):
First floor living space
in the extension,
looking west, 1m scale*

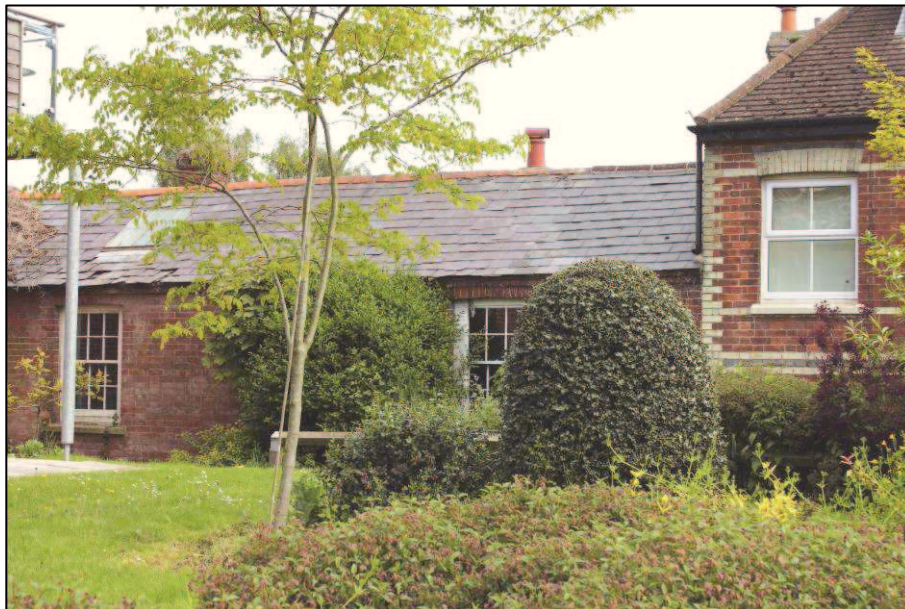
*Plate 26 (Shot 121):
Southwest elevation
of the function room*

- 6.15 Along the southern boundary of the site is a broadly northwest to southeast aligned outbuilding, which abuts No. 6 Andover Road to the southeast. This building is also first shown on the 1880 Ordnance Survey map. It is a red brick structure in Flemish Garden Wall Bond, with double pitched slate roof with ceramic copings. There are two sash windows on the southwest elevation, both with rubbed brick segmental arches. On the northeast elevation, there are two doorways west of the kitchen extension. The first floor opening is boarded up and accessed by a metal staircase. The ground floor opening has a plank and batten door with segmental arch above (Plates 26 and 27).

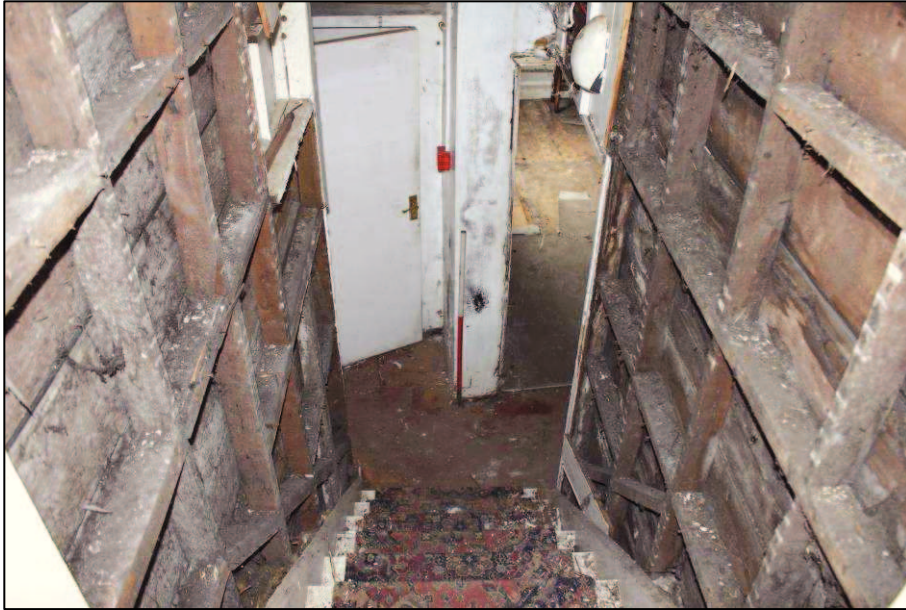
Plate 28 (Shot 58): Staircase adjacent to the kitchen extension leading up to the function room in a large outbuilding, looking northeast, 1m scale

- 6.16 This is a further access into this building from the stairwell located east of the kitchen extension. The elevations of this stairwell are boarded timber stud walls (Plate 28).

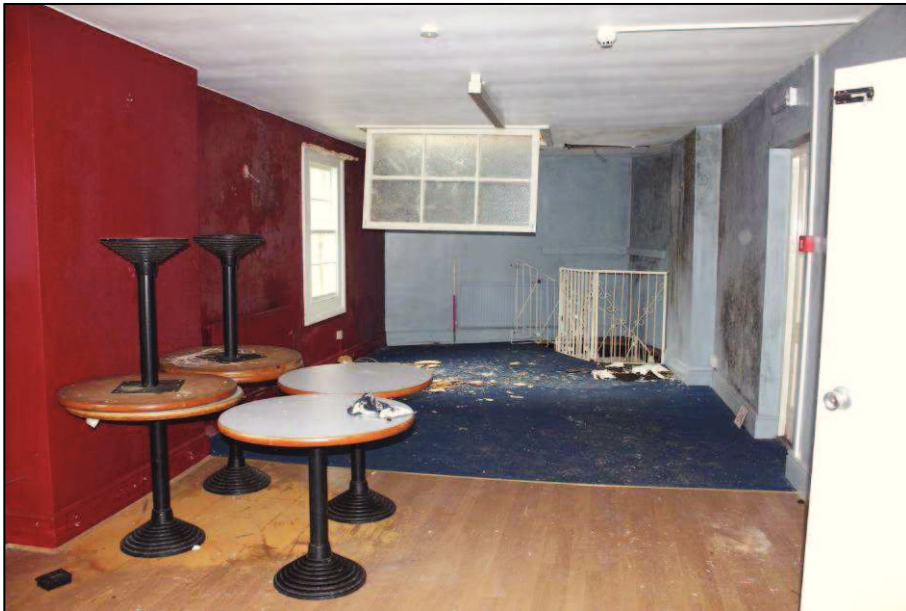
Plate 29 (Shot 60): General view of the function room, looking northwest, 1m scale

- 6.17 The first floor has recently been used as a function room and is modernised throughout (Plate 29). A rooflight has been added to the northwest end (Plate 30). A modern spiral staircase

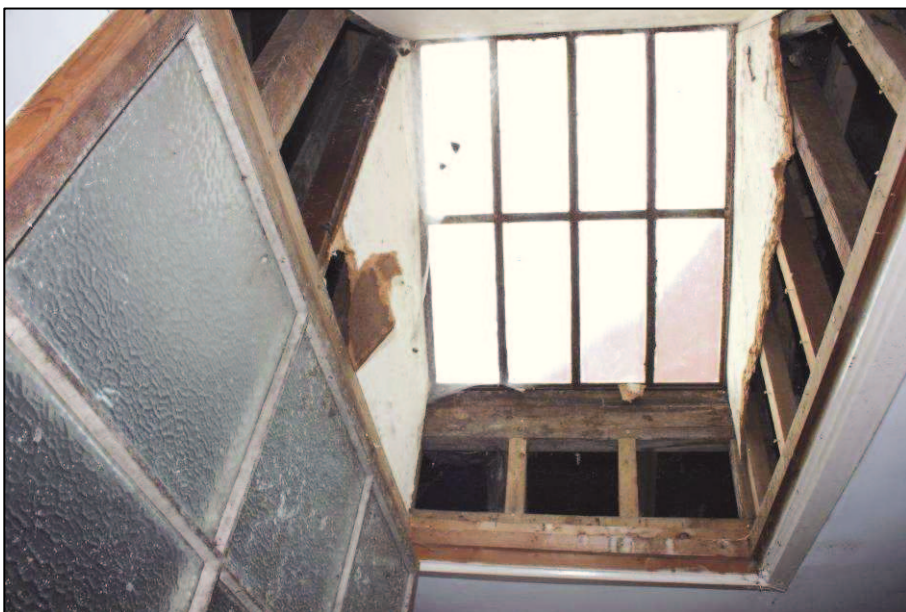
Plate 30 (Shot 62): Rooflight in the function room, looking southwest

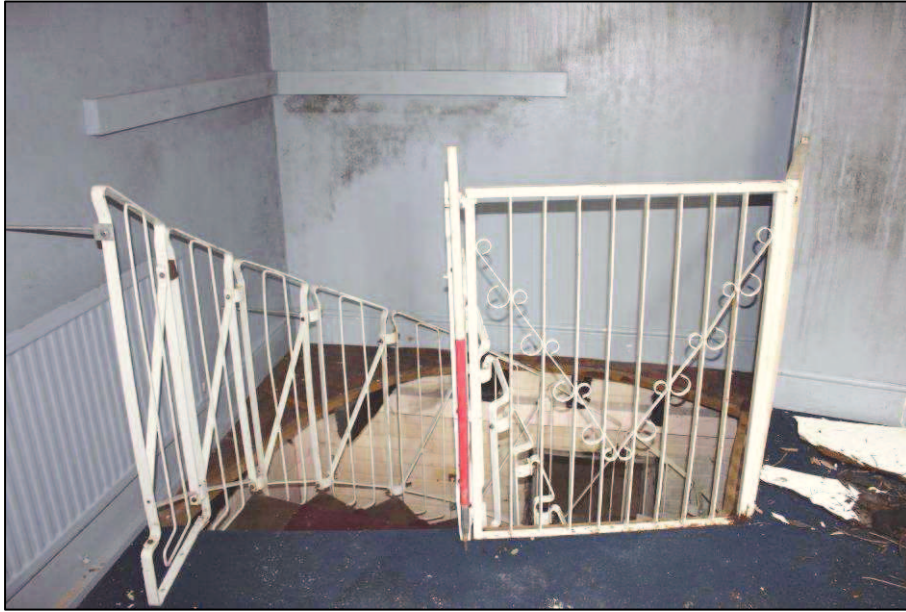
*Plate 31 (shot 63).
Spiral staircase
between first floor and
ground floor, looking
northeast, 1m scale*

leads to the ground floor (Plate 31), which has white painted brick walls and carpeted floor. Metal joists have been added along the centre of the room to support the floor above (Plate 32).

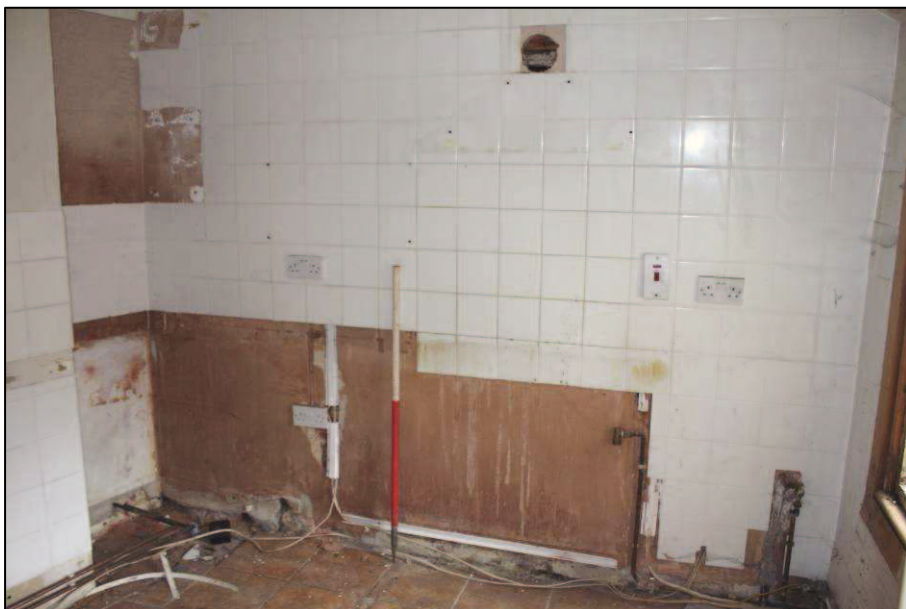
*Plate 33 (Shot 56):
General view of the
kitchen, looking
southwest, 1m scale*

- 6.19 The interior of the kitchen has been refurbished, the walls are plastered and tiled, new pipe work runs along the walls. No original fixtures or fittings were observed (Plate 33).

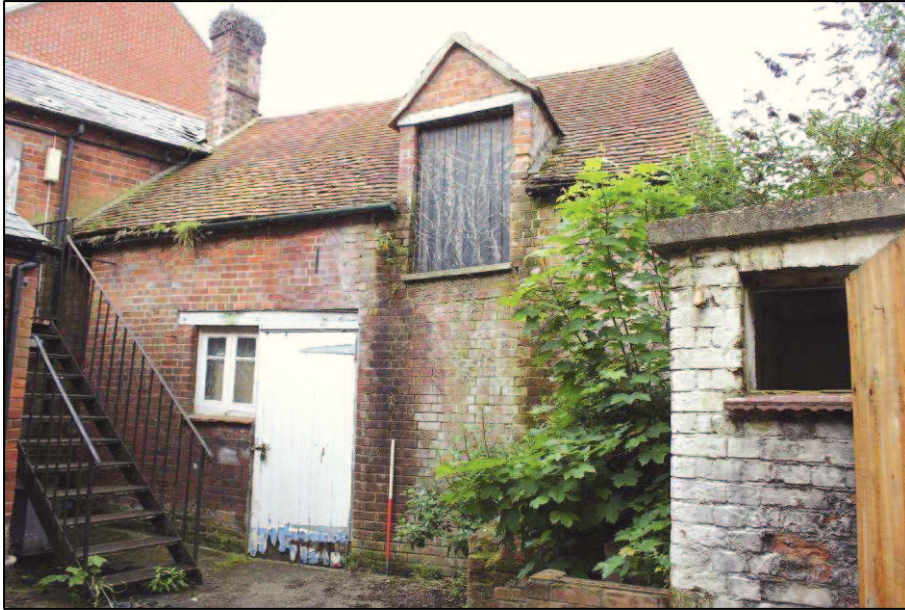
Plate 34 (Shot 95):
Southwest elevation of
the store, looking
west, 1m scale

- 6.20 The store, and former stable also first appears on the 1880 Ordnance Survey map. It is a one and a half storey brick structure in Flemish Bond with later brick repairs. The bond on the northwest and northeast elevation changes from Flemish to Flemish Garden Wall Bond halfway up the wall. The roof is double pitched and covered with plain tiles and at the southwest apex is a tall external square brick chimney. On the southeast elevation ground floor is a side hung casement window and a plank door with strap hinges. The only access to the loft is through a pitching hole in a gable fronted dormer with double pitched roof (Plate 34). There are no openings to the northeast and northwest (Plate 35).

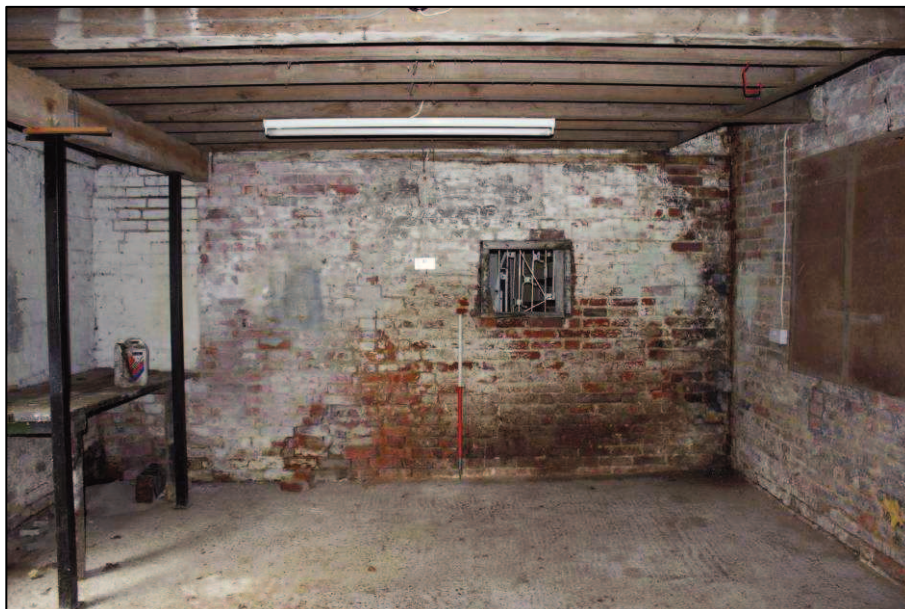
Plate 36 (Shot 67):
Southwest elevation
of the store, 1m scale

- 6.21 The internal southwest elevation does not show any trace of a fireplace, despite the external chimney. Fireplaces in stables were often a feature within the groom's room, but there was no evidence for such a space in this instance (Wade Martins, 1991, p.179). Apart from a small square ventilation window on the southwest elevation, which may be of a later date, and the harness pegs on the northeast elevation, no other fittings remain. The concrete floor is of a later date (Plates 36 and 37).

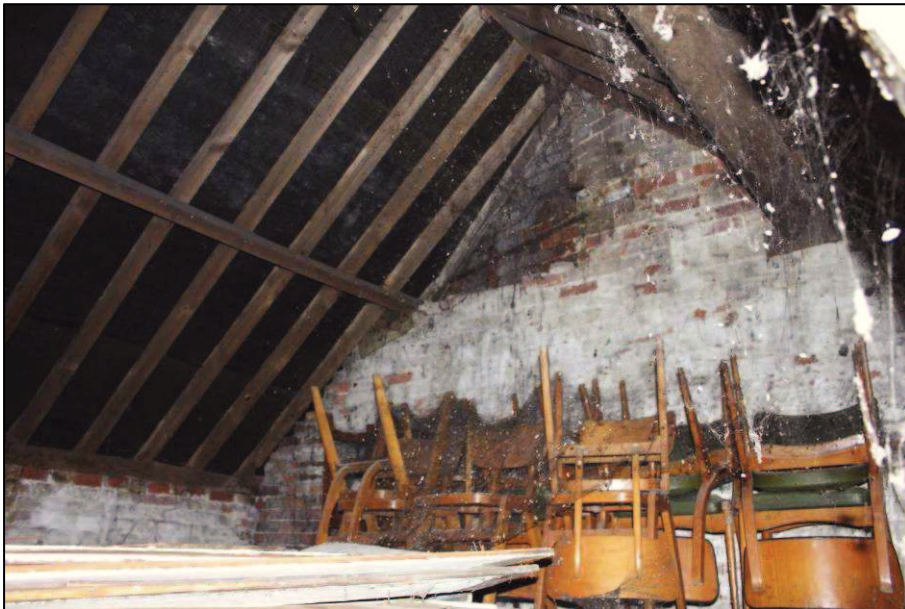
*Plate 38 (Shot 72): Loft
above store, looking
south*

- 6.22 The former hayloft above functions as a store room. The roof structure does not have a tie beam, but instead vertical posts sit on a cross beam and rise to the principal rafters, which are tied with a collar beam. The rafters support trenched purlins and common rafters that are joined at the ridge plank (Plates 38 and 39).

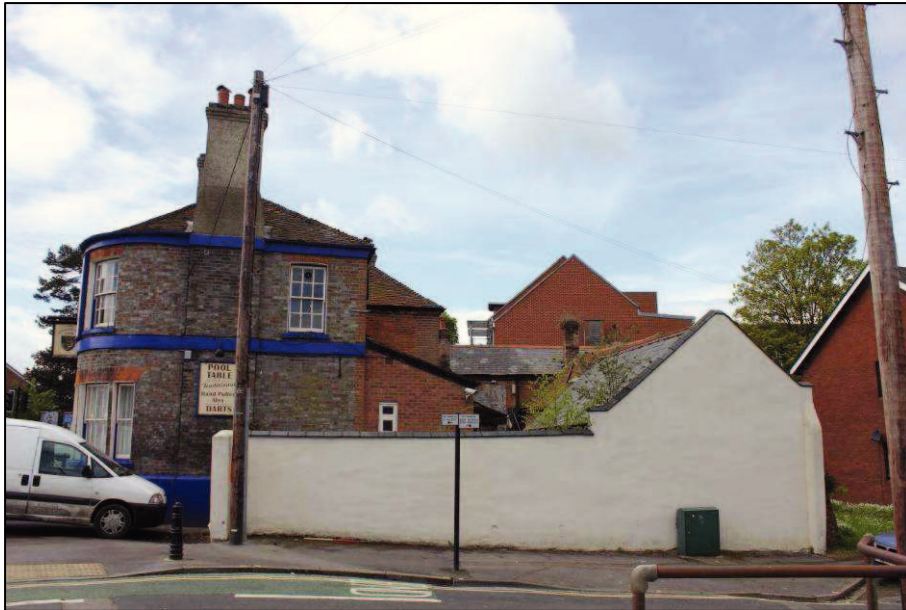
*Plate 40 (Shot 117):
Northeast elevation
and boundary wall,
looking southwest*

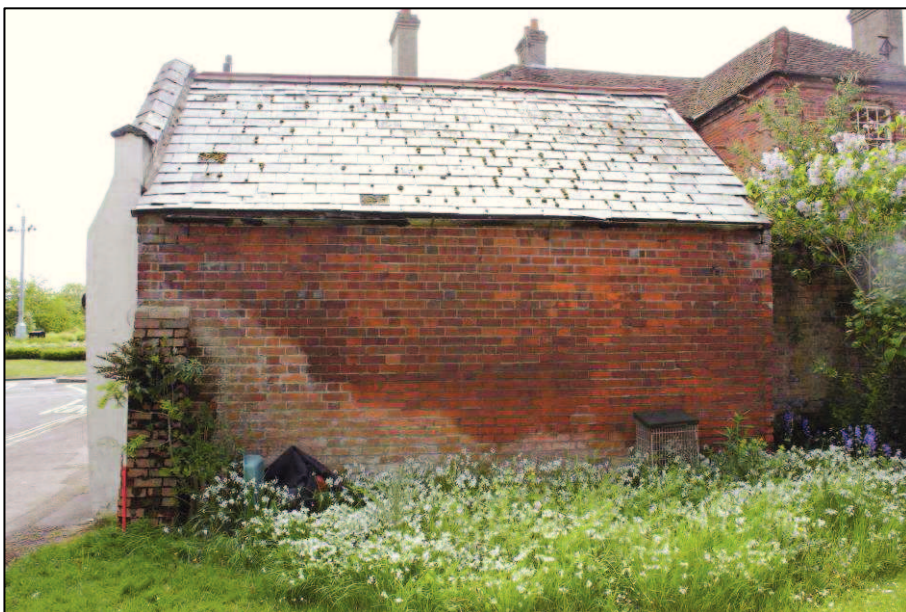
*Plate 42 (Shot 124):
Northwest elevation
of garage, looking
southeast, 1m scale*

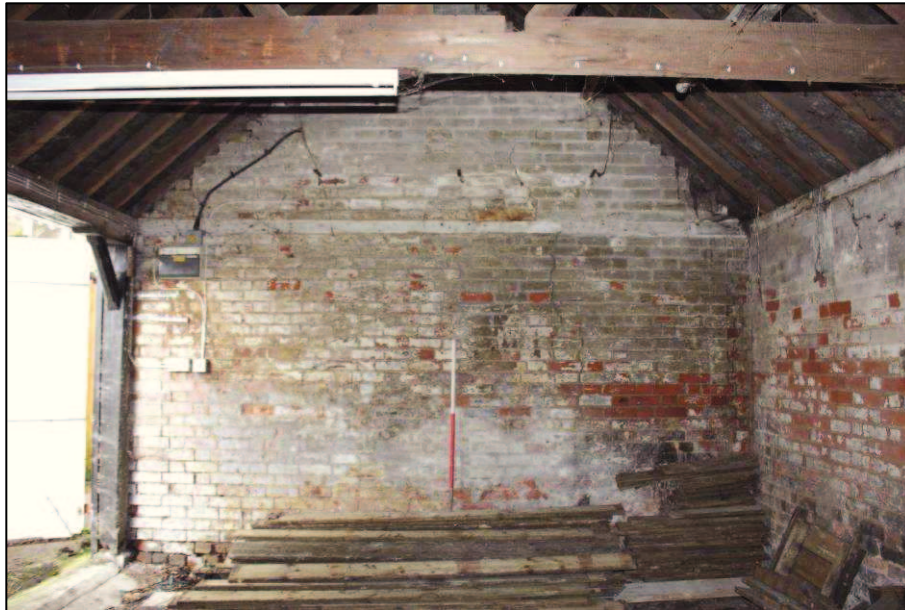
Plate 43 (Shot 82): Southwest internal elevation of the garage, looking southwest, 1m scale

- 6.24 The building runs on a northeast to southwest alignment and abuts the southwest elevation (now a rendered boundary wall) of the former Bull and Dog, fronting Derby Road (Plate 40). It has a double pitched slate roof with ceramic coping tiles and a parapet at the northeastern gable. The only access into the building is from the southeast elevation which comprises two sets of large floor to ceiling plank built double doors with strap hinges (Plate 41).
- 6.25 There is a later buttress supporting the northwest corner (Plate 42).
- 6.26 The interior walls are partially rendered and whitewashed. A kingpost roof structure with diagonal bracing struts supports purlins and common rafters (Plate 43). No original fixtures or fittings were observed.

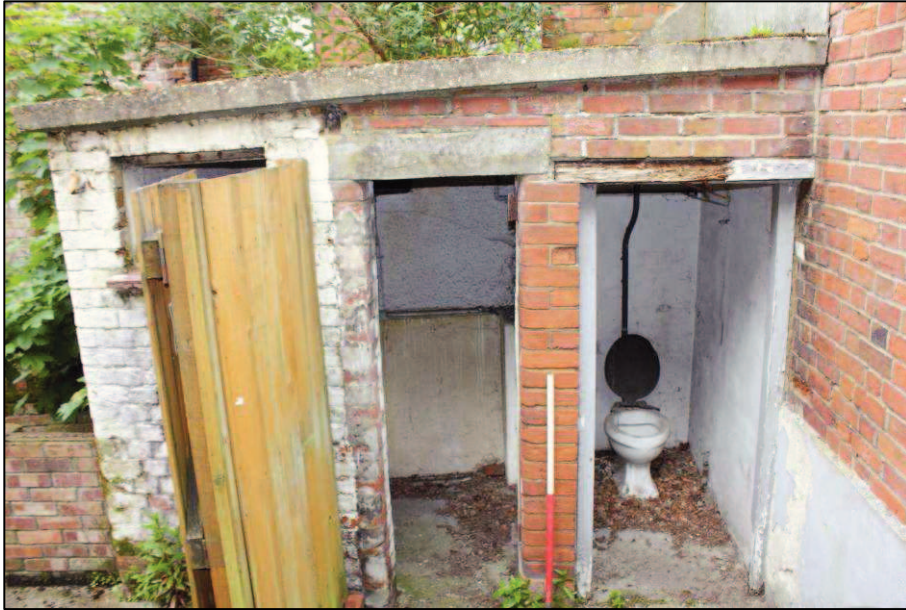
Plate 46 (Shot 92):
Outdoor toilets,
looking northwest, 1m
scale

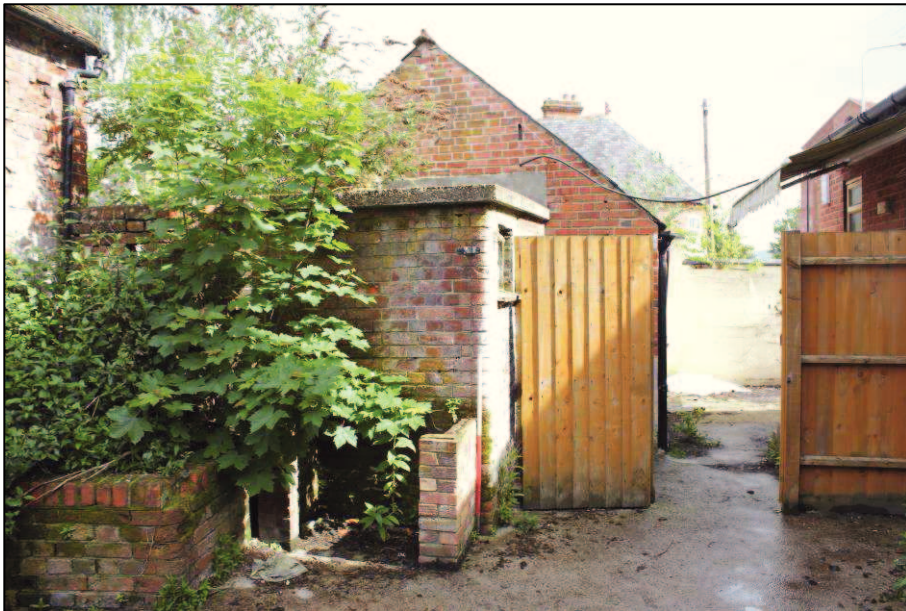
Plate 47 (Shot 94):
Southwest elevation
of outdoor toilets, also
low wall brick
structures, looking
northeast, 1m scale

- 6.27 A block of two outdoor toilets with a mono-pitched concrete roof abut the southwest elevation of the coach house. This is likely to represent a much altered survival of part of a structure shown on the 1880 Ordnance Survey map, although part of this building to the immediate west is no longer present. The northwest elevation is built in stretcher bond, and on the southeast elevation are two doorways and a window opening (Plate 46).
- 6.28 The southwest elevation is in English Bond, and bullnose bricks on the corner could potentially be a survival from the earlier structure (Plate 47). The date and function of the adjacent low brick walls is not clear

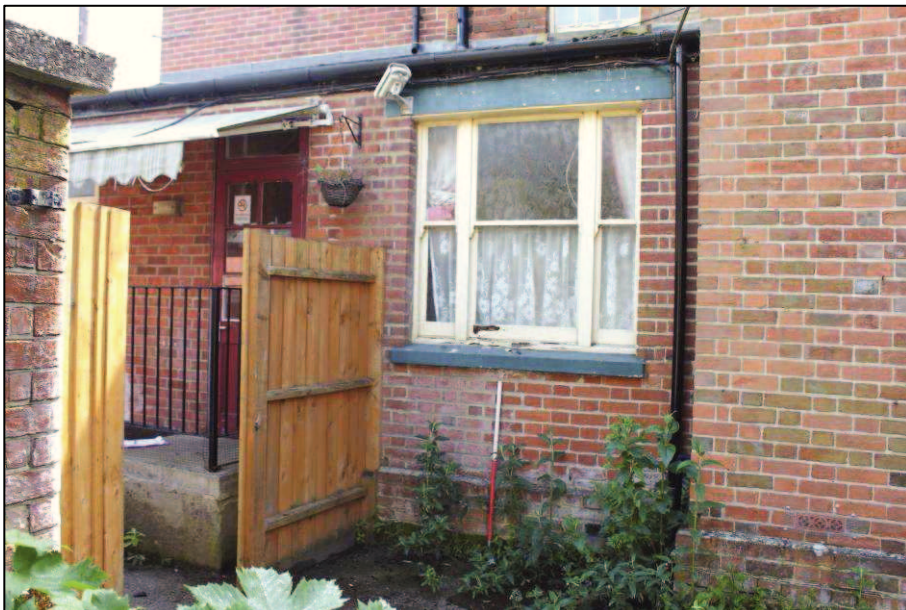
Plate 48 (Shot 110):
Northwest elevation
of toilet block, looking
east, 1m scale

- 6.29 According to the previous assessment this extension, abutting the northwest elevation of the main pub dates to 1980 (WA 2013). It is built in Flemish Bond and Stretcher Bond with a mono pitched slate roof. There is an entrance into the main pub from the northwest elevation; there is also a large sash window and a smaller window with a lower fixed light and an upper awning light. A similar window can be found on the northeast elevation (Plates 48 and 49).
- 6.30 Within the block are a ladies toilet and a men's toilet, both with modern fittings (Plate 50 and 51).
