**HISTORIC BUILDING SURVEY, EARTHWORK SURVEY AND TRIAL TRENCHING REPORT:
LAND AT MANOR FARM, SCHOOL LANE, MEPAL, CAMBRIDGESHIRE**

Planning Reference: 13/0799/FUL
NGR: TL 4411 8097
AAL Site Code: MEMA 14
OASIS Reference Number: allenarc1-182310

By
Allen Archaeology Limited
Report Number AAL2014070

June 2014

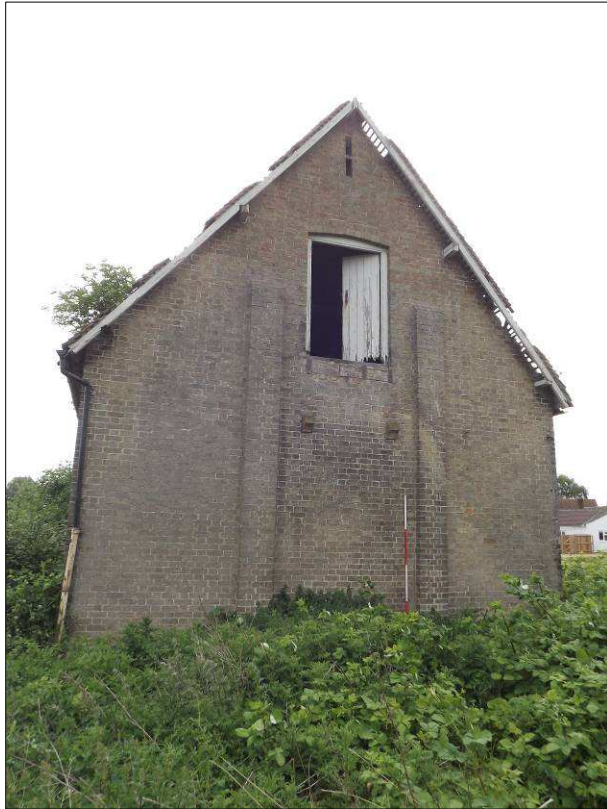
- 6.3 The western gable has two brick buttresses, either side of a doorway or pitching hole at first floor level, with two ventilation slits above (Plate 1). It was not possible to access the first floor at the time of the survey.

Plate 1 (Shot 9): Western gable of Building A, looking east-northeast. 2m scale

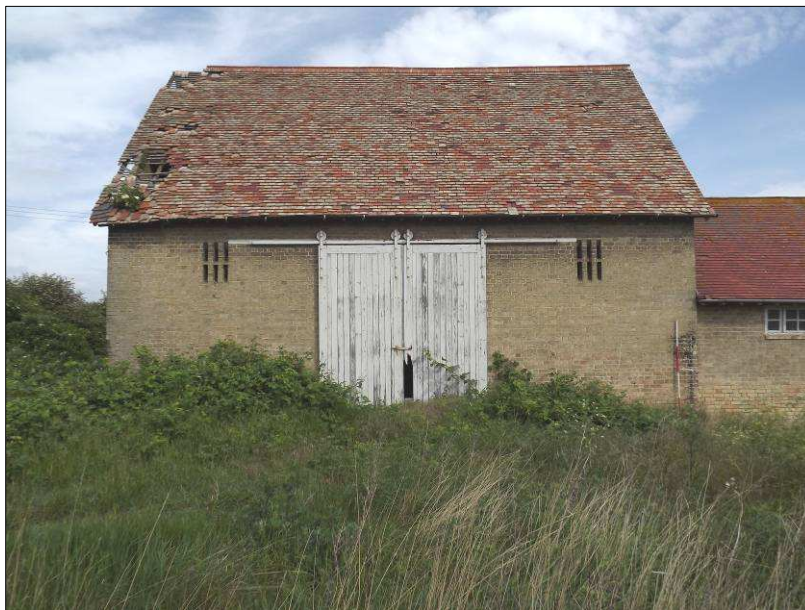
- 6.4 The south elevation has a pair of sliding vertically planked wooden doors over a central entrance, flanked by six ventilation slits to either side (Plate 2). On the northern elevation the corresponding central opening had a segmental arch with a wooden lintel directly above that was likely to have carried sliding doors identical to the opposing elevation (Plate 3). Above this was a protruding brick lintel of uncertain function. The opening below was blocked with brick and breeze block. The layout of the opposing large openings in either side of the barn suggest this was originally a threshing barn.

Plate 2 (Shot 2): South elevation of Building A, looking north-northwest. 2m scale

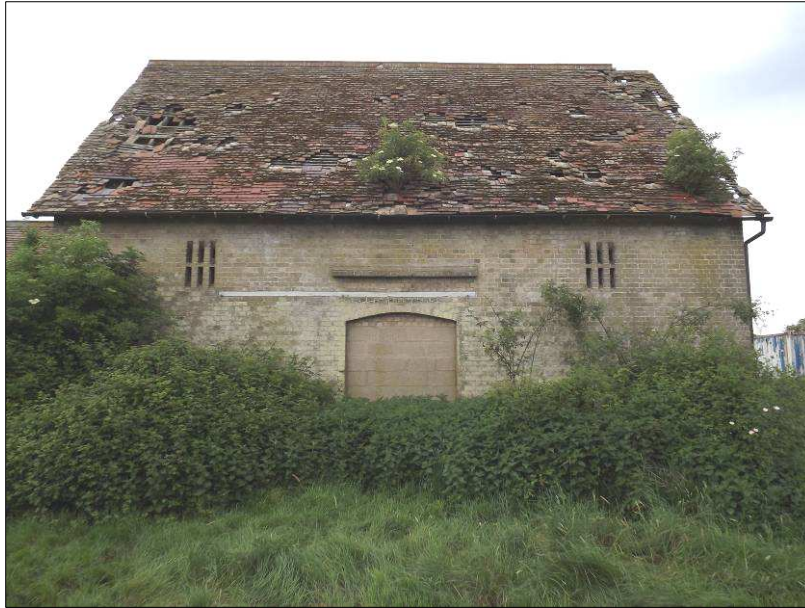
Plate 3 (Shot 10): North elevation of Building A, looking south-southeast

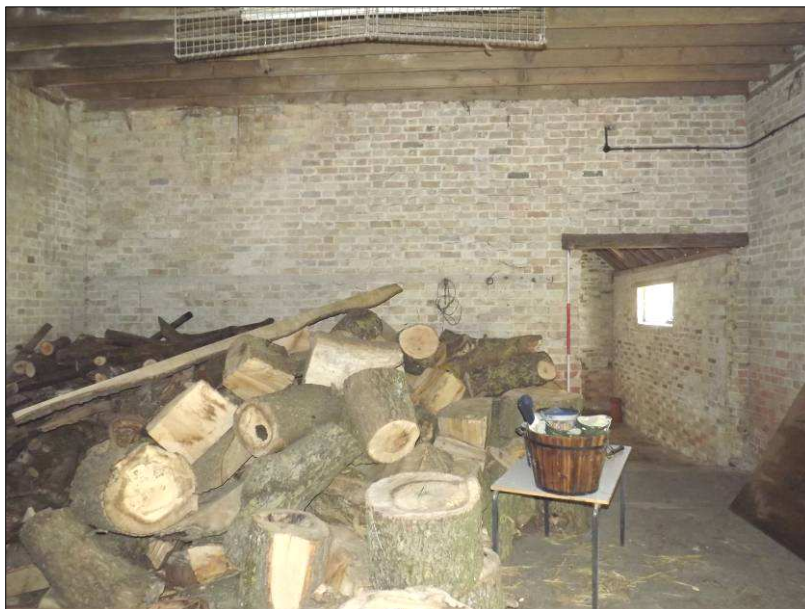
- 6.6 The ground floor of the building was in use as a general purpose store and retained few features of note (Plate 4). It had a concrete floor, and the joists supporting the floor above were modern machine sawn timbers suggesting a recent replacement. There was no access point from the ground floor to the first floor, probably as a result of the floor being replaced.

Plate 4 (Shot 57): Building A interior, looking east-northeast. 2m scale

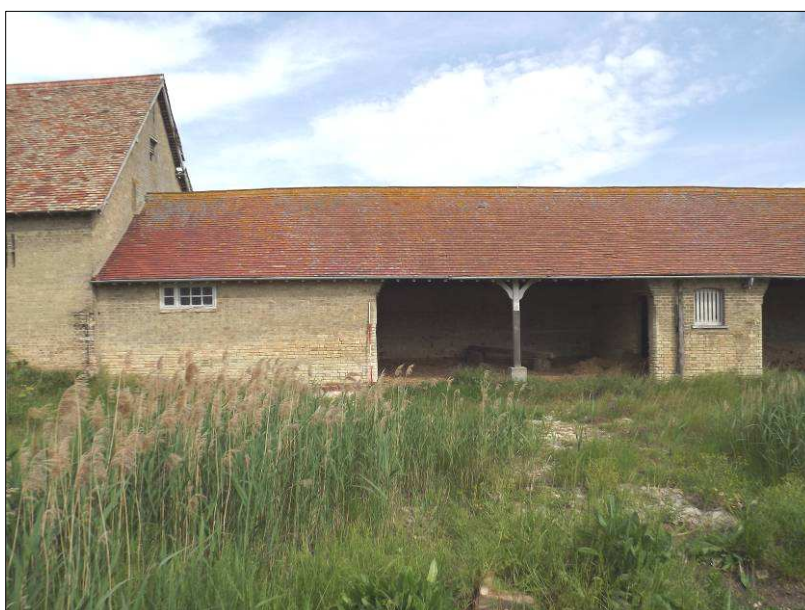
- 6.8 At the west end of the range B1 was a brick fronted component of the building, with a small window in the south elevation (Plate 5). An opening had been formed to allow access into A to the west, with another doorway into B2 to the east. At c.2m height was a series of wooden joists and square sockets indicating a floor for a former hayloft had been removed from within the building (Plate 6). The roof structure was consistent throughout Building B, comprising a series of horizontal tie beams with diagonal bracing struts and collar beams (Plate 7).

Plate 5 (Shot 3): Building B south elevation showing B1 –B3, looking north-northwest. 2m scale

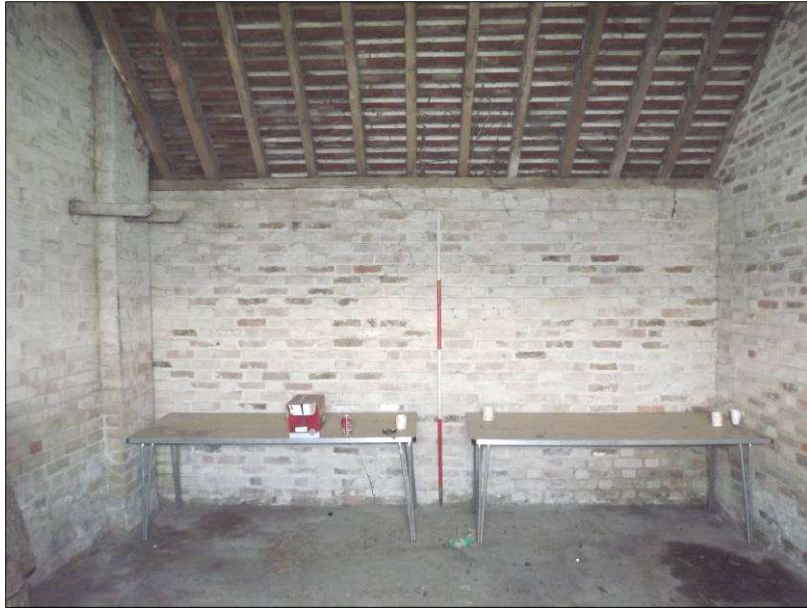
Plate 6 (Shot 55): B1 interior, looking north-northwest. Note former floor joists in wall to left of shot. 2m scale

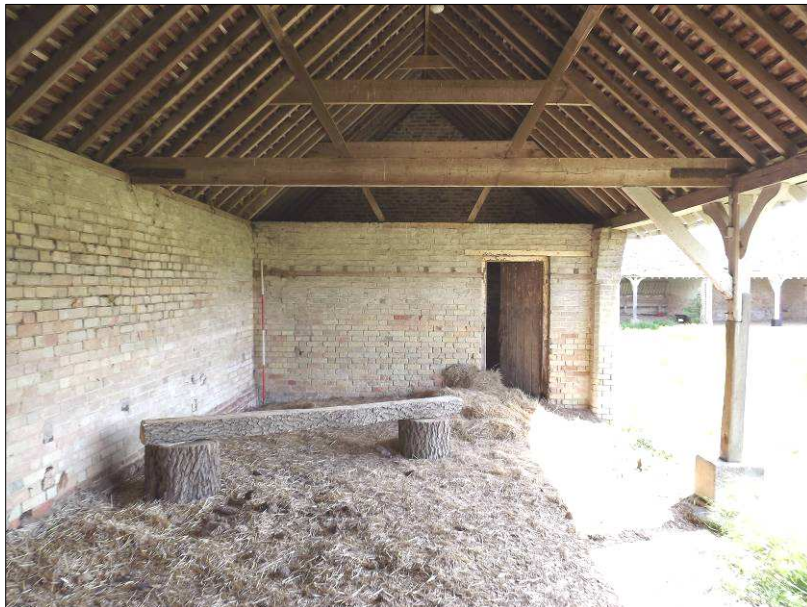
two parts being fitted together with a scarf joint. Attached to the upper part of the post were two reverse ogee diagonal struts supporting the roof lintel and another diagonal strut extended under the roof to the tie beam (Plates 7 and 8).

Plate 7 (Shot 47): B2 interior and roof structure, looking east-northeast. 2m scale

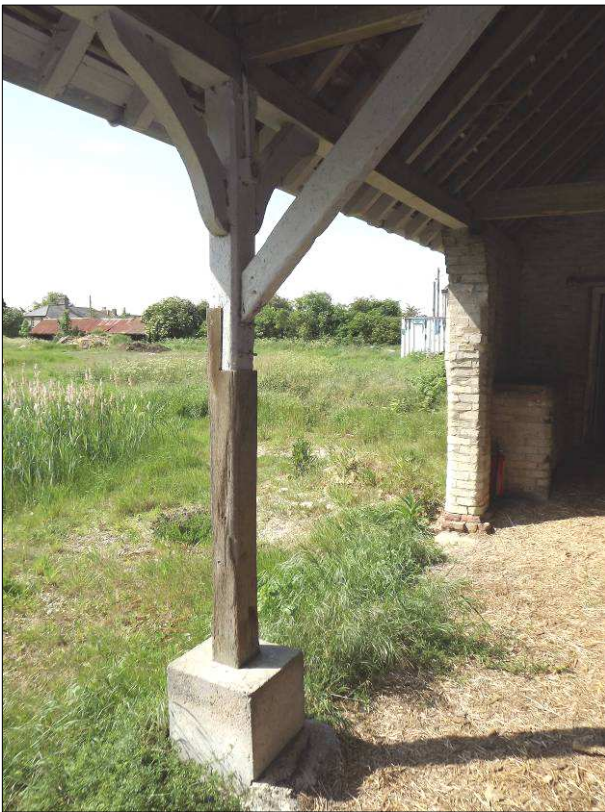
- 6.9 B2 was partially bricked up but mostly open fronted. A wooden lintel was supported by a square wooden post set in a concrete pad. The post had been repaired at some point, with its

Left: Plate 8 (Shot 50): Detail of wooden joist in B2, looking south-southwest

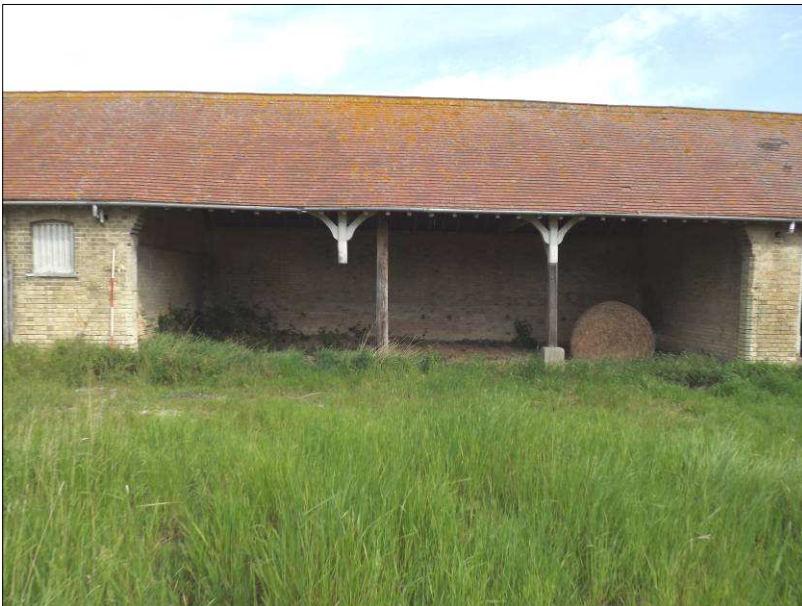
Plate 10 (Shot 5): B4 south elevation, looking, looking north-northwest. 2m scale

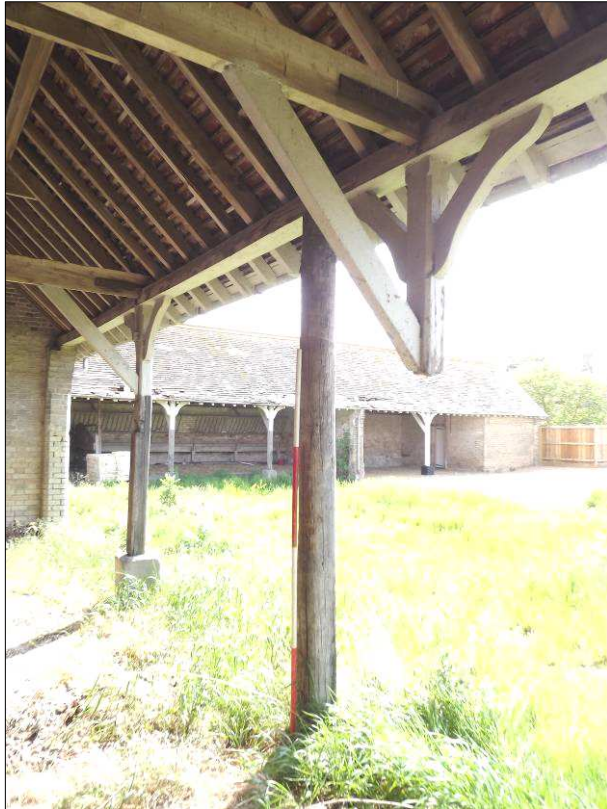
Plate 11 (Shot 43): Detail of cut off roof support and replacement post, looking southeast. 2m scale

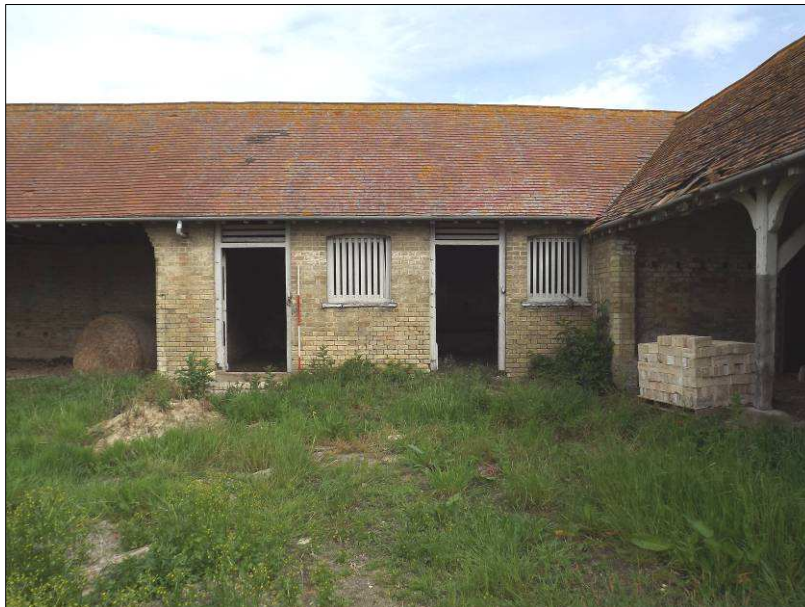
- 6.12 B5 and B6 were both brick fronted (Plate 12), each with a doorway and window in the south elevation. Both windows had a brick segmental arch and wooden slats. B6 had a wooden trough and hayrack on the north elevation (Plate 14). To the east, is a partition wall that appears to be a later addition to the building. Part of the upper half of the partition wall since has been removed to form an opening into B7, the reason for which is not clear, as the retention of the lower part of the wall would preclude the free movement of livestock, people or goods (Plate 15).

Plate 12 (Shot 6): South elevation of B5 and B6, looking north-northwest. 2m scale

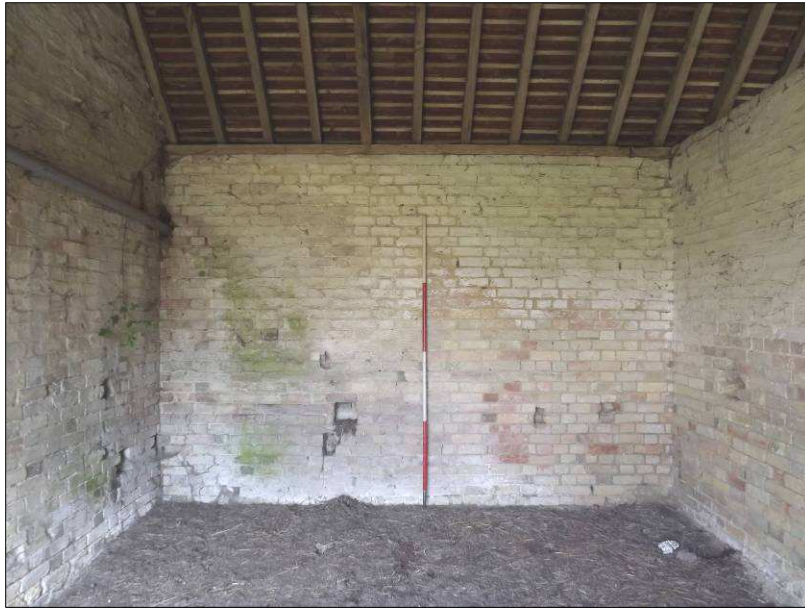
Plate 13 (Shot 37): B5 interior, looking north-northwest. 2m scale

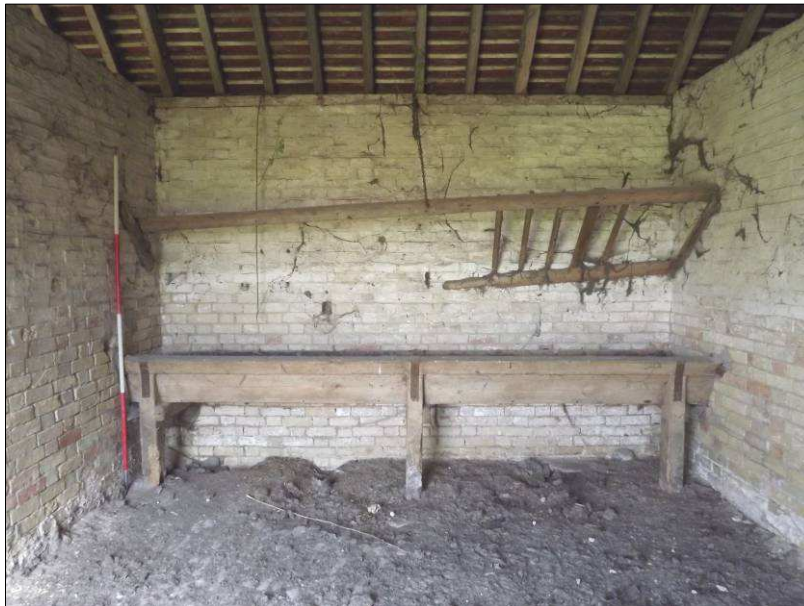
Plate 14 (Shot 35): B6 interior, looking north-northwest. 2m scale

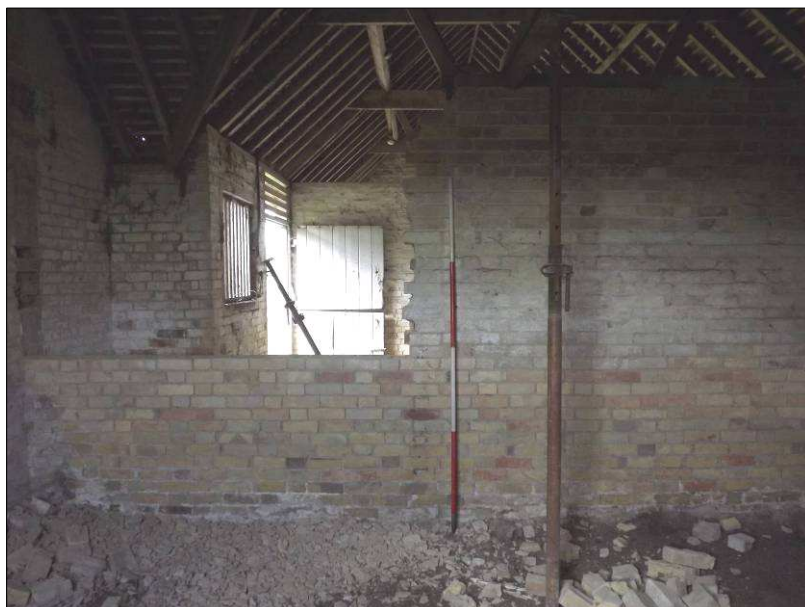
Plate 15 (Shot 33): Partition between B6 and B7, looking west-southwest. 2m scale

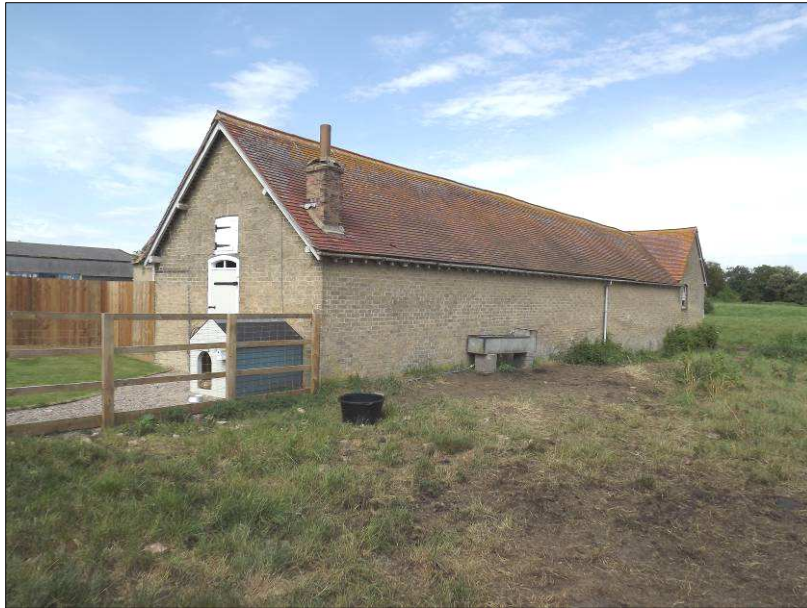
Plate 16 (Shot 75): Building C, south and east elevations, looking northwest. 2m scale

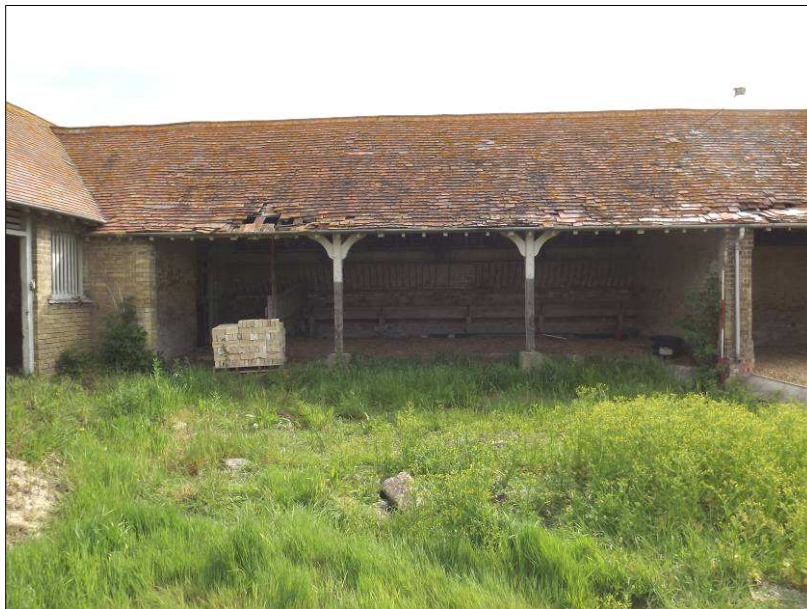
Plate 17 (Shot 7): West elevation of C1, looking east-northeast. 2m scale

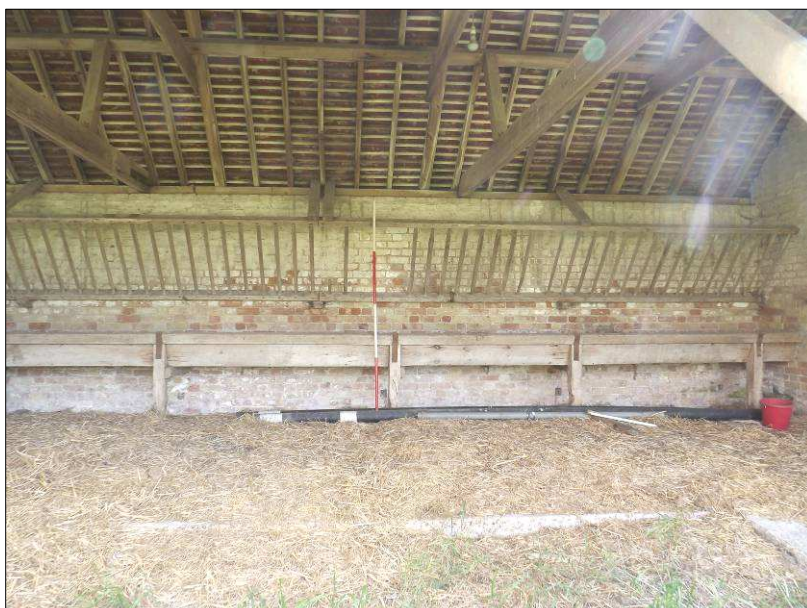
- 6.15 C1 had a wooden trough along the full length of the east elevation, with hayrack above (Plate 18). Part of this trough was subdivided with a rough wooden partition towards its north end, the reason for which is not clear (Plate 19).

Plate 18 (Shot 24): Interior of C1, looking north-northwest. 2m scale

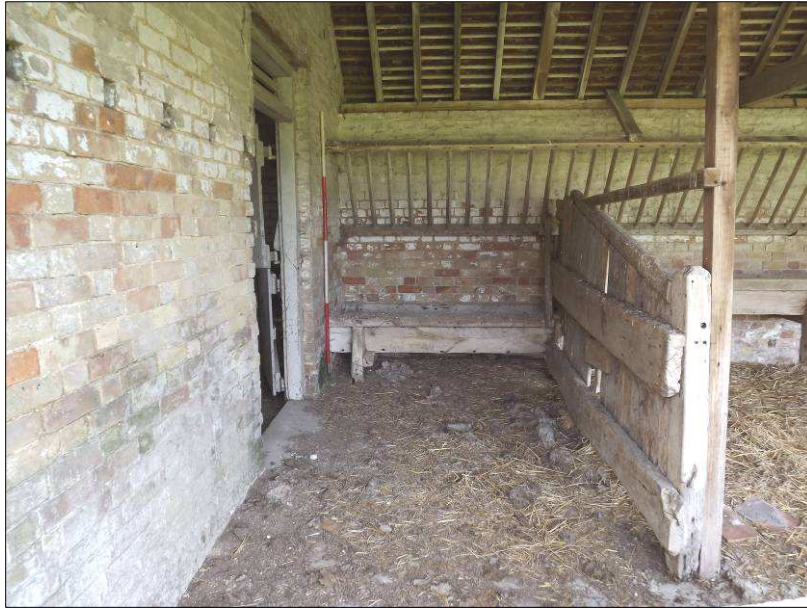
Plate 19 (Shot 26): Partitioned trough at north end of C1, looking north-northwest. 2m scale

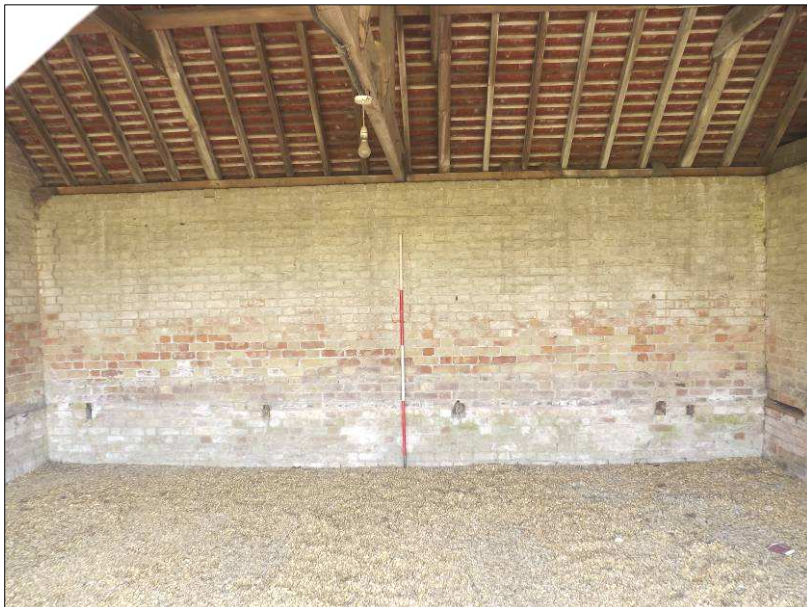
Plate 20 (Shot 21): C2 interior, looking east-northeast. 2m scale

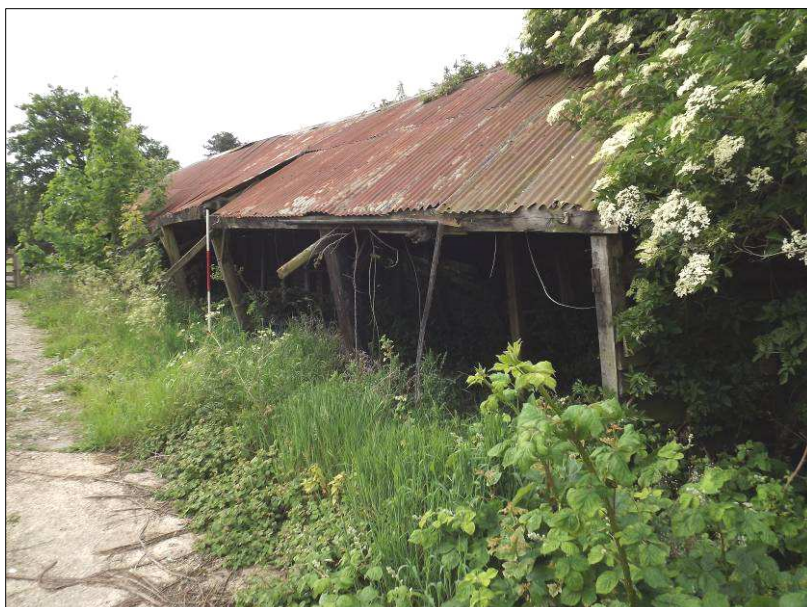
- 6.17 In the southwest corner of the site, Building D is a single storey structure with double pitched gabled roof of corrugated steel (Plate 21). The north, south and west elevations are weatherboarded and in a poor state of repair (Plate 22). The east elevation is open fronted, and supported by square wooden posts. The interior is overgrown and retains no features of note (Plate 23).

Plate 21 (Shot 15): Building D, east elevation, looking south. 2m scale

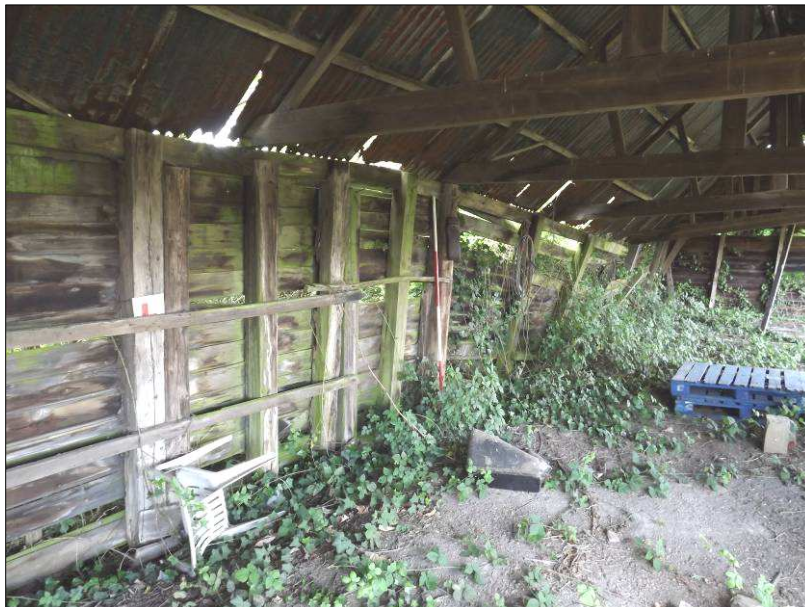
Plate 23 (Shot 69): Interior of Building D, looking northwest. 2m scale

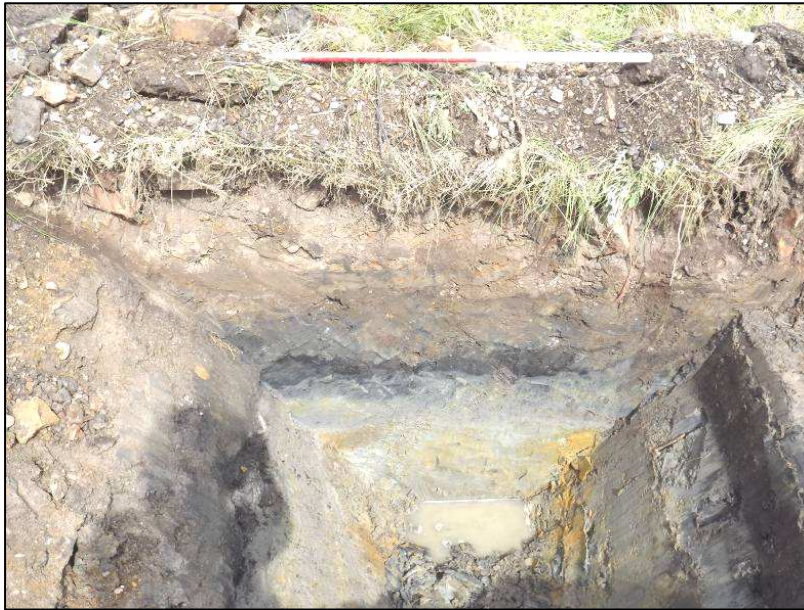
- 6.18 The earliest deposit revealed in Trench 1 was an alluvial deposit of mottled mid yellowish orange silty clay, 105, encountered approximately 1.2m below the current ground surface. It was sealed by a second possible alluvial deposit, 104, which comprised greenish grey silt and was 0.30m thick. A 0.20m thick layer of dark grey organic-rich silt, 103, sealed the alluvial layers and may have been a buried topsoil or former ground surface. It was in turn sealed by a 0.20m thick layer of greyish brown sandy silt, 102, which may have been a further buried soil layer and was overlain by a 0.40m thick deposit of brick and stone rubble, likely to represent a former yard surface. The uppermost deposit in the trench was a further layer of topsoil, which measured 0.10m thick and formed the present ground surface.

Plate 24: Trench 1 section, looking northwest. 1m scale

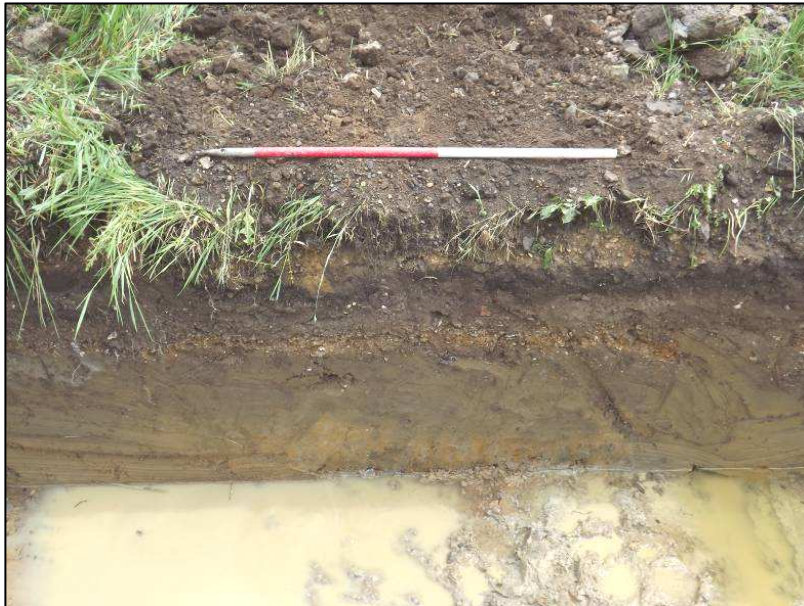
- 6.19 The earliest deposit encountered within the trench was a natural geological deposit of orange brown silty clay, 201. It was cut by a probable linear feature, [207] which was exposed approximately 0.85m below the current ground surface and extended along almost the entire length of the trench on a broadly north-northwest to south-southeast orientation. Only one side of the feature was visible within the trench and whilst it seems likely it was linear in shape it could conceivably have been the edge of a very large discrete feature such as a pond. Excavation of this poorly defined feature was not possible due to water ingress but investigation of its fills by augering indicated that the feature was approximately 0.95m deep. The feature contained three fills, 205, 208 and 212, all of which comprised silty clays and are likely to have been the result of alluvial deposition. An assemblage of four sherds of pottery was recovered from fill 205, all sherds coming from the base of a single jug dated to the 13th or 14th century. The uppermost fill, 212, was sealed by a 0.18m thick layer of brownish grey sandy silt, 211 and was in turn sealed by a 0.04m thick layer of silty sand 210. Both of the layers are most likely alluvially derived and perhaps indicate one or more periods of flooding after feature [207] had been completely infilled.

Plate 25: Trench 2 section, looking southwest. 1m scale

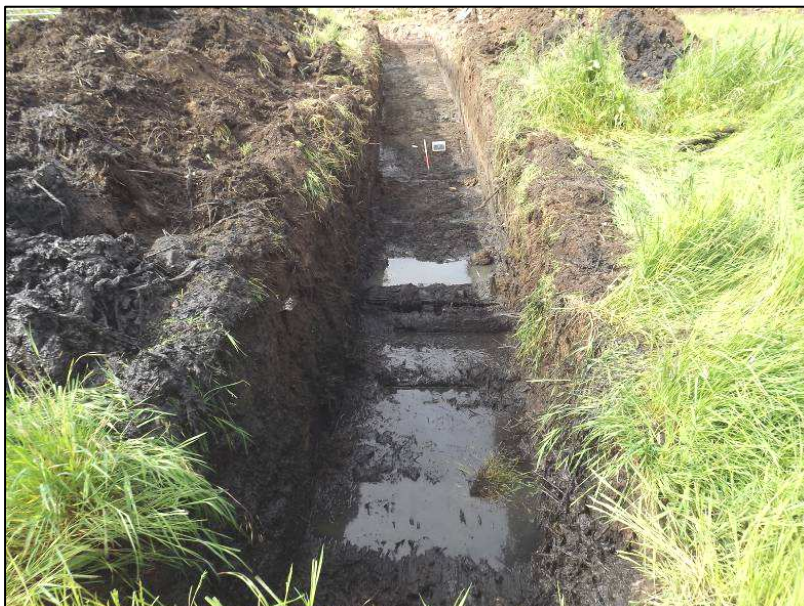
- 6.21 The earliest deposit encountered in Trench 3 was a soft, greyish blue, organic-rich alluvial silt, 306, revealed approximately 1.1m below the current ground surface. It was sealed by a 0.40m thick layer of dark yellowish brown silty sand, 305 which may also have been waterlain.
- 6.22 A 0.45m thick layer of dark brown sandy silt, 304, which contained fragments of modern building material (not retained) had been deposited on top of the alluvial layers, possibly in an attempt to consolidate and level the soft ground below. This deposit was cut at the northeast end of the trench by the cut, [308], of a small pond shown on recent mapping. It contained two undated dumped deposits, 302 and 303. A 0.60m thick, dark brown silty clay layer, 301,

Plate 26: Trench 3 looking southwest. 1m scale

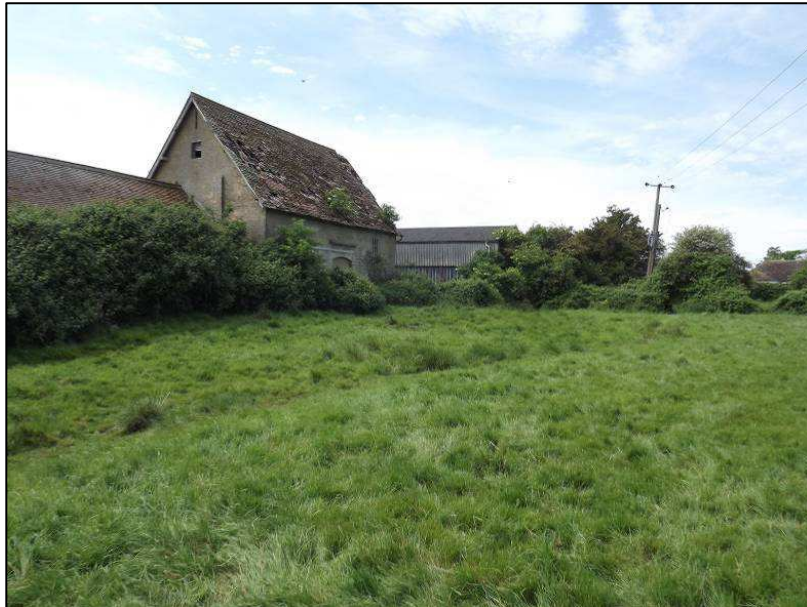
Plate 28: View of the earthworks with ditch [1] in the foreground, looking southwest

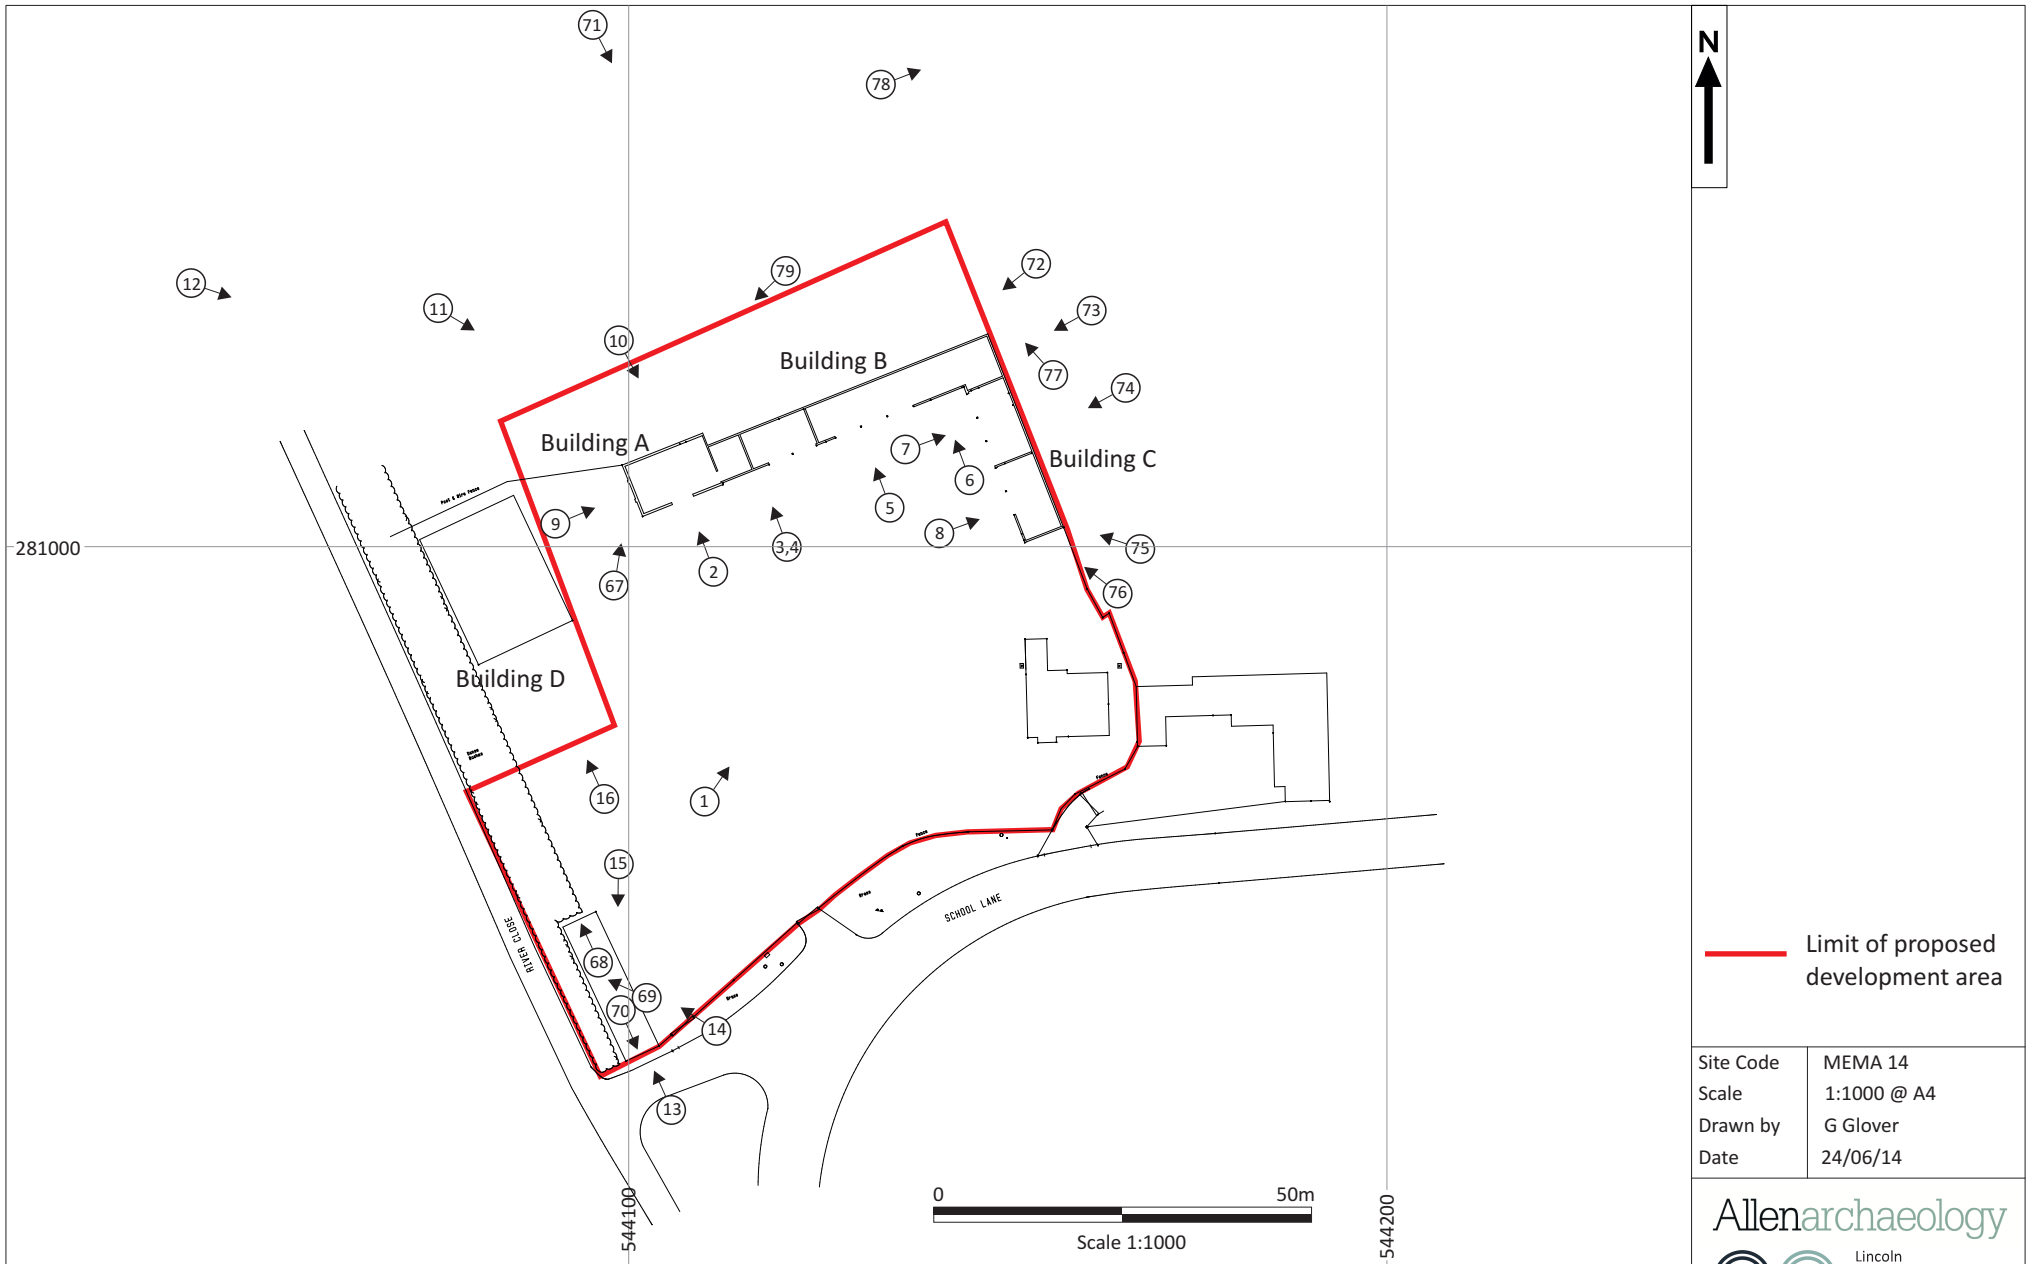
Figure 2: Site location plan showing location and direction of exterior photographs. (Base plan provided by the client)

Building Survey (Figures 2 – 5 and See Appendix 1 for photographs)
