ARCHAEOLOGICAL EVALUATION REPORT:

TRIAL TRENCHING ON LAND AT BIFRANGI, SPA ROAD, LINCOLN, LINCOLNSHIRE

Planning Reference: 2014/0204/F
NGR: SK 99490 71298
AAL Site Code: LIBS 14
Museum Accession Number: LCNCC: 2014.129
OASIS Reference Number: allenarc1-187893

By
Allen Archaeology Limited
Report Number AAL2014092

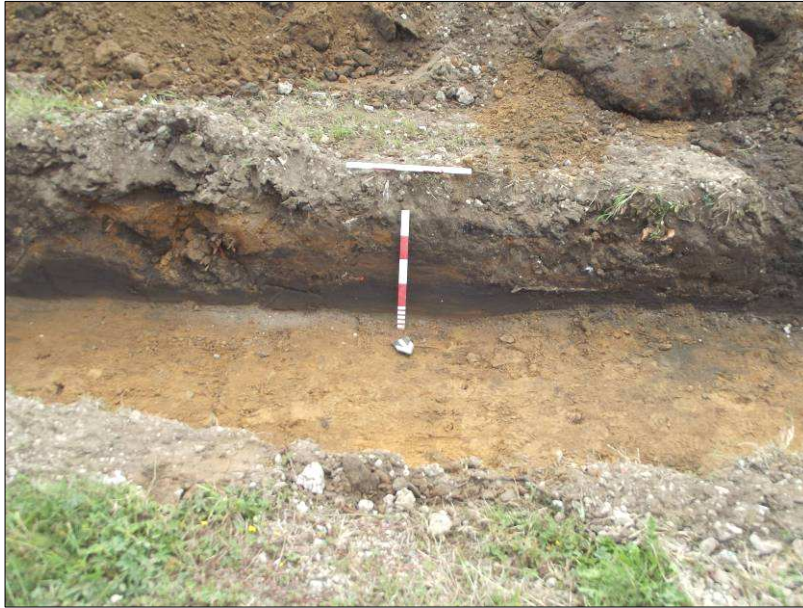
- 6.1 Trench 1 was located in the eastern part of the development site, within a grassed area and running east – west. Removal of the 0.3m thick mid brown sandy silt topsoil 100 revealed an undulating 0.2m – 0.5m thick dark grey sandy silt with abundant concrete that contained large pieces of modern ferrous slag and several modern glass bottles. This dump of Victorian and modern industrial waste overlay natural sand 102.

Plate 1: Trench 1 representative section, scales are 0.5m.

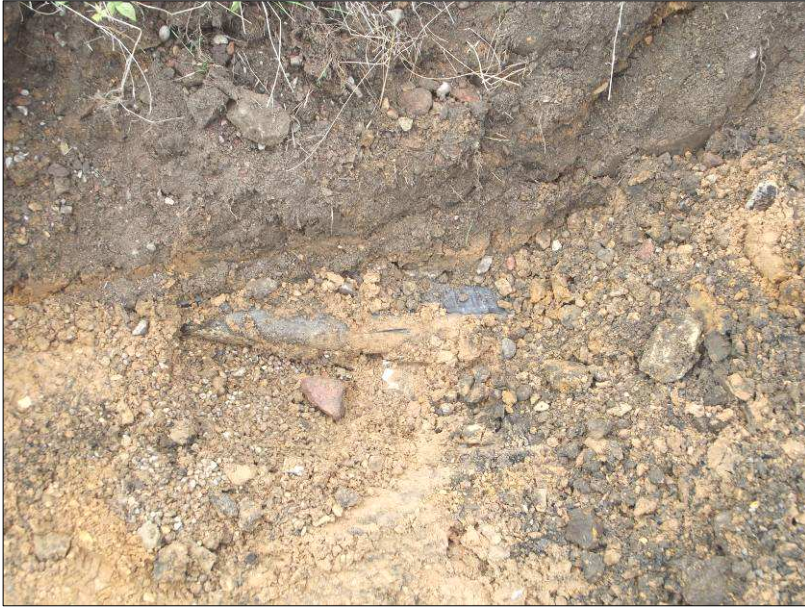
- 6.2 Trench 2 was also located towards the centre of the proposed development site, aligned broadly northwest to southeast. The trench was moved slightly to accommodate a modern large brick soakaway and also a brick drain; however machine excavation soon revealed a c.300mm diameter cable/service of possible Victorian date orientated along the length of the trench. The soil sequence encountered at this stage showed a 0.3m thick topsoil 200 overlay a 0.3m thick contaminated layer of concrete and stone rubble 201 sealing natural orange sand and gravel 202. Due to the presence of the soakaway, drains and cable/service it was clear that it would not be possible to excavate the trench without damaging existing infrastructure or damaging potentially live services.

Plate 2: Exposure of large cable/service pipe in Trench 2.

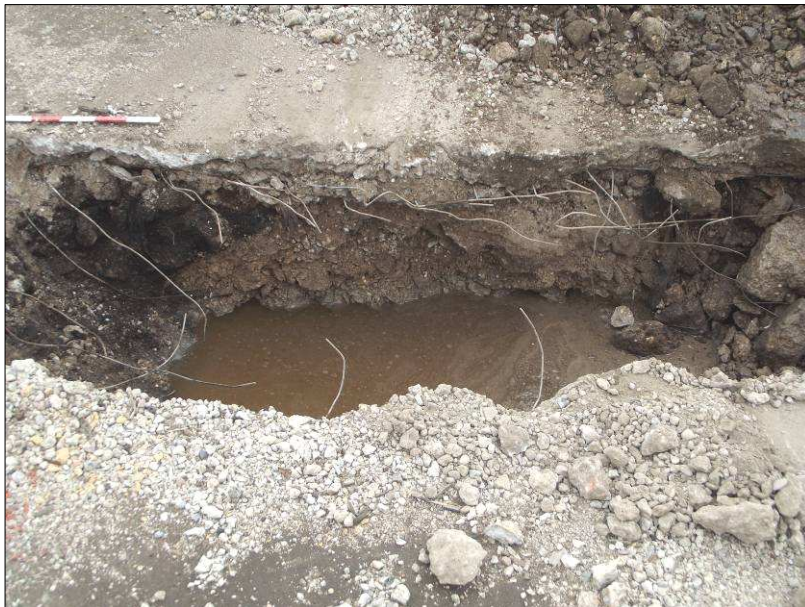
- 6.3 Test Pit 1 was located within the western half of the proposed development site, within the footprint of former structures associated with the industrial activities associated with the site. Due to extensive reinforced concrete across this half of the site, the test pit was located within the footprint of a previous geotechnical pit to make use of a previously excavated area.
- 6.4 Machine excavation removed 0.15m of concrete onto a dump of concrete fragments and hardcore. This layer was shown to be at least 1m deep and the test pit was abandoned at this stage due to the depth of water encountered resulting in a lack of visibility. As services, etc had been encountered elsewhere on the site it was deemed unsafe to continue excavations.

Plate 3: Test Pit 1 looking south, scale is 0.5m

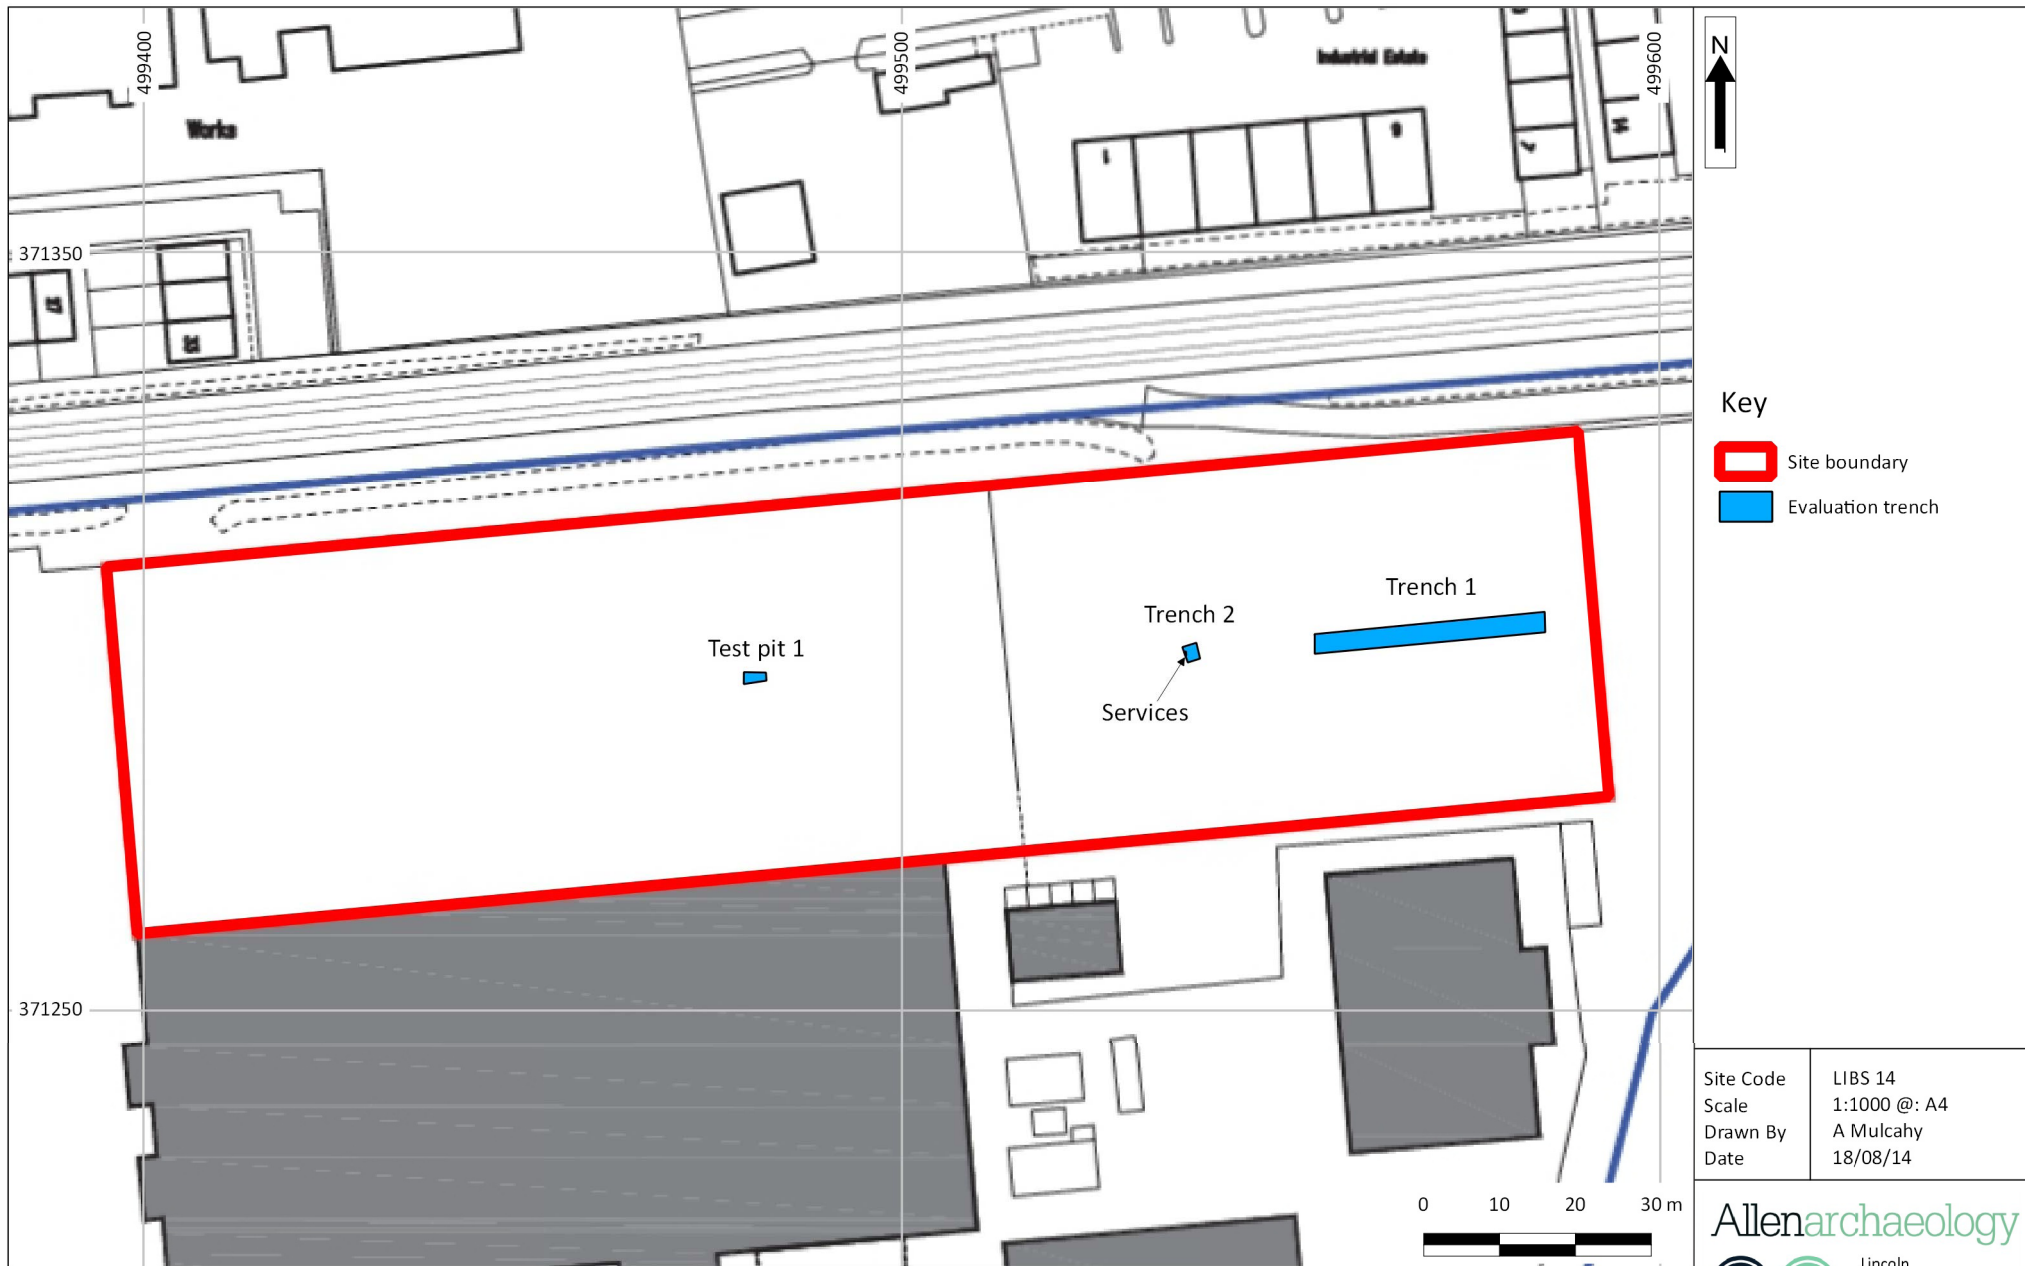
Figure 2: Site location with boundary in red and trenches in blue

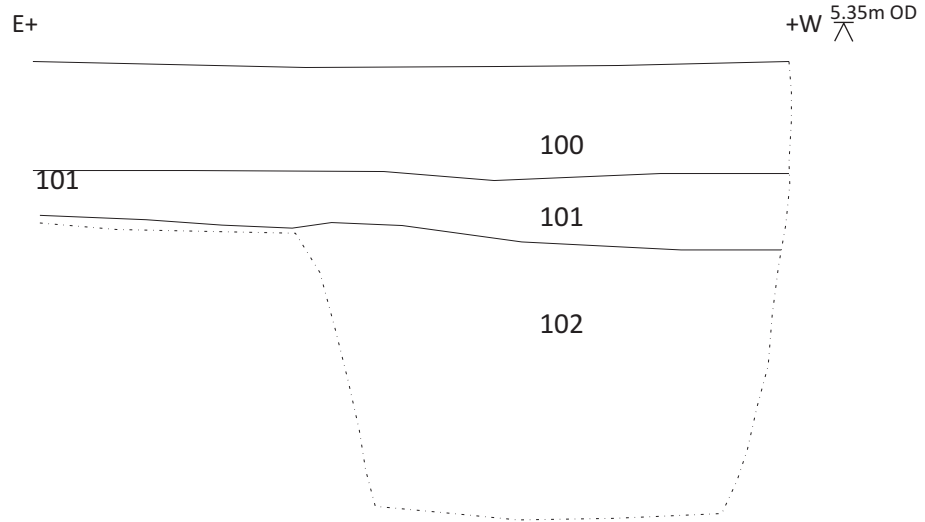
Trench 1
North Facing Section

Figure 3: Trench 1 representative section
