**ARCHAEOLOGICAL EVALUATION REPORT:
TRIAL TRENCHING ON LAND OFF ARGENTS MEAD, HINCKLEY, LEICESTERSHIRE**

Planning Reference: Pre-planning
NGR: SP 4285 9374
AAL Site Code: HIAM 14
OASIS Reference Number: allenarc1-194278
Leicestershire Museums Accession No X.A147.2014

By
Allen Archaeology Limited
Report Number AAL2014130

November 2014

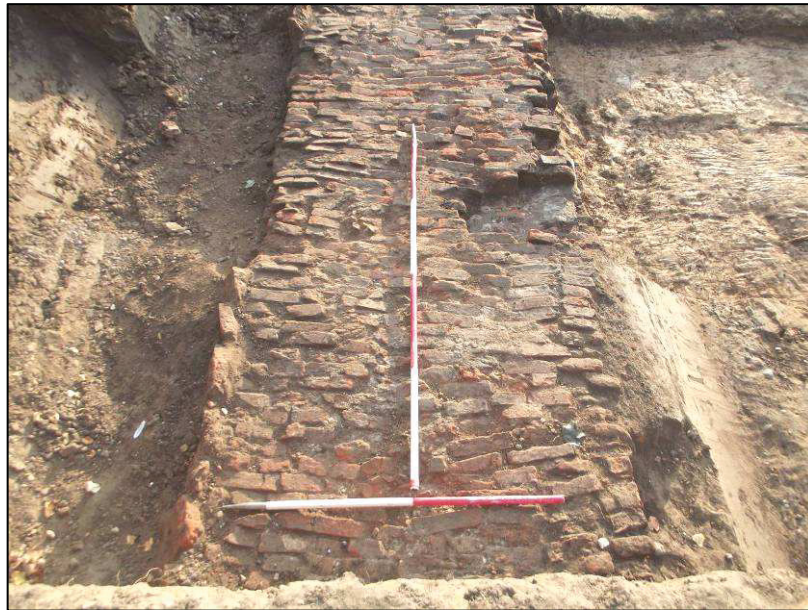
Plate 1: Brick path, 101, looking east. 1 and 2m scales

- 6.2 Towards the north end of the trench was a 0.42m thick levelling and bedding layer, 102, associated with an east to west aligned path of red, handmade bricks of a probable 18th or 19th century date, 101. The path measured approximately 1.58m wide and extended beyond the limit of excavation to the east and west. The bricks had been laid on their side and were bonded with mortar. Along the northern edge were intermittent remains of a brick kerb (Plate 1).

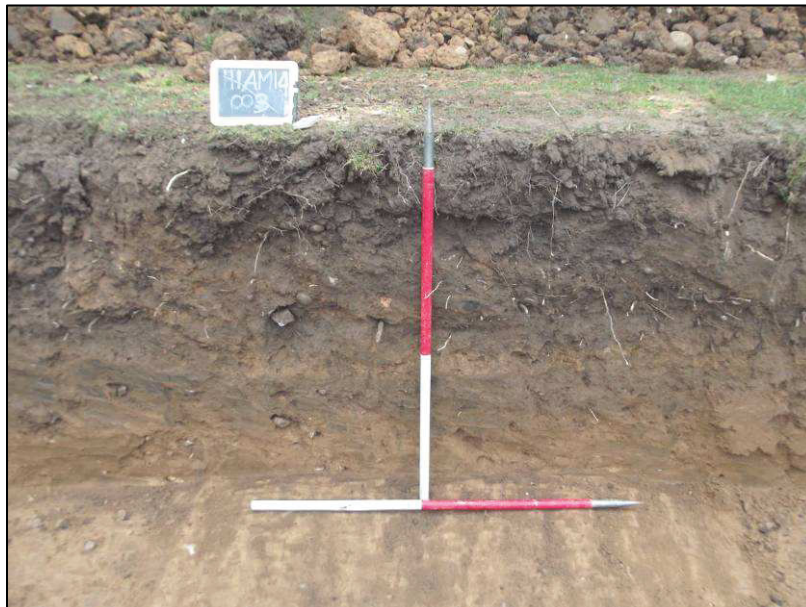
Plate 2: Representative north facing section in Trench 3, 1m scales

- 6.4 Trench 3 was located in a grassed area at the south end of the site. The natural geology, 301, was encountered approximately 1.06m below the current ground surface. It was sealed by two 0.46m modern landscaping layers, 302 and 303, producing occasional small modern brick fragments. The uppermost deposit was a 0.47m thick topsoil, 300 (Plate 2).

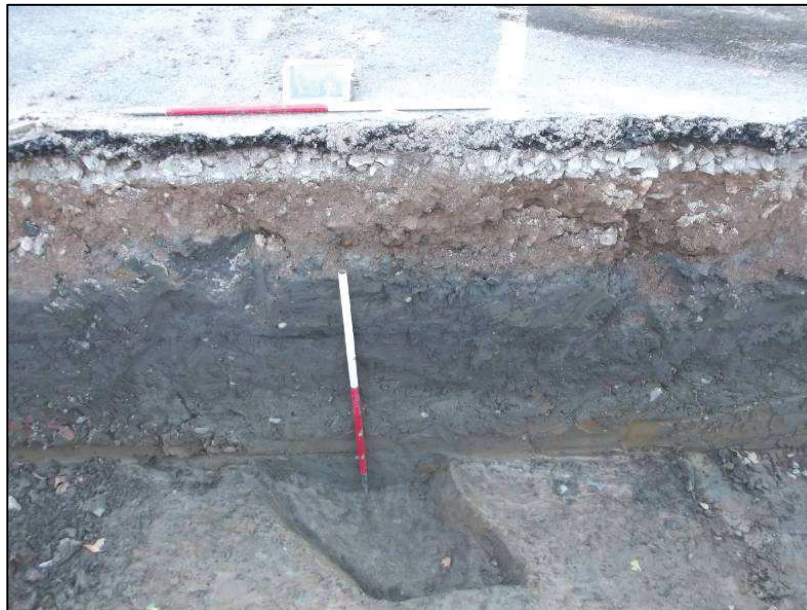
Plate 3: Southwest facing section of linear [405]. 1m scales

- 6.5 Trench 4 was located in a car parking area at the southeast corner of the site. At the base of the sequence was the natural geology, 401, encountered at approximately 1.36m below ground surface. It was cut by an undated northeast to southwest aligned linear feature [405], which contained a single silting deposit, 406. The trench was extended to trace the continuation of this feature, but it was truncated just west of the trench by an area of modern disturbance.
- 6.6 At the north end of the trench was a wide irregular cut, [409], aligned broadly north – south, with a large ceramic pipe. It was backfilled with a layer of cinder/slag 407 and a dark grey silty clay 408 (Plate 3).

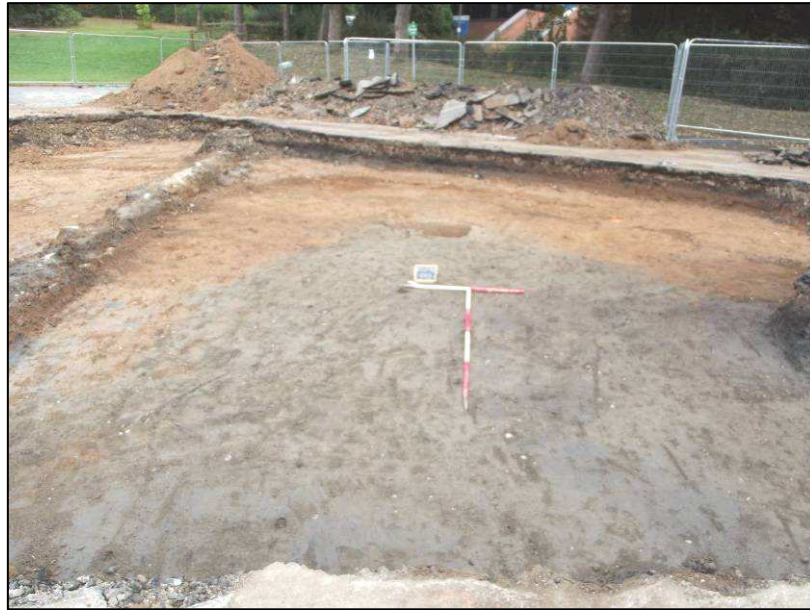
Plate 4: Irregular cut [504], looking northeast. 2m and 1m scales

- 6.8 Trench 5 was located in a car parking area towards the east side of the site. Natural geology, 501, was encountered approximately 0.50m below the modern ground surface. It was cut by a large irregular shallow sided feature [504], measuring more than 8m x 6m across with an approximate depth of 0.64m (Plate 4). It contained two undated grey silty sand fills, 505 and 506 and was sealed by a 0.17m thick landscaping deposit 503, and a bedding layer, 502 and tarmac surface 500.

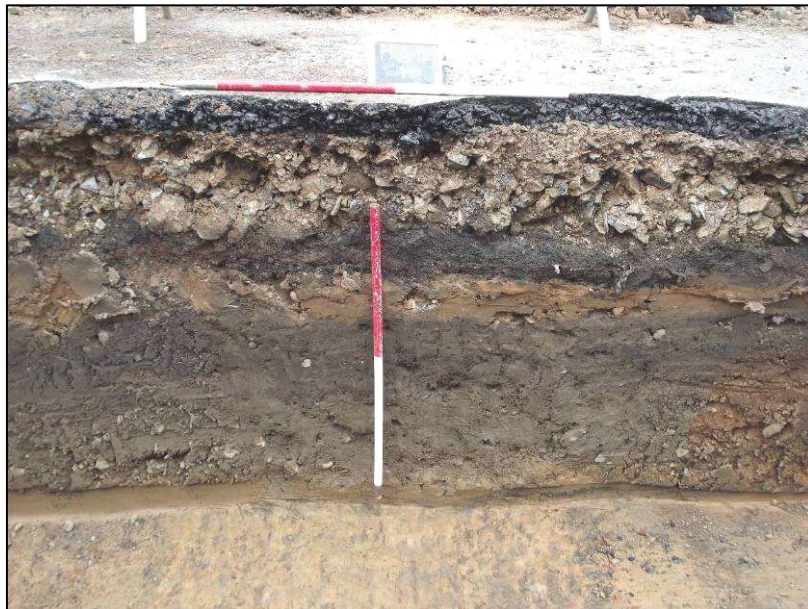
Plate 5: South facing section of Trench 6. 1m scales

6.9 Trench 6 was located in the centre of the site in an access road. At the base of the sequence the natural geology 601 was encountered 1.34m below the modern ground surface, sealed by two modern levelling/landscaping layers 603 and 604. This was in turn sealed by modern tarmac 600 and a bedding layer 602 (Plate 5).

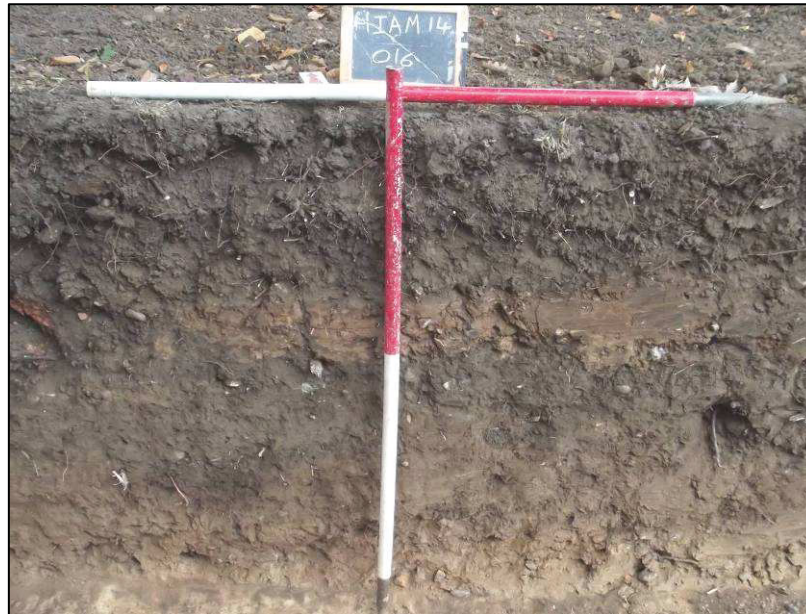
Plate 6: South facing section in trench 7a, 1m scales

6.10 Trench 7a was located in a grassed area towards the west end of the site. The natural geology, 7001 was sealed by a 0.30m thick former garden soil, 7002, probably associated with the former vicarage. Above this layer was a 0.17m thick layer of brick rubble, 7003 representing

material associated with the demolition of the former vicarage. It was cut by a small pit [7004] containing modern domestic waste. The uppermost deposit was a modern topsoil, 7000 (Plate 6).

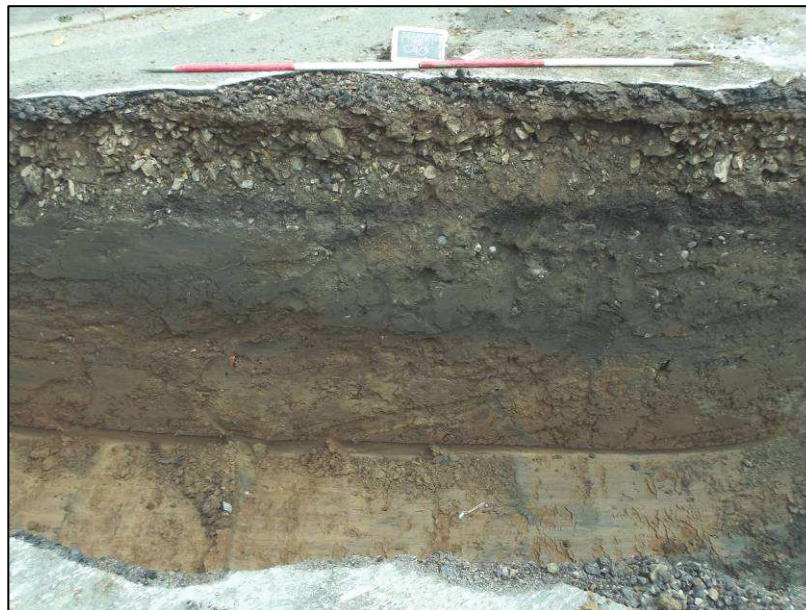
Plate 7: Southwest facing section of Trench 7b. 1m scales

6.11 Trench 7b was situated southeast of 7a, across a former access road. Natural geology, 701, was encountered approximately 1.83m below the modern ground surface, and sealed by two modern made ground/landscaping layers, 703 and 704. Above this was a bedding layer, 702, and modern tarmac surface, 700 (Plate 7).
