**ARCHAEOLOGICAL EVALUATION REPORT:
THE MOUND, CANONS ASHBY, NORTHAMPTONSHIRE**

Planning Reference: n/a
NGR: SP 57517 50805
AAL Site Code: CAMO 14
OASIS Reference Number: allenarc1-197151

Report prepared for National Trust

By
Allen Archaeology Limited
Report Number AAL2014139

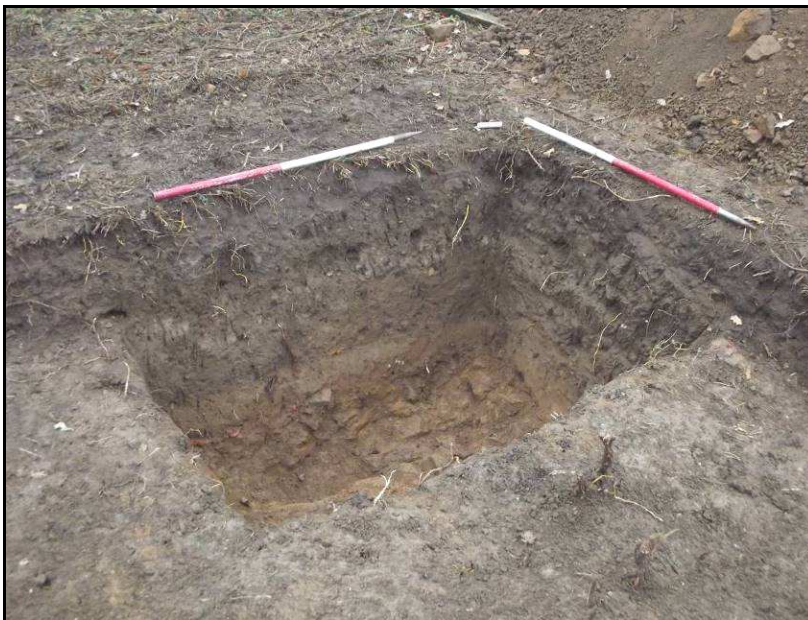
Plate 1: View of Test Pit 1 looking north. 2 x 1m scales

- 6.1 The earliest deposit encountered within Test Pit 1 was a very compact deposit of greenish grey silty sand, 101, with very frequent inclusions of large angular and sub-angular fragments of ironstone (Plate 1). The deposit extended across the test pit and was at least 0.40m thick, extending below the maximum excavated depth. It was encountered from approximately 0.85m below the top of the test pit, an elevation of 165.55m OD but sloped down very slightly to the southwest. The material seems likely to have been deposited during the mound construction but is undated.

- 6.2 A 0.04m thick layer of red roof tiles, 104, sealed the mound material and extended across the test pit. Late medieval and later tiles formed the deposit but the majority were from the post-medieval period and possibly of 16th–17th century date. No structural features were found in association with the deposit.

- 6.3 Sealing the layer of tiles was an undated 0.30m thick layer of mid brownish orange sandy clay, 103, which was in turn sealed by a 0.40m thick layer of greyish green silty clay, 102. This had been subject to considerable root disturbance but produced a small assemblage of pottery dating to the 19th century, along with tiles of both late medieval and post-medieval date. Neither of the deposits appeared to be the product of the gradual accumulation of material on top of the mound and rather seem more likely to have been deliberately deposited, perhaps during an episode of landscaping of the mound summit. The root ball of a small tree, 105 and 106, were set into layer 102 and were sealed by the uppermost deposit in the trench, a layer of dark brown sandy silt, 100, up to 0.50m thick which appeared most likely to be the product of accumulated topsoil and leaf litter.

- 7.6 Root damage to 'The Mound' was evident in both investigated areas. In Test Pit 1 this damage was mainly limited to the later landscaping layers with root penetration to the main construction material being minimal. However, damage to the earlier mound material within Test Pit 2 was more obvious, with one particularly large root leaving a root track within this compact material. Root penetration to the later landscaping layers in this trench was also apparent. Two relatively small areas of active erosion were also apparent on the banks of 'The Mound'. These were probably the result of animal footfall. The uneven nature of the sides of 'The Mound' may be the result of historic erosion.

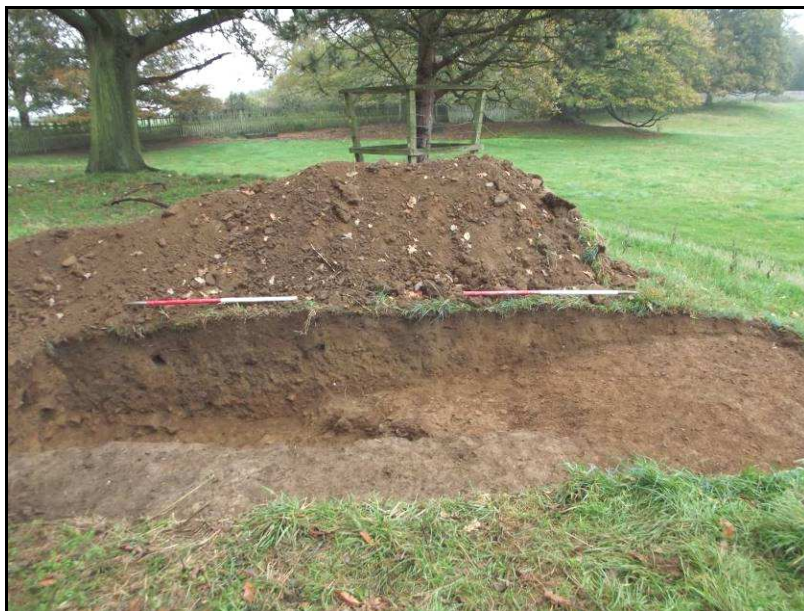
Plate 2: Test Pit 2 looking southeast. 2 x 1m scales

- 6.4 The earliest deposit encountered within Test Pit 2 was an undated, very compact mid brownish orange sandy clay, 203, which contained frequent sub-angular fragments of ironstone (Plate 2). The deposit appeared to have been the result of deliberate dumping most likely during the mound's construction. It was encountered at a depth of 0.10m below the modern land surface at the southwest end of the test pit (a height of 165.15m OD) and as deep as 0.70m below the modern land surface towards the northeast end of the test pit (a height of 164.85m OD). The surface of the deposit therefore formed a distinct slope down towards the interior of the mound but was not considered to be a cut feature. An irregular step within the slope, which extended for a short distance across the deposit, had clearly been caused by a large tree root, the remains of which were encountered during the excavation.

- 6.5 A layer of tile, 202, was encountered in the northeast half of the test pit directly on top of layer 203. Medieval and later tiles were found within the deposit although the majority were of late medieval date. Two sherds of 12th–14th century pottery were also recovered from the deposit. The deposit was up to 0.20m thick and was very similar to layer 104 within Test Pit 2.

- 6.6 The tile-rich layer was sealed by a layer of compact greyish green sand, 201, which measured up to 0.34m thick. A small assemblage of pottery and tile dating to the 17th century or later was recovered from the deposit 201. The deposit was similar to layer 102 Test Pit 1 and may have been a continuation of it, possibly representing an episode of landscaping of the mound summit.

- 6.7 The uppermost deposit encountered in Test Pit 2 was a layer of dark greyish brown sandy silt, 200, up to 0.22m thick. The layer formed a topsoil and turf deposit which extended across the test pit.

- 7.2 Test Pit 2 revealed a gradual but distinct downwards slope of the mound material from the outer edge of the mound towards its interior. It is possible that this is the remnants of a low bank around the outer edge of the mound summit. This feature appears to be contemporary with the construction of the mound and may, at least in part, be responsible for an anomaly revealed during a resistivity survey of 'The Mound' which appeared to show possible walls and rubble on top of the mound (Figure 8). The feature was difficult to discern with the naked eye but is apparent as a very slight bank on the earthwork survey, where it extends around much of the summit but is only prominent in the northeast quarter (Figures 6 and 7).

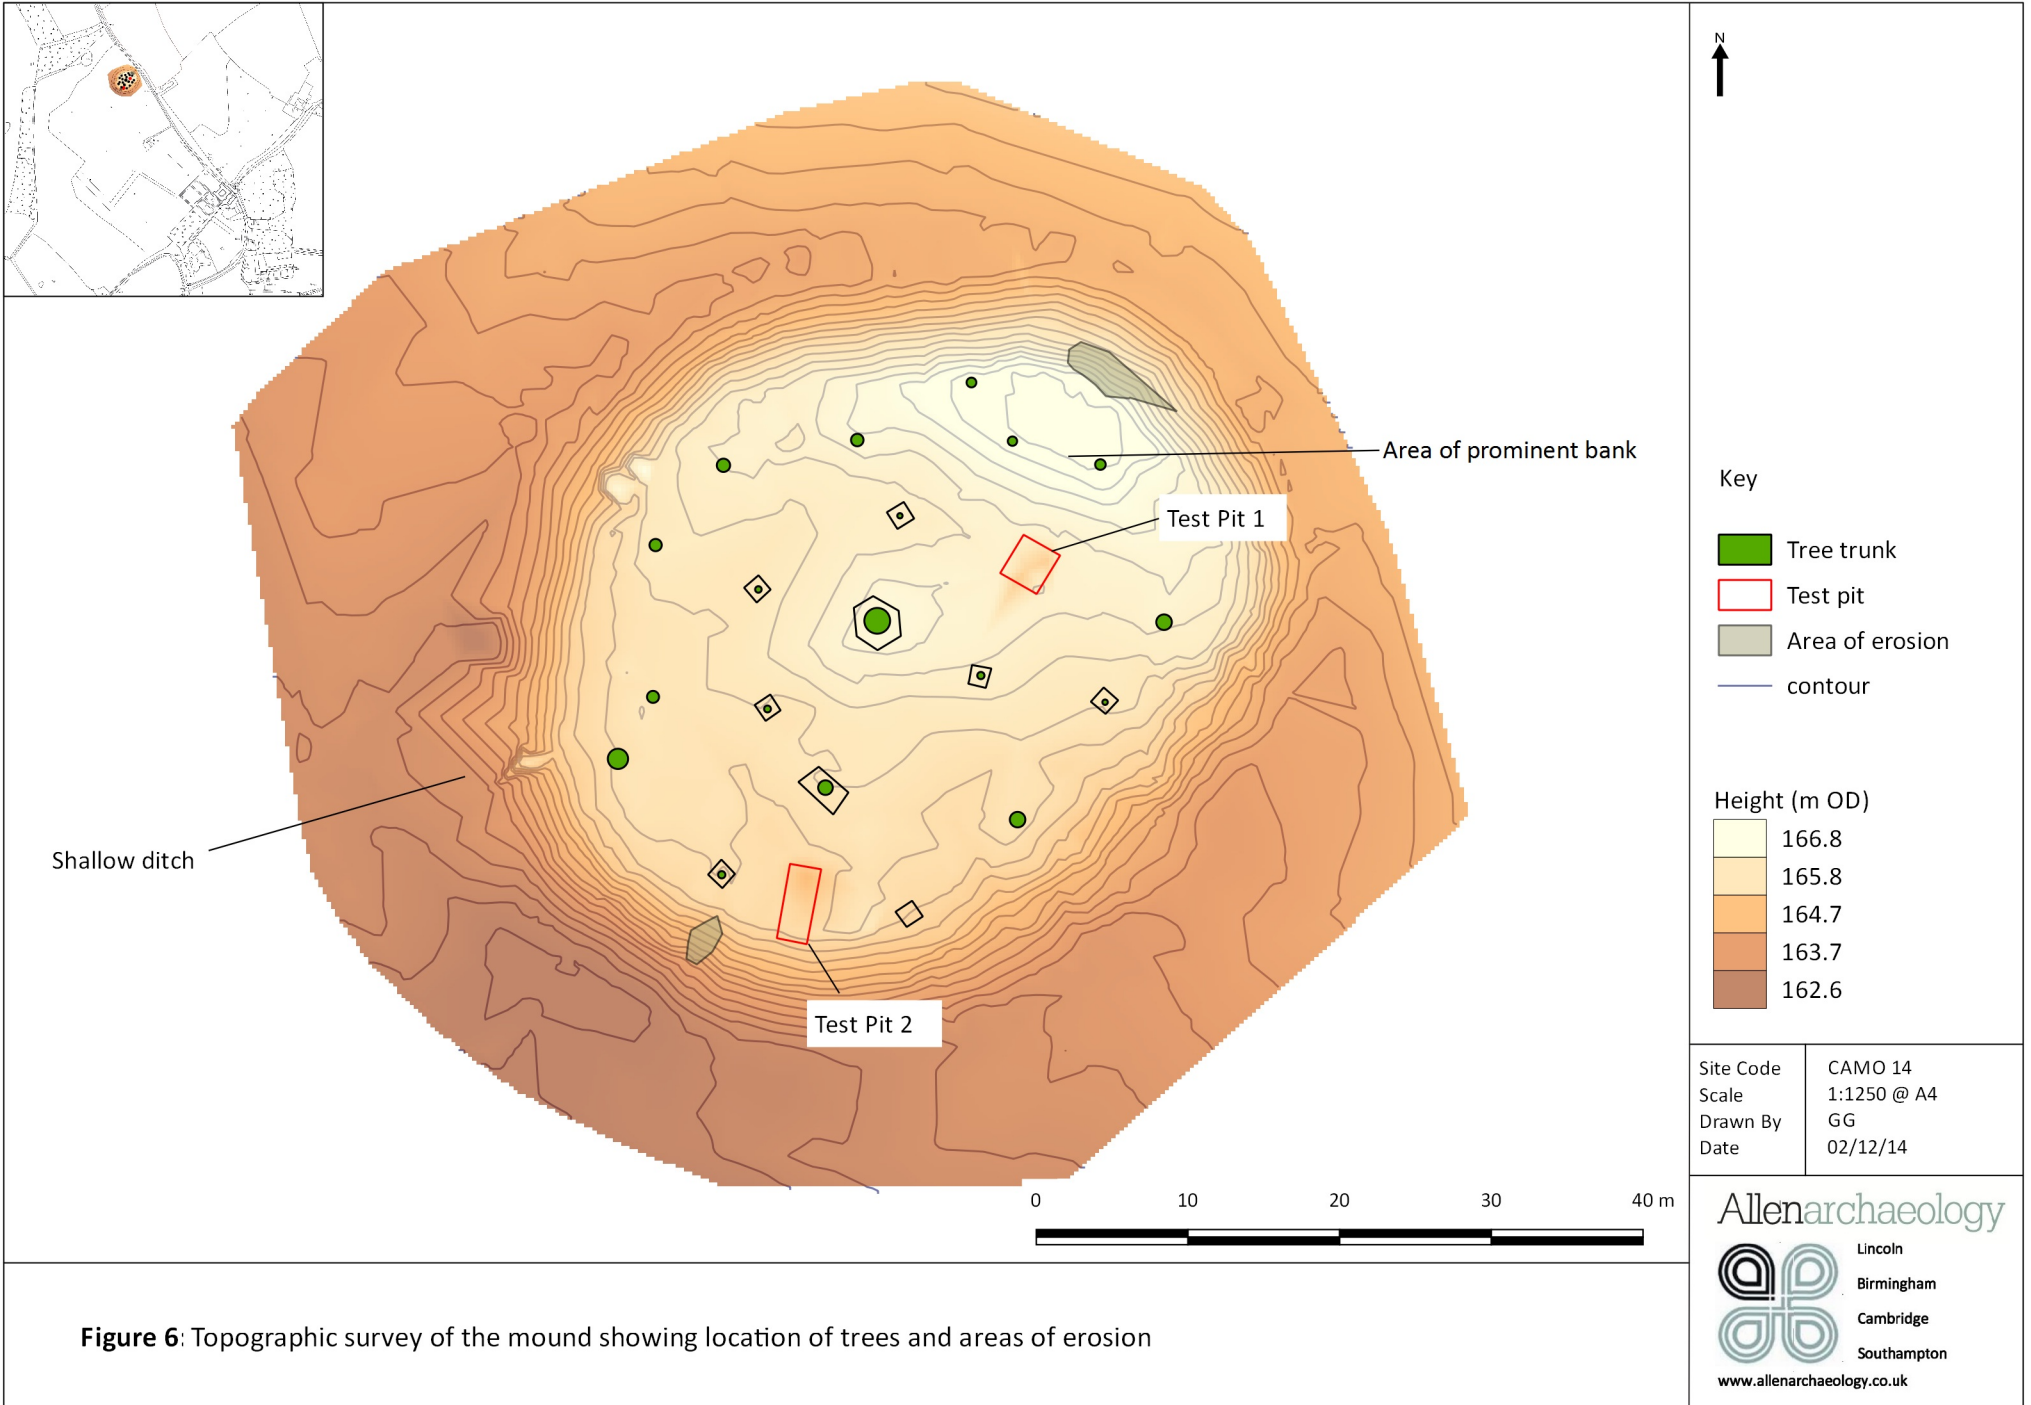
Figure 6: Topographic survey of the mound showing location of trees and areas of erosion

- 6.8 The topographic survey was limited to the mound and its immediate margins. The polygonal form of the mound visible in the earlier earthwork surveys was still apparent with 'The Mound' measuring approximately 57m x 47m and up to 3.5m high. A low bank could be detected in the survey data around most of the top of the mound. With the exception of an area towards the northeast edge of the mound where the bank was quite prominent, the majority of it was barely perceptible. A shallow ditch up to 8m wide surrounded the base of 'The Mound'.
- 6.9 The sides of 'The Mound' were generally steep but were uneven in places, possibly the result of past slippage of the mound sides and/or erosion from animal tracks. Two small areas of 'The Mound', one on its northeast slopes the other on its southwest slopes, had evidently been subject to recent erosion and bare earth was visible.

- 7.9 The two small areas of erosion on 'The Mound' have most likely been caused by the trample of farm animals. In both areas, damage is limited although the irregular form of parts of the sides of 'The Mound' could have resulted, at last in part, from historic erosion. The use of permanent fencing to prevent animals accessing the area may prevent them causing further damage but would also have the effect of creating 'desire lines', as visitors would be forced to access it at specific gate points and could lead to increased vegetation growth making the monument less readable in the landscape. There is a high probability that this would create more serious damage to the mound than the limited erosion from farm animals. It is therefore not recommended that any permanent fencing is erected around 'The Mound' but rather that temporary fencing could be established in very wet or very dry periods when the threat of

erosion is likely to be at its greatest. Dependent on the nature of such fencing, its construction may require Scheduled Monument Consent or agreement with English Heritage.

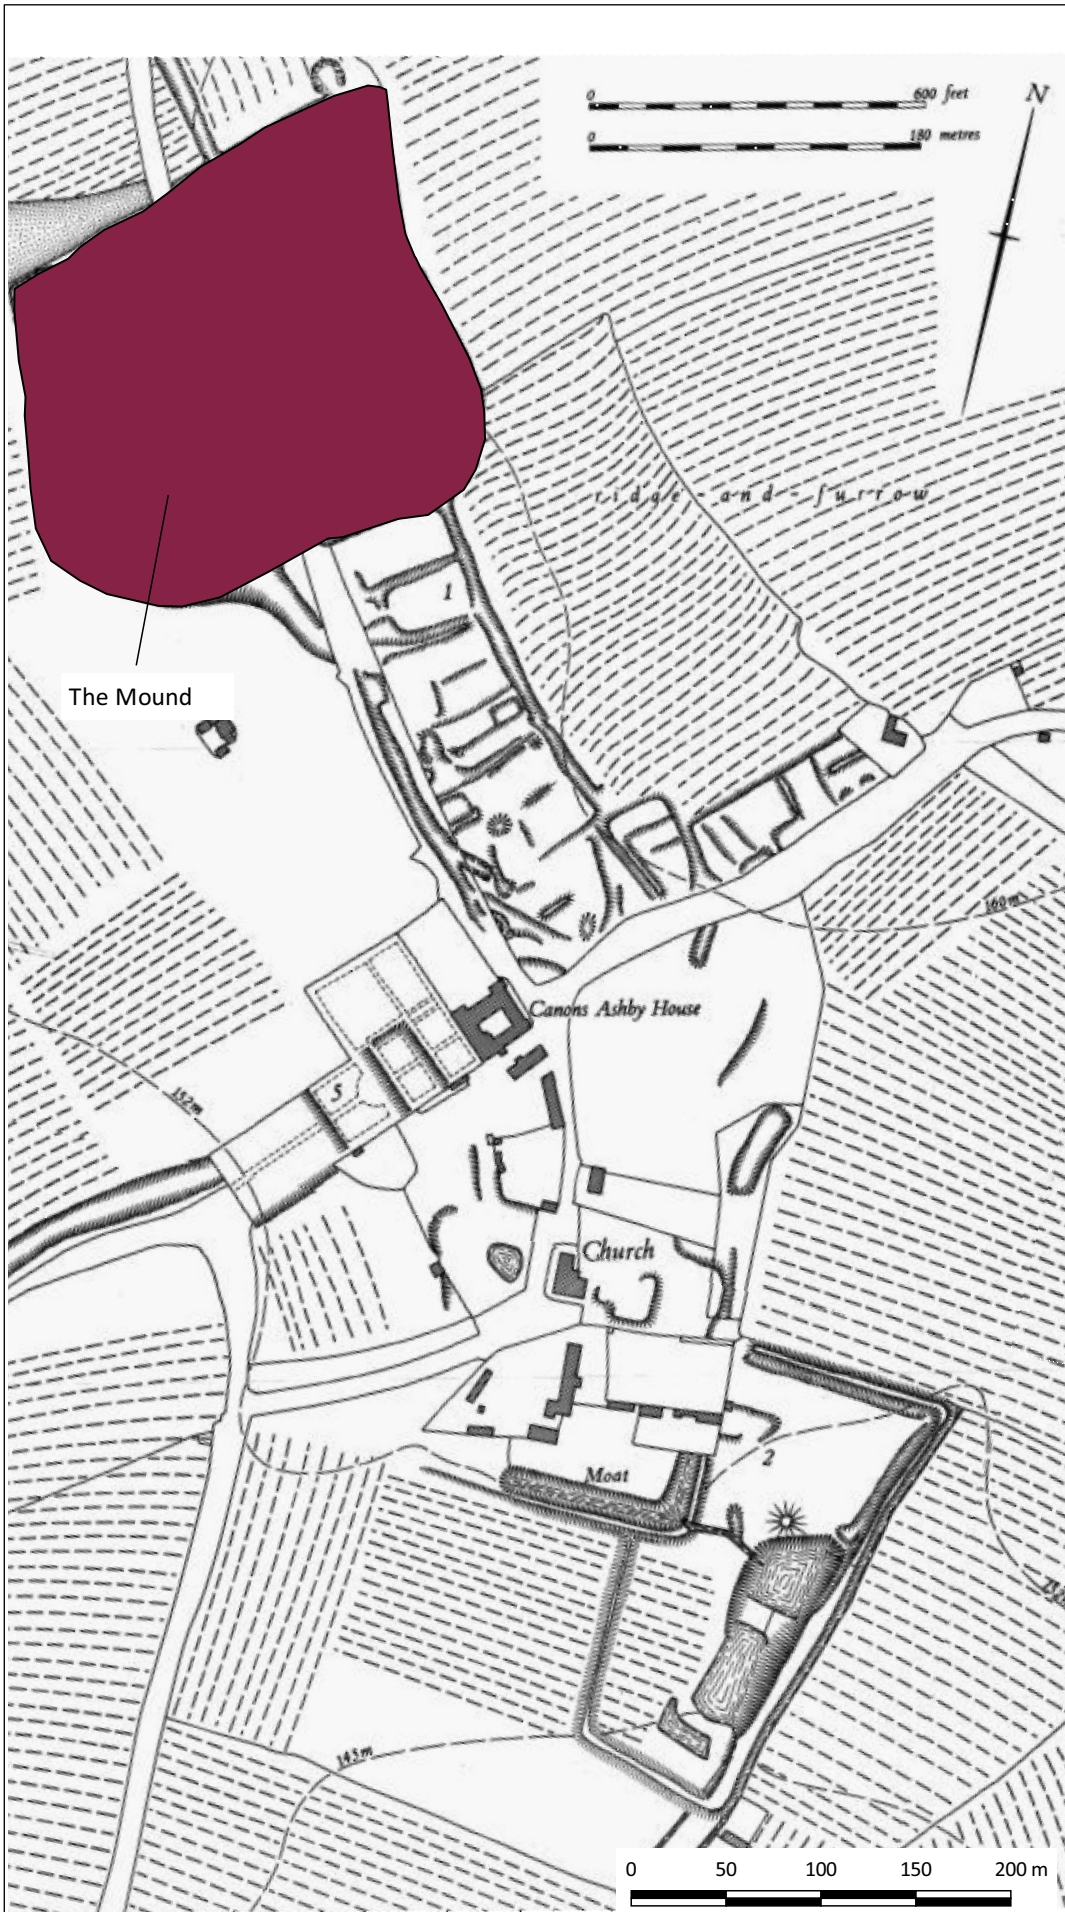
Figure 9: Plan showing the extent of the possible bailey and the RCHME earthwork survey

- 7.5 If the mound had indeed been originally constructed as a motte then the earthworks recorded during the RCHME earthwork survey may partly show the extent of a sub-square bailey with the motte in the southwest quarter (Figure 9). The possible bailey is defined by banks and ditches which may have been incorporated into field boundaries at a later date. The remains of a possible hollow way to the south of 'The Mound' appears to have been the original north road in the medieval village, the remains of properties on its eastern side being clearly visible. The hollow way appears to respect the position of 'The Mound', turning abruptly to avoid it, thereby implying that the mound is of at least medieval origin. The present road to the east of 'The Mound' represents a straightening of the medieval hollow way. Earthworks on its east side within the possible bailey appear most likely to represent a northern extension to the medieval village into the putative former bailey and further suggest that by this time the bailey area may no longer have been associated as closely with the motte.
