**ARCHAEOLOGICAL WATCHING BRIEF REPORT:  
EASTHORPE MILL, BOTTESFORD, LEICESTERSHIRE**

Planning Reference: 14/00763/FULHH  
NGR: SK 8112 3895  
AAL Site Code: BOEM 15  
Museum Accession Number: pending  
OASIS Reference Number: allenarc1-211523

By  
Allen Archaeology Limited  
Report Number AAL 2015120

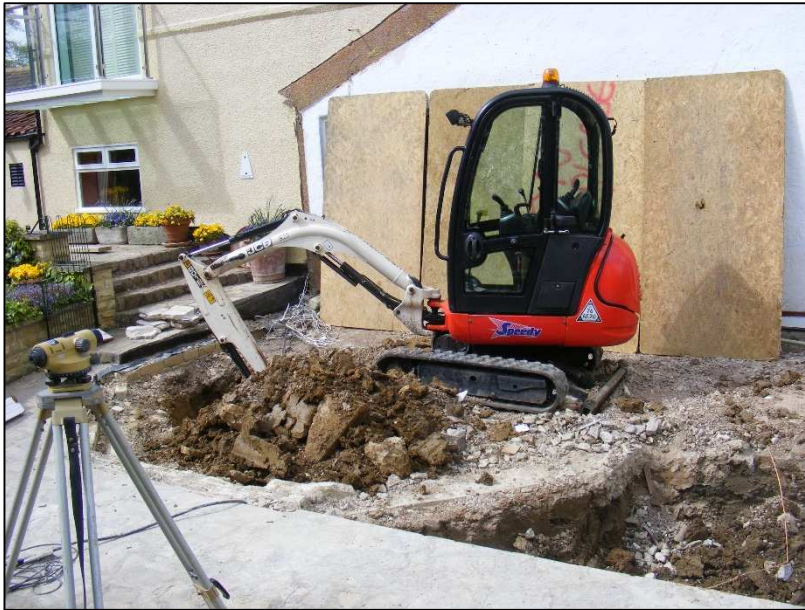
*Plate 1: Northwest view of the development area during excavation*

- 5.1 Groundworks were monitored by an experienced field archaeologist over a period of three days; Monday 27<sup>th</sup>, Tuesday 28<sup>th</sup> April and Friday 1<sup>st</sup> May 2015. Machine excavation was undertaken using a tracked mini-excavator fitted with a toothless bucket (Plate 1:). All exposed plan and section surfaces were inspected for archaeological features and deposits to determine the stratigraphic sequence.

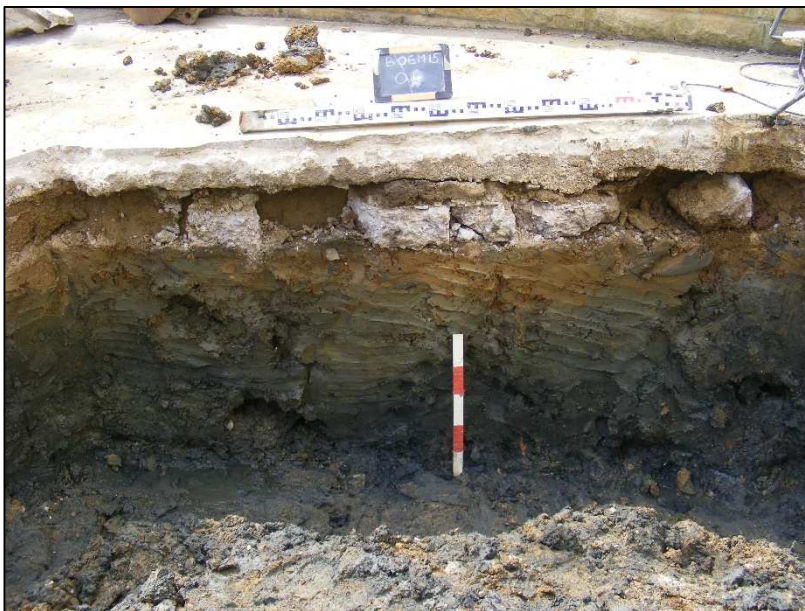
- 6.1 The earliest deposit recorded on the site, within the southwestern section of the footings was a soft, brownish grey clay with occasional organic inclusions, and small brick and stone flecks 109. Measuring at least 0.8m thick this deposit is likely to be an alluvial deposit, mixed with demolition material.

*Plate 2: Alluvial deposit 109, looking west. Scales 1m and 0.5m*

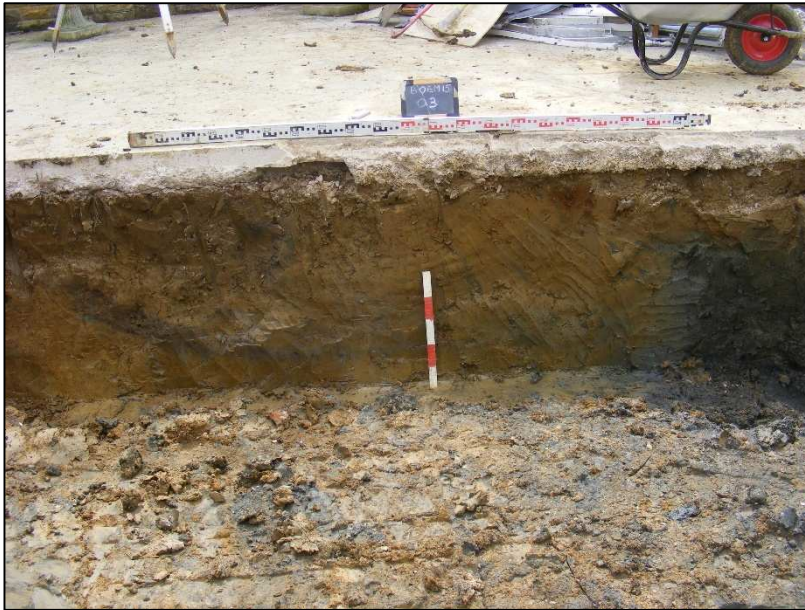
- 6.2 Truncating 109 to the east was a steep sided cut feature [108] that contained a sequence of mixed and mottled clays containing occasional charcoal and brick fragments 105, 106 and 107.

*Plate 3: Cut [108], truncating the alluvial deposit 109 on the right, looking south. Scales 2m and 0.5m*

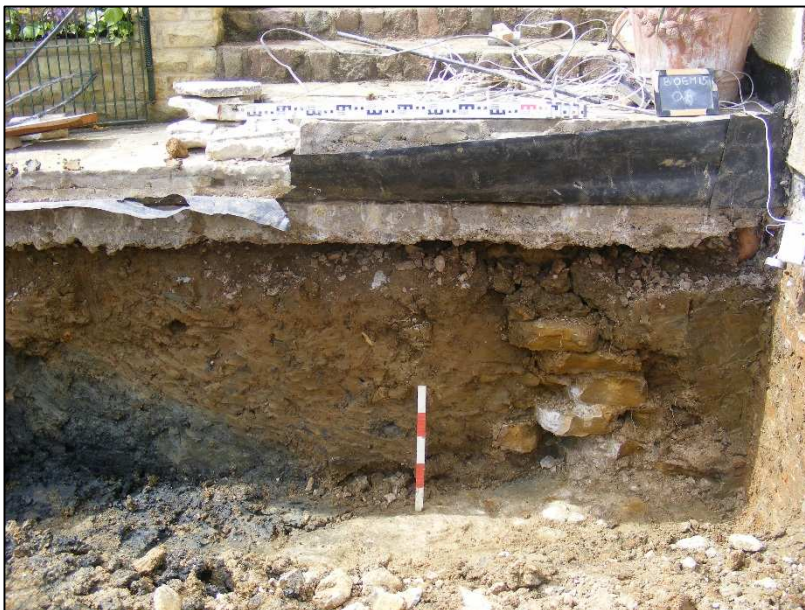
- 6.3 Deposit 109 was also truncated to the north by a wide shallow cut [112] containing a roughly hewn limestone block wall, 110, bonded with lime mortar. Orientated northwest-southeast, the exposed section of wall was recorded running for at least 2m at a height of 1.1m and width of 0.74m. The cut [112] had been backfilled with an undated firm, mid reddish brown clay, 104.

*Plate 4: West facing view of wall 110 and cut [112]. Scale 0.5m*

- 7.1 The watching brief identified a number of features of potential archaeological interest. A stone wall, apparently within a wide shallow cut was recorded, aligned north-northwest to south-southeast, truncating earlier alluvial layers. It is possible that this relates to an episode of ground reduction, levelling and revetting at the eastern edge of the mill race, which although undated, may relate to the 20<sup>th</sup> century conversion of the mill for residential use. Another steep sided cut feature was recorded, the date and function of which is unclear.
