HERITAGE IMPACT ASSESSMENT:

LAND TO THE REAR OF THE RED LION, HIGH STREET, BROUGHTON, NORTH LINCOLNSHIRE

Planning Reference: PA/2014/0999 NGR: SE 9612 0862 AAL Site Code: BRHS 15 North Lincolnshire Museum Site Code: BHCD OASIS Reference Number: allenarc 1-233190

By Allen Archaeology Limited Report Number AAL2015169

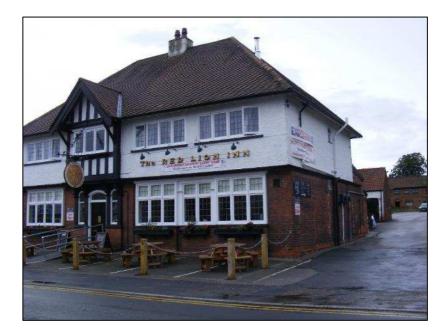
Plate 1: View of the Red Lion pub, looking south

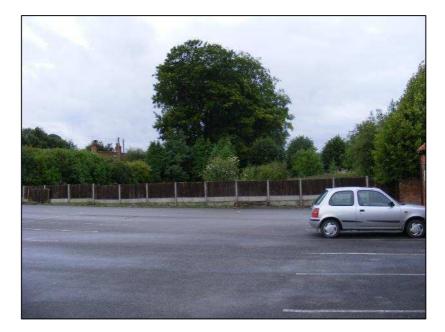
Plate 2: View of the car park and grass behind, looking west

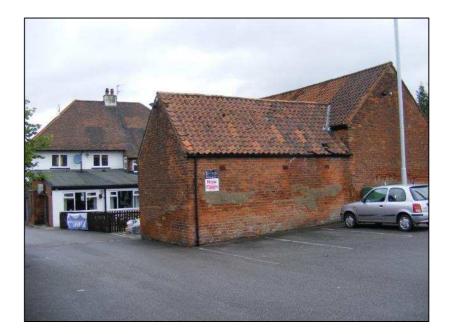
Plate 3: View of the stables and pub, looking northeast

8.2 To the rear of the pub is a brick stable block/outbuilding (Plate 3), which is to be demolished and is the focus of the historic building recording (see section 10.0 below). In the western part of the site is the former bowling green, now an area of rough grass (Plate 4). The whole site slopes down to the north with a step down from the car park into the grassed area.

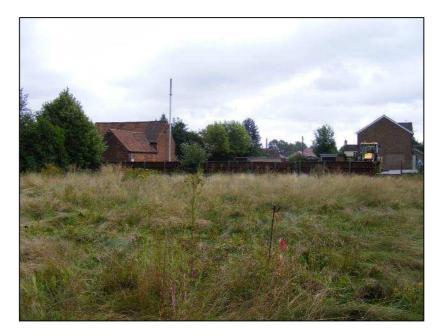
Plate 4: Area of former bowling green, looking east

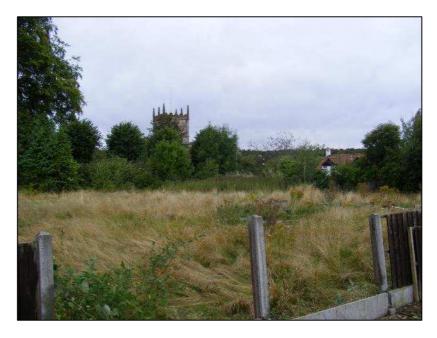
Plate 5: View of the church from the site, looking west

- 9.1 There are no Scheduled Monuments, Registered Battlefields, or Designated Parks or Gardens, on the site or within the study area.
- 9.2 There are seven Listed Buildings within the study area, comprising the Grade I Listed church of St. Mary, the Grade II Listed war memorial and five Grade II Listed dwellings. There is limited intervisibility with the church, on account of extensive screening (Plates 5 and 6). Although the proposed development area may be visible from select points in the upper part of the church tower, this limited visibility will not affect the setting or significance of the church.

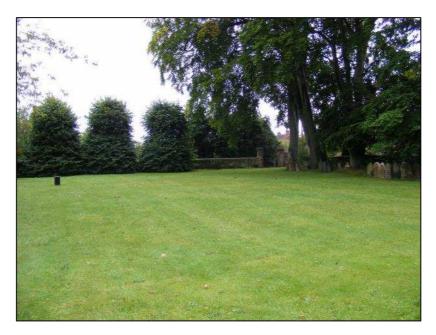
Plate 6: Looking east towards the site from the church

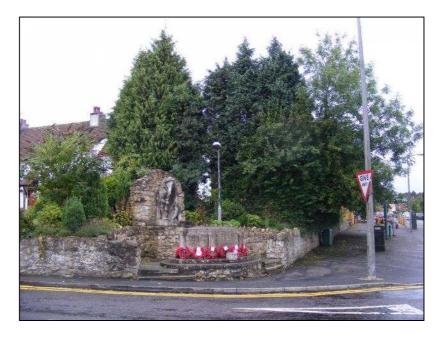
Plate 7: War memorial, looking west towards the development site

- 9.3 The Grade II Listed war memorial is situated just to the east of the development site but visibility between the memorial and the site is restricted by a number of large trees (Plate 7).

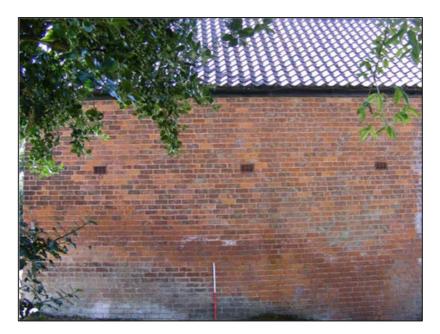
Plate 8 (shot 3): East facing elevation of north-south aligned range of stable block, southern end. 1m scale

10.2 The north – south aligned range is a single storey rectangular 4 bay block measuring *c*.10m x 5.5m. There was no windows in the east facing elevation of the range, but each bay was ventilated by an openwork double air brick set in the $15^{th}/16^{th}$ course down from the eaves (Plate 8).

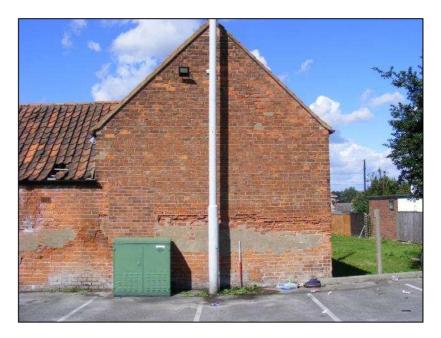
Plate 9 (shot 1): The southern gable end of the north-south range

10.3 The southern gable end of the range had a blocked window on the west side, with a segmental soldier course arch above. To the west of the window the eastern end of the east – west range was bonded into the brickwork, demonstrating that the two ranges of the L-shaped building represent a single phase of construction. To the east of the window the brickwork was heavily weathered, and partly rendered in an attempt to repair the damage (Plate 9).

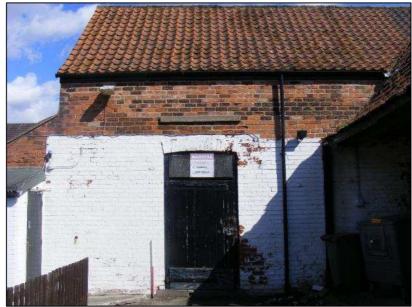
Plate 10 (shot 9): West facing elevation of north-south aligned range of stable block. 1m scale

10.4 The west facing elevation of the range had a single entrance at the northern end, with a single vertically planked wooden door with a blocked fanlight above and a segmental soldier course arch, and 4 courses above this a projecting concrete sill of the same width as the doorway, which seems to have been intended to act as a hood mould. The wall was limewashed to the level of the door lintel. To the south of the entrance there was another blocked widow, which was probably blocked during alterations to the north facing elevation of the east-west aligned range (Plate 10).

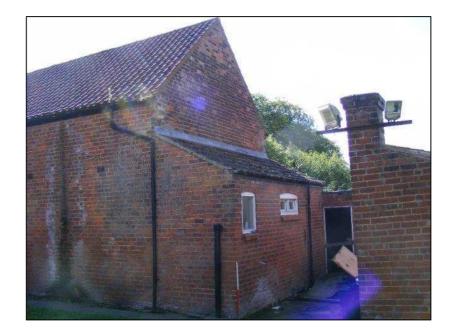
Plate 11 (shot 5): North facing elevation of northern gable end of north-south aligned range of stable block. 1m scale

10.5 Bonded into the northern gable end of the range there was a structure with a mono pitched pantile roof intersecting the gable end wall 8 courses below the level of the eaves. Lead flashing protected the joint between the roof and the gable end wall. The northern elevation of the lean-to structure had two small windows, both with segmental arches above and with sills of a rowlock course of bullnose bricks (Plate 11).

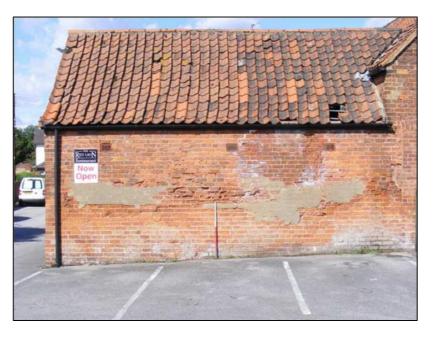
Plate 12 (shot 1): South facing elevation of east-west aligned range of stable block. 1m scale

10.6 The east- west aligned range of the stable block was a single storey rectangular 3 bay block measuring $c.7m \ge 4.6m$. The roofline of this block was lower than that of the north-south aligned range. The south facing elevation of the range had no windows, but each bay was ventilated by a double air brick set into the 6th/7th course down from the eaves. There were extensive areas of erosion of the face of the brickwork, which in places had been rendered to repair the damage. An area between the air bricks of the eastern bays, of darker red stock bricks, may indicate an alteration or repair to the south wall (Plate 12).

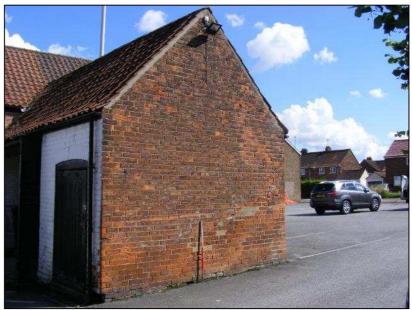
Plate 13 (shot 6): West facing elevation of western gable end of east-west aligned range of stable block. 1m scale

10.7 The brickwork of the western gable end of the range was considerably less weathered than that of the south facing elevation. At the northern side of the gable end wall there were 22 courses of bullnose bricks on the corner, with a bullnose stop above, common bricks above that (Plate 13).

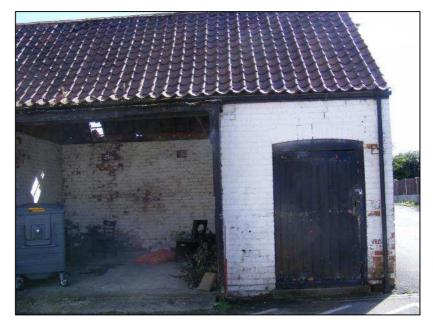
Plate 14 (shot 7): North facing elevation of east-west aligned range of stable block. 1m scale

10.8 The north facing elevation of the range had an entrance to the westernmost bay comprising a rectangular opening with a concrete threshold and a segmental soldier course brick arch above. Into this was set a timber door frame and vertical planked wooden door. The two eastern bays were open fronted, with a timber frame for double leaf coach house doors, which have been removed, although the pivots of the barrel hinges remained attached to the frame (Plate 14).

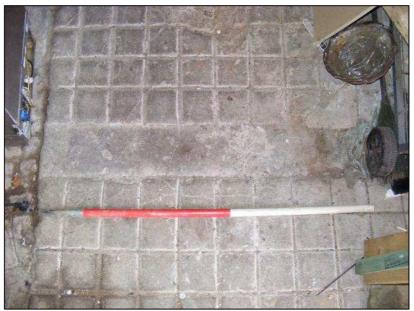
- 10.9 The interior of the main block of the north-south aligned range was divided into a passage on the west and four stalls, each 2.44m (8') wide, on the east. The floor of the passage comprised grooved concrete paving, with a drainage channel c.1m south of the entrance, draining through the base of the wall. This channel was linked to a north-south aligned drainage channel running the length of the block between the passage and the stalls (Plate 15). The flooring within the stalls comprised stone setts. The stall divisions consisted of 150mm² timber heel posts at the south end, with a single row of 40mm thick planks nailed to battens between the posts and the eastern wall of the stable. Both the battens and the top of the planks were raked at a shallow angle between the post and the wall. The stall divisions were 2.9m (9'6") in length, which is over the 9' minimum suggested by a number of guides to stable construction contemporary with the building (e.g. Giraud, 1891; Sutcliffe, 1900). A wooden hayrack, comprising a continuous open trough with vertical struts between horizontal beams, ran along the eastern wall of the northern two stalls (Plate 16). In the north-western corner of the range, at the north end of the passage, a steeply angled wooden ladder gave access to the hayloft. The interior brickwork was limewashed throughout (Plate 17).

Plate 15 (shot 15): Interior of north-south aligned range, detail of flooring and drainage channel. 1m scale.

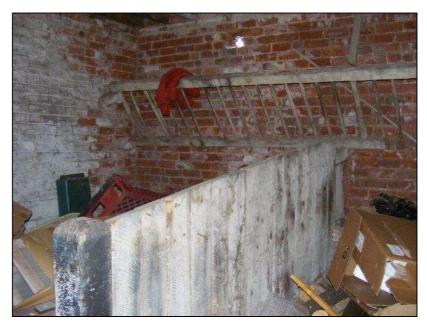
Plate 16 (shot 14): Interior of north-south aligned range, detail of stall division and manger

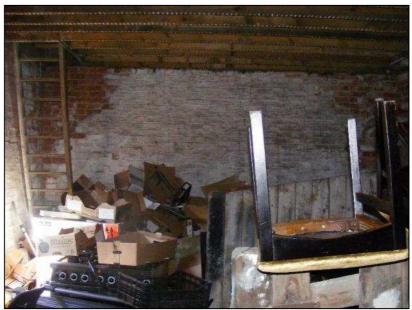
Plate 17 (shot 13): Interior of north-south aligned range, looking north. Timber stall division visible on left hand side. Access ladder to hayloft on right hand side.

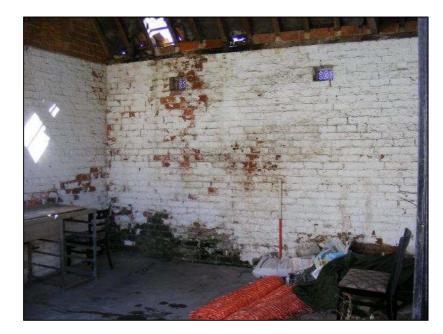
Plate 18 (shot 10): Interior of Room B, east-west aligned range of stable block. 1m scale

10.11 The two eastern bays of the range, which had possibly served as a coach house, had limewashed interior brickwork and a poured concrete floor, probably representing a later alteration to the building. The eastern bay is currently used for storage, and retained no original internal features to indicate its original function. Given the probable functions of other parts of the building, it is likely to have been a tack room (Plate 18).

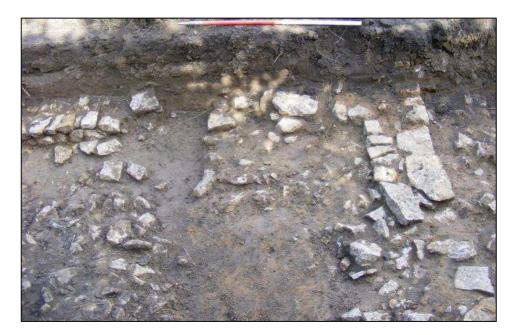
Plate 19: Walls 114 and 115, looking north. Scale is 1m

- 11.3 The walls of two structures were recorded within Trench 1. At the eastern end of the trench a north-south aligned wall 115 extended across the width of the trench, comprising a single course of quarry faced limestone rubble bonded with soft light yellowish brown sandy mortar. The wall returned at its northern end to form a 9.90m long east-west aligned wall 114 of the same construction, surviving to a maximum height of two courses (0.30m). Two gaps in the wall measuring *c*. 1.5m in width may have been caused by agricultural activity in the post-medieval period. The walls were interpreted as the eastern and northern walls of a property fronting onto Church Lane, which pottery evidence suggests may have been constructed in the medieval or late medieval period, and which was probably demolished around the middle of the 16th century. A slot excavated against the southern face of part of the wall showed that it was laid within a construction cut [111] 0.19m deep and 0.46m in width from the face of the wall. No dateable artefacts were recovered from fill 112 of the construction cut.

- 11.4 Where the slot was excavated, the construction cut [111] for the wall appeared to truncate the northern edge of an earlier cut feature [109], with a depth of 0.29m. The shape and function of the feature were unclear, and no finds were recovered from the dark grey sand fill 110.

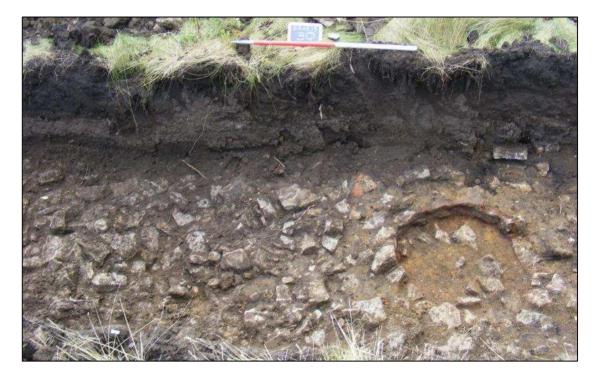
Plate 20: Oven <105> and wall <116>, looking south. Scale is 1m

11.5 At the western end of the trench, part of an ENE-WSW aligned wall 116 was recorded, partially obscured by overlying rubble deposit 104. The wall was 0.8m in width and a length of 3.5m was recorded within the trench. At the east end the wall extended beyond the northern limit of the trench. To the west the wall may have been truncated by the construction of wall 114. Abutting the SSE face of the wall there was a circular structure built from coursed limestone slabs bonded with lime mortar. The structure had an internal diameter of *c*.0.65m and survived to a maximum height of 0.35m, comprising five courses of masonry. The structure was interpreted as a probable oven built against the external wall of a building. The oven had three fills. The lowest fill 108 comprised a 0.10m thick deposit of scorched sand with charcoal inclusions, containing a single sherd of Beverley Type 2 ware of $13^{th} - 14^{th}$ century date. Sealing this, was an undated 0.04m thick layer of spent charcoal or wood ash 107. The upper fill 106 of the structure contained frequent fragments of limestone, and probably derived from the collapse or deliberate demolition of the

domed roof of the oven. Two sherds of $13^{th} - 14^{th}$ century pottery were recovered from the upper fill, suggesting that the use and demolition of the structure took place within this date range.

11.6 Soil samples were taken from all three layers in the oven. The assemblages were generally small and dominated by charcoal and charred heather stems (a common source of fuel), with very occasional cereal grains and pea and bean seeds, and a fragment of walnut shell. The evidence suggests the oven was probably a small multi-functional feature.

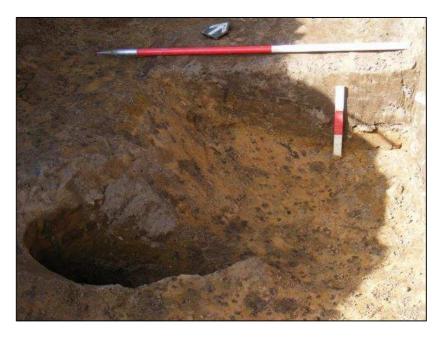
- 11.8 Layer 202 sealed two features. At the northern end of the trench one side of a large cut feature [208] was exposed. The profile of the feature was steep, breaking to a flat base that sloped gradually down from south to north. It contained a single undated fill of brownish grey silty sand. A soil sample from the feature contained moderate quantities of crop processing waste including oats, bread wheat and barley. Such waste was often used in domestic hearths as kindling or tinder, so this material may be the direct result of crop processing nearby, or domestic hearth waste.

- 11.9 To the south of this feature, was a 0.70m deep sub-circular post hole with a diameter of 0.45m, [206]. The axis of the post hole was slightly inclined, with an undercut edge to the southwest. The sand fill 205 of the posthole produced a single sherd of early fine-shelled ware, dated to between the early 9th and early 10th century. The post hole appeared to cut a 0.35m deep pit [204] to the east, although the stratigraphic relationship was not clear. The pit had a width of 2m, and extended beyond the limit of the trench to the east. The pit had two fills, the upper of which contained two sherds of Middle Saxon pottery: a body sherd of early fine-shelled ware and part of the base of a large jug or bowl in northern Maxey-type ware, Fabric B, dated to the 8th to mid-9th century. The form of the shallow pit feature with adjacent posthole, suggests this is likely to represent part of a *grubenhauser* or sunken-featured building. A soil sample from the pit was limited in composition, with small quantities of charcoal and occasional cereal grains.

Plate 23: Pit [204] and posthole [206], from which Saxon pottery was recovered. Scales are 1m and 0.3m

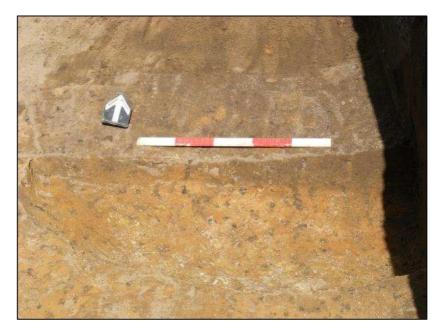
- 11.12 To the south of the pipe trench, and truncated by it, an irregular sub-oval pit [309] with a maximum width of 1m and a depth of 0.28m was recorded in plan and section. No finds were recovered from the fill 308 of the pit. To the north of the pipe trench a sub-rectangular pit [305], measuring 1m x >0.52m x 0.15m in depth and extending beyond the eastern limit of the trench was recorded, and was again undated. To the west of the pit a substantial feature [312] measuring 4.10m in length and over 0.85m wide, with a depth of 0.14m extended beyond the western limit of the trench. No datable material was recovered from the single fill 311.

Plate 24: North facing section of large, shallow feature [312]. Scale is 0.5m
